## Weekly Environmental Compliance Summary

**Sudbury to Hudson Transmission Reliability Project (USEPA Tracking # MAR1003UW)**

Week of: December 9, 2024 to December 13, 2024

# CONSTRUCTION MONITORING REPORT

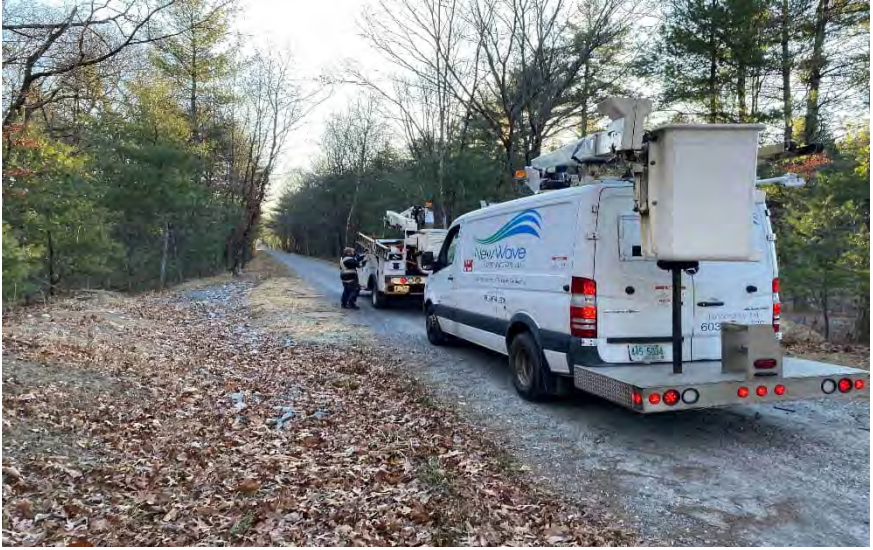
<p>PHOTOGRAPHIC LOG</p>	
<p>Client Name: Eversource</p>		<p>Site Location: Sudbury to Hudson Transmission Reliability Project</p>	<p>Town: Hudson</p>
<p>Photo No.: 2</p>	<p>Date: 12-13-24</p>

<p>Description:</p> <p>New Wave conducting work within segment 5 at handhole #12, looking eastward.</p>

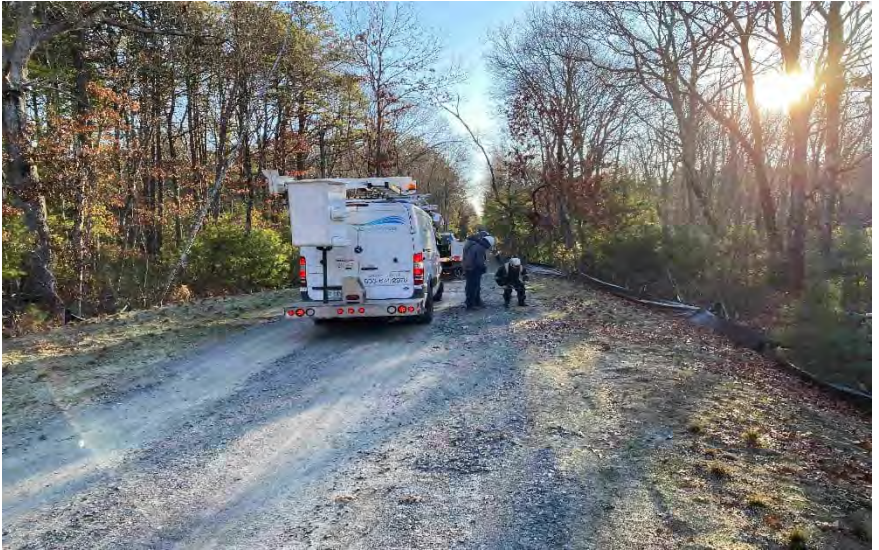
<p>PHOTOGRAPHIC LOG</p>	
<p>Client Name: Eversource</p>		<p>Site Location: Sudbury to Hudson Transmission Reliability Project</p>	<p>Town: Hudson</p>
<p>Photo No.: 3</p>	<p>Date: 12-13-24</p>

<p>Description:</p> <p>New Wave conducting work within segment 6 at handhole #14, looking eastward.</p>

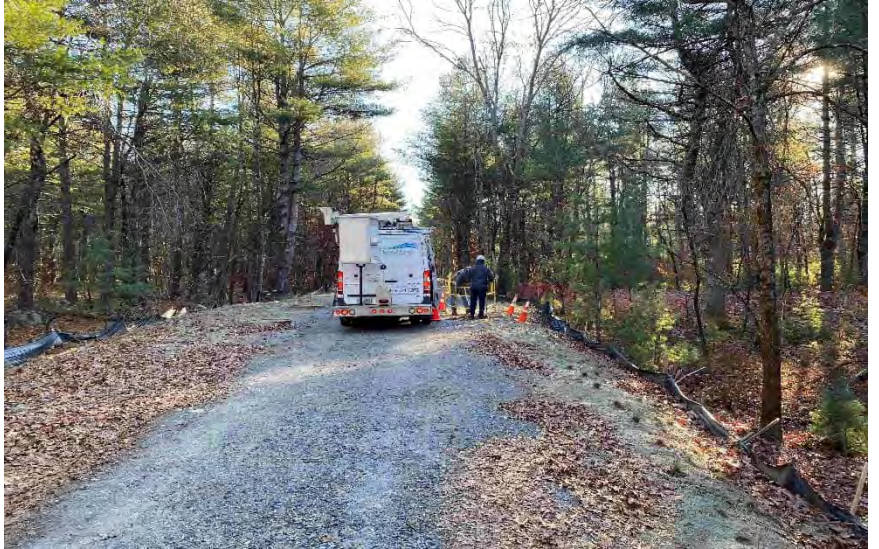
<p>PHOTOGRAPHIC LOG</p>	
<p>Client Name: Eversource</p>		<p>Site Location: Sudbury to Hudson Transmission Reliability Project</p>	<p>Town: Sudbury</p>
<p>Photo No.: 4</p>	<p>Date: 12-13-24</p>

<p>Description:</p> <p>New Wave conducting work within segment 7 at handhole #15, looking eastward.</p>

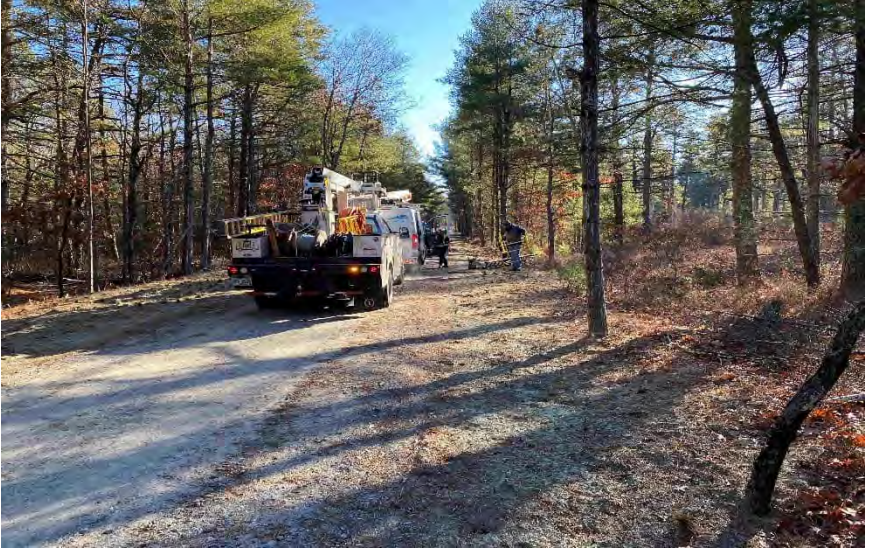
<p>PHOTOGRAPHIC LOG</p>	
<p>Client Name: Eversource</p>		<p>Site Location: Sudbury to Hudson Transmission Reliability Project</p>	<p>Town: Sudbury</p>
<p>Photo No.: 5</p>	<p>Date: 12-13-24</p>

<p>Description:</p> <p>New Wave conducting work within segment 7 at handhole #16, looking eastward.</p>

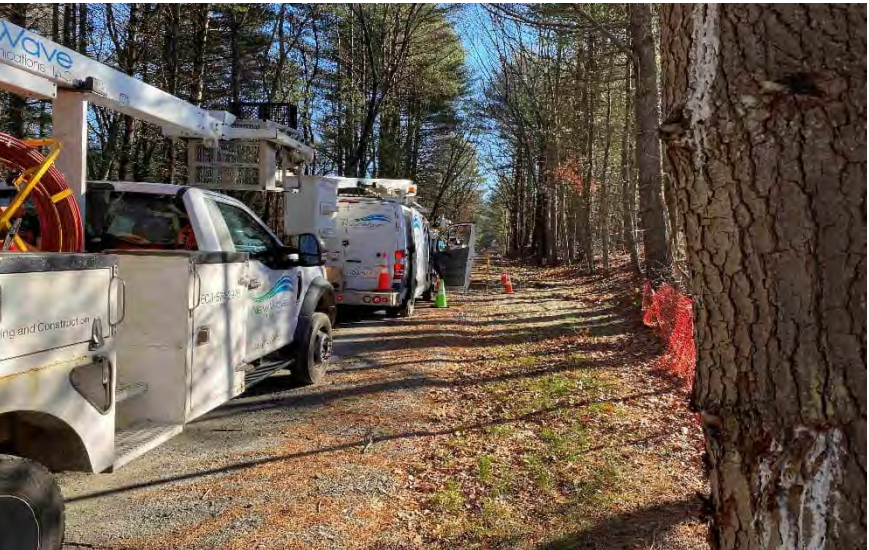
<p>PHOTOGRAPHIC LOG</p>	
<p>Client Name: Eversource</p>		<p>Site Location: Sudbury to Hudson Transmission Reliability Project</p>	<p>Town: Sudbury</p>
<p>Photo No.: 6</p>	<p>Date: 12-13-24</p>

<p>Description:</p> <p>New Wave conducting work within segment 8 at handhole #17, looking eastward.</p>

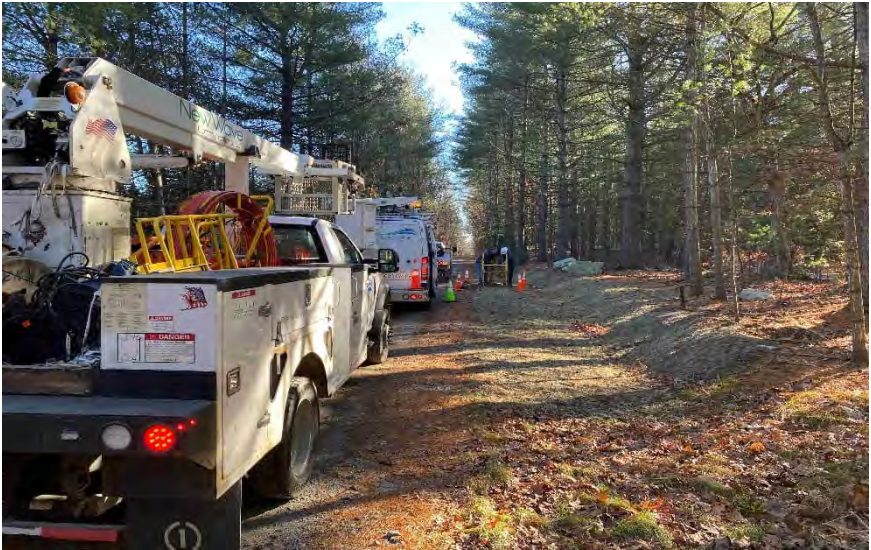
<p>PHOTOGRAPHIC LOG</p>	
<p>Client Name: Eversource</p>		<p>Site Location: Sudbury to Hudson Transmission Reliability Project</p>	<p>Town: Sudbury</p>
<p>Photo No.: 7</p>	<p>Date: 12-13-24</p>

<p>Description:</p> <p>New Wave conducting work within segment 9 at handhole #18, looking eastward.</p>

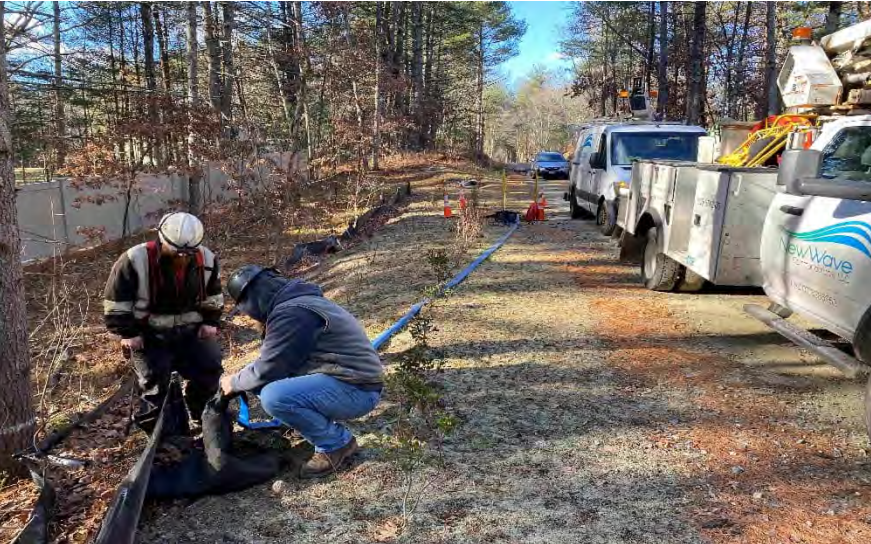
<p>PHOTOGRAPHIC LOG</p>	
<p>Client Name: Eversource</p>		<p>Site Location: Sudbury to Hudson Transmission Reliability Project</p>	<p>Town: Sudbury</p>
<p>Photo No.: 8</p>	<p>Date: 12-13-24</p>

<p>Description:</p> <p>New Wave conducting work within segment 10 at handhole #20, looking westward.</p>

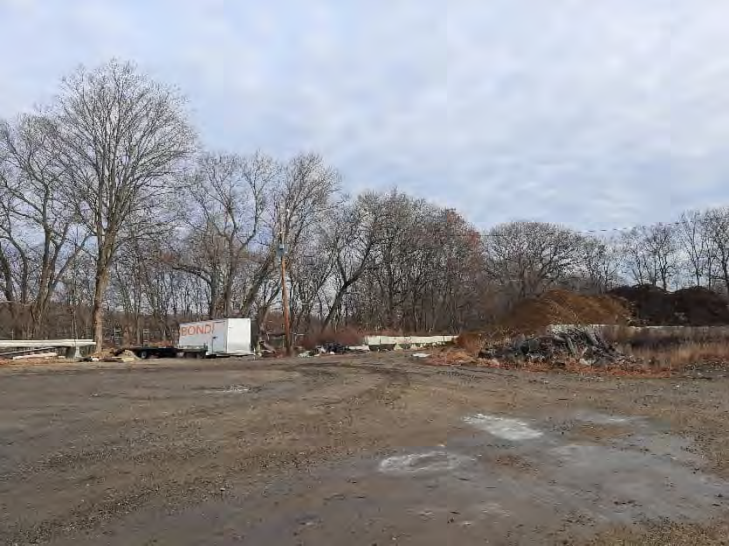
<b>PHOTOGRAPHIC LOG</b>	
Client Name: Eversource		Site Location: Sudbury to Hudson Transmission Reliability Project	Town: Hudson
Photo No.: 2	Date: 12-9-24

Description:  Stowe Court laydown yard, ET&L excavator removed from yard, Bond using yard for a different project, looking southward.

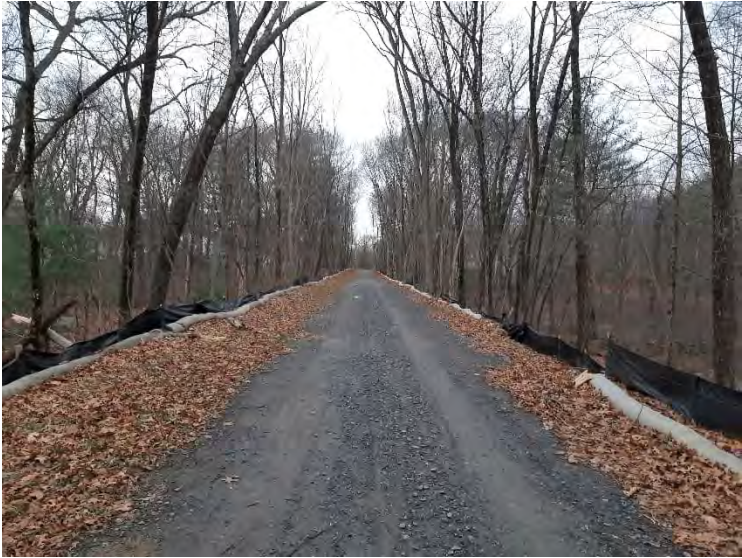
<b>PHOTOGRAPHIC LOG</b>	
Client Name: Eversource		Site Location: Sudbury to Hudson Transmission Reliability Project	Town: Hudson
Photo No.: 3	Date: 12-9-24

Description:  Segment 1, existing and recently repaired erosion controls, no project activity here today, looking westward.

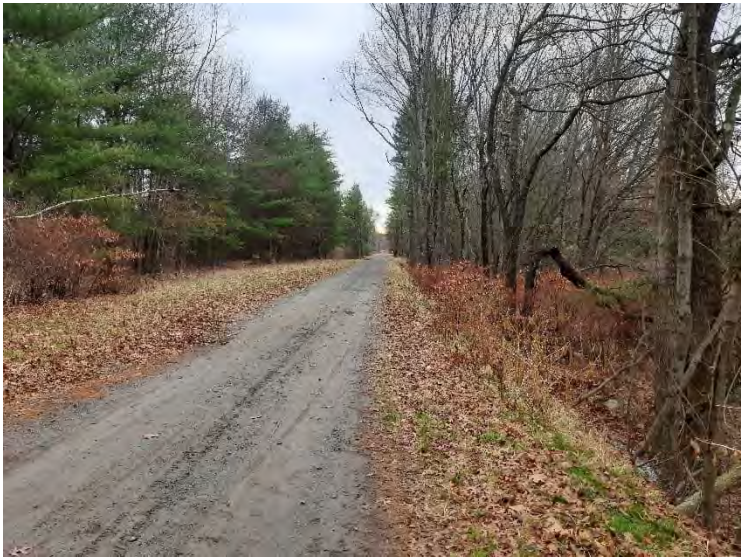
<b>PHOTOGRAPHIC LOG</b>	
Client Name: Eversource		Site Location: Sudbury to Hudson Transmission Reliability Project	Town: Hudson
Photo No.: 4	Date: 12-9-24

Description:  Segment 2, area of marked erosion control removal on south side, no project activity here today, looking eastward.

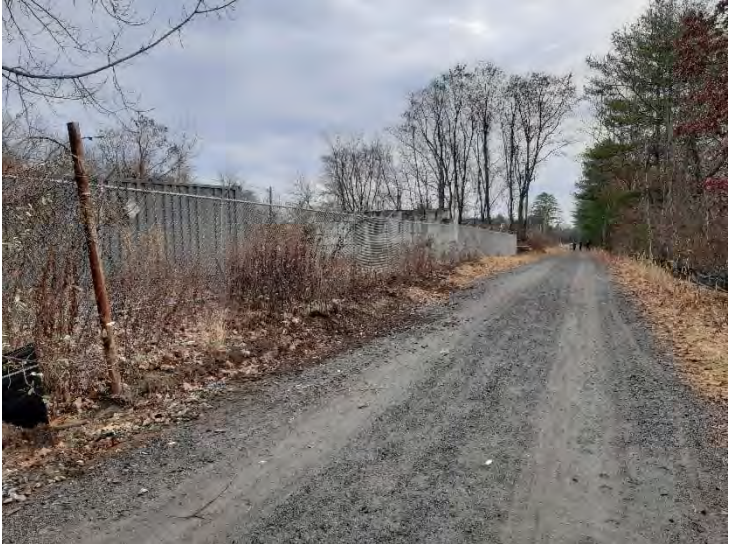
<b>PHOTOGRAPHIC LOG</b>	
Client Name: Eversource		Site Location: Sudbury to Hudson Transmission Reliability Project	Town: Hudson
Photo No.: 5	Date: 12-9-24

Description:  Segment 3, area of marked erosion control removal on north side, no project activity here today, looking eastward.

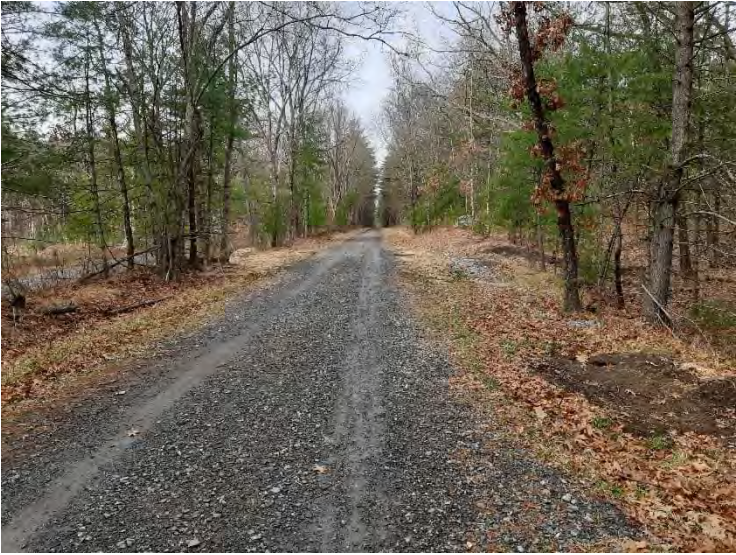
<b>PHOTOGRAPHIC LOG</b>	
Client Name: Eversource		Site Location: Sudbury to Hudson Transmission Reliability Project	Town: Hudson
Photo No.: 7	Date: 12-9-24

Description:  Segment 5, .area of previous marked erosion control removal and recent stump removal, no project activity here today, looking westward.

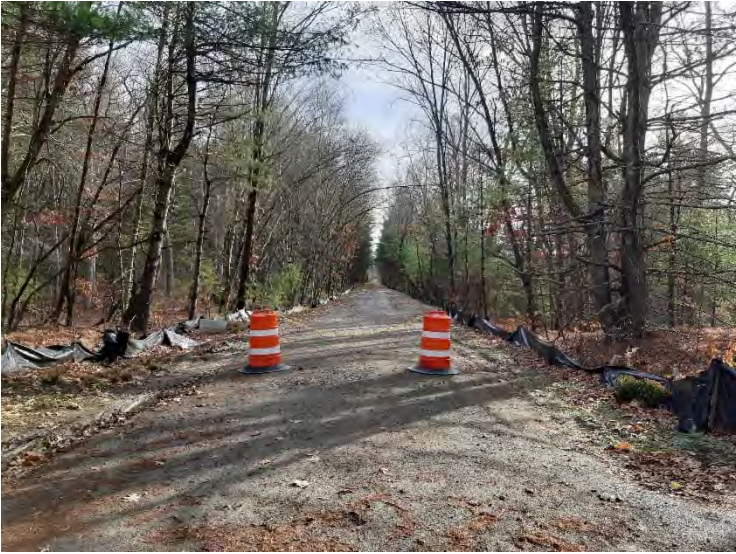
<b>PHOTOGRAPHIC LOG</b>	
Client Name: Eversource		Site Location: Sudbury to Hudson Transmission Reliability Project	Town: Hudson
Photo No.: 8	Date: 12-9-24

Description:  Segment 6, existing erosion controls, no project activity here today, looking eastward.

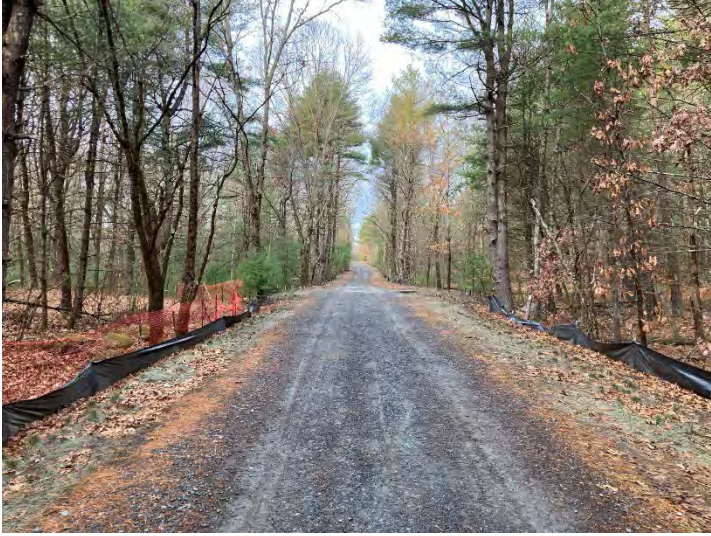
<b>PHOTOGRAPHIC LOG</b>	
Client Name: Eversource		Site Location: Sudbury to Hudson Transmission Reliability Project	Town: Sudbury
Photo No.: 1	Date: 12-09-24

Description: View of E&S controls in segment 7. Facing west.

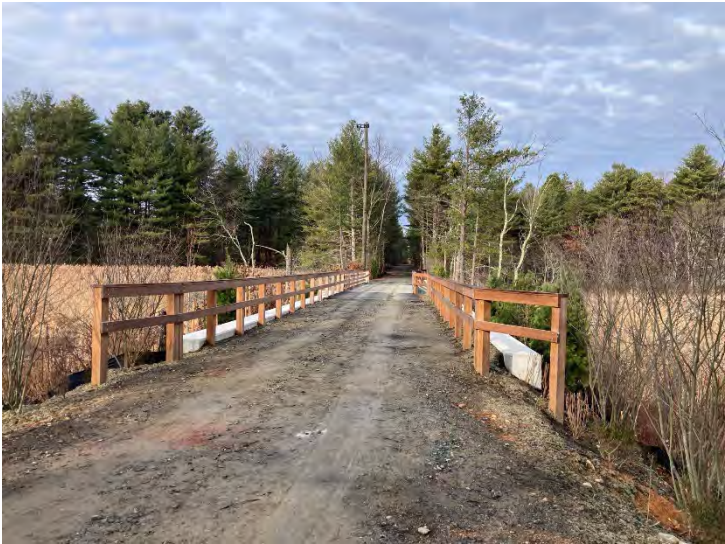
<b>PHOTOGRAPHIC LOG</b>	
Client Name: Eversource		Site Location: Sudbury to Hudson Transmission Reliability Project	Town: Sudbury
Photo No.: 2	Date: 12-09-24

Description: View of bridge 128 from segment 8. Facing west.

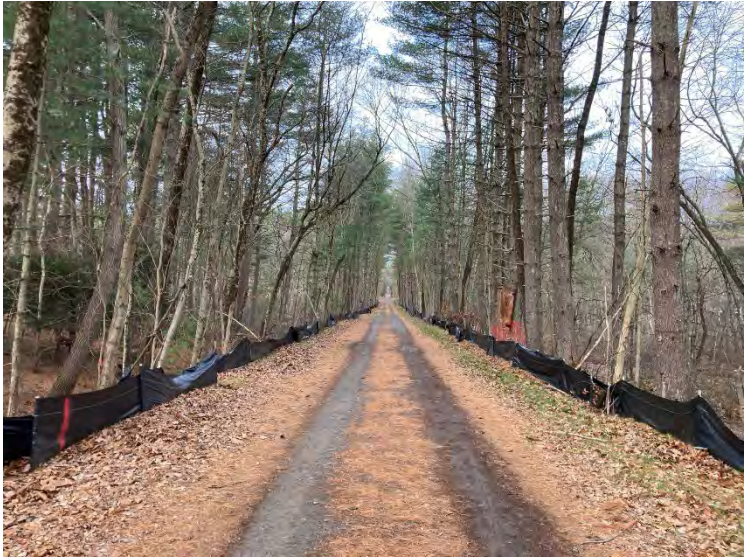
<b>PHOTOGRAPHIC LOG</b>	
Client Name: Eversource		Site Location: Sudbury to Hudson Transmission Reliability Project	Town: Sudbury
Photo No.: 3	Date: 12-09-24

Description: View of E&S controls in segment 10. Facing west.

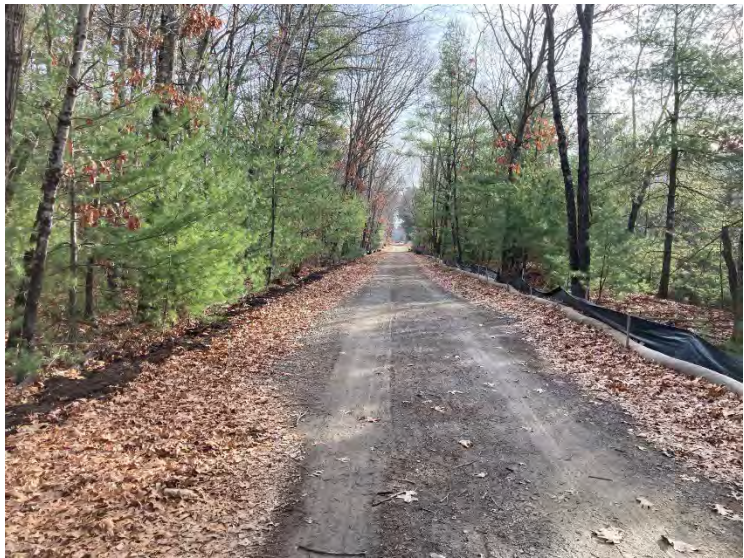
<b>PHOTOGRAPHIC LOG</b>	
Client Name: Eversource		Site Location: Sudbury to Hudson Transmission Reliability Project	Town: Sudbury
Photo No.: 4	Date: 12-09-24

Description: View of E&S controls in segment 11. Portion of controls in this area (left side of photo) have recently been removed. Compost tubes were cut, and compost material was spread. Facing east.

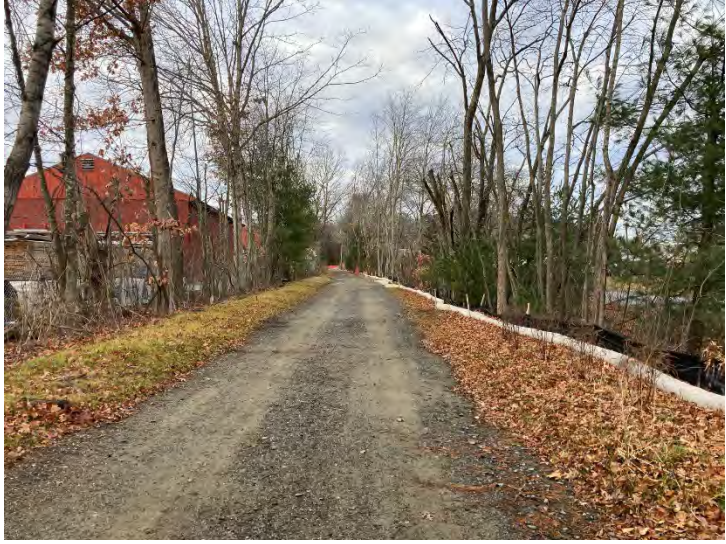
<b>PHOTOGRAPHIC LOG</b>	
Client Name: Eversource		Site Location: Sudbury to Hudson Transmission Reliability Project	Town: Sudbury
Photo No.: 5	Date: 12-09-24

Description: View of E&S controls in segment 12. Facing west.

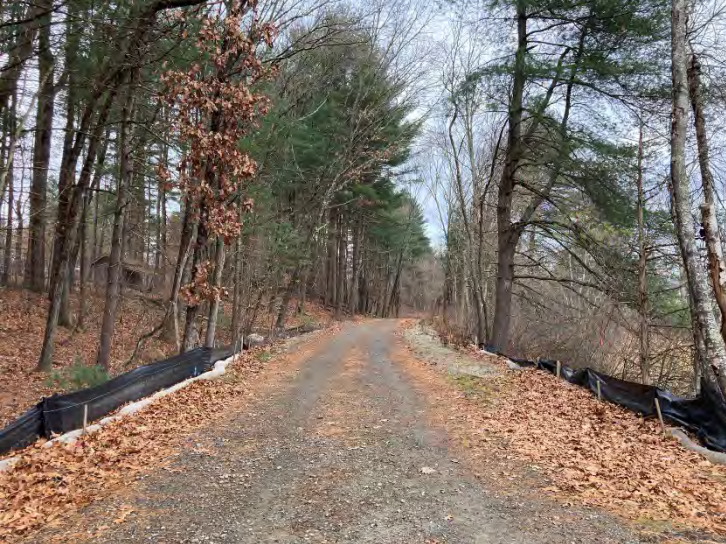
<b>PHOTOGRAPHIC LOG</b>	
Client Name: Eversource		Site Location: Sudbury to Hudson Transmission Reliability Project	Town: Sudbury
Photo No.: 6	Date: 12-09-24

Description: View of E&S controls in segment 13. Facing west.

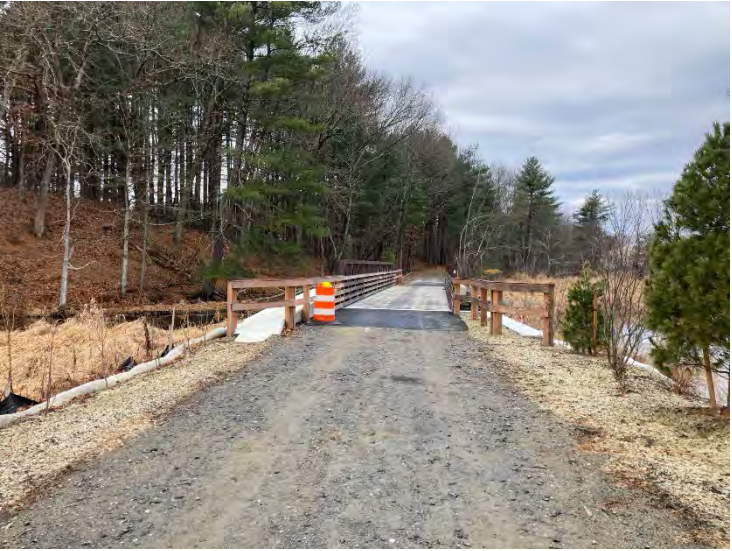
<b>Epsilon</b> ASSOCIATES INC.		<b>PHOTOGRAPHIC LOG</b>	
Client Name: Eversource		Site Location: Sudbury to Hudson Transmission Reliability Project	Town: Sudbury
Photo No.: 7	Date: 12-09-24

Description: View of bridge 127 from segment 14. Facing west.

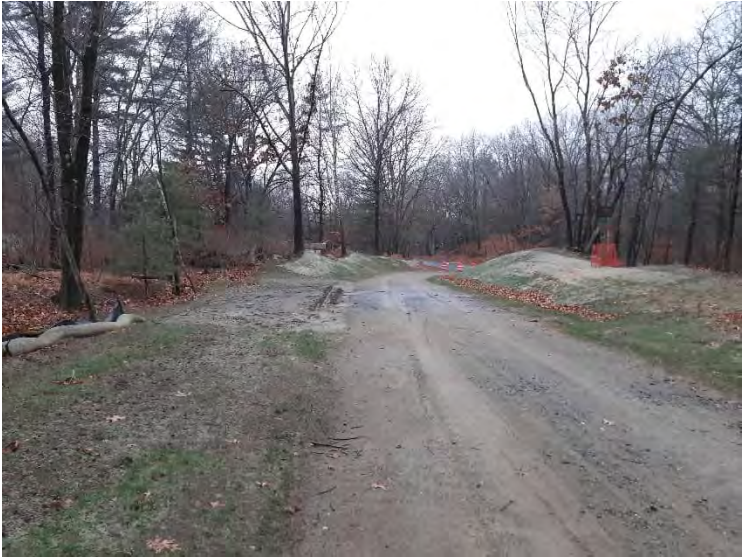
<b>PHOTOGRAPHIC LOG</b>	
Client Name: Eversource		Site Location: Sudbury to Hudson Transmission Reliability Project	Town: Hudson
Photo No.: 3	Date: 12-10-24

Description:  Segment 1, existing erosion controls, no project activity here today, looking westward.

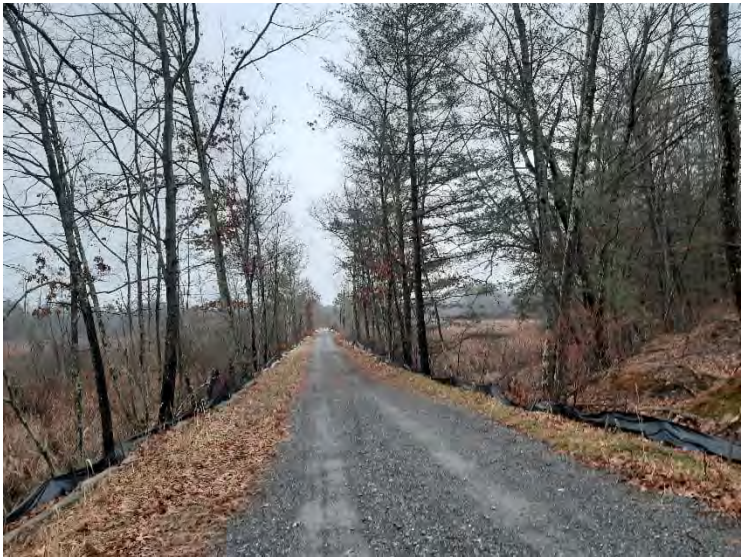
<b>PHOTOGRAPHIC LOG</b>	
Client Name: Eversource		Site Location: Sudbury to Hudson Transmission Reliability Project	Town: Hudson
Photo No.: 4	Date: 12-10-24

Description:  Segment 2, existing erosion controls, no project activity here today, looking eastward.

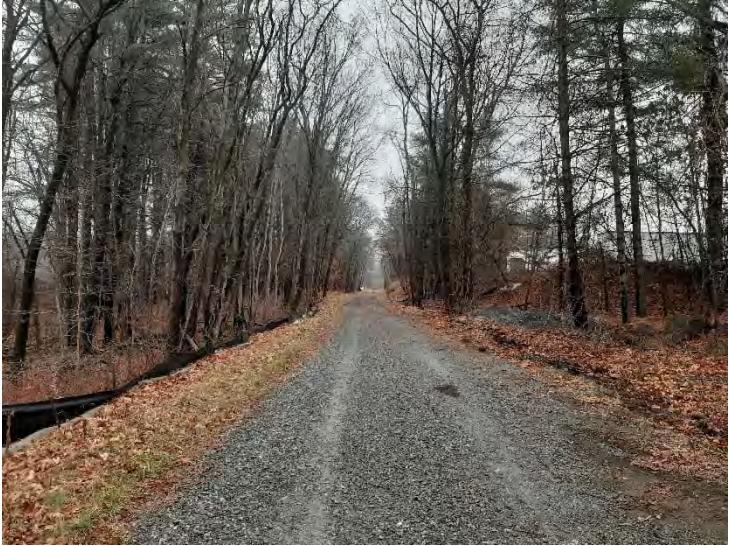
<b>PHOTOGRAPHIC LOG</b>	
Client Name: Eversource		Site Location: Sudbury to Hudson Transmission Reliability Project	Town: Hudson
Photo No.: 5	Date: 12-10-24

Description:  Segment 3, area of marked erosion control removal on south side and repaired erosion controls on north side, no project activity here today, looking eastward.

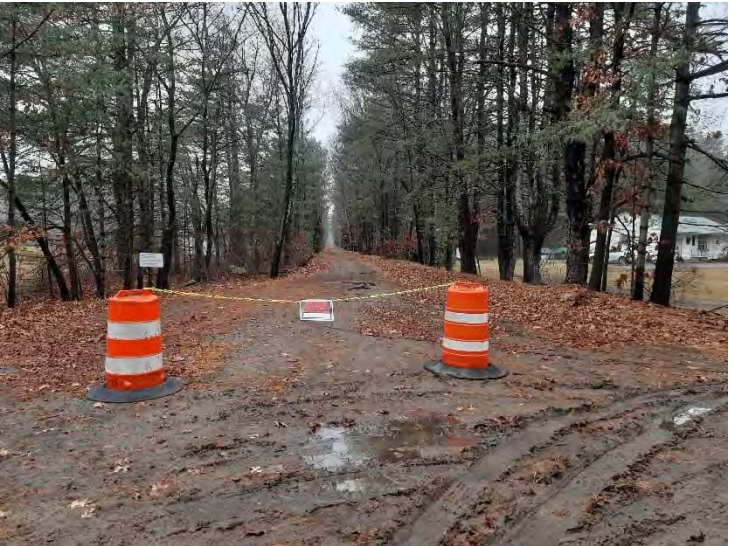
<b>PHOTOGRAPHIC LOG</b>	
Client Name: Eversource		Site Location: Sudbury to Hudson Transmission Reliability Project	Town: Hudson
Photo No.: 6	Date: 12-10-24

Description:  Segment 4, no project activity here today, looking westward.

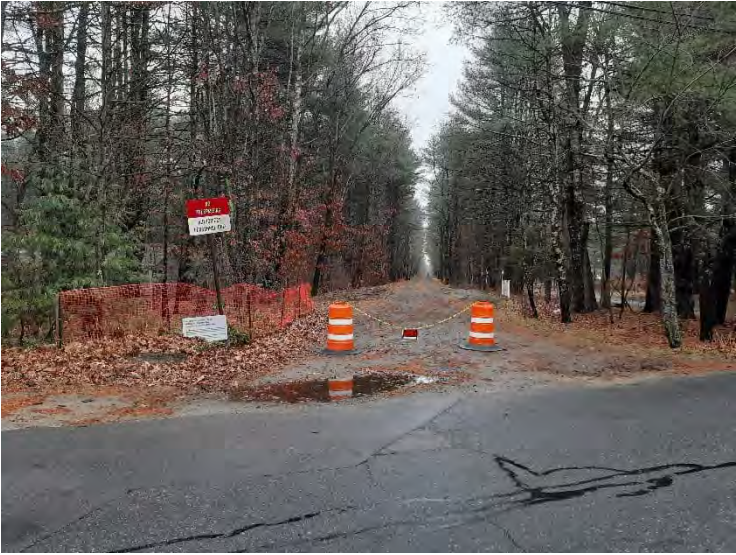
<b>PHOTOGRAPHIC LOG</b>	
Client Name: Eversource		Site Location: Sudbury to Hudson Transmission Reliability Project	Town: Hudson
Photo No.: 7	Date: 12-10-24

Description:  Segment 5, no project activity here today, looking eastward.

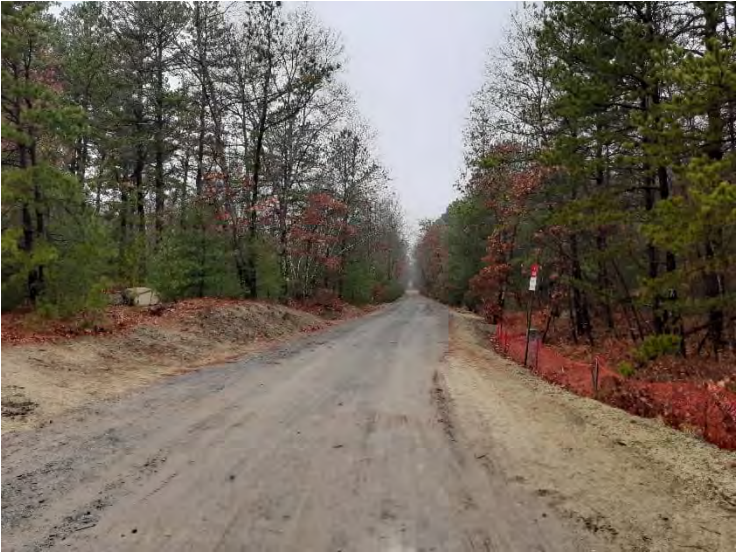
<b>PHOTOGRAPHIC LOG</b>	
Client Name: Eversource		Site Location: Sudbury to Hudson Transmission Reliability Project	Town: Hudson
Photo No.: 8	Date: 12-10-24

Description:  Segment 6 at the town line, no project activity here today, looking westward.

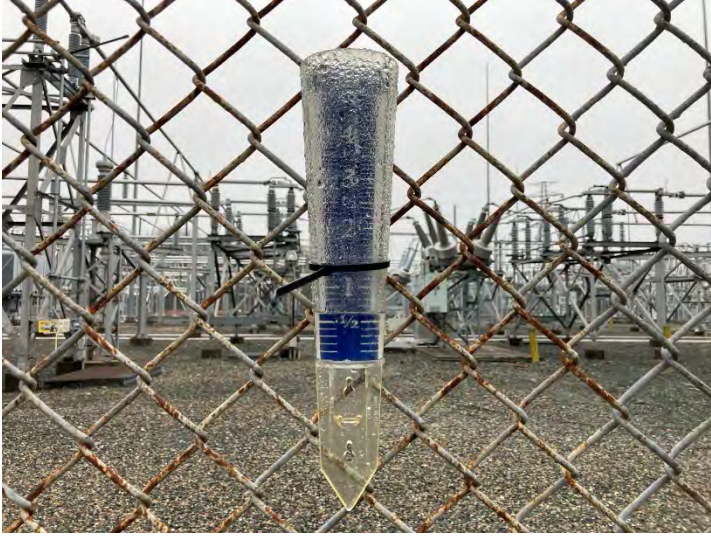
<b>PHOTOGRAPHIC LOG</b>	
Client Name: Eversource		Site Location: Sudbury to Hudson Transmission Reliability Project	Town: Sudbury
Photo No.: 1	Date: 12-10-24

Description: View of rain gauge at Sudbury Substation. 0.60" observed in gauge at 8:20am. Facing south.

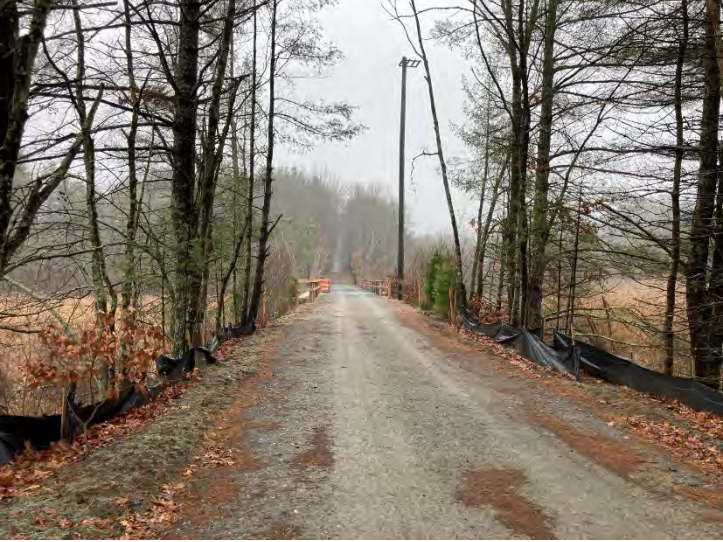
<b>PHOTOGRAPHIC LOG</b>	
Client Name: Eversource		Site Location: Sudbury to Hudson Transmission Reliability Project	Town: Sudbury
Photo No.: 2	Date: 12-10-24

Description: View of E&S controls and osprey nest platform west of bridge 128 in segment 7. Facing east.

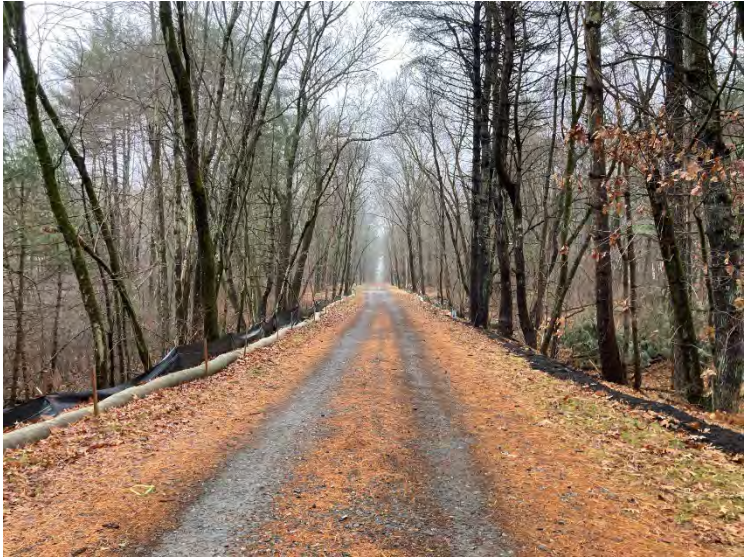
<b>PHOTOGRAPHIC LOG</b>	
Client Name: Eversource		Site Location: Sudbury to Hudson Transmission Reliability Project	Town: Sudbury
Photo No.: 3	Date: 12-10-24

Description: View of E&S controls in segment 9. Portion of controls in this area (right side of photo) have recently been removed. Compost tubes were cut, and compost material was spread. Facing west.

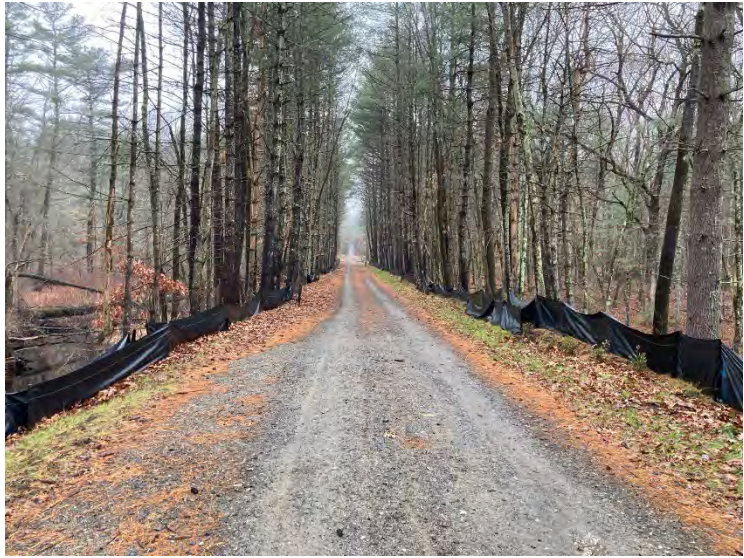
<b>PHOTOGRAPHIC LOG</b>	
Client Name: Eversource		Site Location: Sudbury to Hudson Transmission Reliability Project	Town: Sudbury
Photo No.: 4	Date: 12-10-24

Description: View of E&S controls in segment 10 near Dudley Brook. Facing west.

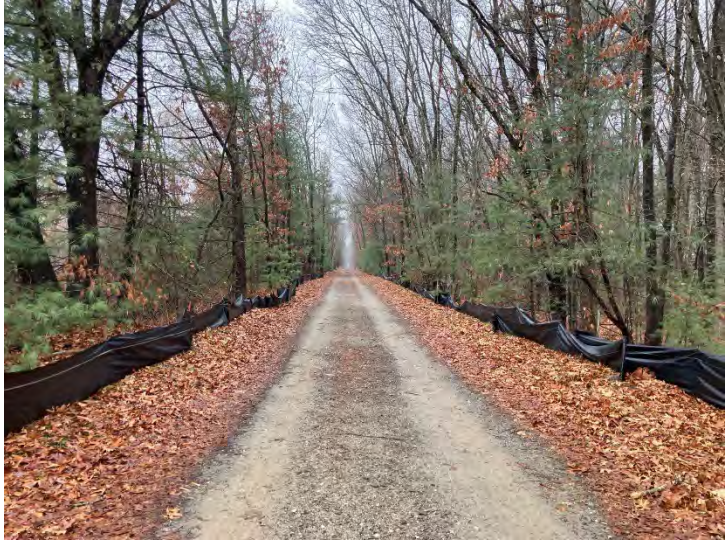
<b>PHOTOGRAPHIC LOG</b>	
Client Name: Eversource		Site Location: Sudbury to Hudson Transmission Reliability Project	Town: Sudbury
Photo No.: 5	Date: 12-10-24

Description: View of E&S controls in segment 11. Facing west.

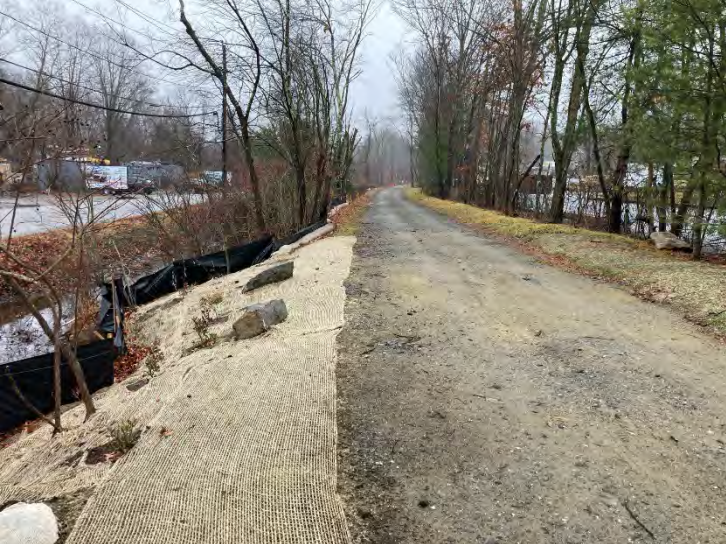
Description: View of E&S controls at culvert replacement area in segment 12. Facing east.

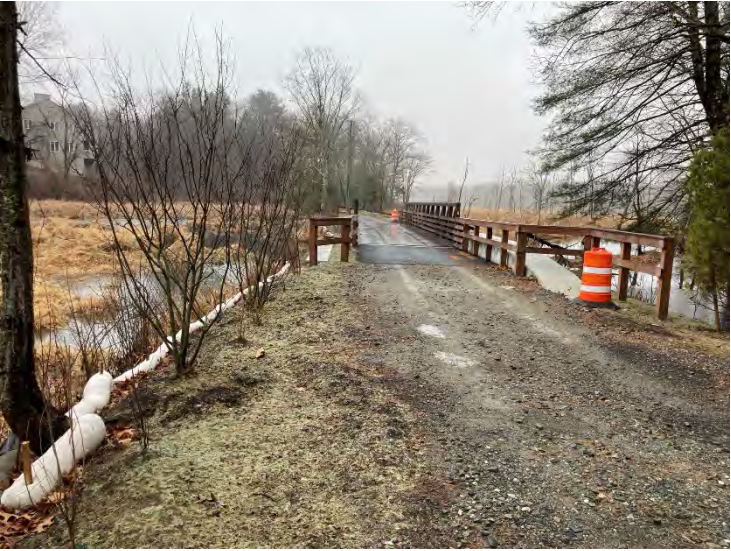
Description: View of E&S controls and plantings west of bridge 127 in segment 13. Facing east.

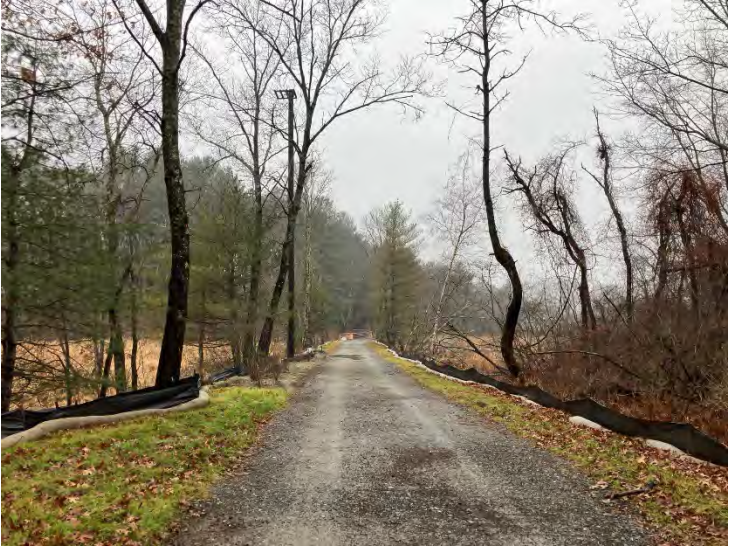
Description: View of E&S controls and osprey nest platform east of bridge 127 in segment 14. Facing west.

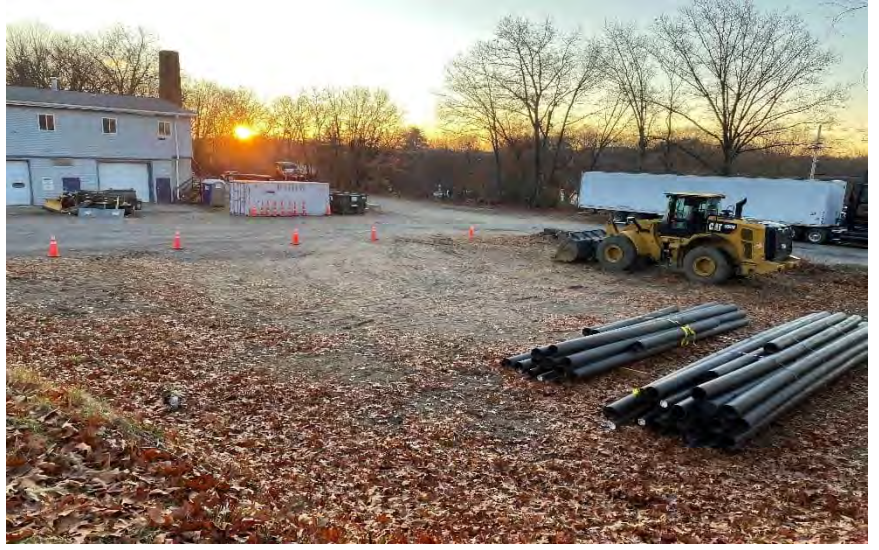
Description:  Bond laydown yard, Bond equipment staged here, looking southward.

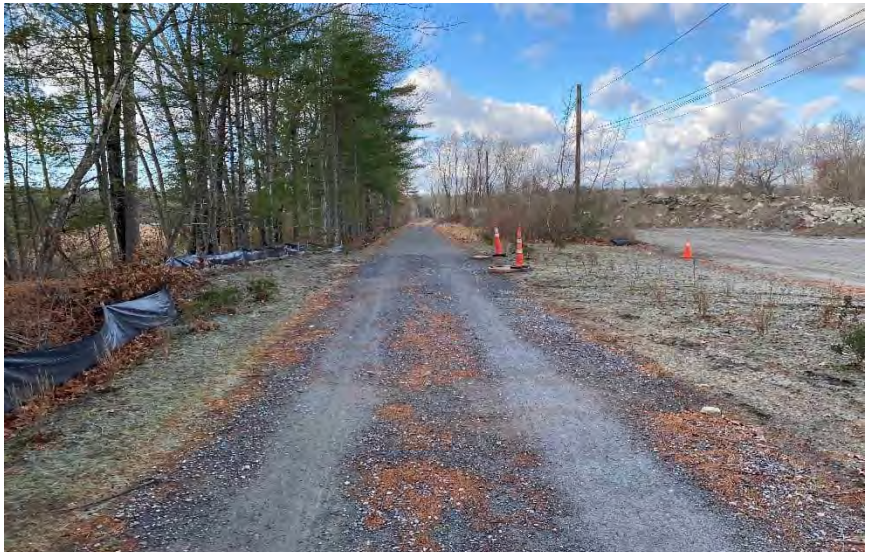
Description:  Work area within segment 3, manhole #8, area recently planted & hydro seeded, existing erosion control, looking westward.

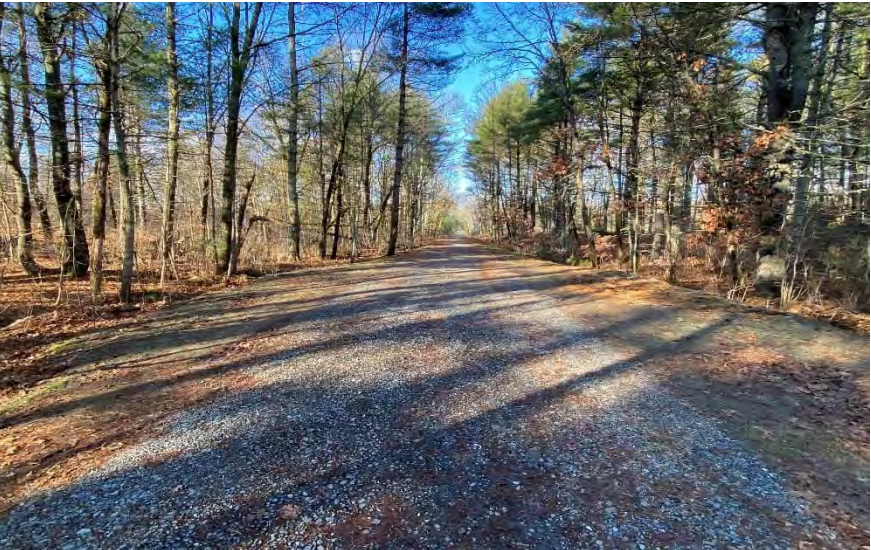
Description:  Work area within segment 5, manhole #13, area recently hydro seeded & planted, erosion control recently removed, looking westward.

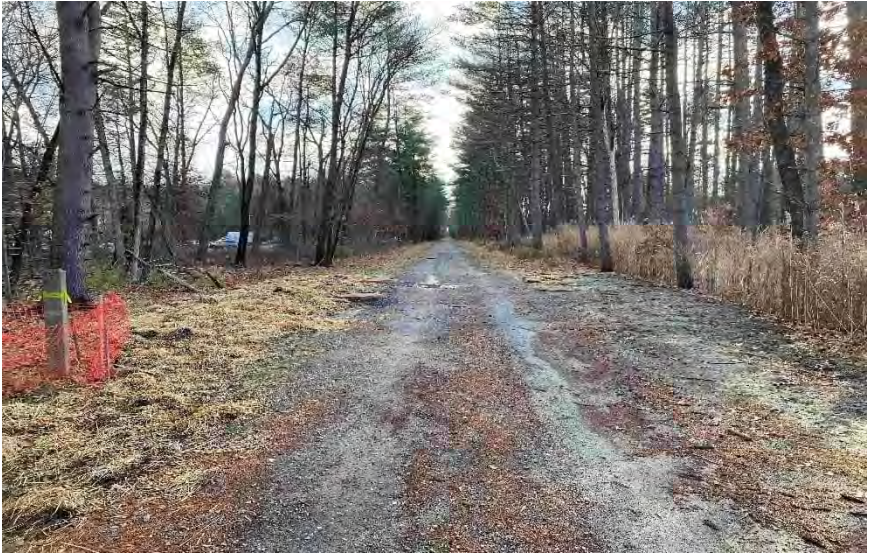
Description:  Work area within segment 4, manhole #10, area recently hydroseeded, existing erosion control, looking eastward.

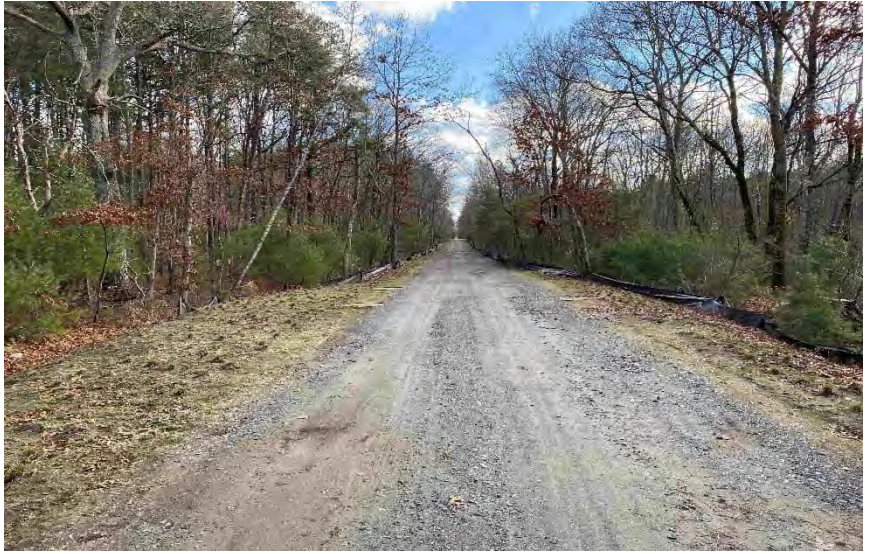
Description:  Work area within segment 6, manhole #14, area recently hydro seeded & planted, existing erosion control, looking eastward.

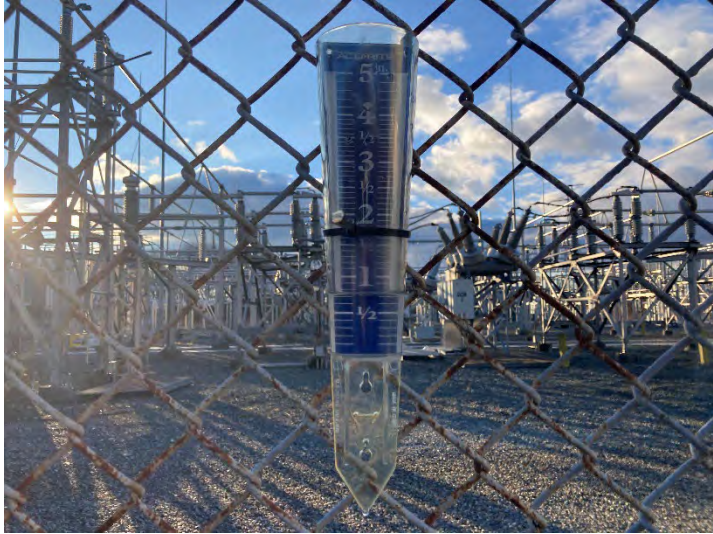
Description: View of rain gauge at Sudbury Substation. 0.75" observed in gauge at 8:15am. Facing south.

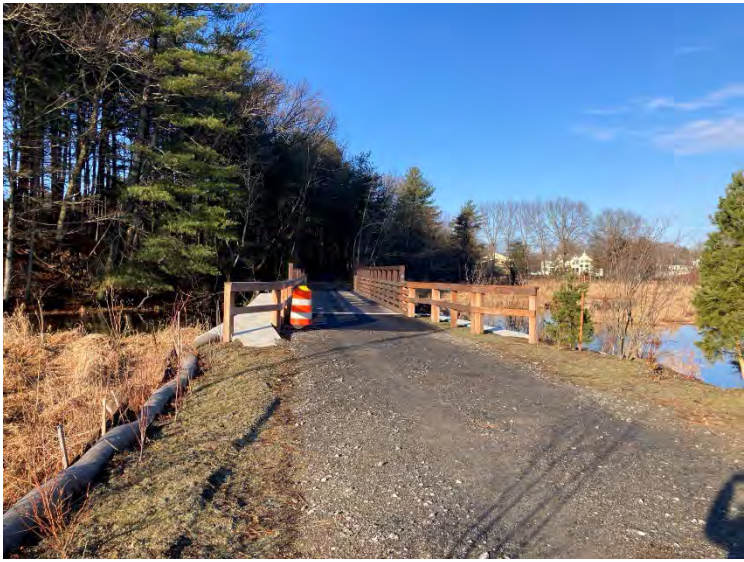
Description: View of E&S controls and plantings on east side of bridge 127 in segment 14. Facing west.

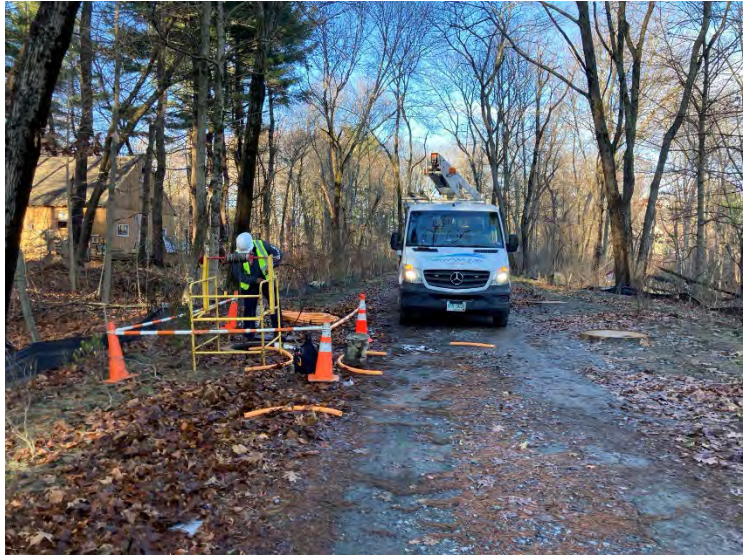
Description: View of New Wave working at HH/MH #25 in segment 13. Photo taken at 9:00am. Facing west.

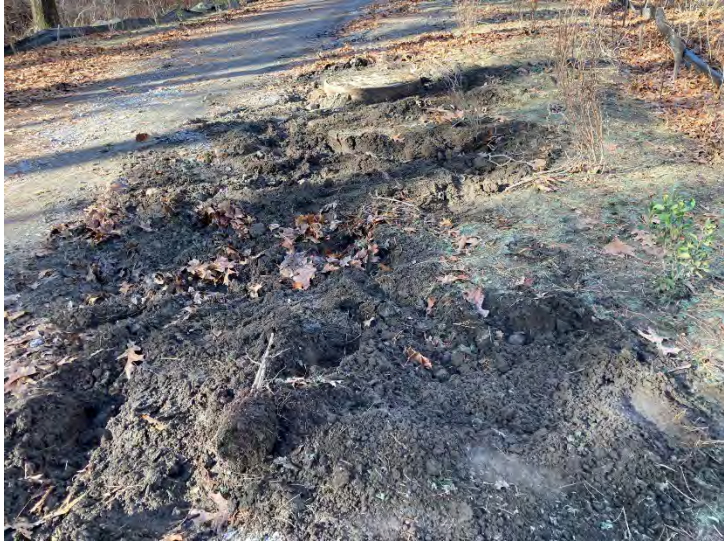
Description: View of MH #25 in segment 13 at 11:20am. Disturbed soils and damage to restoration plantings observed. Facing west.

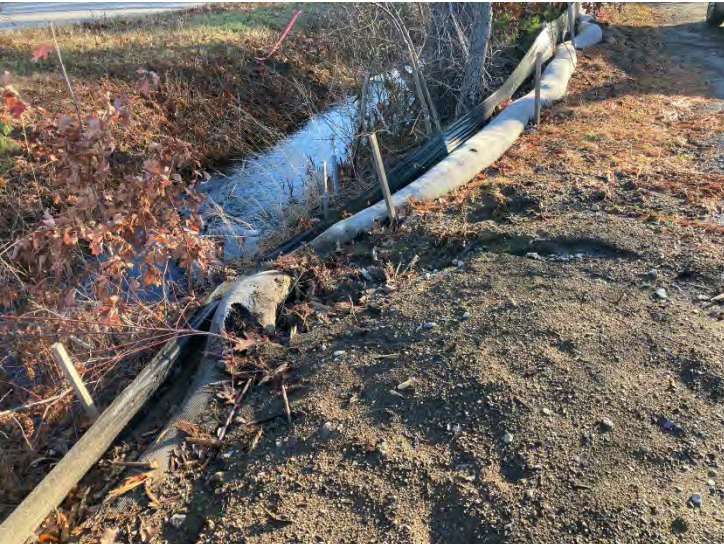
Description: View of erosion washout at west end of segment 12 following storm event. Sedimentation was not observed beyond E&S controls, but controls should be reinforced to ensure sediment deposition does not occur in the future. Facing east.

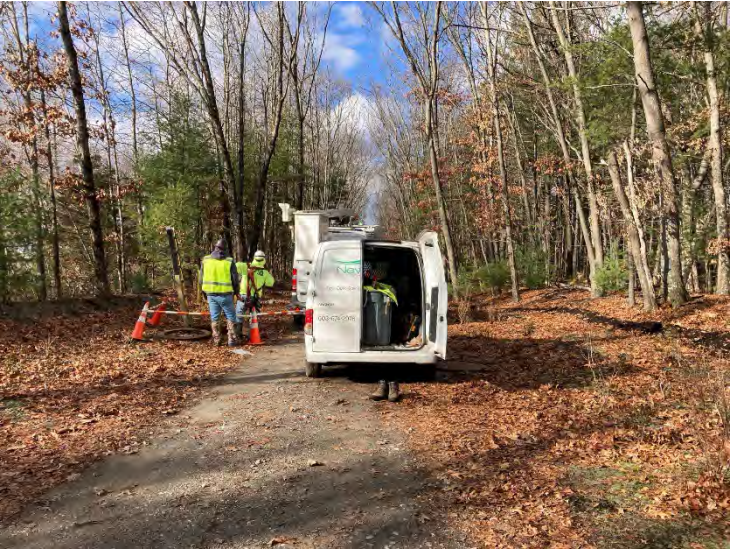
Description: View of New Wave working at HH #23 in segment 11. E&S controls in this area (right side of photo) have recently been removed. Compost tubes were cut, and compost material was spread. Facing west.

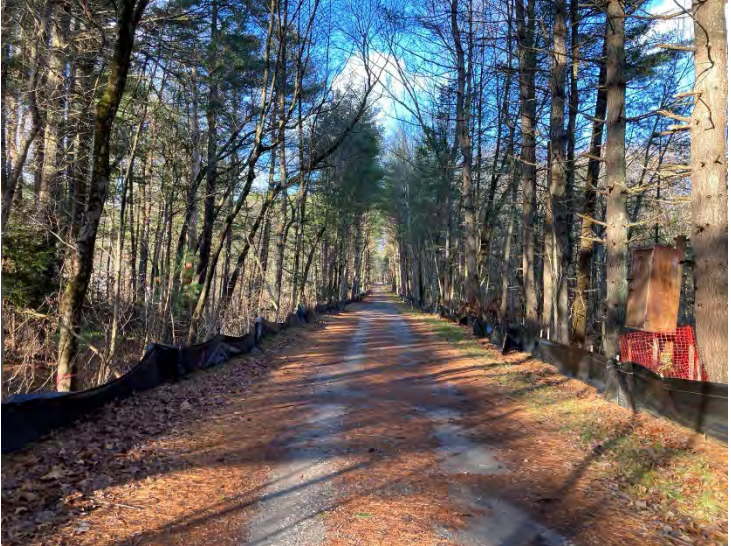
Description: View of E&S controls in segment 10. Controls are in good condition. Facing west.

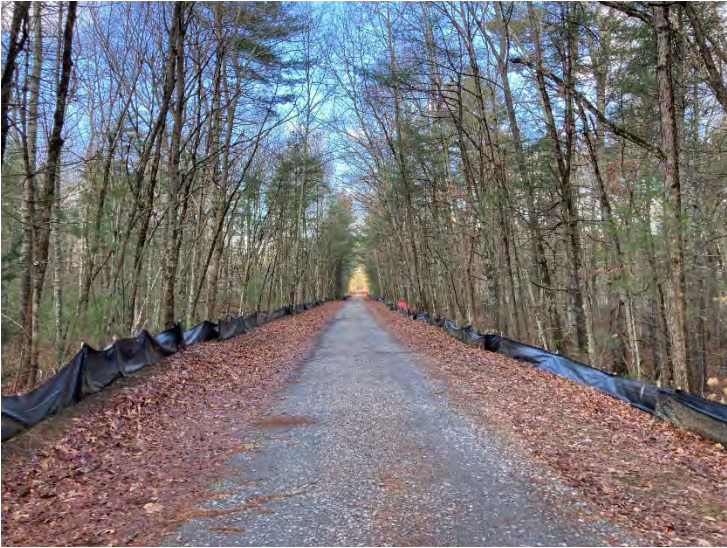
Description: View of E&S controls in segment 8. Controls are in good condition. Facing west.
