## Weekly Environmental Compliance Summary

**Sudbury to Hudson Transmission Reliability Project (USEPA Tracking # MAR1003UW)**

Week of: December 9, 2024 to December 13, 2024

# CONSTRUCTION MONITORING REPORT

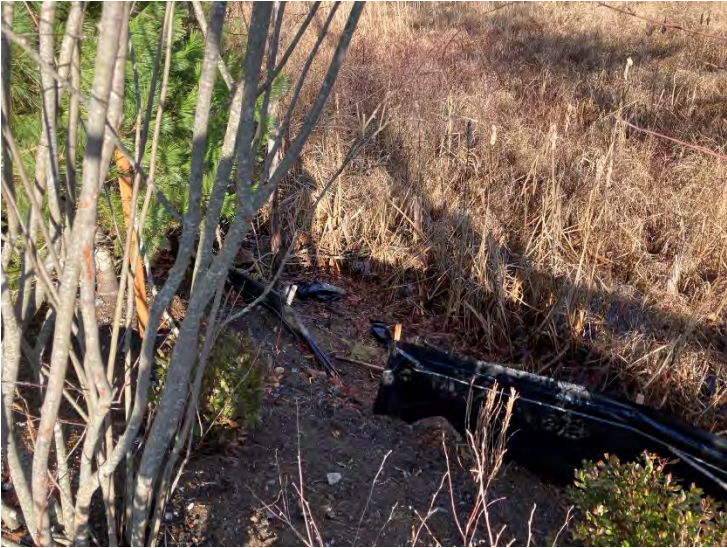
Description: View of damaged silt fence west of bridge 128 in segment 7. Facing north.

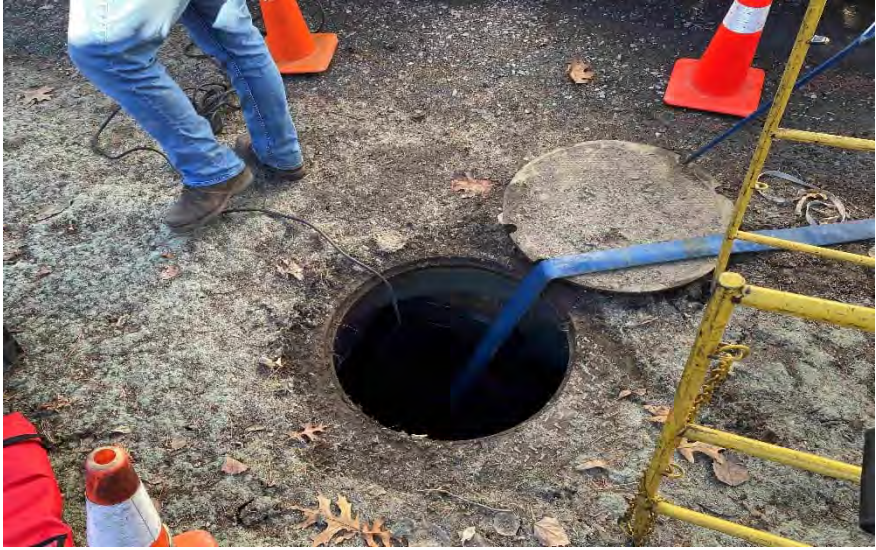
Description: View of area being pumped from handhole #9, segment 3.

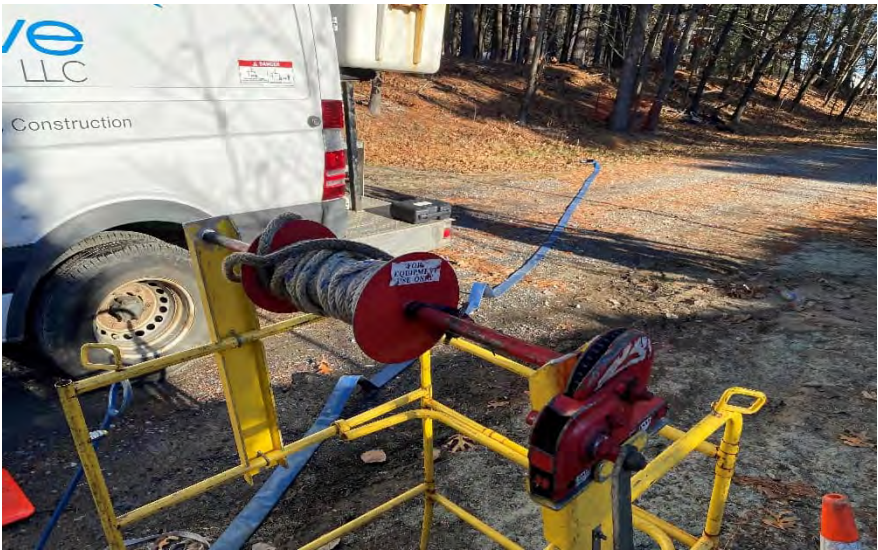
Description: Handhole #9. View of dewatering operation. Looking eastward.

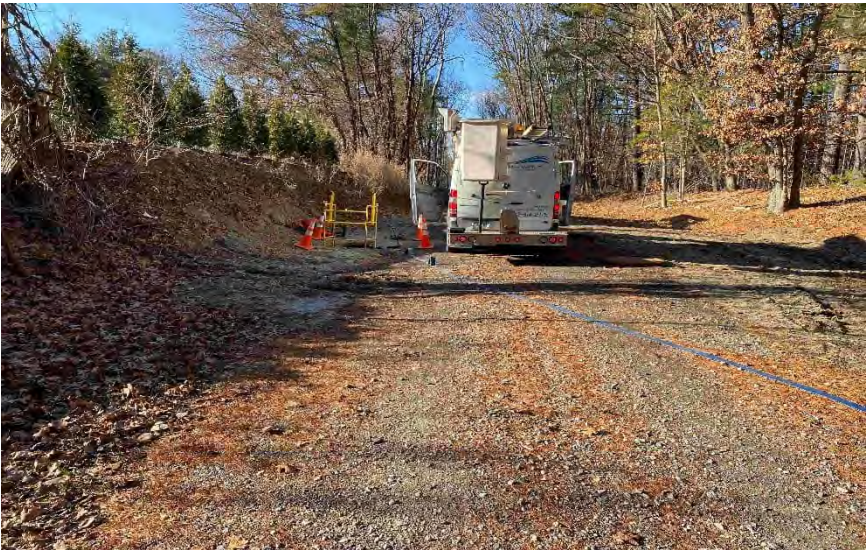
Description: Handhole #9. View of dewatering operation, looking westward.

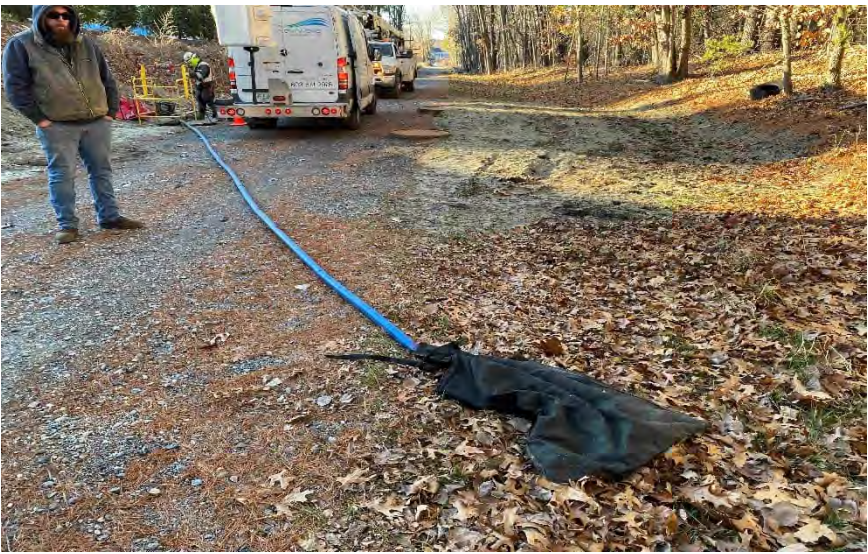
Description: Handhole #9. View of discharge bag, looking westward. Water from bag discharged to adjacent area.

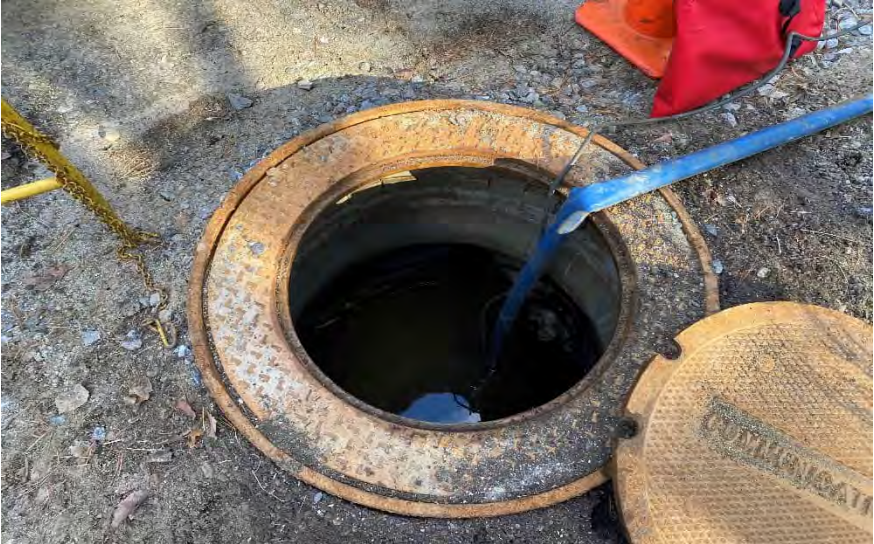
Description: View of area being pumped from handhole #20, segment 10.

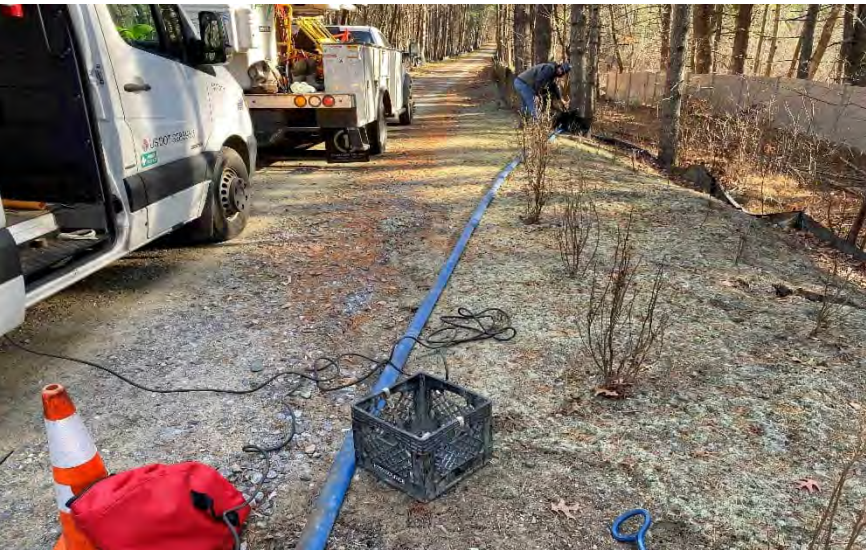
Description: Handhole #20. View of dewatering operation. Looking eastward.

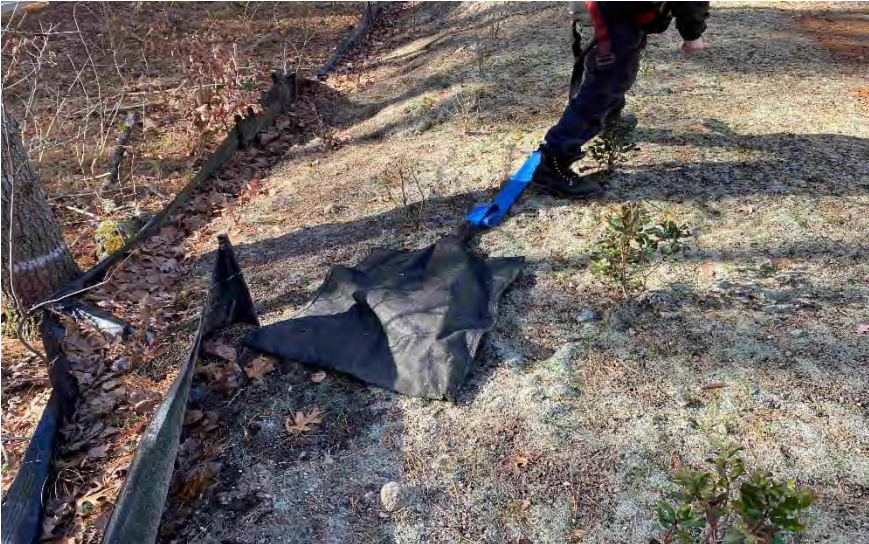
Description: Handhole #20. View of discharge bag, looking westward. Water from bag discharged to adjacent area.
