Environmental Monitor Construction Site Inspection Report
MassDOT Project #608164 Construction Contract # 119678
EM Report #34

Project Description: Bruce Freeman Rail Trail Right-of-Way
 Permit Description(s): Order of Conditions (MGL Chapter 131, Section 40 and 310 CMR 10.00, Mass DEP File No. 301-1362); 2022 EPA NPDES General Permit for Discharges from Construction Areas; U.S. Army Corps of Engineers Permit No NAE-2021-01975.

Project Name:	Bruce Freeman Rail Trail - Phase 2d - Sudbury
Date of Inspections:	11/22/2024
Bi Weekly/ Monthly Period Covered:	November Weekly Inspection #4
Inspector's Name(s):	Anna Haznar
Inspectors' Contact Information:	ahaznar@beta-inc.com

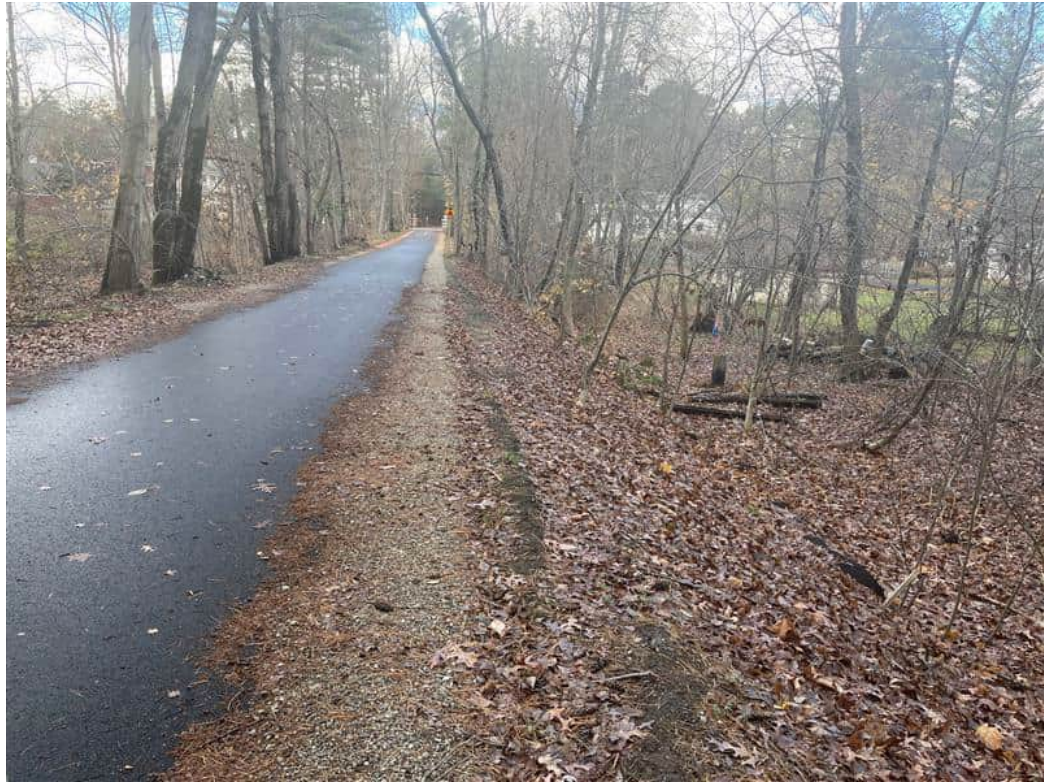
Photo No. 3 **Date:** 11/22/2024

Item	Location/ Description	Observation Date	Resolution Due Date	Recommended/Discussed Resolution	Comments/Updates
59	Multiple locations of exposed soils along the Project corridor require stabilization Priority: High	9/3/2024	9/10/2024	The contactor should apply the approved seed mixture to areas of exposed soils and place straw.	9/3/2024 - Herbicide application caused multiple areas along the path to be no longer stabilized. If thatch is present in these locations the thatch should be removed before seeding occurs. A location near Station 320+50 has been cleared outside of the limit of work and requires stabilization. Other areas along the path where seed did not germinate should be reseeded with the approved seed mix and straw should be placed on the areas of exposed soil. 9/10/2024 - Observation remains, see previous update. A few locations along the trail have been hydroseeded but a majority of the locations of exposed soil require seed and stabilization. 9/16/2024 - Observation remains. The contactor indicated areas of bare soil will be hydroseeded. 9/23/2024 - Observation remains. It does not appear as though any hydroseeding has been done since the last inspection. Areas throughout the trail require removal of thatch and application of seed for stabilization. 9/27/2024 - Observation remains. The contractor reached out and indicated all areas of exposed soils south of Hudson Road were hydroseeded after the inspection occurred. 10/4/2024 - All areas south of Hudson Road were not seeded using hydroseed; hydroseed was applied in a few locations, but there are still large areas of exposed soil both south and north of Hudson Road that require seeding. Thatch was not removed in any areas before hydroseed was applied. The contractor should provide the tag from the seed mix that was used to the Conservation Commission to ensure that the required native seed mix was used per the design plans. Once vegetation has sufficiently stabilized, this item will be closed. 10/8/2024 - Observation remains. See update from 10/4/2024. No additional hydroseed has been applied since the last inspection. 10/15/2024 - Observation remains. See update from 10/4/2024. No additional hydroseed has been applied since the last inspection. No germination has been observed in areas where hydroseed was applied. 10/22/2024 - Observation remains. See update from 10/4/2024. No additional hydroseed has been applied since the last inspection. Some germination has been observed in a few locations where hydroseed was previously applied. 10/29/2024 - Observation remains. No additional hydroseed has been applied since the last inspection. If additional hydroseed is applied leaf litter and thatch should be removed so the seed can make contact with the soil. See update from 10/4/2024. 11/5/2024 - Seed and erosion control blankets have been applied to part of the slope at Station 217+45 and seed has been applied to the exposed soil around a newly installed interpretive sign at Station 181+75. The contractor should provide the tag from the seed mix that was used to the Conservation Commission to ensure that the required native seed mix was used per the design plans. Exposed soil with little to no vegetation is still present throughout the trail. 11/12/2024 - Observation remains. Loam and seed have been placed on an areas where crushed stone had migrated off of the path at 181+00. No additional hydroseed has been applied. 11/19/2024 - Observation remains. Hydroseed has been applied to multiple locations along the path; however, multiple locations of exposed soil were still observed. The contractor should provide the tag from the seed mix that was used to the Conservation Commission to ensure native seed mix was used per the design plan. Seeded areas will continue to be monitored to ensure stabilization occurs before the action item is closed. 11/22/2024 - Observation remains. No germination from the recently applied hydroseed has been observed. See previous update.

View of a location at Station 139+00 that requires stabilization per Long Term Compliance Action Item 59.

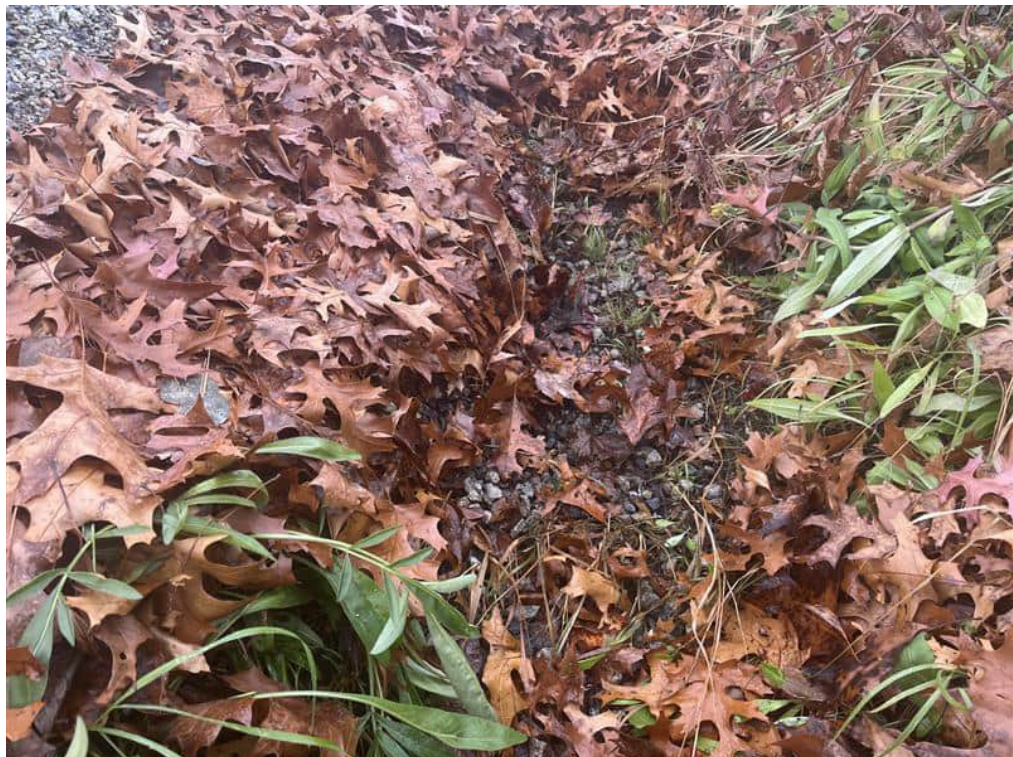
Photo No. 4 **Date:** 11/22/2024

53	Stone was observed requiring removal from the swale on the east side of the trail at Station 172+00 to 173+00 Priority: High	7/29/2024	8/6/2024	Remove stone from the swale.	8/5/2024 - Observation remains. 8/7/2024 - Observation remains. 8/12/2024 - Observation remains. Material was observed to have migrated within the swale to Station 173+50. 8/16/2024 - Stone is still present within the swale. 8/20/2024 - Observation remains. Crushed stone has migrated further down the swale to Station 171+50. 8/27/2024 - Observation remains. Stone is still present within the swale. 9/3/2024 - Observation remains. 9/10/2024 - Observation remains. Stone is still present within the swale. 9/16/2024 - Observation remains. The contractor indicated that the stone within the swale would be hand removed. 9/23/2024 - Observation remains. 9/27/2024 - Observation remains. It appears as though some stone has migrated further south down the swale. 10/4/2024 - Observation remains. Stone is still present within the swale. 10/8/2024 - Observation remains. 10/15/2024 - Observation remains. Stone is covered with vegetation in some areas. 10/22/2024 - Observation remains. Stone is covered with vegetation in some areas. 10/29/2024 - Observation remains. 11/5/2024 - Observation remains. 11/12/2024 - Leaf litter has completely covered the stone in this location. The Contractor should indicate if stone has been removed from this location. 11/19/2024 - See previous update. 11/22/2024 - Observation remains. Stone is still present within the swale and requires removal. Leaf litter is currently covering a majority of the stone.

View of stone that is covered in leaf litter and requires removal from the swale at Station 172+00 to 173+00 per Compliance Action Item 53.

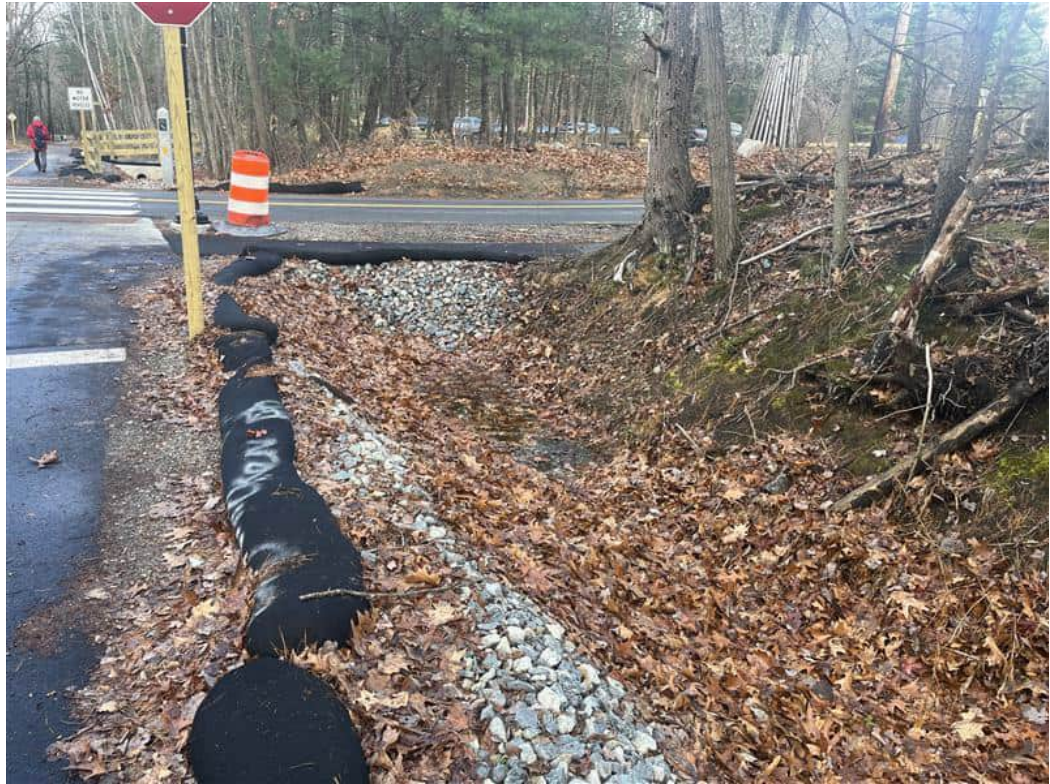
Photo No. 7 **Date:** 11/22/2024

58	<p>Crushed stone used for the dense graded crush stone shoulders has been observed as migrating both onto the path, off the sides of the path, and into the adjacent Resource Areas throughout the Project Priority: High</p>	8/7/2024	8/14/2024	<p>Remove all crushed stone from Resource Areas and develop a plan to cease discharges of stone.</p>	<p>8/12/2024 - Crushed stone is still present in varying amounts throughout the path and on the sides of the path. 8/16/2024 - Observation remains. 8/20/2024 - Crushed stone has been removed from some adjacent resource areas but is still observed as migrating onto and off of the path in multiple locations throughout the Project. 8/27/2024 - Crushed stone has been observed as migrating from the shoulders throughout the path. 9/3/2024 - Crushed stone was observed as migrating both onto the path and off the side of the path in multiple locations. Stone was observed to have discharged to the cattle crossing at Station 190+50 and within the streambed at Station 215+00 to 216+00. Crushed stone was observed to have been placed on the root system of a fallen tree at Station 310+00 near Bank flag #BF4-108. 9/10/2024 - Observation remains. Crushed stone is still present within the cattle crossing, the streambed, and on the root system of the fallen tree. Crushed stone continues to migrate on to and off of the path. 9/16/2024 - Observation remains. The contractor indicated the locations where crushed stone has migrated off the path will be hand removed and crushed stone will be swept off the path prior to the opening of the trail. 9/23/2024 - Observation remains. It does not appear as though crushed stone that has migrated onto or off of the path has been removed in any location along the Project. More crushed stone has migrated onto the path throughout significant portions of the path. 9/27/2024 - Observation remains. Crushed stone is still located on the side of the path and on the path in varying amounts. 10/4/2024 - Crushed stone has been removed from multiple locations along the trail but was still observed on and on the sides of the trail in several locations. 10/8/2024 - Observation remains. Crushed stone is still present in multiple locations on and off the sides of the path. 10/15/2024 - Observation remains. Crushed stone is still present in multiple locations on and off the sides of the path. 10/22/2024 - Observation remains. Crushed stone is still present in multiple locations on and off the sides of the path. The crushed stone shoulders along Station 1000+00 to 1003+00 has been moved back into the shoulders and regraded. 10/29/2024 - Observation remains. Crushed stone is still present in multiple locations on and off the sides of the path. 11/5/2024 - Observation remains. See previous update. 11/12/2024 - Observation remains. Crushed stone is still present on the side of the path in multiple locations, within the streambed and drainage swale and within the cattle crossing at Station 190+50. 11/19/2024 - Crushed stone was removed from the cattle crossing at Station 190+50. Further removal of stone is required in multiple locations along the path that are currently covered with leaf litter. 11/22/2024 - Observation remains. See previous update.</p>

View of crushed stone within the streambed at Station 215+00 per Long Term Compliance Action Item 58.

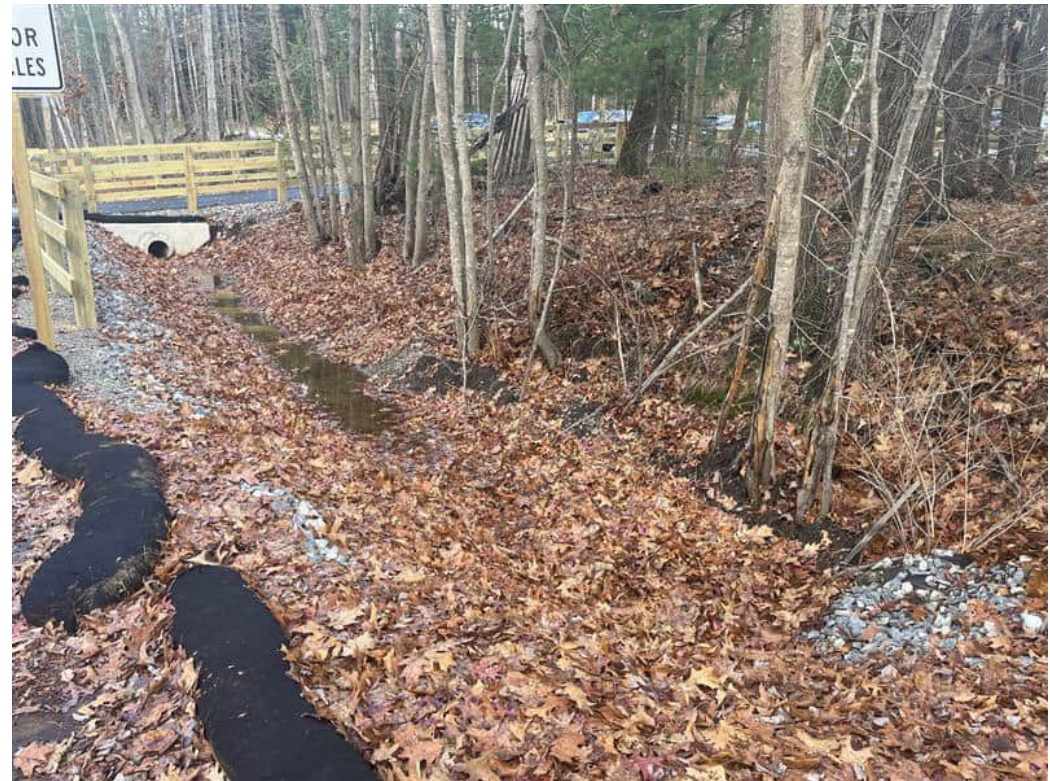
Photo No. 8 **Date:** 11/22/2024

41	Stream Bank has been regraded beyond the limit of work at Station 216+00 Priority: High	5/28/2024	6/4/2024	The Contractor should confirm if this work was permitted by the Conservation Commission, as it does not appear to be a part of the approved plans/impacts. MassDOT should be consulted on next steps regarding notification and potential restoration.	<p>5/31/2024 - Observation remains. 6/7/2024 - Observation remains. 6/14/2024 - Observation remains. 6/17/2024 - Observation remains. 6/24/2024 - Observation remains. 6/27/2024 - Observation remains. 7/8/2024 - Observation remains. 7/15/2024 - This area could not be assessed due to paving operations ongoing during the inspection. 7/22/2024 - Crushed stone and sediment continue to be discharged to the stream between Stations 215+00 and 217+00 due to overtopped and undermined compost filter tubes. 7/29/2024 - Observation remains. 8/5/2024 - Observation remains. 8/7/2024 - Observation remains. 8/12/2024 - Observation remains. Crushed stone is still present in the streambed at this location. 8/16/2024 - Observation remains. 8/20/2024 - Stone has been removed; however, additional alteration to Resource Areas beyond the limit of work continue. 8/27/2024 - Observation remains. 9/3/2024 - Observation remains. 9/10/2024 - Observation remains. Stone has been observed as discharging into the streambed in this location again. 9/16/2024 - Observation remains. 9/23/2024 - Observation remains. Stone is still present within the streambed at this location. 9/27/2024 - Observation remains. 10/4/2024 - Observation remains. 10/8/2024 - Observation remains. 10/15/2024 - Observation remains. Stone is still present within the streambed at this location. 10/22/2024 - Observation remains. Stone is still present within the streambed at this location. 10/29/2024 - Observation remains. Stone is still present within the streambed at this location. 11/5/2024 - Observation remains. The PVC pipe that was installed at this location was observed to be covered with stone and is no longer visible near Station 215+00. Stone is still present within the streambed at this location. 11/12/2024 - Observation remains. The streambed in this location is covered with leaf litter. See previous update. 11/19/2024 - Observation remains. As discussed with the Conservation Agent in the field, further coordination between the Town and MassDOT will be required to clean/repair the culvert, as the degraded condition of the culvert prompted the contractor to armor the stream banks. Further coordination will also be required for restoration of banks. 11/22/2024 - Observation remains. See previous update.</p>

View of crushed stone within the streambed and the location where the stream bank has been regraded beyond the limits of work at Station 216+00 per Long Term Compliance Action Item 41.
