Environmental Monitor Construction Site Inspection Report
MassDOT Project #608164 Construction Contract # 119678
EM Report #36

Project Description: Bruce Freeman Rail Trail Right-of-Way
 Permit Description(s): Order of Conditions (MGL Chapter 131, Section 40 and 310 CMR 10.00, Mass DEP File No. 301-1362); 2022 EPA NPDES General Permit for Discharges from Construction Areas; U.S. Army Corps of Engineers Permit No NAE-2021-01975.

Project Name:	Bruce Freeman Rail Trail - Phase 2d - Sudbury
Date of Inspections:	12/2/2024
Bi Weekly/ Monthly Period Covered:	December Weekly Inspection #1
Inspector's Name(s):	Anna Haznar
Inspectors' Contact Information:	ahaznar@beta-inc.com

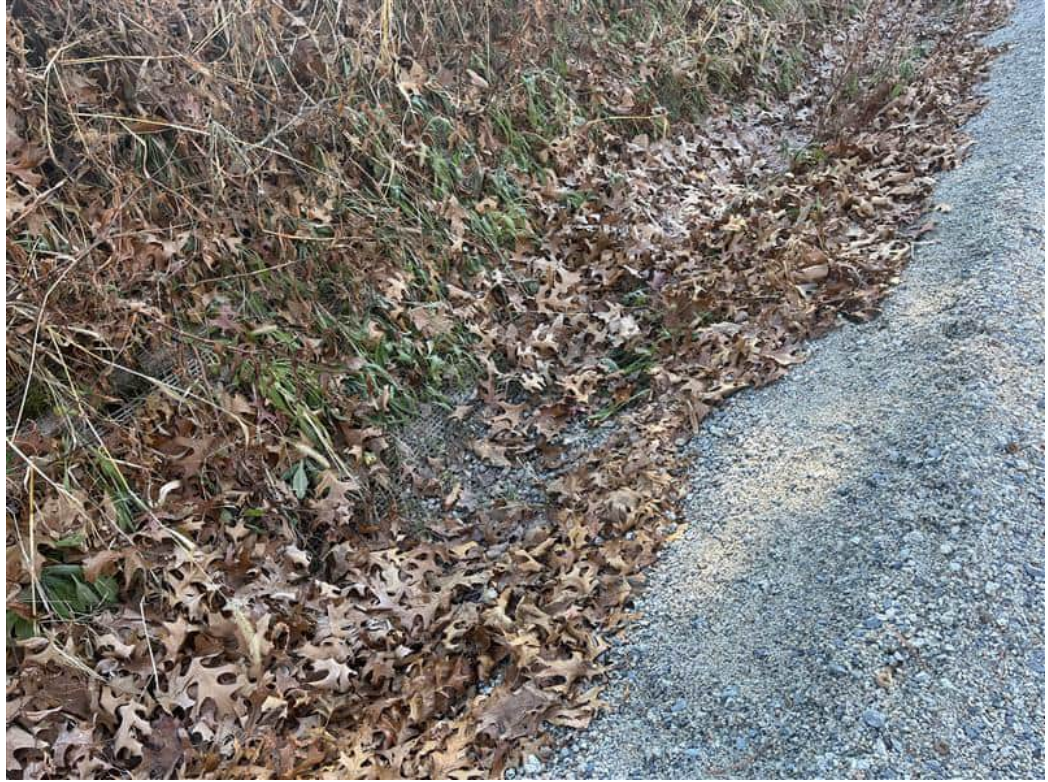
Photo No. 3 **Date:**
12/2/2024

53	<p>Stone was observed requiring removal from the swale on the east side of the trail at Station 172+00 to 173+00 Priority: High</p>	7/29/2024	8/6/2024	Remove stone from the swale.	<p>8/5/2024 - Observation remains. 8/7/2024 - Observation remains. 8/12/2024 - Observation remains. Material was observed to have migrated within the swale to Station 173+50. 8/16/2024 - Stone is still present within the swale. 8/20/2024 - Observation remains. Crushed stone has migrated further down the swale to Station 171+50. 8/27/2024 - Observation remains. Stone is still present within the swale. 9/3/2024 - Observation remains. 9/10/2024 - Observation remains. Stone is still present within the swale. 9/16/2024 - Observation remains. The contractor indicated that the stone within the swale would be hand removed. 9/23/2024 - Observation remains. 9/27/2024 - Observation remains. It appears as though some stone has migrated further south down the swale. 10/4/2024 - Observation remains. Stone is still present within the swale. 10/8/2024 - Observation remains. 10/15/2024 - Observation remains. Stone is covered with vegetation in some areas. 10/22/2024 - Observation remains. Stone is covered with vegetation in some areas. 10/29/2024 - Observation remains. 11/5/2024 - Observation remains. 11/12/2024 - Leaf litter has completely covered the stone in this location. The Contractor should indicate if stone has been removed from this location. 11/19/2024 - See previous update. 11/22/2024 - Observation remains. Stone is still present within the swale and requires removal. Leaf litter is currently covering a majority of the stone. 11/25/2024 - Observation remains. Leaf litter is covering a majority of the stone. 12/2/2024 - Observation remains. Stone is present within the swale under leaf litter.</p>

View of stone that is covered in leaf litter and requires removal from the swale at Station 172+00 to 173+00 per Compliance Action Item 53.

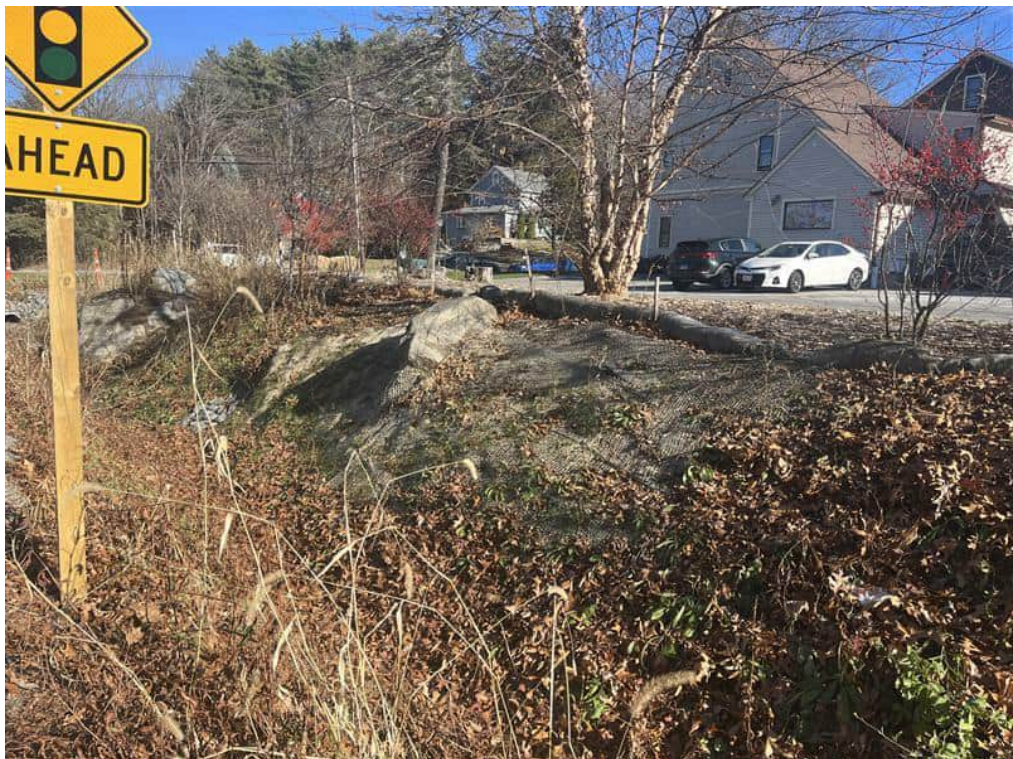
Photo No. 4 **Date:**
12/2/2024

6	<p>Exposed sediment slope at Station 172+00 to 175+00 Priority: High</p>	5/8/2024	5/15/2024	<p>Install temporary sediment controls along the slope such as jute netting and/or straw following the application of seed.</p>	<p>5/16/2024 - Observation remains. 5/21/2024 - Observation remains. 5/28/2024 - Partial germination was observed. 5/31/2024 - See previous update. 6/7/2024 - Further earthwork has occurred and soils require stabilization. 6/14/2024 - Observation remains. 6/17/2024 - Observation remains. 6/24/2024 - Observation remains. 6/27/2024 - The area has been regraded and loam has been spread. New trees have been planted upgradient of the swale. Stabilization is still required. 7/8/2024 - Jute netting has been installed over the applied seed, and the area will be monitored for germination. 7/15/2024 - See previous update. 7/22/2024 - Observation remains. 7/29/2024 - Observation remains. 8/5/2024 - Observation remains. 8/7/2024 - Regrowth of vegetation was observed in this location. This item will remain open until stabilization has been completed. 8/12/2024 - Observation remains. 8/16/2024 - Observation remains. 8/20/2024 - Application of the approved seed mixture is required at this location. 8/27/2024 - Observation remains. 9/3/2024 - Vegetation that is present in this location generally consists of lady's thumb smartweed, a non-native species. Removal of non-native species and application of the approved seed mixture is required at this location. 9/16/2024 - See previous update. 9/23/2024 - Observation remains. See 9/3/2024 update. 9/27/2024 - Observation remains. The contractor reached out hydroseed has been applied to this area. 10/4/2024 - Hydroseed has been applied to this area; the hydroseed was observed to have been applied over the erosion control blanket that is located in this area. Once vegetation has sufficiently stabilized this area the item will be closed. The contractor should provide the tag from the seed mix that was used to the Conservation Commission to ensure that the required native seed mix was used per the design plans. 10/8/2024 - Observation remains. See update from 10/4/2024. 10/15/2024 - Observation remains. See update from 10/4/2024. 10/22/2024 - Observation remains. See update from 10/4/2024. 10/29/2024 - Observation remains. No germination has been observed in this location since the application of hydroseed. See update from 10/4/2024. 11/5/2024 - Observation remains. Some germination has been observed but the area is not considered stabilized. 11/12/2024 - Observation remains. 11/19/2024 - Germination has been observed in this location but it has not fully stabilized. 11/22/2024 - Observation remains. See previous update. 11/25/2024 - Observation remains. See update from 11/19/2024. 12/2/2024 - Observation remains. See update for 11/19/2024.</p>

View of hydroseed with some germination along slopes at Station 172+00 to 175+00 per Compliance Action Item 6.

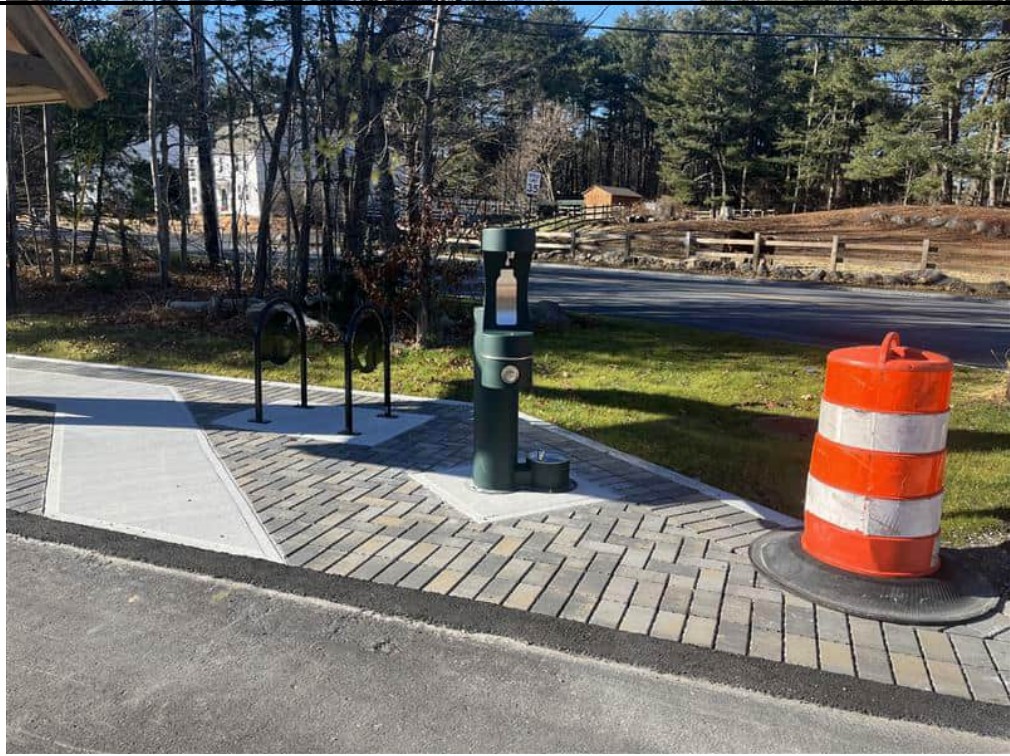
Photo No. 5 **Date:**
12/2/2024

Typical view of the recently installed hydration station at Station 174+50, hydration stations have been installed in multiple locations along the path.

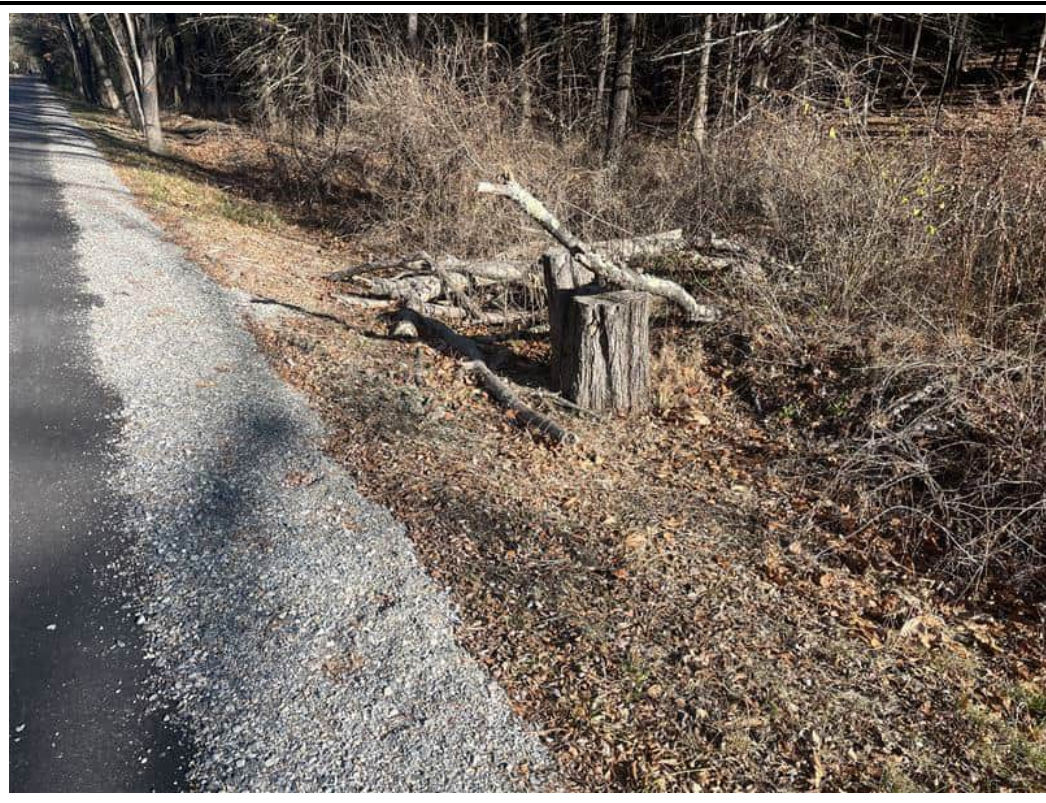
Photo No. 6 **Date:**
12/2/2024

58	<p>Crushed stone used for the dense graded crush stone shoulders has been observed as migrating both onto the path, off the sides of the path, and into the adjacent Resource Areas throughout the Project Priority: High</p>	8/7/2024	8/14/2024	<p>Remove all crushed stone from Resource Areas and develop a plan to cease discharges of stone.</p>	<p>8/12/2024 - Crushed stone is still present in varying amounts throughout the path and on the sides of the path. 8/16/2024 - Observation remains. 8/20/2024 - Crushed stone has been removed from some adjacent resource areas but is still observed as migrating onto and off of the path in multiple locations throughout the Project. 8/27/2024 - Crushed stone has been observed as migrating from the shoulders throughout the path. 9/3/2024 - Crushed stone was observed as migrating both onto the path and off the side of the path in multiple locations. Stone was observed to have discharged to the cattle crossing at Station 190+50 and within the streambed at Station 215+00 to 216+00. Crushed stone was observed to have been placed on the root system of a fallen tree at Station 310+00 near Bank flag #BF4-108. 9/10/2024 - Observation remains. Crushed stone is still present within the cattle crossing, the streambed, and on the root system of the fallen tree. Crushed stone continues to migrate on to and off of the path. 9/16/2024 - Observation remains. The contractor indicated the locations where crushed stone has migrated off the path will be hand removed and crushed stone will be swept off the path prior to the opening of the trail. 9/23/2024 - Observation remains. It does not appear as though crushed stone that has migrated onto or off of the path has been removed in any location along the Project. More crushed stone has migrated onto the path throughout significant portions of the path. 9/27/2024 - Observation remains. Crushed stone is still located on the side of the path and on the path in varying amounts. 10/4/2024 - Crushed stone has been removed from multiple locations along the trail but was still observed on and on the sides of the trail in several locations. 10/8/2024 - Observation remains. Crushed stone is still present in multiple locations on and off the sides of the path. 10/15/2024 - Observation remains. Crushed stone is still present in multiple locations on and off the sides of the path. 10/22/2024 - Observation remains. Crushed stone is still present in multiple locations on and off the sides of the path. The crushed stone shoulders along Station 1000+00 to 1003+00 has been moved back into the shoulders and regraded. 10/29/2024 - Observation remains. Crushed stone is still present in multiple locations on and off the sides of the path. 11/5/2024 - Observation remains. See previous update. 11/12/2024 - Observation remains. Crushed stone is still present on the side of the path in multiple locations, within the streambed and drainage swale and within the cattle crossing at Station 190+50. 11/19/2024 - Crushed stone was removed from the cattle crossing at Station 190+50. Further removal of stone is required in multiple locations along the path that are currently covered with leaf litter. 11/22/2024 - Observation remains. See previous update. 11/25/2024 - Observation remains. See update from 11/19/2024. 12/2/2024 - Observation remains. Stone is covered with leaf litter in multiple locations along the path.</p>

View of a location where hydroseed was recently applied with no observable germination and crushed stone that requires removal at Station 179+00 per Long Term Compliance Action Item 58 and 59.

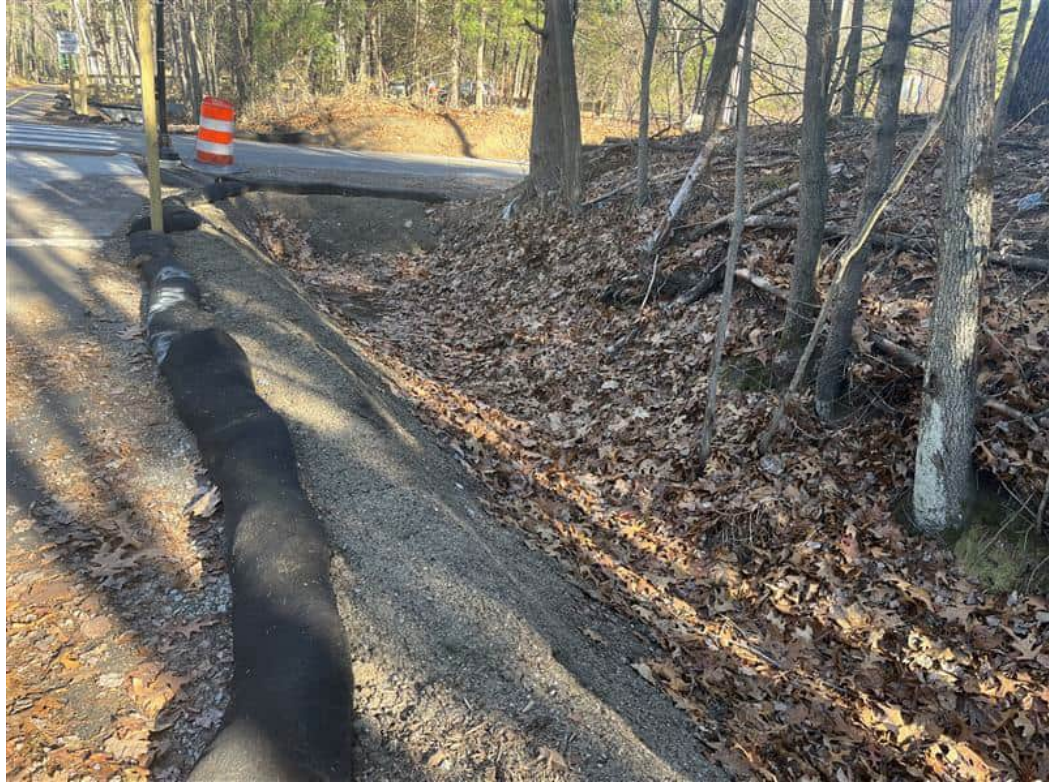
Photo No. 7 **Date:** 12/2/2024

Item	Location/ Description	Observation Date	Resolution Due Date	Recommended Resolution / Resolution Date	Comments/Updates
62	Loam and seed were applied to the streambank at Station 216+00 to 217+00 and requires further stabilization	11/25/2024	12/2/2024	An erosion control blanket should be installed along this slope.	12/2/2024 - Loam and seed have been applied to the streambank at Station 215+00. Stabilization is required at Stations 215+00 to 217+00.
61	Invasive vegetation including Japanese knotweed (<i>Reynoutria japonica</i>), bittersweet (<i>Celastrus orbiculatus</i>), bush honeysuckle (<i>Lonicera</i> spp.), burning bush (<i>Euonymus alatus</i>), purple loosestrife (<i>Lythrum salicaria</i>), glossy buckthorn (<i>Frangula alnus</i>) and garlic mustard (<i>Alliaria petiolata</i>) have been observed throughout the path. Priority: High	10/22/2024	10/29/2024	Invasive Species should be removed by manual and/or chemical removal methods	10/29/2024 - Invasive species are present throughout the trail both within upland and Resource Areas. Populations of glossy buckthorn and purple loosestrife are present within the wetland replication area. 11/5/2024 - Observation remains. See update from 10/29/2024. 11/12/2024 - Observation remains. Invasive species are still present throughout the trail. Some invasives have been observed with no leaves due to winter die back. 11/19/2024 - Observation remains. Further invasive species management will be required during the next growing season. 11/22/2024 - Observation remains. 11/25/2024 - Observation remains. 12/2/2024 - Observation remains.

View of newly placed loam that requires stabilization at Station 215+00 per Compliance Action Item 62.

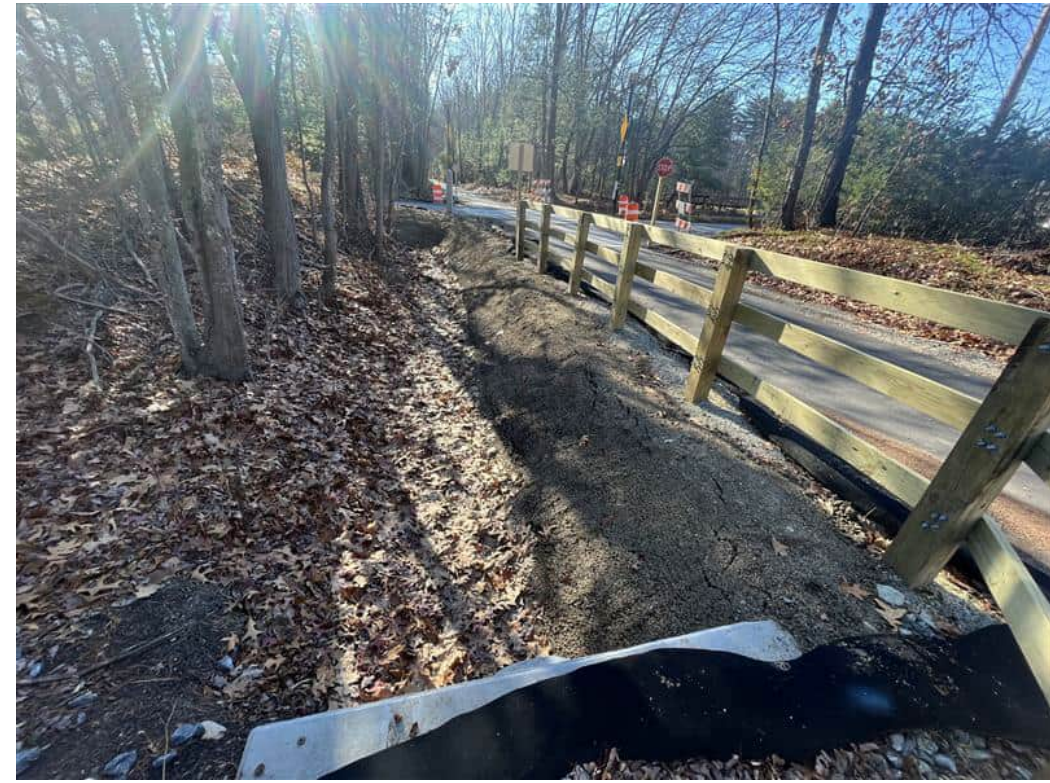
Photo No. 8 **Date:** 12/2/2024

41	Stream Bank has been regraded beyond the limit of work at Station 216+00 Priority: High	5/28/2024	6/4/2024	The Contractor should confirm if this work was permitted by the Conservation Commission, as it does not appear to be a part of the approved plans/impacts. MassDOT should be consulted on next steps regarding notification and potential restoration.	<p>5/31/2024 - Observation remains. 6/7/2024 - Observation remains. 6/14/2024 - Observation remains. 6/17/2024 - Observation remains. 6/24/2024 - Observation remains. 6/27/2024 - Observation remains. 7/8/2024 - Observation remains. 7/15/2024 - This area could not be assessed due to paving operations ongoing during the inspection. 7/22/2024 - Crushed stone and sediment continue to be discharged to the stream between Stations 215+00 and 217+00 due to overtopped and undermined compost filter tubes. 7/29/2024 - Observation remains. 8/5/2024 - Observation remains. 8/7/2024 - Observation remains. 8/12/2024 - Observation remains. Crushed stone is still present in the streambed at this location. 8/16/2024 - Observation remains. 8/20/2024 - Stone has been removed; however, additional alteration to Resource Areas beyond the limit of work continue. 8/27/2024 - Observation remains. 9/3/2024 - Observation remains. 9/10/2024 - Observation remains. Stone has been observed as discharging into the streambed in this location again. 9/16/2024 - Observation remains. 9/23/2024 - Observation remains. Stone is still present within the streambed at this location. 9/27/2024 - Observation remains. 10/4/2024 - Observation remains. 10/8/2024 - Observation remains. 10/15/2024 - Observation remains. Stone is still present within the streambed at this location. 10/22/2024 - Observation remains. Stone is still present within the streambed at this location. 10/29/2024 - Observation remains. Stone is still present within the streambed at this location. 11/5/2024 - Observation remains. The PVC pipe that was installed at this location was observed to be covered with stone and is no longer visible near Station 215+00. Stone is still present within the streambed at this location. 11/12/2024 - Observation remains. The streambed in this location is covered with leaf litter. See previous update. 11/19/2024 - Observation remains. As discussed with the Conservation Agent in the field, further coordination between the Town and MassDOT will be required to clean/repair the culvert, as the degraded condition of the culvert prompted the contractor to armor the stream banks. Further coordination will also be required for restoration of banks. 11/22/2024 - Observation remains. See previous update. 11/25/2024 - Observation remains. See update from 11/19/2024. 12/2/2024 - Observation remains. See update from 11/19/2024.</p>

Description:
View of the location where the stream bank has been regraded beyond the limits of work and where stabilization of the newly placed loam is required at Station 216+00 per Long Term Compliance Action Item 41 and 62.

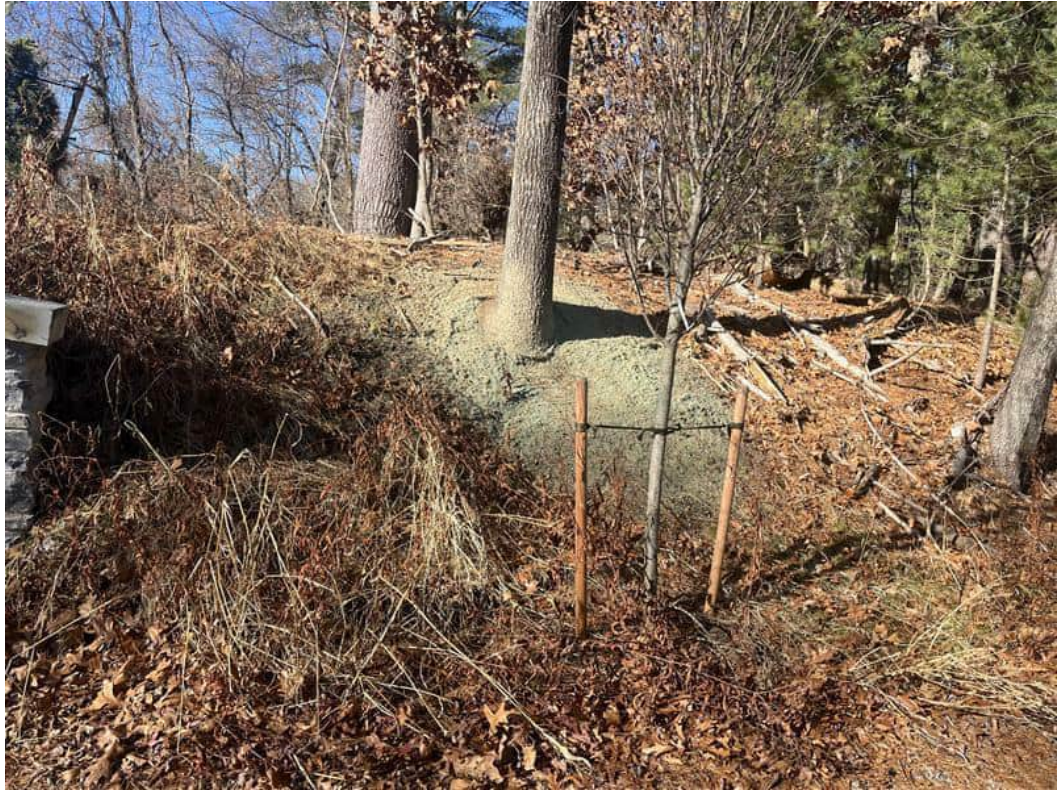
Photo No. 11 **Date:**
12/2/2024

34	<p>Sediment is eroding downhill from behind the cemented stone masonry wall at Station 217+45 Priority: Low</p>	5/28/2024	6/4/2024	<p>Apply seed and temporarily stabilize the soils along the slope with straw, jute netting, etc.</p>	<p>5/31/2024 - Observation remains. 6/7/2024 - Observation remains. 6/14/2024 - Observation remains. 6/17/2024 - Observation remains. 6/24/2024 - Observation remains. 6/27/2024 - Rills were raked, loam was added, and hydroseed was applied. 7/8/2024 - Observation remains. Grass was observed to be germinating at this location. Comment will remain open until stabilization is complete. 7/8/2024 - See previous update. 7/15/2024 - Additional hydroseed is required due to washouts. 7/22/2024 - Observation remains. 7/29/2024 - Observation remains. 8/5/2024 - Observation remains. 8/7/2024 - Regrowth of vegetation has been observed in this area. This item will remain open until the area is fully stabilized. 8/12/2024 - Observation remains. Regrowth has stabilized a portion of this hill; however, reseeded and additional temporary stabilized measures are recommended on the section that is currently unvegetated. 8/16/2024 - Observation remains. 8/20/2024 - Application of the approved seed mixture is required at this location. 8/27/2024 - Observation remains. 9/3/2024 - Vegetation that is present in this location generally consists of lady's thumb smartweed (<i>Persicaria maculosa</i>), a non-native species. Removal of non-native species and application of the approved seed mixture is required at this location. 9/10/2024 - Observation remains. See previous update. 9/16/2024 - Observation remains. See update from 9/3/2024. 9/23/2024 - Observation remains. See update from 9/3/2024. 9/27/2024 - Observation remains. 10/4/2024 - Observation remains. See update from 9/3/2024. 10/8/2024 - Observation remains. See update from 9/3/2024. 10/15/2024 - Observation remains. See update from 9/3/2024. 10/22/2024 - Observation remains. See update from 9/3/2024. 10/29/2024 - Observation remains. No additional seed has been applied to this location and the slope is generally vegetated by non-native species. See update from 9/3/2024. 11/5/2024 - Observation remains. Erosion control and seed has been applied to part of this slope, no germination has been observed. 11/12/2024 - Observation remains. No germination has been observed in this location. 11/19/2024 - Observation remains. 11/22/2024 - Observation remains. No germination has been observed in this location. 11/25/2024 - Observation remains. No germination has been observed in this location. 12/2/2024 - Observation remains. No germination has been observed in this location.</p>

View of the slope where hydroseed was applied at Station 217+45 per Compliance Action Item 34.

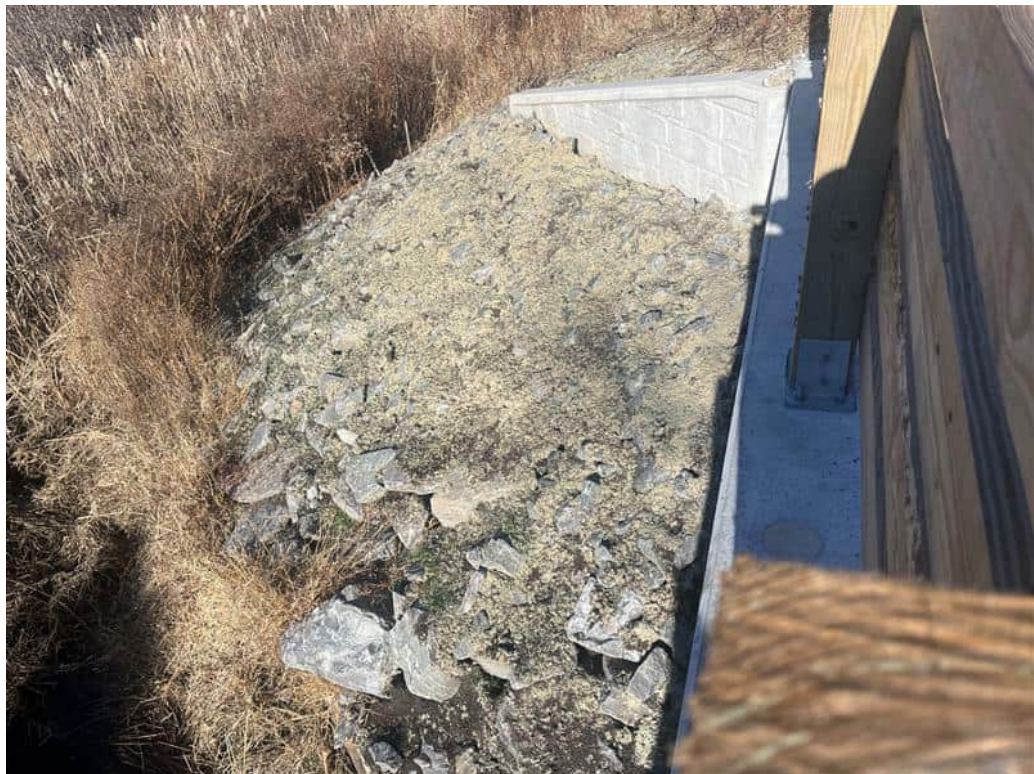
Photo No. 12 **Date:**
12/2/2024

View of the bank of Pantry Brook with hydroseed and no observable germination at Station 264+50 per Long Term Compliance Action Item 59.
