Environmental Monitor Construction Site Inspection Report
MassDOT Project #608164 Construction Contract # 119678
EM Report #37

Project Description: Bruce Freeman Rail Trail Right-of-Way
 Permit Description(s): Order of Conditions (MGL Chapter 131, Section 40 and 310 CMR 10.00, Mass DEP File No. 301-1362); 2022 EPA NPDES General Permit for Discharges from Construction Areas; U.S. Army Corps of Engineers Permit No NAE-2021-01975.

Project Name:	Bruce Freeman Rail Trail - Phase 2d - Sudbury
Date of Inspections:	12/6/2024
Bi Weekly/ Monthly Period Covered:	December Weekly Inspection #2
Inspector's Name(s):	Anna Haznar
Inspectors' Contact Information:	ahaznar@beta-inc.com

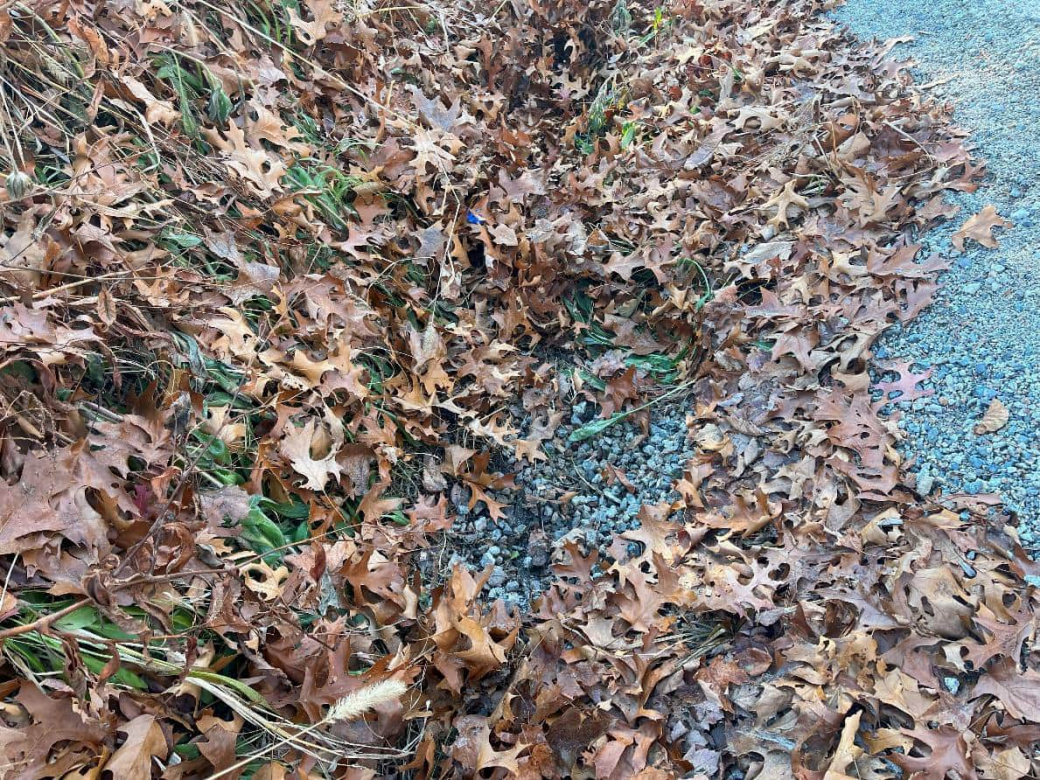
Site Location Bruce Freeman Rail Trail Right-of-Way		BETA Project No. 24.10326.23
Photo No. 3	Date: 12/6/2024

Direction Photo Taken: Toward the South		
Description: View of stone that is covered in leaf litter and requires removal from the swale at Station 172+00 to 173+00 per Compliance Action Item 53.		
Photo No. 4	Date: 12/6/2024	 
Direction Photo Taken: Toward the East		
Description: View of hydroseed with some germination along slopes at Station 172+00 to 175+00 per Compliance Action Item 6.

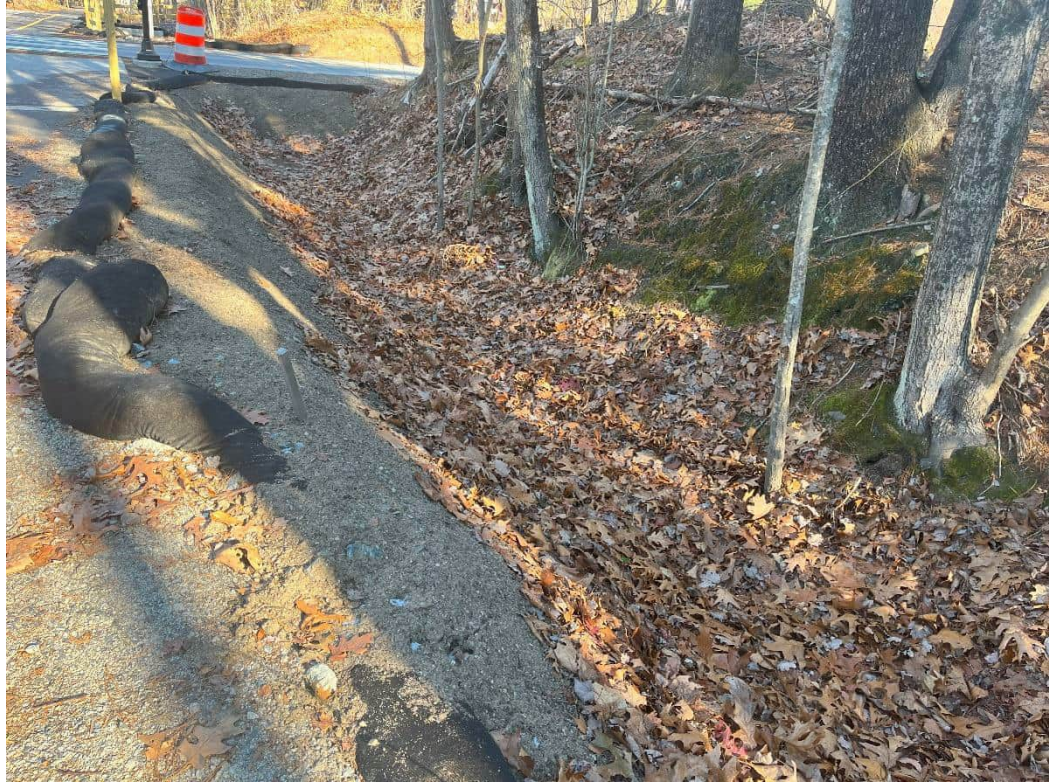
Photo No. 7 **Date:** 12/6/2024

Item	Location/ Description	Observation Date	Resolution Due Date	Recommended Resolution / Resolution Date	Comments/Updates
62	Loam and seed was applied to the streambank at Station 216+00 to 217+00 and requires further stabilization Priority: High	11/25/2024	12/2/2024	An erosion control blanket should be installed along this slope.	12/2/2024 - Loam and seed have been applied to the streambank at Station 215+00. Stabilization is required at Stations 215+00 to 217+00. 12/6/2024 - Observation remains. See previous update.
53	Stone was observed requiring removal from the swale on the east side of the trail at Station 172+00 to 173+00 Priority: High	7/29/2024	8/6/2024	Remove stone from the swale.	8/5/2024 - Observation remains. 8/7/2024 - Observation remains. 8/12/2024 - Observation remains. Material was observed to have migrated within the swale to Station 173+50. 8/16/2024 - Stone is still present within the swale. 8/20/2024 - Observation remains. Crushed stone has migrated further down the swale to Station 171+50. 8/27/2024 - Observation remains. Stone is still present within the swale. 9/3/2024 - Observation remains. 9/10/2024 - Observation remains. Stone is still present within the swale. 9/16/2024 - Observation remains. The contractor indicated that the stone within the swale would be hand removed. 9/23/2024 - Observation remains. 9/27/2024 - Observation remains. It appears as though some stone has migrated further south down the swale. 10/4/2024 - Observation remains. Stone is still present within the swale. 10/8/2024 - Observation remains. 10/15/2024 - Observation remains. Stone is covered with vegetation in some areas. 10/22/2024 - Observation remains. Stone is covered with vegetation in some areas. 10/29/2024 - Observation remains. 11/5/2024 - Observation remains. 11/12/2024 - Leaf litter has completely covered the stone in this location. The Contractor should indicate if stone has been removed from this location. 11/19/2024 - See previous update. 11/22/2024 - Observation remains. Stone is still present within the swale and requires removal. Leaf litter is currently covering a majority of the stone. 11/25/2024 - Observation remains. Leaf litter is covering a majority of the stone. 12/2/2024 - Observation remains. Stone is present within the swale under leaf litter. 12/6/2024 - Observation remains. See previous update.

View of newly placed loam that requires stabilization at Station 215+00 per Compliance Action Item 62.

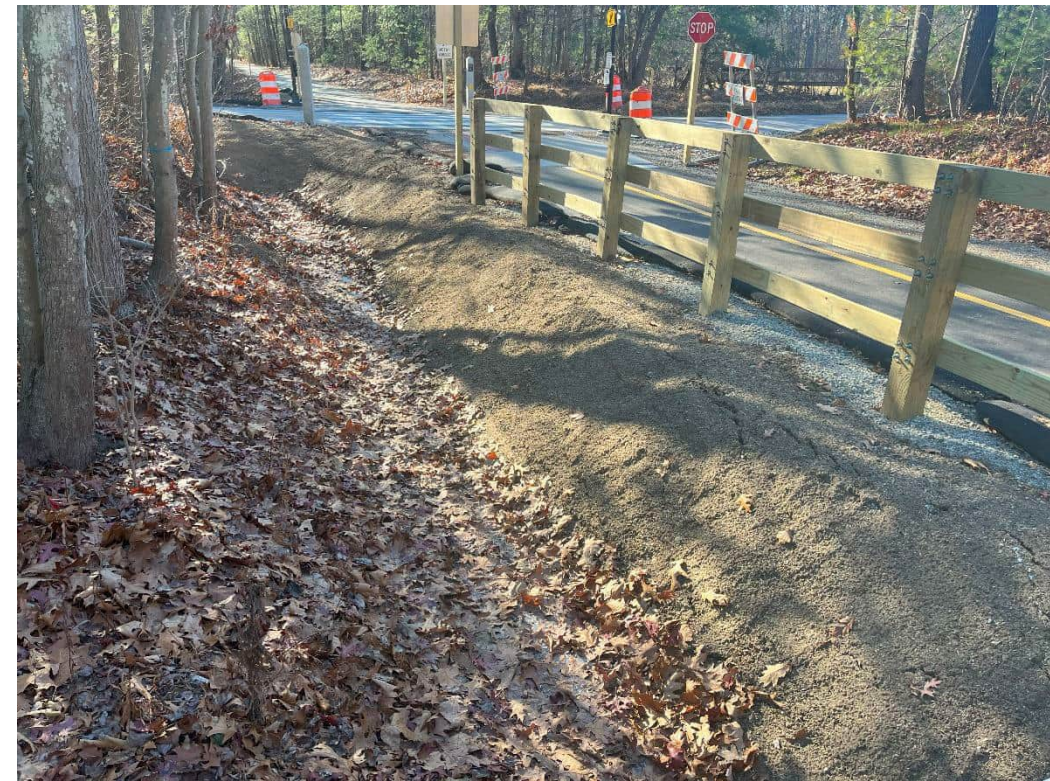
Photo No. 8 **Date:** 12/6/2024

41	Stream Bank has been regraded beyond the limit of work at Station 216+00 Priority: High	5/28/2024	6/4/2024	The Contractor should confirm if this work was permitted by the Conservation Commission, as it does not appear to be a part of the approved plans/impacts. MassDOT should be consulted on next steps regarding notification and potential restoration.	<p>5/31/2024 - Observation remains. 6/7/2024 - Observation remains. 6/14/2024 - Observation remains. 6/17/2024 - Observation remains. 6/24/2024 - Observation remains. 6/27/2024 - Observation remains. 7/8/2024 - Observation remains. 7/15/2024 - This area could not be assessed due to paving operations ongoing during the inspection. 7/22/2024 - Crushed stone and sediment continue to be discharged to the stream between Stations 215+00 and 217+00 due to overtopped and undermined compost filter tubes. 7/29/2024 - Observation remains. 8/5/2024 - Observation remains. 8/7/2024 - Observation remains. 8/12/2024 - Observation remains. Crushed stone is still present in the streambed at this location. 8/16/2024 - Observation remains. 8/20/2024 - Stone has been removed; however, additional alteration to Resource Areas beyond the limit of work continue. 8/27/2024 - Observation remains. 9/3/2024 - Observation remains. 9/10/2024 - Observation remains. Stone has been observed as discharging into the streambed in this location again. 9/16/2024 - Observation remains. 9/23/2024 - Observation remains. Stone is still present within the streambed at this location. 9/27/2024 - Observation remains. 10/4/2024 - Observation remains. 10/8/2024 - Observation remains. 10/15/2024 - Observation remains. Stone is still present within the streambed at this location. 10/22/2024 - Observation remains. Stone is still present within the streambed at this location. 10/29/2024 - Observation remains. Stone is still present within the streambed at this location. 11/5/2024 - Observation remains. The PVC pipe that was installed at this location was observed to be covered with stone and is no longer visible near Station 215+00. Stone is still present within the streambed at this location. 11/12/2024 - Observation remains. The streambed in this location is covered with leaf litter. See previous update. 11/19/2024 - Observation remains. As discussed with the Conservation Agent in the field, further coordination between the Town and MassDOT will be required to clean/repair the culvert, as the degraded condition of the culvert prompted the contractor to armor the stream banks. Further coordination will also be required for restoration of banks. 11/22/2024 - Observation remains. See previous update. 11/25/2024 - Observation remains. See update from 11/19/2024. 12/2/2024 - Observation remains. See update from 11/19/2024. 12/6/2024 - Observation remains. See update from 11/19/2024.</p>

View of the location where the stream bank has been regraded beyond the limits of work and where stabilization of the newly placed loam is required at Station 216+00 per Long Term Compliance Action Item 41 and 62.

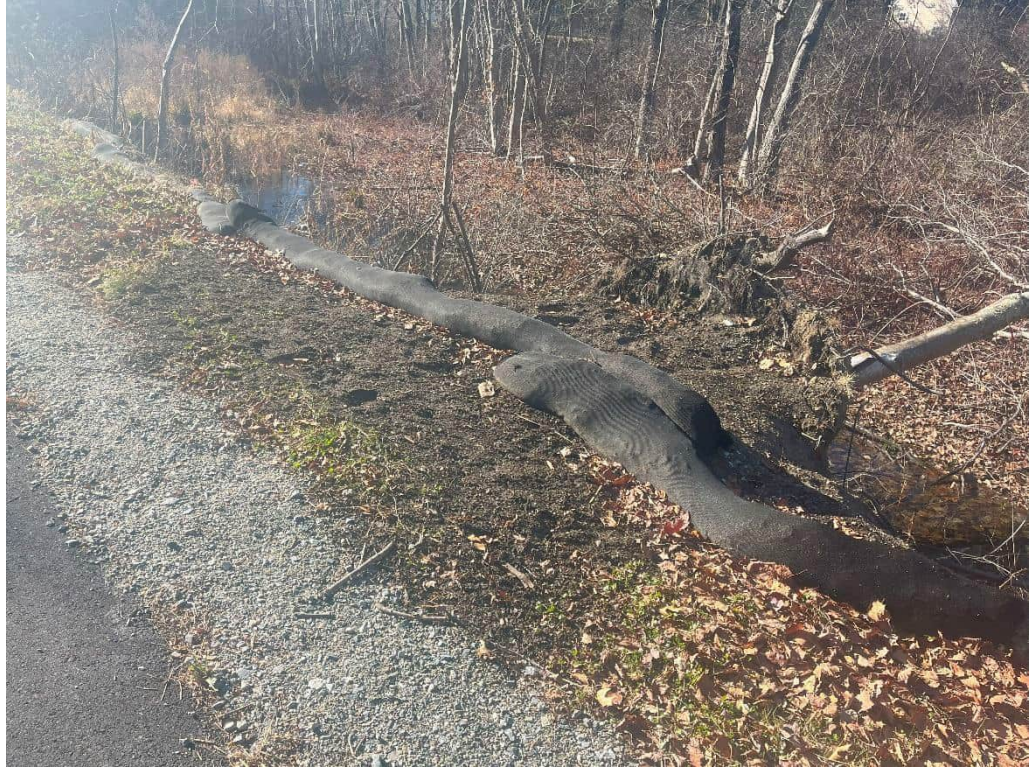
Photo No. 13 **Date:** 12/6/2024

View of placed loam that requires stabilization at Station 311+00 per Long Term Compliance Action Item 59.

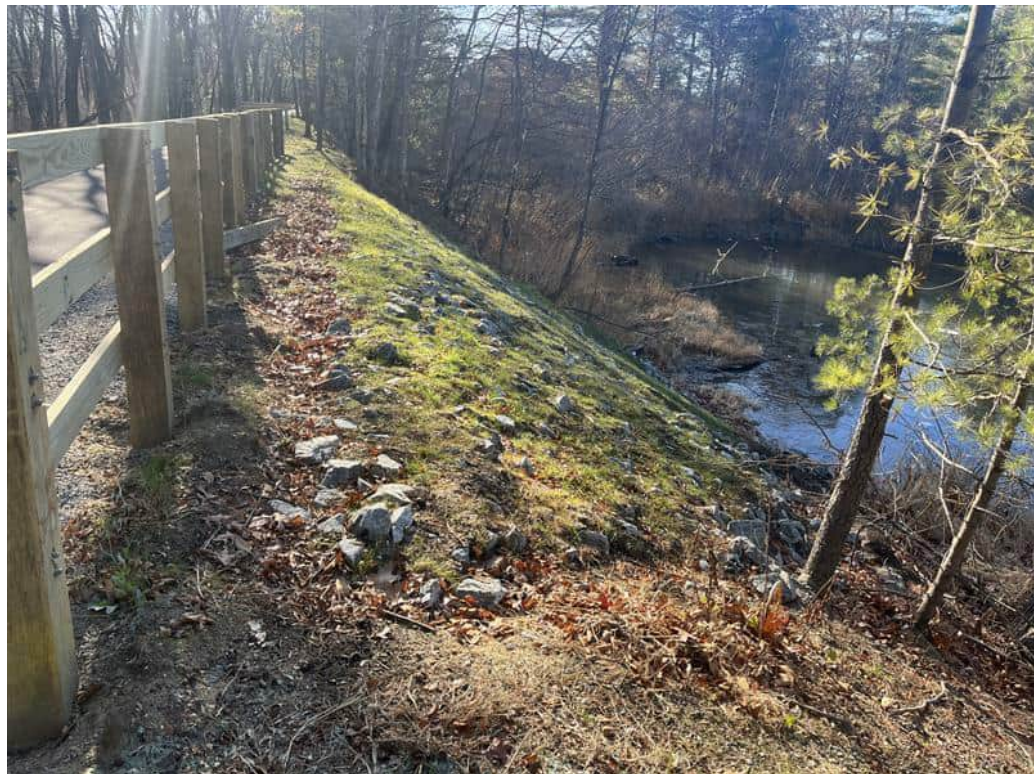
Photo No. 14 **Date:** 12/6/2024

42	<p>Riprap slope extends beyond limits of work along the WF1 Series wetland near flags 103 to 107 Priority: High</p>	5/28/2024	6/4/2024	<p>The Contractor should confirm if this work was permitted by the Conservation Commission, as it does not appear to be a part of the approved plans/impacts. MassDOT should be consulted on next steps regarding notification and potential restoration.</p>	<p>5/31/2024 - Observation remains. 6/7/2024 - Observation remains. 6/14/2024 - Riprap slope has been altered and active construction is repairing the area. 6/17/2024 - During this inspection, additional work in support of the repair/potential replacement of an underlying pipe has been ongoing. It is recommended that the contractor confirm that they have coordinated with the Conservation Commission for this work and provide a restoration plan for the area once work is complete. 6/24/2024 - During this inspection, BETA was informed that the existing cast iron pipe was replaced with a new concrete 12-inch reinforced concrete pipe. It appears that riprap was replaced along the side slopes to mirror conditions observed prior to this inspection. 6/27/2024 - During this inspection, the area was observed to have been rolled and prepared for paving. Hydroseed was applied and plantings were installed. 7/8/2024 - Germination was observed and the area will be monitored for stabilization. See previous updates regarding Conservation Commission coordination. 7/15/2024 - This area could not be assessed due to paving operations ongoing during the inspection. 7/22/2024 - See previous updates regarding Conservation Commission coordination. 7/29/2024 - Observation remains. 8/5/2024 - Observation remains. 8/7/2024 - Observation remains. 8/12/2024 - Observation remains. Regrowth of vegetation has been observed in this area and will continue to be monitored. 8/16/2024 - Observation remains. 8/20/2024 - Observation remains. 8/27/2024 - Observation remains. 9/3/2024 - Observation remains. 9/10/2024 - Observation remains. 9/16/2024 - Observation remains. 9/23/2024 - Observation remains. 9/27/2024 - Observation remains. 10/4/2024 - Observation remains. 10/8/2024 - Observation remains. 10/15/2024 - Observation remains. 10/22/2024 - Observation remains. 10/29/2024 - Observation remains. 11/5/2024 - Observation remains. 11/12/2024 - Observation remains. The timber fence has been installed upgradient of this area. 11/19/2024 - Observation remains. As discussed with the Conservation Agent in the field, an as-built should be prepared for this area to quantify any additional impacts that may be addressed through a permit amendment. 11/22/2024 - Observation remains. See previous update. 11/25/2024 - Observation remains. See update from 11/19/2024. 12/2/2024 - Observation remains. See update from 11/19/2024. 12/6/2024 - Observation remains. See update from 11/19/2024.</p>

View of the riprap slope that extends beyond the limit of work along the WF1 Series wetland and hydroseed with no germination at Station 332+00 per Long Term Compliance Action Item 42.
