**Environmental Monitor Construction Site Inspection Report  
MassDOT Project #608164 Construction Contract # 119678  
EM Report #38**

Project Description: Bruce Freeman Rail Trail Right-of-Way  
Permit Description(s): Order of Conditions (MGL Chapter 131, Section 40 and 310 CMR 10.00, Mass DEP File No. 301-1362); 2022 EPA NPDES General Permit for Discharges from Construction Areas; U.S. Army Corps of Engineers Permit No NAE-2021-01975.

Project Name:	Bruce Freeman Rail Trail - Phase 2d - Sudbury
Date of Inspections:	12/12/2024
Bi Weekly/ Monthly Period Covered:	December Weekly Inspection #3
Inspector's Name(s):	Anna Haznar
Inspectors' Contact Information:	<a href="mailto:ahaznar@beta-inc.com">ahaznar@beta-inc.com</a>

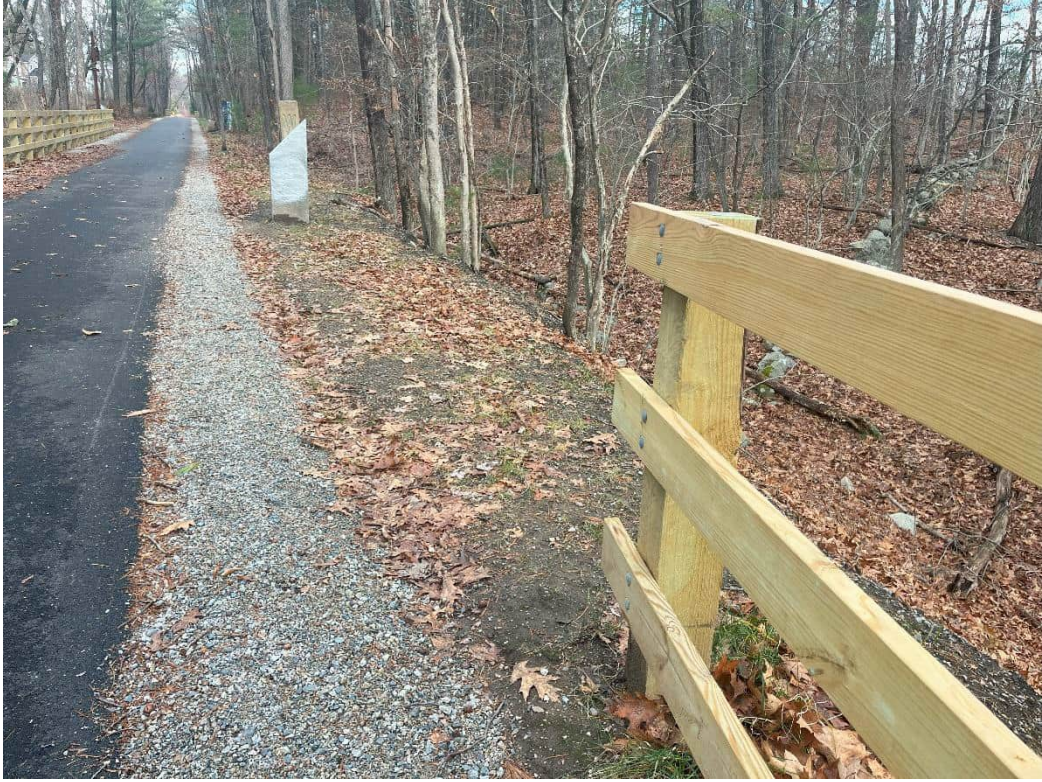
**Photo No. 3**     **Date:**  
12/12/2024

View of exposed soil Station 165+00 that requires stabilization per Long Term Compliance Action Item 59.

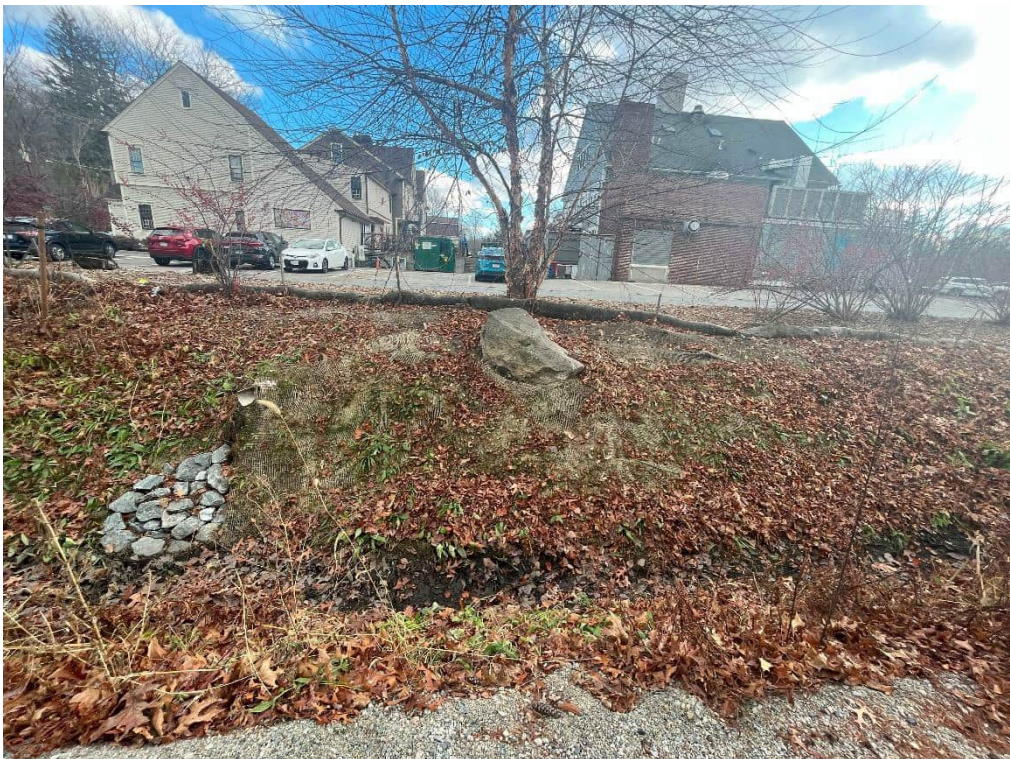
**Photo No. 4**     **Date:**  
12/12/2024

View of hydroseed with some germination along slopes at Station 172+00 to 175+00 per Compliance Action Item 6.

6	Exposed sediment slope at Station 172+00 to 175+00 <b>Priority: High</b>	5/8/2024	5/15/2024	Install temporary sediment controls along the slope such as jute netting and/or straw following the application of seed.	<p>5/16/2024 - Observation remains.  5/21/2024 - Observation remains.  5/28/2024 - Partial germination was observed.  5/31/2024 - See previous update.  6/7/2024 - Further earthwork has occurred and soils require stabilization.  6/14/2024 - Observation remains.  6/17/2024 - Observation remains.  6/24/2024 - Observation remains.  6/27/2024 - The area has been regraded and loam has been spread. New trees have been planted upgradient of the swale. Stabilization is still required.  7/8/2024 - Jute netting has been installed over the applied seed, and the area will be monitored for germination.  7/15/2024 - See previous update.  7/22/2024 - Observation remains.  7/29/2024 - Observation remains.  8/5/2024 - Observation remains.  8/7/2024 - Regrowth of vegetation was observed in this location. This item will remain open until stabilization has been completed.  8/12/2024 - Observation remains.  8/16/2024 - Observation remains.  8/20/2024 - Application of the approved seed mixture is required at this location.  8/27/2024 - Observation remains.  9/3/2024 - Vegetation that is present in this location generally consists of lady's thumb smartweed, a non-native species. Removal of non-native species and application of the approved seed mixture is required at this location.  9/16/2024 - See previous update.  9/23/2024 - Observation remains. See 9/3/2024 update.  9/27/2024 - Observation remains. The contractor reached out hydroseed has been applied to this area.  10/4/2024 - Hydroseed has been applied to this area; the hydroseed was observed to have been applied over the erosion control blanket that is located in this area. Once vegetation has sufficiently stabilized this area the item will be closed. The contractor should provide the tag from the seed mix that was used to the Conservation Commission to ensure that the required native seed mix was used per the design plans.  10/8/2024 - Observation remains. See update from 10/4/2024.  10/15/2024 - Observation remains. See update from 10/4/2024.  10/22/2024 - Observation remains. See update from 10/4/2024.  10/29/2024 - Observation remains. No germination has been observed in this location since the application of hydroseed. See update from 10/4/2024.  11/5/2024 - Observation remains. Some germination has been observed but the area is not considered stabilized.  11/12/2024 - Observation remains.  11/19/2024 - Germination has been observed in this location but it has not fully stabilized.  11/22/2024 - Observation remains. See previous update.  11/25/2024 - Observation remains. See update from 11/19/2024.  12/2/2024 - Observation remains. See update for 11/19/2024.  12/6/2024 - Observation remains. See update for 11/19/2024.  12/12/2024 - Observation remains. Some germination has been observed within this location. Observation will remain open until stabilization is complete.</p>

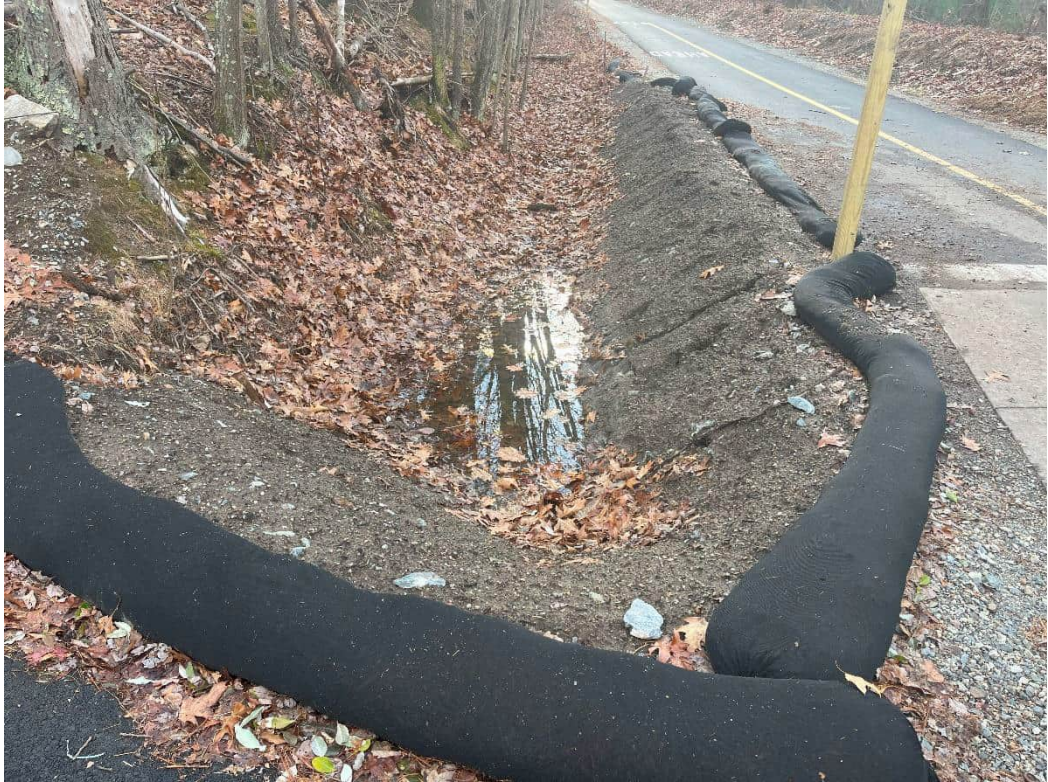
**Photo No. 7**     **Date:** 12/12/2024

View of loam that requires stabilization at Station 215+00 per Compliance Action Item 62. Note rill erosion is occurring in this area.

Item	Location/ Description	Observation Date	Resolution Due Date	Recommended Resolution / Resolution Date	Comments/Updates
62	Loam and seed was applied to the streambank at Station 216+00 to 217+00 and requires further stabilization <b>Priority: High</b>	11/25/2024	12/2/2024	An erosion control blanket should be installed along this slope.	12/2/2024 - Loam and seed have been applied to the streambank at Station 215+00. Stabilization is required at Stations 215+00 to 217+00. 12/6/2024 - Observation remains. See previous update. 12/12/2024 - Observation remains. Rill erosion was observed within the loam applied to this area from Station 215+00 to 216+00.
53	Stone was observed requiring removal from the swale on the east side of the trail at Station 172+00 to 173+00 <b>Priority: High</b>	7/29/2024	8/6/2024	Remove stone from the swale.	8/5/2024 - Observation remains. 8/7/2024 - Observation remains. 8/12/2024 - Observation remains. Material was observed to have migrated within the swale to Station 173+50. 8/16/2024 - Stone is still present within the swale. 8/20/2024 - Observation remains. Crushed stone has migrated further down the swale to Station 171+50. 8/27/2024 - Observation remains. Stone is still present within the swale. 9/3/2024 - Observation remains. 9/10/2024 - Observation remains. Stone is still present within the swale. 9/16/2024 - Observation remains. The contractor indicated that the stone within the swale would be hand removed. 9/23/2024 - Observation remains. 9/27/2024 - Observation remains. It appears as though some stone has migrated further south down the swale. 10/4/2024 - Observation remains. Stone is still present within the swale. 10/8/2024 - Observation remains. 10/15/2024 - Observation remains. Stone is covered with vegetation in some areas. 10/22/2024 - Observation remains. Stone is covered with vegetation in some areas. 10/29/2024 - Observation remains. 11/5/2024 - Observation remains. 11/12/2024 - Leaf litter has completely covered the stone in this location. The Contractor should indicate if stone has been removed from this location. 11/19/2024 - See previous update. 11/22/2024 - Observation remains. Stone is still present within the swale and requires removal. Leaf litter is currently covering a majority of the stone. 11/25/2024 - Observation remains. Leaf litter is covering a majority of the stone. 12/2/2024 - Observation remains. Stone is present within the swale under leaf litter. 12/6/2024 - Observation remains. See previous update. 12/12/2024 - Observation remains. Stone is present within the swale under the leaf litter.

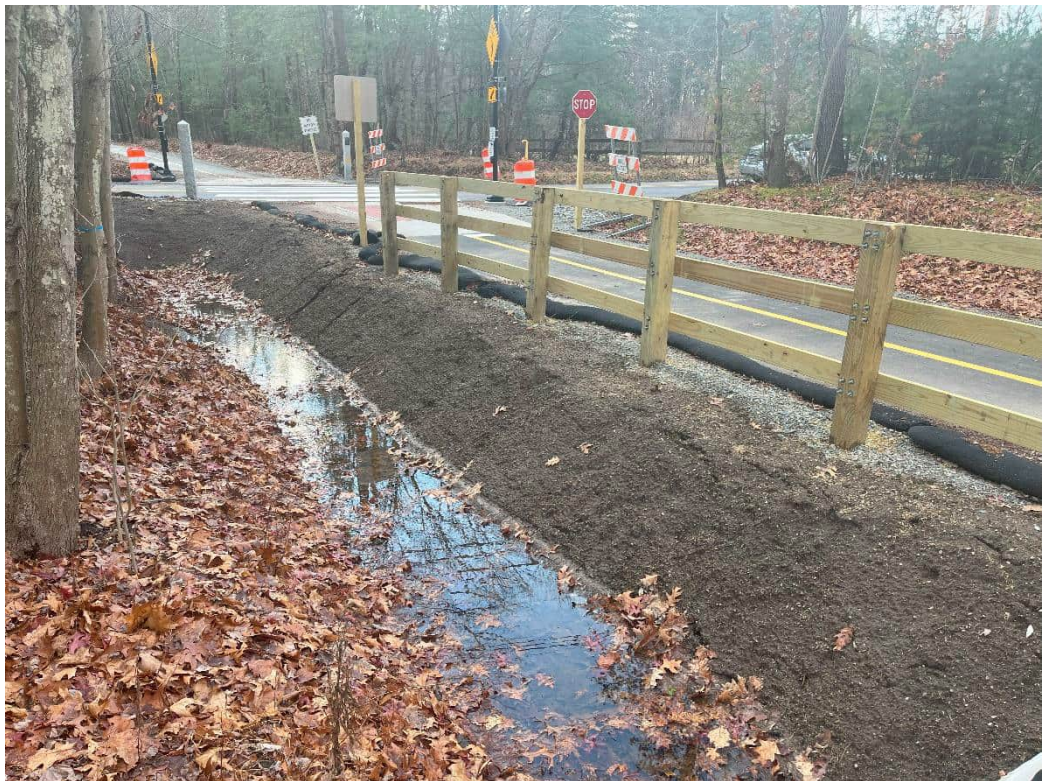
**Photo No. 8**     **Date:** 12/12/2024

View of the location where the stream bank has been regraded beyond the limits of work and stabilization of loam is required at Station 216+00 per Long Term Compliance Action Item 41 and 62. Note rill erosion is occurring in this area.

41	Stream Bank has been regraded beyond the limit of work at Station 216+00 <b>Priority: High</b>	5/28/2024	6/4/2024	The Contractor should confirm if this work was permitted by the Conservation Commission, as it does not appear to be a part of the approved plans/impacts. MassDOT should be consulted on next steps regarding notification and potential restoration.	<p>5/31/2024 - Observation remains.  6/7/2024 - Observation remains.  6/14/2024 - Observation remains.  6/17/2024 - Observation remains.  6/24/2024 - Observation remains.  6/27/2024 - Observation remains.  7/8/2024- Observation remains.  7/15/2024 - This area could not be assessed due to paving operations ongoing during the inspection.  7/22/2024 - Crushed stone and sediment continue to be discharged to the stream between Stations 215+00 and 217+00 due to overtopped and undermined compost filter tubes.  7/29/2024 - Observation remains.  8/5/2024 - Observation remains.  8/7/2024 - Observation remains.  8/12/2024 - Observation remains. Crushed stone is still present in the streambed at this location.  8/16/2024 - Observation remains.  8/20/2024 - Stone has been removed; however, additional alteration to Resource Areas beyond the limit of work continue.  8/27/2024 - Observation remains.  9/3/2024 - Observation remains.  9/10/2024 - Observation remains. Stone has been observed as discharging into the streambed in this location again.  9/16/2024 - Observation remains.  9/23/2024 - Observation remains. Stone is still present within the streambed at this location.  9/27/2024 - Observation remains.  10/4/2024 - Observation remains.  10/8/2024 - Observation remains.  10/15/2024 - Observation remains. Stone is still present within the streambed at this location.  10/22/2024 - Observation remains. Stone is still present within the streambed at this location.  10/29/2024 - Observation remains. Stone is still present within the streambed at this location.  11/5/2024 - Observation remains. The PVC pipe that was installed at this location was observed to be covered with stone and is no longer visible near Station 215+00. Stone is still present within the streambed at this location.  11/12/2024 - Observation remains. The streambed in this location is covered with leaf litter. See previous update.  11/19/2024 - Observation remains. As discussed with the Conservation Agent in the field, further coordination between the Town and MassDOT will be required to clean/repair the culvert, as the degraded condition of the culvert prompted the contractor to armor the stream banks. Further coordination will also be required for restoration of banks.  11/22/2024 - Observation remains. See previous update.  11/25/2024 - Observation remains. See update from 11/19/2024.  12/2/2024 - Observation remains. See update from 11/19/2024.  12/6/2024 - Observation remains. See update from 11/19/2024.  12/12/2024 - Observation remains. See update from 11/19/2024.</p>

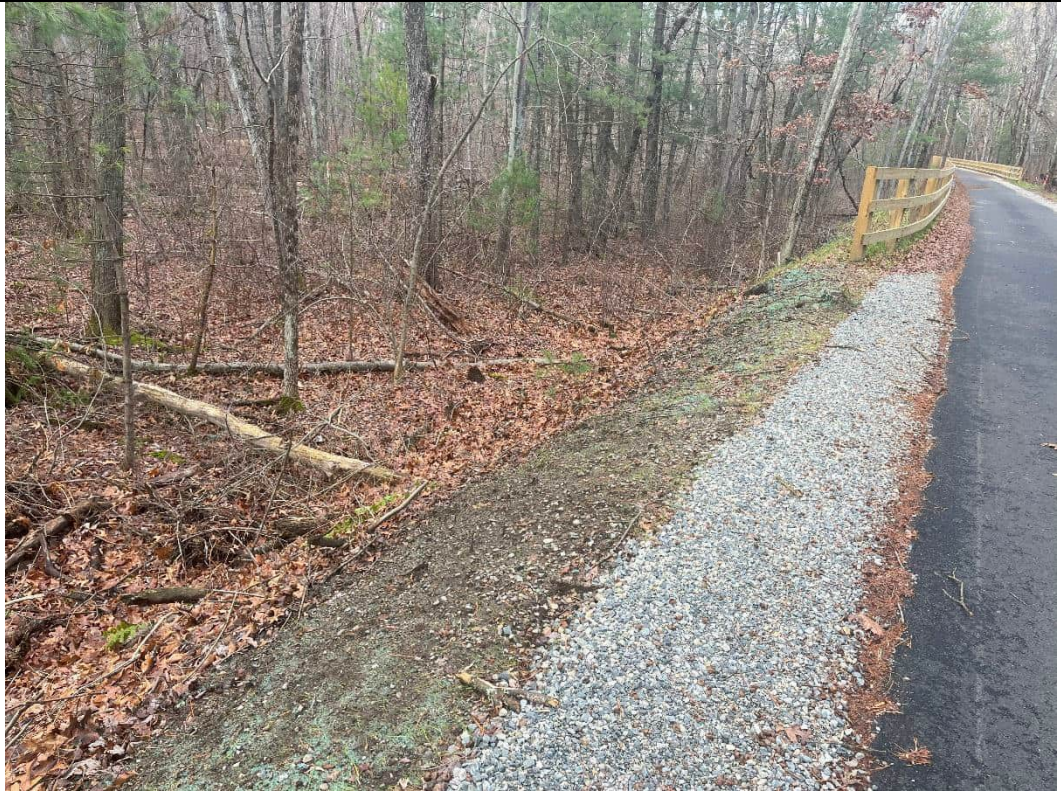
**Photo No. 11**    **Date:** 12/12/2024

View of the location where hydroseed has been applied at Station 224+00 per Long Term Compliance Action Item 59 and Compliance Action Item 32.

32	<p>Soil and organic debris has been placed within the wetland between wetland flagging WF#23-119 and WF#23-118 at Station 224+00  <b>Priority: High</b></p>	5/21/2024	5/28/2024	<p>Remove all material and provide stabilization of the area with the approved wetland seed mixture. Straw should also be placed for interim stabilization.</p>	<p>5/28/2024 - Observation remains.  5/31/2024 - Observation remains.  6/7/2024 - Observation remains.  6/14/2024 - Observation remains.  6/17/2024 - This area has been hydroseeded multiple times, but the debris should also be removed from the downgradient wetland.  6/24/2024 - Observation remains.  6/27/2024 - Observation remains. The area was hydroseeded again.  7/8/2024 - Germination was observed and the area will be monitored for stabilization.  7/15/2024 - See previous update.  7/22/2024 - Observation remains.  7/29/2024 - Observation remains.  8/5/2024 - Observation remains.  8/7/2024 - Regrowth of vegetation has been observed in this area. This item will remain open until the area is fully stabilized. Debris is still present in wetland and requires removal.  8/12/2024 - Observation remains.  8/16/2024 - Observation remains.  8/20/2024 - Debris is still present within the wetland.  8/27/2024 - Observation remains.  9/3/2024 - Debris is still present in the wetland and slopes upgradient of the wetland require stabilization.  9/10/2024 - Observation remains.  9/16/2024 - Debris has been removed from the wetland; however, soils require stabilization.  9/23/2024 - Observation remains. Soils require stabilization at this location.  9/27/2024 - Observation remains. The contractor indicated hydroseed will be applied to this area soon.  10/4/2024 - Observation remains. Hydroseed has not been applied to this area.  10/8/2024 - Observation remains. Hydroseed has not been applied to this area.  10/15/2024 - Observation remains. Hydroseed has not been applied to this area.  10/22/2024 - Observation remains. Hydroseed has not been applied to this area.  10/29/2024 - Observation remains. Hydroseed has not been applied to this area.  10/29/2024 - Observation remains. Hydroseed has not been applied to this area.  11/5/2024 - Observation remains. Hydroseed has not been applied to this area.  11/12/2024 - Observation remains.  11/19/2024 - Hydroseed has been applied to this location. Once the area has become stabilized this action item will be closed.  11/22/2024 - Observation remains. No germination has been observed in this area.  11/25/2024 - Observation remains. No germination has been observed in this area.  12/2/2024 - Observation remains. No germination has been observed in this area.  12/6/2024 - Observation remains. No germination has been observed in this area.  12/12/2024 - Observation remains. Some germination has been observed within this location. Observation will remain open until stabilization is complete.</p>

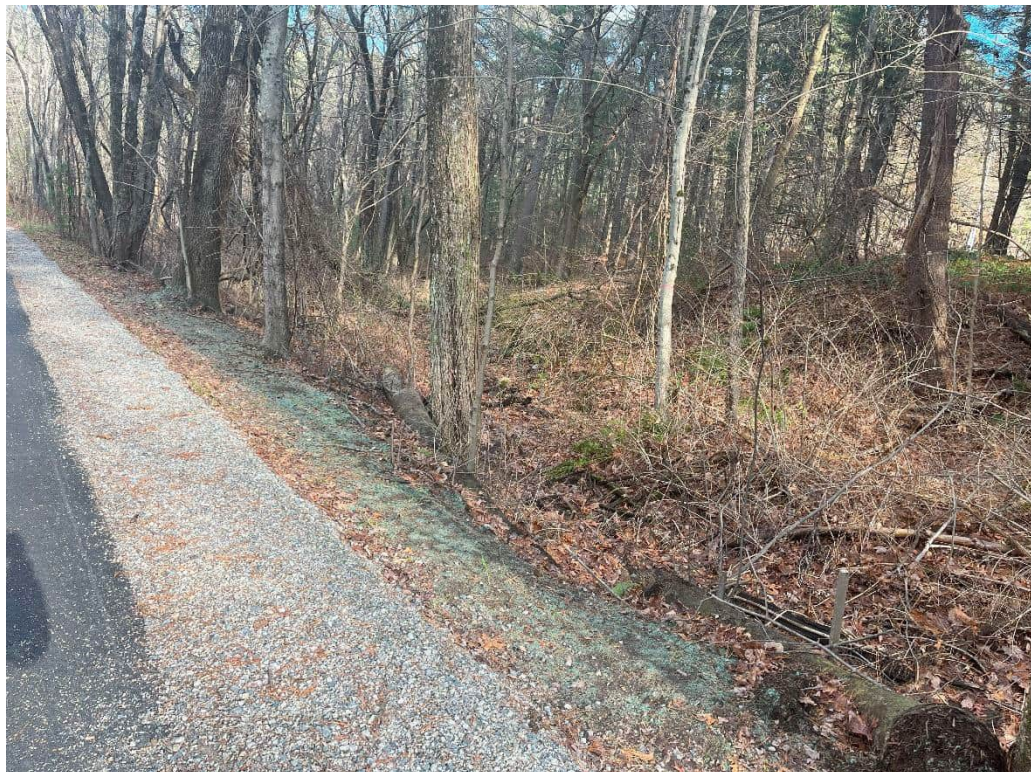
**Photo No. 12**    **Date:** 12/12/2024

View of another location where hydroseed has been applied at Station 226+00 per Long Term Compliance Action Item 59.

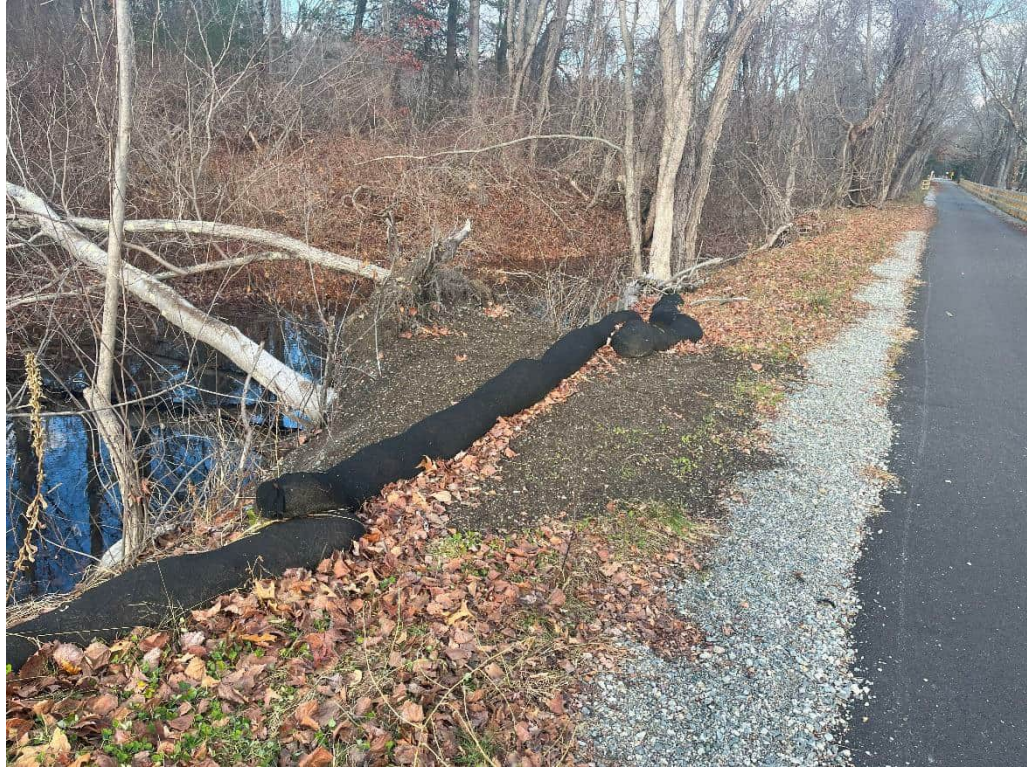
**Photo No. 13**    **Date:** 12/12/2024

View of placed loam that requires stabilization at Station 311+00 per Long Term Compliance Action Item 59.

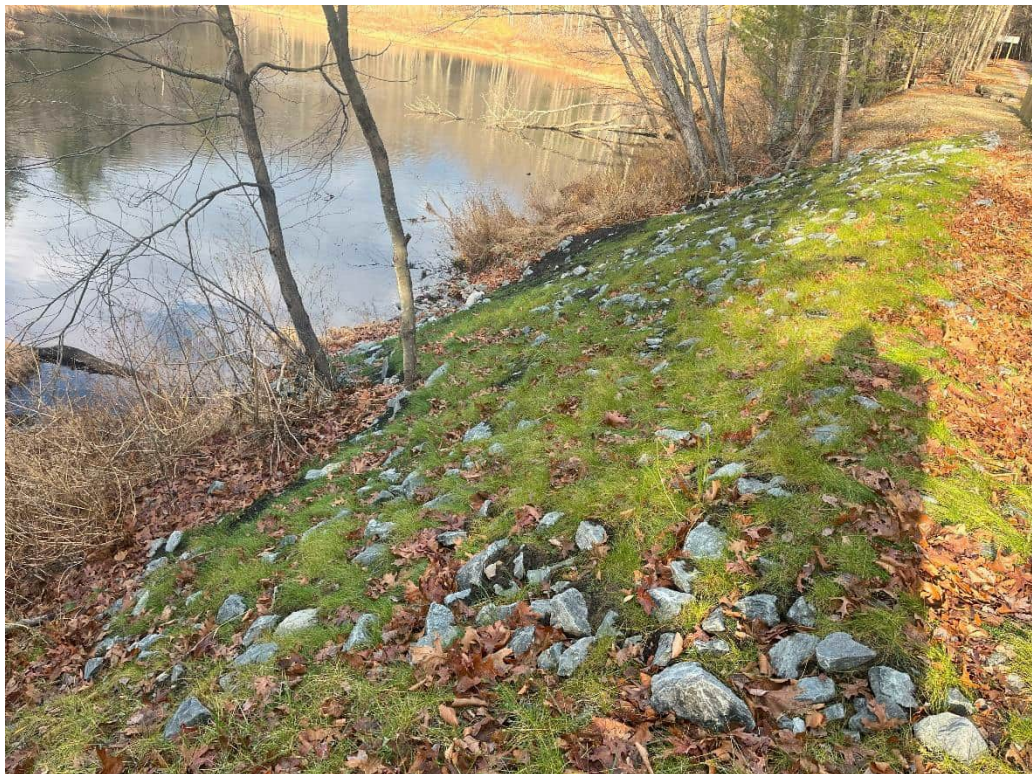
**Photo No. 14**    **Date:** 12/12/2024

View of the riprap slope that extends beyond the limit of work along the WF1 Series wetland at Station 332+00 per Long Term Compliance Action Item 42.

42	Riprap slope extends beyond limits of work along the WF1 Series wetland near flags 103 to 107 <b>Priority: High</b>	5/28/2024	6/4/2024	The Contractor should confirm if this work was permitted by the Conservation Commission, as it does not appear to be a part of the approved plans/impacts. MassDOT should be consulted on next steps regarding notification and potential restoration.	<p>5/31/2024 - Observation remains.</p> <p>6/7/2024 - Observation remains.</p> <p>6/14/2024 - Riprap slope has been altered and active construction is repairing the area.</p> <p>6/17/2024 - During this inspection, additional work in support of the repair/potential replacement of an underlying pipe has been ongoing. It is recommended that the contractor confirm that they have coordinated with the Conservation Commission for this work and provide a restoration plan for the area once work is complete.</p> <p>6/24/2024 - During this inspection, BETA was informed that the existing cast iron pipe was replaced with a new concrete 12-inch reinforced concrete pipe. It appears that riprap was replaced along the side slopes to mirror conditions observed prior to this inspection.</p> <p>6/27/2024 - During this inspection, the area was observed to have been rolled and prepared for paving. Hydroseed was applied and plantings were installed.</p> <p>7/8/2024 - Germination was observed and the area will be monitored for stabilization. See previous updates regarding Conservation Commission coordination.</p> <p>7/15/2024 - This area could not be assessed due to paving operations ongoing during the inspection.</p> <p>7/22/2024 - See previous updates regarding Conservation Commission coordination.</p> <p>7/29/2024 - Observation remains.</p> <p>8/5/2024 - Observation remains.</p> <p>8/7/2024 - Observation remains.</p> <p>8/12/2024 - Observation remains. Regrowth of vegetation has been observed in this area and will continue to be monitored.</p> <p>8/16/2024 - Observation remains.</p> <p>8/20/2024 - Observation remains.</p> <p>8/27/2024 - Observation remains.</p> <p>9/3/2024 - Observation remains.</p> <p>9/10/2024 - Observation remains.</p> <p>9/16/2024 - Observation remains.</p> <p>9/23/2024 - Observation remains.</p> <p>9/27/2024 - Observation remains.</p> <p>10/4/2024 - Observation remains.</p> <p>10/8/2024 - Observation remains.</p> <p>10/15/2024 - Observation remains.</p> <p>10/22/2024 - Observation remains.</p> <p>10/29/2024 - Observation remains.</p> <p>11/5/2024 - Observation remains.</p> <p>11/12/2024 - Observation remains. The timber fence has been installed upgradient of this area.</p> <p>11/19/2024 - Observation remains. As discussed with the Conservation Agent in the field, an as-built should be prepared for this area to quantify any additional impacts that may be addressed through a permit amendment.</p> <p>11/22/2024 - Observation remains. See previous update.</p> <p>11/25/2024 - Observation remains. See update from 11/19/2024.</p> <p>12/2/2024 - Observation remains. See update from 11/19/2024.</p> <p>12/6/2024 - Observation remains. See update from 11/19/2024.</p> <p>12/12/2024 - Observation remains. See update from 11/19/2024.</p>
