Environmental Monitor Construction Site Inspection Report MassDOT Project #608164 Construction Contract # 119678 EM Report #39

Project Description: Bruce Freeman Rail Trail Right-of-Way

Project Name:	Bruce Freeman Rail Trail - Phase 2d - Sudbury			
Date of Inspections:	ttions: 12/20/2024			
Bi Weekly/ Monthly Period Covered:	eekly/ Monthly Period Covered: December Weekly Inspection #4			
Inspector's Name(s):	Anna Haznar			
Inspectors' Contact Information:	ahaznar@beta-inc.com

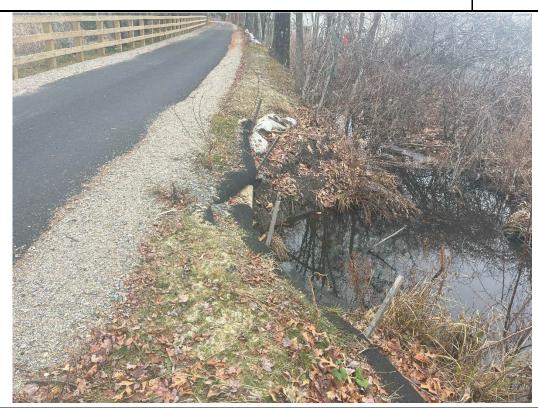
Photo Date: No. 1 12/20

View of the overtopped compost filter tube beyond the limits of work at Station 105+00 per Compliance Action Item 43.

43	Overtopped compost filter tubes and exposed soils beyond the limits of work at Station 105+00 Priority: High	6/7/2024		Stabilize the area with the approved seed mixture and provide interim stabilization such as straw mulch.	6/14/2024 - Observation remains. 6/14/2024 - Observation remains. 6/24/2024 - Observation remains. 6/24/2024 - Observation remains. 7/15/2024 - Observation remains. 7/15/2024 - Observation remains. 7/22/2024 - Observation remains. 7/22/2024 - Observation remains. 7/29/2024 - Observation remains. 8/5/2024 - Observation remains. 8/5/2024 - Observation remains. 8/1/2024 - Observation remains. 9/12/2024 - Observation remains. 9/12/2024 - Observation remains. 9/12/2024 - Observation remains. 9/10/2024 - Observation remains. 9/23/2024 - Observation remains. 9/23/2024 - Observation remains. 10/4/2024 - Hydroseed has been applied here; however, the contractor should provide an update on long-term slope stabilization plans. 10/4/2024 - Observation remains. Germination has not been observed. 10/15/2024 - Observation remains. Germination has not been observed but the area is not considered stabilized. 10/29/2024 - Observation remains. Some germination has been observed but the area is not considered stabilized. 10/29/2024 - Observation remains. Some germination has been observed but the area is not considered stabilized. 11/2/2024 - Observation remains. Soed has stabilized the area. 11/12/2024 - Observation remains. See pudate from 11/19/2024. 11/12/2024 - Observation remains. See previous update. 11/12/2024 - Observation remains. See update from 11/19/2024. 12/2/2024 - Observation remains. See update from 11/19/2024.

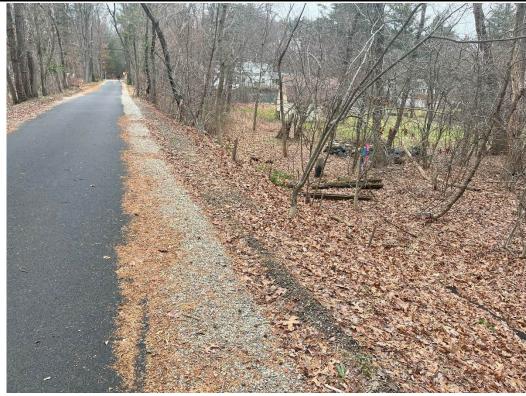
Photo No. 2 Date: 12/20/2024

View of exposed soil Station 139+00 that requires stabilization per Long Term Compliance Action Item 59.

59	Multiple locations of exposed soils along the Project corridor require stabilization Priority: High	9/3/2024	9/10/2024	The contactor should apply the approved seed mixture to areas of exposed soils and place straw.	9/3/2024 - Herbicide application caused multiple areas along the path to be no longer stabilized. If thatch is present in these locations the thatch should be removed before seeding occurs. A location near Station 320+50 has been cleared outside of the limit of work and requires stabilization. Other areas along the path where seed did not germinate should be reseeded with the approved seed mix and straw should be placed on the areas of exposed soil. 9/10/2024 - Observation remains, see previous update. A few locations along the trail have been hydroseeded but a majority of the locations of exposed soil require seed and stabilization. 9/16/2024 - Observation remains. The contactor indicated areas of bare soil will be hydroseeded. 9/23/2024 - Observation remains. It does not appear as though any hydroseeding has been done since the last inspection. Areas throughout the trail require removal of thatch and application of seed for stabilization. 9/21/2024 - Observation remains. The contractor reached out and indicated all areas of exposed soils south of Hudson Road were not seeded using hydroseed; hydroseed was applied in a few locations, but there are still large areas of exposed soil both south and north of Hudson Road that require seeding. That has not removed in any areas before hydroseed was applied. The contractor should provide the tag from the seed mix that was used to the Conservation Commission to ensure that the required native seed mix was used to the Conservation Commission to ensure that the required native seed mix was used to the Conservation and the form 10/4/2024. No additional hydroseed has been applied since the last inspection. No germination has been observed in areas where hydroseed was applied. 10/23/2024 - Observation remains. See update from 10/4/2024. No additional hydroseed has been applied since the last inspection. No germination has been observed in a few locations where hydroseed has been applied since the last inspection. Sone germination has been observed in a few locations where

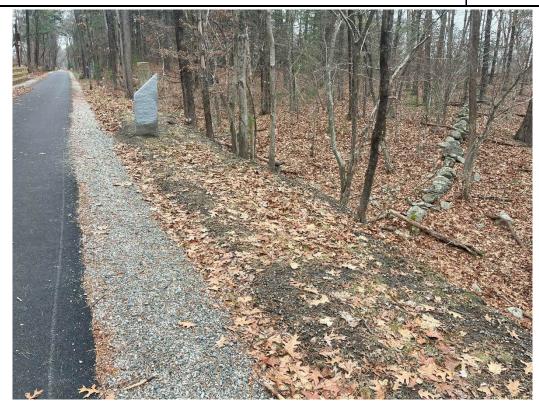
Photo Date: No. 3

View of exposed soil Station 165+00 that requires stabilization per Long Term Compliance Action Item 59.

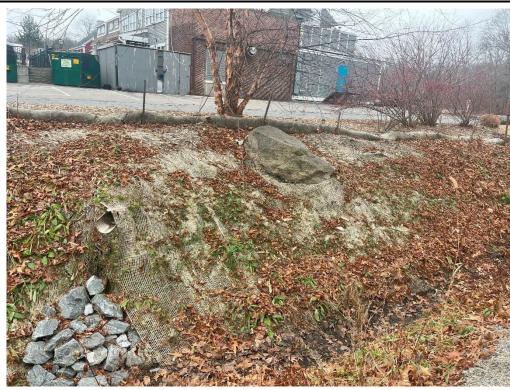
Photo No. 4

View of hydroseed with some germination along slopes at Station 172+00 to 175+00 per Compliance Action Item 6.

6	Exposed sediment slope at Station 172+00 to 175+00 Priority: High	5/8/2024	5/15/2024	Install temporary sediment controls along the slope such as jute netting and/or straw following the application of seed.	5/16/2024 - Observation remains. 5/21/2024 - Observation remains. 5/21/2024 - Observation remains. 5/21/2024 - Observation remains. 6/3/2024 - See previous update. 6/3/2024 - Observation remains. 6/14/2024 - Observation remains. 6/24/2024 - Observation remains. 6/24/2024 - Observation remains. 6/24/2024 - Observation remains. 6/24/2024 - Observation is still required. 7/8/2024 - Inter earthwork has been regraded and loam has been spread. New trees have been planted upgradient of the swales. Stabilization is still required. 7/8/2024 - Interecting has been installed over the applied seed, and the area will be monitored for germination. 7/15/2024 - See previous update. 7/22/2024 - Observation remains. 8/2/2024 - Observation remains. 8/3/2024 - Observation remains. 9/3/2024 - Observation remains. 9/3/2024 - Observation remains. 9/3/2024 - Observation remains. 9/3/2024 - Observation remains. See place and application of the approved seed mixture is required at this location. 9/3/2024 - Observation remains. See place and application of the approved seed mixture is required at this location. 9/3/2024 - Observation remains. See place and application of the approved seed mixture is required at this location. 9/3/2024 - Observation remains. See place from 10/4/2024. 9/3/2024 - Observation remains. See update from 10/4/2024. 10/3/2024 - Observation remains. See update from 10/4/2024. 10/3/2024 - Observation remains. See updat

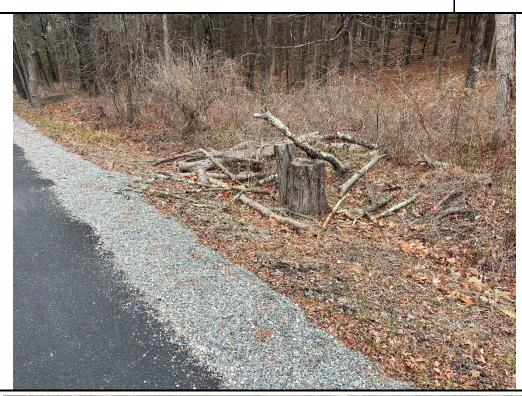
Photo Date: No. 5 12/20

View of a location where hydroseed was recently applied with no observable germination and crushed stone that requires removal at Station 180+00 per Long Term Compliance Action Item 58 and 59

Crushed stone used for the dense graded crush stone shoulders has been observed as migrating both onto the path, off the sides of the path, and into the adjacent Resource Areas throughout the Project Priority: High	8/14/2024	Remove all crushed stone from Resource Areas and develop a plan to cease discharges of stone.	8/12/2024 - Crushed stone is still present in varying amounts throughout the path and on the sides of the path. 8/16/2024 - Observation remains. 8/20/2024 - Crushed stone has been removed from some adjacent resource areas but is still observed as migrating onto and off of the path in multiple locations throughout the Project. 8/27/2024 - Crushed stone has been observed as migrating both onto the path and off the side of the path in multiple locations. Stone was observed as migrating both onto the path and off the side of the path in multiple locations. Stone was observed to have discharged to the cattle crossing at Station 190-50 and within the streambed at Station 215-00 to 216-00. Crushed stone was observed to have been placed on the root system of a fallen tree at Station 310-00 near Bank flag #84-108. 9/10/2024 - Observation remains. Crushed stone is still present within the cattle crossing, the streambed, and on the root system of the fallen tree. Crushed stone continues to migrate on to and off of the path. 9/16/2024 - Observation remains. The contractor indicated the locations where crushed stone has migrated off the path will be hand removed and crushed stone will be swept off the path prior to the opening of the trail. 9/23/2024 - Observation remains. It does not appear as though crushed stone has migrated onto or flof the path has been removed in any location along the Project. More crushed stone has migrated onto the path in varying amounts. 9/27/2024 - Observation remains. Crushed stone is still present in multiple locations on and off the sides of the path in varying amounts. 9/18/2024 - Observation remains. Crushed stone is still present in multiple locations on and off the sides of the path. 9/18/2024 - Observation remains. Crushed stone is still present in multiple locations on and off the sides of the path. 9/18/2024 - Observation remains. Crushed stone is still present in multiple locations on and off the sides of the path. 9/18/2024 - Observation remains. Crushed stone is still present in mul

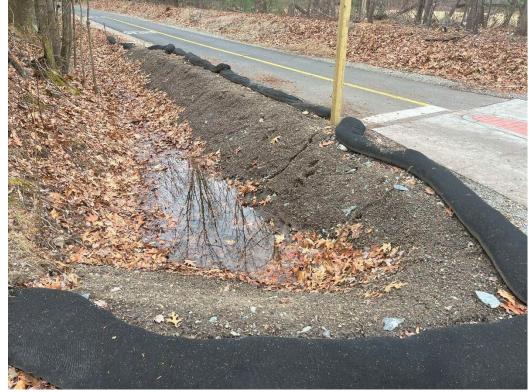
Photo Date: No. 6 12/20/2024

View of loam that requires stabilization at Station 215+00 per Compliance Action Item 62. Note rill erosion is occurring in this area.

Ite	n Location/ Description	Observation Date	Resolution Due Date	Recommended Resolution / Resolution Date	Comments/Updates
62	Loam and seed was applied to the streambank at Station 216+00 to 217+00 and requires further stabilization Priority: High	11/25/2024	12/2/2024	An erosion control blanket should be installed along this slope.	12/2/2024 - Loam and seed have been applied to the streambank at Station 215+00. Stabilization is required at Stations 215+00 to 217+00. 12/6/2024 - Observation remains. See previous update. 12/12/2024 - Observation remains. Rill erosion was observed within the loam applied to this area from Station 215+00 to 216+00. 12/20/2024 - Observation remains. Loam has begun to erode, resulting in a discharge to the stream at Station 216+50.
53	Stone was observed requiring removal from the swale on the east side of the trail at Station 172+00 to 173+00 Priority: High	7/29/2024	8/6/2024	Remove stone from the swale.	8/5/2024 - Observation remains. 8/7/2024 - Observation remains. 8/12/2024 - Observation remains. Material was observed to have migrated within the swale to Station 173+50. 8/16/2024 - Stone is still present within the swale. 8/20/2024 - Observation remains. Crushed stone has migrated further down the swale to Station 171+50. 8/16/2024 - Observation remains. Stone is still present within the swale. 9/3/2024 - Observation remains. 9/10/2024 - Observation remains. Stone is still present within the swale. 9/16/2024 - Observation remains. The contractor indicated that the stone within the swale would be hand removed. 9/23/2024 - Observation remains. The contractor indicated that the stone within the swale would be hand removed. 9/23/2024 - Observation remains. It appears as though some stone has migrated further south down the swale. 10/4/2024 - Observation remains. Stone is still present within the swale. 10/8/2024 - Observation remains. 10/15/2024 - Observation remains. 10/15/2024 - Observation remains. Stone is covered with vegetation in some areas. 10/22/2024 - Observation remains. 11/2/2024 - Observation remains. 11/12/2024 - Observation remains. 11/12/2024 - Leaf litter has completely covered the stone in this location. The Contractor should indicate if stone has been removed from this location. 11/19/2024 - See previous update. 11/12/2024 - See previous update. 11/22/2024 - Observation remains. Stone is still present within the swale and requires removal. Leaf litter is currently covering a majority of the stone. 12/2/2024 - Observation remains. Stone is present within the swale under leaf litter. 12/6/2024 - Observation remains. Stone is present within the swale under the leaf litter.

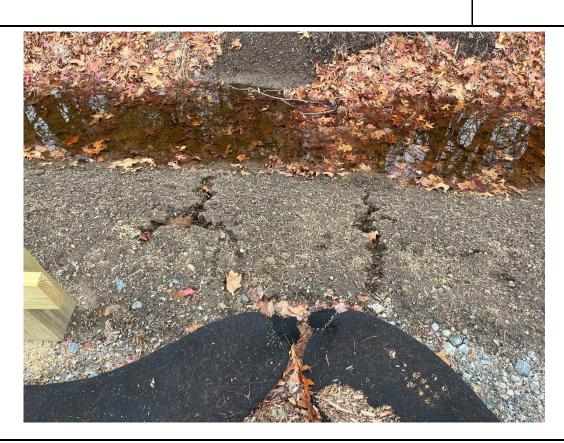
Photo No. 7 Date:

Temperature:	34	32	40	31		
Unusual Conditions (drought, severe storm):						
Have any discharges occurred since the last inspection report?	No	No	No	Yes		
If yes, please describe:						
				Erosion of exposed soils has resulted in a discharge to the stream at Station 216+50

View of the location where loam that was placed on the streambank has eroded into the streambed at Station 216+50, resulting in a discharge per Compliance Action Item 62.

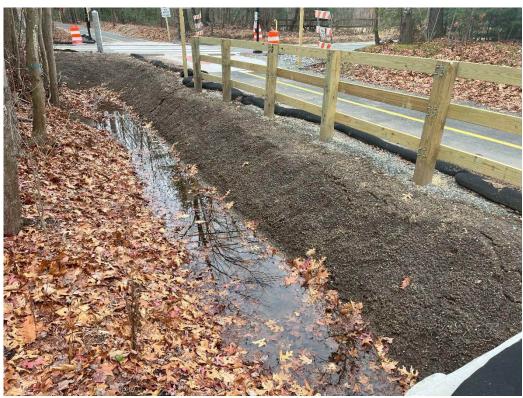
Photo No. 8

View of the location where the stream bank has been regraded beyond the limits of work and stabilization of loam is required at Station 216+00 per Long Term Compliance Action Item 41 and 62. Note rill erosion is occurring in this area.

41	Stream Bank has been regraded beyond the limit of work at Station 216+00 Priority: High	5/28/2024	6/4/2024 VI. Agency Suhmittals	The Contractor should confirm if this work was permitted by the Conservation Commission, as it does not appear to be a part of the approved plans/impacts. MassDOT should be consulted on next steps regarding notification and potential restoration.	5/31/2024 - Observation remains. 6/14/2024 - Observation remains. 6/14/2024 - Observation remains. 6/14/2024 - Observation remains. 6/24/2024 - Observation remains. 6/24/2024 - Observation remains. 6/24/2024 - Observation remains. 6/24/2024 - Observation remains. 7/8/2024 - Observation remains. 7/8/2024 - Observation remains. 7/15/2024 - This area could not be assessed due to paving operations ongoing during the inspection. 7/22/2024 - Crushed stone and sediment continue to be discharged to the stream between Stations 215+00 and 217+00 due to overtopped and undermined compost filter tubes. 7/29/2024 - Observation remains. 8/5/2024 - Observation remains. 8/5/2024 - Observation remains. 8/12/2024 - Observation remains. 8/12/2024 - Observation remains. 8/16/2024 - Observation remains. 8/20/2024 - Stone has been removed; however, additional alteration to Resource Areas beyond the limit of work continue. 8/27/2024 - Observation remains. 9/23/2024 - Observation remains. 9/3/2024 - Observation remains. 9/3/2024 - Observation remains. 9/3/2024 - Observation remains. 9/10/2024 - Observation remains. 10/8/2024 - Observation remains. 10/8/2024 - Observation remains. 10/8/2024 - Observation remains. 10/8/2024 - Observation remains. Stone is still present within the streambed at this location. 10/29/2024 - Observation remains. Stone is still present within the streambed at this location. 10/29/2024 - Observation remains. Stone is still present within the streambed at this location. 10/29/2024 - Observation remains. Stone is still present within the streambed at this location. 10/29/2024 - Observation remains. Stone is still present within the streambed at this location. 10/29/2024 - Observation remains. Stone is still present within the streambed at this location. 10/29/2024 - Observation remains. Stone is still present within the streambed at this location. 10/29/2024 - Observation remains. St

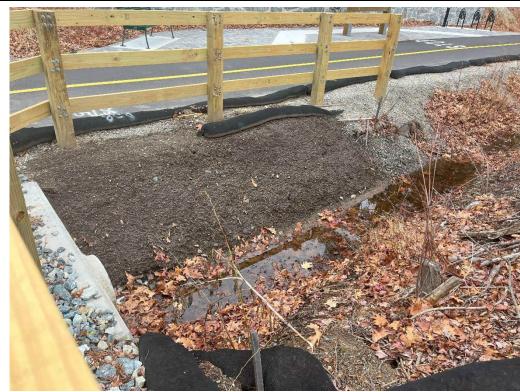
Photo No. 9 Date:

View of loam that requires stabilization at Station 217+00 per Compliance Action Item 62.

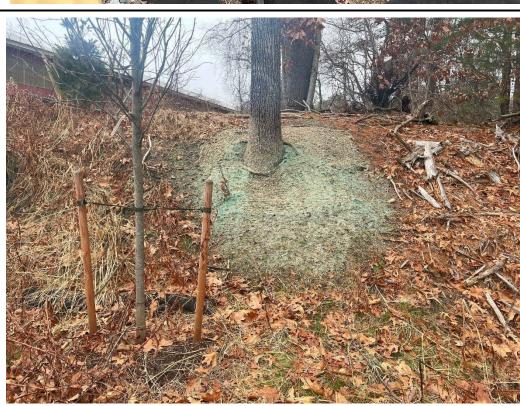
No. 10 12/20/2024

View of the slope where hydroseed was applied and some germination has occurred at Station 217+45 per Compliance Action Item 34.

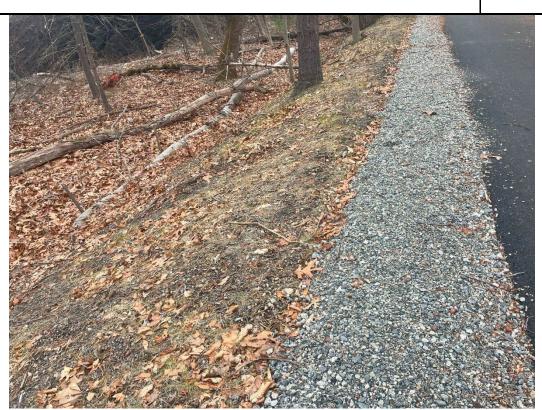
Photo No. 11

View of an area of exposed soil at Station 297+50 per Long Term Compliance Action Item 59.

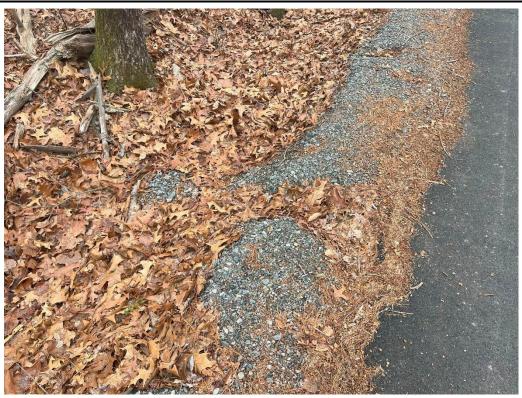
Photo No. 12

View of crushed stone that requires removal from the swale at Station 303+00 per Long Term Compliance Action Item 58.

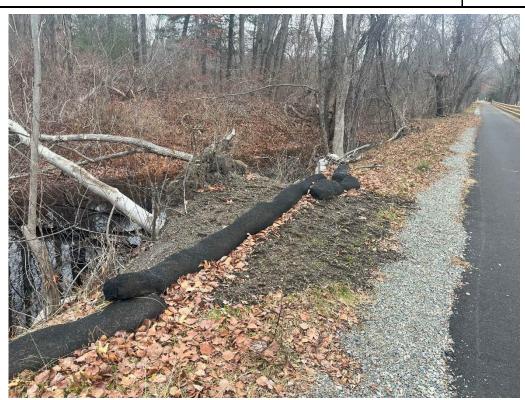
Photo No. 13

View of placed loam that requires stabilization at Station 311+00 per Long Term Compliance Action Item 59.

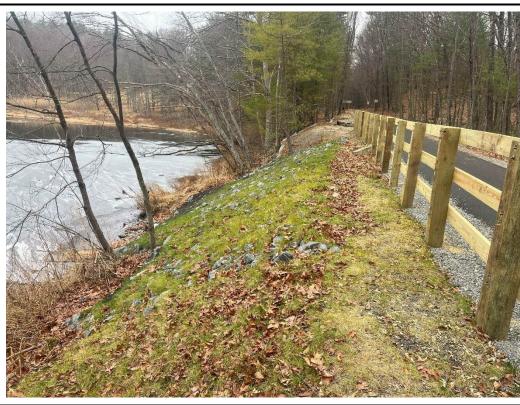
Photo Date: No. 14 12/20

View of the riprap slope that extends beyond the limit of work along the WF1 Series wetland at Station 332+00 per Long Term Compliance Action Item 42.

42	Riprap slope extends beyond limits of work along the WF1 Series wetland near flags 103 to 107 Priority: High	5/28/2024	6/4/2024	The Contractor should confirm if this work was permitted by the Conservation Commission, as it does not appear to be a part of the approved plans/impacts. MassDOT should be consulted on next steps regarding notification and potential restoration.	5/31/2024 - Observation remains. 6/7/2024 - Observation remains. 6/7/2024 - Observation remains. 6/14/2024 - Riprap slope has been altered and active construction is repairing the area. 6/14/2024 - During this inspection, additional work in support of the repair/potential replacement of an underlying pipe has was ongoing, it is recommended that the contractor confirm that they have coordinated with the Conservation Commission for this work and provide a restoration plan for the area once work is complete. 6/24/2024 - During this inspection, BETA was informed that the existing cast iron pipe was replaced with a new concrete 12-inch reinforced reinf
