**Sudbury to Hudson TRP Week of 1/06/2025**

**Epsilon Team Full SWPPP Inspection Report(s)**

## Sudbury to Hudson Transmission Project

Weekly    Storm Event    Other   Date: **1-09-2025**   Time: **11:00am-12:30pm**

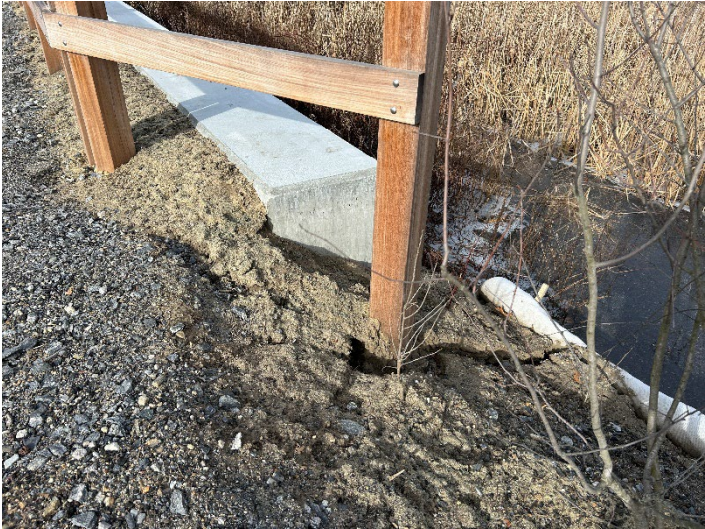
<b>PHOTOGRAPHIC LOG</b>	
<b>Client Name:</b> Eversource		<b>Site Location:</b> Sudbury to Hudson Transmission Reliability Project	<b>Town:</b> Hudson
<b>Photo No.:</b> 4	<b>Date:</b> 1-09-2025

-Rill erosion observed at bridge 130 and in segment 6. Sediment accumulation in E&S controls noted below erosion. It is recommended that these areas are repaired. See photos 4 and 7.

<b>Description:</b> View of E&S controls at northwest corner of bridge 130 in segment 3. Rill erosion and sediment accumulation in compost filter tube noted in multiple locations on this side of bridge. Facing northwest.

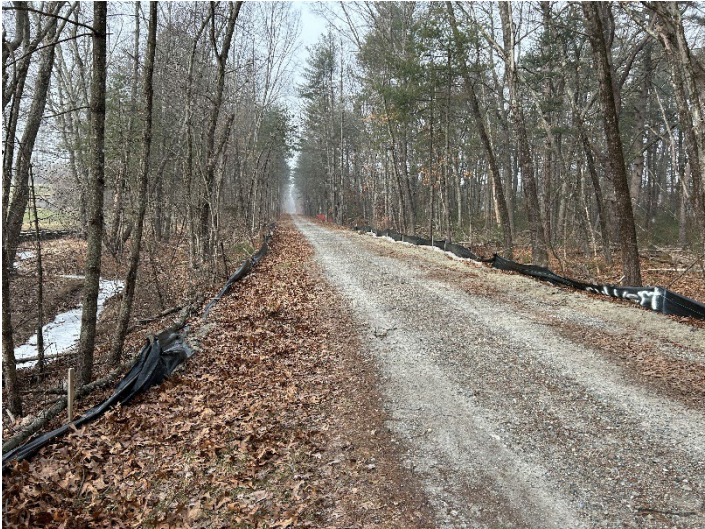
<b>Epsilon</b> ASSOCIATES INC.		<b>PHOTOGRAPHIC LOG</b>	
Client Name: Eversource		Site Location: Sudbury to Hudson Transmission Reliability Project	Town: Hudson
Photo No.: 5	Date: 1-09-2025

-Fallen tree at culvert in segment 4 has been moved, silt fence has not been repaired. See photo 5.

<b>Description:</b> View of E&S controls at culvert in segment 4. The fallen tree has been removed from the work area, but silt fence is still in need of repair. Facing west.

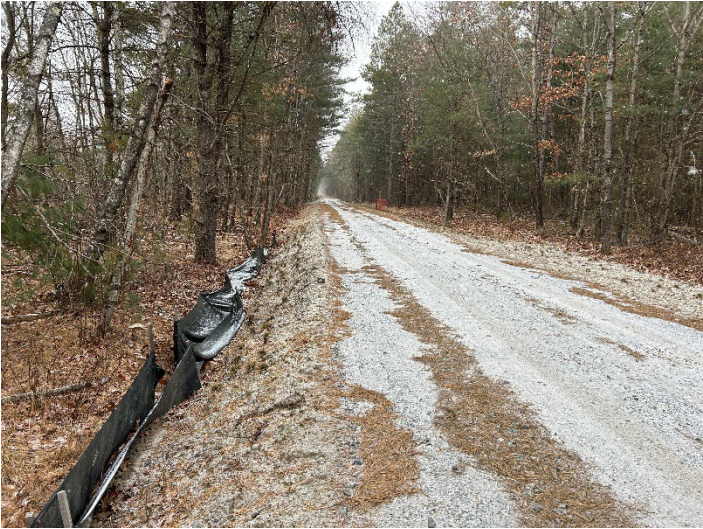
<b>PHOTOGRAPHIC LOG</b>	
<b>Client Name:</b> Eversource		<b>Site Location:</b> Sudbury to Hudson Transmission Reliability Project	<b>Town:</b> Hudson
<b>Photo No.:</b> 7	<b>Date:</b> 1-09-2025

<b>Description:</b> View of E&S controls in segment 6. Minor rill erosion noted and sediment accumulation observed in silt fence below erosion. Facing west.

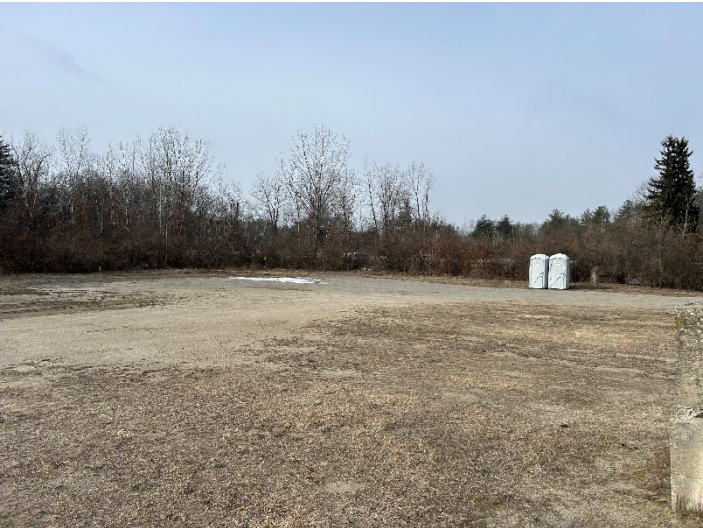
<b>PHOTOGRAPHIC LOG</b>	
<b>Client Name:</b> Eversource		<b>Site Location:</b> Sudbury to Hudson Transmission Reliability Project	<b>Town:</b> Hudson
<b>Photo No.:</b> 8	<b>Date:</b> 1-09-2025

<b>Description:</b> View of Haugland's former laydown yard. Two sanitary facilities remain. Facing northwest.

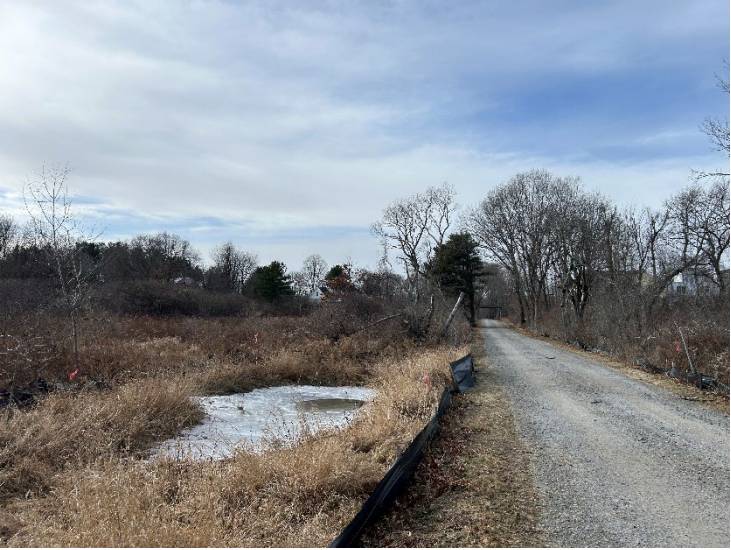
<b>PHOTOGRAPHIC LOG</b>	
Client Name: Eversource		Site Location: Sudbury to Hudson Transmission Reliability Project	Town: Sudbury
Photo No.: 1	Date: 1-09-2025

<b>Description:</b>  View of work area within segment 14, wetland replication area, area flagged, existing erosion control. Facing west.

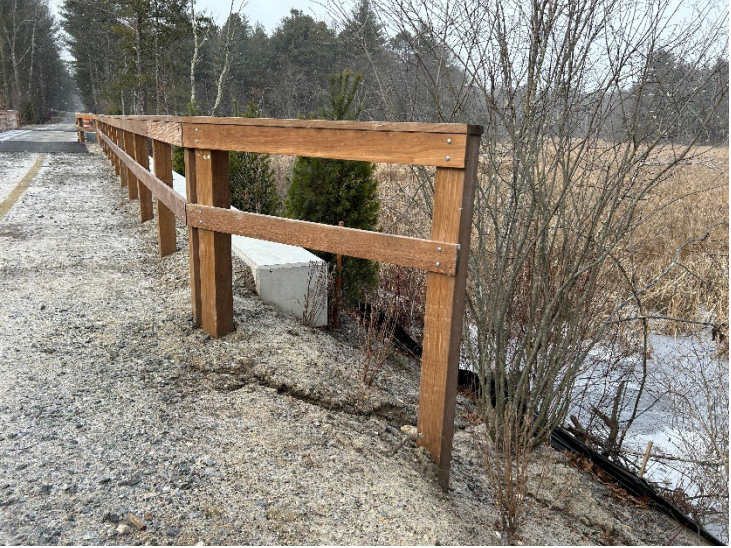
<b>PHOTOGRAPHIC LOG</b>	
Client Name: Eversource		Site Location: Sudbury to Hudson Transmission Reliability Project	Town: Sudbury
Photo No.: 2	Date: 1-09-2025

-Rill erosion noted at bridge 128. Sediment accumulation in E&S controls noted below erosion. It is recommended that these areas are repaired. See photo 2.

<b>Description:</b>  View of E&S controls at northeast corner of bridge 128 in segment 8. Rill erosion and sediment accumulation in silt fencing noted. Facing west.

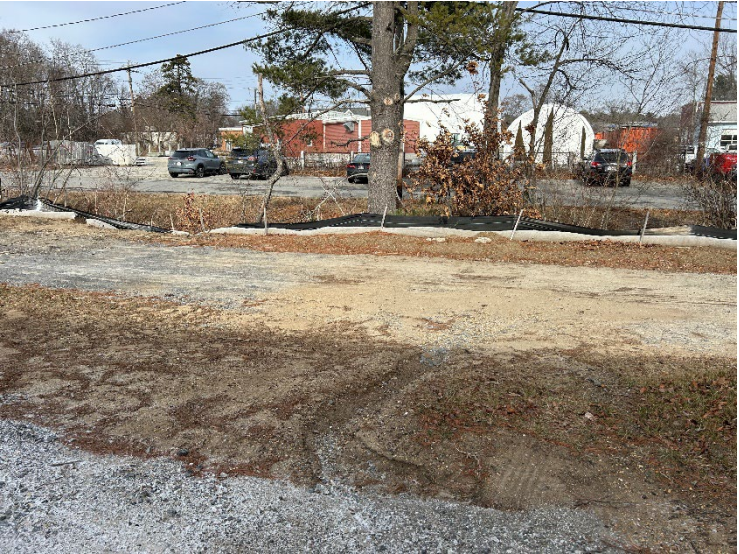
<b>Epsilon</b> ASSOCIATES INC.		<b>PHOTOGRAPHIC LOG</b>	
Client Name: Eversource		Site Location: Sudbury to Hudson Transmission Reliability Project	Town: Sudbury
Photo No.: 3	Date: 1-09-2025

-Erosion noted from shoulder onto graded area within segment 12. See photo 3. No resource impacted.

<b>Description:</b>  View of work area within segment 12, noted erosion from shoulder to graded area, existing erosion control. Facing north.
