Weekly Environmental Compliance Summary

Sudbury to Hudson Transmission Reliability Project (USEPA Tracking # MAR1003UW)

Week of: December 23, 2024 to December 27, 2024

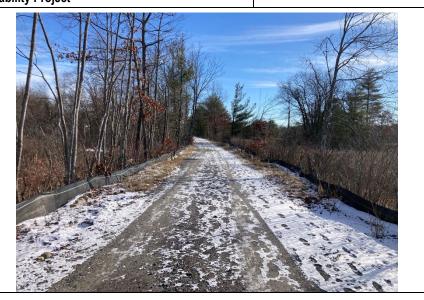
Photo No.: 3

View of E&S controls in segment 3 near bridge 130. Facing east.

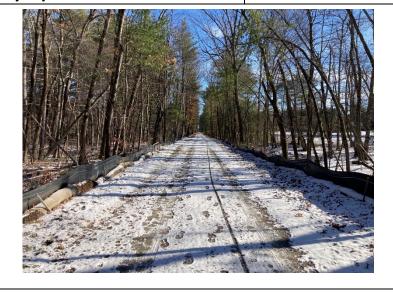
Photo No.: 4 Date: 12-23-2024

View of E&S controls in segment 4. Facing east.

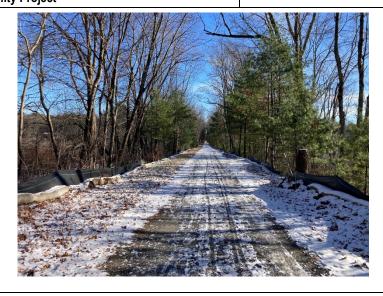
Photo No.: 5

View of E&S controls in segment

5. Facing west.

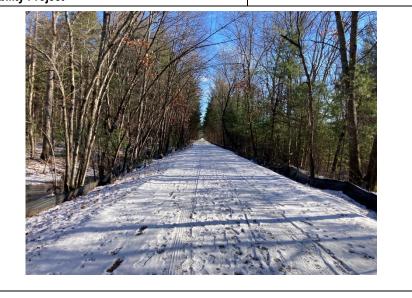
Photo No.: 6 Date: 12-23-2024

View of E&S controls in segment

6. Facing east.

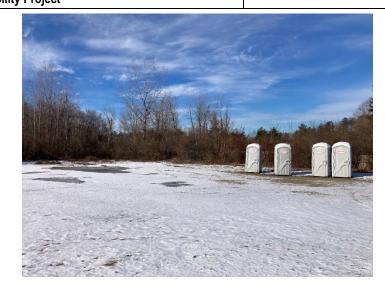
Photo No.: 7

View of Haugland's former laydown yard. Sanitary waste facitlites remain. Facing northwest.

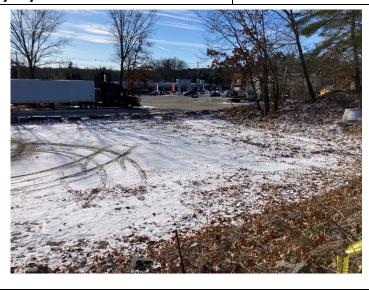
Photo No.: 8

View of Bond's former laydown yard at 188 Central St. Conduit and project materials have been removed. Facing south.

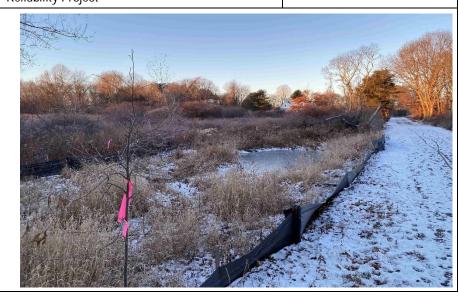
Work area within segment 14, wetland replication area, area flagged, dusting of snow on-site, existing erosion control, looking westward.

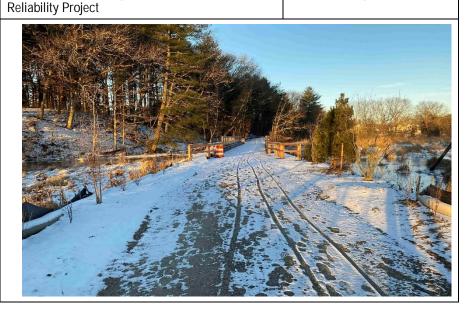
Work area within segment 14, Bridge 127, area of previous planting & hydro seeding, dusting of snow on-site, existing erosion control, looking westward.

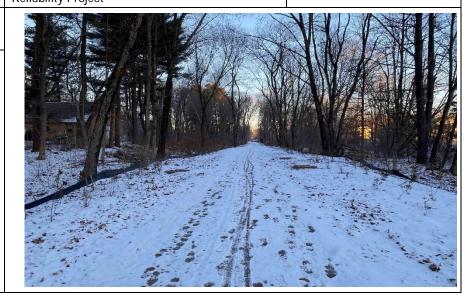
Work area within segment 13, manhole #25 area, area of previous planting & hydroseeding, dusting of snow on-site, existing erosion control, looking westward.

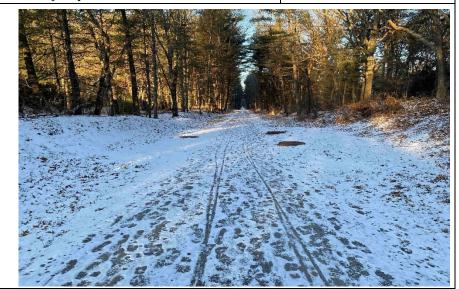
Work area within segment 11, manhole #22 area, area of previous hydroseeding, dusting of snow on-site, looking westward.

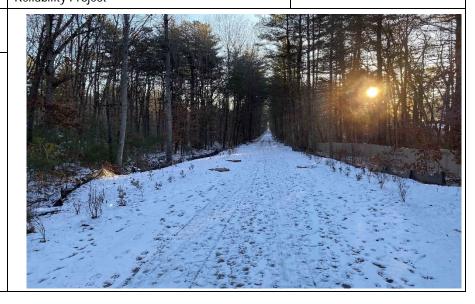
Work area within segment 10, manhole #20 area, area of previous planting & hydroseeding, dusting of snow on-site, existing erosion control, looking westward.

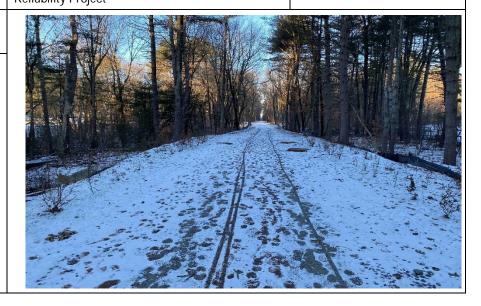
Work area within segment 9, manhole #19 area, area of previous planting & hydroseeding, dusting of snow on-site, existing erosion control, looking westward.

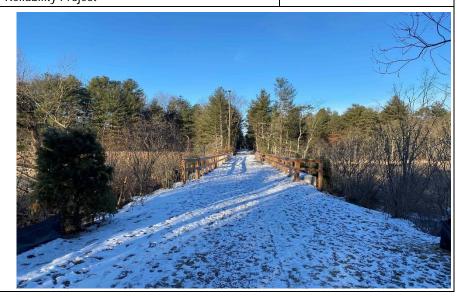
Work area within segment 8, Bridge 128, area of previous planting & hydro seeding, osprey platform (left side-background) dusting of snow on-site, existing erosion control, looking westward.

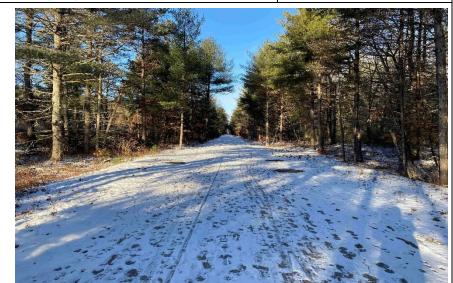
Work area within segment 7, manhole #16 area, area of previous planting & hydroseeding, dusting of snow on-site, existing erosion control, looking westward.
