**Sudbury to Hudson TRP Week of 12/30/2024**

**Epsilon Team Full SWPPP Inspection Report(s)**

## Sudbury to Hudson Transmission Project

Weekly  Storm Event  Other Date: **12-30-2024** Time: **8:00am-12:00pm**

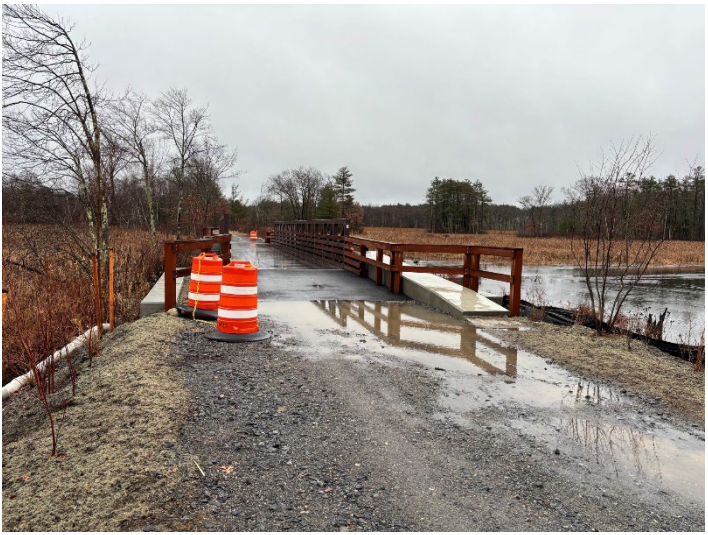
<b>PHOTOGRAPHIC LOG</b>	
<b>Client Name:</b> Eversource		<b>Site Location:</b> Sudbury to Hudson Transmission Reliability Project	<b>Town:</b> Hudson
<b>Photo No.:</b> 2	<b>Date:</b> 12-30-2024

<b>Description:</b> View of bridge 130 from segment 2. E&S controls are in good condition on this side of the bridge. Facing east.

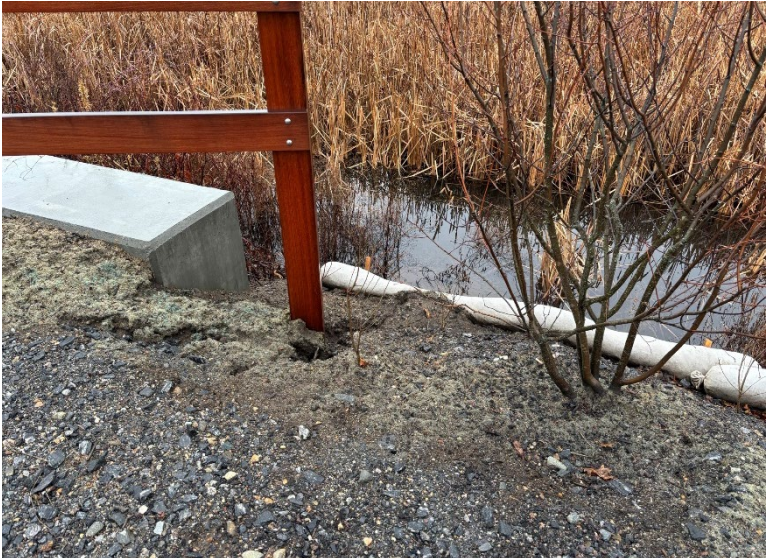
<b>Epsilon</b> ASSOCIATES INC.		<b>PHOTOGRAPHIC LOG</b>	
Client Name: Eversource		Site Location: Sudbury to Hudson Transmission Reliability Project	Town: Hudson
Photo No.: 3	Date: 12-30-2024

-Rill erosion observed at bridge 130 and in segment 6. Sediment accumulation in E&S controls noted below erosion. It is recommended that these areas are repaired. See photos 3 and 7.

-Rill erosion observed at bridge 130 on 12/30/2024. Sediment accumulation in E&S controls noted below erosion. It is recommended that these areas are repaired.
<b>9. Inlet protection</b>	<input type="checkbox"/> Yes <input checked="" type="checkbox"/> No	N/A	<input type="checkbox"/> Yes <input checked="" type="checkbox"/> No	N/A	Roadwork completed for 2024 season, silt sack inlet protection has been removed.
<b>10. Turbidity curtain/floating silt fencing in Hudson</b>	<input type="checkbox"/> Yes <input checked="" type="checkbox"/> No	N/A	<input type="checkbox"/> Yes <input checked="" type="checkbox"/> No	N/A	Floating silt fencing/turbidity curtain removed within segments 2/3 at Bridge 130 on 11/15/2024. Filter tubes were placed at the base of slopes adjacent to Fort Meadow Brook.
<b>11. Silt fence &amp; Filter Tubes along Forest Ave at MH #4</b>	<input type="checkbox"/> Yes <input checked="" type="checkbox"/> No	N/A	<input type="checkbox"/> Yes <input checked="" type="checkbox"/> No	N/A	Silt fence & filter tubes were removed at this location when road work was completed for the 2023 season.

<b>Description:</b> View of E&S controls at northwest corner of bridge 130 in segment 3. Rill erosion and sediment accumulation in compost filter tube noted in multiple locations on this side of bridge. Facing north.

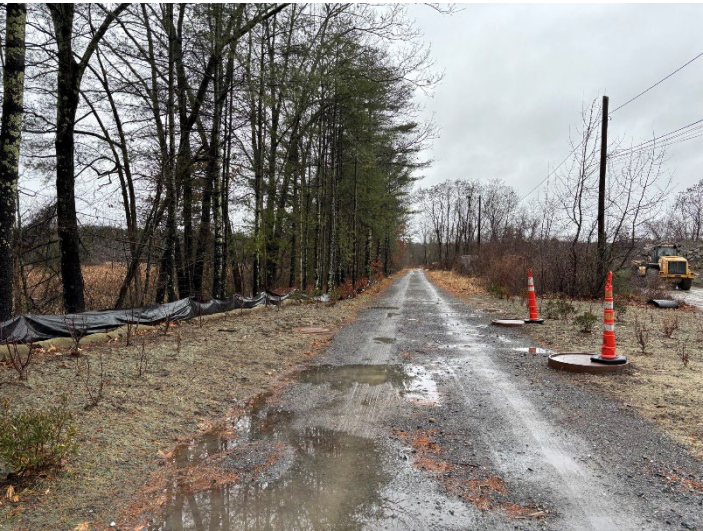
<b>Epsilon</b> ASSOCIATES INC.		<b>PHOTOGRAPHIC LOG</b>	
Client Name: Eversource		Site Location: Sudbury to Hudson Transmission Reliability Project	Town: Hudson
Photo No.: 4	Date: 12-30-2024

<b>Description:</b> View of E&S controls and plantings at MH #8 in segment 3. Facing west.

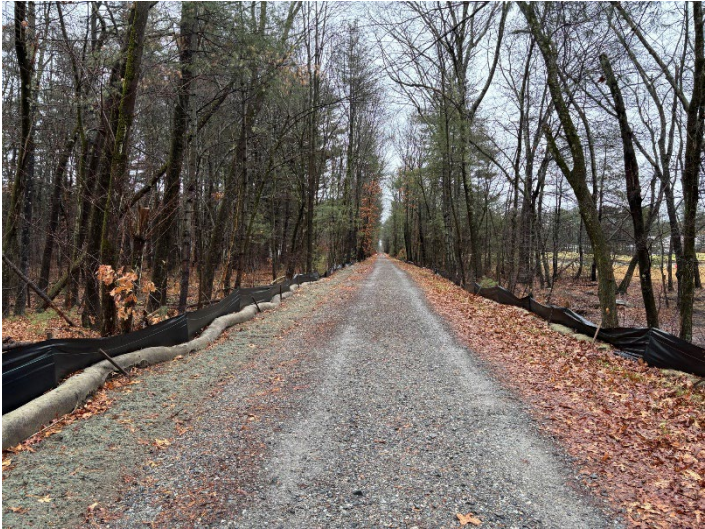
<b>Epsilon</b> ASSOCIATES INC.		<b>PHOTOGRAPHIC LOG</b>	
<b>Client Name:</b> Eversource		<b>Site Location:</b> Sudbury to Hudson Transmission Reliability Project	<b>Town:</b> Hudson
<b>Photo No.:</b> 5	<b>Date:</b> 12-30-2024

<b>Description:</b> View of E&S controls in segment 4. Facing east.

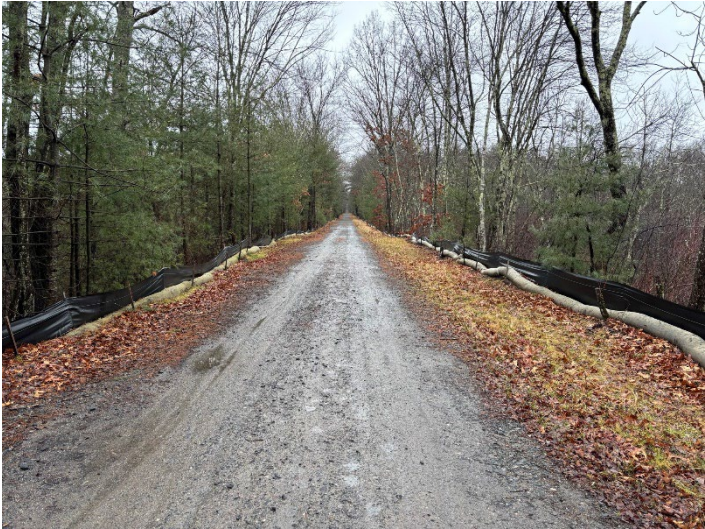
<b>Epsilon</b> ASSOCIATES INC.		<b>PHOTOGRAPHIC LOG</b>	
<b>Client Name:</b> Eversource		<b>Site Location:</b> Sudbury to Hudson Transmission Reliability Project	<b>Town:</b> Hudson
<b>Photo No.:</b> 6	<b>Date:</b> 12-30-2024

<b>Description:</b> View of E&S controls in segment 5. Facing west.

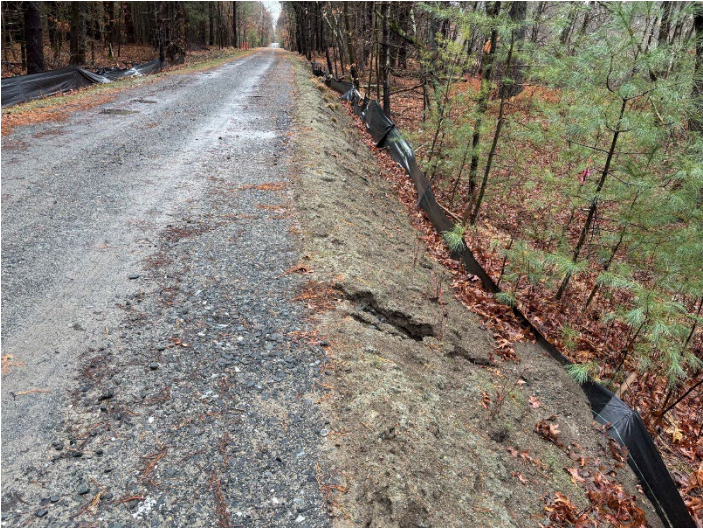
<b>PHOTOGRAPHIC LOG</b>	
<b>Client Name:</b> Eversource		<b>Site Location:</b> Sudbury to Hudson Transmission Reliability Project	<b>Town:</b> Hudson
<b>Photo No.:</b> 7	<b>Date:</b> 12-30-2024

<b>Description:</b> View of E&S controls near Sta. #347 in segment 6. Rill erosion noted and sediment accumulation observed in silt fence below erosion. Facing east.

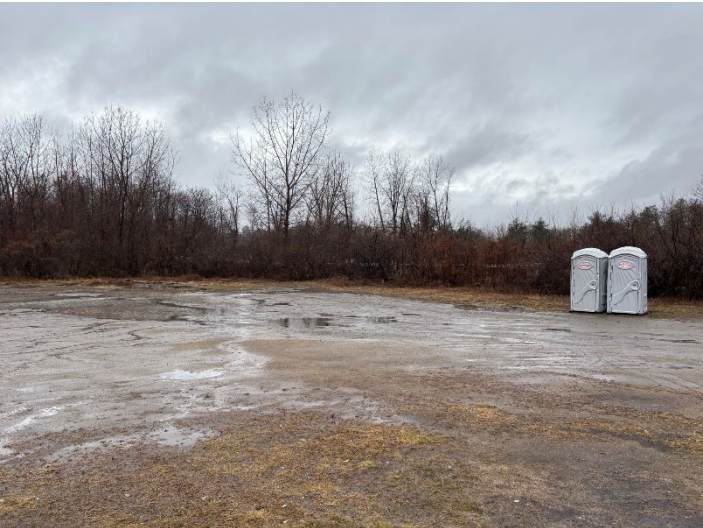
<b>PHOTOGRAPHIC LOG</b>	
<b>Client Name:</b> Eversource		<b>Site Location:</b> Sudbury to Hudson Transmission Reliability Project	<b>Town:</b> Hudson
<b>Photo No.:</b> 8	<b>Date:</b> 12-30-2024

<b>Description:</b> View of Haugland's former laydown yard. Two sanitary waste facilities have been removed; two facilities remain. Facing northwest.

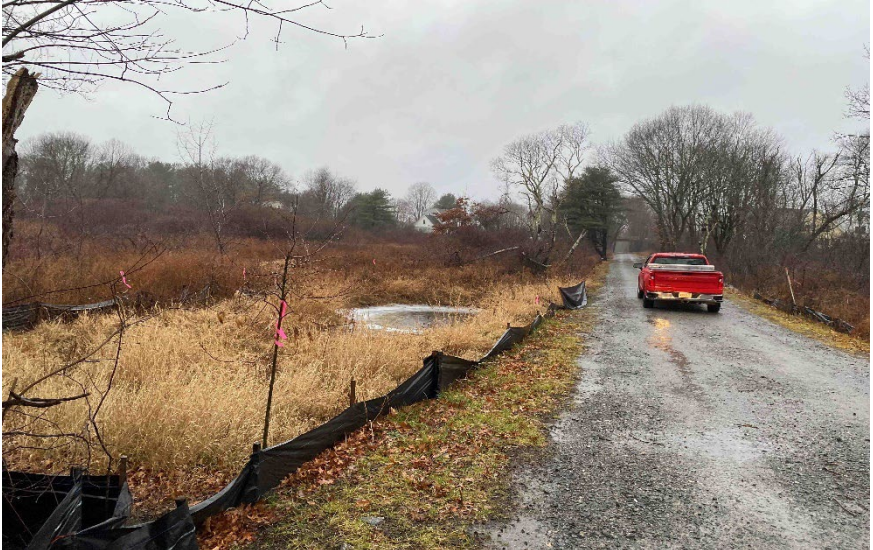
<b>PHOTOGRAPHIC LOG</b>	
<b>Client Name:</b> Eversource		<b>Site Location:</b> Sudbury to Hudson Transmission Reliability Project	<b>Town:</b> Sudbury
<b>Photo No.:</b> 1	<b>Date:</b> 12-30-24

<b>Description:</b>  Work area within segment 14, wetland replication area, area flagged, ET&L on-site conducting survey activities, existing erosion control, looking westward.

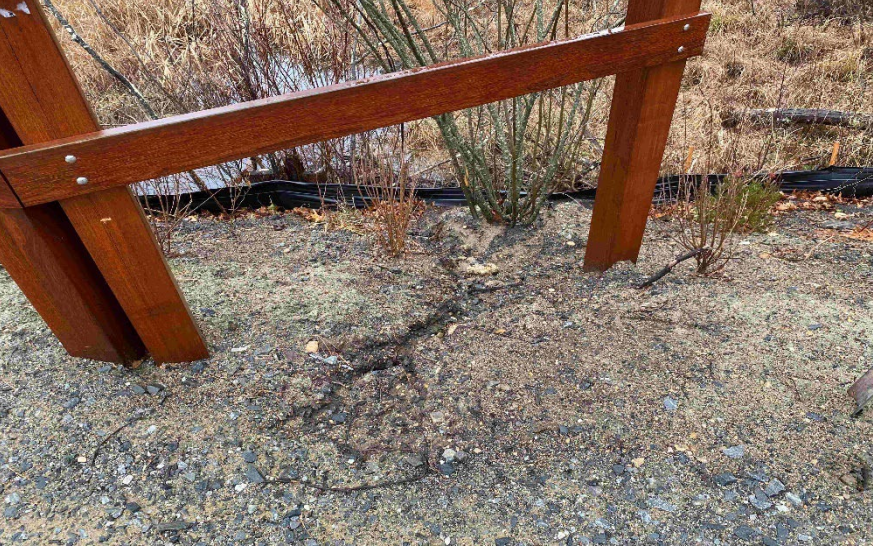
<b>PHOTOGRAPHIC LOG</b>	
<b>Client Name:</b> Eversource		<b>Site Location:</b> Sudbury to Hudson Transmission Reliability Project	<b>Town:</b> Sudbury
<b>Photo No.:</b> 2	<b>Date:</b> 12-30-24

Noted erosion rills formed near bridge 128, with accumulated sediment downslope next to silt fencing. Please see Photo 2, i.e., Segment 8-north side.

<b>Description:</b>  Work area within segment 8, Bridge 128, area of erosion, existing erosion control, looking northward.

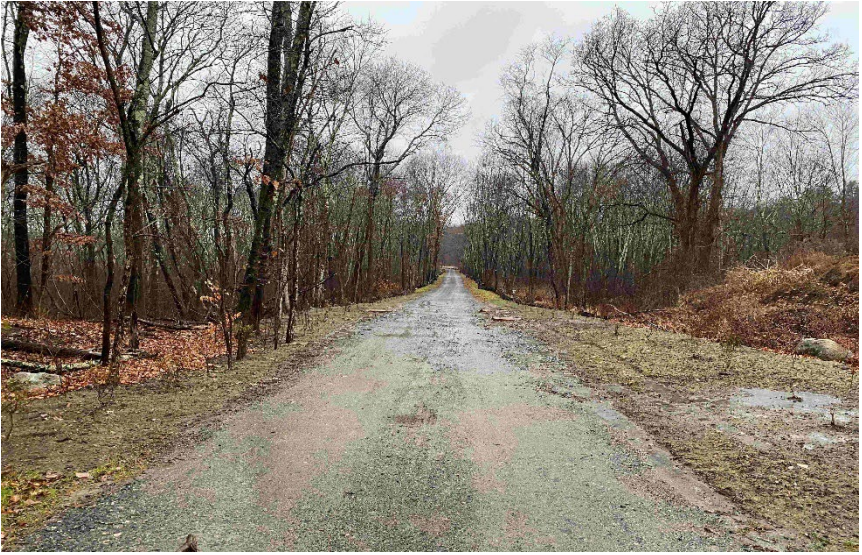
<b>PHOTOGRAPHIC LOG</b>	
<b>Client Name:</b> Eversource		<b>Site Location:</b> Sudbury to Hudson Transmission Reliability Project	<b>Town:</b> Sudbury
<b>Photo No.:</b> 3	<b>Date:</b> 12-30-24

<b>Description:</b>  Work area within segment 14, manhole #27, area of previous planting & hydroseeding, existing erosion control, looking westward.

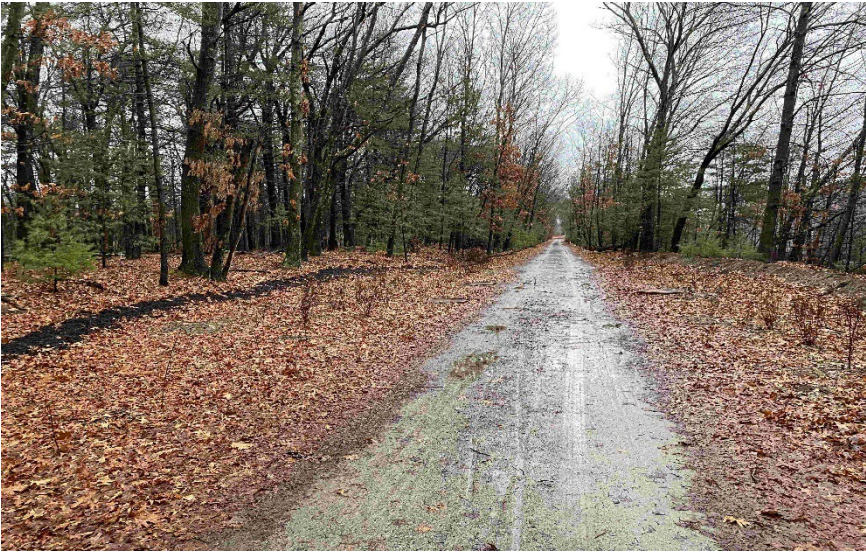
<b>PHOTOGRAPHIC LOG</b>	
<b>Client Name:</b> Eversource		<b>Site Location:</b> Sudbury to Hudson Transmission Reliability Project	<b>Town:</b> Sudbury
<b>Photo No.:</b> 4	<b>Date:</b> 12-30-24

<b>Description:</b>  Work area within segment 11, manhole #23, area of previous erosion control removal (left), planting & hydroseeding, existing erosion control (right), looking eastward.

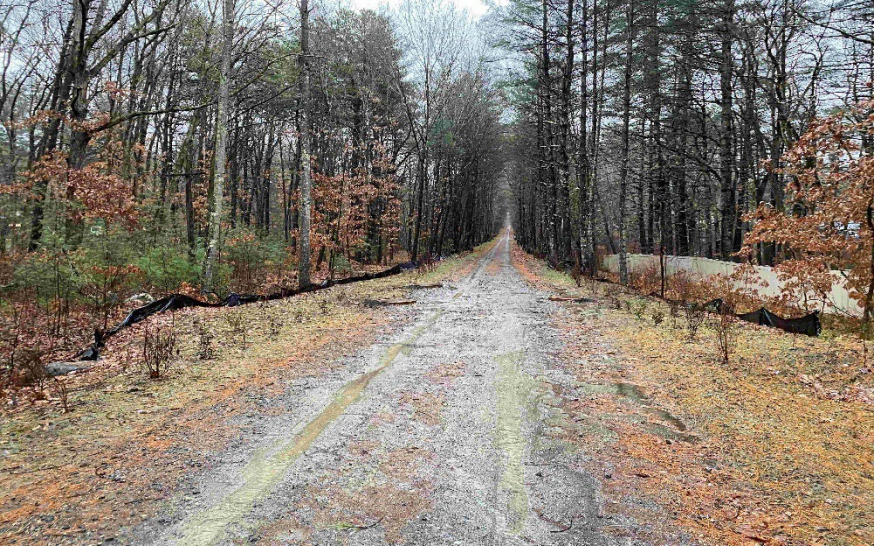
<b>PHOTOGRAPHIC LOG</b>	
Client Name: Eversource		Site Location: Sudbury to Hudson Transmission Reliability Project	Town: Sudbury
Photo No.: 5	Date: 12-30-24

Description:  Work area within segment 10, manhole #20, area of previous planting & hydroseeding, existing erosion control, looking eastward.

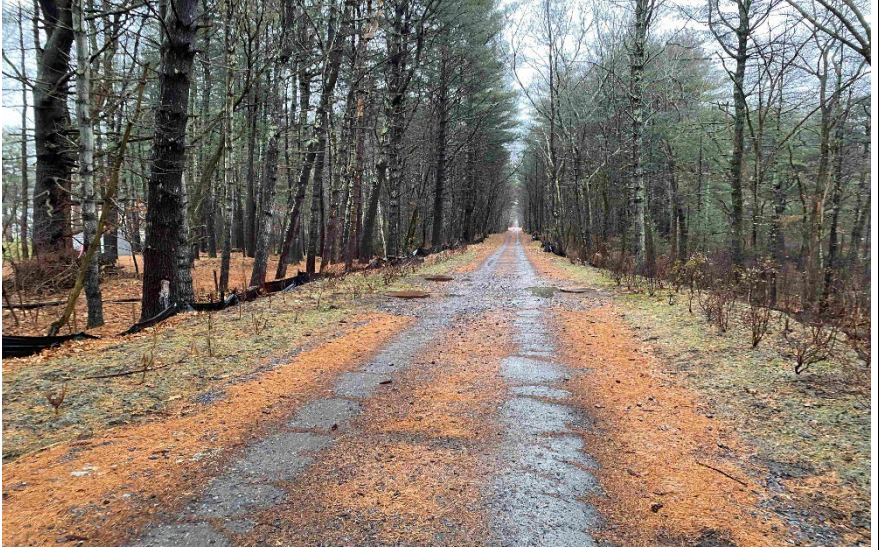
<b>PHOTOGRAPHIC LOG</b>	
Client Name: Eversource		Site Location: Sudbury to Hudson Transmission Reliability Project	Town: Sudbury
Photo No.: 6	Date: 12-30-24

Description:  Work area within segment 9, manhole #19, area of previous planting & hydroseeding, existing erosion control, looking westward.

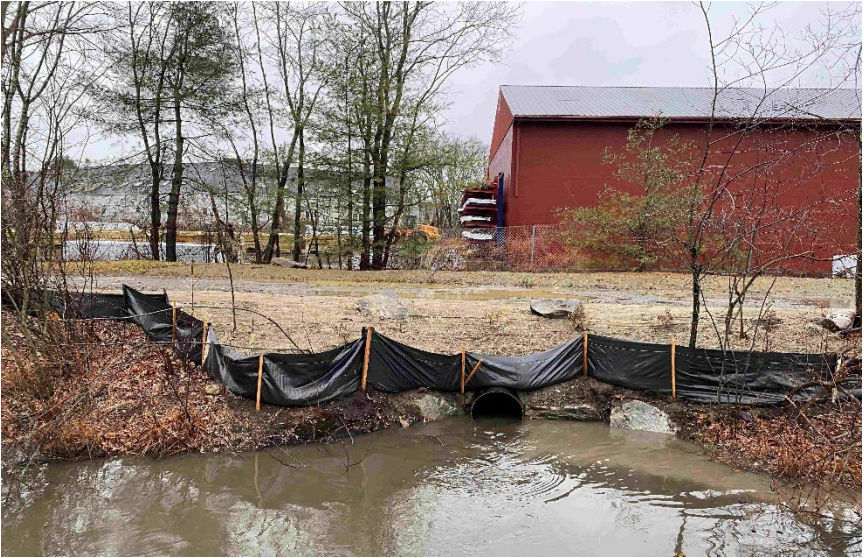
<b>Epsilon</b> ASSOCIATES INC.		<b>PHOTOGRAPHIC LOG</b>	
Client Name: Eversource		Site Location: Sudbury to Hudson Transmission Reliability Project	Town: Sudbury
Photo No.: 7	Date: 12-30-24

<b>Description:</b>  Work area within segment 12, area of previous culvert extension, hydro seeding & planting, existing erosion control, looking westward.

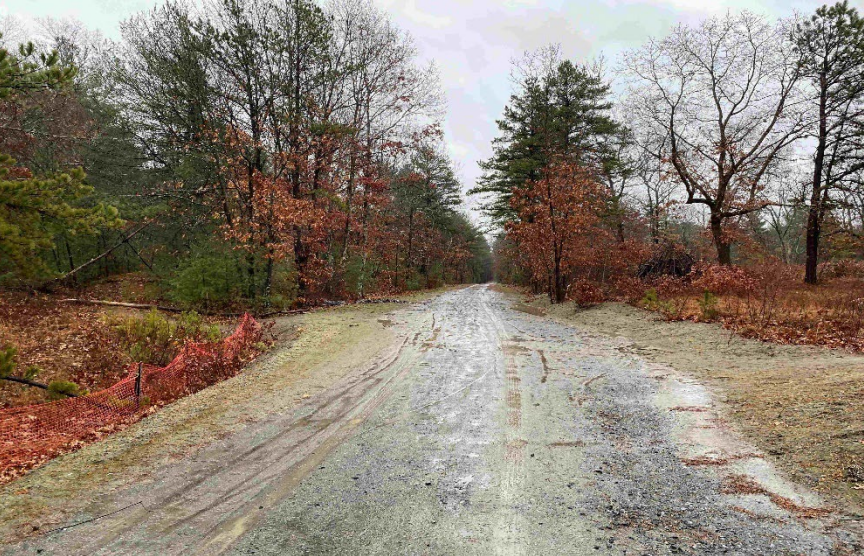
<b>Epsilon</b> ASSOCIATES INC.		<b>PHOTOGRAPHIC LOG</b>	
Client Name: Eversource		Site Location: Sudbury to Hudson Transmission Reliability Project	Town: Sudbury
Photo No.: 8	Date: 12-30-24

<b>Description:</b>  Work area within segment 7 at town line (Sudbury-Hudson) area, area of hydroseeding, brush pile (right side-middle of photo), looking eastward.

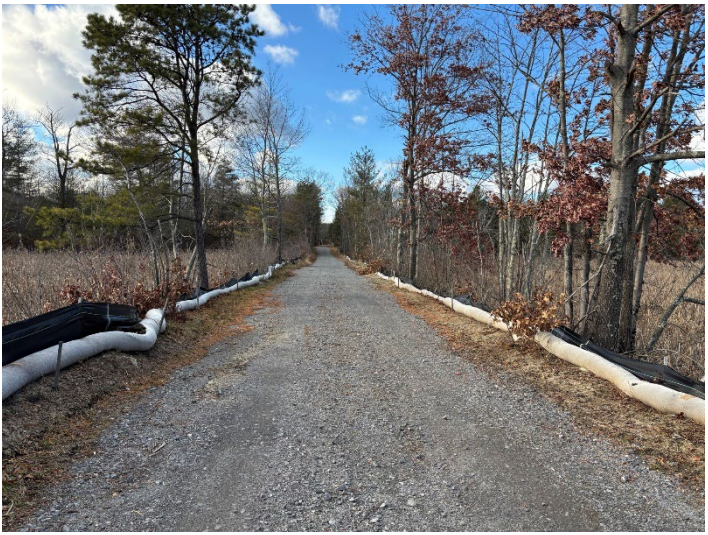
<b>PHOTOGRAPHIC LOG</b>	
<b>Client Name:</b> Eversource		<b>Site Location:</b> Sudbury to Hudson Transmission Reliability Project	<b>Town:</b> Hudson
<b>Photo No.:</b> 2	<b>Date:</b> 1-02-2025

<b>Description:</b> View of E&S controls in segment 2. Facing west.

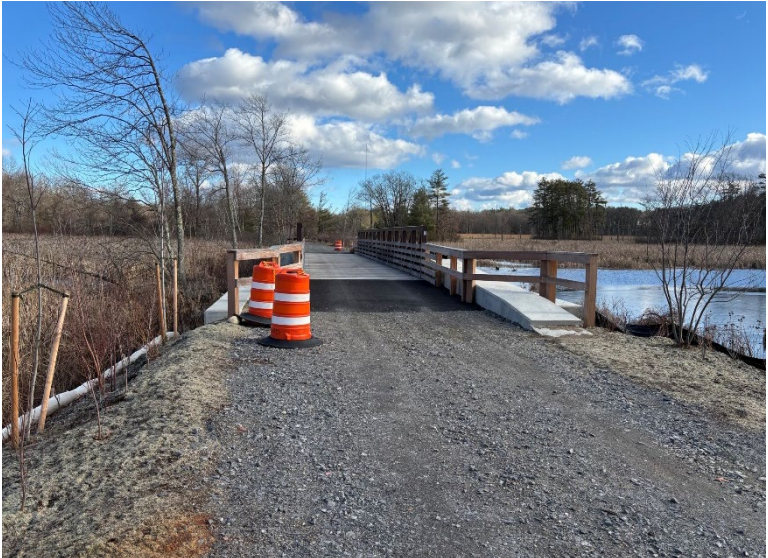
<b>PHOTOGRAPHIC LOG</b>	
<b>Client Name:</b> Eversource		<b>Site Location:</b> Sudbury to Hudson Transmission Reliability Project	<b>Town:</b> Hudson
<b>Photo No.:</b> 3	<b>Date:</b> 1-02-2025

<b>Description:</b> View of bridge 130 from segment 2. Facing east.

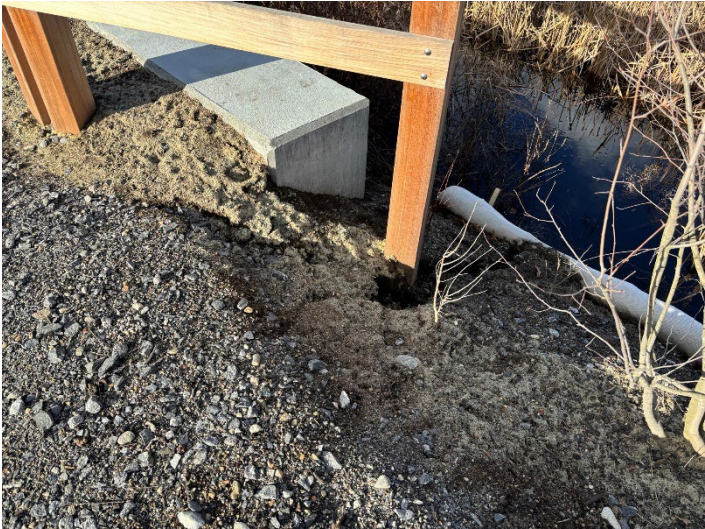
<b>PHOTOGRAPHIC LOG</b>	
<b>Client Name:</b> Eversource		<b>Site Location:</b> Sudbury to Hudson Transmission Reliability Project	<b>Town:</b> Hudson
<b>Photo No.:</b> 4	<b>Date:</b> 1-02-2025

-Rill erosion observed at bridge 130 and in segment 6. Sediment accumulation in E&S controls noted below erosion. It is recommended that these areas are repaired. See photos 4 and 7.

<b>Description:</b> View of E&S controls at northwest corner of bridge 130 in segment 3. Rill erosion and sediment accumulation in compost filter tube noted in multiple locations on this side of bridge. Facing northwest.

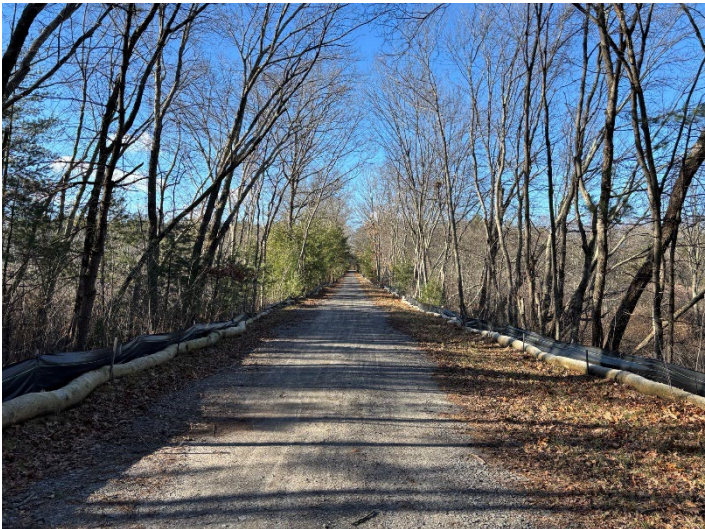
<b>Epsilon</b> ASSOCIATES INC.		<b>PHOTOGRAPHIC LOG</b>	
Client Name: Eversource		Site Location: Sudbury to Hudson Transmission Reliability Project	Town: Hudson
Photo No.: 6	Date: 1-02-2025

<b>Description:</b> View of E&S controls in segment 5. Facing west.

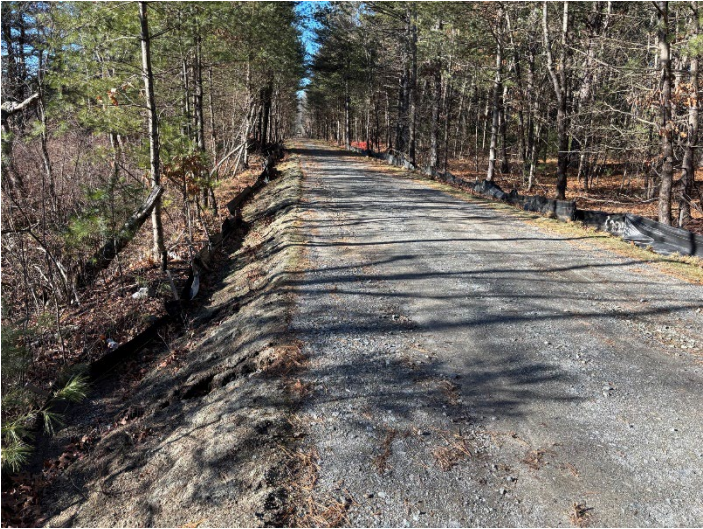
<b>Epsilon</b> ASSOCIATES INC.		<b>PHOTOGRAPHIC LOG</b>	
Client Name: Eversource		Site Location: Sudbury to Hudson Transmission Reliability Project	Town: Hudson
Photo No.: 7	Date: 1-02-2025

<b>Description:</b> View of E&S controls near Sta. #347 in segment 6. Rill erosion noted and sediment accumulation observed in silt fence below erosion. Facing west.

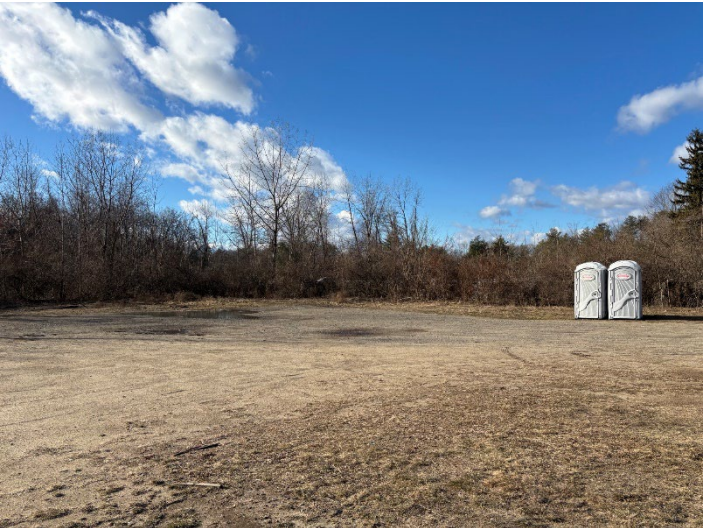
<b>Epsilon</b> ASSOCIATES INC.		<b>PHOTOGRAPHIC LOG</b>	
Client Name: Eversource		Site Location: Sudbury to Hudson Transmission Reliability Project	Town: Hudson
Photo No.: 8	Date: 1-02-2025

<b>Description:</b> View of Haugland's former laydown yard. Two sanitary facilities remain. Facing northwest.

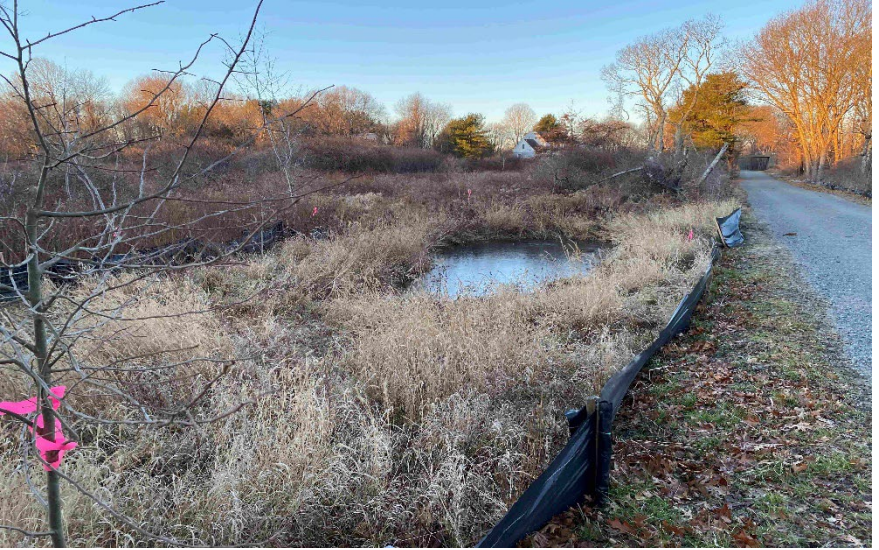
<b>PHOTOGRAPHIC LOG</b>	
<b>Client Name:</b> Eversource		<b>Site Location:</b> Sudbury to Hudson Transmission Reliability Project	<b>Town:</b> Sudbury
<b>Photo No.:</b> 1	<b>Date:</b> 1-2-25

<b>Description:</b>  Work area within segment 14, wetland replication area, area flagged, existing erosion control, looking westward.

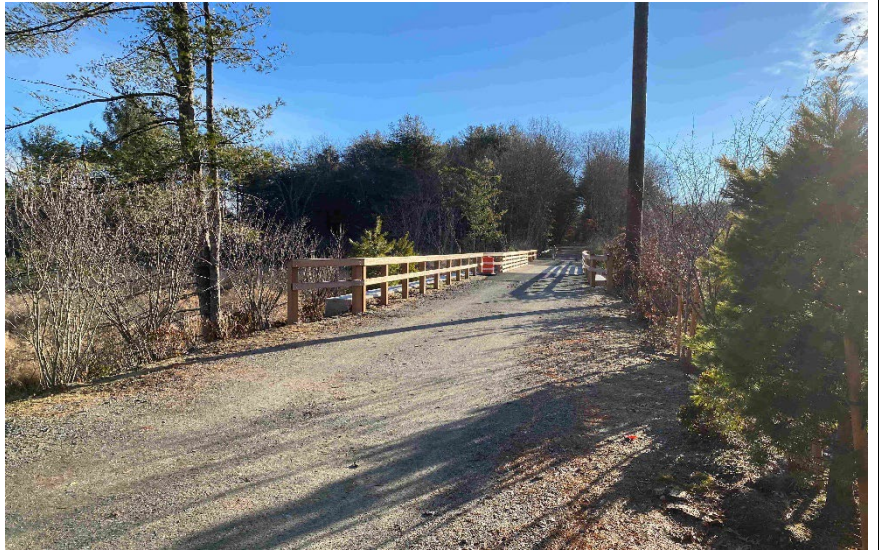
<b>PHOTOGRAPHIC LOG</b>	
<b>Client Name:</b> Eversource		<b>Site Location:</b> Sudbury to Hudson Transmission Reliability Project	<b>Town:</b> Sudbury
<b>Photo No.:</b> 2	<b>Date:</b> 1-2-25

<b>Description:</b>  Work area within segment 7, Bridge 128, area of new plantings & hydro seeding, existing erosion control, looking eastward.

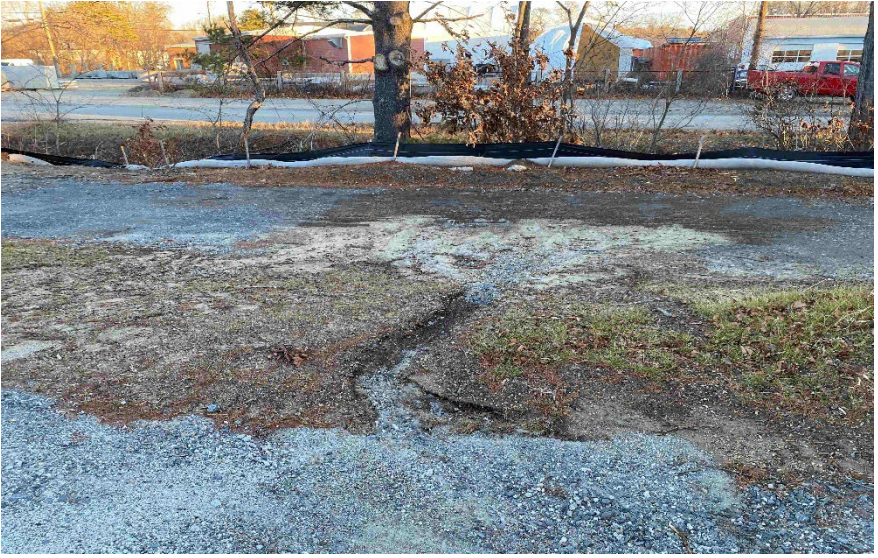
<b>PHOTOGRAPHIC LOG</b>	
Client Name: Eversource		Site Location: Sudbury to Hudson Transmission Reliability Project	Town: Sudbury
Photo No.: 3	Date: 1-2-25

Erosion noted from shoulder onto graded area within segment 12, see photo 3. No resource impacted.

<b>Description:</b>  Work area within segment 12, noted erosion from shoulder to graded area, existing erosion control, looking eastward.

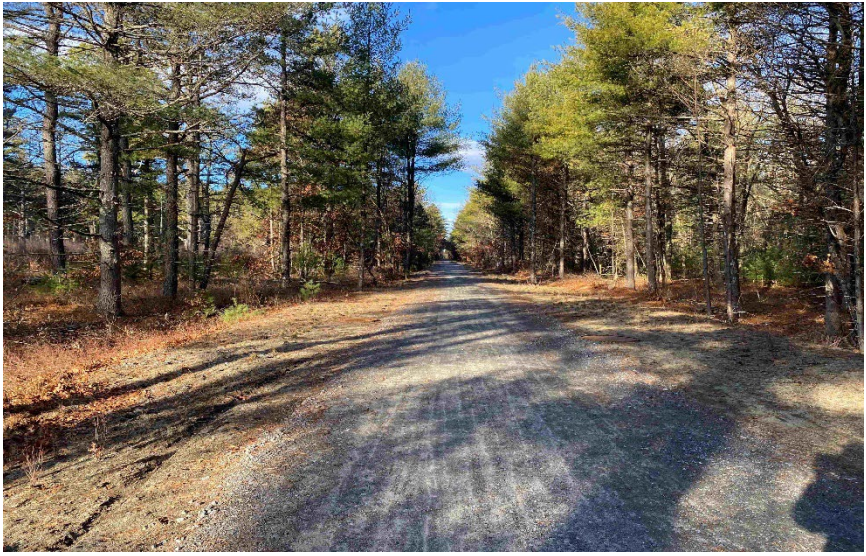
<b>PHOTOGRAPHIC LOG</b>	
Client Name: Eversource		Site Location: Sudbury to Hudson Transmission Reliability Project	Town: Sudbury
Photo No.: 4	Date: 1-2-25

<b>Description:</b>  Work area within segment 7, manhole #16, area of previous planting & hydroseeding, existing erosion control, looking westward

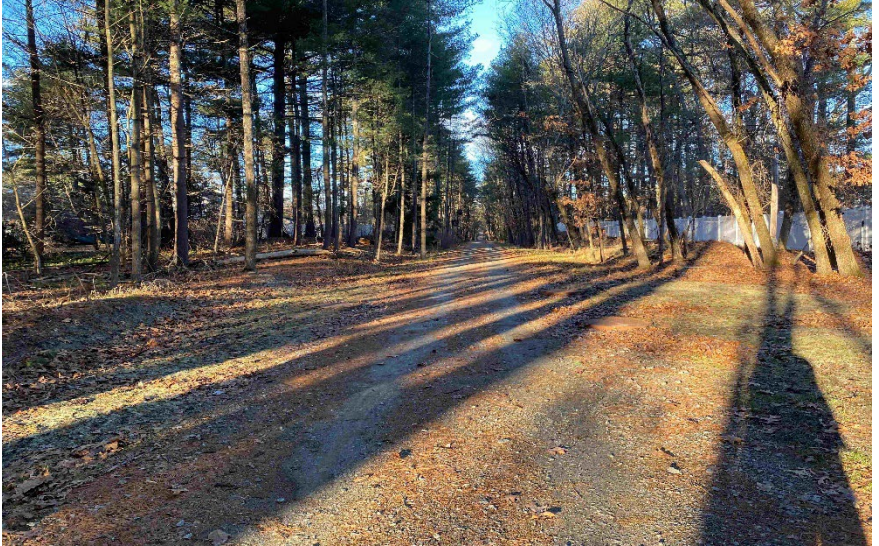
<b>PHOTOGRAPHIC LOG</b>	
<b>Client Name:</b> Eversource		<b>Site Location:</b> Sudbury to Hudson Transmission Reliability Project	<b>Town:</b> Sudbury
<b>Photo No.:</b> 5	<b>Date:</b> 1-2-25

<b>Description:</b>  Work area within segment 10, manhole #21, area of previous planting & hydroseeding, existing erosion control, looking westward.

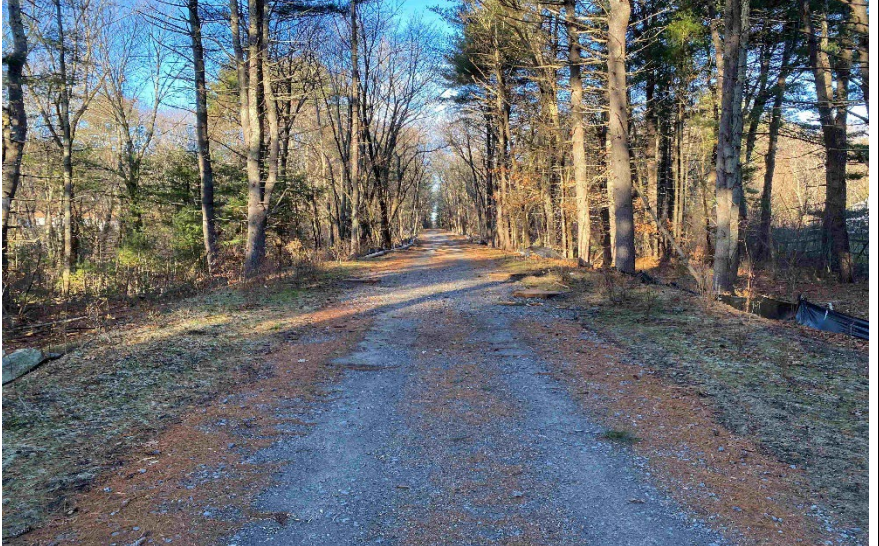
<b>PHOTOGRAPHIC LOG</b>	
<b>Client Name:</b> Eversource		<b>Site Location:</b> Sudbury to Hudson Transmission Reliability Project	<b>Town:</b> Sudbury
<b>Photo No.:</b> 6	<b>Date:</b> 1-2-25

<b>Description:</b>  Work area within segment 9, manhole #19, area of previous planting & hydroseeding, existing erosion control, looking westward.

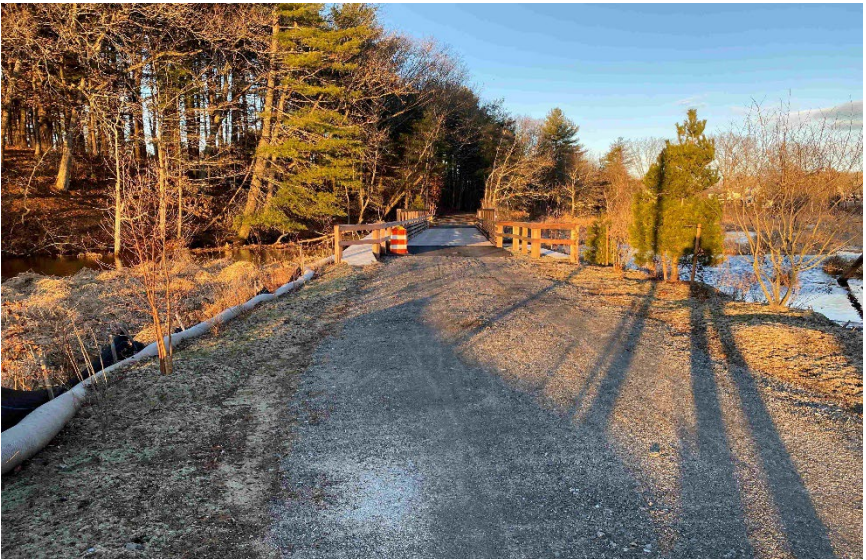
<b>PHOTOGRAPHIC LOG</b>	
<b>Client Name:</b> Eversource		<b>Site Location:</b> Sudbury to Hudson Transmission Reliability Project	<b>Town:</b> Sudbury
<b>Photo No.:</b> 7	<b>Date:</b> 1-2-25

<b>Description:</b>  Work area within segment 14, Bridge 127, area of previous hydro seeding & planting, existing erosion control, looking westward.

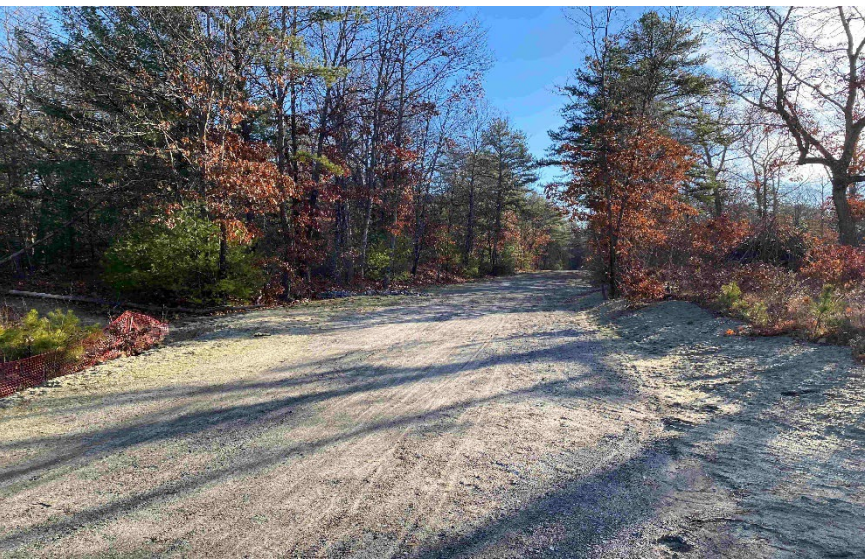
<b>PHOTOGRAPHIC LOG</b>	
<b>Client Name:</b> Eversource		<b>Site Location:</b> Sudbury to Hudson Transmission Reliability Project	<b>Town:</b> Sudbury
<b>Photo No.:</b> 8	<b>Date:</b> 1-2-25

<b>Description:</b>  Work area within segment 7 at town line (Sudbury-Hudson) area, area of hydroseeding, brush pile (right side-middle of photo), looking eastward.
