Environmental Monitor Construction Site Inspection Report
MassDOT Project #608164 Construction Contract # 119678
EM Report #40

Project Description: Bruce Freeman Rail Trail Right-of-Way
 Permit Description(s): Order of Conditions (MGL Chapter 131, Section 40 and 310 CMR 10.00, Mass DEP File No. 301-1362); 2022 EPA NPDES General Permit for Discharges from Construction Areas; U.S. Army Corps of Engineers Permit No NAE-2021-01975.

Project Name:	Bruce Freeman Rail Trail - Phase 2d - Sudbury
Date of Inspections:	12/26/2024
Bi Weekly/ Monthly Period Covered:	December Weekly Inspection #5
Inspector's Name(s):	Anna Haznar
Inspectors' Contact Information:	ahaznar@beta-inc.com

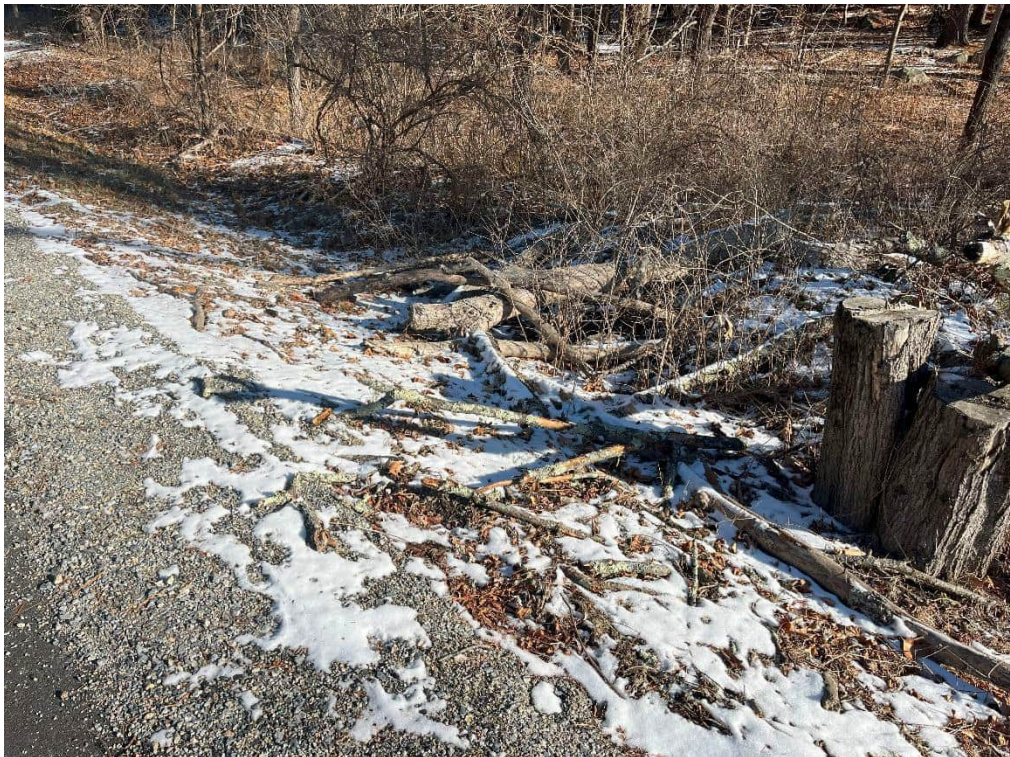
Photo No. 4 **Date:**
12/26/2024

View of a location where hydroseed was recently applied with no observable germination and crushed stone that requires removal at Station 180+00 per Long Term Compliance Action Item 58 and 59.

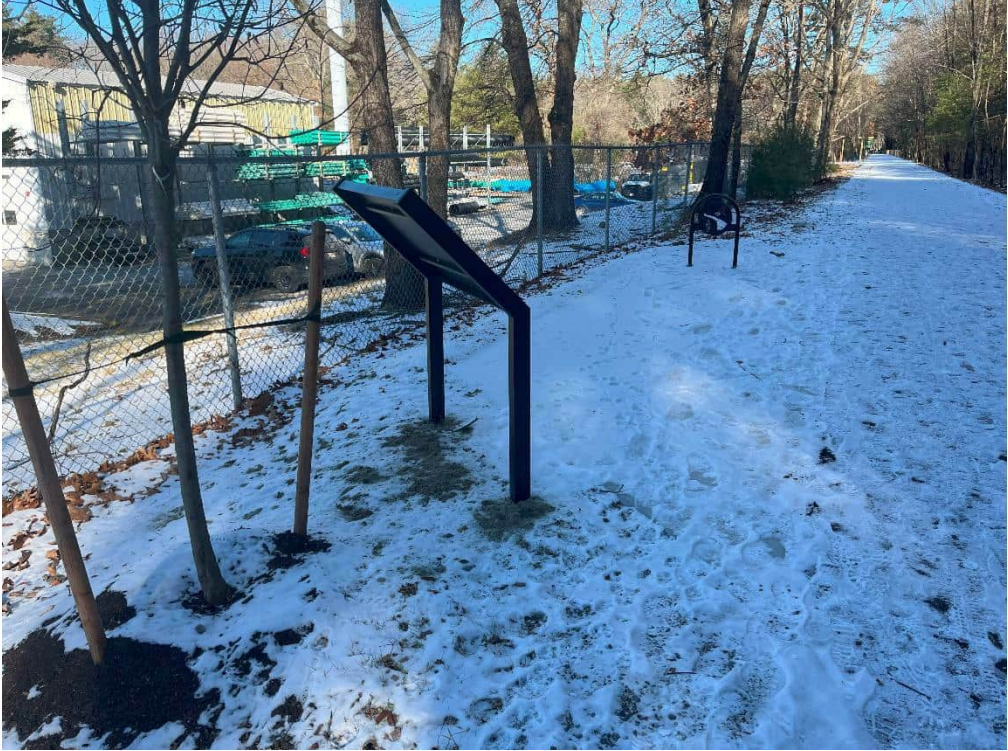
Direction Photo Taken: Toward the North		
Description: View of a location where hydroseed has been placed at Station 182+00 per Compliance Action Item 59.		
Photo No. 6	Date: 12/26/2024

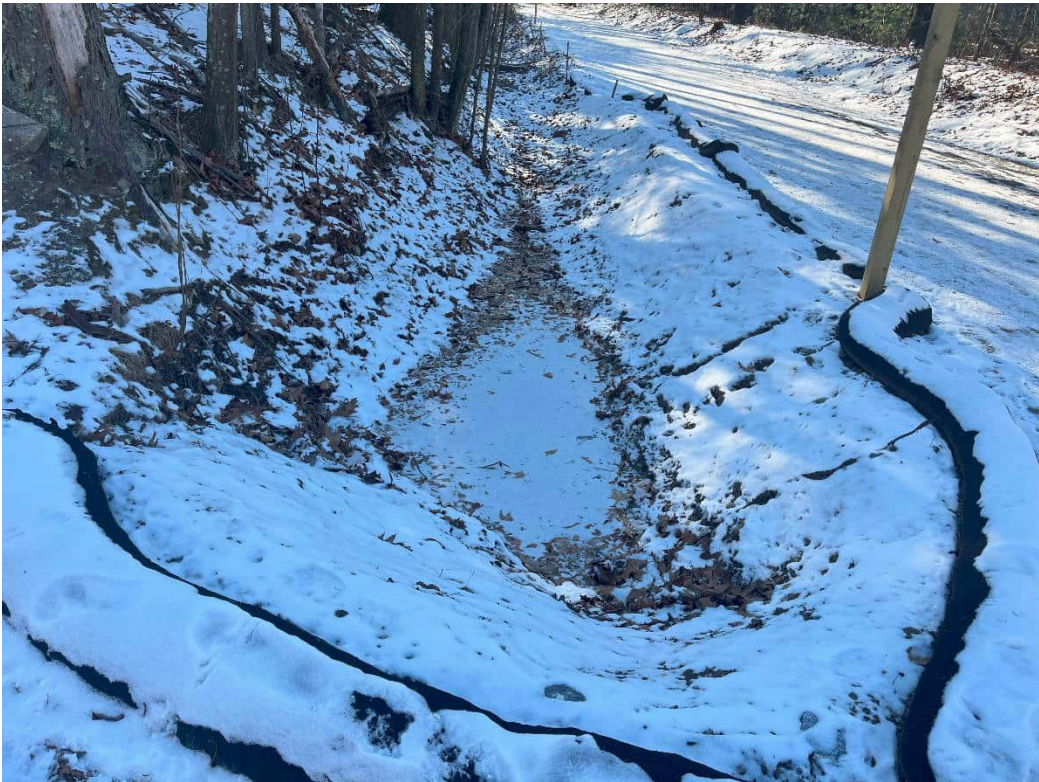
Item	Location/ Description	Observation Date	Resolution Due Date	Recommended Resolution / Resolution Date	Comments/Updates
62	Loam and seed was applied to the streambank at Station 216+00 to 217+00 and requires further stabilization Priority: High	11/25/2024	12/2/2024	An erosion control blanket should be installed along this slope.	12/2/2024 - Loam and seed have been applied to the streambank at Station 215+00. Stabilization is required at Stations 215+00 to 217+00. 12/6/2024 - Observation remains. See previous update. 12/12/2024 - Observation remains. Rill erosion was observed within the loam applied to this area from Station 215+00 to 216+00. 12/20/2024 - Observation remains. Loam has begun to erode, resulting in a discharge to the stream at Station 216+50. 12/26/2024 - Observation remains. No further discharge was observed in this location.
53	Stone was observed requiring removal from the swale on the east side of the trail at Station 172+00 to 173+00 Priority: High	7/29/2024	8/6/2024	Remove stone from the swale.	8/5/2024 - Observation remains. 8/7/2024 - Observation remains. 8/12/2024 - Observation remains. Material was observed to have migrated within the swale to Station 173+50. 8/16/2024 - Stone is still present within the swale. 8/20/2024 - Observation remains. Crushed stone has migrated further down the swale to Station 171+50. 8/27/2024 - Observation remains. Stone is still present within the swale. 9/3/2024 - Observation remains. 9/10/2024 - Observation remains. Stone is still present within the swale. 9/16/2024 - Observation remains. The contractor indicated that the stone within the swale would be hand removed. 9/23/2024 - Observation remains. 9/27/2024 - Observation remains. It appears as though some stone has migrated further south down the swale. 10/4/2024 - Observation remains. Stone is still present within the swale. 10/8/2024 - Observation remains. 10/15/2024 - Observation remains. Stone is covered with vegetation in some areas. 10/22/2024 - Observation remains. Stone is covered with vegetation in some areas. 10/29/2024 - Observation remains. 11/5/2024 - Observation remains. 11/12/2024 - Leaf litter has completely covered the stone in this location. The Contractor should indicate if stone has been removed from this location. 11/19/2024 - See previous update. 11/22/2024 - Observation remains. Stone is still present within the swale and requires removal. Leaf litter is currently covering a majority of the stone. 11/25/2024 - Observation remains. Leaf litter is covering a majority of the stone. 12/2/2024 - Observation remains. Stone is present within the swale under leaf litter. 12/6/2024 - Observation remains. See previous update. 12/12/2024 - Observation remains. Stone is present within the swale under the leaf litter. 12/20/2024 - Observation remains. Stone is present within the swale under the leaf litter. 12/26/2024 - Observation remains. Stone is present within the swale under the leaf litter and snow.

Direction Photo Taken: Toward the South		
Description: View of loam that requires stabilization at Station 215+00 per Compliance Action Item 62. Note rill erosion is occurring in this area.

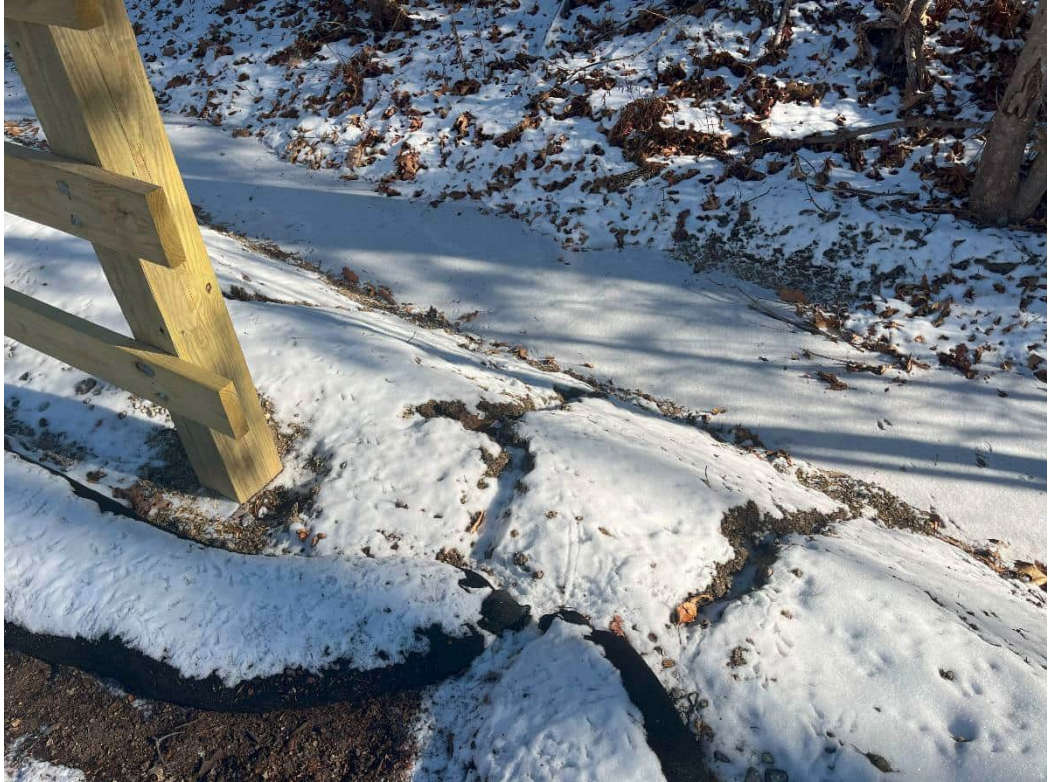
Photo No. 7 **Date:**
12/26/2024

Unusual Conditions (drought, severe storm):					Approximately 2" of snow cover	
Have any discharges occurred since the last inspection report?	No	No	No	Yes	No	
If yes, please describe:				Erosion of exposed soils has resulted in a discharge to the stream at Station 216+50

View of the location where loam that was placed on the streambank has eroded into the streambed at Station 216+50, resulting in a discharge per Compliance Action Item 62.

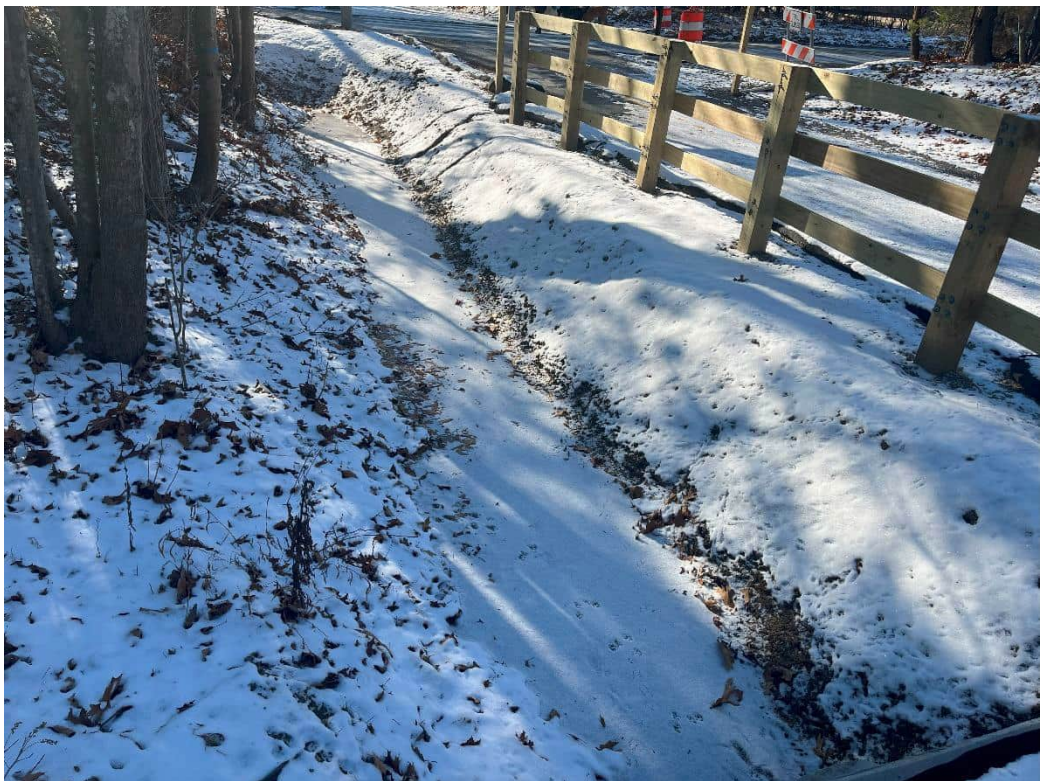
Photo No. 8 **Date:**
12/26/2024

41	Stream Bank has been regraded beyond the limit of work at Station 216+00 Priority: High	5/28/2024	6/4/2024	The Contractor should confirm if this work was permitted by the Conservation Commission, as it does not appear to be a part of the approved plans/impacts. MassDOT should be consulted on next steps regarding notification and potential restoration.	<p>5/31/2024 - Observation remains. 6/7/2024 - Observation remains. 6/14/2024 - Observation remains. 6/17/2024 - Observation remains. 6/24/2024 - Observation remains. 6/27/2024 - Observation remains. 7/8/2024 - Observation remains. 7/15/2024 - This area could not be assessed due to paving operations ongoing during the inspection. 7/22/2024 - Crushed stone and sediment continue to be discharged to the stream between Stations 215+00 and 217+00 due to overtopped and undermined compost filter tubes. 7/29/2024 - Observation remains. 8/5/2024 - Observation remains. 8/7/2024 - Observation remains. 8/12/2024 - Observation remains. Crushed stone is still present in the streambed at this location. 8/16/2024 - Observation remains. 8/20/2024 - Stone has been removed; however, additional alteration to Resource Areas beyond the limit of work continue. 8/27/2024 - Observation remains. 9/3/2024 - Observation remains. 9/10/2024 - Observation remains. Stone has been observed as discharging into the streambed in this location again. 9/16/2024 - Observation remains. 9/23/2024 - Observation remains. Stone is still present within the streambed at this location. 9/27/2024 - Observation remains. 10/4/2024 - Observation remains. 10/8/2024 - Observation remains. 10/15/2024 - Observation remains. Stone is still present within the streambed at this location. 10/22/2024 - Observation remains. Stone is still present within the streambed at this location. 10/29/2024 - Observation remains. Stone is still present within the streambed at this location. 11/5/2024 - Observation remains. The PVC pipe that was installed at this location was observed to be covered with stone and is no longer visible near Station 215+00. Stone is still present within the streambed at this location. 11/12/2024 - Observation remains. The streambed in this location is covered with leaf litter. See previous update. 11/19/2024 - Observation remains. As discussed with the Conservation Agent in the field, further coordination between the Town and MassDOT will be required to clean/repair the culvert, as the degraded condition of the culvert prompted the contractor to armor the stream banks. Further coordination will also be required for restoration of banks. 11/22/2024 - Observation remains. See previous update. 11/25/2024 - Observation remains. See update from 11/19/2024. 12/2/2024 - Observation remains. See update from 11/19/2024. 12/6/2024 - Observation remains. See update from 11/19/2024. 12/12/2024 - Observation remains. See update from 11/19/2024. 12/20/2024 - Observation remains. See update from 11/19/2024. 12/26/2024 - Observation remains. See update from 11/19/2024.</p>

View of the location where the stream bank has been regraded beyond the limits of work and stabilization of loam is required at Station 216+00 per Long Term Compliance Action Item 41 and 62. Note rill erosion is occurring in this area.

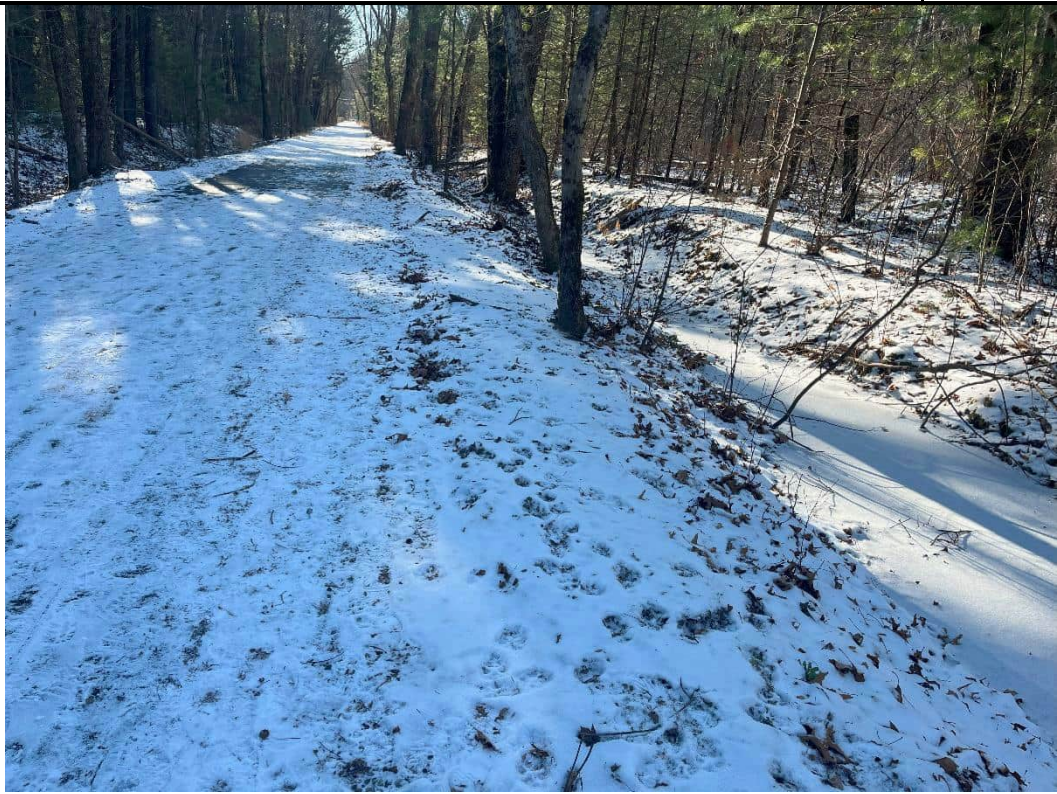
Photo No. 11 **Date:** 12/26/2024

View of an area of exposed soil at Station 297+50 per Long Term Compliance Action Item 59. Note exposed soil is currently covered in snow.

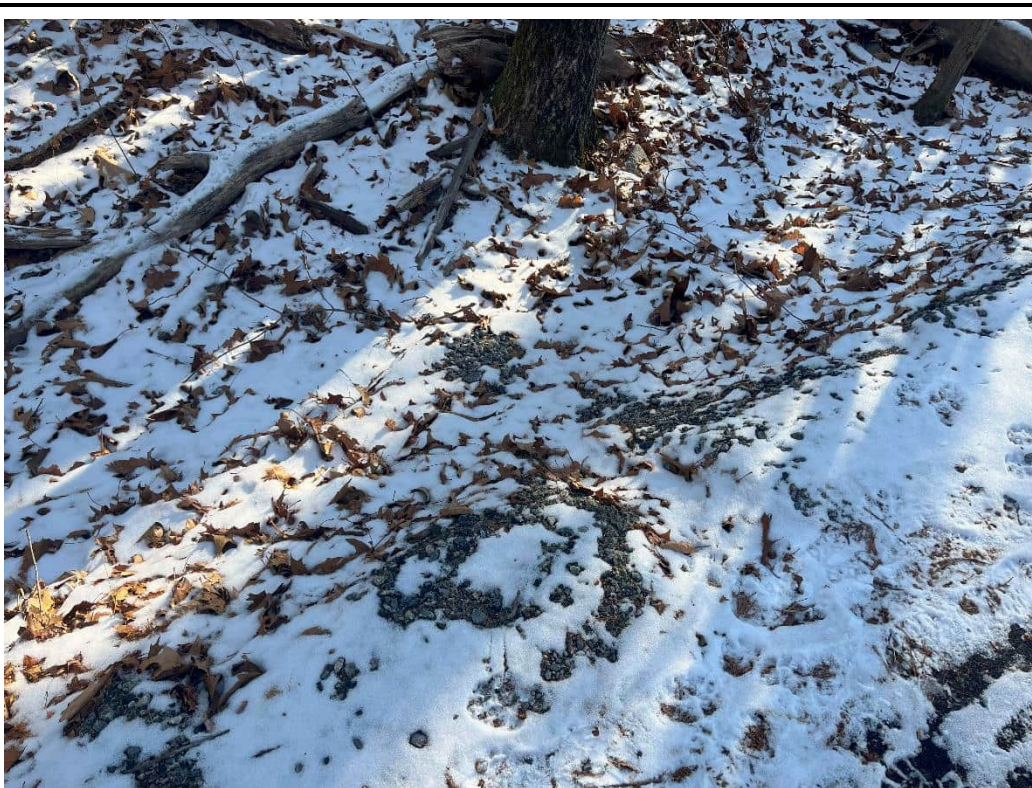
Photo No. 12 **Date:** 12/26/2024

View of crushed stone that requires removal from the swale at Station 303+00 per Long Term Compliance Action Item 58.

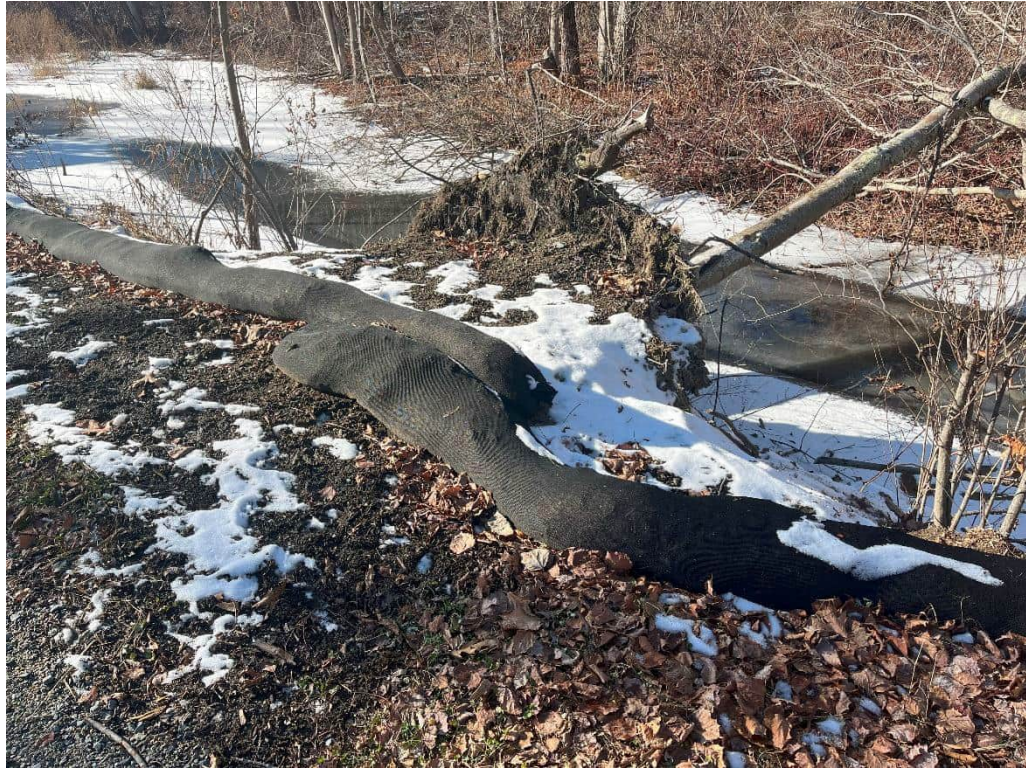
Photo No. 13 **Date:** 12/26/2024

View of placed loam that requires stabilization at Station 311+00 per Long Term Compliance Action Item 59.

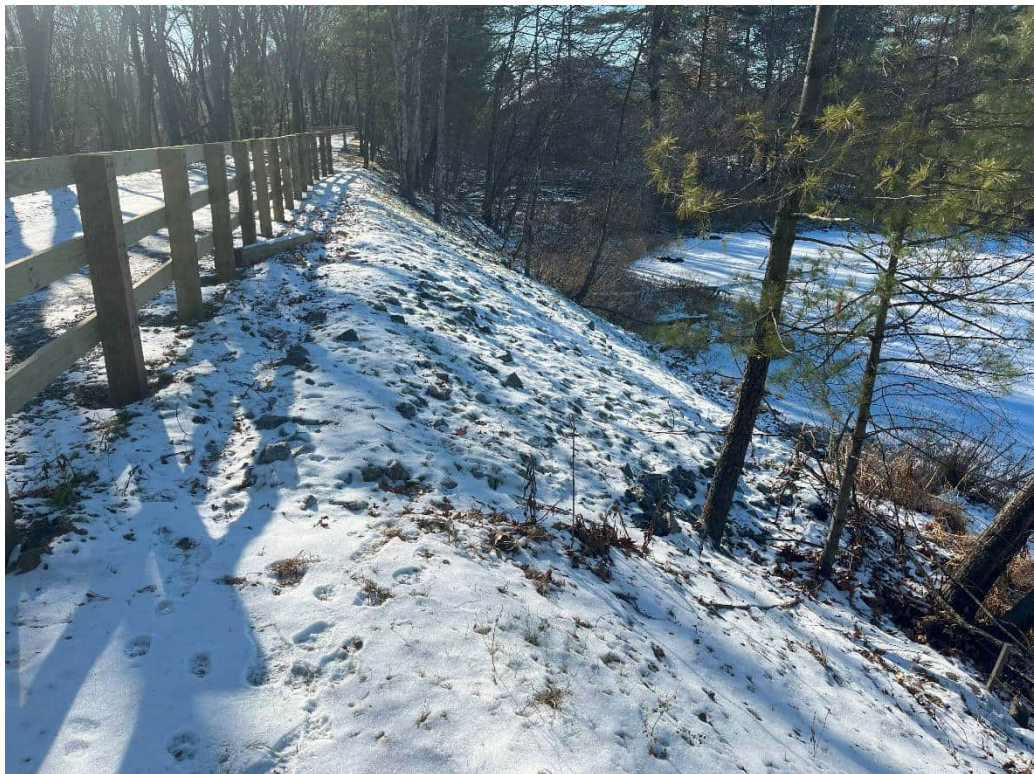
Photo No. 14 **Date:** 12/26/2024

42	<p>Riprap slope extends beyond limits of work along the WF1 Series wetland near flags 103 to 107 Priority: High</p>	5/28/2024	6/4/2024	<p>The Contractor should confirm if this work was permitted by the Conservation Commission, as it does not appear to be a part of the approved plans/impacts. MassDOT should be consulted on next steps regarding notification and potential restoration.</p>	<p>5/31/2024 - Observation remains. 6/7/2024 - Observation remains. 6/14/2024 - Riprap slope has been altered and active construction is repairing the area. 6/17/2024 - During this inspection, additional work in support of the repair/potential replacement of an underlying pipe has been ongoing. It is recommended that the contractor confirm that they have coordinated with the Conservation Commission for this work and provide a restoration plan for the area once work is complete. 6/24/2024 - During this inspection, BETA was informed that the existing cast iron pipe was replaced with a new concrete 12-inch reinforced concrete pipe. It appears that riprap was replaced along the side slopes to mirror conditions observed prior to this inspection. 6/27/2024 - During this inspection, the area was observed to have been rolled and prepared for paving. Hydroseed was applied and plantings were installed. 7/8/2024 - Germination was observed and the area will be monitored for stabilization. See previous updates regarding Conservation Commission coordination. 7/15/2024 - This area could not be assessed due to paving operations ongoing during the inspection. 7/22/2024 - See previous updates regarding Conservation Commission coordination. 7/29/2024 - Observation remains. 8/5/2024 - Observation remains. 8/7/2024 - Observation remains. 8/12/2024 - Observation remains. Regrowth of vegetation has been observed in this area and will continue to be monitored. 8/16/2024 - Observation remains. 8/20/2024 - Observation remains. 8/27/2024 - Observation remains. 9/3/2024 - Observation remains. 9/10/2024 - Observation remains. 9/16/2024 - Observation remains. 9/23/2024 - Observation remains. 9/27/2024 - Observation remains. 10/4/2024 - Observation remains. 10/8/2024 - Observation remains. 10/15/2024 - Observation remains. 10/22/2024 - Observation remains. 10/29/2024 - Observation remains. 11/5/2024 - Observation remains. 11/12/2024 - Observation remains. The timber fence has been installed upgradient of this area. 11/19/2024 - Observation remains. As discussed with the Conservation Agent in the field, an as-built should be prepared for this area to quantify any additional impacts that may be addressed through a permit amendment. 11/22/2024 - Observation remains. See previous update. 11/25/2024 - Observation remains. See update from 11/19/2024. 12/2/2024 - Observation remains. See update from 11/19/2024. 12/6/2024 - Observation remains. See update from 11/19/2024. 12/12/2024 - Observation remains. See update from 11/19/2024. 12/20/2024 - Observation remains. See update from 11/19/2024. 12/26/2024 - Observation remains. See update from 11/19/2024.</p>

View of the riprap slope that extends beyond the limit of work along the WF1 Series wetland at Station 332+00 per Long Term Compliance Action Item 42.
