Environmental Monitor Construction Site Inspection Report
MassDOT Project #608164 Construction Contract # 119678
EM Report #45

Project Description: Bruce Freeman Rail Trail Right-of-Way
 Permit Description(s): Order of Conditions (MGL Chapter 131, Section 40 and 310 CMR 10.00, Mass DEP File No. 301-1362); 2022 EPA NPDES General Permit for Discharges from Construction Areas; U.S. Army Corps of Engineers Permit No NAE-2021-01975.

Project Name:	Bruce Freeman Rail Trail - Phase 2d - Sudbury
Date of Inspections:	1/23/2025
Bi Weekly/ Monthly Period Covered:	January Weekly Inspection #4
Inspector's Name(s):	Anna Haznar
Inspectors' Contact Information:	ahaznar@beta-inc.com

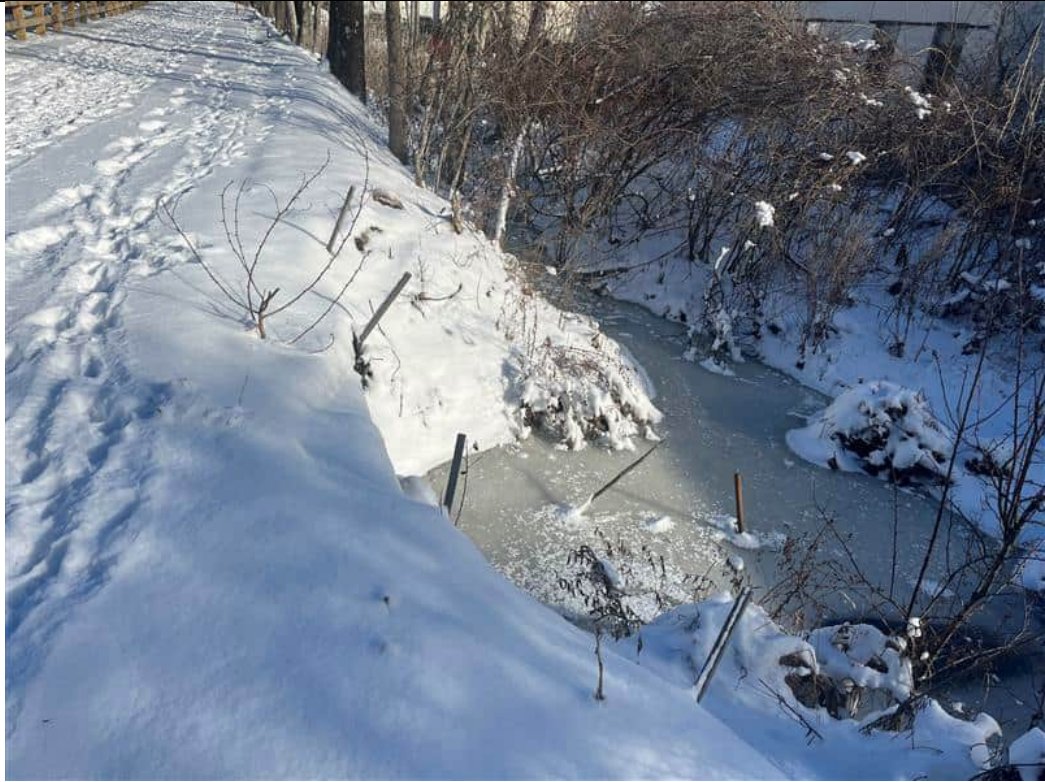
Photo No. 1 **Date:**
1/23/2025

43	Overtopped compost filter tubes and exposed soils beyond the limits of work at Station 105+00 Priority: High	6/7/2024	6/14/2024	Stabilize the area with the approved seed mixture and provide interim stabilization such as straw mulch.	<p>6/14/2024 - Observation remains.</p> <p>6/17/2024 - Observation remains.</p> <p>6/24/2024 - Observation remains.</p> <p>6/27/2024 - Observation remains.</p> <p>7/8/2024 - Observation remains.</p> <p>7/15/2024 - Observation remains.</p> <p>7/22/2024 - Observation remains.</p> <p>7/29/2024 - Observation remains.</p> <p>8/5/2024 - Observation remains.</p> <p>8/7/2024 - Observation remains.</p> <p>8/12/2024 - Observation remains. Some material has migrated off of the compost filter tubes due to erosion.</p> <p>8/16/2024 - Observation remains.</p> <p>8/20/2024 - Application of the approved seed mixture is required at this location.</p> <p>8/27/2024 - Observation remains.</p> <p>9/3/2024 - Observation remains.</p> <p>9/10/2024 - Observation remains. Application of the approved seed mixture is required at this location.</p> <p>9/16/2024 - Observation remains.</p> <p>9/23/2024 - Observation remains.</p> <p>9/27/2024 - Observation remains.</p> <p>10/4/2024 - Hydroseed has been applied here; however, the contractor should provide an update on long-term slope stabilization plans.</p> <p>10/8/2024 - Observation remains. Germination has not been observed.</p> <p>10/15/2024 - Observation remains. Germination has not been observed.</p> <p>10/22/2024 - Observation remains. Some germination has been observed but the area is not considered stabilized.</p> <p>10/29/2024 - Observation remains. No further germination has been observed since the last inspection.</p> <p>11/5/2024 - Observation remains. Some germination has been observed but the area is not considered stabilized.</p> <p>11/12/2024 - Observation remains. Seed has stabilized the area.</p> <p>11/19/2024 - The area adjacent to the path has become stabilized; however, exposed soil is still present next to the culvert past the limit of work.</p> <p>11/22/2024 - Observation remains. See previous update.</p> <p>11/25/2024 - Observation remains. See update from 11/19/2024.</p> <p>12/2/2024 - Observation remains. See update from 11/19/2024.</p> <p>12/6/2024 - Observation remains. See update for 11/19/2024.</p> <p>12/12/2024 - Observation remains. See update from 11/19/2024.</p> <p>12/20/2024 - Observation remains. See update from 11/19/2024.</p> <p>12/26/2024 - Observation remains. See update from 11/19/2024.</p> <p>12/31/2024 - Observation remains. See update from 11/19/2024.</p> <p>1/2/2025 - Observation remains. See update from 11/19/2024.</p> <p>1/9/2025 - Observation remains. See update from 11/19/2024.</p> <p>1/15/2025 - Observation remains. Exposed soils are still present next to the culvert past the limit of work.</p> <p>1/23/2025 - Observation remains. See previous update.</p>

View of the overtopped compost filter tube and exposed soils beyond the limits of work at Station 105+00 per Compliance Action Item 43. Note exposed soil is covered with snow.

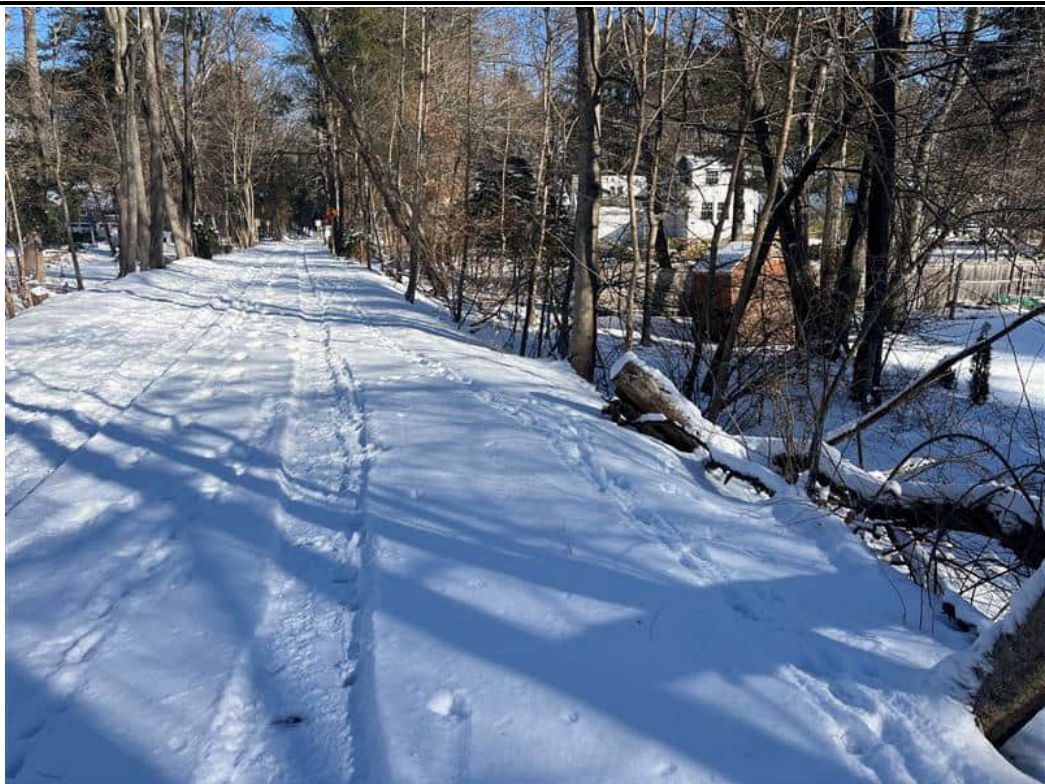
Photo No. 2 **Date:**
1/23/2025

View of exposed soil at Station 139+00 that requires stabilization per Long Term Compliance Action Item. Note exposed soil is covered with snow.

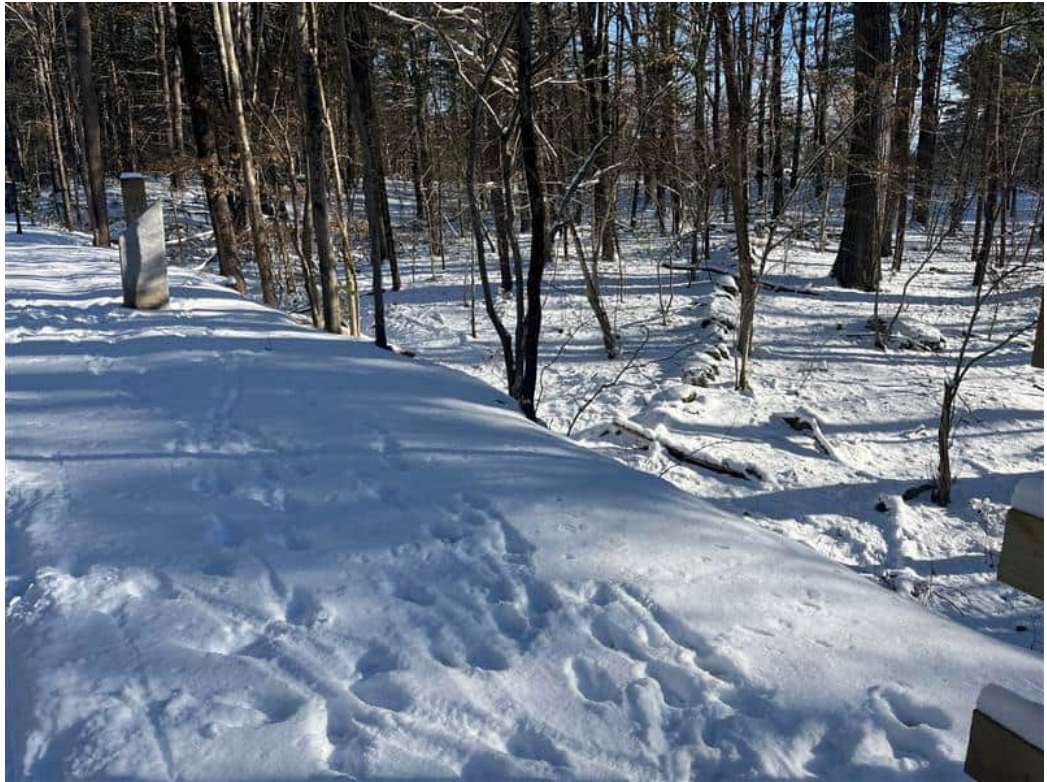
Photo No. 3 **Date:**
1/23/2025

View of exposed soil at Station 165+00 that requires stabilization per Long Term Compliance Action item 59. Note exposed soil is covered with snow.

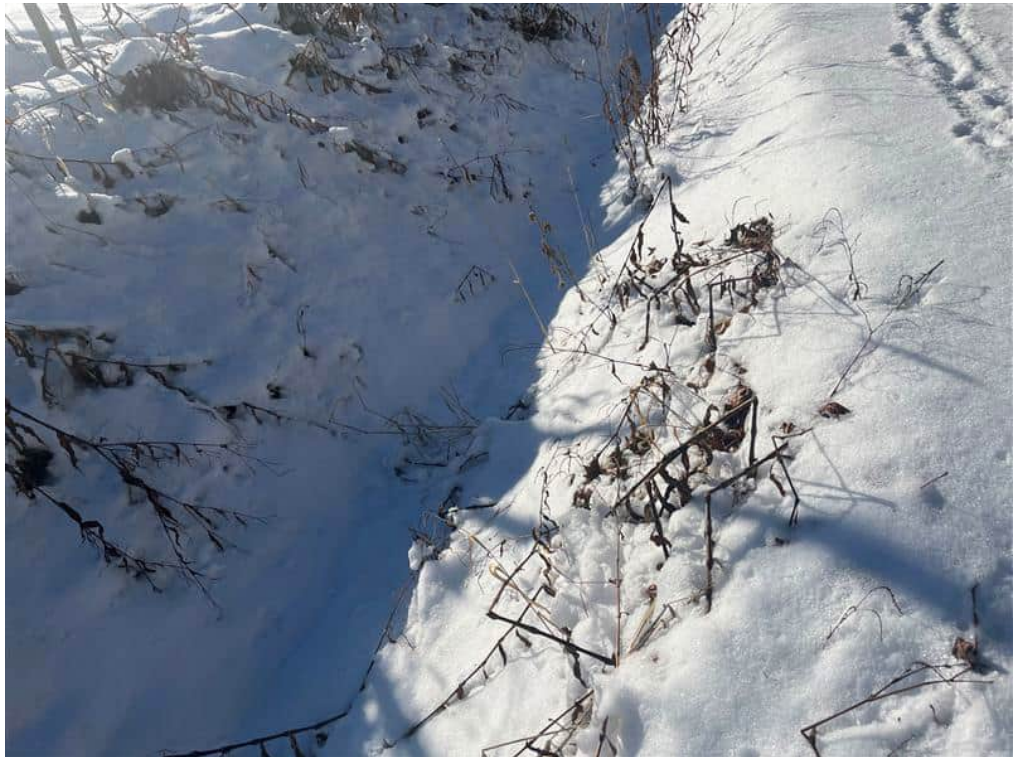
Photo No. 4 **Date:**
1/23/2025

53	<p>Stone was observed requiring removal from the swale on the east side of the trail at Station 172+00 to 173+00 Priority: High</p>	7/29/2024	8/6/2024	Remove stone from the swale.	<p>8/5/2024 - Observation remains. 8/7/2024 - Observation remains. 8/12/2024 - Observation remains. Material was observed to have migrated within the swale to Station 173+50. 8/16/2024 - Stone is still present within the swale. 8/20/2024 - Observation remains. Crushed stone has migrated further down the swale to Station 171+50. 8/27/2024 - Observation remains. Stone is still present within the swale. 9/3/2024 - Observation remains. 9/10/2024 - Observation remains. Stone is still present within the swale. 9/16/2024 - Observation remains. The contractor indicated that the stone within the swale would be hand removed. 9/23/2024 - Observation remains. 9/27/2024 - Observation remains. It appears as though some stone has migrated further south down the swale. 10/4/2024 - Observation remains. Stone is still present within the swale. 10/8/2024 - Observation remains. 10/15/2024 - Observation remains. Stone is covered with vegetation in some areas. 10/22/2024 - Observation remains. Stone is covered with vegetation in some areas. 10/29/2024 - Observation remains. 11/5/2024 - Observation remains. 11/12/2024 - Leaf litter has completely covered the stone in this location. The Contractor should indicate if stone has been removed from this location. 11/19/2024 - See previous update. 11/22/2024 - Observation remains. Stone is still present within the swale and requires removal. Leaf litter is currently covering a majority of the stone. 11/25/2024 - Observation remains. Leaf litter is covering a majority of the stone. 12/2/2024 - Observation remains. Stone is present within the swale under leaf litter. 12/6/2024 - Observation remains. See previous update. 12/12/2024 - Observation remains. Stone is present within the swale under the leaf litter. 12/20/2024 - Observation remains. Stone is present within the swale under the leaf litter. 12/26/2024 - Observation remains. Stone is present within the swale under the leaf litter and snow. 12/31/2024 - Observation remains. Stone is present within the swale under the leaf litter. 1/2/2025 - Observation remains. Stone is present within the swale under the leaf litter. 1/9/2025 - Observation remains. Stone is present within the swale under the leaf litter. 1/15/2025 - Observation remains. Further stone has discharged into the swale at this location, and stone is still present under leaf litter. 1/23/2025 - Observation remains. Stone is present within the swale under the leaf litter and snow.</p>

View of crushed stone within the swale at Station 172+00 per Compliance Action item 53. Note stone is covered with snow and leaf litter.

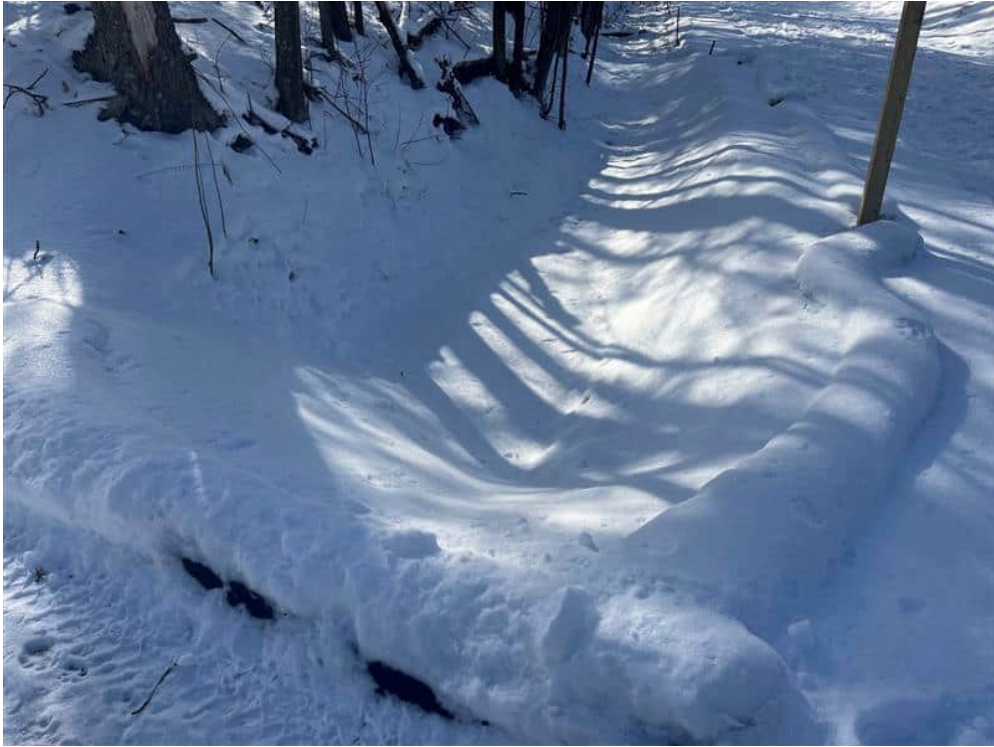
Item	Location/ Description	Observation Date	Resolution Due Date	Recommended Resolution / Resolution Date	Comments/Updates
62	Loam and seed was applied to the streambank at Station 216+00 to 217+00 and requires further stabilization Priority: High	11/25/2024	12/2/2024	An erosion control blanket should be installed along this slope.	<p>12/2/2024 - Loam and seed have been applied to the streambank at Station 215+00. Stabilization is required at Stations 215+00 to 217+00.</p> <p>12/6/2024 - Observation remains. See previous update.</p> <p>12/12/2024 - Observation remains. Rill erosion was observed within the loam applied to this area from Station 215+00 to 216+00.</p> <p>12/20/2024 - Observation remains. Loam has begun to erode, resulting in a discharge to the stream at Station 216+50.</p> <p>12/26/2024 - Observation remains. No further discharge was observed in this location.</p> <p>12/31/2024 - Observation remains. Additional loam has eroded resulting in a discharge to the stream at Station 216+50.</p> <p>1/2/2025 - Observation remains. No further discharge was observed in this location.</p> <p>1/9/2025 - Observation remains. Straw was observed to have been placed along portions of the streambank; however, this area should be stabilized using an erosion control blanket.</p> <p>1/15/2025 - Observation remains. Erosion causing a discharge of loam and straw into the stream was observed at Station 216+50.</p> <p>1/23/2025 - Observation remains. Snow coverage is present within the stream and on the streambank. No further discharge was observed during this inspection.</p>

Direction Photo Taken: Toward the South		
Description: View of loam that requires stabilization at Station 215+00 per Compliance Action Item 62. Note loam is covered with snow.		
Photo No. 6	Date: 1/23/2025

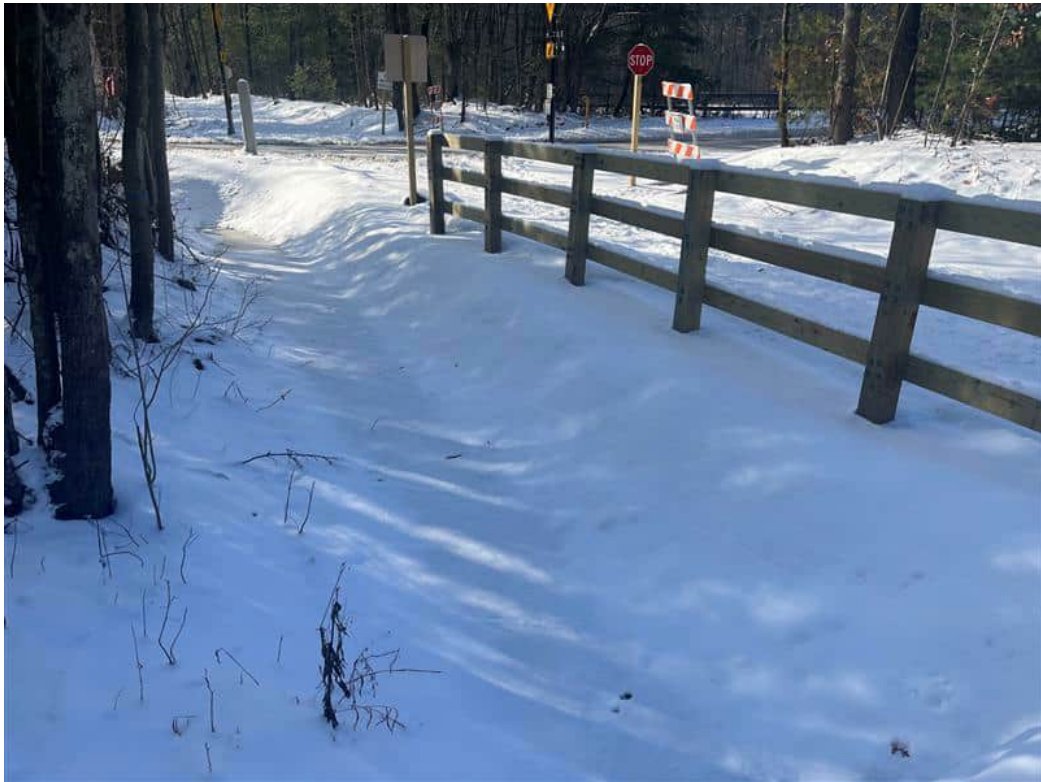
41	Stream Bank has been regraded beyond the limit of work at Station 216+00 Priority: High	5/28/2024	6/4/2024	;0.].	<p>5/31/2024 - Observation remains. 6/7/2024 - Observation remains. 6/14/2024 - Observation remains. 6/17/2024 - Observation remains. 6/24/2024 - Observation remains. 6/27/2024 - Observation remains. 7/8/2024 - Observation remains. 7/15/2024 - This area could not be assessed due to paving operations ongoing during the inspection. 7/22/2024 - Crushed stone and sediment continue to be discharged to the stream between Stations 215+00 and 217+00 due to overtopped and undermined compost filter tubes. 7/29/2024 - Observation remains. 8/5/2024 - Observation remains. 8/7/2024 - Observation remains. 8/12/2024 - Observation remains. Crushed stone is still present in the streambed at this location. 8/16/2024 - Observation remains. 8/20/2024 - Stone has been removed; however, additional alteration to Resource Areas beyond the limit of work continue. 8/27/2024 - Observation remains. 9/3/2024 - Observation remains. 9/10/2024 - Observation remains. Stone has been observed as discharging into the streambed in this location again. 9/16/2024 - Observation remains. 9/23/2024 - Observation remains. Stone is still present within the streambed at this location. 9/27/2024 - Observation remains. 10/4/2024 - Observation remains. 10/8/2024 - Observation remains. 10/15/2024 - Observation remains. Stone is still present within the streambed at this location. 10/22/2024 - Observation remains. Stone is still present within the streambed at this location. 10/29/2024 - Observation remains. Stone is still present within the streambed at this location. 11/5/2024 - Observation remains. The PVC pipe that was installed at this location was observed to be covered with stone and is no longer visible near Station 215+00. Stone is still present within the streambed at this location. 11/12/2024 - Observation remains. The streambed in this location is covered with leaf litter. See previous update. 11/19/2024 - Observation remains. As discussed with the Conservation Agent in the field, further coordination between the Town and MassDOT will be required to clean/repair the culvert, as the degraded condition of the culvert prompted the contractor to armor the stream banks. Further coordination will also be required for restoration of banks. 11/22/2024 - Observation remains. See previous update. 11/25/2024 - Observation remains. See update from 11/19/2024. 12/2/2024 - Observation remains. See update from 11/19/2024. 12/6/2024 - Observation remains. See update from 11/19/2024. 12/12/2024 - Observation remains. See update from 11/19/2024. 12/20/2024 - Observation remains. See update from 11/19/2024. 12/26/2024 - Observation remains. See update from 11/19/2024. 12/31/2024 - Observation remains. See update from 11/19/2024. 1/2/2025 - Observation remains. See update from 11/19/2024. 1/9/2025 - Observation remains. See update from 11/19/2024. 1/15/2025 - Observation remains. See update from 11/19/2024. 1/23/2025 - Observation remains. See update from 11/19/2024.</p>

Direction Photo Taken: Toward the South		
Description: View of the location where the stream bank has been regraded beyond the limits of work and stabilization of loam is required at Station 216+00 per Long Term Compliance Action Item 41 and 62. Note loam is covered with snow.

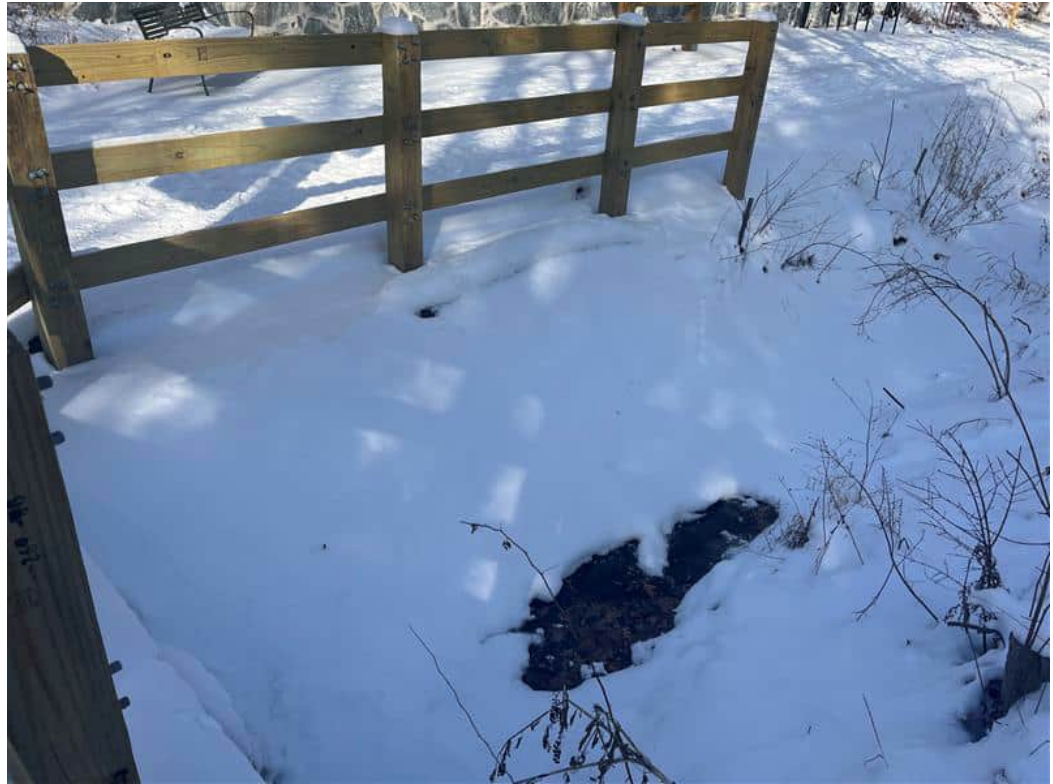
Photo No. 7 **Date:**
1/23/2025

View of loam that requires stabilization at Station 217+00 per Compliance Action Item 62. Note loam is covered with snow.

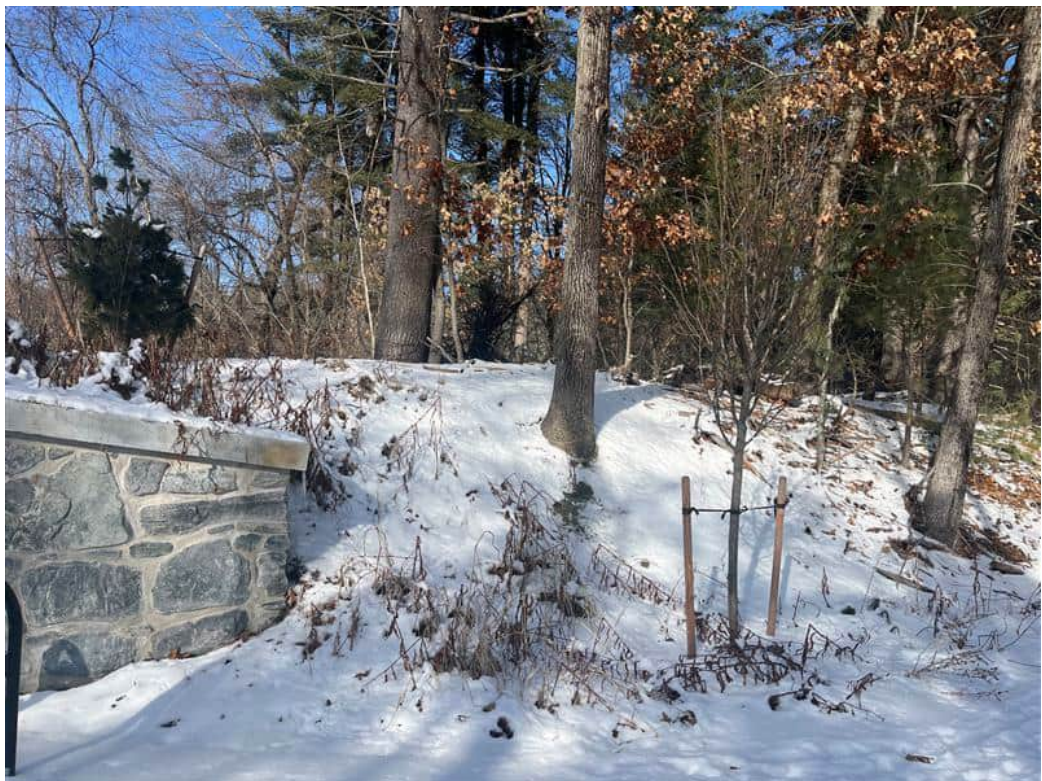
Photo No. 8 **Date:**
1/23/2025

34	<p>Sediment is eroding downhill from behind the cemented stone masonry wall at Station 217+45 Priority: Low</p>	5/28/2024	6/4/2024	<p>Apply seed and temporarily stabilize the soils along the slope with straw, jute netting, etc.</p>	<p>5/31/2024 - Observation remains. 6/7/2024 - Observation remains. 6/14/2024 - Observation remains. 6/17/2024 - Observation remains. 6/24/2024 - Observation remains. 6/27/2024 - Rills were raked, loam was added, and hydroseed was applied. 7/8/2024 - Observation remains. Grass was observed to be germinating at this location. Comment will remain open until stabilization is complete. 7/8/2024 - See previous update. 7/15/2024 - Additional hydroseed is required due to washouts. 7/22/2024 - Observation remains. 7/29/2024 - Observation remains. 8/5/2024 - Observation remains. 8/7/2024 - Regrowth of vegetation has been observed in this area. This item will remain open until the area is fully stabilized. 8/12/2024 - Observation remains. Regrowth has stabilized a portion of this hill; however, reseeding and additional temporary stabilized measures are recommended on the section that is currently unvegetated. 8/16/2024 - Observation remains. 8/20/2024 - Application of the approved seed mixture is required at this location. 8/27/2024 - Observation remains. 9/3/2024 - Vegetation that is present in this location generally consists of lady's thumb smartweed (<i>Persicaria maculosa</i>), a non-native species. Removal of non-native species and application of the approved seed mixture is required at this location. 9/10/2024 - Observation remains. See previous update. 9/16/2024 - Observation remains. See update from 9/3/2024. 9/23/2024 - Observation remains. See update from 9/3/2024. 9/27/2024 - Observation remains. 10/4/2024 - Observation remains. See update from 9/3/2024. 10/8/2024 - Observation remains. See update from 9/3/2024. 10/15/2024 - Observation remains. See update from 9/3/2024. 10/22/2024 - Observation remains. See update from 9/3/2024. 10/29/2024 - Observation remains. No additional seed has been applied to this location and the slope is generally vegetated by non-native species. See update from 9/3/2024. 11/5/2024 - Observation remains. Erosion control and seed has been applied to part of this slope, no germination has been observed. 11/12/2024 - Observation remains. No germination has been observed in this location. 11/19/2024 - Observation remains. 11/22/2024 - Observation remains. No germination has been observed in this location. 11/25/2024 - Observation remains. No germination has been observed in this location. 12/2/2024 - Observation remains. No germination has been observed in this location. 12/6/2024 - Observation remains. No germination has been observed in this location. 12/12/2024 - Observation remains. Some germination has been observed within this location. Observation will remain open until stabilization is complete. 12/20/2024 - Observation remains. See previous update. 12/26/2024 - Observation remains. See update from 12/12/2024. 12/31/2024 - Observation remains. See update from 12/12/2024. 1/2/2025 - Observation remains. See update from 12/12/2024. 1/9/2025 - Observation remains. See update from 12/12/2024. 1/15/2025 - Observation remains. 1/23/2025 - Observation remains.</p>

View of the slope where hydroseed was applied and some germination has occurred at Station 217+45 per Compliance Action Item 34. Note area is covered with snow.

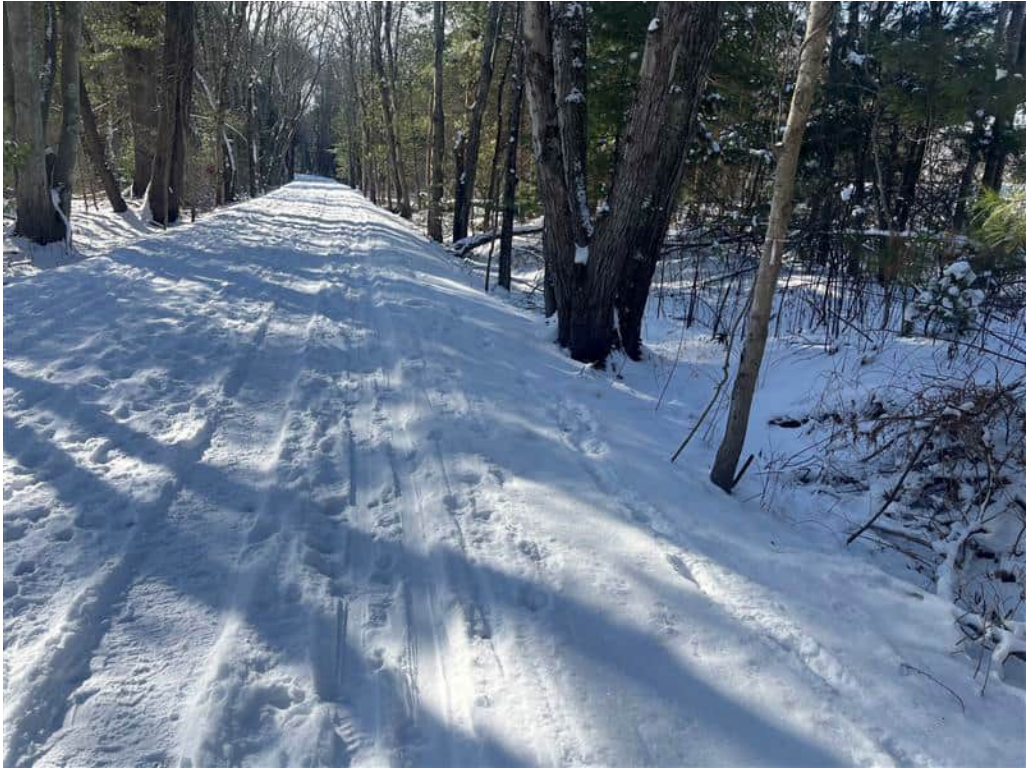
Direction Photo Taken: Toward the South		
Description: View of an area of exposed soil at Station 297+50 per Long Term Compliance Action Item 59. Note area is covered with snow.		
Photo No. 10	Date: 1/23/2025

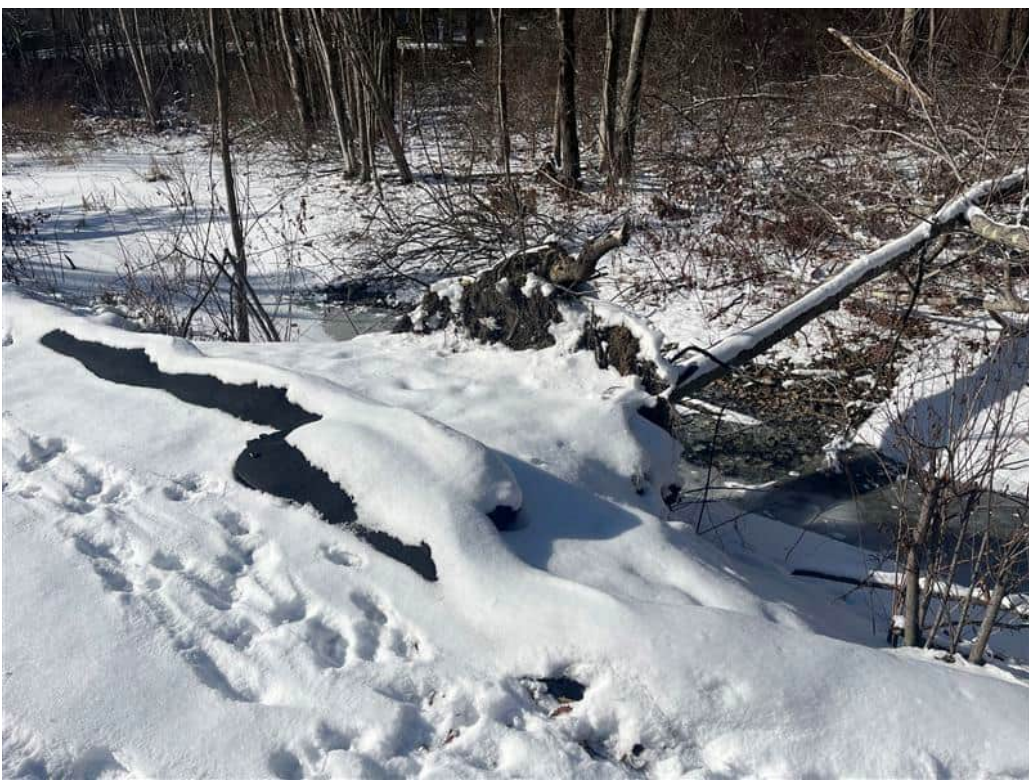
Direction Photo Taken: Toward the Southwest		
Description: View of placed loam that requires stabilization at Station 311+00 per Long Term Compliance Action Item 59. Note exposed soil is covered with snow.

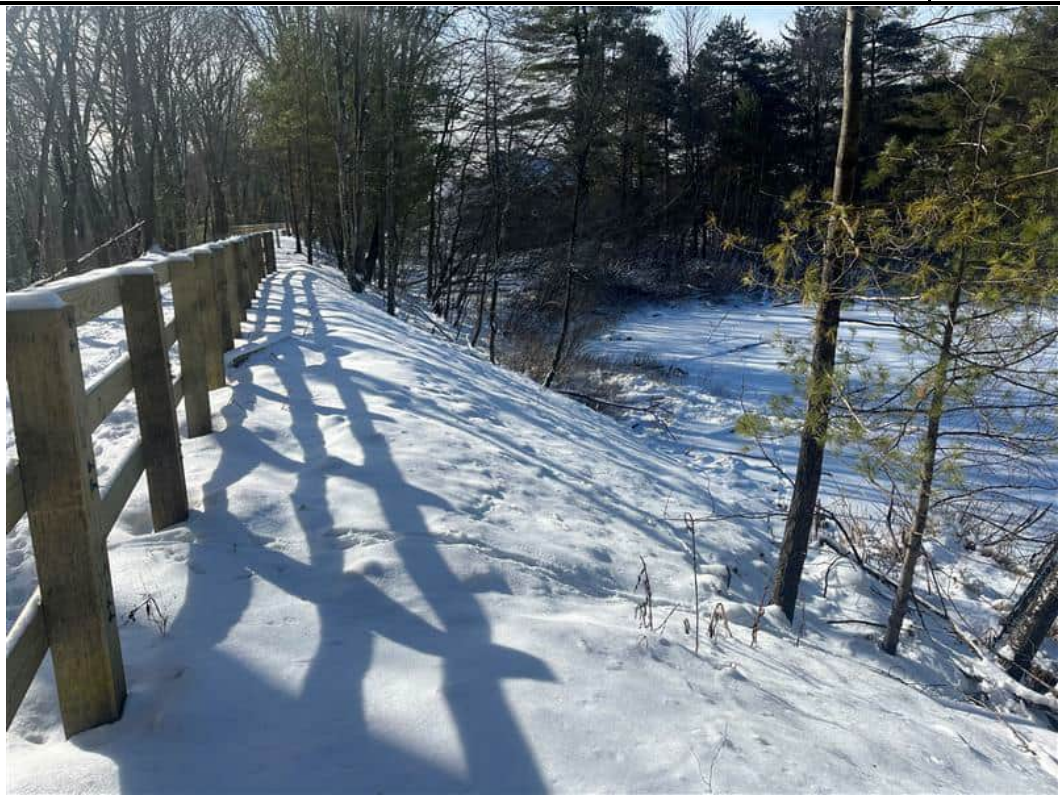
Photo No. 11 **Date:**
1/23/2025

42	<p>Riprap slope extends beyond limits of work along the WF1 Series wetland near flags 103 to 107</p> <p>Priority: High</p>	5/28/2024	6/4/2024	<p>The Contractor should confirm if this work was permitted by the Conservation Commission, as it does not appear to be a part of the approved plans/impacts. MassDOT should be consulted on next steps regarding notification and potential restoration.</p>	<p>5/31/2024 - Observation remains.</p> <p>6/7/2024 - Observation remains.</p> <p>6/14/2024 - Riprap slope has been altered and active construction is repairing the area.</p> <p>6/17/2024 - During this inspection, additional work in support of the repair/potential replacement of an underlying pipe has been ongoing. It is recommended that the contractor confirm that they have coordinated with the Conservation Commission for this work and provide a restoration plan for the area once work is complete.</p> <p>6/24/2024 - During this inspection, BETA was informed that the existing cast iron pipe was replaced with a new concrete 12-inch reinforced concrete pipe. It appears that riprap was replaced along the side slopes to mirror conditions observed prior to this inspection.</p> <p>6/27/2024 - During this inspection, the area was observed to have been rolled and prepared for paving. Hydroseed was applied and plantings were installed.</p> <p>7/8/2024 - Germination was observed and the area will be monitored for stabilization. See previous updates regarding Conservation Commission coordination.</p> <p>7/15/2024 - This area could not be assessed due to paving operations ongoing during the inspection.</p> <p>7/22/2024 - See previous updates regarding Conservation Commission coordination.</p> <p>7/29/2024 - Observation remains.</p> <p>8/5/2024 - Observation remains.</p> <p>8/7/2024 - Observation remains.</p> <p>8/12/2024 - Observation remains. Regrowth of vegetation has been observed in this area and will continue to be monitored.</p> <p>8/16/2024 - Observation remains.</p> <p>8/20/2024 - Observation remains.</p> <p>8/27/2024 - Observation remains.</p> <p>9/3/2024 - Observation remains.</p> <p>9/10/2024 - Observation remains.</p> <p>9/16/2024 - Observation remains.</p> <p>9/23/2024 - Observation remains.</p> <p>9/27/2024 - Observation remains.</p> <p>10/4/2024 - Observation remains.</p> <p>10/8/2024 - Observation remains.</p> <p>10/15/2024 - Observation remains.</p> <p>10/22/2024 - Observation remains.</p> <p>10/29/2024 - Observation remains.</p> <p>11/5/2024 - Observation remains.</p> <p>11/12/2024 - Observation remains. The timber fence has been installed upgradient of this area.</p> <p>11/19/2024 - Observation remains. As discussed with the Conservation Agent in the field, an as-built should be prepared for this area to quantify any additional impacts that may be addressed through a permit amendment.</p> <p>11/22/2024 - Observation remains. See previous update.</p> <p>11/25/2024 - Observation remains. See update from 11/19/2024.</p> <p>12/2/2024 - Observation remains. See update from 11/19/2024.</p> <p>12/6/2024 - Observation remains. See update from 11/19/2024.</p> <p>12/12/2024 - Observation remains. See update from 11/19/2024.</p> <p>12/20/2024 - Observation remains. See update from 11/19/2024.</p> <p>12/26/2024 - Observation remains. See update from 11/19/2024.</p> <p>12/31/2024 - Observation remains. See update from 11/19/2024.</p> <p>1/2/2025 - Observation remains. Leaf litter that was previously observed at the bottom of the slope has blown away and it appears that exposed soil with no observable germination is present.</p> <p>1/9/2025 - Observation remains. See update from 1/2/2025 and 11/19/2024.</p> <p>1/15/2025 - Observation remains. See update from 1/2/2025 and 11/19/2024.</p> <p>1/23/2025 - Observation remains. See update from 1/2/2025 and 11/19/2024.</p>

View of the riprap slope that extends beyond the limit of work along the WF1 Series wetland at Station 332+00 per Long Term Compliance Action Item 42.
