CONSTRUCTION MONITORING REPORT Sudbury to Hudson Transmission Project

Environmental Monitoring Photographs

CONSTRUCTION MONITORING REPORT **Sudbury to Hudson Transmission Project**

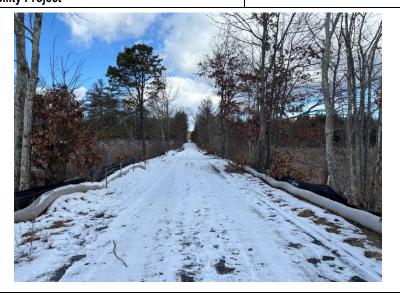
Photo No.: 3

View of E&S controls and snowcover in segment 2. Facing west.

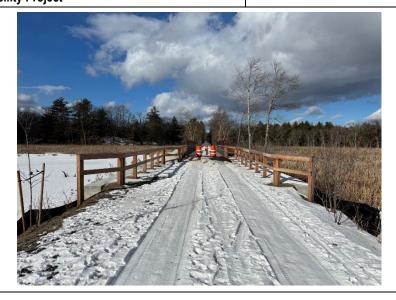
Photo No.: 4 Date: 1-28-2025

View of bridge 130 from segment 3. Facing west.

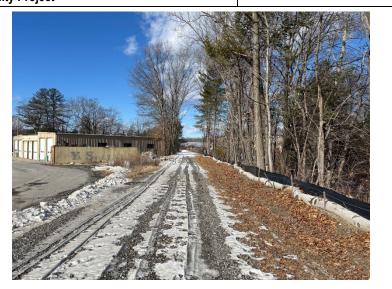
Photo No.: 5

View of E&S controls and snow melting in segment 3. Facing west.

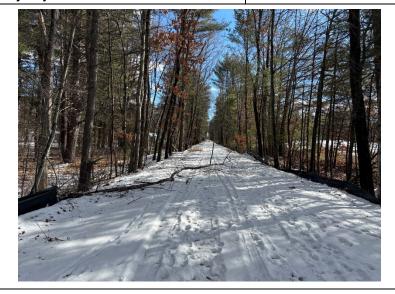
Photo No.: 6

View of downed tree in segment 4. Damage to E&S controls was minimal. Facing east.

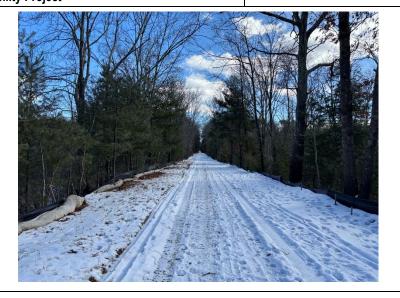
Photo No.: 7

View of E&S controls and snow cover in segment 5. Facing east.

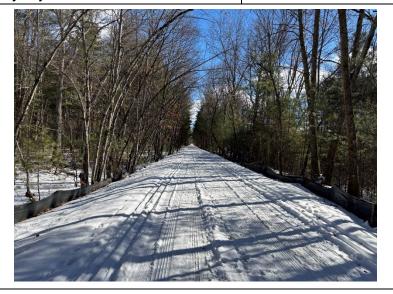
Photo No.: 8 **Description:**

View of E&S controls and snowcover in segment 6. Facing

east.

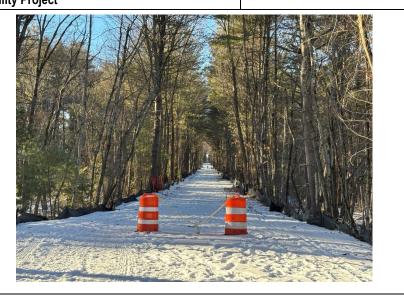
Photo No.: 3

View of entrance to segment 9 from Peakham Rd. Facing west.

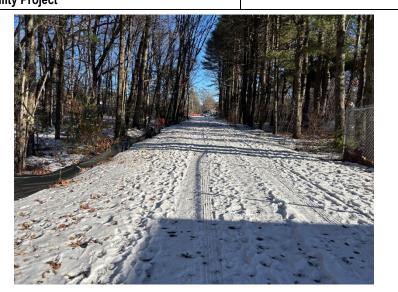
View of E&S controls and snowcover in segment 11. Facing

east.

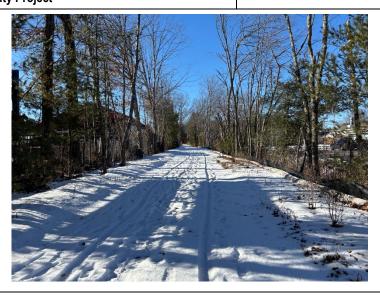
View of E&S controls, plantings, and snowcover in segment 12. Facing west.

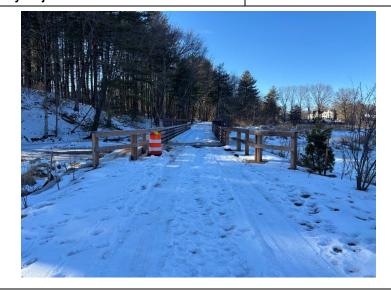
View of bridge 127 from segment 14. Facing west.
