**Sudbury to Hudson TRP Week of 2/03/2025**

**Epsilon Team Full SWPPP Inspection Report(s)**

## Sudbury to Hudson Transmission Project

Inspection Location Description (include segment # and stationing): **Segments 1-6 & MHs #1-4 on Wilkins and Forest Ave (Hudson)**

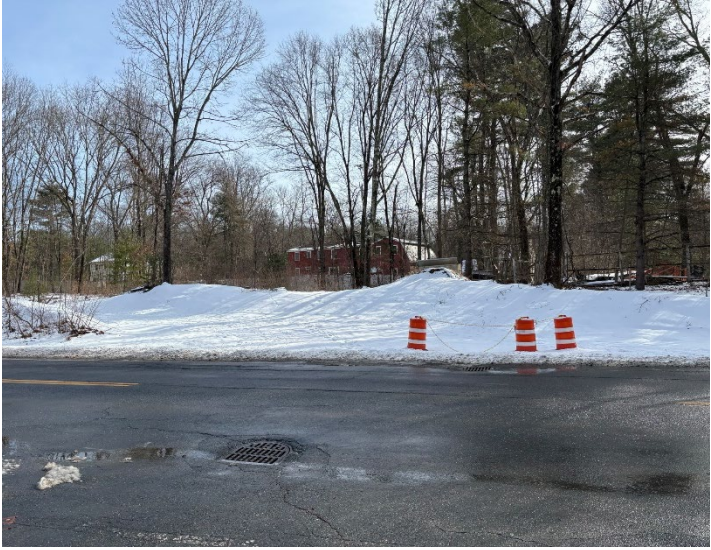
| <b>Photo No.:</b> 1 | <b>Date:</b> 2-03-2025 | | |

| <b>Description:</b><br>View of entrance to segment 1 at Wilkins St. Facing east. | | | |

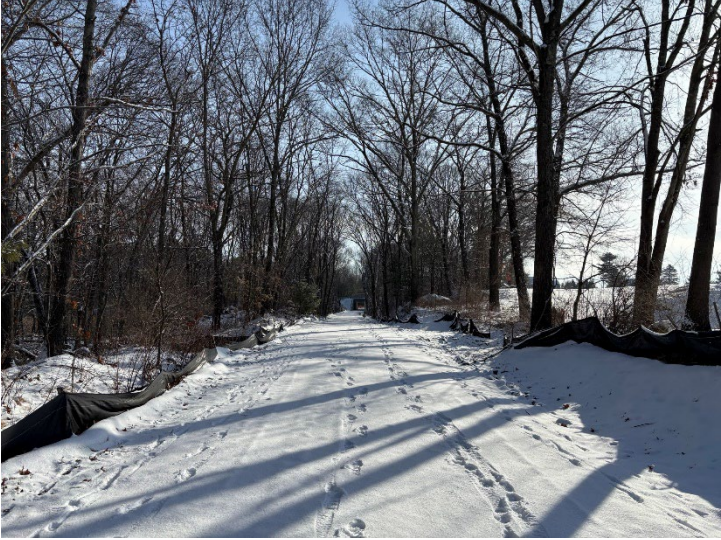
| <b>Photo No.:</b> 2 | <b>Date:</b> 2-03-2025 | | |

| <b>13. Rock lined swale &amp; rock check dams within segment 1</b> | <input type="checkbox"/> Yes <input checked="" type="checkbox"/> No | N/A | <input type="checkbox"/> Yes <input checked="" type="checkbox"/> No | N/A | Rock lined swale & check dams installed and operating properly within segment 1 (Hudson & Stow). |

| <b>Description:</b><br>View of E&S controls and snow cover in segment 1. Facing west. | | | |

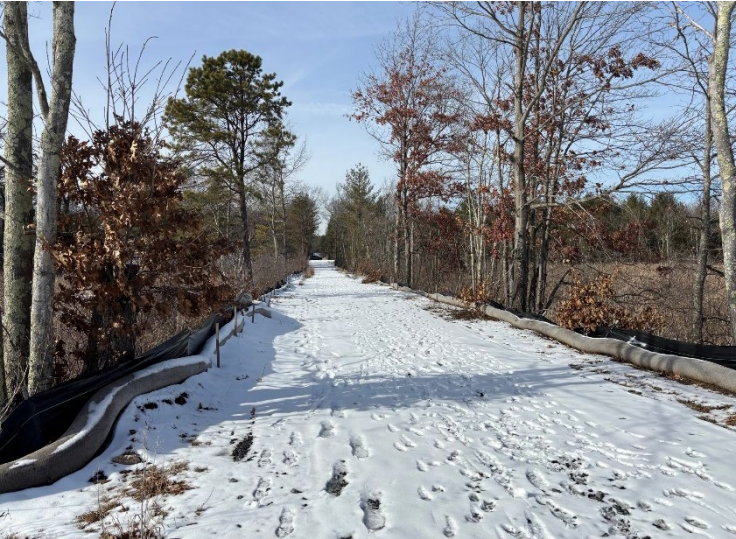
| Photo No.: 3 | Date: 2-03-2025 | | |

| Description:<br>View of E&S controls and snowcover in segment 2. Facing west. | | | |

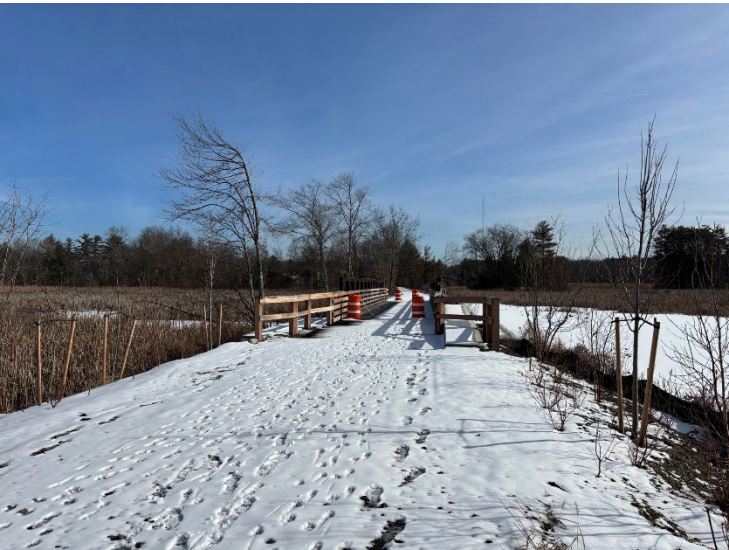
| Photo No.: 4 | Date: 2-03-2025 | | |

| Type and Location of E&S Control | Conditions Requiring Routine Maintenance? <sup>1</sup> | If “Yes,” How Many Times (Including This Occurrence) Has This Condition Been Identified? | Conditions Requiring Corrective Action? <sup>2, 3</sup> | Date on Which Condition First Observed (If Applicable)? | Description of Conditions Observed |
|---|---|--|---|---|---|
| <b>6. Silt Fencing on ROW in Hudson</b> | <input type="checkbox"/> Yes <input checked="" type="checkbox"/> No | N/A | <input type="checkbox"/> Yes <input checked="" type="checkbox"/> No | N/A | -Silt fence is installed and operating properly in segments 1-6.<br>-Portions of erosion controls approved and marked for removal were removed between 11/25 & 12/06/2024.<br>-Additional sections of silt fence were added in front of compost filter tubes on east side of bridge 130 for additional protection on 1/14/2025. |

| Description:<br>View of bridge 130 from segment 2. Facing east. | | | |

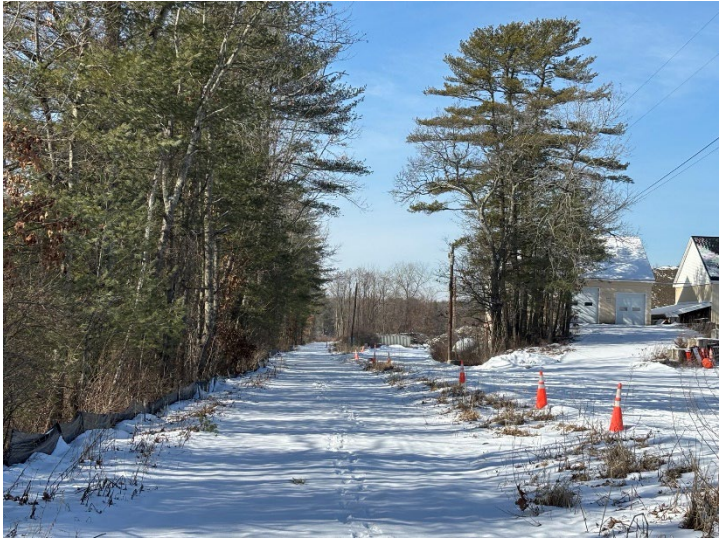
| Photo No.: 5 | Date: 2-03-2025 | | |

| <b>14. Rock lined swale &amp; rock check dams within segment 3</b> | <input type="checkbox"/> Yes <input checked="" type="checkbox"/> No | N/A | <input type="checkbox"/> Yes <input checked="" type="checkbox"/> No | N/A | Rock lined swale & check dams installed and operating properly within segment 3. |

| <b>Description:</b><br>View of E&S controls and snowcover in segment 3. Facing west. | | | |

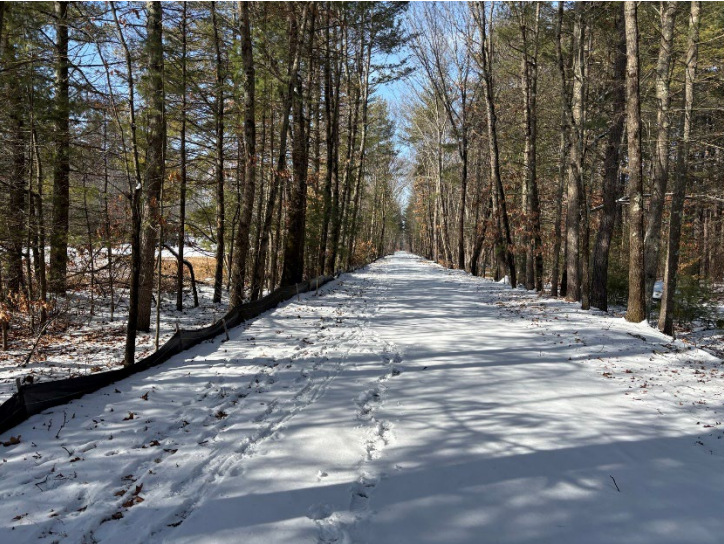
| Photo No.: 6 | Date: 2-03-2025 | | |

| <b>15. Rock check dams within segment 4</b> | <input type="checkbox"/> Yes <input checked="" type="checkbox"/> No | N/A | <input type="checkbox"/> Yes <input checked="" type="checkbox"/> No | N/A | Rock check dams installed and operating properly within segment 4. |

| <b>Description:</b><br>View of E&S controls and snowcover in segment 4. Facing west. | | | |

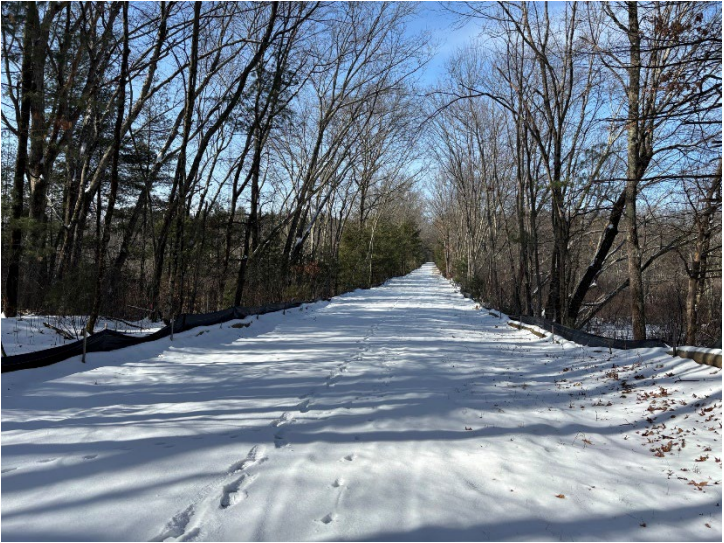
| Photo No.: 7 | Date: 2-03-2025 | | |

| <b>Description:</b><br>View of E&S controls and snow cover in segment 5. Facing west. | | | |

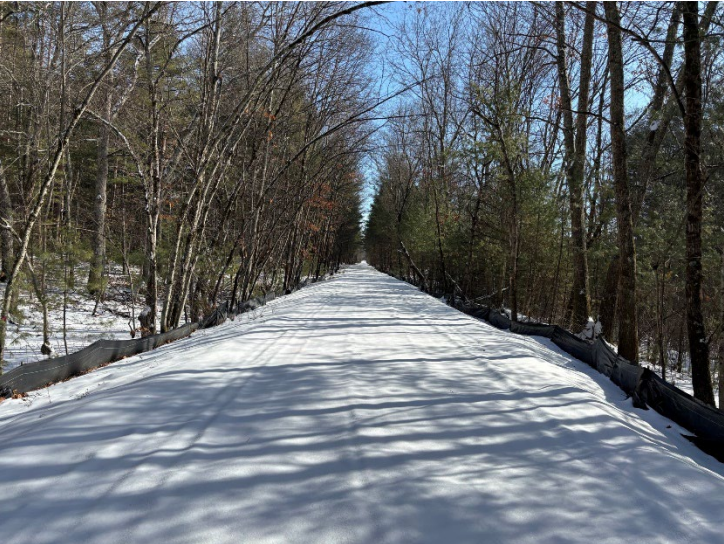
| Photo No.: 8 | Date: 2-03-2025 | | |

| <b>Description:</b><br>View of E&S controls and snowcover in segment 6. Facing east. | | | |

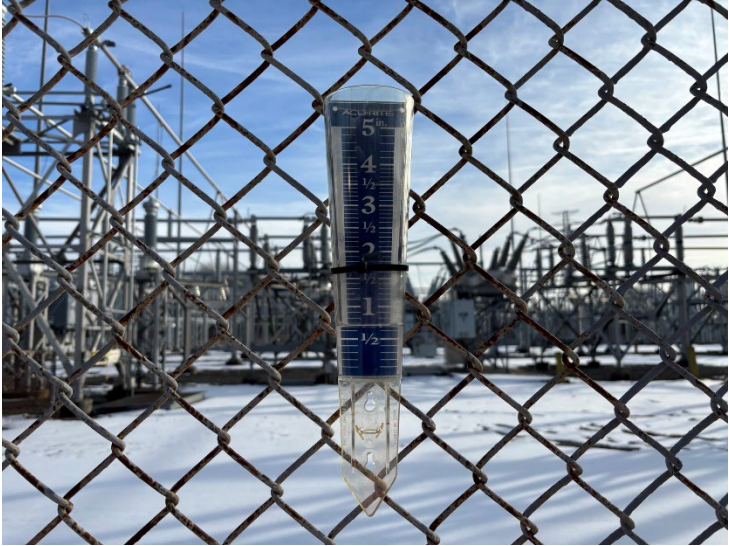
| <b>Photo No.:</b> 1 | <b>Date:</b> 2-03-2025 | | |

| <b>Description:</b><br>View of rain gauge at Sudbury substation. 0.65" observed within gauge on 2/03/2025. Facing south. | | | |

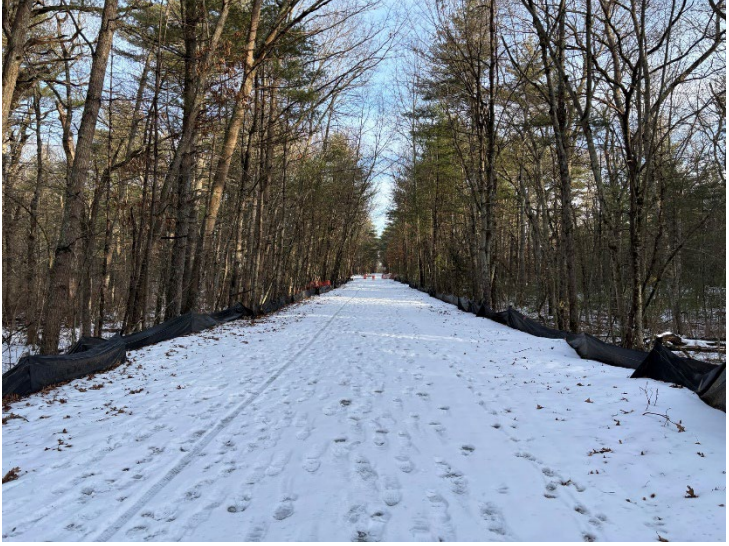
| <b>Photo No.:</b> 2 | <b>Date:</b> 2-03-2025 | | |

| <b>Description:</b><br>View of E&S controls and snowcover in segment 8. Facing east. | | | |

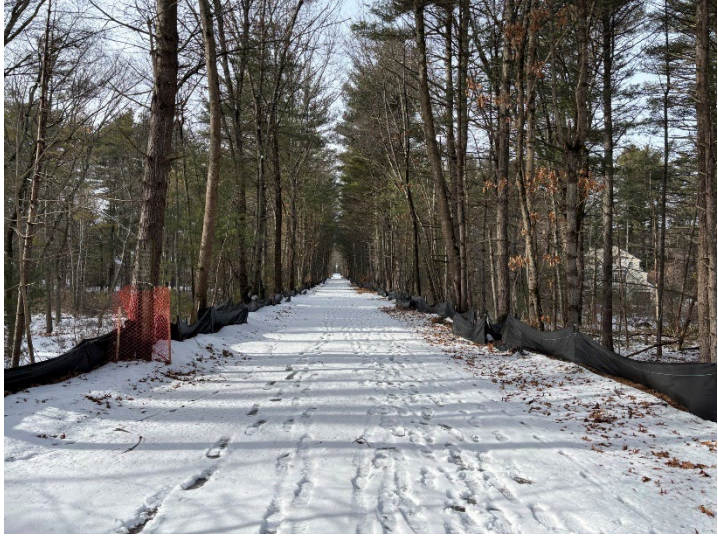
| Photo No.: 3 | Date: 2-03-2025 | | |

| <b>Description:</b><br>View of E&S controls and snowcover in segment 9. Facing west. | | | |

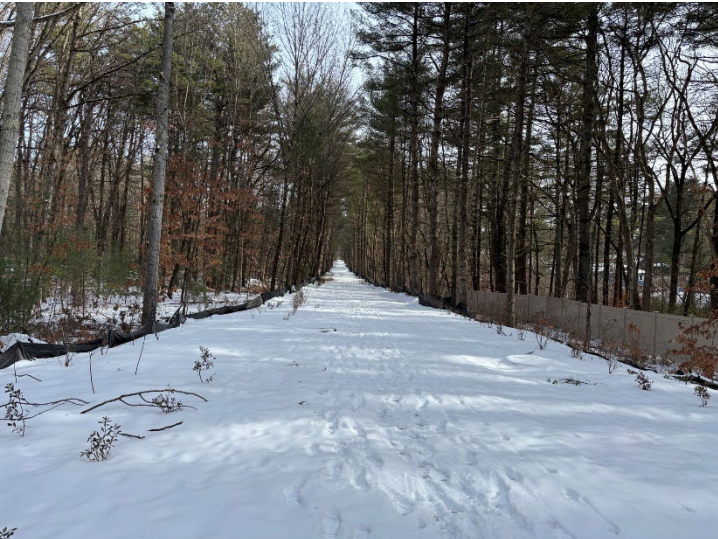
| Photo No.: 4 | Date: 2-03-2025 | | |

| <b>Description:</b><br>View of MH #20 area in segment 10. Facing east. | | | |

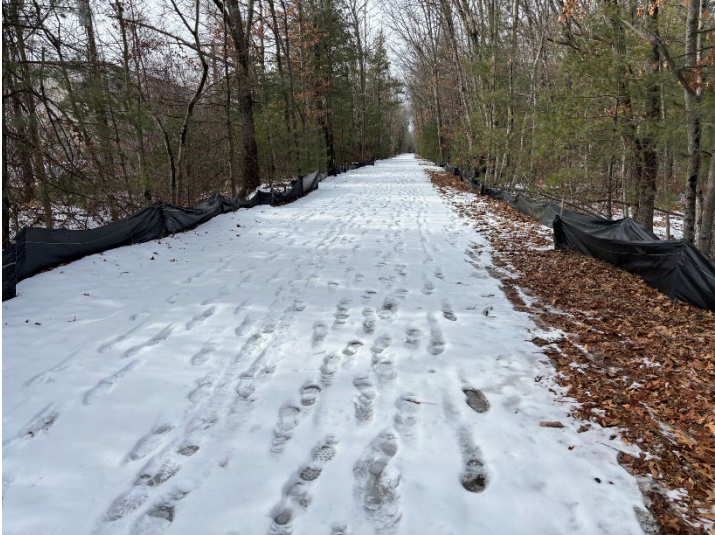
| Photo No.: 5 | Date: 2-03-2025 | | |

| <b>Description:</b><br>View of E&S controls and snowcover in segment 11. Facing west. | | | |

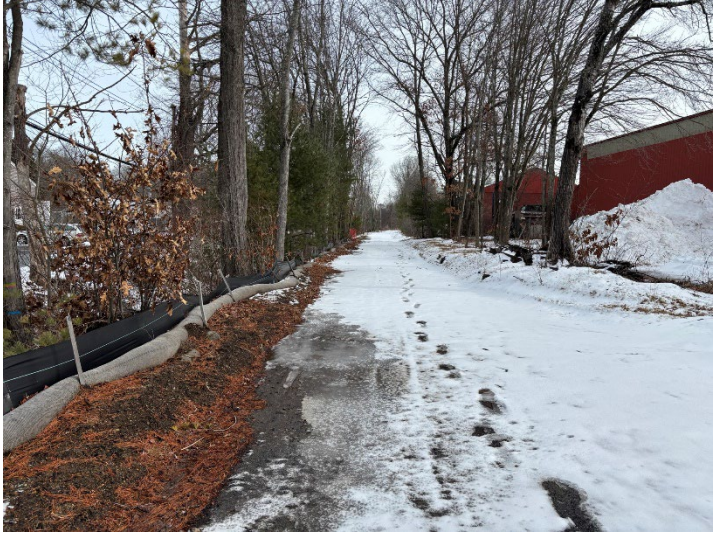
| Photo No.: 6 | Date: 2-03-2025 | | |

| <b>Description:</b><br>View of E&S controls, snowcover, and ice in segment 12. Facing east. | | | |

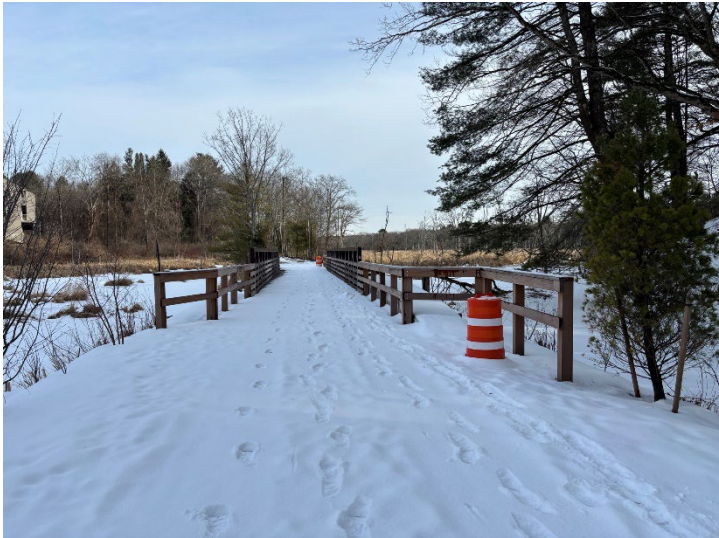
| <b>Photo No.:</b> 7 | <b>Date:</b> 2-03-2025 | | |

| <b>Description:</b><br>View of bridge 127 from segment 13. Facing east. | | | |

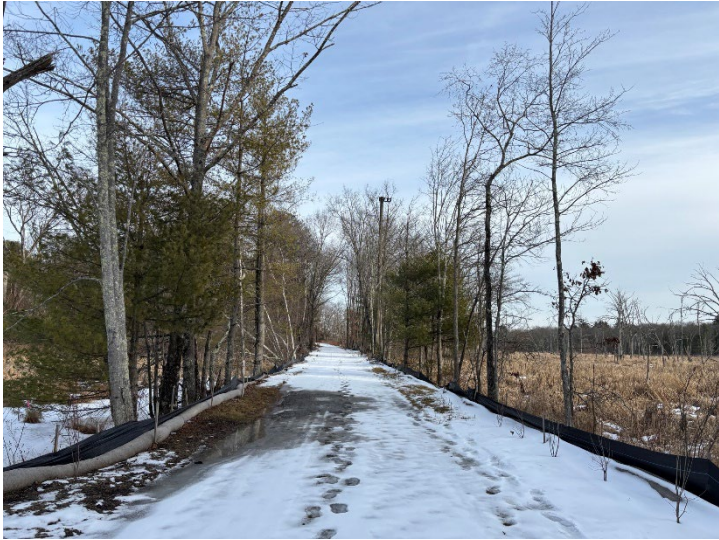
| <b>Photo No.:</b> 8 | <b>Date:</b> 2-03-2025 | | |

| <b>Description:</b><br>View of E&S controls and osprey nest platform at west end of segment 14. Facing east. | | | |
