CONSTRUCTION MONITORING REPORT Sudbury to Hudson Transmission Project

☑ Weekly ☑ Storm Event ☐ Other D	ate: 2-10-2025 Time: 12:00pm-3:00pm		Project Name:		
	<u> </u>	<u></u>	Sudbury to Hudson		
CGP Certified	Gabriella Suazo (SWCA), Compliance Monitor,	EPA	Transmission Reliability Project		
Others present/affiliation(s): N/A			Project Location:		
Precipitation/Weather (since last inspection):	• •		Sudbury, Hudson, Stow, and		
,	re outlook): Partly cloudy, snowcover and ice, 3		Marlborough, MA		
Wilkins and Forest Ave (Hudson)	nent # and stationing): Segments 1-6 & MHs #1-4	on	USEPA #:		
	7/25 Duration:N/A Amount of rainfall (inches):N/A		MAR1003UW		
See comments.					
Summary of Activities/Locations Inspecte					
No activities observed onsite. All E&S cor	trols in Hudson inspected.				
Inspection Notes: Any Significant Discharges of Sediment (or o	ther) or Non-Compliance Actions? Yes N	No.			
Any Significant Discharges of Sediment (of o	iner) of Nort-Compliance Actions? \Box res \Box	NO

☑ Weekly ☑ Storm Event ☐ Other Date: 2-10-2025 Time: 8:30am-12:00pm	Project Name:
Inspector name(s), title(s), and qualifications: Gabriella Suazo (SWCA), Compliance Monitor, EPA CGP Certified	Sudb

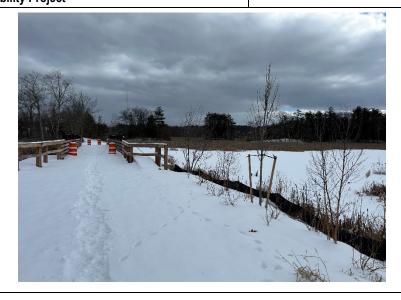
View of bridge 130 from segment

2. Facing east.

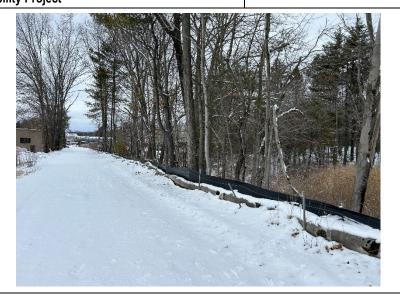
View of E&S controls and snowcover in segment 3. Facing

west.

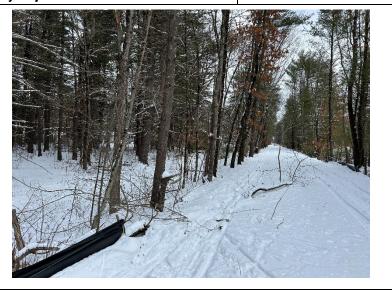
View of fallen branch in ROW within segment 4. Facing east.

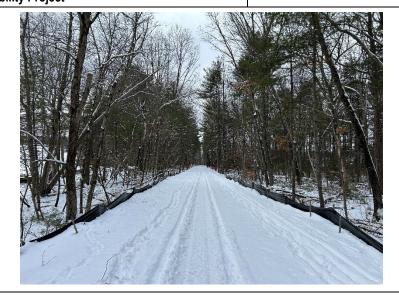
View of E&S controls and snowcover in segment 4. Facing west.

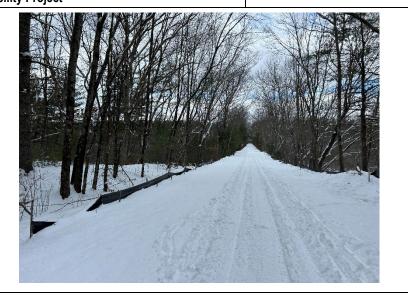
View of E&S controls and snow cover in segment 5. Facing west.

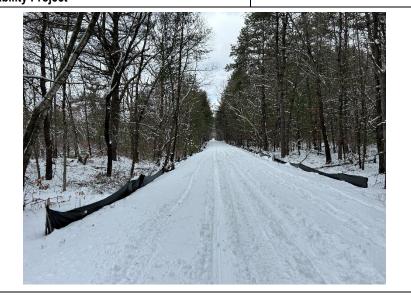
View of E&S controls and snowcover in segment 6. Facing west.

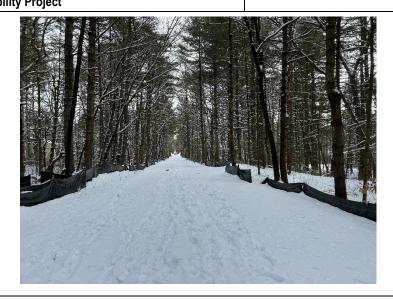
View of E&S controls and snowcover in segment 9. Facing

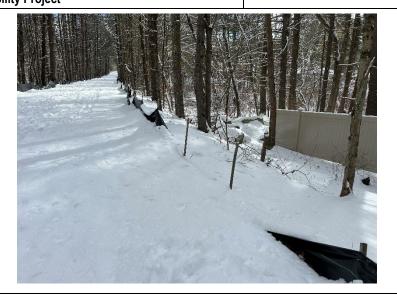
View of silt fence damaged by the snow near MH #20 in segment 10. Facing east.

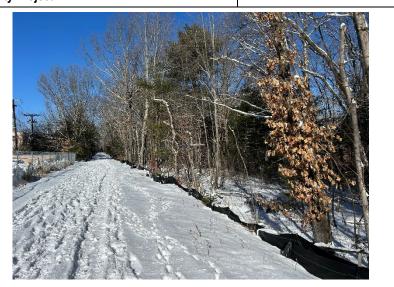
View of E&S controls and snowcover in segment 11. Facing west.

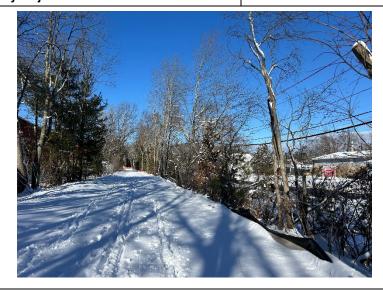
View of E&S controls and snowcover in segment 12. Facing west.

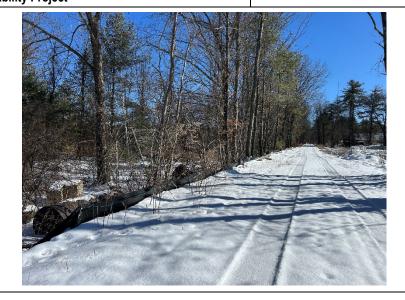
View of E&S controls and snowcover in segment 3. Facing east.

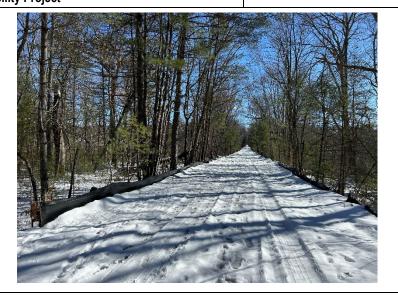
View of E&S controls and snow cover in segment 5. Facing west.

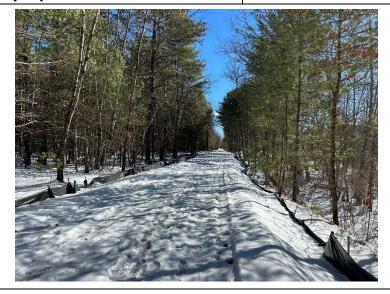
View of E&S controls and snowcover in segment 6. Facing east.

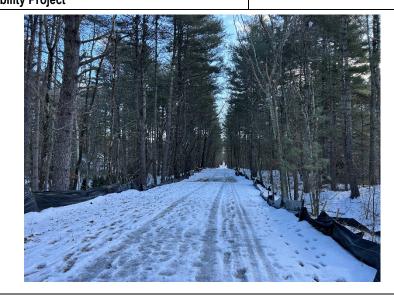
View of E&S controls and snowcover in segment 9. Facing

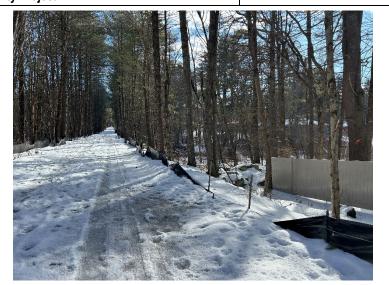
View of silt fence damaged by the snow near MH #20 in segment 10. Facing east.

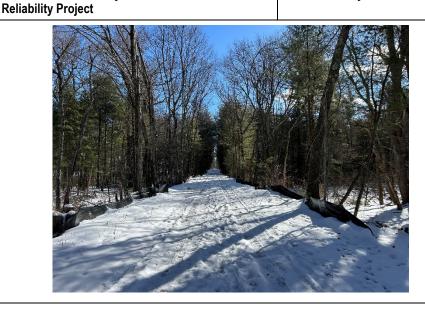
View of E&S controls and snowcover in segment 11. Facing

east.

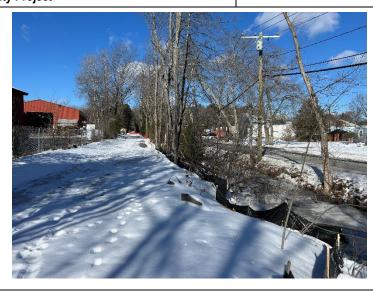
View of E&S controls and snowcover in segment 12. Facing

west.
