Sudbury to Hudson TRP Week of 2/17/2025

Epsilon Team Full SWPPP Inspection Report(s)

CONSTRUCTION MONITORING REPORT

Sudbury to Hudson Transmission Project

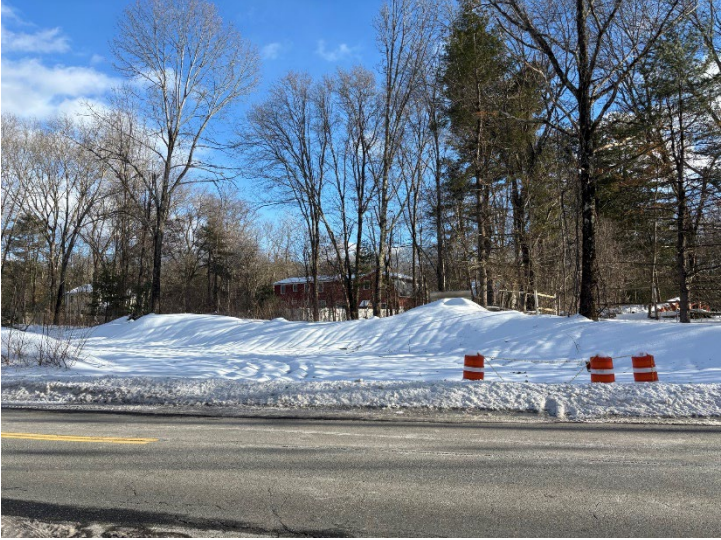
PHOTOGRAPHIC LOG	
Client Name: Eversource		Site Location: Sudbury to Hudson Transmission Reliability Project	Town: Hudson
Photo No.: 2	Date: 2-18-2025

Description: View of entrance to segment 1 at Wilkins St. Facing east.

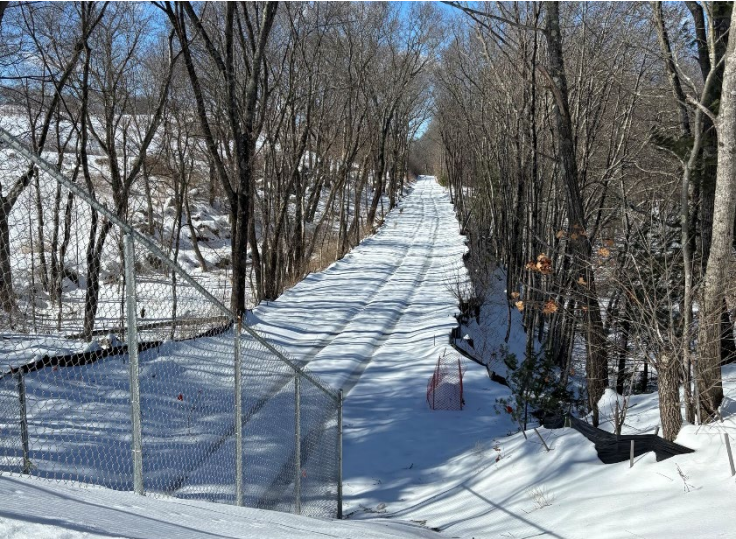
Epsilon ASSOCIATES INC.		PHOTOGRAPHIC LOG	
Client Name: Eversource		Site Location: Sudbury to Hudson Transmission Reliability Project	Town: Hudson
Photo No.: 3	Date: 2-18-2025

Description: View of segment 1 from Chestnut St. Facing west.

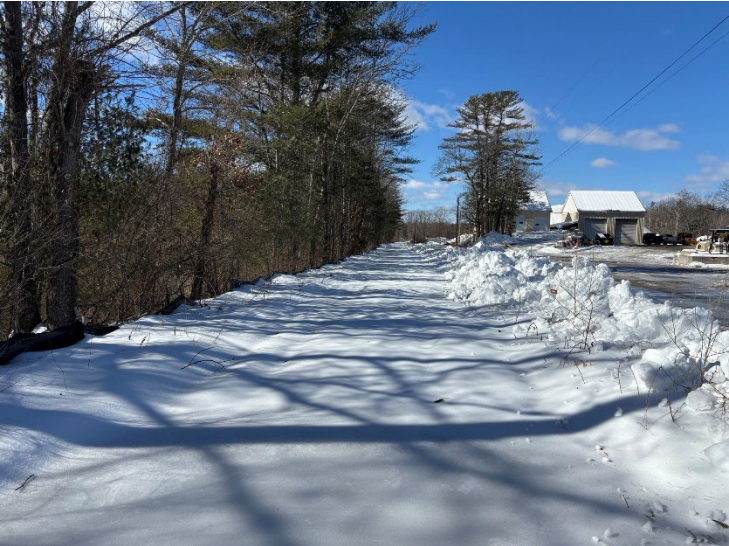
Epsilon ASSOCIATES INC.		PHOTOGRAPHIC LOG	
Client Name: Eversource		Site Location: Sudbury to Hudson Transmission Reliability Project	Town: Hudson
Photo No.: 4	Date: 2-18-2025

Description: View of E&S controls and snowcover in segment 3. Facing west.

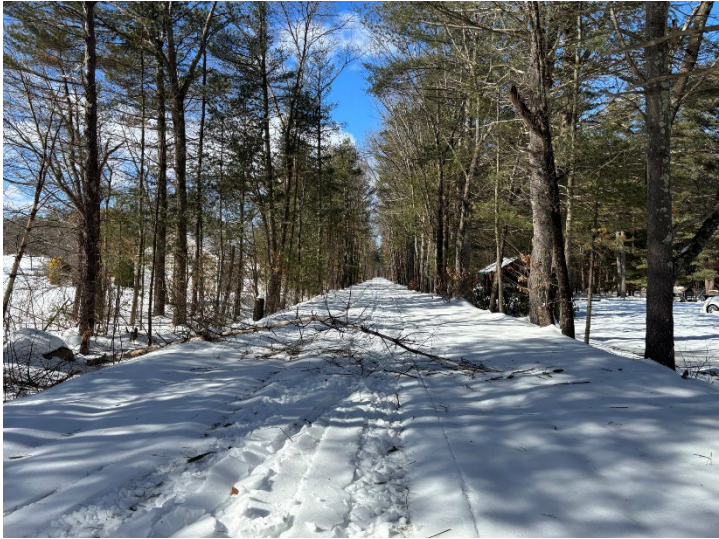
Epsilon ASSOCIATES INC.		PHOTOGRAPHIC LOG	
Client Name: Eversource		Site Location: Sudbury to Hudson Transmission Reliability Project	Town: Hudson
Photo No.: 5	Date: 2-18-2025

-Additional tree has fallen in segment 4.

Description: View of tree that has recently fallen in segment 4. Facing west.

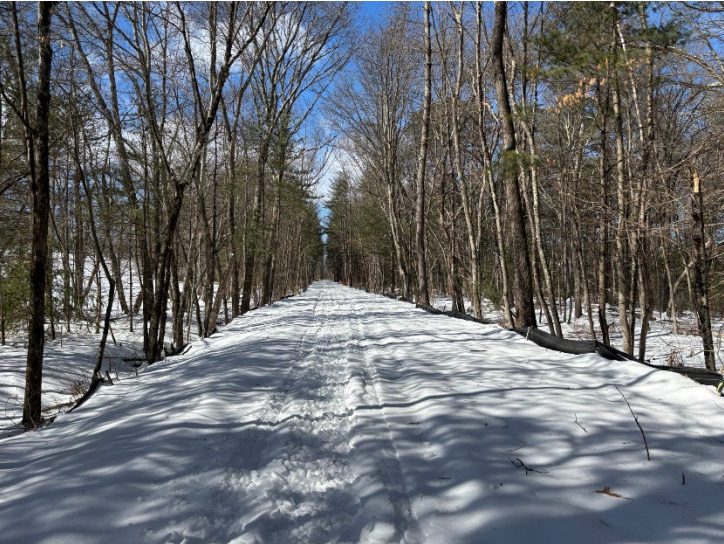
Epsilon ASSOCIATES INC.		PHOTOGRAPHIC LOG	
Client Name: Eversource		Site Location: Sudbury to Hudson Transmission Reliability Project	Town: Hudson
Photo No.: 6	Date: 2-18-2025

Description: View of E&S controls and snowcover in segment 4. Facing west.

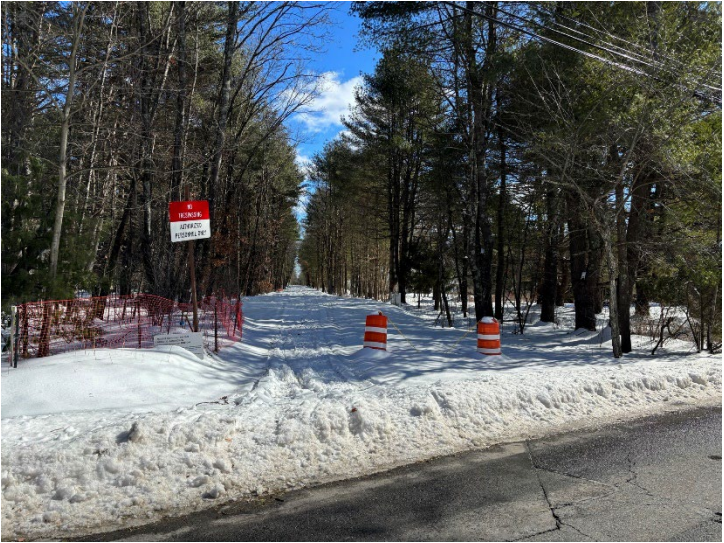
PHOTOGRAPHIC LOG	
Client Name: Eversource		Site Location: Sudbury to Hudson Transmission Reliability Project	Town: Hudson
Photo No.: 7	Date: 2-18-2025

Description: View of entrance to segment 5 off Peakham Rd. Facing east.

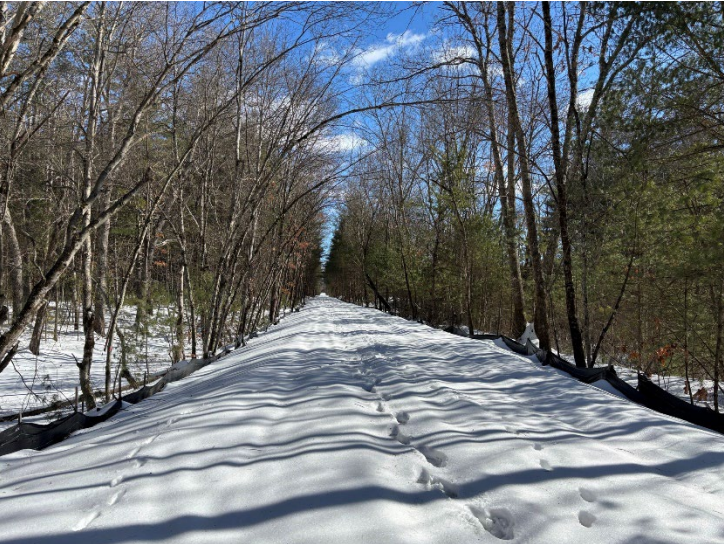
PHOTOGRAPHIC LOG	
Client Name: Eversource		Site Location: Sudbury to Hudson Transmission Reliability Project	Town: Hudson
Photo No.: 8	Date: 2-18-2025

Description: View of E&S controls and snowcover in segment 6. Facing east.

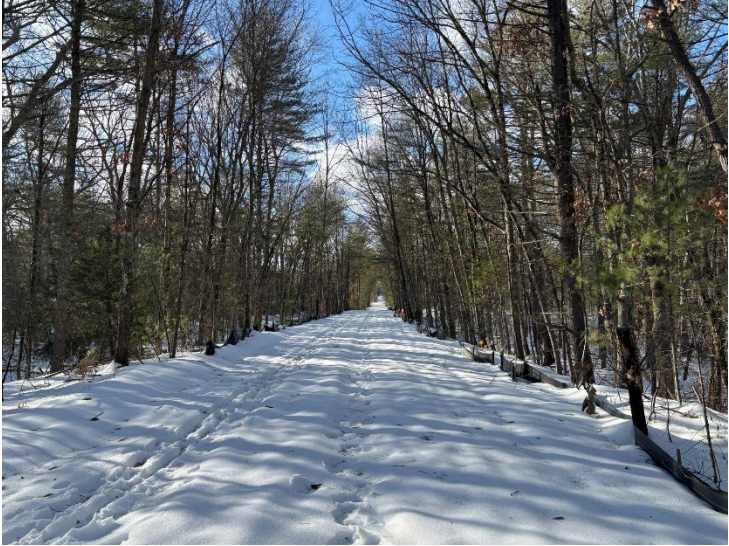
PHOTOGRAPHIC LOG	
Client Name: Eversource		Site Location: Sudbury to Hudson Transmission Reliability Project	Town: Sudbury
Photo No.: 1	Date: 2-18-2025

Description: View of E&S controls and snowcover in segment 8. Facing west.

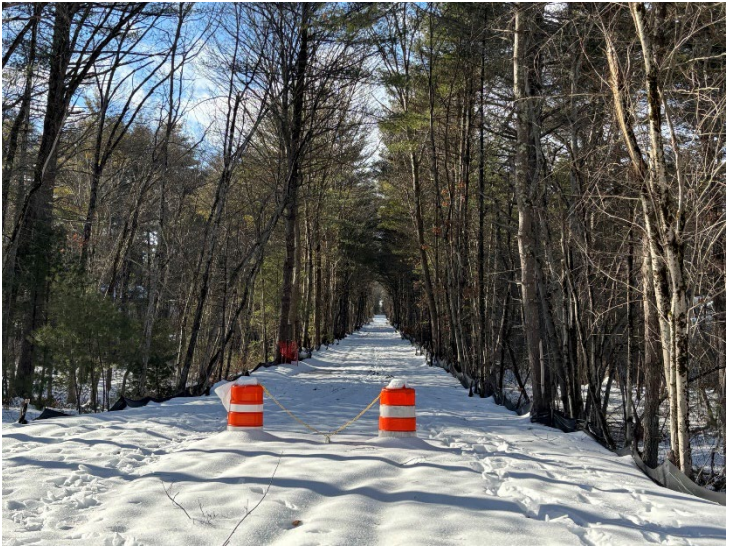
PHOTOGRAPHIC LOG	
Client Name: Eversource		Site Location: Sudbury to Hudson Transmission Reliability Project	Town: Sudbury
Photo No.: 2	Date: 2-18-2025

Description: View of E&S controls and snowcover in segment 9. Facing west.

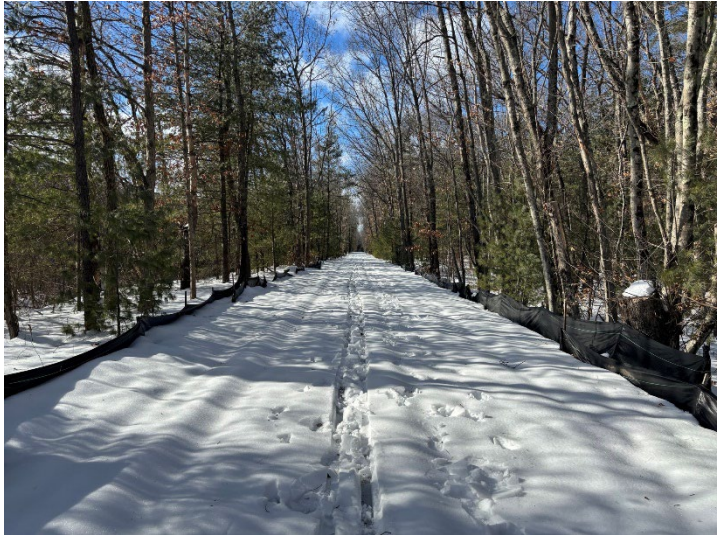
Epsilon ASSOCIATES INC.		PHOTOGRAPHIC LOG	
Client Name: Eversource		Site Location: Sudbury to Hudson Transmission Reliability Project	Town: Sudbury
Photo No.: 3	Date: 2-18-2025

Description: View of E&S controls and snowcover in segment 11. Facing west.

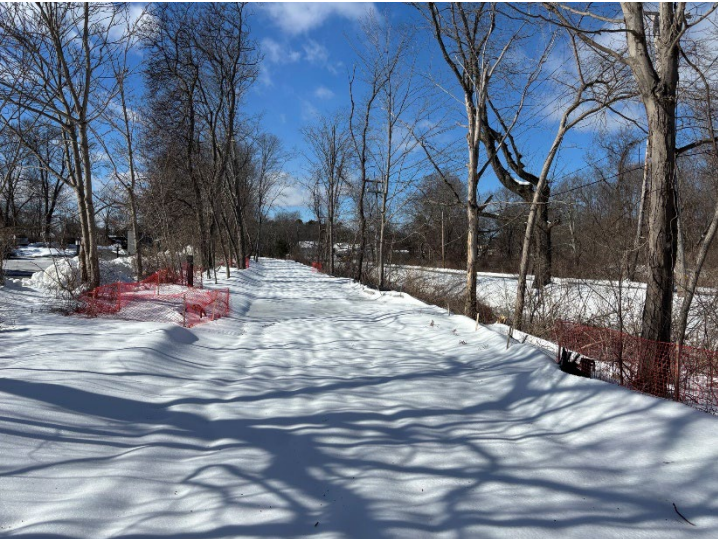
Epsilon ASSOCIATES INC.		PHOTOGRAPHIC LOG	
Client Name: Eversource		Site Location: Sudbury to Hudson Transmission Reliability Project	Town: Sudbury
Photo No.: 4	Date: 2-18-2025

Description: View of E&S controls and snowcover in segment 12. Facing west.

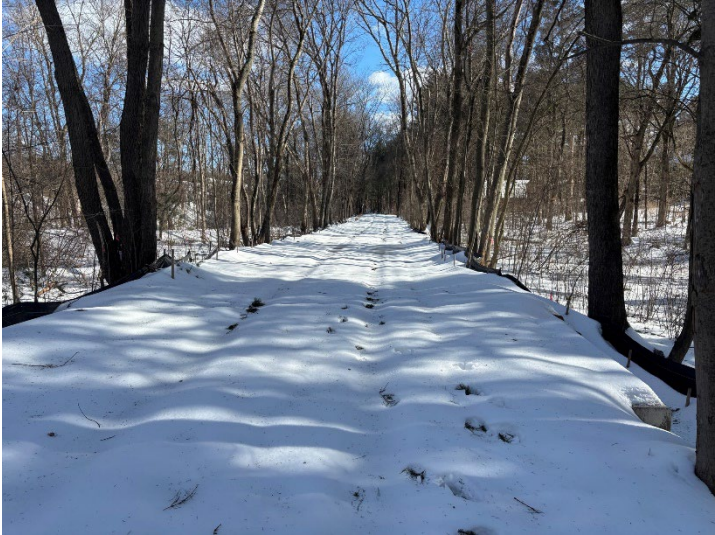
Epsilon ASSOCIATES INC.		PHOTOGRAPHIC LOG	
Client Name: Eversource		Site Location: Sudbury to Hudson Transmission Reliability Project	Town: Sudbury
Photo No.: 5	Date: 2-18-2025

Description: View of E&S controls and snowcover in segment 13. Facing east.

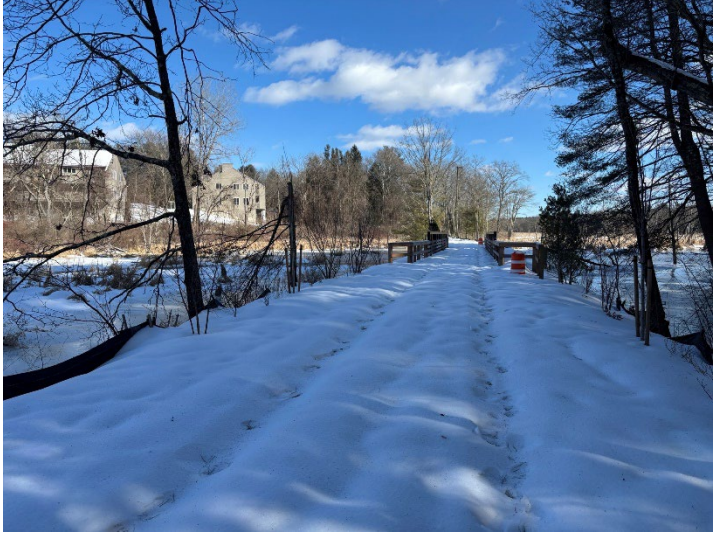
Epsilon ASSOCIATES INC.		PHOTOGRAPHIC LOG	
Client Name: Eversource		Site Location: Sudbury to Hudson Transmission Reliability Project	Town: Sudbury
Photo No.: 6	Date: 2-18-2025

Description: View of bridge 127 from segment 13. Facing east.

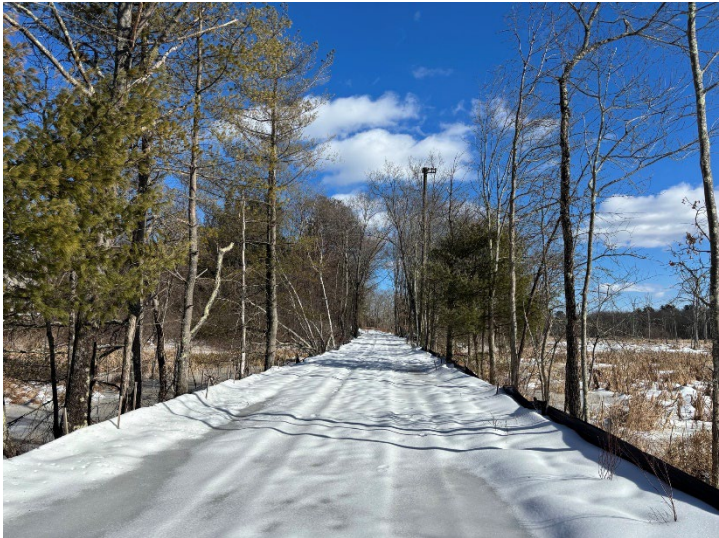
Epsilon ASSOCIATES INC.		PHOTOGRAPHIC LOG	
Client Name: Eversource		Site Location: Sudbury to Hudson Transmission Reliability Project	Town: Sudbury
Photo No.: 7	Date: 2-18-2025

Description: View of E&S controls and osprey nest platform at west end of segment 14. Facing east.

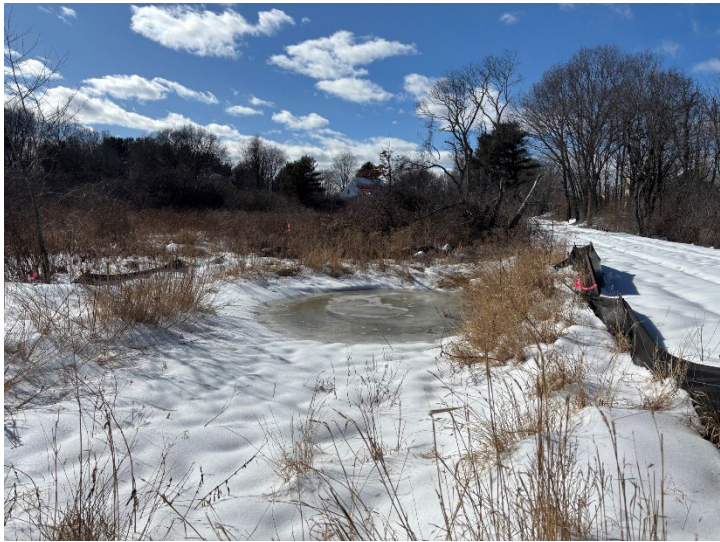
Epsilon ASSOCIATES INC.		PHOTOGRAPHIC LOG	
Client Name: Eversource		Site Location: Sudbury to Hudson Transmission Reliability Project	Town: Sudbury
Photo No.: 8	Date: 2-18-2025

Description: View of wetland replication area at east end of segment 14. Facing west.
