Field Report No. 30
---------------------

Project Name: Inspector:	Town of Sudbury Sudbury-Hudson Transmission Reliability Jeffrey Polidor			
	Project No:			22012F	
Horsley Witten	Inspection Date:	12/23/24	Arrival Time:	9:30 AM	
Group, Inc.	Weather:			12:30 PM	
Contractor(s)	equipment:		Reference Plan:		
( )	• •		Sudbury to Hudson	n	
			115kV Undergrour	nd Transmission Line	
			Sudbury - Hudson,	MA	
			Date: November 1	6. 2018

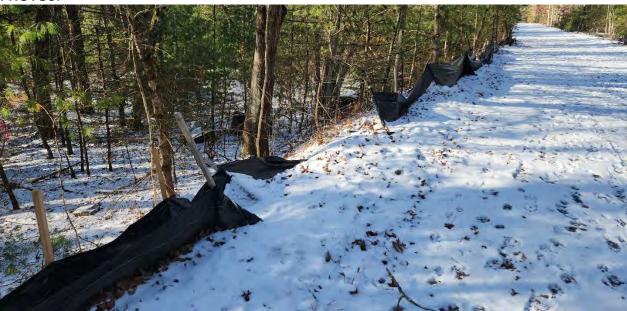
- Silt fence and filter tube are functioning properly along segments 9 and 13-14.
- Broken stake in the silt fence along segment 7 (Photo 1).
- Trail connection along segment 8 with Hop Brook Conservation Land (Photo 2).
- Broken stakes in the silt fence along segment 8 (Photo 3).
- Rip in the silt fence along segment 10 (Photo 4).
- Rip in the silt fence along segment 11 (Photo 5).
- Rip in the silt fence along segment 12 (Photo 6).

**Photo 1:** Broken stake in the silt fence along segment 7. Photo taken on 12/23/24

1. Repair silt fence as noted above prior to initiating next phase of construction.

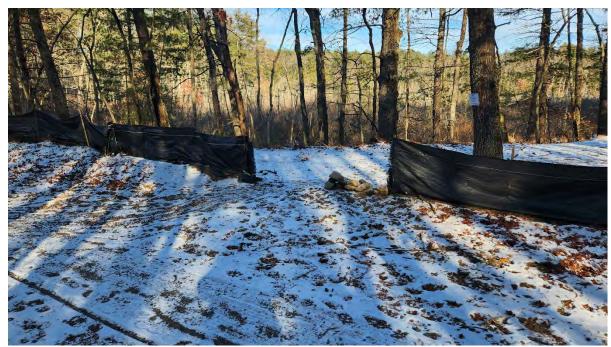
**Photo 2:** Trail connection along segment 8 with Hop Brook Conservation Land. Photo taken on 12/23/24

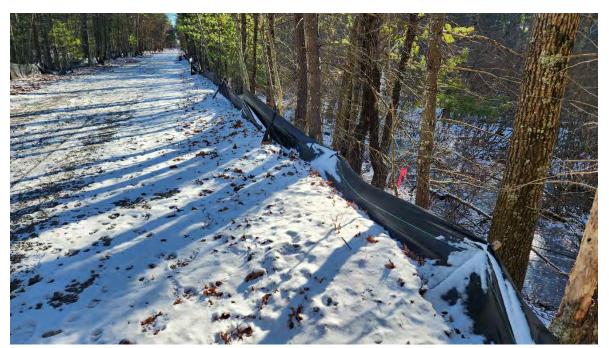
**Photo 3:** Broken stakes in the silt fence along segment 8. Photo taken on 12/23/24

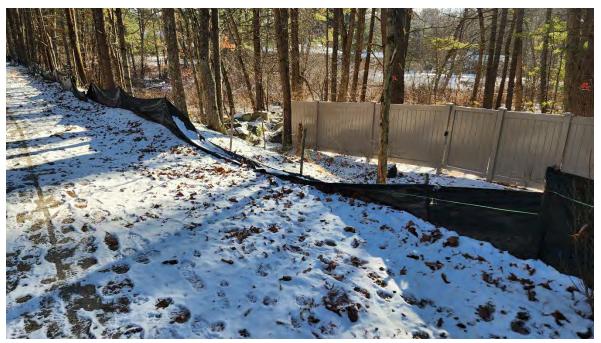
**Photo 4:** Rip in the silt fence along segment 10. Photo taken on 12/23/24

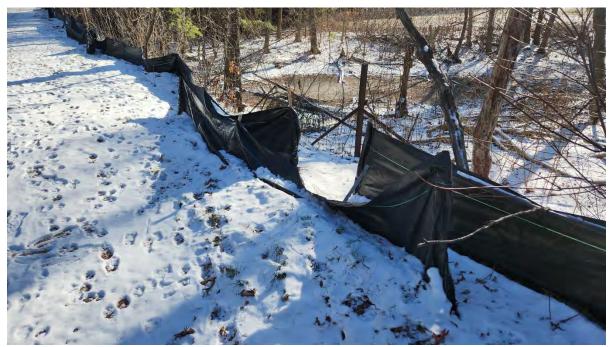
**Photo 5:** Rip in the silt fence along segment 11. Photo taken on 12/23/24.

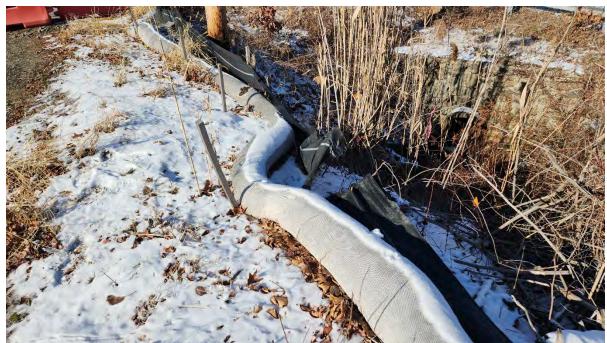
**Photo 6:** Rip in the silt fence along segment 12. Photo taken on 12/23/24.
