Horsley Witten Group, Inc.

Client:..... Town of Sudbury
 Project Name:..... Sudbury-Hudson Transmission Reliability
 Inspector:..... Jeffrey Polidor
 Project No:..... 22012F
 Inspection Date:..... 1/28/25 Arrival Time:..... 9:30 AM
 Weather:..... Flurries, 25°F Departure Time:..... 12:30 PM

Sudbury to Hudson
 115kV Underground Transmission Line
 Sudbury - Hudson, MA
 Date: November 16, 2018

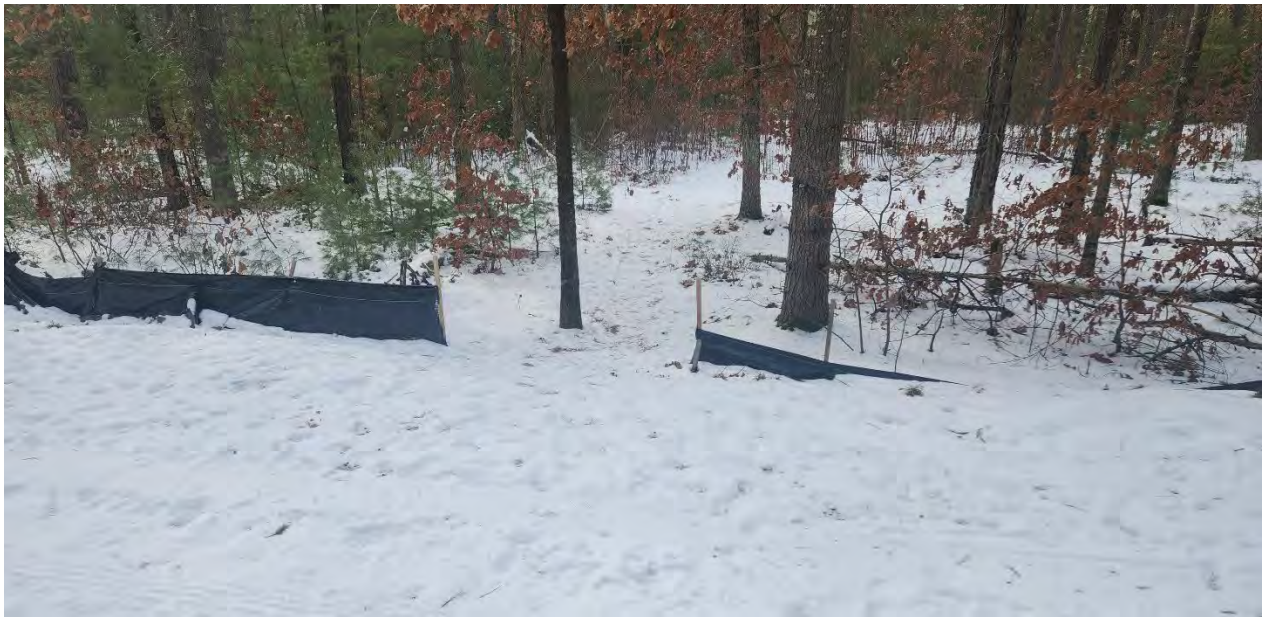
- Silt fence and filter tube are functioning properly along segments 10 and 12-13.
- Rip in the silt fence at a trail connection along segment 7 (Photo 1).
- Plantings along Hop Brook Bridge (Photo 2).
- Silt fence is ripped from stake along segment 8 (Photo 3).
- Silt fence is ripped from stake along segment 9 (Photo 4).
- Rip in the silt fence along segment 11 (Photo 5).
- Broken Stake in the silt fence along segment 14 (Photo 6).

Photo 1: Rip in the silt fence at a trail connection along segment 7.
Photo taken on 1/28/25

1. Repair silt fence as noted above prior to initiating next phase of construction.

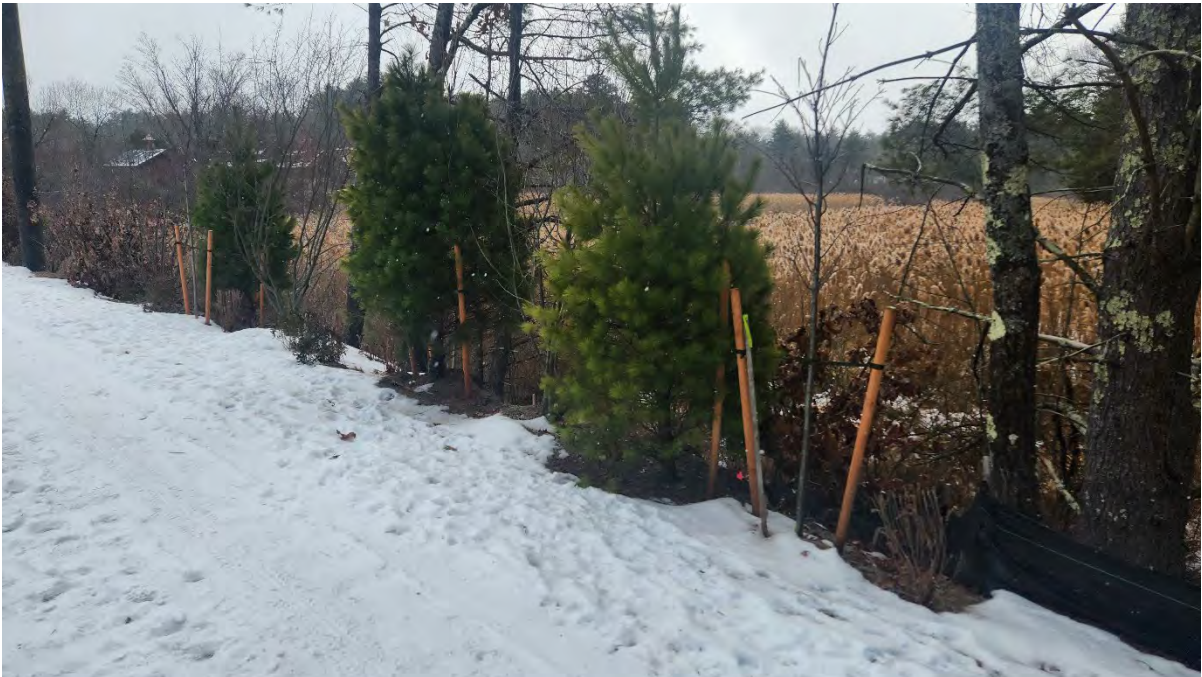
Photo 2: Plantings along Hop Brook Bridge.
Photo taken on 1/28/25

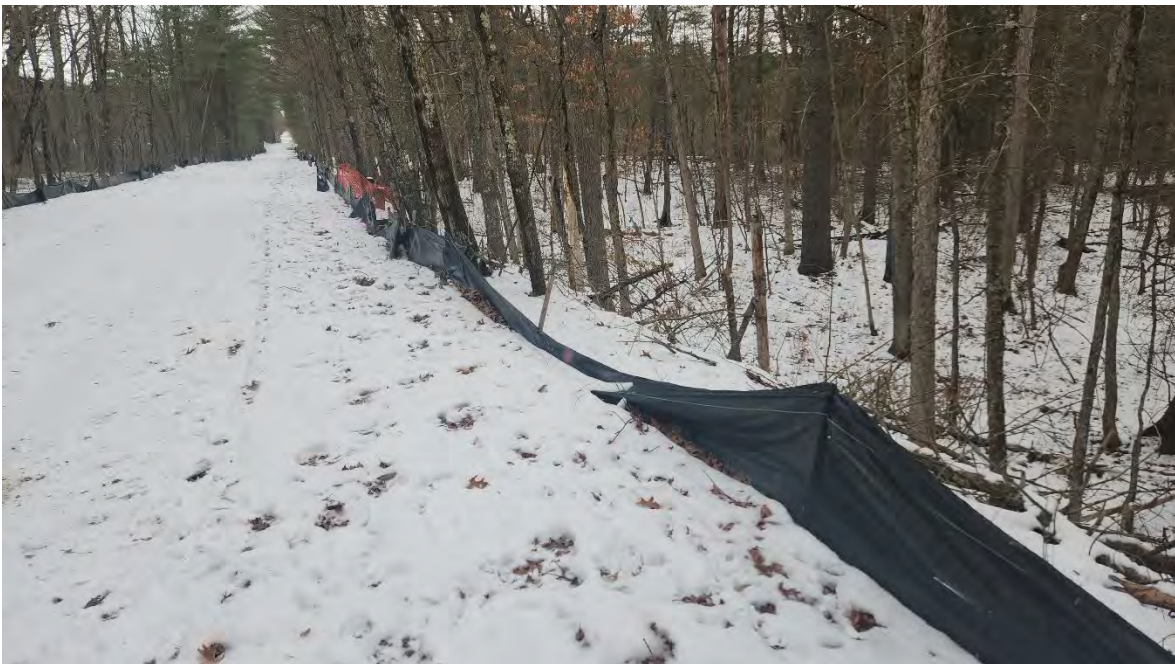
Photo 3: Silt fence is ripped from stake along segment 8.
Photo taken on 1/28/25

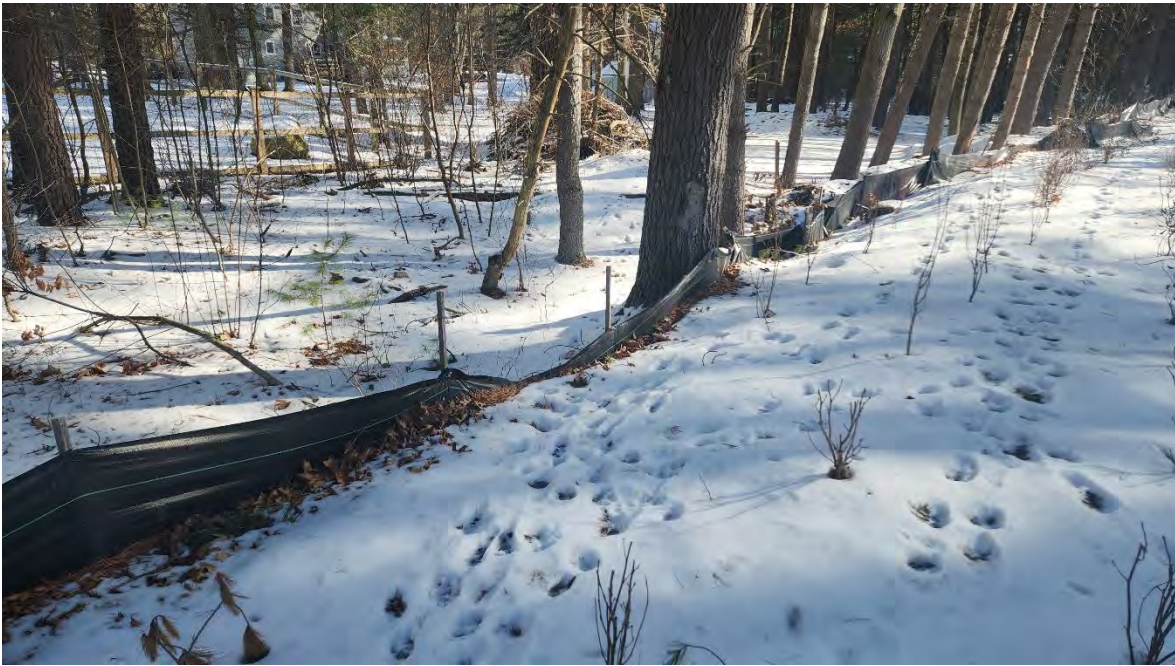
Photo 4: Silt fence is ripped from stake along segment 9.
Photo taken on 1/28/25

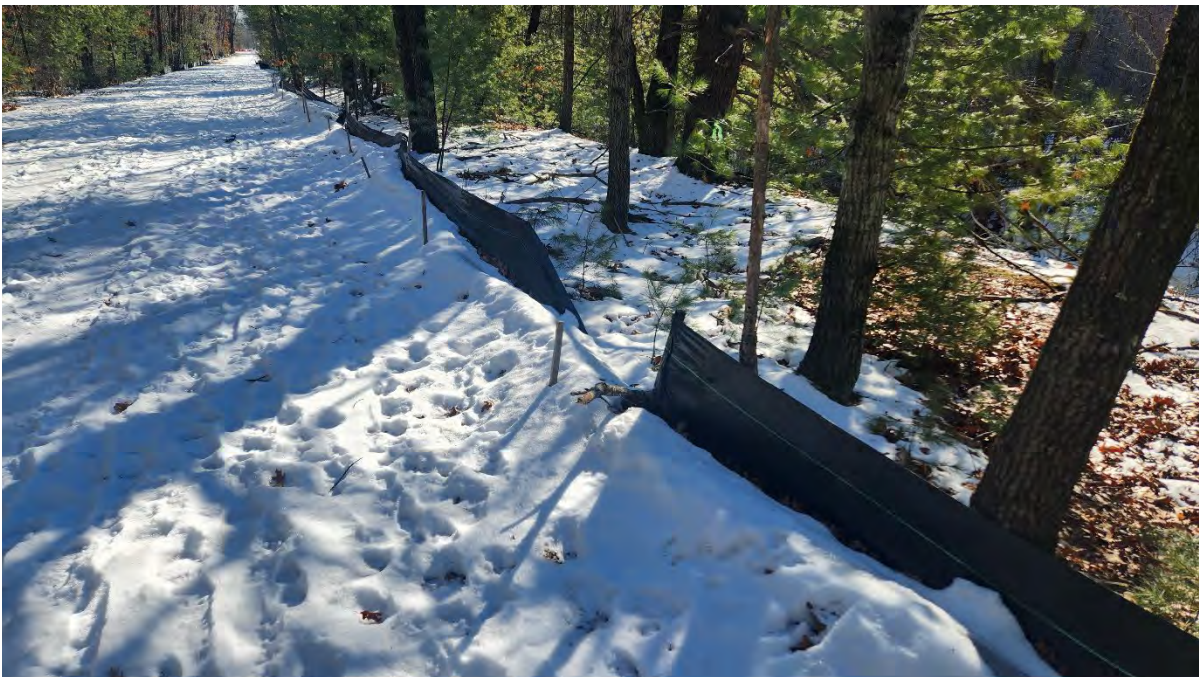
Photo 5: Rip in the silt fence along segment 11.
Photo taken on 1/28/25.

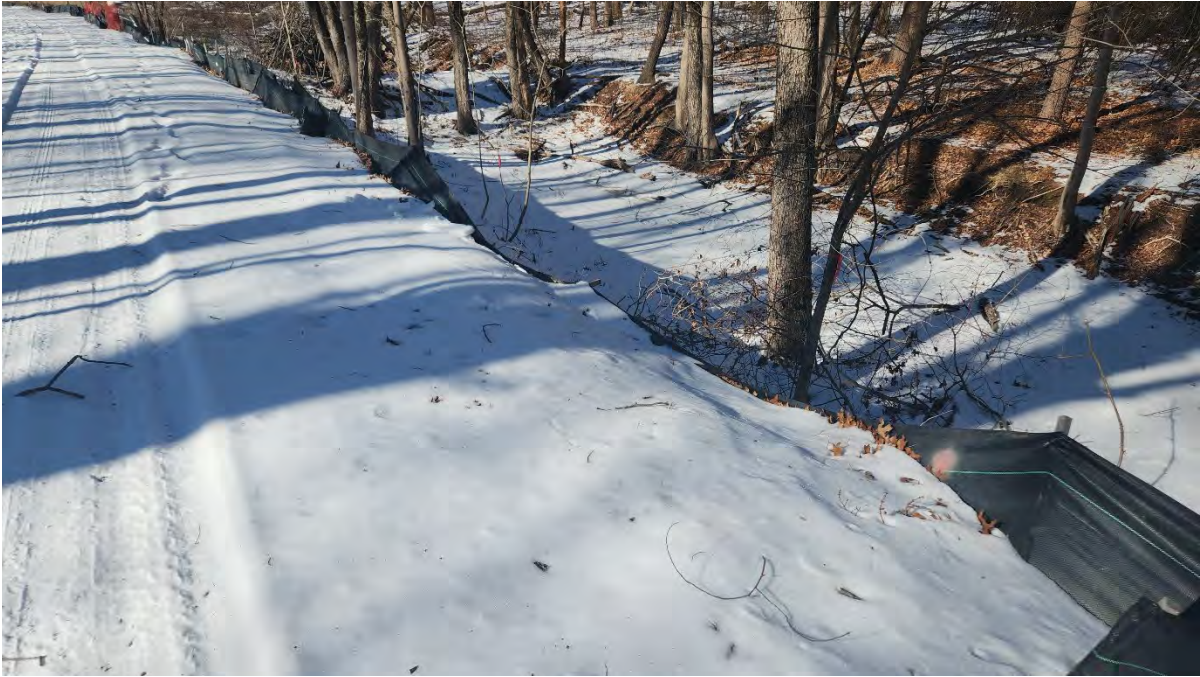
Photo 6: Broken Stake in the silt fence along segment 14.
Photo taken on 1/28/25.
