Environmental Monitor Construction Site Inspection Report
MassDOT Project #608164 Construction Contract # 119678
EM Report #46

Project Description: Bruce Freeman Rail Trail Right-of-Way
 Permit Description(s): Order of Conditions (MGL Chapter 131, Section 40 and 310 CMR 10.00, Mass DEP File No. 301-1362); 2022 EPA NPDES General Permit for Discharges from Construction Areas; U.S. Army Corps of Engineers Permit No NAE-2021-01975.

Project Name:	Bruce Freeman Rail Trail - Phase 2d - Sudbury
Date of Inspections:	1/30/2025
Bi Weekly/ Monthly Period Covered:	January Weekly Inspection #5
Inspector's Name(s):	Anna Haznar
Inspectors' Contact Information:	ahaznar@beta-inc.com

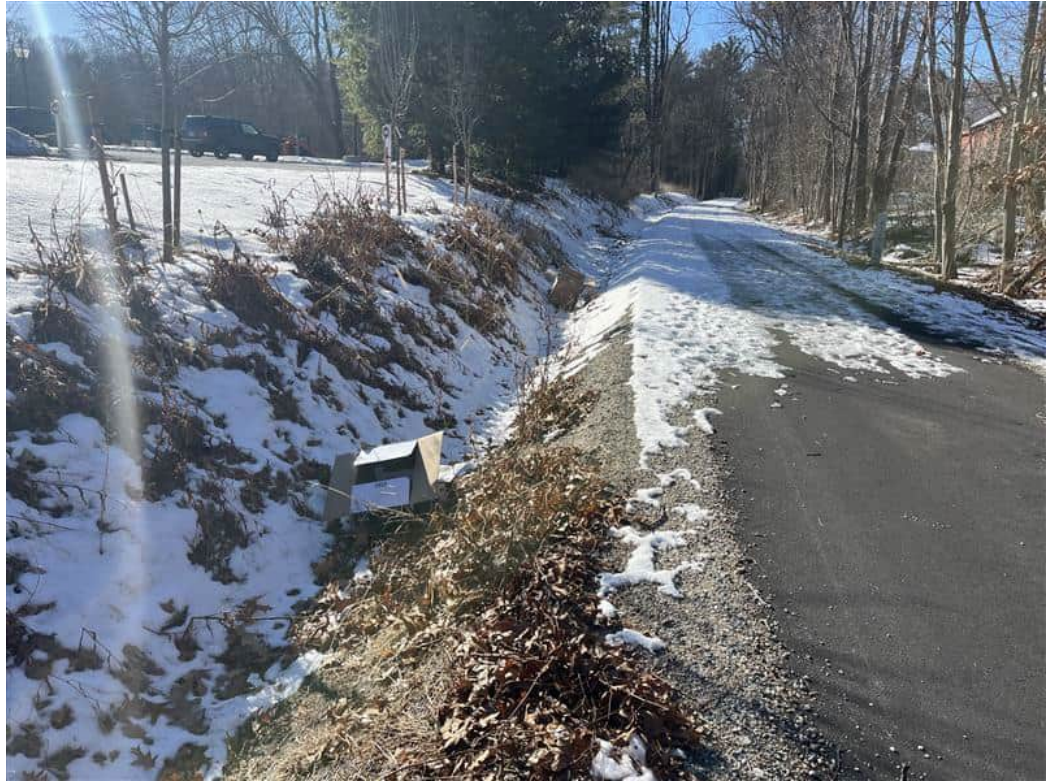
Photo No. 3 **Date:**
1/30/2025

53	<p>Stone was observed requiring removal from the swale on the east side of the trail at Station 172+00 to 173+00 Priority: High</p>	7/29/2024	8/6/2024	Remove stone from the swale.	<p>8/5/2024 - Observation remains. 8/7/2024 - Observation remains. 8/12/2024 - Observation remains. Material was observed to have migrated within the swale to Station 173+50. 8/16/2024 - Stone is still present within the swale. 8/20/2024 - Observation remains. Crushed stone has migrated further down the swale to Station 171+50. 8/27/2024 - Observation remains. Stone is still present within the swale. 9/3/2024 - Observation remains. 9/10/2024 - Observation remains. Stone is still present within the swale. 9/16/2024 - Observation remains. The contractor indicated that the stone within the swale would be hand removed. 9/23/2024 - Observation remains. 9/27/2024 - Observation remains. It appears as though some stone has migrated further south down the swale. 10/4/2024 - Observation remains. Stone is still present within the swale. 10/8/2024 - Observation remains. 10/15/2024 - Observation remains. Stone is covered with vegetation in some areas. 10/22/2024 - Observation remains. Stone is covered with vegetation in some areas. 10/29/2024 - Observation remains. 11/5/2024 - Observation remains. 11/12/2024 - Leaf litter has completely covered the stone in this location. The Contractor should indicate if stone has been removed from this location. 11/19/2024 - See previous update. 11/22/2024 - Observation remains. Stone is still present within the swale and requires removal. Leaf litter is currently covering a majority of the stone. 11/25/2024 - Observation remains. Leaf litter is covering a majority of the stone. 12/2/2024 - Observation remains. Stone is present within the swale under leaf litter. 12/6/2024 - Observation remains. See previous update. 12/12/2024 - Observation remains. Stone is present within the swale under the leaf litter. 12/20/2024 - Observation remains. Stone is present within the swale under the leaf litter. 12/26/2024 - Observation remains. Stone is present within the swale under the leaf litter and snow. 12/31/2024 - Observation remains. Stone is present within the swale under the leaf litter. 1/2/2025 - Observation remains. Stone is present within the swale under the leaf litter. 1/9/2025 - Observation remains. Stone is present within the swale under the leaf litter. 1/15/2025 - Observation remains. Further stone has discharged into the swale at this location, and stone is still present under leaf litter. 1/23/2025 - Observation remains. Stone is present within the swale under the leaf litter and snow. 1/30/2025 - Observation remains. Stone is present within the swale under the leaf litter and snow. Trash was also observed within the swale in this area.</p>

View of the location where crushed stone was observed in the swale at Station 172+00 per Compliance Action item 53. Note stone is covered with snow and leaf litter.

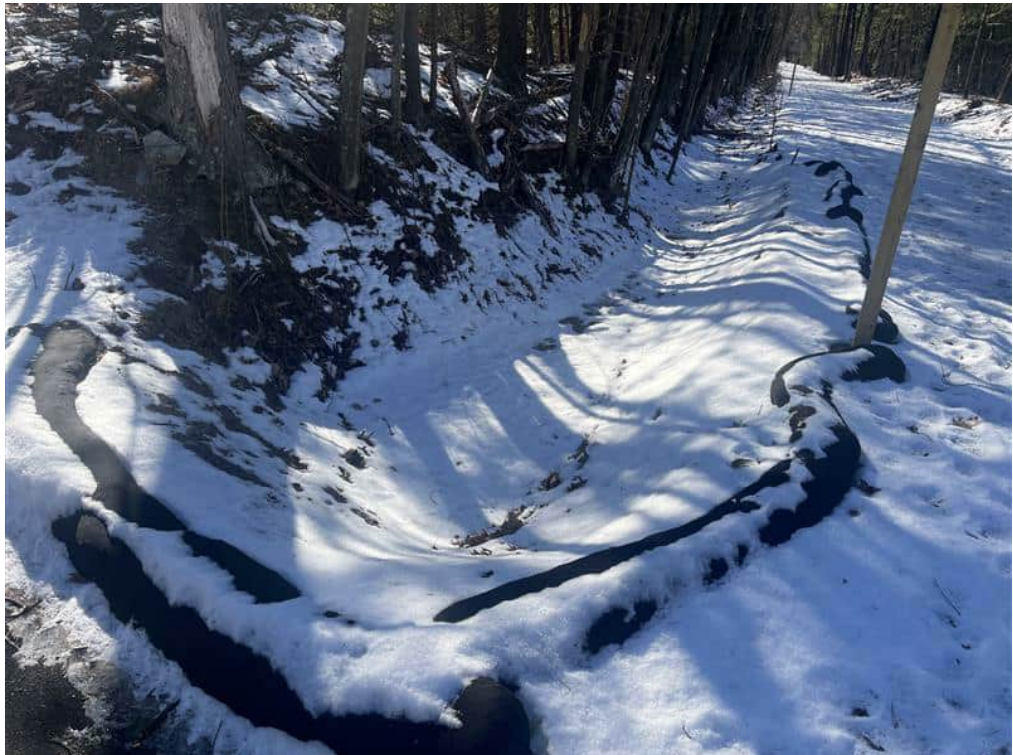
Photo No. 4 **Date:**
1/30/2025

Item	Location/ Description	Observation Date	Resolution Due Date	Recommended Resolution / Resolution Date	Comments/Updates
62	Loam and seed was applied to the streambank at Station 216+00 to 217+00 and requires further stabilization Priority: High	11/25/2024	12/2/2024	An erosion control blanket should be installed along this slope.	12/2/2024 - Loam and seed have been applied to the streambank at Station 215+00. Stabilization is required at Stations 215+00 to 217+00. 12/6/2024 - Observation remains. See previous update. 12/12/2024 - Observation remains. Rill erosion was observed within the loam applied to this area from Station 215+00 to 216+00. 12/20/2024 - Observation remains. Loam has begun to erode, resulting in a discharge to the stream at Station 216+50. 12/26/2024 - Observation remains. No further discharge was observed in this location. 12/31/2024 - Observation remains. Additional loam has eroded resulting in a discharge to the stream at Station 216+50. 1/2/2025 - Observation remains. No further discharge was observed in this location. 1/9/2025 - Observation remains. Straw was observed to have been placed along portions of the streambank; however, this area should be stabilized using an erosion control blanket. 1/15/2025 - Observation remains. Erosion causing a discharge of loam and straw into the stream was observed at Station 216+50. 1/23/2025 - Observation remains. Snow coverage is present within the stream and on the streambank. No further discharge was observed during this inspection. 1/30/2025 - Observation remains. Snow coverage is present within the stream and on the streambank. No further discharge was observed during this inspection.

View of loam that requires stabilization at Station 215+00 per Compliance Action Item 62. Note loam is covered with snow.

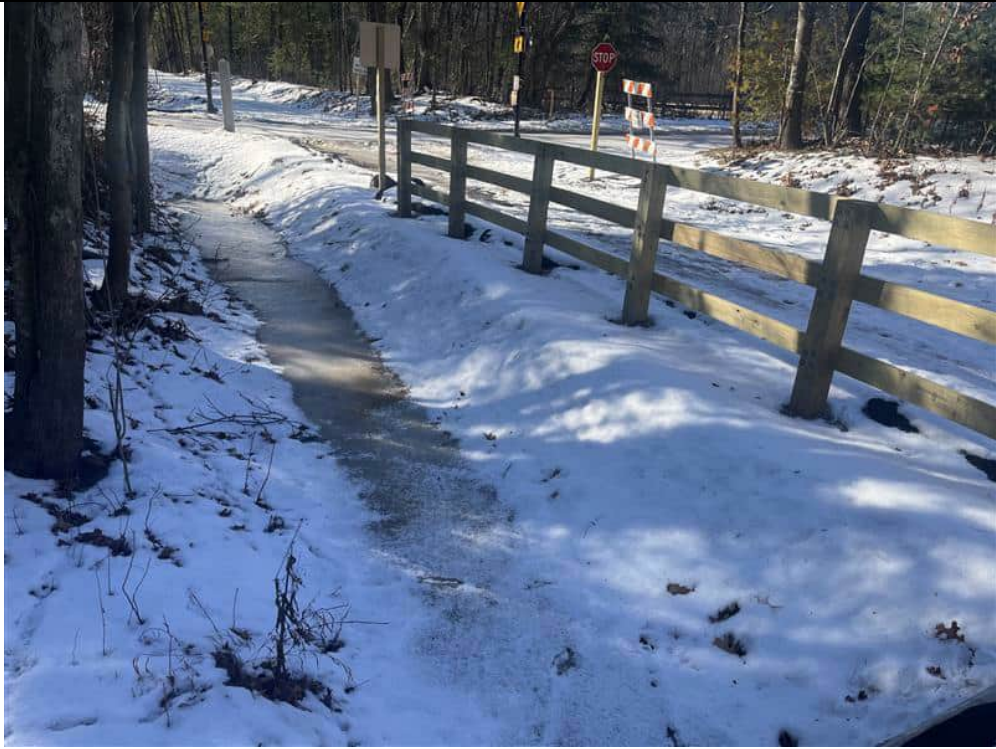
Photo No. 5 **Date:**
1/30/2025

41	Stream Bank has been regraded beyond the limit of work at Station 216+00 Priority: High	5/28/2024	6/4/2024	The Contractor should confirm if this work was permitted by the Conservation Commission, as it does not appear to be a part of the approved plans/impacts. MassDOT should be consulted on next steps regarding notification and potential restoration.	<p>5/31/2024 - Observation remains.</p> <p>6/7/2024 - Observation remains.</p> <p>6/14/2024 - Observation remains.</p> <p>6/17/2024 - Observation remains.</p> <p>6/24/2024 - Observation remains.</p> <p>6/27/2024 - Observation remains.</p> <p>7/8/2024 - Observation remains.</p> <p>7/15/2024 - This area could not be assessed due to paving operations ongoing during the inspection.</p> <p>7/22/2024 - Crushed stone and sediment continue to be discharged to the stream between Stations 215+00 and 217+00 due to overtopped and undermined compost filter tubes.</p> <p>7/29/2024 - Observation remains.</p> <p>8/5/2024 - Observation remains.</p> <p>8/7/2024 - Observation remains.</p> <p>8/12/2024 - Observation remains. Crushed stone is still present in the streambed at this location.</p> <p>8/16/2024 - Observation remains.</p> <p>8/20/2024 - Stone has been removed; however, additional alteration to Resource Areas beyond the limit of work continue.</p> <p>8/27/2024 - Observation remains.</p> <p>9/3/2024 - Observation remains.</p> <p>9/10/2024 - Observation remains. Stone has been observed as discharging into the streambed in this location again.</p> <p>9/16/2024 - Observation remains.</p> <p>9/23/2024 - Observation remains. Stone is still present within the streambed at this location.</p> <p>9/27/2024 - Observation remains.</p> <p>10/4/2024 - Observation remains.</p> <p>10/8/2024 - Observation remains.</p> <p>10/15/2024 - Observation remains. Stone is still present within the streambed at this location.</p> <p>10/22/2024 - Observation remains. Stone is still present within the streambed at this location.</p> <p>10/29/2024 - Observation remains. Stone is still present within the streambed at this location.</p> <p>11/5/2024 - Observation remains. The PVC pipe that was installed at this location was observed to be covered with stone and is no longer visible near Station 215+00. Stone is still present within the streambed at this location.</p> <p>11/12/2024 - Observation remains. The streambed in this location is covered with leaf litter. See previous update.</p> <p>11/19/2024 - Observation remains. As discussed with the Conservation Agent in the field, further coordination between the Town and MassDOT will be required to clean/repair the culvert, as the degraded condition of the culvert prompted the contractor to armor the stream banks. Further coordination will also be required for restoration of banks.</p> <p>11/22/2024 - Observation remains. See previous update.</p> <p>11/25/2024 - Observation remains. See update from 11/19/2024.</p> <p>12/2/2024 - Observation remains. See update from 11/19/2024.</p> <p>12/6/2024 - Observation remains. See update from 11/19/2024.</p> <p>12/12/2024 - Observation remains. See update from 11/19/2024.</p> <p>12/20/2024 - Observation remains. See update from 11/19/2024.</p> <p>12/26/2024 - Observation remains. See update from 11/19/2024.</p> <p>12/31/2024 - Observation remains. See update from 11/19/2024.</p> <p>1/2/2025 - Observation remains. See update from 11/19/2024.</p> <p>1/9/2025 - Observation remains. See update from 11/19/2024.</p> <p>1/15/2025 - Observation remains. See update from 11/19/2024.</p> <p>1/23/2025 - Observation remains. See update from 11/19/2024.</p> <p>1/30/2024 - Observation remains. See update from 11/19/2024.</p>

Description:
View of the location where the stream bank has been regraded beyond the limits of work and stabilization of loam is required at Station 216+00 per Long Term Compliance Action Item 41 and 62. Note loam is covered with snow.

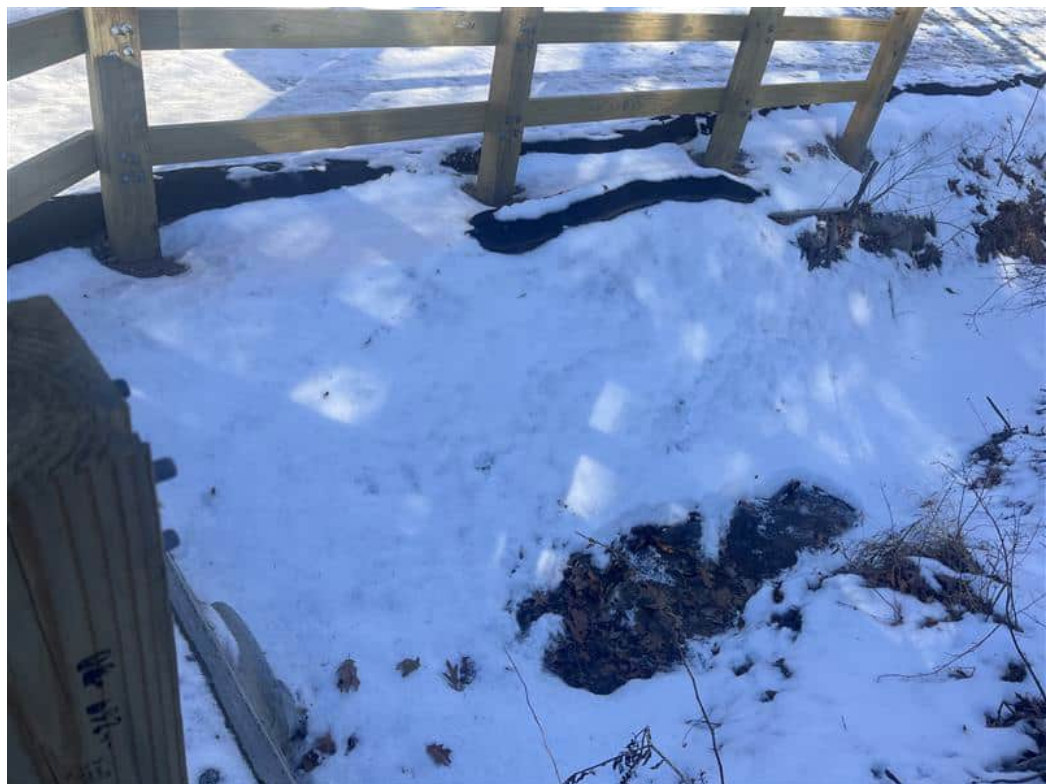
Photo No. 6 **Date:**
1/30/2025

Description:
View of loam that requires stabilization at Station 217+00 per Compliance Action Item 62. Note loam is covered with snow.

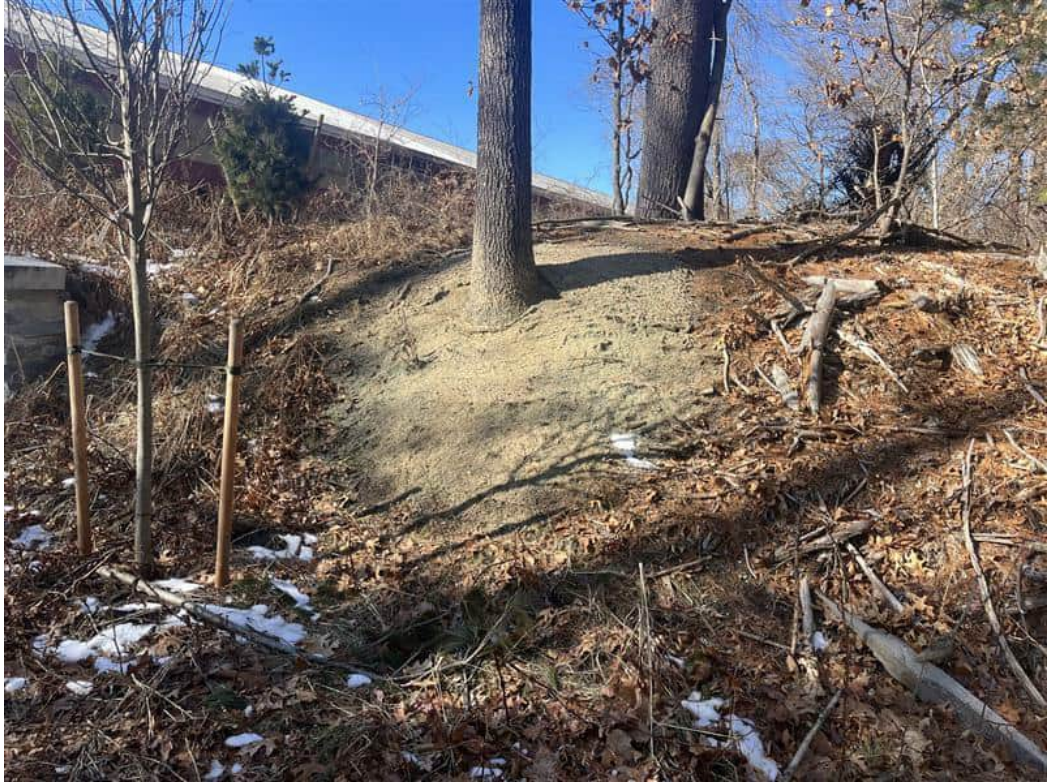
Photo No. 7 **Date:**
1/30/2025

34	Sediment is eroding downhill from behind the cemented stone masonry wall at Station 217+45 Priority: Low	5/28/2024	6/4/2024	Apply seed and temporarily stabilize the soils along the slope with straw, jute netting, etc.	<p>5/31/2024 - Observation remains. 6/7/2024 - Observation remains. 6/14/2024 - Observation remains. 6/17/2024 - Observation remains. 6/24/2024 - Observation remains. 6/27/2024 - Rills were raked, loam was added, and hydroseed was applied. 7/8/2024 - Observation remains. Grass was observed to be germinating at this location. Comment will remain open until stabilization is complete. 7/8/2024 - See previous update. 7/15/2024 - Additional hydroseed is required due to washouts. 7/22/2024 - Observation remains. 7/29/2024 - Observation remains. 8/5/2024 - Observation remains. 8/7/2024 - Regrowth of vegetation has been observed in this area. This item will remain open until the area is fully stabilized. 8/12/2024 - Observation remains. Regrowth has stabilized a portion of this hill; however, reseeded and additional temporary stabilized measures are recommended on the section that is currently unvegetated. 8/16/2024 - Observation remains. 8/20/2024 - Application of the approved seed mixture is required at this location. 8/27/2024 - Observation remains. 9/3/2024 - Vegetation that is present in this location generally consists of lady's thumb smartweed (<i>Persicaria maculosa</i>), a non-native species. Removal of non-native species and application of the approved seed mixture is required at this location. 9/10/2024 - Observation remains. See previous update. 9/16/2024 - Observation remains. See update from 9/3/2024. 9/23/2024 - Observation remains. See update from 9/3/2024. 9/27/2024 - Observation remains. 10/4/2024 - Observation remains. See update from 9/3/2024. 10/8/2024 - Observation remains. See update from 9/3/2024. 10/15/2024 - Observation remains. See update from 9/3/2024. 10/22/2024 - Observation remains. See update from 9/3/2024. 10/29/2024 - Observation remains. No additional seed has been applied to this location and the slope is generally vegetated by non-native species. See update from 9/3/2024. 11/5/2024 - Observation remains. Erosion control and seed has been applied to part of this slope, no germination has been observed. 11/12/2024 - Observation remains. No germination has been observed in this location. 11/19/2024 - Observation remains. 11/22/2024 - Observation remains. No germination has been observed in this location. 11/25/2024 - Observation remains. No germination has been observed in this location. 12/2/2024 - Observation remains. No germination has been observed in this location. 12/6/2024 - Observation remains. No germination has been observed in this location. 12/12/2024 - Observation remains. Some germination has been observed within this location. Observation will remain open until stabilization is complete. 12/20/2024 - Observation remains. See previous update. 12/26/2024 - Observation remains. See update from 12/12/2024. 12/31/2024 - Observation remains. See update from 12/12/2024. 1/2/2025 - Observation remains. See update from 12/12/2024. 1/9/2025 - Observation remains. See update from 12/12/2024. 1/15/2025 - Observation remains. 1/23/2025 - Observation remains. 1/30/2025 - Observation remains.</p>

View of the slope where hydroseed was applied and some germination has occurred at Station 217+45 per Compliance Action Item 34.

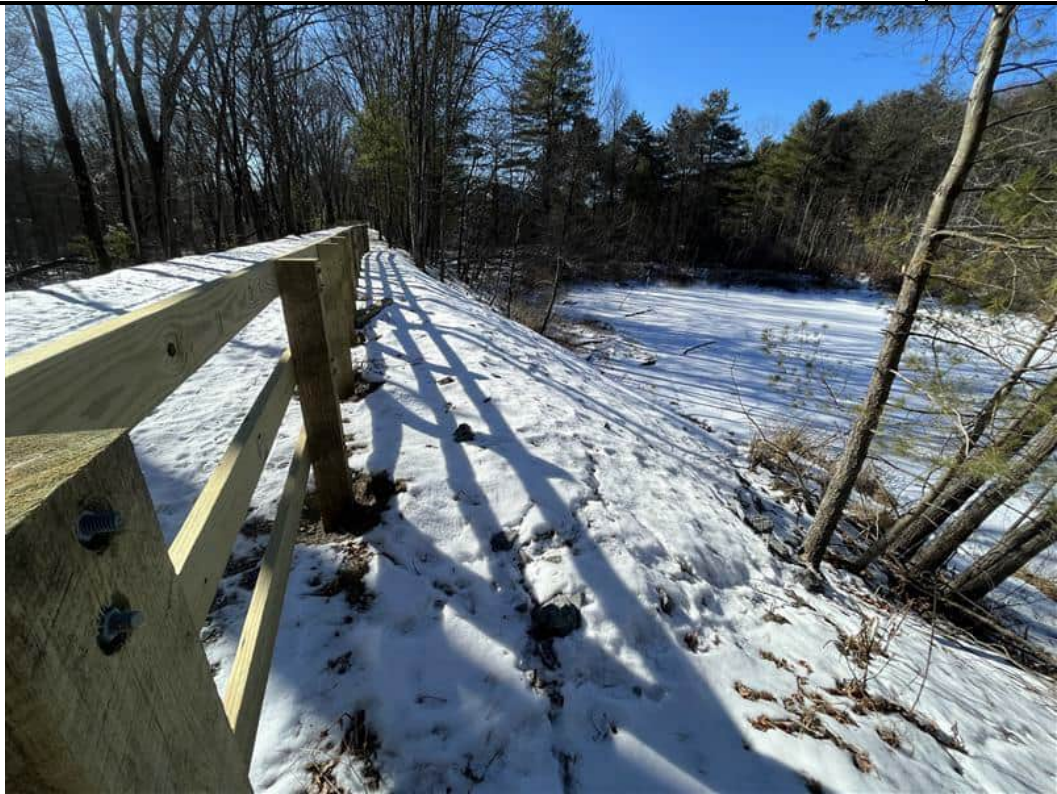
Photo No. 11 **Date:**
1/30/2025

42	<p>Riprap slope extends beyond limits of work along the WF1 Series wetland near flags 103 to 107</p> <p>Priority: High</p>	5/28/2024	6/4/2024	<p>The Contractor should confirm if this work was permitted by the Conservation Commission, as it does not appear to be a part of the approved plans/impacts. MassDOT should be consulted on next steps regarding notification and potential restoration.</p>	<p>5/31/2024 - Observation remains. 6/7/2024 - Observation remains. 6/14/2024 - Riprap slope has been altered and active construction is repairing the area. 6/17/2024 - During this inspection, additional work in support of the repair/potential replacement of an underlying pipe has been ongoing. It is recommended that the contractor confirm that they have coordinated with the Conservation Commission for this work and provide a restoration plan for the area once work is complete. 6/24/2024 - During this inspection, BETA was informed that the existing cast iron pipe was replaced with a new concrete 12-inch reinforced concrete pipe. It appears that riprap was replaced along the side slopes to mirror conditions observed prior to this inspection. 6/27/2024 - During this inspection, the area was observed to have been rolled and prepared for paving. Hydroseed was applied and plantings were installed. 7/8/2024 - Germination was observed and the area will be monitored for stabilization. See previous updates regarding Conservation Commission coordination. 7/15/2024 - This area could not be assessed due to paving operations ongoing during the inspection. 7/22/2024 - See previous updates regarding Conservation Commission coordination. 7/29/2024 - Observation remains. 8/5/2024 - Observation remains. 8/7/2024 - Observation remains. 8/12/2024 - Observation remains. Regrowth of vegetation has been observed in this area and will continue to be monitored. 8/16/2024 - Observation remains. 8/20/2024 - Observation remains. 8/27/2024 - Observation remains. 9/3/2024 - Observation remains. 9/10/2024 - Observation remains. 9/16/2024 - Observation remains. 9/23/2024 - Observation remains. 9/27/2024 - Observation remains. 10/4/2024 - Observation remains. 10/8/2024 - Observation remains. 10/15/2024 - Observation remains. 10/22/2024 - Observation remains. 10/29/2024 - Observation remains. 11/5/2024 - Observation remains. 11/12/2024 - Observation remains. The timber fence has been installed upgradient of this area. 11/19/2024 - Observation remains. As discussed with the Conservation Agent in the field, an as-built should be prepared for this area to quantify any additional impacts that may be addressed through a permit amendment. 11/22/2024 - Observation remains. See previous update. 11/25/2024 - Observation remains. See update from 11/19/2024. 12/2/2024 - Observation remains. See update from 11/19/2024. 12/6/2024 - Observation remains. See update from 11/19/2024. 12/12/2024 - Observation remains. See update from 11/19/2024. 12/20/2024 - Observation remains. See update from 11/19/2024. 12/26/2024 - Observation remains. See update from 11/19/2024. 12/31/2024 - Observation remains. See update from 11/19/2024. 1/2/2025 - Observation remains. Leaf litter that was previously observed at the bottom of the slope has blown away and it appears that exposed soil with no observable germination is present. 1/9/2025 - Observation remains. See update from 1/2/2025 and 11/19/2024. 1/15/2025 - Observation remains. See update from 1/2/2025 and 11/19/2024. 1/23/2025 - Observation remains. See update from 1/2/2025 and 11/19/2024. 1/30/2025 - Observation remains. See update from 1/2/2025 and 11/19/2024.</p>

View of the riprap slope that extends beyond the limit of work along the WF1 Series wetland at Station 332+00 per Long Term Compliance Action Item 42.
