Environmental Monitor Construction Site Inspection Report
MassDOT Project #608164 Construction Contract # 119678
EM Report #47

Project Description: Bruce Freeman Rail Trail Right-of-Way
 Permit Description(s): Order of Conditions (MGL Chapter 131, Section 40 and 310 CMR 10.00, Mass DEP File No. 301-1362); 2022 EPA NPDES General Permit for Discharges from Construction Areas; U.S. Army Corps of Engineers Permit No NAE-2021-01975.

Project Name:	Bruce Freeman Rail Trail - Phase 2d - Sudbury
Date of Inspections:	2/4/2025
Bi Weekly/ Monthly Period Covered:	February Weekly Inspection #1
Inspector's Name(s):	Anna Haznar
Inspectors' Contact Information:	ahaznar@beta-inc.com

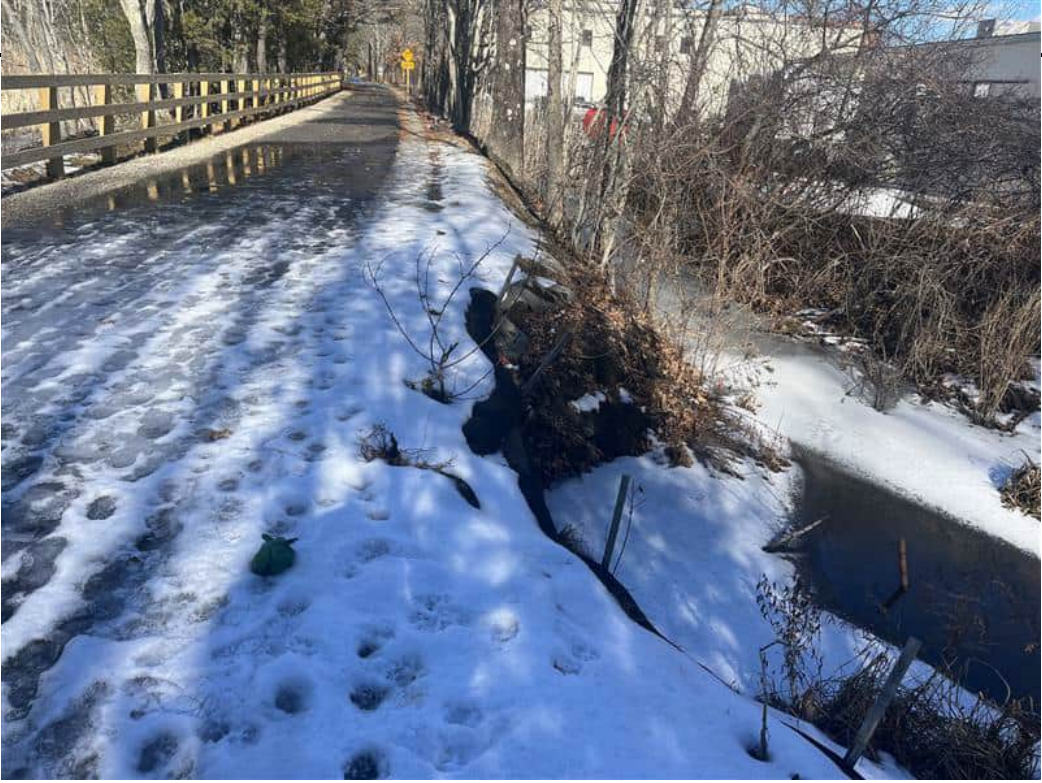
Bruce Freeman Rail Trail Right-of-Way		BETA Project No. 24.10326.23
Site Location		
Photo No. 1	Date: 2/4/2025

43	<p>Overtopped compost filter tubes and exposed soils beyond the limits of work at Station 105+00</p> <p>Priority: High</p>	6/7/2024	6/14/2024	<p>Stabilize the area with the approved seed mixture and provide interim stabilization such as straw mulch.</p>	<p>6/14/2024 - Observation remains. 6/17/2024 - Observation remains. 6/24/2024 - Observation remains. 6/27/2024 - Observation remains. 7/8/2024 - Observation remains. 7/15/2024 - Observation remains. 7/22/2024 - Observation remains. 7/29/2024 - Observation remains. 8/5/2024 - Observation remains. 8/7/2024 - Observation remains. 8/12/2024 - Observation remains. Some material has migrated off of the compost filter tubes due to erosion. 8/16/2024 - Observation remains. 8/20/2024 - Application of the approved seed mixture is required at this location. 8/27/2024 - Observation remains. 9/3/2024 - Observation remains. 9/10/2024 - Observation remains. Application of the approved seed mixture is required at this location. 9/16/2024 - Observation remains. 9/23/2024 - Observation remains. 9/27/2024 - Observation remains. 10/4/2024 - Hydroseed has been applied here; however, the contractor should provide an update on long-term slope stabilization plans. 10/8/2024 - Observation remains. Germination has not been observed. 10/15/2024 - Observation remains. Germination has not been observed. 10/22/2024 - Observation remains. Some germination has been observed but the area is not considered stabilized. 10/29/2024 - Observation remains. No further germination has been observed since the last inspection. 11/5/2024 - Observation remains. Some germination has been observed but the area is not considered stabilized. 11/12/2024 - Observation remains. Seed has stabilized the area. 11/19/2024 - The area adjacent to the path has become stabilized; however, exposed soil is still present next to the culvert past the limit of work. 11/22/2024 - Observation remains. See previous update. 11/25/2024 - Observation remains. See update from 11/19/2024. 12/2/2024 - Observation remains. See update from 11/19/2024. 12/6/2024 - Observation remains. See update from 11/19/2024. 12/12/2024 - Observation remains. See update from 11/19/2024. 12/20/2024 - Observation remains. See update from 11/19/2024. 12/26/2024 - Observation remains. See update from 11/19/2024. 12/31/2024 - Observation remains. See update from 11/19/2024. 1/2/2025 - Observation remains. See update from 11/19/2024. 1/9/2025 - Observation remains. See update from 11/19/2024. 1/15/2025 - Observation remains. Exposed soils are still present next to the culvert past the limits of work. 1/23/2025 - Observation remains. See previous update. 1/30/2025 - Observation remains. Exposed soils are present next to the culvert past the limits of work. 2/4/2025 - Observation remains. Exposed soils are present next to the culvert past the limits of work.</p>

Direction Photo Taken: Toward the North		
Description: View of the overtopped compost filter tube and exposed soils beyond the limits of work at Station 105+00 per Compliance Action Item 43. Note exposed soil is partially covered with snow.		
Photo No. 2	Date: 2/4/2025

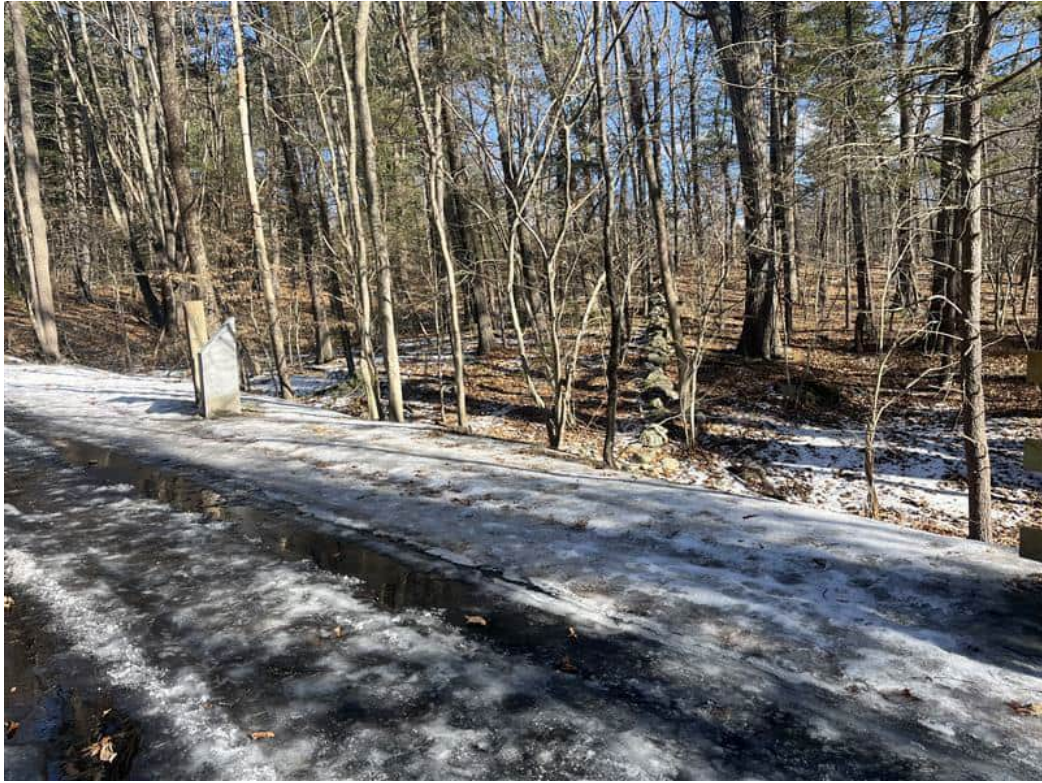
Direction Photo Taken: Toward the Northeast		
Description: View of exposed soil at Station 165+00 that requires stabilization per Long Term Compliance Action item 59. Note exposed soil is covered with snow.

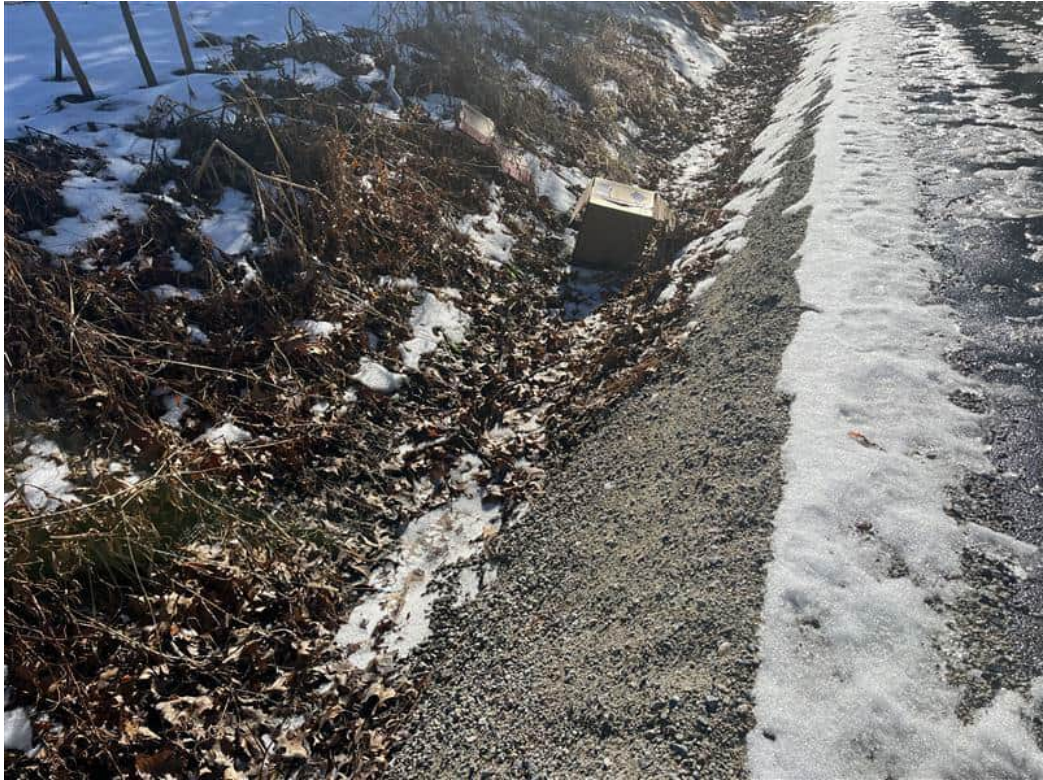
Photo No. 3 **Date:** 2/4/2025

53	<p>Stone was observed requiring removal from the swale on the east side of the trail at Station 172+00 to 173+00 Priority: High</p>	7/29/2024	8/6/2024	Remove stone from the swale.	<p>8/5/2024 - Observation remains. 8/7/2024 - Observation remains. 8/12/2024 - Observation remains. Material was observed to have migrated within the swale to Station 173+50. 8/16/2024 - Stone is still present within the swale. 8/20/2024 - Observation remains. Crushed stone has migrated further down the swale to Station 171+50. 8/27/2024 - Observation remains. Stone is still present within the swale. 9/3/2024 - Observation remains. 9/10/2024 - Observation remains. Stone is still present within the swale. 9/16/2024 - Observation remains. The contractor indicated that the stone within the swale would be hand removed. 9/23/2024 - Observation remains. 9/27/2024 - Observation remains. It appears as though some stone has migrated further south down the swale. 10/4/2024 - Observation remains. Stone is still present within the swale. 10/8/2024 - Observation remains. 10/15/2024 - Observation remains. Stone is covered with vegetation in some areas. 10/22/2024 - Observation remains. Stone is covered with vegetation in some areas. 10/29/2024 - Observation remains. 11/5/2024 - Observation remains. 11/12/2024 - Leaf litter has completely covered the stone in this location. The Contractor should indicate if stone has been removed from this location. 11/19/2024 - See previous update. 11/22/2024 - Observation remains. Stone is still present within the swale and requires removal. Leaf litter is currently covering a majority of the stone. 11/25/2024 - Observation remains. Leaf litter is covering a majority of the stone. 12/2/2024 - Observation remains. Stone is present within the swale under leaf litter. 12/6/2024 - Observation remains. See previous update. 12/12/2024 - Observation remains. Stone is present within the swale under the leaf litter. 12/20/2024 - Observation remains. Stone is present within the swale under the leaf litter. 12/26/2024 - Observation remains. Stone is present within the swale under the leaf litter and snow. 12/31/2024 - Observation remains. Stone is present within the swale under the leaf litter. 1/2/2025 - Observation remains. Stone is present within the swale under the leaf litter. 1/9/2025 - Observation remains. Stone is present within the swale under the leaf litter. 1/15/2025 - Observation remains. Further stone has discharged into the swale at this location, and stone is still present under leaf litter. 1/23/2025 - Observation remains. Stone is present within the swale under the leaf litter and snow. 1/30/2025 - Observation remains. Stone is present within the swale under the leaf litter and snow. Trash was also observed within the swale in this area. 2/4/2025 - Observation remains. Stone is present within the swale under the leaf litter and snow. Trash was also present within the swale in this area.</p>

View of the location where crushed stone was observed in the swale at Station 172+00 per Compliance Action item 53. Note stone is covered with snow and leaf litter.

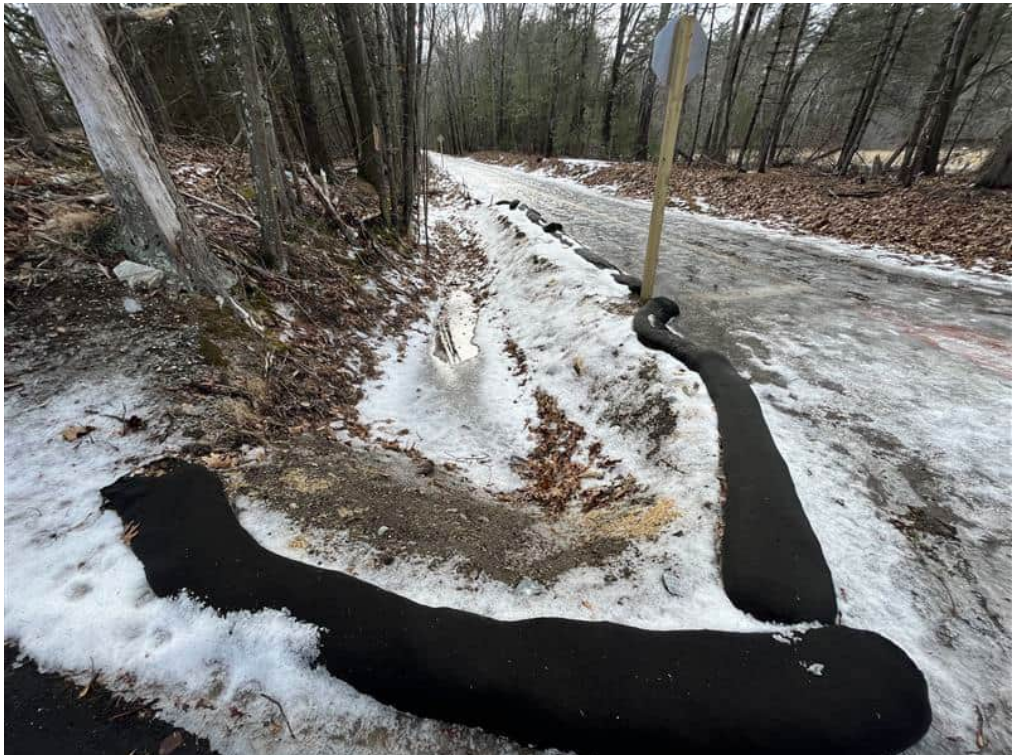
Photo No. 4 **Date:** 2/4/2025

Item	Location/ Description	Observation Date	Resolution Due Date	Recommended Resolution / Resolution Date	Comments/Updates
62	Loam and seed was applied to the streambank at Station 216+00 to 217+00 and requires further stabilization Priority: High	11/25/2024	12/2/2024	An erosion control blanket should be installed along this slope.	<p>12/2/2024 - Loam and seed have been applied to the streambank at Station 215+00. Stabilization is required at Stations 215+00 to 217+00.</p> <p>12/6/2024 - Observation remains. See previous update.</p> <p>12/12/2024 - Observation remains. Rill erosion was observed within the loam applied to this area from Station 215+00 to 216+00.</p> <p>12/20/2024 - Observation remains. Loam has begun to erode, resulting in a discharge to the stream at Station 216+50.</p> <p>12/26/2024 - Observation remains. No further discharge was observed in this location.</p> <p>12/31/2024 - Observation remains. Additional loam has eroded resulting in a discharge to the stream at Station 216+50.</p> <p>1/2/2025 - Observation remains. No further discharge was observed in this location.</p> <p>1/9/2025 - Observation remains. Straw was observed to have been placed along portions of the streambank; however, this area should be stabilized using an erosion control blanket.</p> <p>1/15/2025 - Observation remains. Erosion causing a discharge of loam and straw into the stream was observed at Station 216+50.</p> <p>1/23/2025 - Observation remains. Snow coverage is present within the stream and on the streambank. No further discharge was observed during this inspection.</p> <p>1/30/2025 - Observation remains. Snow coverage is present within the stream and on the streambank. No further discharge was observed during this inspection.</p> <p>2/4/2025 - Observation remains. Snow coverage is still present over a majority of the stream and on the streambank. No further discharge was observed; however, stabilization is still required.</p>

View of loam that requires stabilization at Station 215+00 per Compliance Action Item 62. Note loam is partially covered with snow.

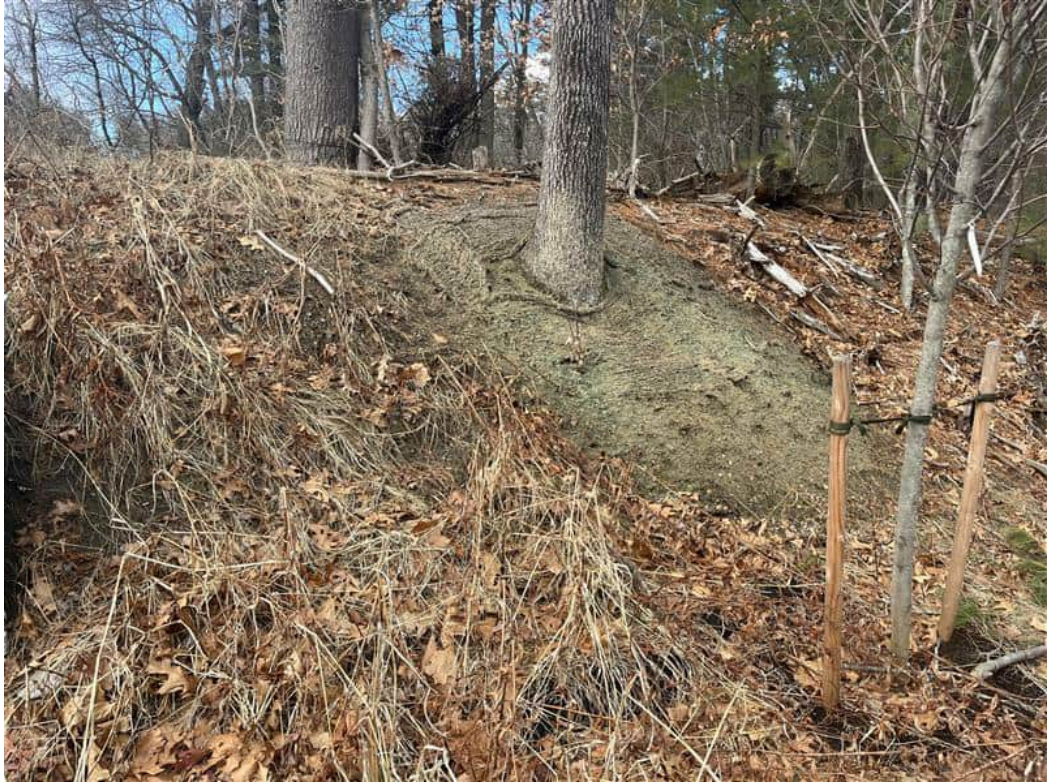
Site Location Bruce Freeman Rail Trail Right-of-Way		BETA Project No. 24.10326.23
Photo No. 7	Date: 2/4/2025

34	<p>Sediment is eroding downhill from behind the cemented stone masonry wall at Station 217+45 Priority: Low</p>	5/28/2024	6/4/2024	<p>Apply seed and temporarily stabilize the soils along the slope with straw, jute netting, etc.</p>	<p>5/31/2024 - Observation remains. 6/7/2024 - Observation remains. 6/14/2024 - Observation remains. 6/17/2024 - Observation remains. 6/24/2024 - Observation remains. 6/27/2024 - Rills were raked, loam was added, and hydroseed was applied. 7/8/2024- Observation remains. Grass was observed to be germinating at this location. Comment will remain open until stabilization is complete. 7/8/2024 - See previous update. 7/15/2024 - Additional hydroseed is required due to washouts. 7/22/2024 - Observation remains. 7/29/2024 - Observation remains. 8/5/2024 - Observation remains. 8/7/2024 - Regrowth of vegetation has been observed in this area. This item will remain open until the area is fully stabilized. 8/12/2024 - Observation remains. Regrowth has stabilized a portion of this hill; however, reseeding and additional temporary stabilized measures are recommended on the section that is currently unvegetated. 8/16/2024 - Observation remains. 8/20/2024 - Application of the approved seed mixture is required at this location. 8/27/2024 - Observation remains. 9/3/2024 - Vegetation that is present in this location generally consists of lady's thumb smartweed (<i>Persicaria maculosa</i>), a non-native species. Removal of non-native species and application of the approved seed mixture is required at this location. 9/10/2024 - Observation remains. See previous update. 9/16/2024 - Observation remains. See update from 9/3/2024. 9/23/2024 - Observation remains. See update from 9/3/2024. 9/27/2024 - Observation remains. 10/4/2024 - Observation remains. See update from 9/3/2024. 10/8/2024 - Observation remains. See update from 9/3/2024. 10/15/2024 - Observation remains. See update from 9/3/2024. 10/22/2024 - Observation remains. See update from 9/3/2024. 10/29/2024 - Observation remains. No additional seed has been applied to this location and the slope is generally vegetated by non-native species. See update from 9/3/2024. 11/5/2024 - Observation remains. Erosion control and seed has been applied to part of this slope, no germination has been observed. 11/12/2024 - Observation remains. No germination has been observed in this location. 11/19/2024 - Observation remains. 11/22/2024 - Observation remains. No germination has been observed in this location. 11/25/2024 - Observation remains. No germination has been observed in this location. 12/2/2024 - Observation remains. No germination has been observed in this location. 12/6/2024 - Observation remains. No germination has been observed in this location. 12/12/2024 - Observation remains. Some germination has been observed within this location. Observation will remain open until stabilization is complete. 12/20/2024 - Observation remains. See previous update. 12/26/2024 - Observation remains. See update from 12/12/2024. 12/31/2024 - Observation remains. See update from 12/12/2024. 1/2/2025 - Observation remains. See update from 12/12/2024. 1/9/2025 - Observation remains. See update from 12/12/2024. 1/15/2025 - Observation remains. 1/23/2025 - Observation remains. 1/30/2025 - Observation remains. 2/4/2025 - Observation remains.</p>

Direction Photo Taken: Toward the West		
Description: View of the slope where hydroseed was applied and some germination has occurred at Station 217+45 per Compliance Action Item 34.		
Photo No. 8	Date: 2/4/2025	 
Direction Photo Taken: Toward the North		
Description: View of the location where wood chips have discharged into the wetland and stream near flags WF4-108 and B4-103 at Station 311+00.

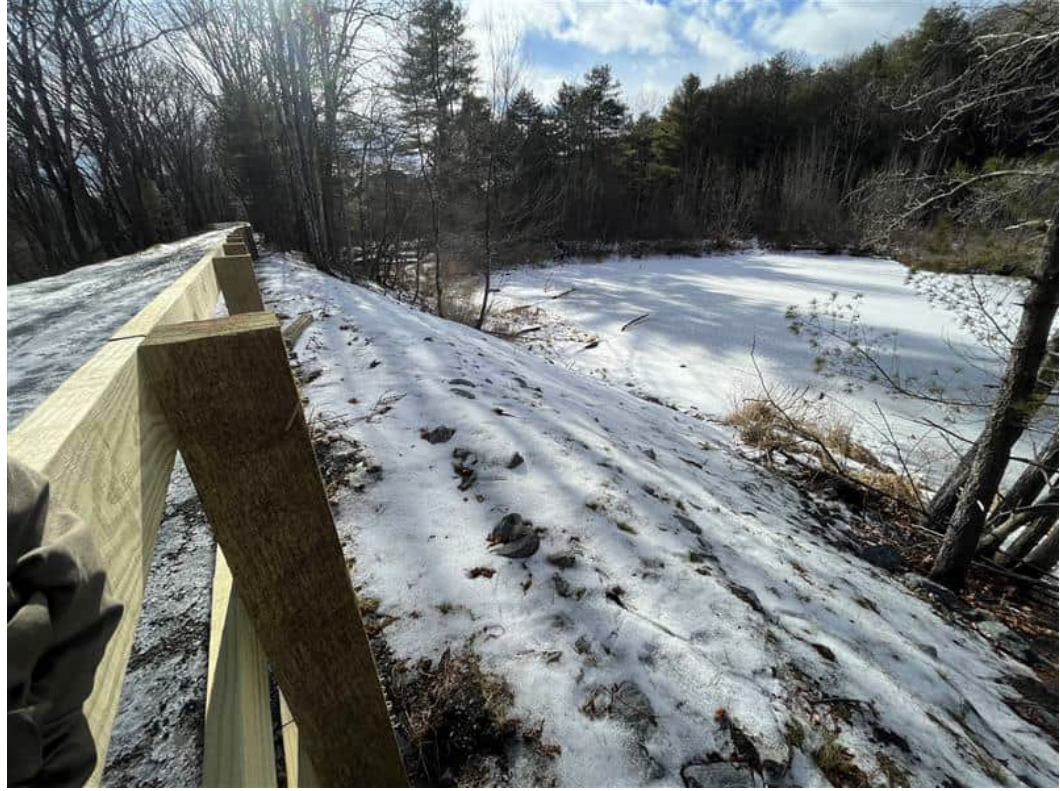
Photo No. 11 **Date:**
2/4/2025

42	<p>Riprap slope extends beyond limits of work along the WF1 Series wetland near flags 103 to 107</p> <p>Priority: High</p>	5/28/2024	6/4/2024	<p>The Contractor should confirm if this work was permitted by the Conservation Commission, as it does not appear to be a part of the approved plans/impacts. MassDOT should be consulted on next steps regarding notification and potential restoration.</p>	<p>5/31/2024 - Observation remains. 6/7/2024 - Observation remains. 6/14/2024 - Riprap slope has been altered and active construction is repairing the area. 6/17/2024 - During this inspection, additional work in support of the repair/potential replacement of an underlying pipe has been ongoing. It is recommended that the contractor confirm that they have coordinated with the Conservation Commission for this work and provide a restoration plan for the area once work is complete. 6/24/2024 - During this inspection, BETA was informed that the existing cast iron pipe was replaced with a new concrete 12-inch reinforced concrete pipe. It appears that riprap was replaced along the side slopes to mirror conditions observed prior to this inspection. 6/27/2024 - During this inspection, the area was observed to have been rolled and prepared for paving. Hydroseed was applied and plantings were installed. 7/8/2024 - Germination was observed and the area will be monitored for stabilization. See previous updates regarding Conservation Commission coordination. 7/15/2024 - This area could not be assessed due to paving operations ongoing during the inspection. 7/22/2024 - See previous updates regarding Conservation Commission coordination. 7/29/2024 - Observation remains. 8/5/2024 - Observation remains. 8/7/2024 - Observation remains. 8/12/2024 - Observation remains. Regrowth of vegetation has been observed in this area and will continue to be monitored. 8/16/2024 - Observation remains. 8/20/2024 - Observation remains. 8/27/2024 - Observation remains. 9/3/2024 - Observation remains. 9/10/2024 - Observation remains. 9/16/2024 - Observation remains. 9/23/2024 - Observation remains. 9/27/2024 - Observation remains. 10/4/2024 - Observation remains. 10/8/2024 - Observation remains. 10/15/2024 - Observation remains. 10/22/2024 - Observation remains. 10/29/2024 - Observation remains. 11/5/2024 - Observation remains. 11/12/2024 - Observation remains. The timber fence has been installed upgradient of this area. 11/19/2024 - Observation remains. As discussed with the Conservation Agent in the field, an as-built should be prepared for this area to quantify any additional impacts that may be addressed through a permit amendment. 11/22/2024 - Observation remains. See previous update. 11/25/2024 - Observation remains. See update from 11/19/2024. 12/2/2024 - Observation remains. See update from 11/19/2024. 12/6/2024 - Observation remains. See update from 11/19/2024. 12/12/2024 - Observation remains. See update from 11/19/2024. 12/20/2024 - Observation remains. See update from 11/19/2024. 12/26/2024 - Observation remains. See update from 11/19/2024. 12/31/2024 - Observation remains. See update from 11/19/2024. 1/2/2025 - Observation remains. Leaf litter that was previously observed at the bottom of the slope has blown away and it appears that exposed soil with no observable germination is present. 1/9/2025 - Observation remains. See update from 1/2/2025 and 11/19/2024. 1/15/2025 - Observation remains. See update from 1/2/2025 and 11/19/2024. 1/23/2025 - Observation remains. See update from 1/2/2025 and 11/19/2024. 1/30/2025 - Observation remains. See update from 1/2/2025 and 11/19/2024. 2/4/2025 - Observation remains. See update from 1/2/2025 and 11/19/2024.</p>

View of the riprap slope that extends beyond the limit of work along the WF1 Series wetland at Station 332+00 per Long Term Compliance Action Item 42.
