Environmental Monitor Construction Site Inspection Report
MassDOT Project #608164 Construction Contract # 119678
EM Report #48

Project Description: Bruce Freeman Rail Trail Right-of-Way
 Permit Description(s): Order of Conditions (MGL Chapter 131, Section 40 and 310 CMR 10.00, Mass DEP File No. 301-1362); 2022 EPA NPDES General Permit for Discharges from Construction Areas; U.S. Army Corps of Engineers Permit No NAE-2021-01975.

Project Name:	Bruce Freeman Rail Trail - Phase 2d - Sudbury
Date of Inspections:	2/11/2025
Bi Weekly/ Monthly Period Covered:	February Weekly Inspection #2
Inspector's Name(s):	Anna Haznar
Inspectors' Contact Information:	ahaznar@beta-inc.com

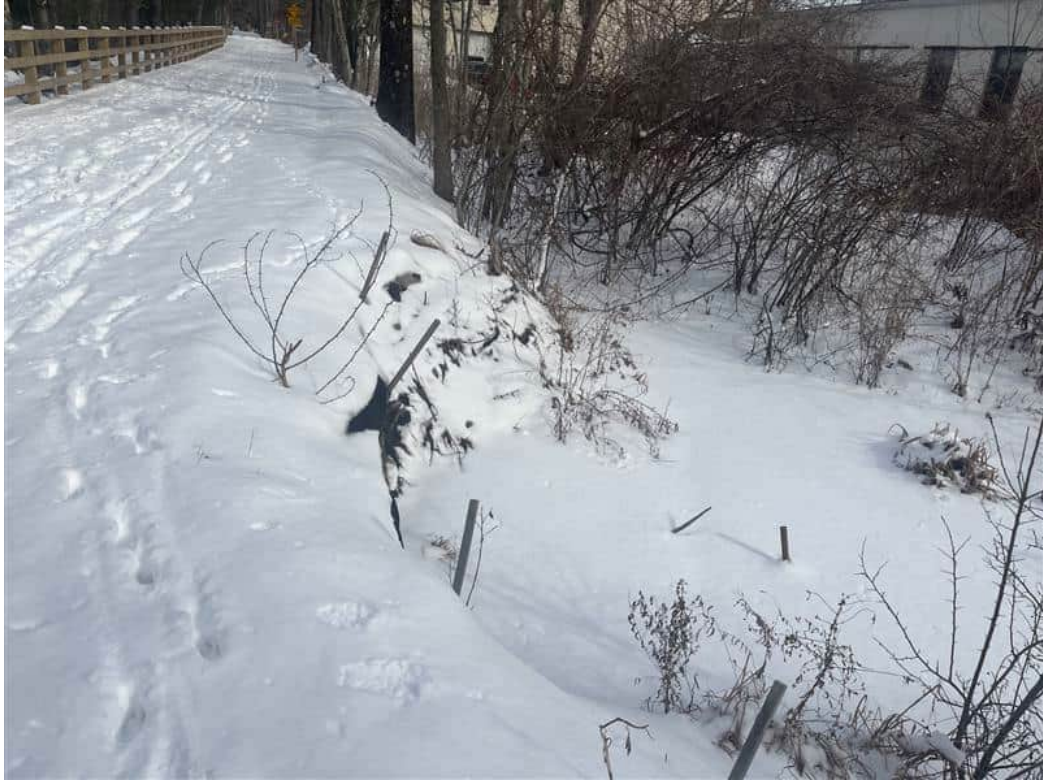
Photo No. 1 **Date:**
2/11/2025

43	<p>Overtopped compost filter tubes and exposed soils beyond the limits of work at Station 105+00 Priority: High</p>	6/7/2024	6/14/2024	<p>Stabilize the area with the approved seed mixture and provide interim stabilization such as straw mulch.</p>	<p>6/14/2024 - Observation remains. 6/17/2024 - Observation remains. 6/24/2024 - Observation remains. 6/27/2024 - Observation remains. 7/8/2024 - Observation remains. 7/15/2024 - Observation remains. 7/22/2024 - Observation remains. 7/29/2024 - Observation remains. 8/5/2024 - Observation remains. 8/7/2024 - Observation remains. 8/12/2024 - Observation remains. Some material has migrated off of the compost filter tubes due to erosion. 8/16/2024 - Observation remains. 8/20/2024 - Application of the approved seed mixture is required at this location. 8/27/2024 - Observation remains. 9/3/2024 - Observation remains. 9/10/2024 - Observation remains. Application of the approved seed mixture is required at this location. 9/16/2024 - Observation remains. 9/23/2024 - Observation remains. 9/27/2024 - Observation remains. 10/4/2024 - Hydroseed has been applied here; however, the contractor should provide an update on long-term slope stabilization plans. 10/8/2024 - Observation remains. Germination has not been observed. 10/15/2024 - Observation remains. Germination has not been observed. 10/22/2024 - Observation remains. Some germination has been observed but the area is not considered stabilized. 10/29/2024 - Observation remains. No further germination has been observed since the last inspection. 11/5/2024 - Observation remains. Some germination has been observed but the area is not considered stabilized. 11/12/2024 - Observation remains. Seed has stabilized the area. 11/19/2024 - The area adjacent to the path has become stabilized; however, exposed soil is still present next to the culvert past the limit of work. 11/22/2024 - Observation remains. See previous update. 11/25/2024 - Observation remains. See update from 11/19/2024. 12/2/2024 - Observation remains. See update from 11/19/2024. 12/6/2024 - Observation remains. See update for 11/19/2024. 12/12/2024 - Observation remains. See update from 11/19/2024. 12/20/2024 - Observation remains. See update from 11/19/2024. 12/26/2024 - Observation remains. See update from 11/19/2024. 12/31/2024 - Observation remains. See update from 11/19/2024. 1/2/2025 - Observation remains. See update from 11/19/2024. 1/9/2025 - Observation remains. See update from 11/19/2024. 1/15/2025 - Observation remains. Exposed soils are still present next to the culvert past the limits of work. 1/23/2025 - Observation remains. See previous update. 1/30/2025 - Observation remains. Exposed soils are present next to the culvert past the limits of work. 2/4/2025 - Observation remains. Exposed soils are present next to the culvert past the limits of work. 2/11/2025 - Observation remains. Exposed soils past the limits of work are currently frozen and covered with snow.</p>

View of the location of the overtopped compost filter tube and exposed soils beyond the limits of work at Station 105+00 per Compliance Action Item 43. Note exposed soil is covered with snow.

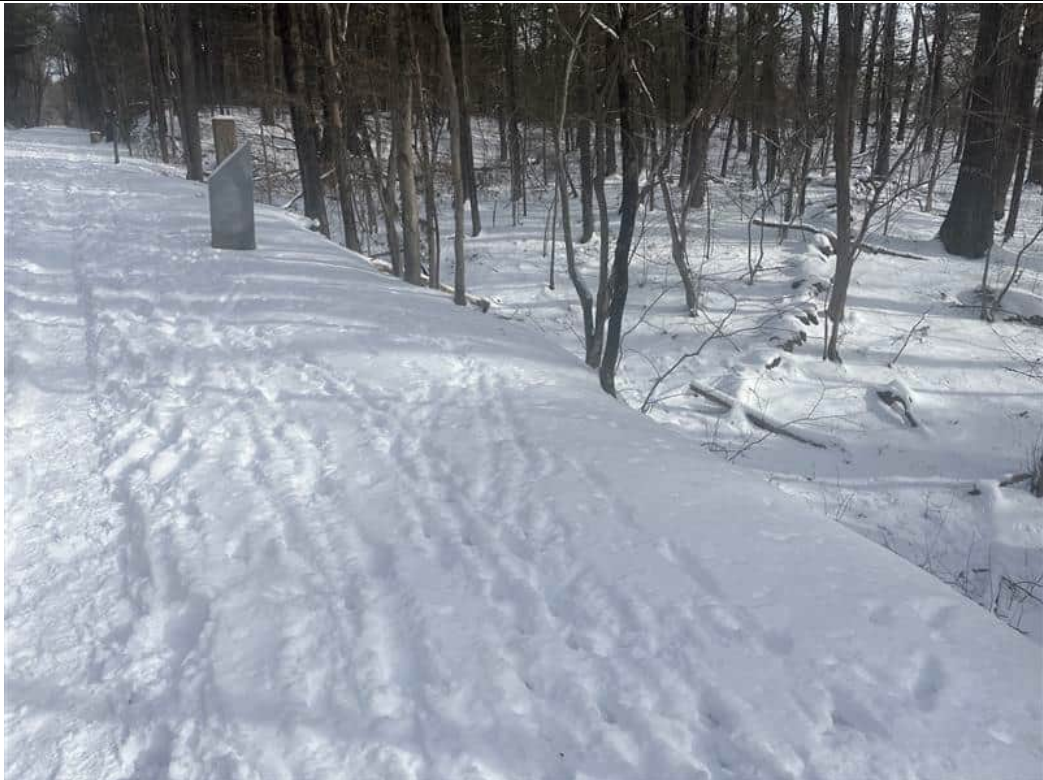
Photo No. 2 **Date:**
2/11/2025

View of the location of exposed soil at Station 166+00 that requires stabilization per Long Term Compliance Action item 59. Note exposed soil is covered with snow.

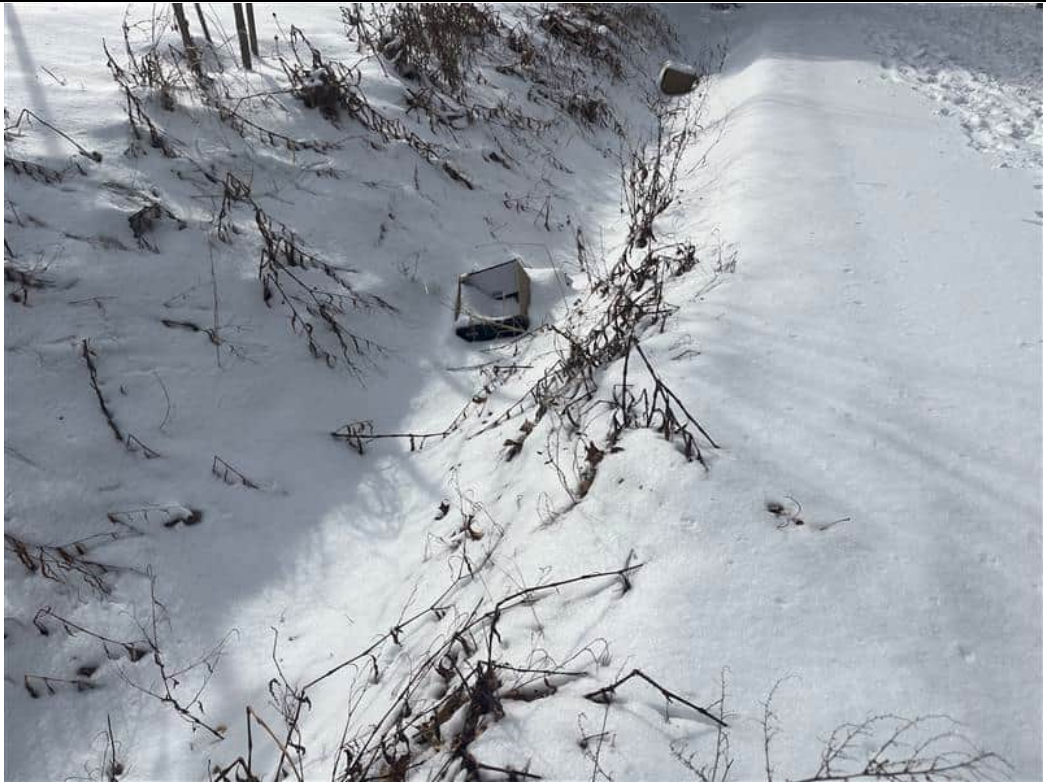
Photo No. 3 **Date:**
2/11/2025

53	<p>Stone was observed requiring removal from the swale on the east side of the trail at Station 172+00 to 173+00 Priority: High</p>	7/29/2024	8/6/2024	Remove stone from the swale.	<p>8/5/2024 - Observation remains. 8/7/2024 - Observation remains. 8/12/2024 - Observation remains. Material was observed to have migrated within the swale to Station 173+50. 8/16/2024 - Stone is still present within the swale. 8/20/2024 - Observation remains. Crushed stone has migrated further down the swale to Station 171+50. 8/27/2024 - Observation remains. Stone is still present within the swale. 9/3/2024 - Observation remains. 9/10/2024 - Observation remains. Stone is still present within the swale. 9/16/2024 - Observation remains. The contractor indicated that the stone within the swale would be hand removed. 9/23/2024 - Observation remains. 9/27/2024 - Observation remains. It appears as though some stone has migrated further south down the swale. 10/4/2024 - Observation remains. Stone is still present within the swale. 10/8/2024 - Observation remains. 10/15/2024 - Observation remains. Stone is covered with vegetation in some areas. 10/22/2024 - Observation remains. Stone is covered with vegetation in some areas. 10/29/2024 - Observation remains. 11/5/2024 - Observation remains. 11/12/2024 - Leaf litter has completely covered the stone in this location. The Contractor should indicate if stone has been removed from this location. 11/19/2024 - See previous update. 11/22/2024 - Observation remains. Stone is still present within the swale and requires removal. Leaf litter is currently covering a majority of the stone. 11/25/2024 - Observation remains. Leaf litter is covering a majority of the stone. 12/2/2024 - Observation remains. Stone is present within the swale under leaf litter. 12/6/2024 - Observation remains. See previous update. 12/12/2024 - Observation remains. Stone is present within the swale under the leaf litter. 12/20/2024 - Observation remains. Stone is present within the swale under the leaf litter. 12/26/2024 - Observation remains. Stone is present within the swale under the leaf litter and snow. 12/31/2024 - Observation remains. Stone is present within the swale under the leaf litter. 1/2/2025 - Observation remains. Stone is present within the swale under the leaf litter. 1/9/2025 - Observation remains. Stone is present within the swale under the leaf litter. 1/15/2025 - Observation remains. Further stone has discharged into the swale at this location, and stone is still present under leaf litter. 1/23/2025 - Observation remains. Stone is present within the swale under the leaf litter and snow. 1/30/2025 - Observation remains. Stone is present within the swale under the leaf litter and snow. Trash was also observed within the swale in this area. 2/4/2025 - Observation remains. Stone is present within the swale under the leaf litter and snow. Trash was also present within the swale in this area. 2/11/2025 - Observation remains. Stone is present within the swale under the leaf litter and snow. Trash is present within the swale in this area.</p>

View of the location where crushed stone was observed in the swale at Station 172+00 per Compliance Action item 53. Note stone is covered with snow and leaf litter.

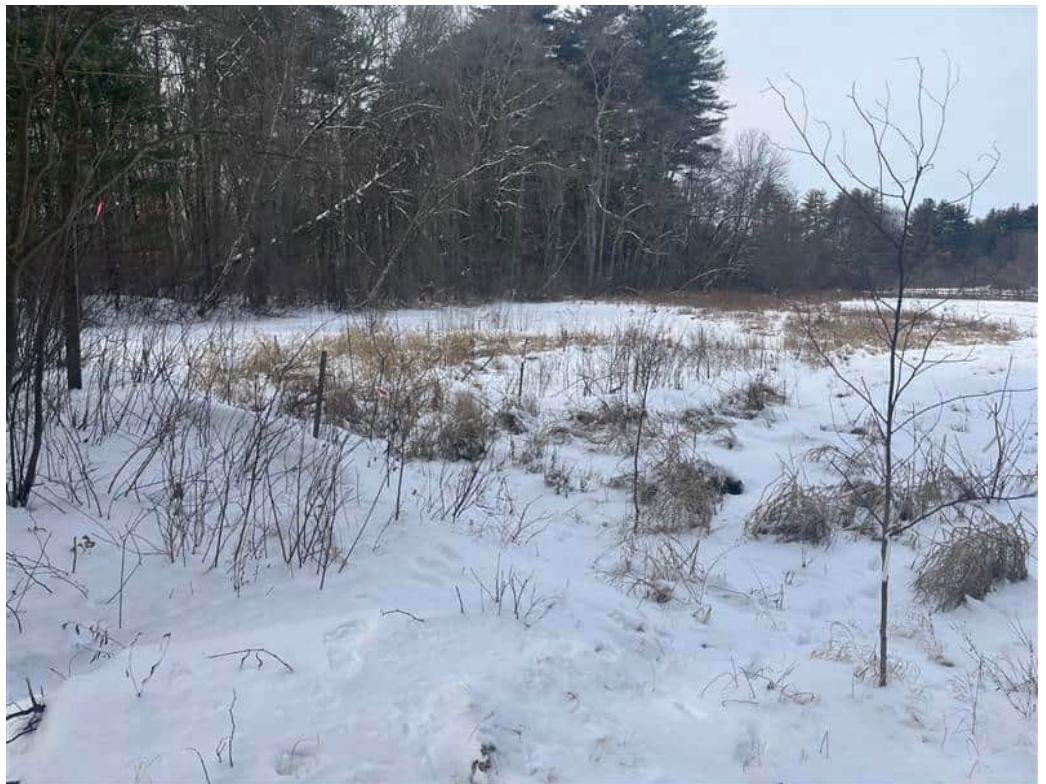
Photo No. 4 **Date:**
2/11/2025

View of the wetland replication area.

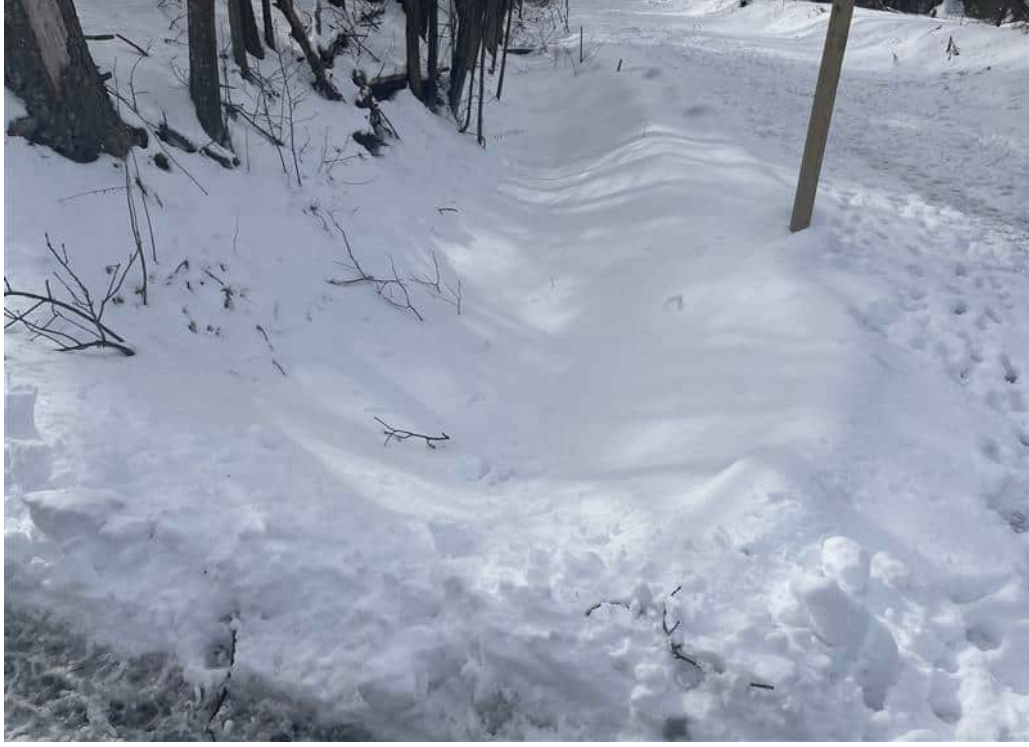
Site Location Bruce Freeman Rail Trail Right-of-Way		BETA Project No. 24.10326.23
Photo No. 5	Date: 2/11/2025

Item	Location/ Description	Observation Date	Resolution Due Date	Recommended Resolution / Resolution Date	Comments/Updates
62	Loam and seed was applied to the streambank at Station 216+00 to 217+00 and requires further stabilization Priority: High	11/25/2024	12/2/2024	An erosion control blanket should be installed along this slope.	<p>12/2/2024 - Loam and seed have been applied to the streambank at Station 215+00. Stabilization is required at Stations 215+00 to 217+00.</p> <p>12/6/2024 - Observation remains. See previous update.</p> <p>12/12/2024 - Observation remains. Rill erosion was observed within the loam applied to this area from Station 215+00 to 216+00.</p> <p>12/20/2024 - Observation remains. Loam has begun to erode, resulting in a discharge to the stream at Station 216+50.</p> <p>12/26/2024 - Observation remains. No further discharge was observed in this location.</p> <p>12/31/2024 - Observation remains. Additional loam has eroded resulting in a discharge to the stream at Station 216+50.</p> <p>1/2/2025 - Observation remains. No further discharge was observed in this location.</p> <p>1/9/2025 - Observation remains. Straw was observed to have been placed along portions of the streambank; however, this area should be stabilized using an erosion control blanket.</p> <p>1/15/2025 - Observation remains. Erosion causing a discharge of loam and straw into the stream was observed at Station 216+50.</p> <p>1/23/2025 - Observation remains. Snow coverage is present within the stream and on the streambank. No further discharge was observed during this inspection.</p> <p>1/30/2025 - Observation remains. Snow coverage is present within the stream and on the streambank. No further discharge was observed during this inspection.</p> <p>2/4/2025 - Observation remains. Snow coverage is still present over a majority of the stream and on the streambank. No further discharge was observed; however, stabilization is still required.</p> <p>2/11/2025 - Observation remains. Snow coverage is present over the stream and on the streambank.</p>

Direction Photo Taken: Toward the South		
Description: View of the location of loam that requires stabilization at Station 215+00 per Compliance Action Item 62. Note loam is covered with snow.		
Photo No. 6	Date: 2/11/2025

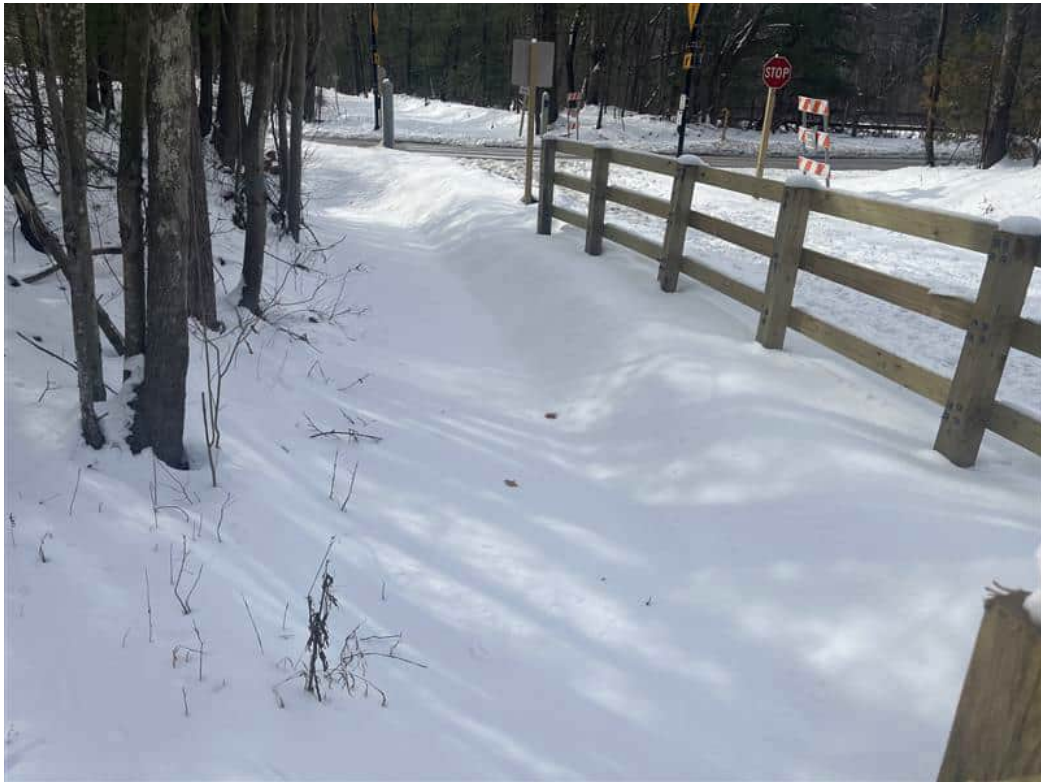
41	Stream Bank has been regraded beyond the limit of work at Station 216+00 Priority: High	5/28/2024	6/4/2024	The Contractor should confirm if this work was permitted by the Conservation Commission, as it does not appear to be a part of the approved plans/impacts. MassDOT should be consulted on next steps regarding notification and potential restoration.	<p>5/31/2024 - Observation remains. 6/7/2024 - Observation remains. 6/14/2024 - Observation remains. 6/17/2024 - Observation remains. 6/24/2024 - Observation remains. 6/27/2024 - Observation remains. 7/8/2024 - Observation remains. 7/15/2024 - This area could not be assessed due to paving operations ongoing during the inspection. 7/22/2024 - Crushed stone and sediment continue to be discharged to the stream between Stations 215+00 and 217+00 due to overtopped and undermined compost filter tubes. 7/29/2024 - Observation remains. 8/5/2024 - Observation remains. 8/7/2024 - Observation remains. 8/12/2024 - Observation remains. Crushed stone is still present in the streambed at this location. 8/16/2024 - Observation remains. 8/20/2024 - Stone has been removed; however, additional alteration to Resource Areas beyond the limit of work continue. 8/27/2024 - Observation remains. 9/3/2024 - Observation remains. 9/10/2024 - Observation remains. Stone has been observed as discharging into the streambed in this location again. 9/16/2024 - Observation remains. 9/23/2024 - Observation remains. Stone is still present within the streambed at this location. 9/27/2024 - Observation remains. 10/4/2024 - Observation remains. 10/8/2024 - Observation remains. 10/15/2024 - Observation remains. Stone is still present within the streambed at this location. 10/22/2024 - Observation remains. Stone is still present within the streambed at this location. 10/29/2024 - Observation remains. Stone is still present within the streambed at this location. 11/5/2024 - Observation remains. The PVC pipe that was installed at this location was observed to be covered with stone and is no longer visible near Station 215+00. Stone is still present within the streambed at this location. 11/12/2024 - Observation remains. The streambed in this location is covered with leaf litter. See previous update. 11/19/2024 - Observation remains. As discussed with the Conservation Agent in the field, further coordination between the Town and MassDOT will be required to clean/repair the culvert, as the degraded condition of the culvert prompted the contractor to armor the stream banks. Further coordination will also be required for restoration of banks. 11/22/2024 - Observation remains. See previous update. 11/25/2024 - Observation remains. See update from 11/19/2024. 12/2/2024 - Observation remains. See update from 11/19/2024. 12/6/2024 - Observation remains. See update from 11/19/2024. 12/12/2024 - Observation remains. See update from 11/19/2024. 12/20/2024 - Observation remains. See update from 11/19/2024. 12/26/2024 - Observation remains. See update from 11/19/2024. 12/31/2024 - Observation remains. See update from 11/19/2024. 1/2/2025 - Observation remains. See update from 11/19/2024. 1/9/2025 - Observation remains. See update from 11/19/2024. 1/15/2025 - Observation remains. See update from 11/19/2024. 1/23/2025 - Observation remains. See update from 11/19/2024. 1/30/2024 - Observation remains. See update from 11/19/2024. 2/4/2025 - Observation remains. See update from 11/19/2024. 2/11/2025 - Observation remains. See update from 11/19/2024.</p>

Direction Photo Taken: Toward the South		
Description: View of the location where the stream bank has been regraded beyond the limits of work and stabilization of loam is required at Station 216+00 per Long Term Compliance Action Item 41 and 62. Note loam is covered with snow.

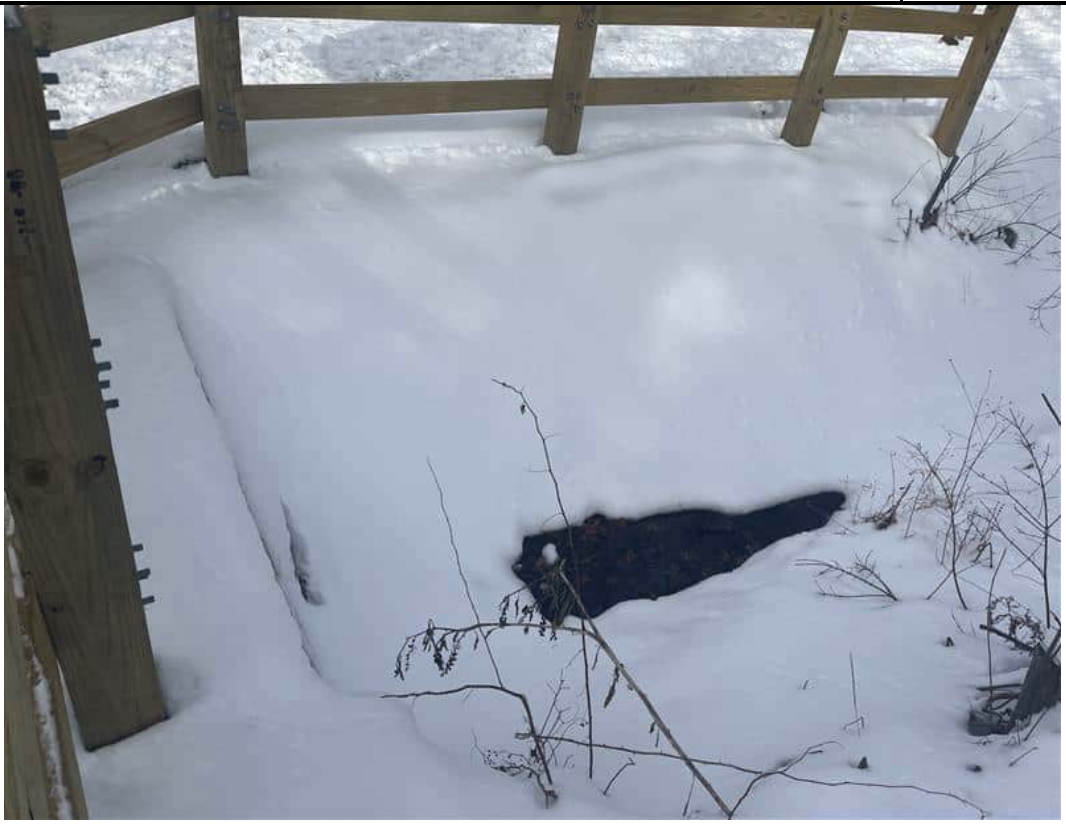
Photo No. 7 **Date:**
2/11/2025

View of the location of loam that requires stabilization at Station 217+00 per Compliance Action Item 62. Note loam is covered with snow.

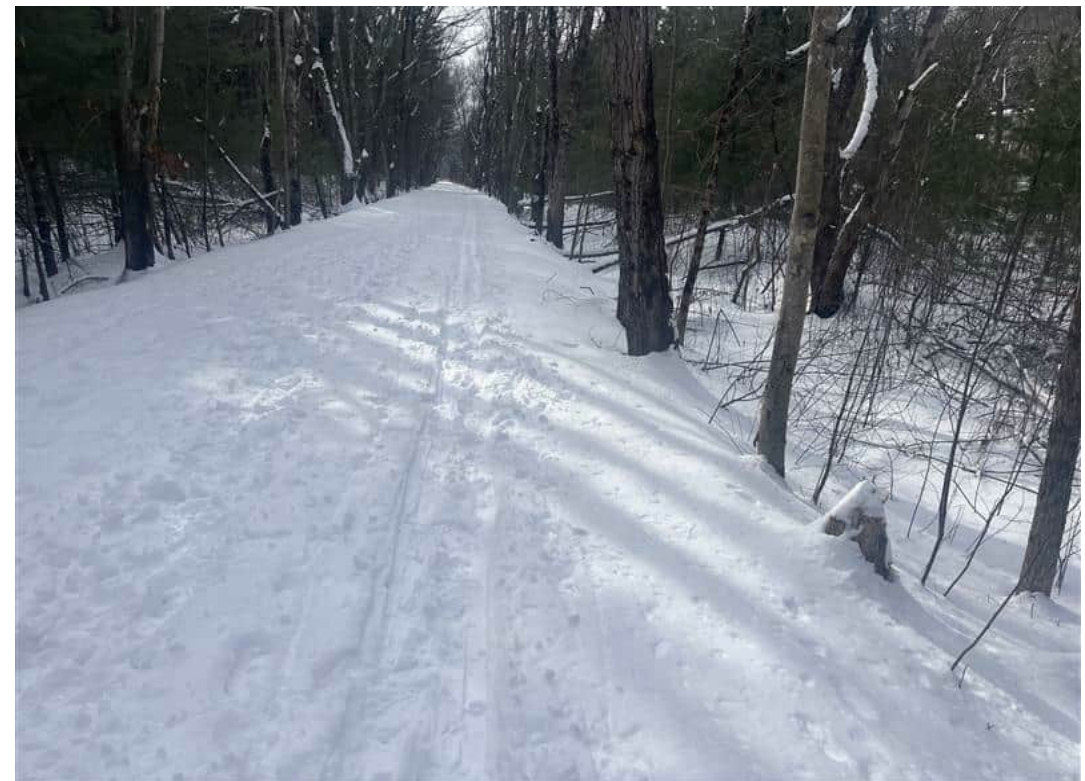
Photo No. 8 **Date:**
2/11/2025

View of the location of exposed soil at Station 297+50 per Long Term Compliance Action item 59. Note exposed soil is covered with snow.

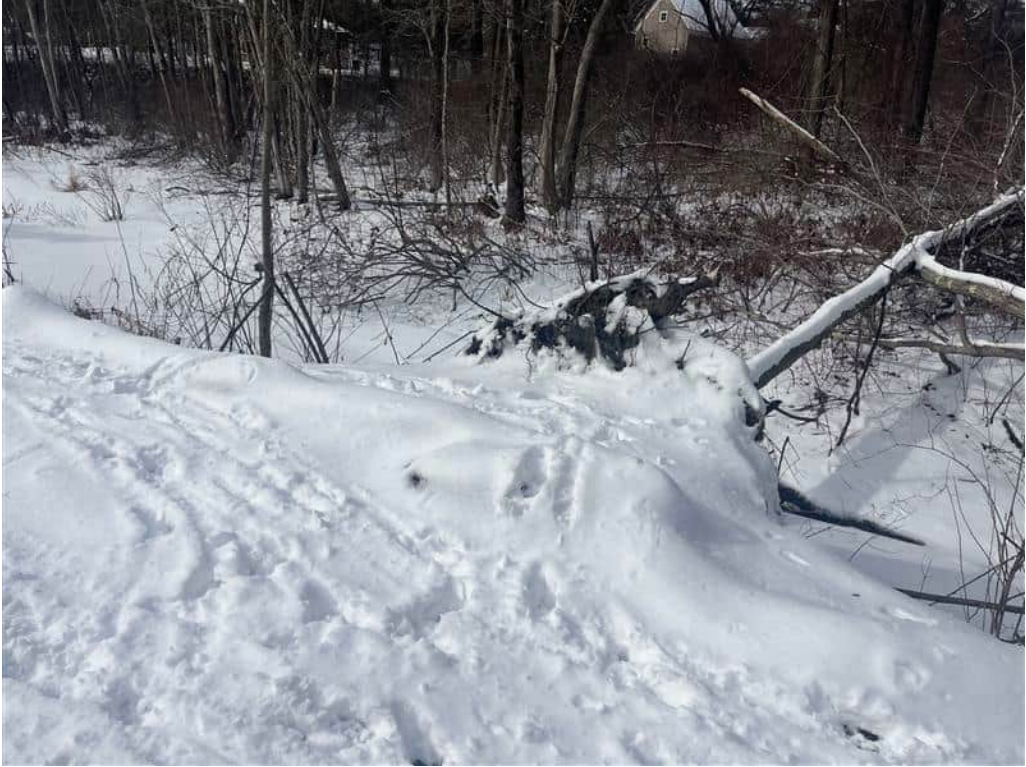
Site Location Bruce Freeman Rail Trail Right-of-Way		BETA Project No. 24.10326.23
Photo No. 9	Date: 2/11/2025

Direction Photo Taken: Toward the West		
Description: View of the location of placed loam that requires stabilization at Station 311+50 per Long Term Compliance Action Item 59. Note loam is covered with snow.		
Photo No. 10	Date: 2/11/2025

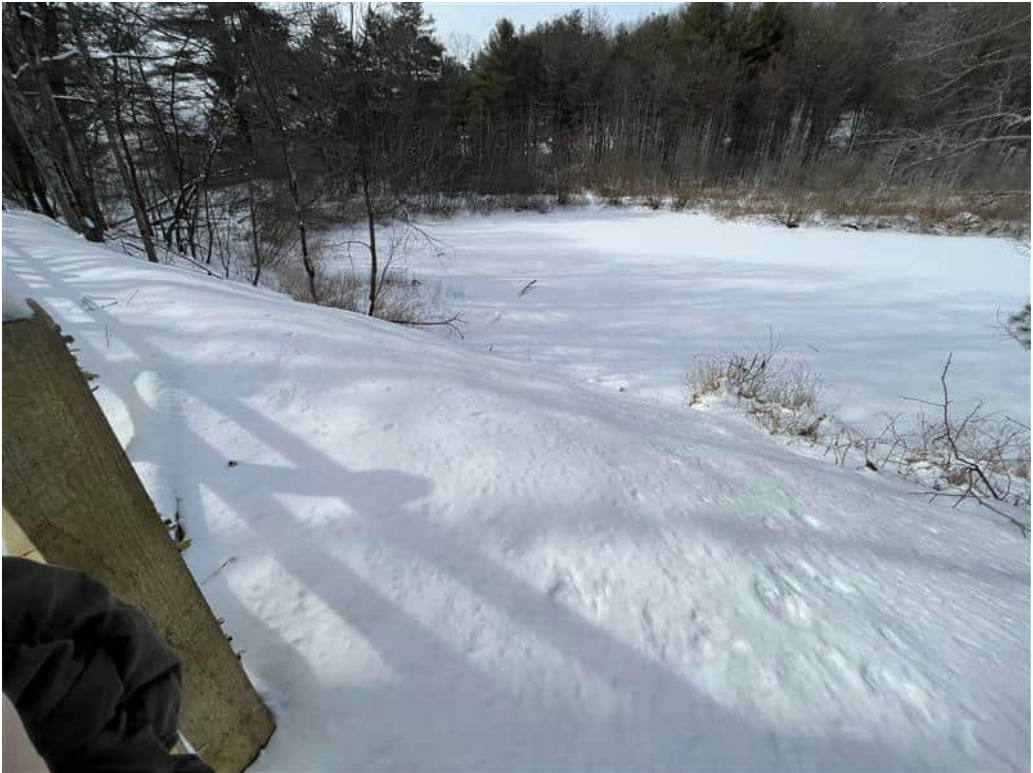
Direction Photo Taken: Toward the West		
Description: View of the location of the riprap slope that extends beyond the limit of work along the WF1 Series wetland at Station 332+00 per Long Term Compliance Action Item 42. Note area is covered with snow.
