Sudbury to Hudson TRP Week of 3/03/2025

Epsilon Team Full SWPPP Inspection Report(s)

CONSTRUCTION MONITORING REPORT

Sudbury to Hudson Transmission Project

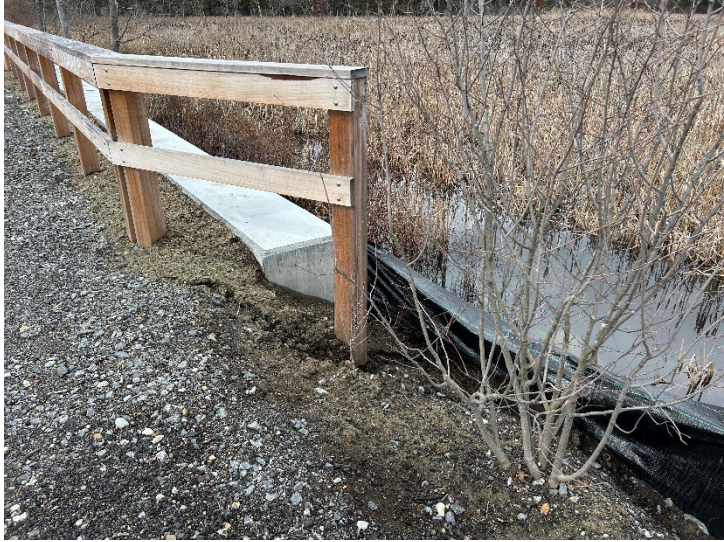
PHOTOGRAPHIC LOG	
Client Name: Eversource		Site Location: Sudbury to Hudson Transmission Reliability Project	Town: Hudson
Photo No.: 1	Date: 3-6-2025

-Rill erosion noted at bridge 130 and near Station 347 in segment 6.

Description: View of rill erosion at northeast corner of bridge 130. Facing northwest.

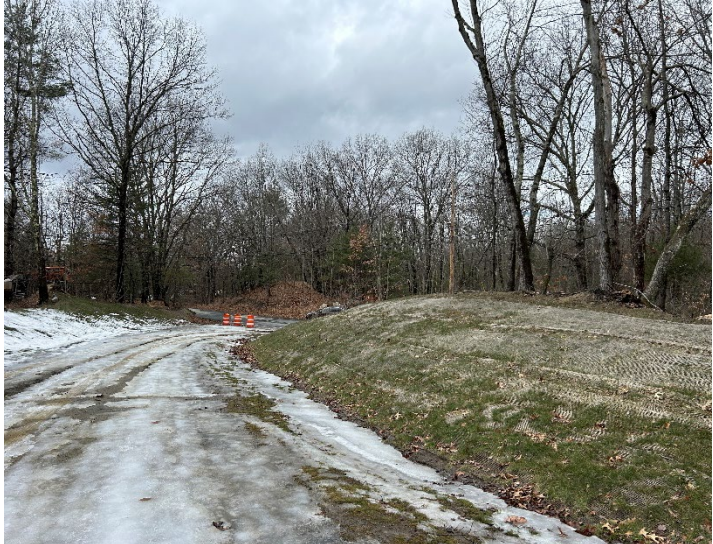
PHOTOGRAPHIC LOG	
Client Name: Eversource		Site Location: Sudbury to Hudson Transmission Reliability Project	Town: Hudson
Photo No.: 2	Date: 3-6-2025

Description: View of slope stabilized with jute netting at entrance to segment 1. Facing northwest.

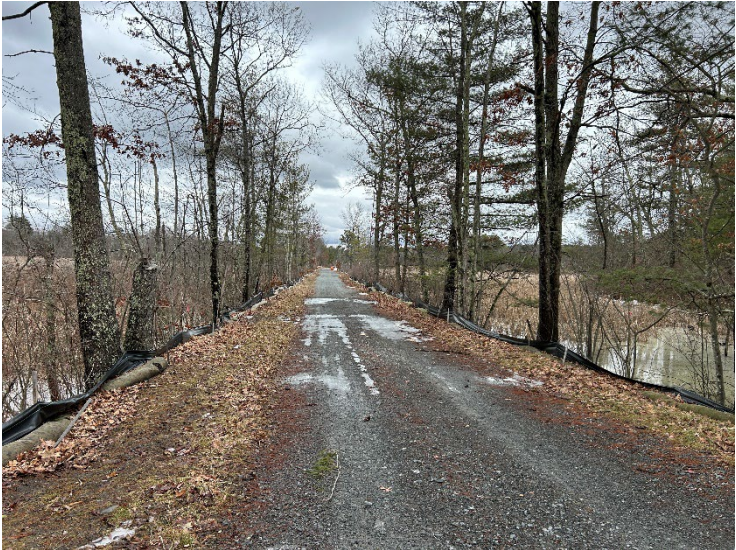
Epsilon ASSOCIATES INC.		PHOTOGRAPHIC LOG	
Client Name: Eversource		Site Location: Sudbury to Hudson Transmission Reliability Project	Town: Hudson
Photo No.: 3	Date: 3-6-2025

Description: View of E&S controls in segment 2. Facing east.

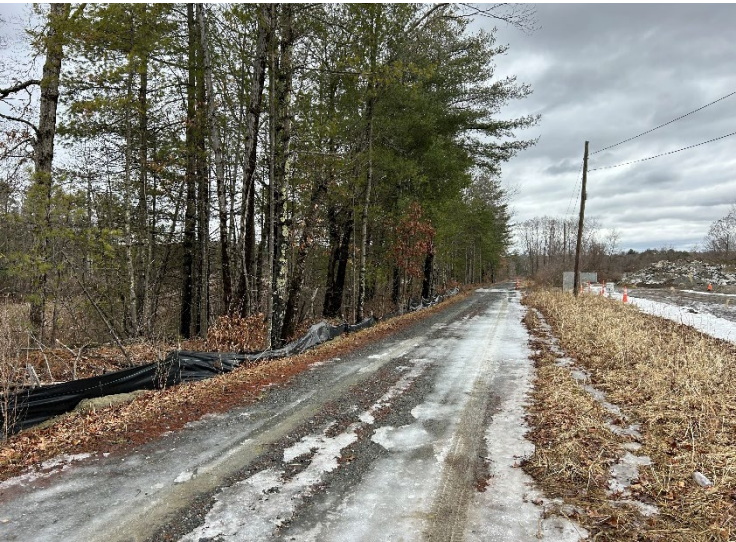
Epsilon ASSOCIATES INC.		PHOTOGRAPHIC LOG	
Client Name: Eversource		Site Location: Sudbury to Hudson Transmission Reliability Project	Town: Hudson
Photo No.: 4	Date: 3-6-2025

Description: View of E&S controls in segment 3. Facing west.

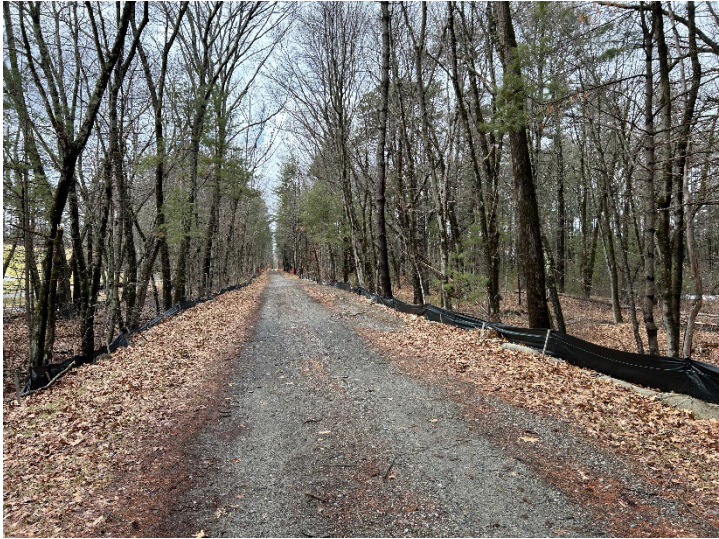
Epsilon ASSOCIATES INC.		PHOTOGRAPHIC LOG	
Client Name: Eversource		Site Location: Sudbury to Hudson Transmission Reliability Project	Town: Hudson
Photo No.: 5	Date: 3-6-2025

Description: View of E&S controls in segment 4. Facing west.

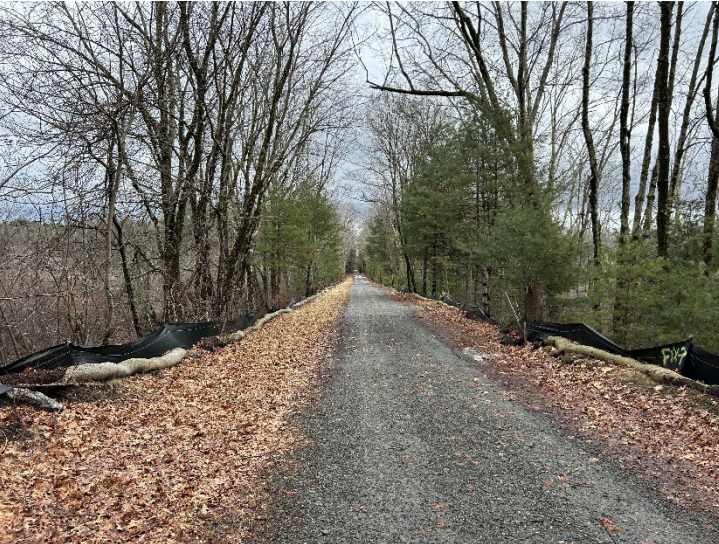
Epsilon ASSOCIATES INC.		PHOTOGRAPHIC LOG	
Client Name: Eversource		Site Location: Sudbury to Hudson Transmission Reliability Project	Town: Hudson
Photo No.: 6	Date: 3-6-2025

Description: View of E&S controls 5 in segment 5. Facing east.

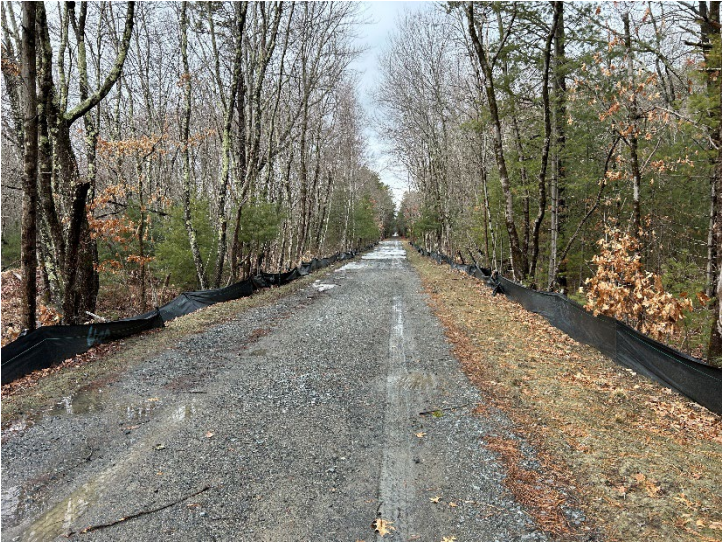
Epsilon ASSOCIATES INC.		PHOTOGRAPHIC LOG	
Client Name: Eversource		Site Location: Sudbury to Hudson Transmission Reliability Project	Town: Hudson
Photo No.: 7	Date: 3-6-2025

Description: View of E&S controls in segment 6. Facing west.

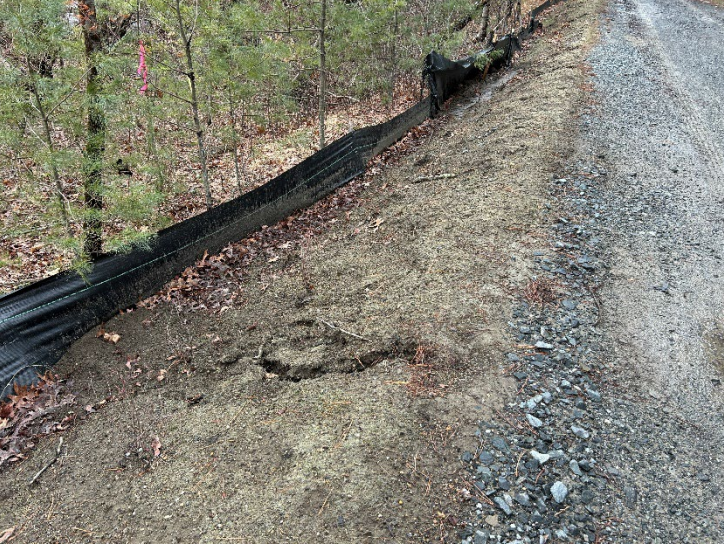
Epsilon ASSOCIATES INC.		PHOTOGRAPHIC LOG	
Client Name: Eversource		Site Location: Sudbury to Hudson Transmission Reliability Project	Town: Hudson
Photo No.: 8	Date: 3-6-2025

Description: View of rill erosion in segment 6 near station 347. Facing west.

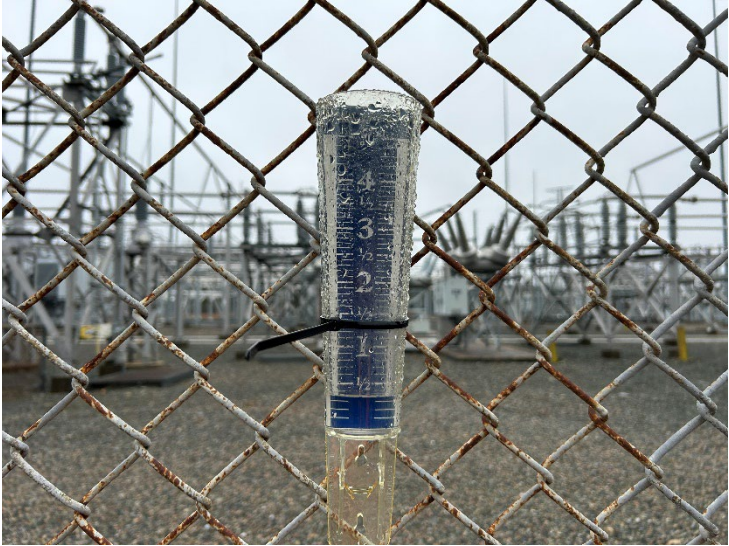
PHOTOGRAPHIC LOG	
Client Name: Eversource		Site Location: Sudbury to Hudson Transmission Reliability Project	
Town: Sudbury			
Photo No.: 1	Date: 3-6-2025

Description: View of rain gauge at Sudbury substation. Approximately 0.40" of rain observed in gauge on 3/6/2025. Facing south.

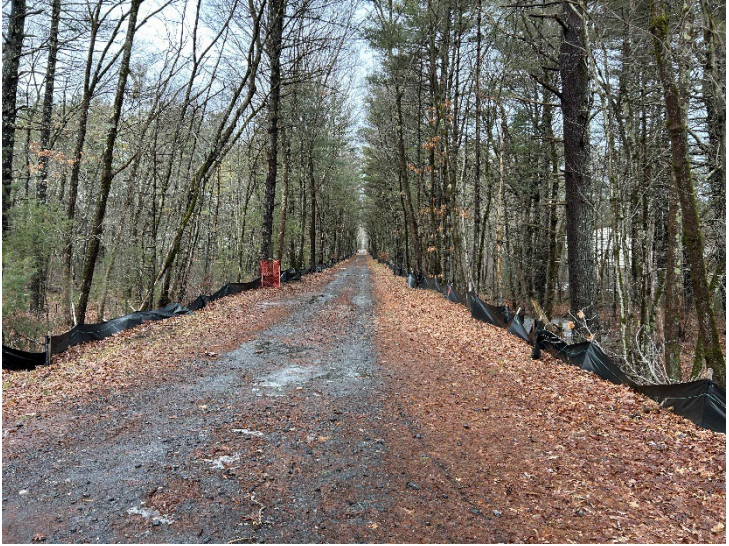
PHOTOGRAPHIC LOG	
Client Name: Eversource		Site Location: Sudbury to Hudson Transmission Reliability Project	
Town: Sudbury			
Photo No.: 2	Date: 3-6-2025

Description: View of E&S controls in segment 9. Facing west.

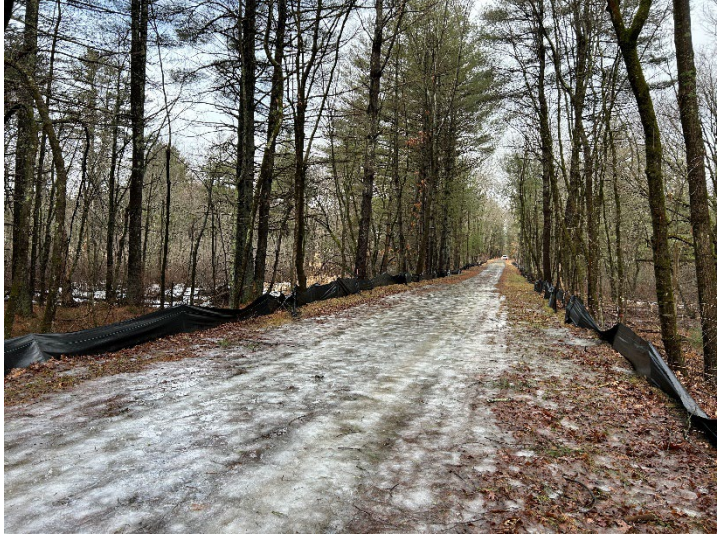
Epsilon ASSOCIATES INC.		PHOTOGRAPHIC LOG	
Client Name: Eversource		Site Location: Sudbury to Hudson Transmission Reliability Project	Town: Sudbury
Photo No.: 3	Date: 3-6-2025

Description: View of E&S controls in segment 11. Facing west.

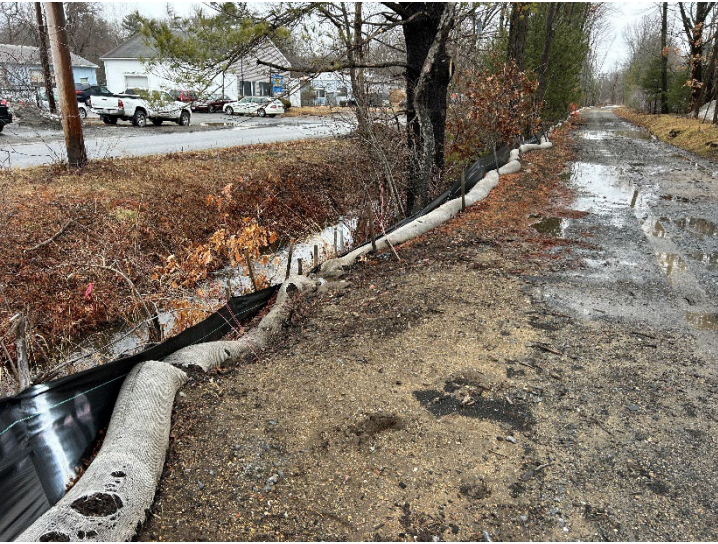
Epsilon ASSOCIATES INC.		PHOTOGRAPHIC LOG	
Client Name: Eversource		Site Location: Sudbury to Hudson Transmission Reliability Project	Town: Sudbury
Photo No.: 4	Date: 3-6-2025

Description: View of erosion in segment 12. Sediment is accumulating at filter tubes. Facing east.

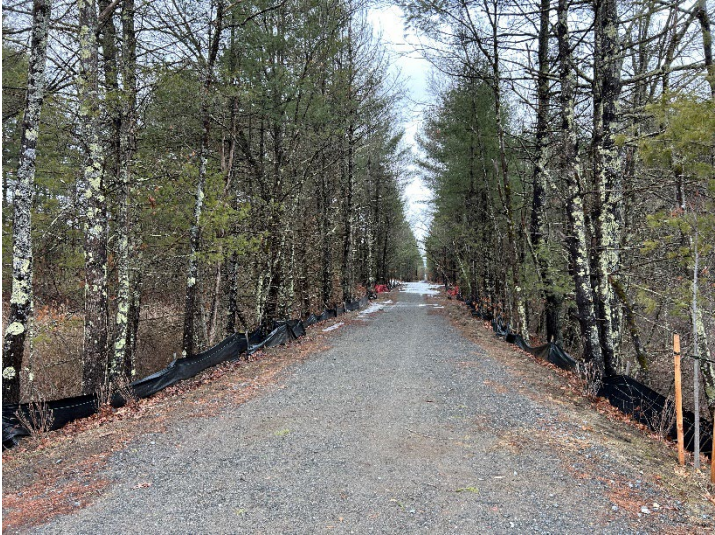
Epsilon ASSOCIATES INC.		PHOTOGRAPHIC LOG	
Client Name: Eversource		Site Location: Sudbury to Hudson Transmission Reliability Project	Town: Sudbury
Photo No.: 5	Date: 3-6-2025

Description: View of E&S controls in segment 7. Facing west.

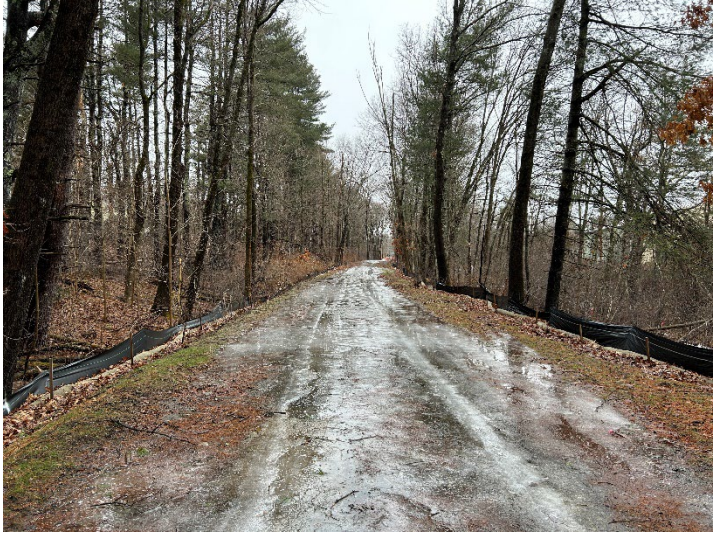
Epsilon ASSOCIATES INC.		PHOTOGRAPHIC LOG	
Client Name: Eversource		Site Location: Sudbury to Hudson Transmission Reliability Project	Town: Sudbury
Photo No.: 6	Date: 3-6-2025

Description: View of E&S controls in segment 13. Facing west.

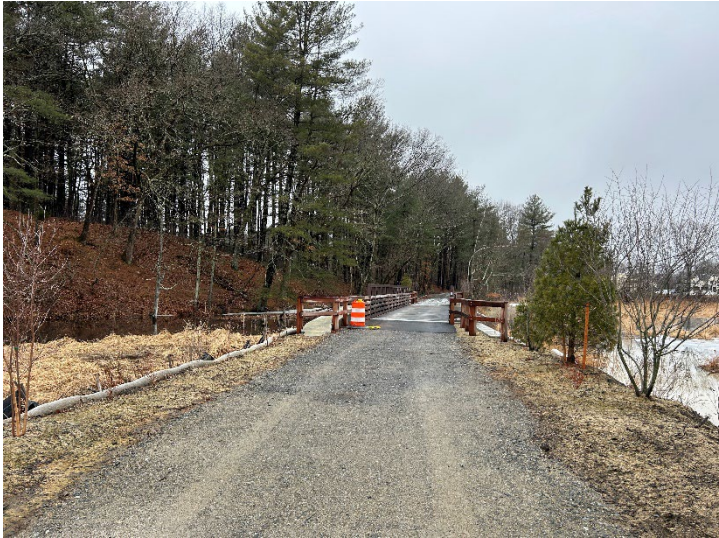
Epsilon ASSOCIATES INC.		PHOTOGRAPHIC LOG	
Client Name: Eversource		Site Location: Sudbury to Hudson Transmission Reliability Project	Town: Sudbury
Photo No.: 7	Date: 3-6-2025

Description: View of bridge 127 from segment 14. Facing west.

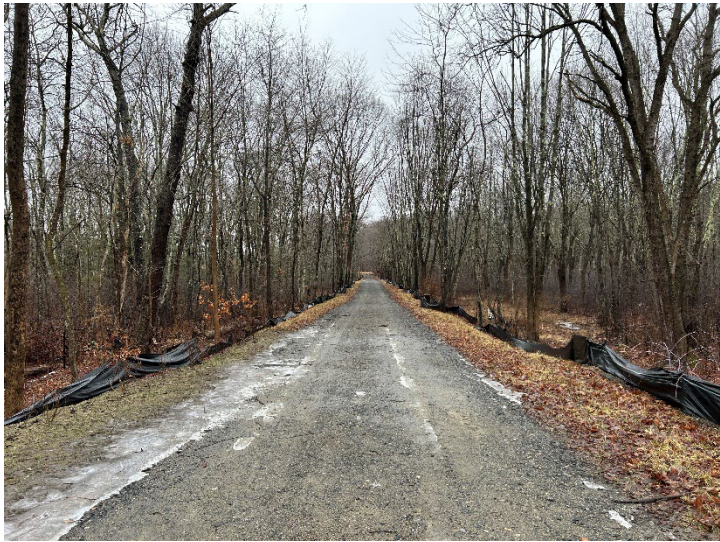
Epsilon ASSOCIATES INC.		PHOTOGRAPHIC LOG	
Client Name: Eversource		Site Location: Sudbury to Hudson Transmission Reliability Project	Town: Sudbury
Photo No.: 8	Date: 3-6-2025

Description: View of E&S controls in segment 14. Facing west.
