Sudbury to Hudson TRP Week of 3/17/2025

Epsilon Team Full SWPPP Inspection Report(s)

CONSTRUCTION MONITORING REPORT

Project Name:
Sudbury to Hudson Transmission Reliability Project

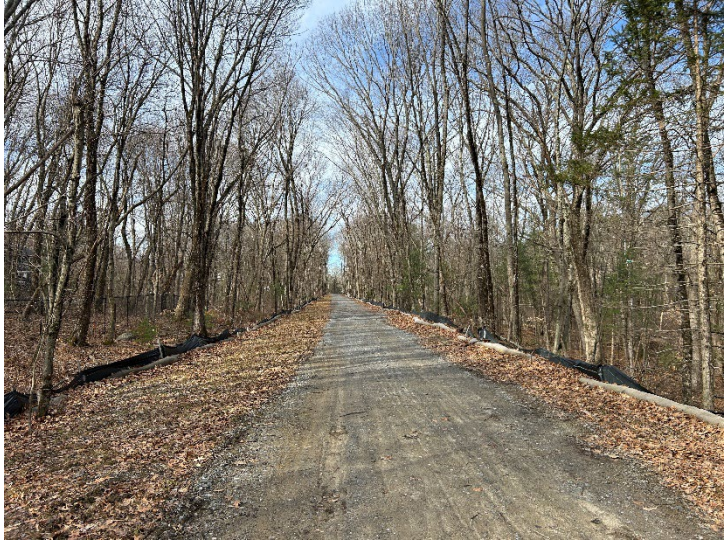
PHOTOGRAPHIC LOG	
Client Name: Eversource		Site Location: Sudbury to Hudson Transmission Reliability Project	Town: Hudson
Photo No.: 1	Date: 3-18-2025

Description: View of E&S controls in segment 1. Facing west.

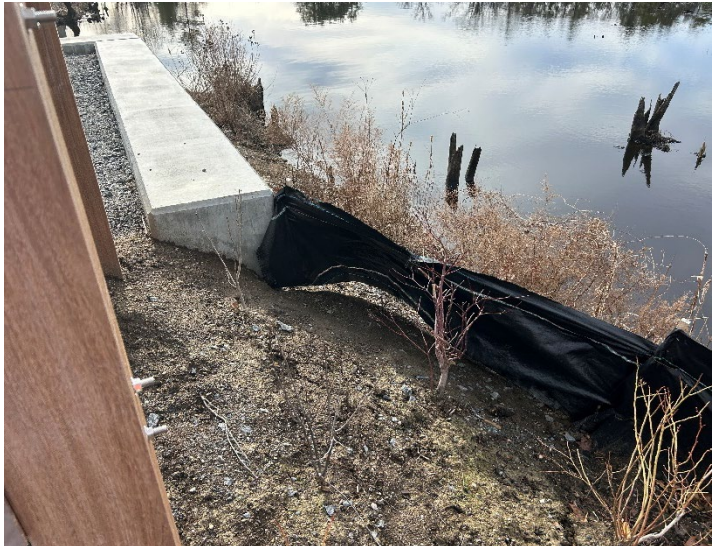
PHOTOGRAPHIC LOG	
Client Name: Eversource		Site Location: Sudbury to Hudson Transmission Reliability Project	Town: Hudson
Photo No.: 2	Date: 3-18-2025

6. Silt Fencing on ROW in Hudson	<input checked="" type="checkbox"/> Yes <input type="checkbox"/> No	1	<input type="checkbox"/> Yes <input checked="" type="checkbox"/> No	3/18/25	-Silt fence is installed and operating properly in segments 1-6. -Portions of erosion controls approved and marked for removal were removed between 11/25 & 12/06/2024. -Additional sections of silt fence were added in front of compost filter tubes on east side of bridge 130 for additional protection on 1/14/2025. -Small section of silt fencing on west side of bridge 130 needs to be keyed in.

Description: View of silt fence at bridge 130. Silt fence should be keyed in. Facing southeast.

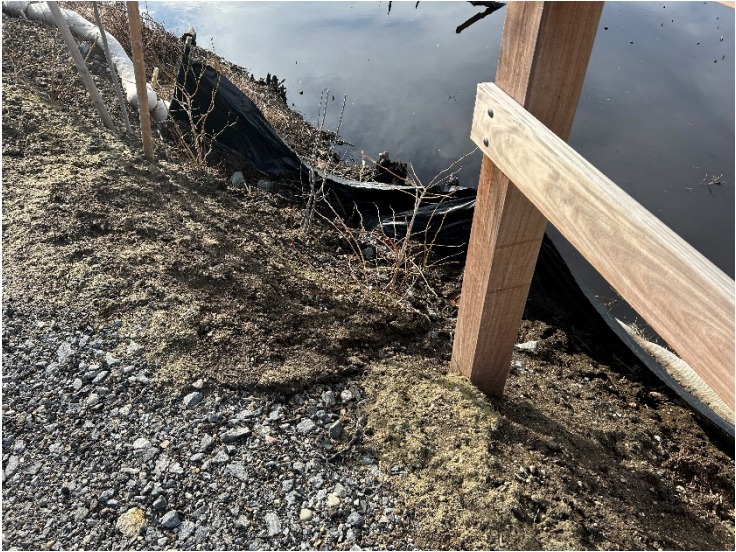
Epsilon ASSOCIATES INC.		PHOTOGRAPHIC LOG	
Client Name: Eversource		Site Location: Sudbury to Hudson Transmission Reliability Project	Town: Hudson
Photo No.: 3	Date: 3-18-2025

Description: View of rill erosion at the southeast corner of bridge 130. Facing southeast.

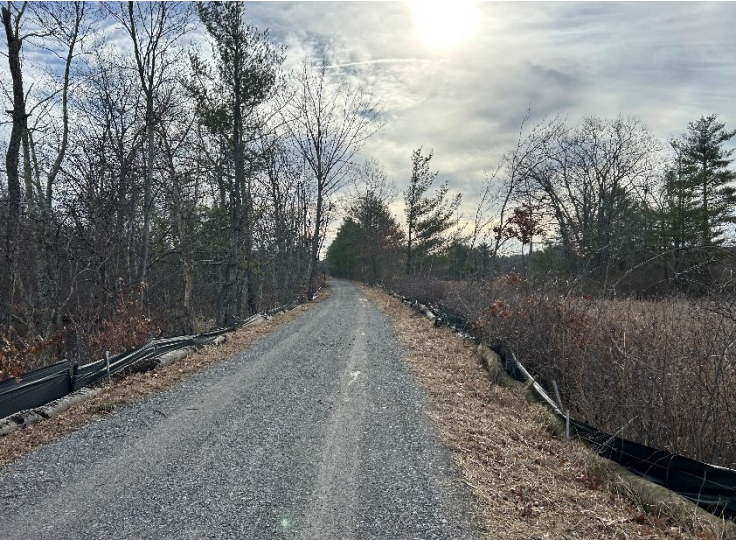
Epsilon ASSOCIATES INC.		PHOTOGRAPHIC LOG	
Client Name: Eversource		Site Location: Sudbury to Hudson Transmission Reliability Project	Town: Hudson
Photo No.: 4	Date: 3-18-2025

14. Rock lined swale & rock check dams within segment 3	<input type="checkbox"/> Yes <input checked="" type="checkbox"/> No	N/A	<input type="checkbox"/> Yes <input checked="" type="checkbox"/> No	N/A	Rock lined swale & check dams installed and operating properly within segment 3.

Description: View of E&S controls in segment 3. Facing east.

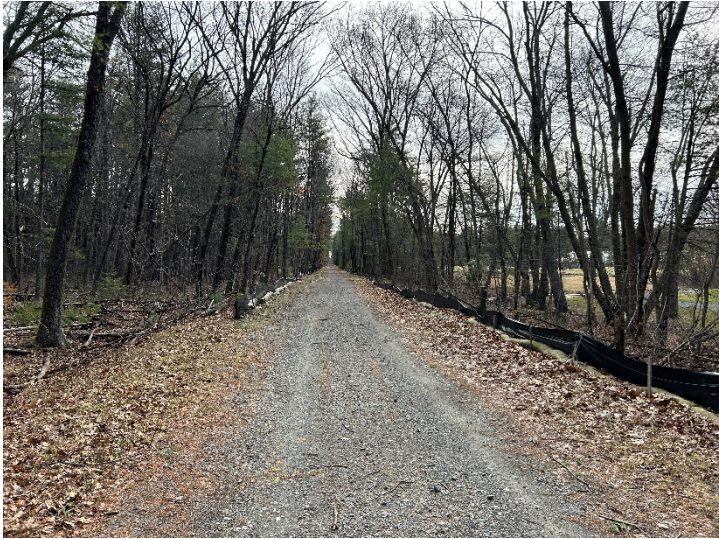
Epsilon ASSOCIATES INC.		PHOTOGRAPHIC LOG	
Client Name: Eversource		Site Location: Sudbury to Hudson Transmission Reliability Project	Town: Hudson
Photo No.: 5	Date: 3-18-2025

15. Rock check dams within segment 4	<input type="checkbox"/> Yes <input checked="" type="checkbox"/> No	N/A	<input type="checkbox"/> Yes <input checked="" type="checkbox"/> No	N/A	Rock check dams installed and operating properly within segment 4.

Description: View of E&S controls in segment 4. Facing east.

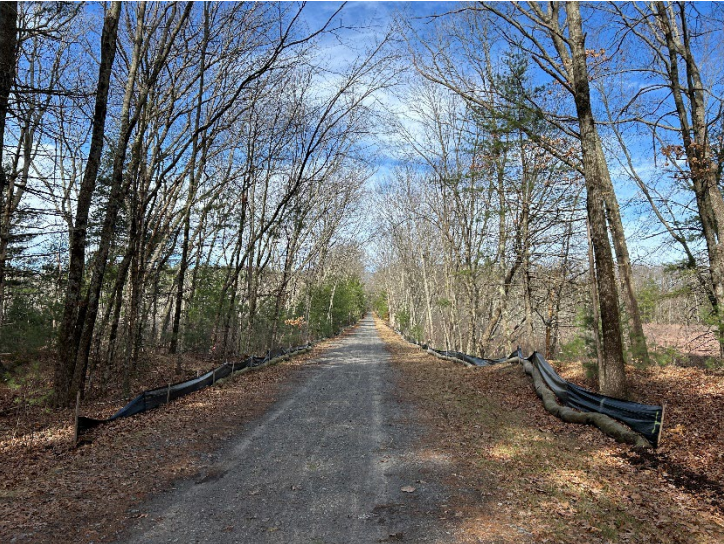
Epsilon ASSOCIATES INC.		PHOTOGRAPHIC LOG	
Client Name: Eversource		Site Location: Sudbury to Hudson Transmission Reliability Project	Town: Hudson
Photo No.: 6	Date: 3-18-2025

16. Rock lined swale & rock check dams within segment 5	<input type="checkbox"/> Yes <input checked="" type="checkbox"/> No	N/A	<input type="checkbox"/> Yes <input checked="" type="checkbox"/> No	N/A	Rock lined swale & check dams installed and operating properly within segment 5.

Description: View of E&S controls in segment 5. Facing west.

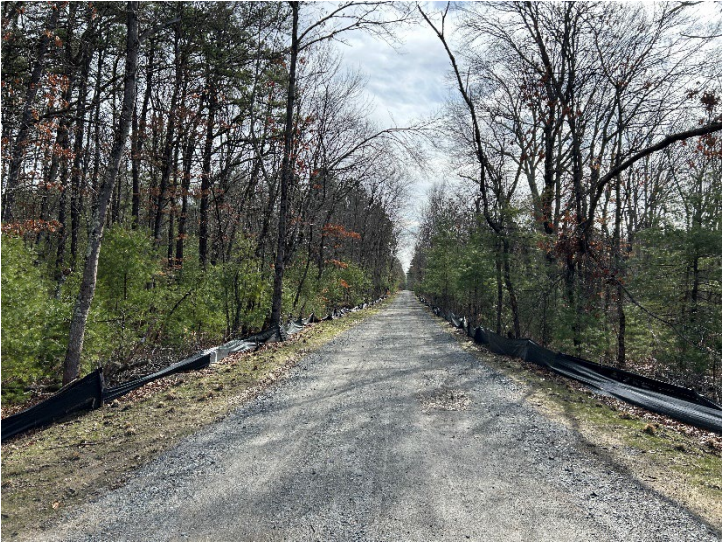
Epsilon ASSOCIATES INC.		PHOTOGRAPHIC LOG	
Client Name: Eversource		Site Location: Sudbury to Hudson Transmission Reliability Project	Town: Hudson
Photo No.: 7	Date: 3-18-2025

17. Swale & rock check dams within segment 6	<input type="checkbox"/> Yes <input checked="" type="checkbox"/> No	N/A	<input type="checkbox"/> Yes <input checked="" type="checkbox"/> No	N/A	Swale & check dams installed and operating properly within segment 6.
If the same routine maintenance was found to be necessary three or more times for the same control at the same location (including this occurrence), follow the corrective action requirements and record the required information in your corrective action log, or describe here why you believe the specific condition should still be addressed as routine maintenance:

Description: View of E&S controls in segment 6. Facing east.

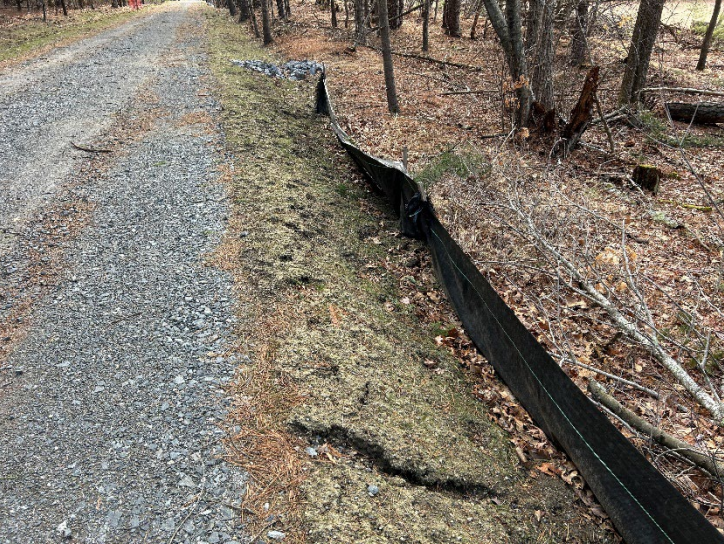
Epsilon ASSOCIATES INC.		PHOTOGRAPHIC LOG	
Client Name: Eversource		Site Location: Sudbury to Hudson Transmission Reliability Project	Town: Hudson
Photo No.: 8	Date: 3-18-2025

Description: View of rill erosion in segment 6 near station 347. Facing east.

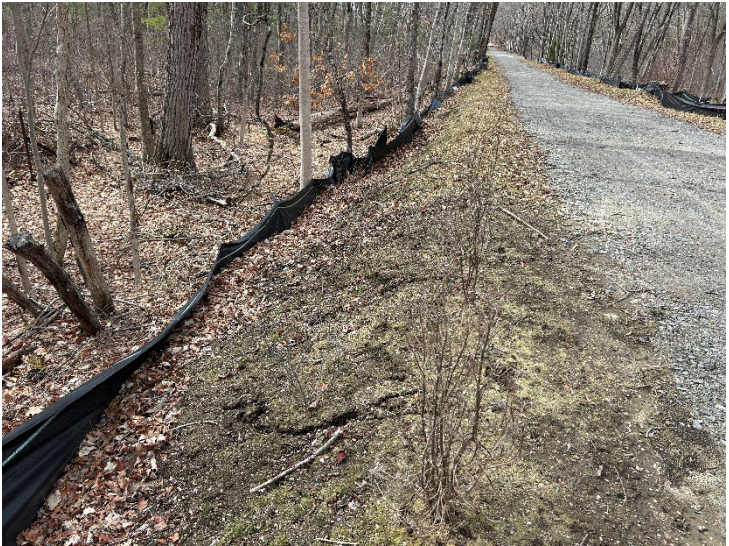
PHOTOGRAPHIC LOG	
Client Name: Eversource		Site Location: Sudbury to Hudson Transmission Reliability Project	Town: Sudbury
Photo No.: 2	Date: 3-18-2025

-Rill erosion noted around bridge 128, in segment 12 near Union Ave, and on the hydroseeded slope between approximately Station 738+00 and 741+00 in segment 14.

Description: View of rill erosion on the hydroseeded slope between approximately Station 738+00 and 741+00 in segment 14. Facing west.

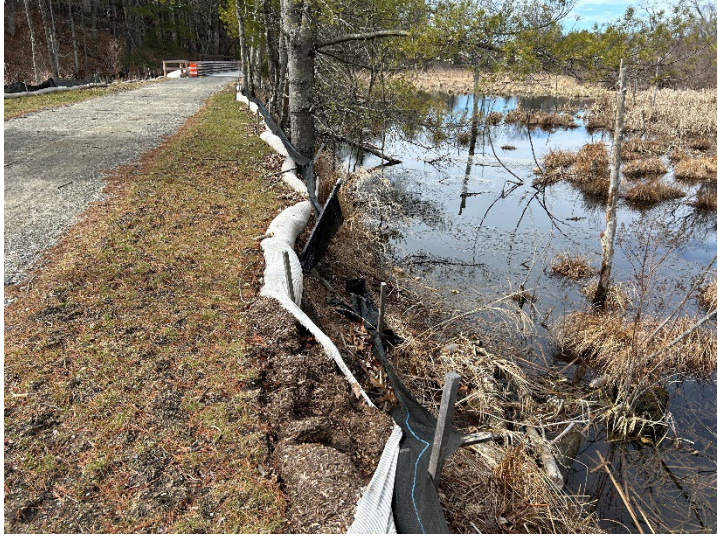
Epsilon ASSOCIATES INC.		PHOTOGRAPHIC LOG	
Client Name: Eversource		Site Location: Sudbury to Hudson Transmission Reliability Project	Town: Sudbury
Photo No.: 3	Date: 3-18-2025

Description: View of damaged E&S controls near bridge 127 in segment 14. Facing west.

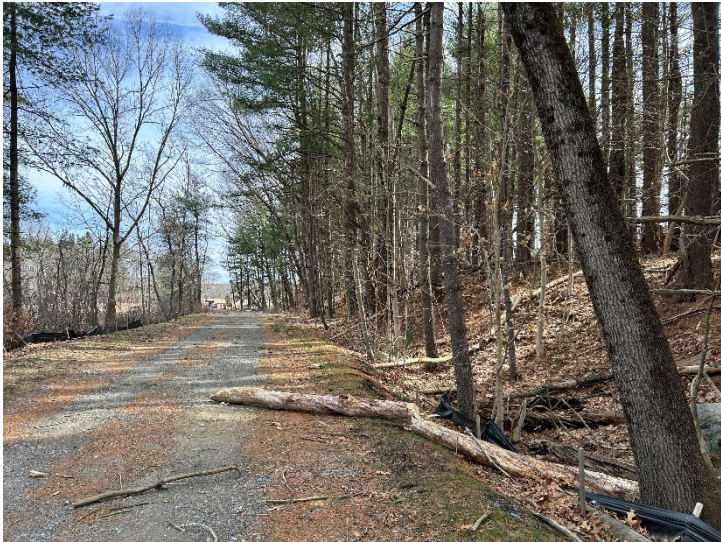
Epsilon ASSOCIATES INC.		PHOTOGRAPHIC LOG	
Client Name: Eversource		Site Location: Sudbury to Hudson Transmission Reliability Project	Town: Sudbury
Photo No.: 4	Date: 3-18-2025

Description: View of fallen tree in segment 13. Facing east.

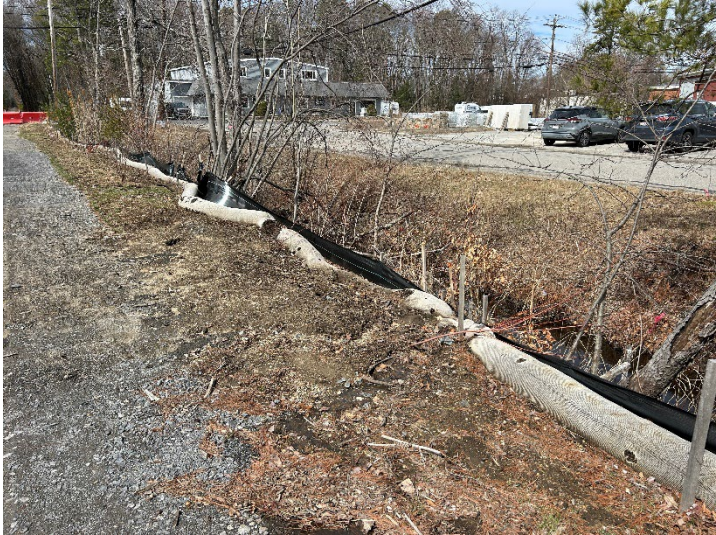
Epsilon ASSOCIATES INC.		PHOTOGRAPHIC LOG	
Client Name: Eversource		Site Location: Sudbury to Hudson Transmission Reliability Project	Town: Sudbury
Photo No.: 5	Date: 3-18-2025

Description: View of rill erosion in segment 12 near Union Ave. Facing northwest.

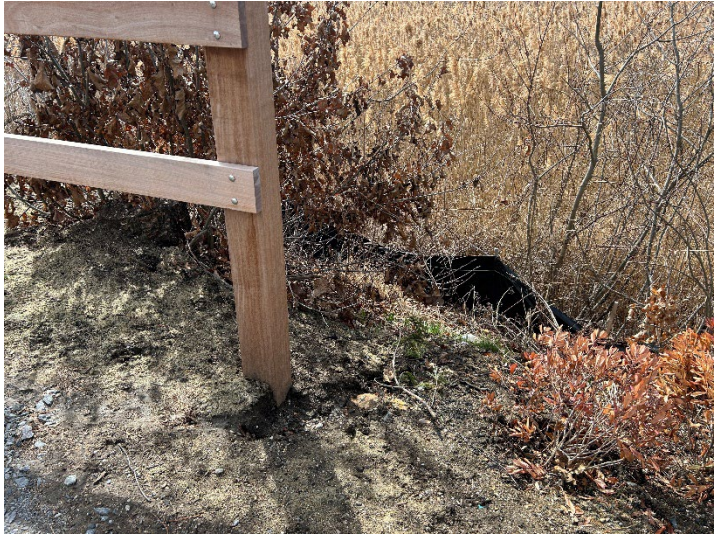
Epsilon ASSOCIATES INC.		PHOTOGRAPHIC LOG	
Client Name: Eversource		Site Location: Sudbury to Hudson Transmission Reliability Project	Town: Sudbury
Photo No.: 6	Date: 3-18-2025

Description: View of rill erosion at the southwest corner of bridge 128. Facing south.

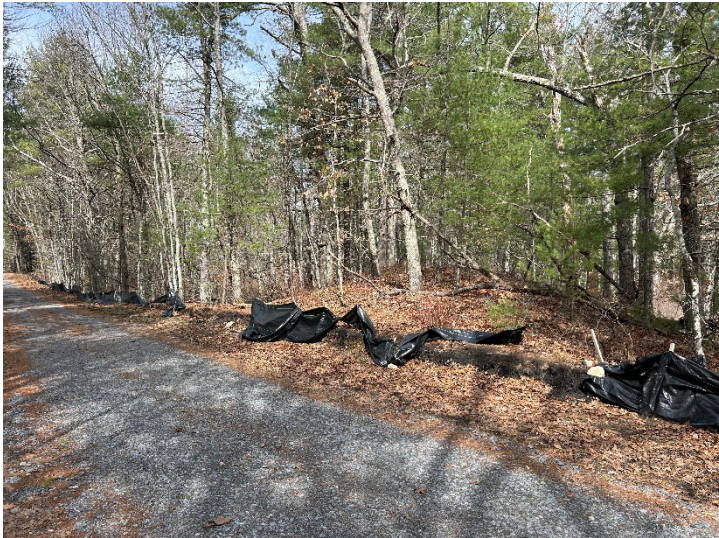
Epsilon ASSOCIATES INC.		PHOTOGRAPHIC LOG	
Client Name: Eversource		Site Location: Sudbury to Hudson Transmission Reliability Project	Town: Sudbury
Photo No.: 7	Date: 3-18-2025

Description: View of damaged silt fence at approximately station 409+50 in segment 8. Facing northwest.

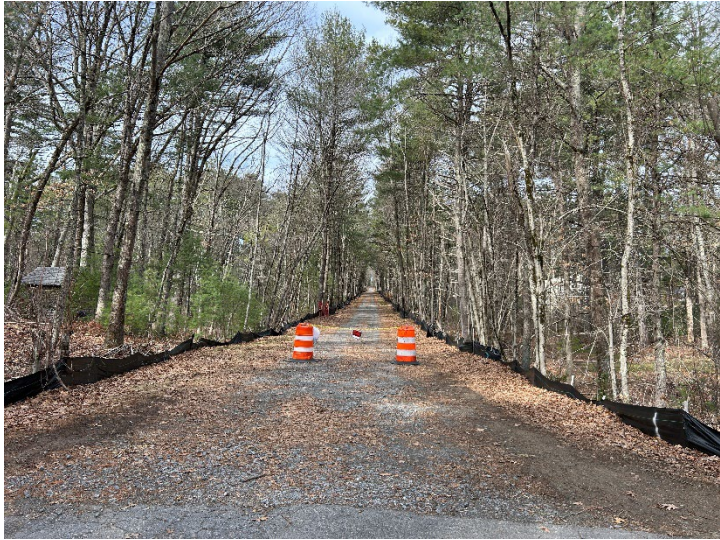
Epsilon ASSOCIATES INC.		PHOTOGRAPHIC LOG	
Client Name: Eversource		Site Location: Sudbury to Hudson Transmission Reliability Project	Town: Sudbury
Photo No.: 8	Date: 3-18-2025

Description: View of E&S controls in segment 9. Facing west.
