**Sudbury to Hudson TRP Week of 3/24/2025**

**Epsilon Team Full SWPPP Inspection Report(s)**

# CONSTRUCTION MONITORING REPORT

## Sudbury to Hudson Transmission Project

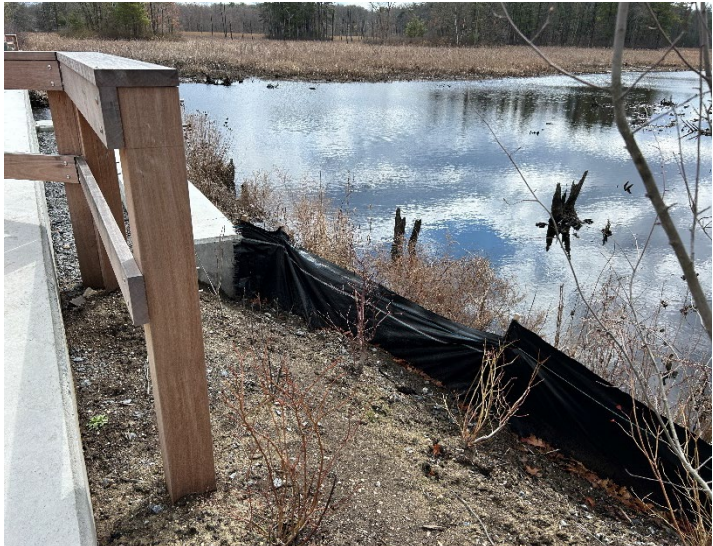
<b>PHOTOGRAPHIC LOG</b>	
<b>Client Name:</b> Eversource		<b>Site Location:</b> Sudbury to Hudson Transmission Reliability Project	<b>Town:</b> Hudson
<b>Photo No.:</b> 2	<b>Date:</b> 3-25-2025

<b>Description:</b> View of repaired silt fence at bridge 130. Repairs were made on 3/21/25. Facing southeast.

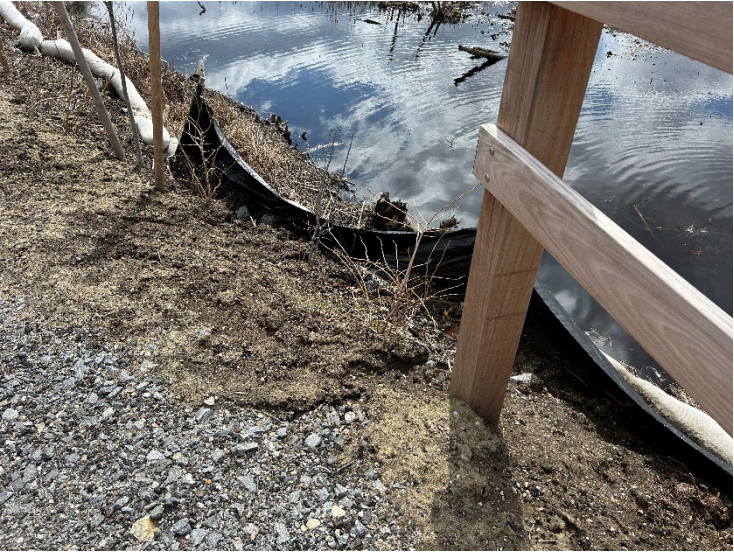
<b>Epsilon</b> ASSOCIATES INC.		<b>PHOTOGRAPHIC LOG</b>	
Client Name: Eversource		Site Location: Sudbury to Hudson Transmission Reliability Project	Town: Hudson
Photo No.: 3	Date: 3-25-2025

<b>Description:</b> View of rill erosion at the southeast corner of bridge 130. Facing southeast.

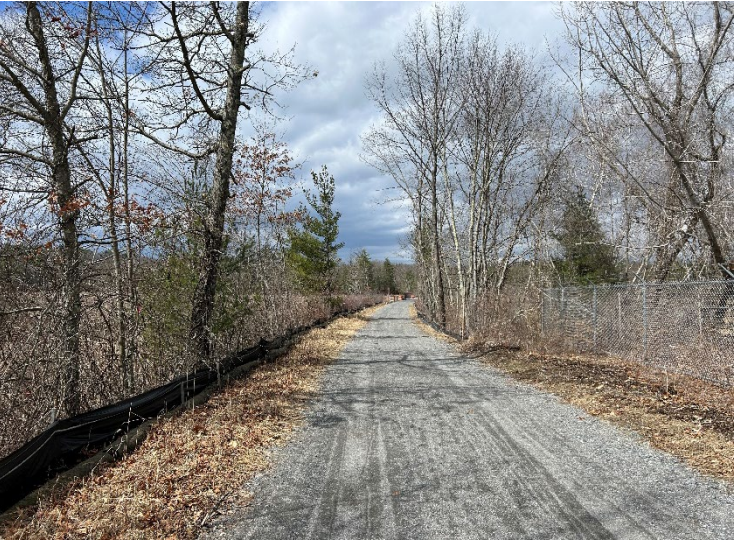
<b>Epsilon</b> ASSOCIATES INC.		<b>PHOTOGRAPHIC LOG</b>	
Client Name: Eversource		Site Location: Sudbury to Hudson Transmission Reliability Project	Town: Hudson
Photo No.: 4	Date: 3-25-2025

<b>Description:</b> View of E&S controls in segment 3. Facing west.

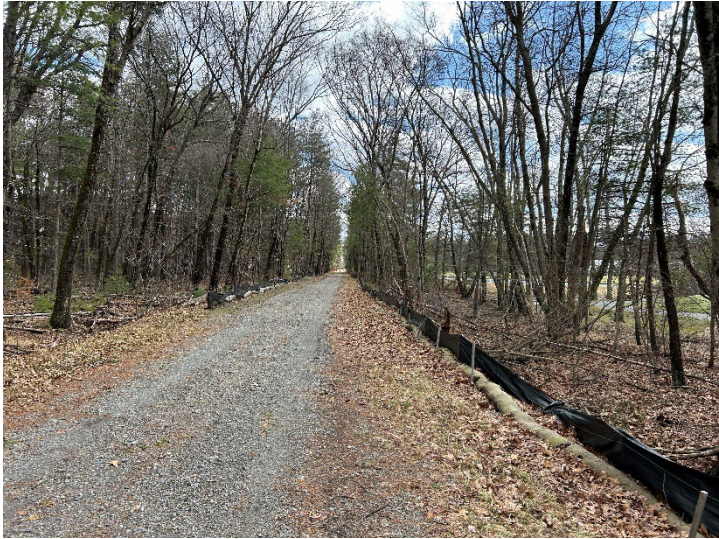
<b>Epsilon</b> ASSOCIATES INC.		<b>PHOTOGRAPHIC LOG</b>	
<b>Client Name:</b> Eversource		<b>Site Location:</b> Sudbury to Hudson Transmission Reliability Project	<b>Town:</b> Hudson
<b>Photo No.:</b> 5	<b>Date:</b> 3-25-2025

<b>Description:</b> View of E&S controls in segment 4. Facing east.

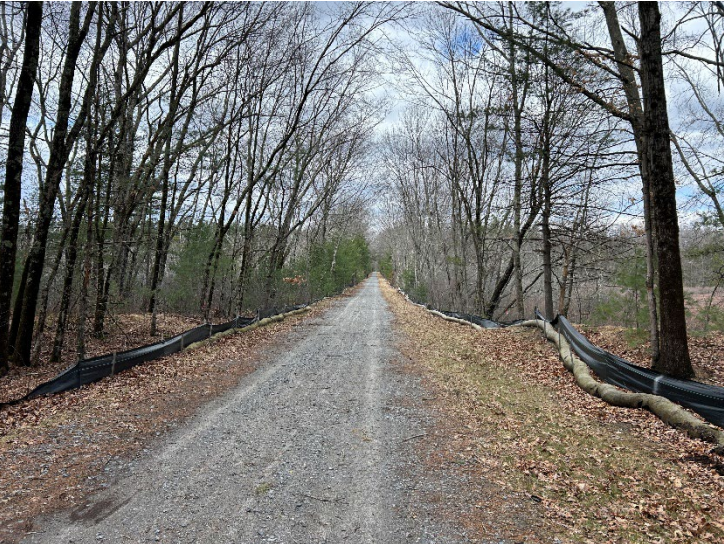
<b>Epsilon</b> ASSOCIATES INC.		<b>PHOTOGRAPHIC LOG</b>	
<b>Client Name:</b> Eversource		<b>Site Location:</b> Sudbury to Hudson Transmission Reliability Project	<b>Town:</b> Hudson
<b>Photo No.:</b> 6	<b>Date:</b> 3-25-2025

<b>Description:</b> View of E&S controls in segment 5. Facing west.

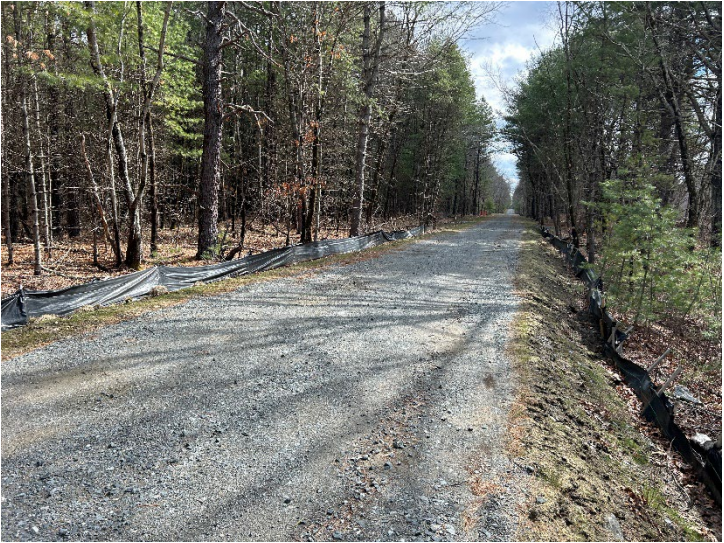
<b>Epsilon</b> ASSOCIATES INC.		<b>PHOTOGRAPHIC LOG</b>	
Client Name: Eversource		Site Location: Sudbury to Hudson Transmission Reliability Project	Town: Hudson
Photo No.: 7	Date: 3-25-2025

Description: View of E&S controls in segment 6. Facing east.

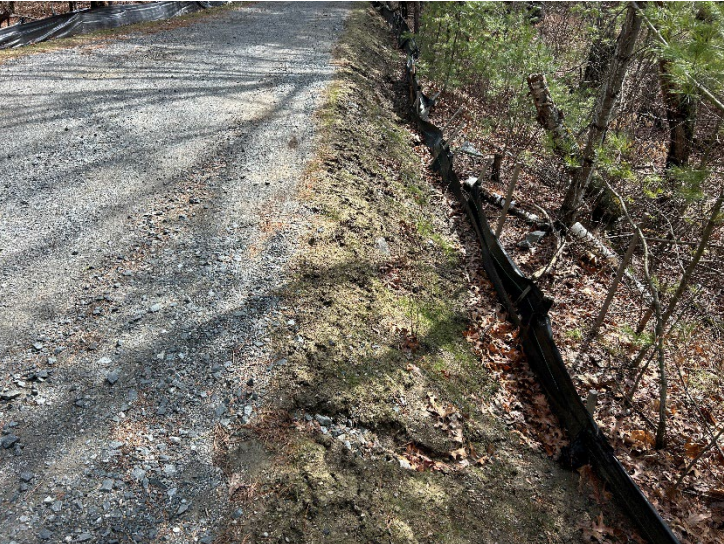
<b>Epsilon</b> ASSOCIATES INC.		<b>PHOTOGRAPHIC LOG</b>	
Client Name: Eversource		Site Location: Sudbury to Hudson Transmission Reliability Project	Town: Hudson
Photo No.: 8	Date: 3-25-2025

Description: View of rill erosion in segment 6 near station 347. Facing east.

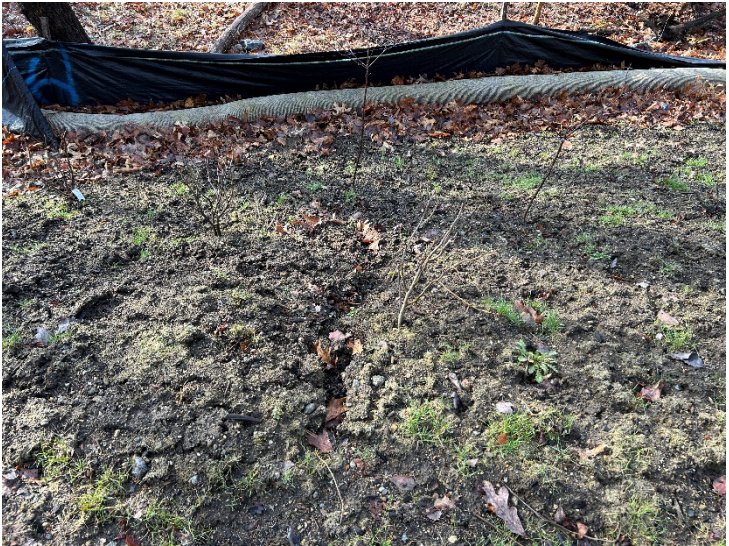
<b>PHOTOGRAPHIC LOG</b>	
Client Name: Eversource		Site Location: Sudbury to Hudson Transmission Reliability Project	Town: Sudbury
Photo No.: 2	Date: 3-25-2025

-Rill erosion noted around bridge 128, in segment 12 near Union Ave, and on the hydroseeded slope between approximately Station 738+00 and 741+00 in segment 14.

<b>Description:</b> View of rill erosion on the hydroseeded slope between approximately Station 738+00 and 741+00 in segment 14. Facing south.

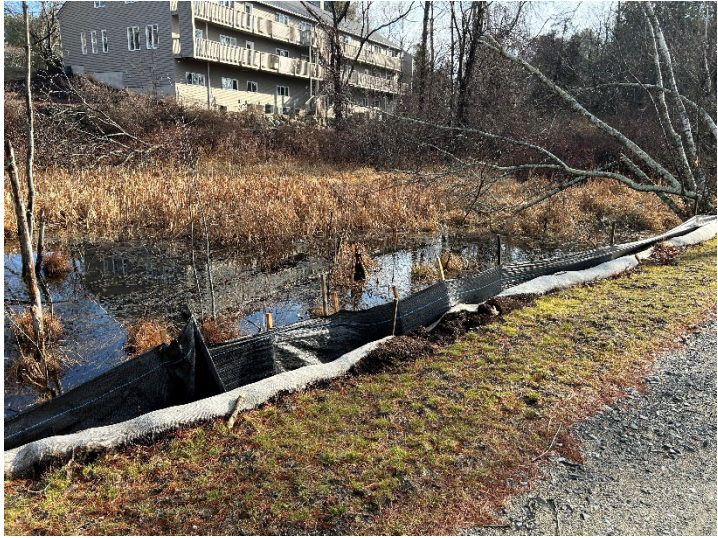
<b>Epsilon</b> ASSOCIATES INC.		<b>PHOTOGRAPHIC LOG</b>	
Client Name: Eversource		Site Location: Sudbury to Hudson Transmission Reliability Project	Town: Sudbury
Photo No.: 3	Date: 3-25-2025

-Damaged silt fence in segment 8 at approximately station 409+50, in segment 14 at the wetland replication area, at approximately station 749, station 745+50, and near bridge 127, north side of the work area were repaired on 3/21/25.

<b>Description:</b> View of repaired silt fence near bridge 127 in segment 14. Repairs were made on 3/21/25. Facing northeast.

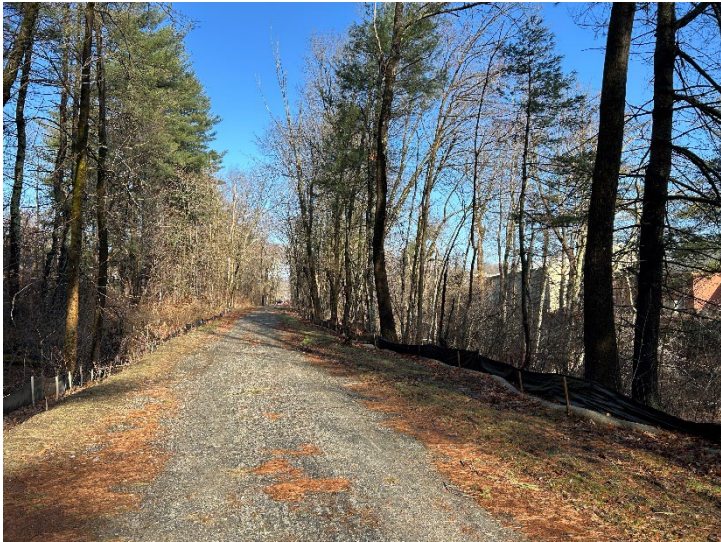
<b>Epsilon</b> ASSOCIATES INC.		<b>PHOTOGRAPHIC LOG</b>	
Client Name: Eversource		Site Location: Sudbury to Hudson Transmission Reliability Project	Town: Sudbury
Photo No.: 4	Date: 3-25-2025

<b>Description:</b> View of E&S controls in segment 13. Facing west.

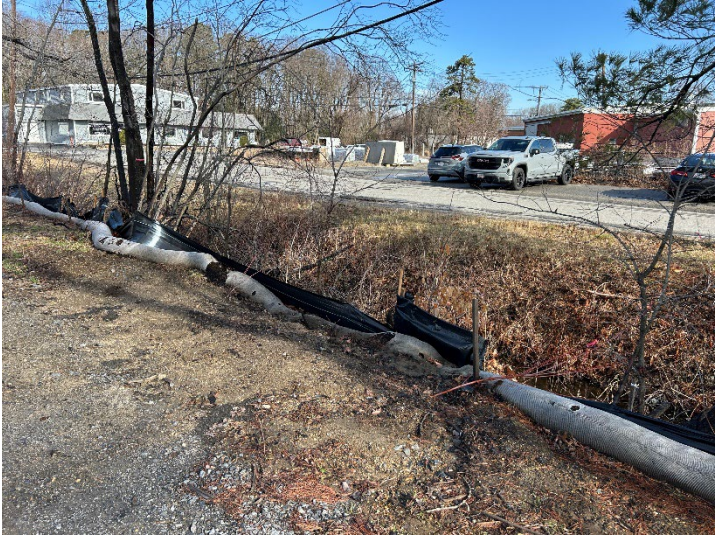
<b>Epsilon</b> ASSOCIATES INC.		<b>PHOTOGRAPHIC LOG</b>	
Client Name: Eversource		Site Location: Sudbury to Hudson Transmission Reliability Project	Town: Sudbury
Photo No.: 5	Date: 3-25-2025

<b>Description:</b> View of rill erosion in segment 12 near Union Ave. Silt fence has been reinforced in this area. Facing northwest.

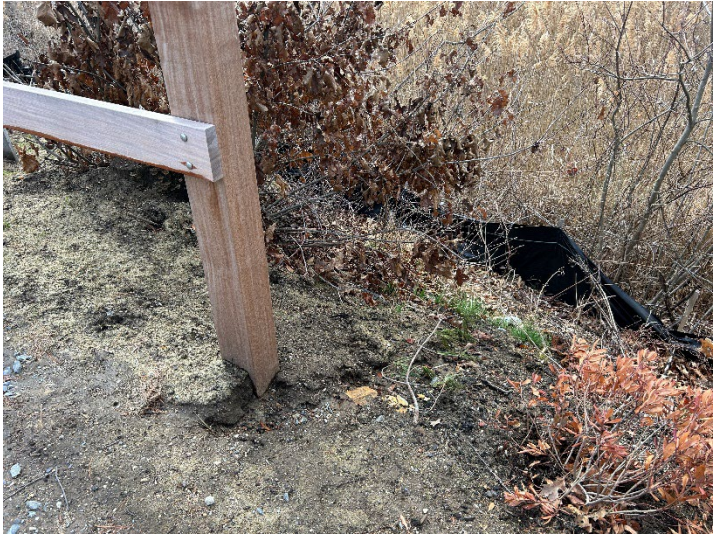
<b>Epsilon</b> ASSOCIATES INC.		<b>PHOTOGRAPHIC LOG</b>	
Client Name: Eversource		Site Location: Sudbury to Hudson Transmission Reliability Project	Town: Sudbury
Photo No.: 6	Date: 3-25-2025

<b>Description:</b> View of rill erosion at the southwest corner of bridge 128. Facing south.

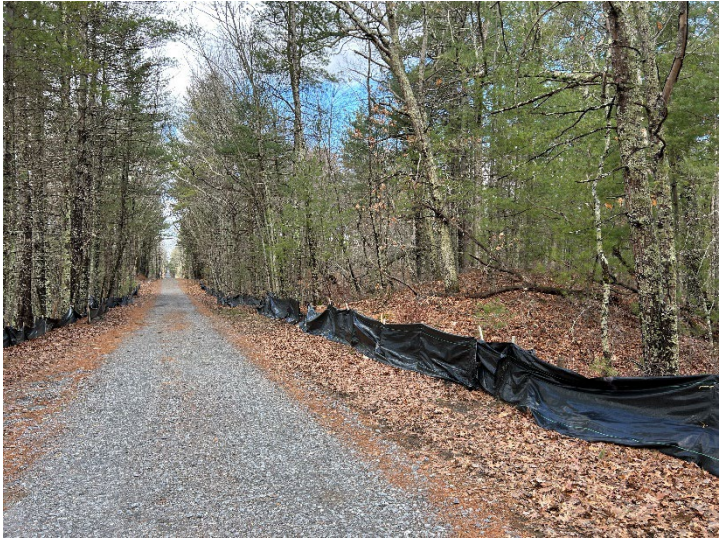
<b>Epsilon</b> ASSOCIATES INC.		<b>PHOTOGRAPHIC LOG</b>	
Client Name: Eversource		Site Location: Sudbury to Hudson Transmission Reliability Project	Town: Sudbury
Photo No.: 7	Date: 3-25-2025

<b>Description:</b> View of repaired silt fence at approximately station 409+50 in segment 8. Repairs were made on 3/21/25. Facing northwest.

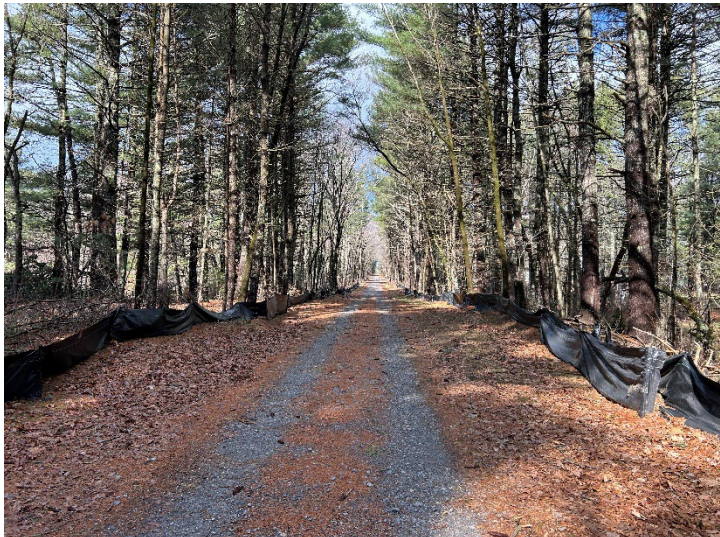
<b>Epsilon</b> ASSOCIATES INC.		<b>PHOTOGRAPHIC LOG</b>	
Client Name: Eversource		Site Location: Sudbury to Hudson Transmission Reliability Project	Town: Sudbury
Photo No.: 8	Date: 3-25-2025

<b>Description:</b> View of E&S controls in segment 9. Facing west.
