CONSTRUCTION MONITORING REPORT Sudbury to Hudson Transmission Project

☐ Weekly ☐ Storm Event ☐ Other Date: 4-1-2025 Time: 12:00pm-2:45pm	Project Name:
Inspector name(s), title(s), and qualifications: Gabriella Suazo (SWCA), Compliance Monitor, QCIS, QPSWPPP, EPA CGP Certified	Sudbury to Hudson Transmission Reliability
Others present/affiliation(s): N/A	Project
Precipitation/Weather (since last inspection): Mixed, 20s-60s	Project Location:
Weather conditions (time of inspection & future outlook): Partly cloudy, 40s	Sudbury, Hudson, Stow, and Marlborough, MA
Inspection Location Description (include segment # and stationing): Segments 1-6 & MHs #1-4 on Wilkins and Forest Ave (Hudson)	USEPA#:
*Storm event info (approx):Start date/time:3/31 @11:50pm Duration:3hrs Amount of rainfall (inches):0.59"	MAR1003UW
Summary of Activities/Locations Inspected (include segment # and stationing): Eversource conducting drone survey in segment 6. ET&L placing stakes in segment 5. All E&S controls	n in Hudoon increated

☐ Weekly ☑ Storm Event ☐ Other	Date: 4-1-2025 Time: 9:00am-12:00pm		Project Name:		
Inspector name(s), title(s), and qualifications: Gab	Sudbury to Hudson				
QPSWPPP, EPA CGP Certified

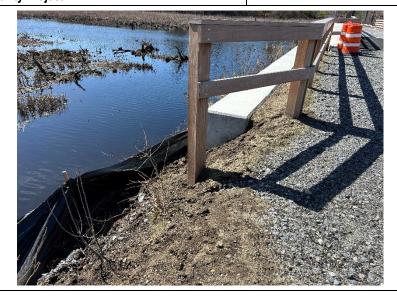
Photo No.: 3

-Rain gauge onsite only collected a trace amount of liquid, but multiple online precipitation data source show approximately 0.74" of rain for the area on 3/24/2025.	Authorized Signature
-Rill erosion noted at bridge 130 and near Station 347 in segment 6. Scheduled to be repaired 4/04/2025	. Date
-Multiple trees/limbs have fallen in segment 4.	4/1/2025
EVERSOURCE PROJECT MANAGER ENVIRONMENTAL CONSULTANT PRIME CON	TRACTOR (BOND)

View of rill erosion at the southeast corner of bridge 130. Facing southwest.

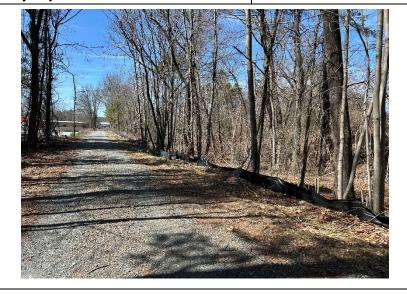
View of E&S controls in segment 3. Facing west.

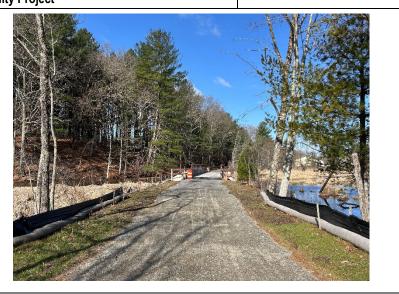
View of bridge 127 from segment 14. Facing west.

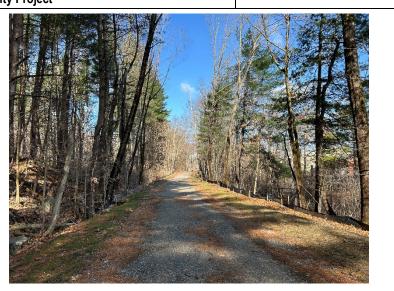
View of E&S controls in segment 13. Facing west.

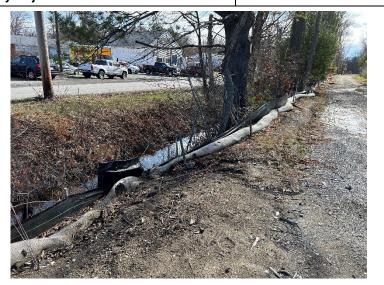
View of rill erosion in segment 12 near Union Ave. Silt fence has been reinforced in this area. Facing east.

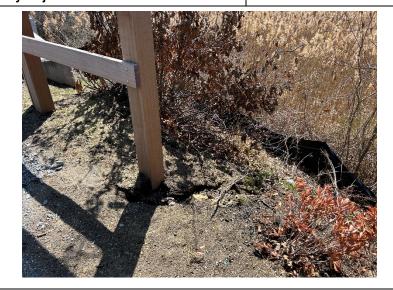
View of rill erosion at the southwest corner of bridge 128. Facing south.

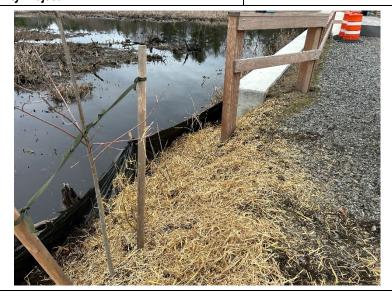
View of repaired rill erosion at the southeast corner of bridge 130. Facing southwest.

Bond repairing silt fence and erosion at Bridge 130 and in segment 6. All E&S controls in Hudson inspect	ted.					
Inspection Notes:						
Any Significant Discharges of Sediment (or other) or Non-Compliance Actions? ☐ Yes ☐ No						
Identify presence of stockpiles and document when placed and when removed (week maximum for stockpiles)	☐ Yes					
Compliance with Previous Observations? \boxtimes Yes \square No						
New Corrective Action Recommendations? ☐ Yes						
New Routine Maintenance Recommendations? $\ \square$ Yes $\ \boxtimes$ No						
ENVIRONMENTAL COMPLIANCE						
Compliant with applicable permits and applicable environmental requirements? $\ oxtimes$ Yes $\ oxtimes$ No $\ \ $ If not, explain:						
Other Comments & Observations						
-This SWPPP inspection covers Segments 1-6 & MHs #1-4 on Wilkins and Forest Ave (Hudson). Balance						
of SWPPP inspection- Segments 7-14 and Sudbury Substation reported separately.	Oppor

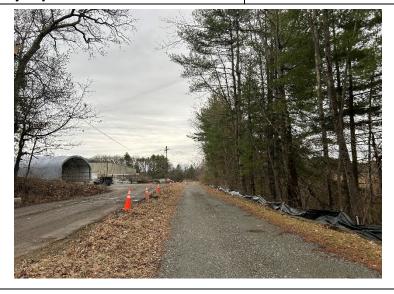
View of E&S controls in segment 3. Facing east.

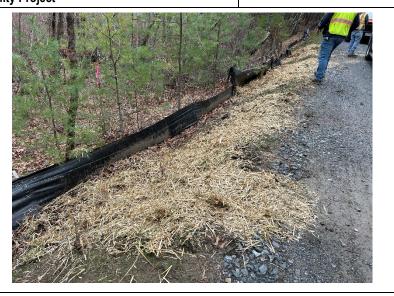
View of repaired rill erosion in segment 6 near station 347. Facing southwest.

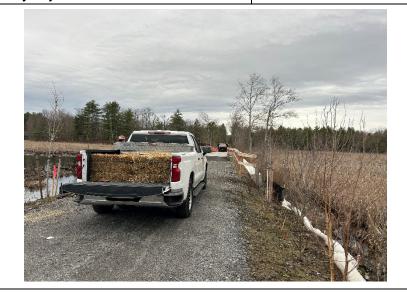
View of Bond working at Bridge 130. Facing west.

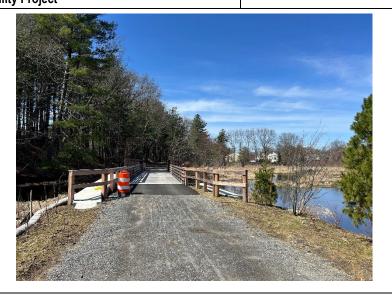
View of bridge 127 from segment

14. Facing west.

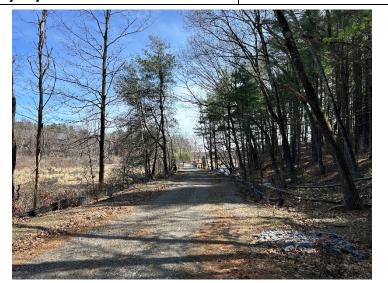
View of E&S controls in segment

13. Facing east.

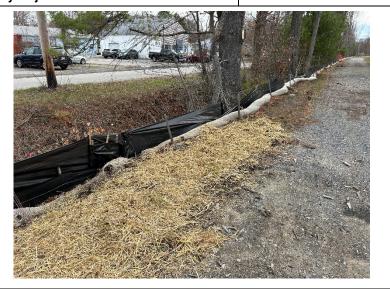
Photo No.: 5

View of repaired rill erosion and reinforced silt fence in segment 12 near Union Ave. Facing east.

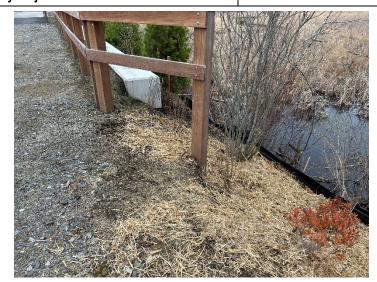
View of repaired rill erosion at the southwest corner of bridge 128. Facing southeast.
