Environmental Monitor Construction Site Inspection Report MassDOT Project #608164 Construction Contract # 119678 EM Report #52						
Project Description: Bruce Freeman Rail Trail Right-of-Way Permit Description(s): Order of Conditions (MGL Chapter 131, Section 40 and 310 CMR 10.00, Mass DEP File No. 301-1362); 2022 EPA NPDES General Permit for Discharges from Construction Areas; U.S. Army Corps of Engineers Permit No NAE-2021-01975.

I. General Project Information						
Project Name:	Bruce Freeman Rail Trail - Phase 2d - Sudbury					
Date of Inspections:	4/21/2025					
Bi Weekly/ Monthly Period Covered:	April Weekly Inspection #4					
Inspector's Name(s):	Anna Haznar					
Inspectors' Contact Information:	ahaznar@beta-inc.com					
II. Weather Information						
	Inspection #1	Inspection #2	Inspection #3	Inspection #4	Inspection #5	Inspection #6
WeatherUnderground	Inspector: Anna Haznar 4/2/2025	Inspector: Anna Haznar 4/7/2025	Inspector: Anna Haznar 4/14/2025	Inspector: Anna Haznar 4/21/2025	Inspector:	Inspector:
Type of Inspection (i.e. non-storm event, pre-storm event, during-storm event or post-storm event):	Post-storm	Post-storm	Post-storm	Non-storm		
Number of days since last rai

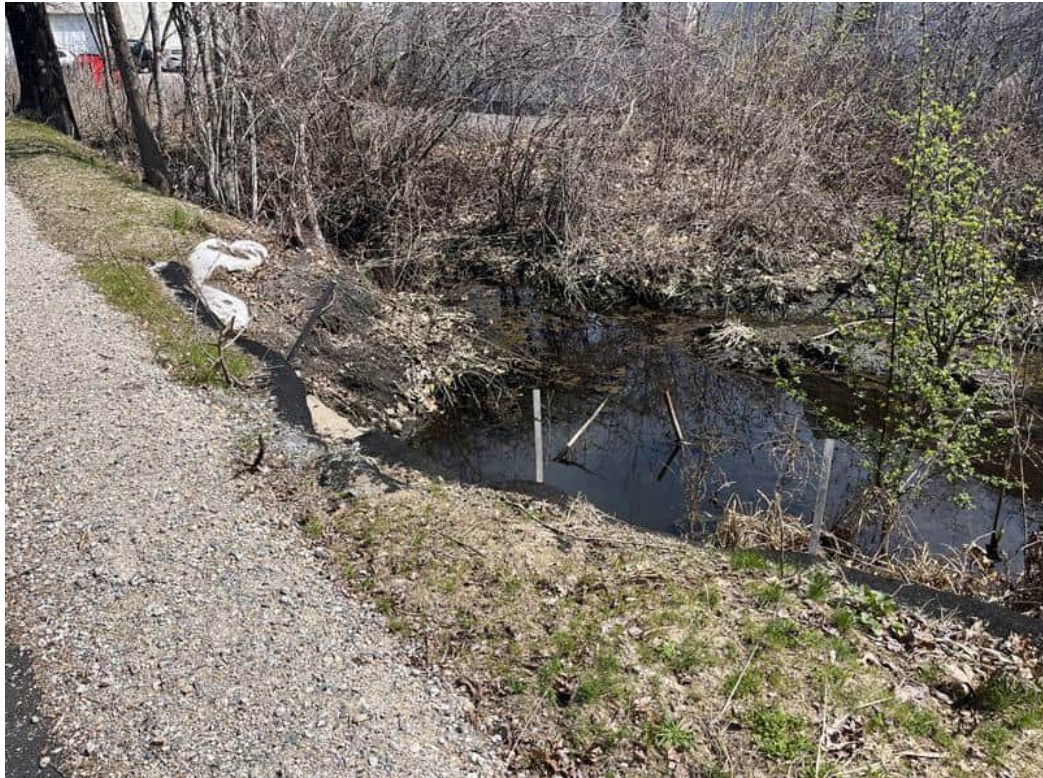
Site Location		Bruce Freeman Rail Trail Right-of-Way	BETA Project No. 24.10326.23
Photo No. 1	Date: 4/21/2025

43	<p>Overtopped compost filter tubes and exposed soils beyond the limits of work at Station 105+00</p> <p>Priority: High</p>	6/7/2024	6/14/2024	<p>Stabilize the area with the approved seed mixture and provide interim stabilization such as straw mulch.</p>	<p>6/14/2024 - Observation remains.</p> <p>6/17/2024 - Observation remains.</p> <p>6/24/2024 - Observation remains.</p> <p>6/27/2024 - Observation remains.</p> <p>7/8/2024 - Observation remains.</p> <p>7/15/2024 - Observation remains.</p> <p>7/22/2024 - Observation remains.</p> <p>7/29/2024 - Observation remains.</p> <p>8/5/2024 - Observation remains.</p> <p>8/7/2024 - Observation remains.</p> <p>8/12/2024 - Observation remains. Some material has migrated off of the compost filter tubes due to erosion.</p> <p>8/16/2024 - Observation remains.</p> <p>8/20/2024 - Application of the approved seed mixture is required at this location.</p> <p>8/27/2024 - Observation remains.</p> <p>9/3/2024 - Observation remains.</p> <p>9/10/2024 - Observation remains. Application of the approved seed mixture is required at this location.</p> <p>9/16/2024 - Observation remains.</p> <p>9/23/2024 - Observation remains.</p> <p>9/27/2024 - Observation remains.</p> <p>10/4/2024 - Hydroseed has been applied here; however, the contractor should provide an update on long-term slope stabilization plans.</p> <p>10/8/2024 - Observation remains. Germination has not been observed.</p> <p>10/15/2024 - Observation remains. Germination has not been observed.</p> <p>10/22/2024 - Observation remains. Some germination has been observed but the area is not considered stabilized.</p> <p>10/29/2024 - Observation remains. No further germination has been observed since the last inspection.</p> <p>11/5/2024 - Observation remains. Some germination has been observed but the area is not considered stabilized.</p> <p>11/12/2024 - Observation remains. Seed has stabilized the area.</p> <p>11/19/2024 - The area adjacent to the path has become stabilized; however, exposed soil is still present next to the culvert past the limit of work.</p> <p>11/22/2024 - Observation remains. See previous update.</p> <p>11/25/2024 - Observation remains. See update from 11/19/2024.</p> <p>12/2/2024 - Observation remains. See update from 11/19/2024.</p> <p>12/6/2024 - Observation remains. See update for 11/19/2024.</p> <p>12/12/2024 - Observation remains. See update from 11/19/2024.</p> <p>12/20/2024 - Observation remains. See update from 11/19/2024.</p> <p>12/26/2024 - Observation remains. See update from 11/19/2024.</p> <p>12/31/2024 - Observation remains. See update from 11/19/2024.</p> <p>1/2/2025 - Observation remains. See update from 11/19/2024.</p> <p>1/9/2025 - Observation remains. See update from 11/19/2024.</p> <p>1/15/2025 - Observation remains. Exposed soils are still present next to the culvert past the limits of work.</p> <p>1/23/2025 - Observation remains. See previous update.</p> <p>1/30/2025 - Observation remains. Exposed soils are present next to the culvert past the limits of work.</p> <p>2/4/2025 - Observation remains. Exposed soils are present next to the culvert past the limits of work.</p> <p>2/11/2025 - Observation remains. Exposed soils past the limits of work are currently frozen and covered with snow.</p> <p>4/2/2025 - Observation remains. Exposed soil past the limits of work is present and requires further stabilization.</p> <p>4/7/2025 - Observation remains. See previous update.</p> <p>4/14/2025 - Observation remains. Exposed soil past the limits of work is present and requires further stabilization.</p> <p>4/21/2025 - Observation remains. Exposed soil past the limits of work is present and requires further stabilization.</p>

Direction Photo Taken: Toward the North			
Description: View of the location of the overtopped compost filter tube and exposed soils beyond the limits of work at Station 105+00 per Compliance Action Item 43.			
Photo No. 2	Date: 4/21/2025

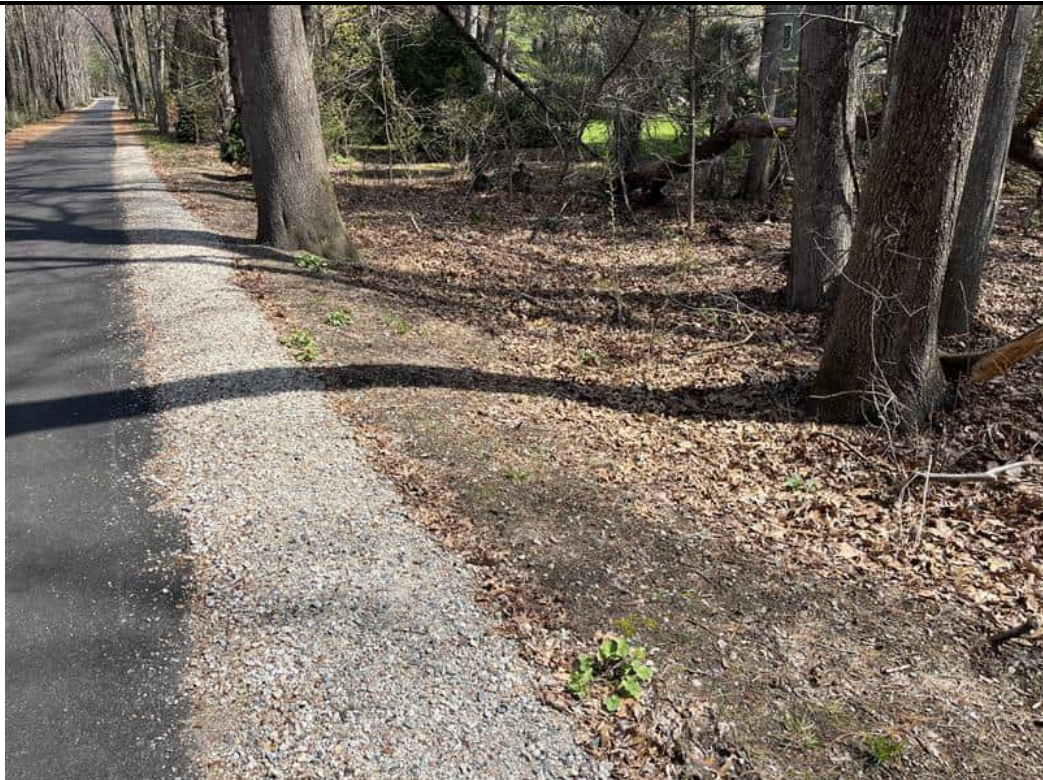
Item	Location/ Description	Observation Date	Resolution Due Date	Recommended/Discussed Resolution	Comments/Updates
61	Invasive/ non-native vegetation including Japanese knotweed (<i>Reynoutria japonica</i>), bittersweet (<i>Celastrus orbiculatus</i>), bush honeysuckle (<i>Lonicera spp.</i>), burning bush (<i>Euonymus alatus</i>), purple loosestrife (<i>Lythrum salicaria</i>), glossy buckthorn (<i>Frangula alnus</i>) and garlic mustard (<i>Alliaria petiolata</i>) have been observed throughout the path. Priority: High	10/22/2024	10/29/2024	Invasive Species should be removed by manual and/or chemical removal methods	<p>10/29/2024 - Invasive species are present throughout the trail both within upland and Resource Areas. Populations of glossy buckthorn and purple loosestrife are present within the wetland replication area.</p> <p>11/5/2024 - Observation remains. See update from 10/29/2024.</p> <p>11/12/2024 - Observation remains. Invasive species are still present throughout the trail. Some invasives have been observed with no leaves due to winter die back.</p> <p>11/19/2024 - Observation remains. Further invasive species management will be required during the next growing season.</p> <p>11/22/2024 - Observation remains.</p> <p>11/25/2024 - Observation remains.</p> <p>12/2/2024 - Observation remains.</p> <p>12/6/2024 - Observation remains. This action item has been moved to the Long-Term Compliance Items section because it can only be resolved during the next growing season.</p> <p>12/12/2024 - Observation remains.</p> <p>12/20/2024 - Observation remains.</p> <p>12/26/2024 - Observation remains.</p> <p>12/31/2024 - Observation remains.</p> <p>1/2/2025 - Observation remains.</p> <p>1/9/2025 - Observation remains.</p> <p>1/15/2025 - Observation remains.</p> <p>1/23/2025 - Observation remains.</p> <p>1/30/2025 - Observation remains.</p> <p>2/4/2025 - Observation remains.</p> <p>2/11/2025 - Observation remains.</p> <p>4/2/2025 - Observation remains. Invasive species including, bush honeysuckle, multiflora rose, garlic mustard and buckthorn were observed to be developing buds and leaves throughout the site. In addition, non-invasives but non-native species have been observed along the corridor within areas where the establishment of native species is required.</p> <p>4/7/2025 - Observation remains. See previous update.</p> <p>4/14/2025 - Observation remains. Invasive/non-native species are present throughout the trail.</p> <p>4/21/2025 - Observation remains. Lesser celandine (<i>Ficaria verna</i>) was observed along the trail at Station 312+00.</p> <p>Other invasive species are present along the trail.</p>

59	Multiple locations of exposed soils along the Project corridor require stabilization Priority: High	9/3/2024	9/10/2024	The contactor should apply the approved seed mixture to areas of exposed soils and place straw.	<p>4/21/2025 - For readability all previous observations have been removed from the report. Please reference the report from 4/14/2025 to see past observations. Observation remains. Vegetation has begun sprouting in some areas that were hydroseeded; however, most areas are not considered fully stabilized. Multiple areas of exposed soil along the trail still require the application of hydroseed. The seed mix used for stabilization should be submitted to the Conservation Commission.</p>
58	Crushed stone used for the dense graded crush stone shoulders has been observed as migrating both onto the path, off the sides of the path, and into the adjacent Resource Areas throughout the Project Priority: High	8/7/2024	8/14/2024	Remove all crushed stone from Resource Areas and develop a plan to cease discharges of stone.	<p>4/21/2025 - For readability all previous observations have been removed from the report. Please reference the report from 4/14/2025 to see past observations. Observation remains. Crushed stone was observed both on and off the trail in multiple locations.</p>

Direction Photo Taken: Toward the North			
Description: View of exposed soil at Station 138+00 and garlic mustard per Long Term Compliance Action Item 59 and 61.

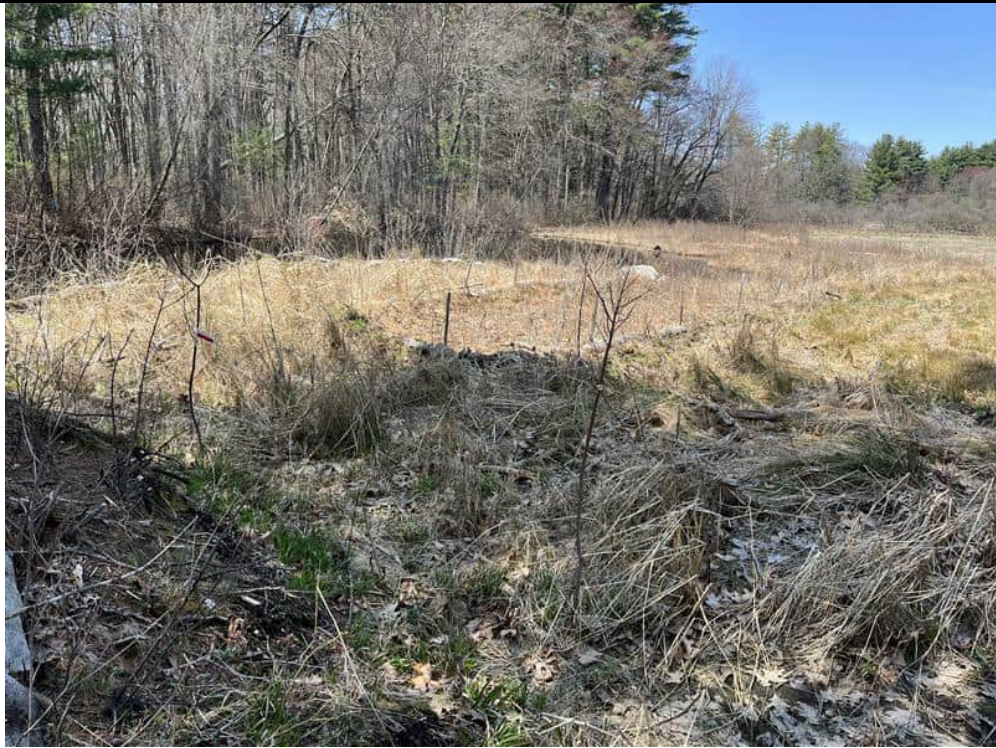
Site Location		Bruce Freeman Rail Trail Right-of-Way	BETA Project No. 24.10326.23
Photo No. 5	Date: 4/21/2025

Direction Photo Taken: Toward the West			
Description: View of the wetland replication area.			
Photo No. 6	Date: 4/21/2025

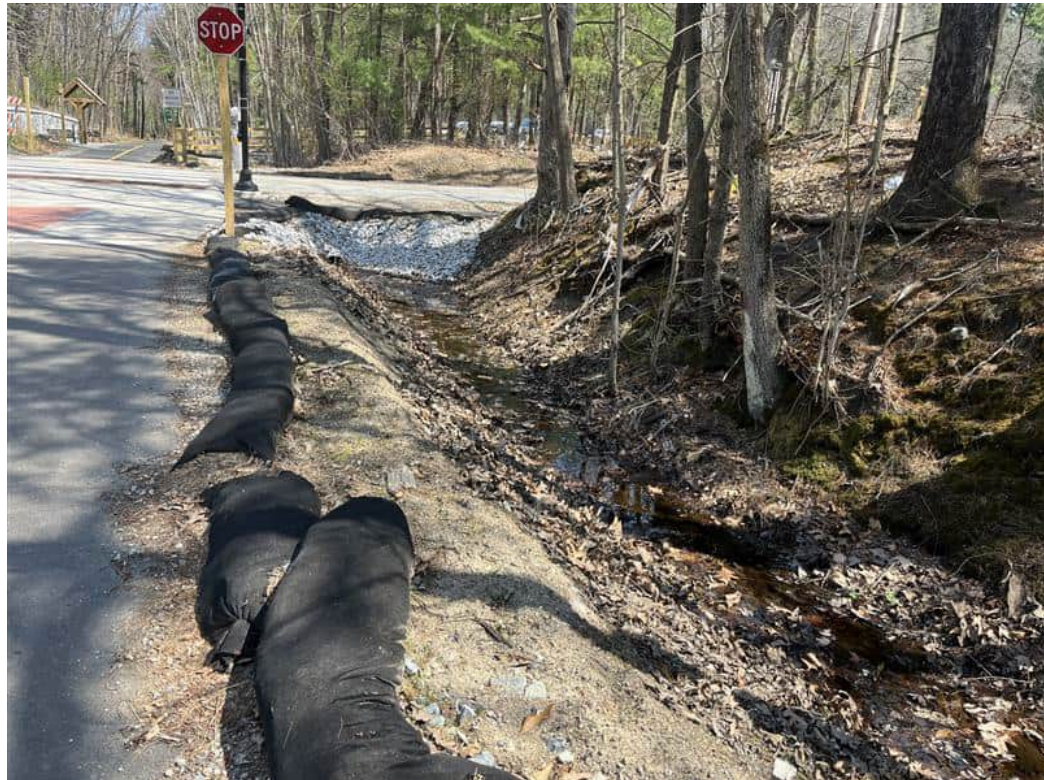
Item	Location/ Description	Observation Date	Resolution Due Date	Recommended Resolution / Resolution Date	Comments/Updates
62	Loam and seed was applied to the streambank at Station 215+00 to 217+00 and requires further stabilization Priority: High	11/25/2024	12/2/2024	An erosion control blanket should be installed along this slope.	<p>12/2/2024 - Loam and seed have been applied to the streambank at Station 215+00. Stabilization is required at Stations 215+00 to 217+00.</p> <p>12/6/2024 - Observation remains. See previous update.</p> <p>12/12/2024 - Observation remains. Rill erosion was observed within the loam applied to this area from Station 215+00 to 216+00.</p> <p>12/20/2024 - Observation remains. Loam has begun to erode, resulting in a discharge to the stream at Station 216+50.</p> <p>12/26/2024 - Observation remains. No further discharge was observed in this location.</p> <p>12/31/2024 - Observation remains. Additional loam has eroded resulting in a discharge to the stream at Station 216+50.</p> <p>1/2/2025 - Observation remains. No further discharge was observed in this location.</p> <p>1/9/2025 - Observation remains. Straw was observed to have been placed along portions of the streambank; however, this area should be stabilized using an erosion control blanket.</p> <p>1/15/2025 - Observation remains. Erosion causing a discharge of loam and straw into the stream was observed at Station 216+50.</p> <p>1/23/2025 - Observation remains. Snow coverage is present within the stream and on the streambank. No further discharge was observed during this inspection.</p> <p>1/30/2025 - Observation remains. Snow coverage is present within the stream and on the streambank. No further discharge was observed during this inspection.</p> <p>2/4/2025 - Observation remains. Snow coverage is still present over a majority of the stream and on the streambank. No further discharge was observed; however, stabilization is still required.</p> <p>2/11/2025 - Observation remains. Snow coverage is present over the stream and on the streambank.</p> <p>4/2/2025 - Observation remains. Loam was observed to have eroded and discharged into the stream at Station 215+75. Rill erosion was also observed on the streambank at Station 216+25.</p> <p>4/7/2025 - Observation remains. Stone has been installed around the culvert at Station 215+75 to stabilize the Bank. No further discharge in this location was observed; however stabilization still required.</p> <p>4/14/2025 - Observation remains. Some vegetative growth was observed along the Bank of the stream at Station 216+25; however, the area is not considered stabilized. Hydroseed should be applied to the exposed soil.</p> <p>4/21/2025 - Observation remains. No further vegetative growth was observed along the Bank of the stream. Hydroseed should be applied to the exposed soil.</p>

41	Stream Bank has been regraded beyond the limit of work at Station 216+00 Priority: High	5/28/2024	6/4/2024	<p>The Contractor should confirm if this work was permitted by the Conservation Commission, as it does not appear to be a part of the approved plans/impacts. MassDOT should be consulted on next steps regarding notification and potential restoration.</p>	<p>5/31/2024 - Observation remains. 6/7/2024 - Observation remains. 6/14/2024 - Observation remains. 6/17/2024 - Observation remains. 6/24/2024 - Observation remains. 6/27/2024 - Observation remains. 7/8/2024- Observation remains. 7/15/2024 - This area could not be assessed due to paving operations ongoing during the inspection. 7/22/2024 - Crushed stone and sediment continue to be discharged to the stream between Stations 215+00 and 217+00 due to overtopped and undermined compost filter tubes. 7/29/2024 - Observation remains. 8/5/2024 - Observation remains. 8/7/2024 - Observation remains. 8/12/2024 - Observation remains. Crushed stone is still present in the streambed at this location. 8/16/2024 - Observation remains. 8/20/2024 - Stone has been removed; however, additional alteration to Resource Areas beyond the limit of work continue. 8/27/2024 - Observation remains. 9/3/2024 - Observation remains. 9/10/2024 - Observation remains. Stone has been observed as discharging into the streambed in this location again. 9/16/2024 - Observation remains. 9/23/2024 - Observation remains. Stone is still present within the streambed at this location. 9/27/2024 - Observation remains. 10/4/2024 - Observation remains. 10/8/2024 - Observation remains. 10/15/2024 - Observation remains. Stone is still present within the streambed at this location. 10/22/2024 - Observation remains. Stone is still present within the streambed at this location. 10/29/2024 - Observation remains. Stone is still present within the streambed at this location. 11/5/2024 - Observation remains. The PVC pipe that was installed at this location was observed to be covered with stone and is no longer visible near Station 215+00. Stone is still present within the streambed at this location. 11/12/2024 - Observation remains. The streambed in this location is covered with leaf litter. See previous update. 11/19/2024 - Observation remains. As discussed with the Conservation Agent in the field, further coordination between the Town and MassDOT will be required to clean/repair the culvert, as the degraded condition of the culvert prompted the contractor to armor the stream banks. Further coordination will also be required for restoration of banks. 11/22/2024 - Observation remains. See previous update. 11/25/2024 - Observation remains. See update from 11/19/2024. 12/2/2024 - Observation remains. See update from 11/19/2024. 12/6/2024 - Observation remains. See update from 11/19/2024. 12/12/2024 - Observation remains. See update from 11/19/2024. 12/20/2024 - Observation remains. See update from 11/19/2024. 12/26/2024 - Observation remains. See update from 11/19/2024. 12/31/2024 - Observation remains. See update from 11/19/2024. 1/2/2025 - Observation remains. See update from 11/19/2024. 1/9/2025 - Observation remains. See update from 11/19/2024. 1/15/2025 - Observation remains. See update from 11/19/2024. 1/23/2025 - Observation remains. See update from 11/19/2024. 1/30/2024 - Observation remains. See update from 11/19/2024. 2/4/2025 - Observation remains. See update from 11/19/2024. 2/11/2025 - Observation remains. See update from 11/19/2024. 4/2/2025 - Observation remains. See update from 11/19/2024. 4/7/2025 - Observation remains. Stone was placed along the culvert to stabilize the Bank at Station 215+75. See update from 11/19/2024. 4/14/2025 - Observation remains, see update from 11/19/2024. 4/21/2025 - Observation remains, see update from 11/19/2024.</p>

Direction Photo Taken: Toward the North			
Description: View of the location where the stream bank has been regraded beyond the limits of work and exposed soils along the Bank at Station 215+75 per Long Term Compliance Action Items 41 and 62.

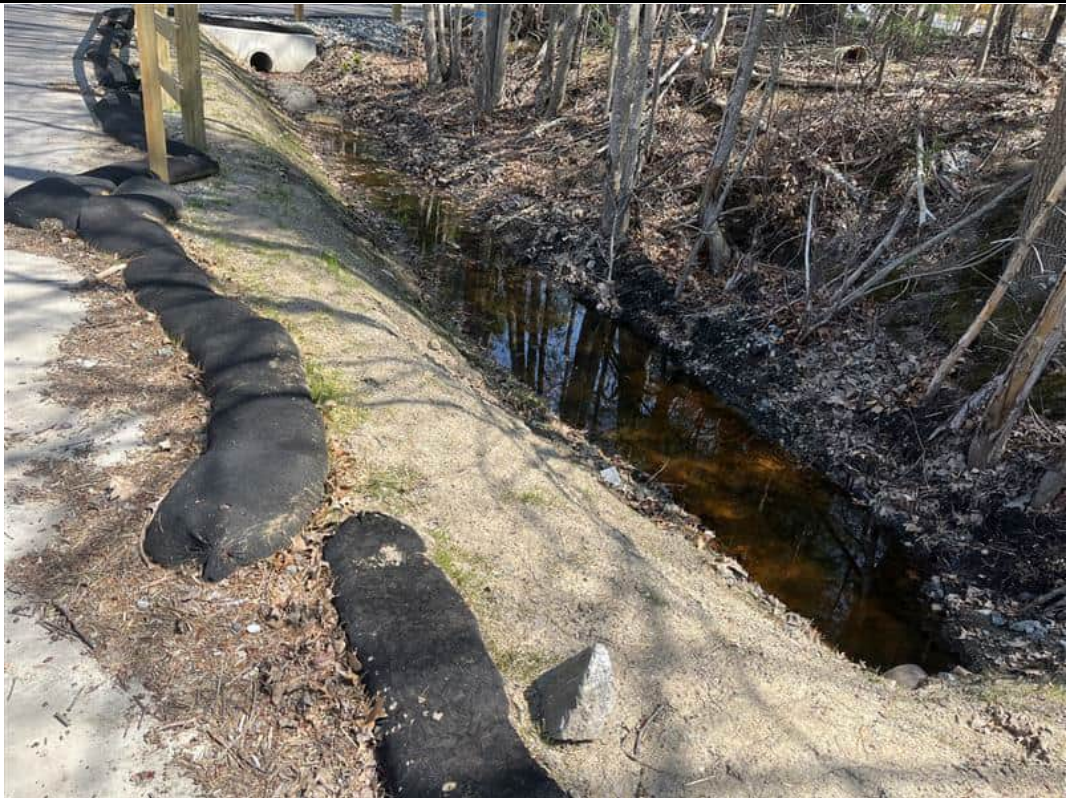
Site Location		Bruce Freeman Rail Trail Right-of-Way	BETA Project No. 24.10326.23
Photo No. 7	Date: 4/21/2025

Direction Photo Taken: Toward the North			
Description: View of exposed soils requiring stabilization at Station 216+00 per Compliance Action Item 62. Note some vegetation has been observed along the Bank.			
Photo No. 8	Date: 4/21/2025	 	
Direction Photo Taken: Toward the West			
Description: View of exposed soils requiring stabilization at Station 217+25 per Long Term Compliance Action item 62.

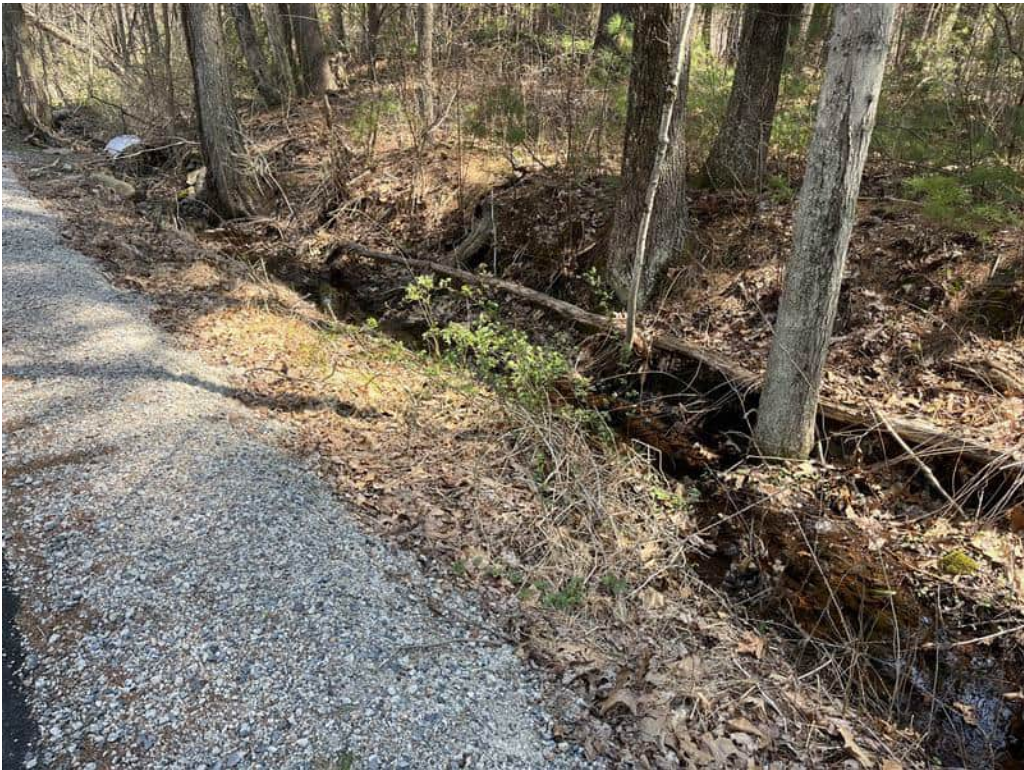
Site Location		Bruce Freeman Rail Trail Right-of-Way		BETA Project No. 24.10326.23
Photo No. 9	Date: 4/21/2025

Direction Photo Taken: Toward the North				
Description: View of multiflora rose along the WF23 wetland at Station 225+00 per Long Term Compliance Action item 61.				
Photo No. 10	Date: 4/21/2025

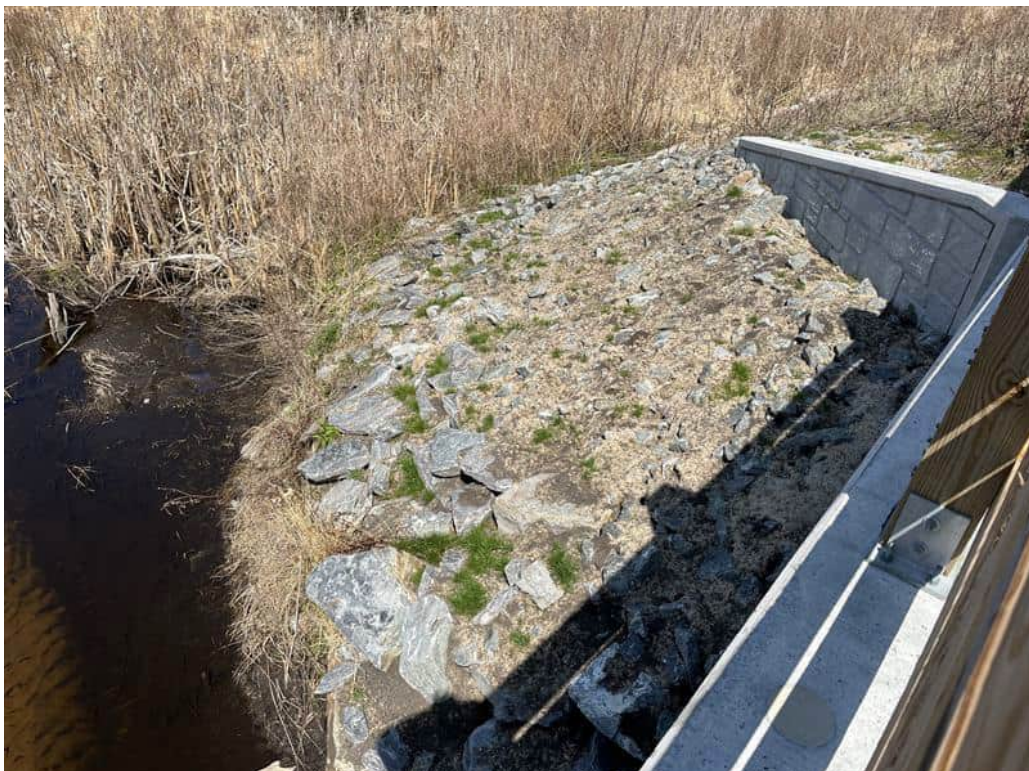
Direction Photo Taken: Toward the West				
Description: View of the Bank of Pantry Brook that has been hydroseeded but is not considered stabilized at Station 264+50 per Long Term Compliance Action Item 59.

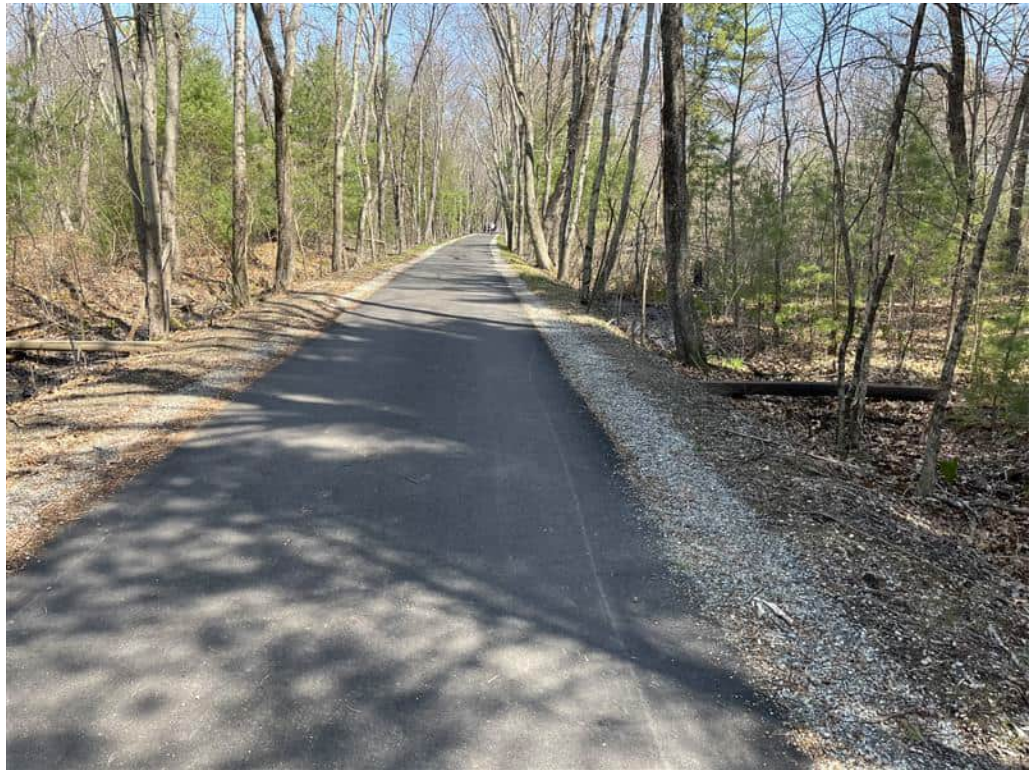
Site Location		Bruce Freeman Rail Trail Right-of-Way	BETA Project No. 24.10326.23
Photo No. 13	Date: 4/21/2025

Direction Photo Taken: Toward the South			
Description: View of exposed soil that requires stabilization at Station 298+00 per Long Term Compliance Action Item 59.			
Photo No. 14	Date: 4/21/2025

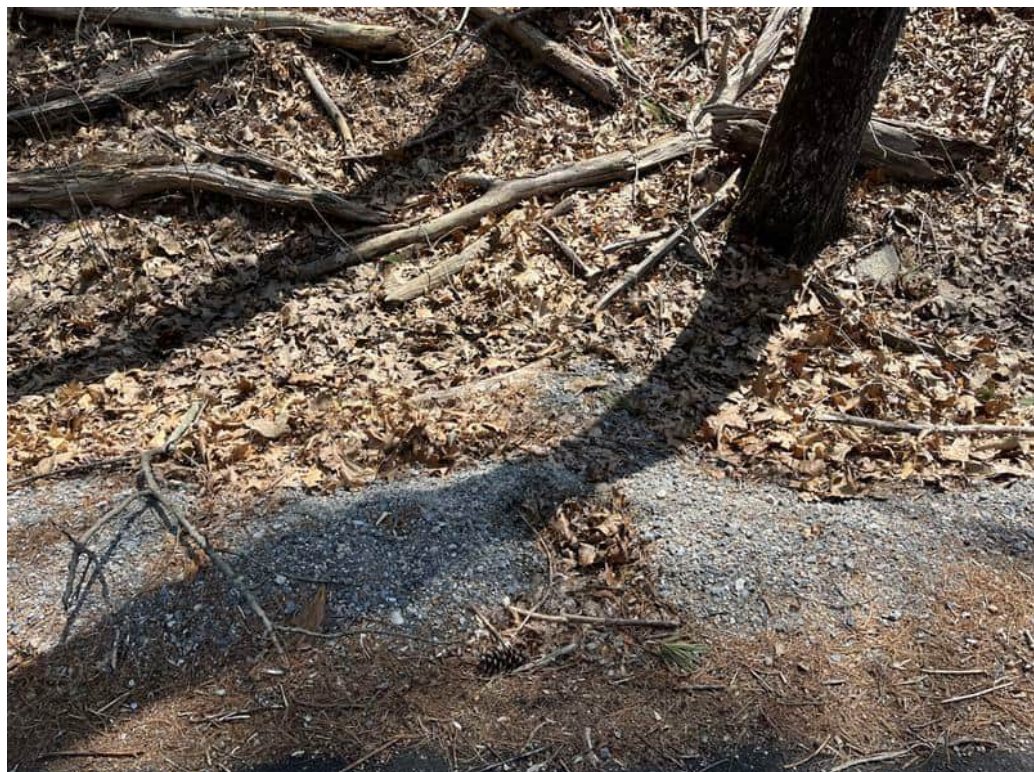
Direction Photo Taken: Toward the East			
Description: View of a location where crushed stone has migrated off of the path at Station 303+00 per Compliance Action Item 58.

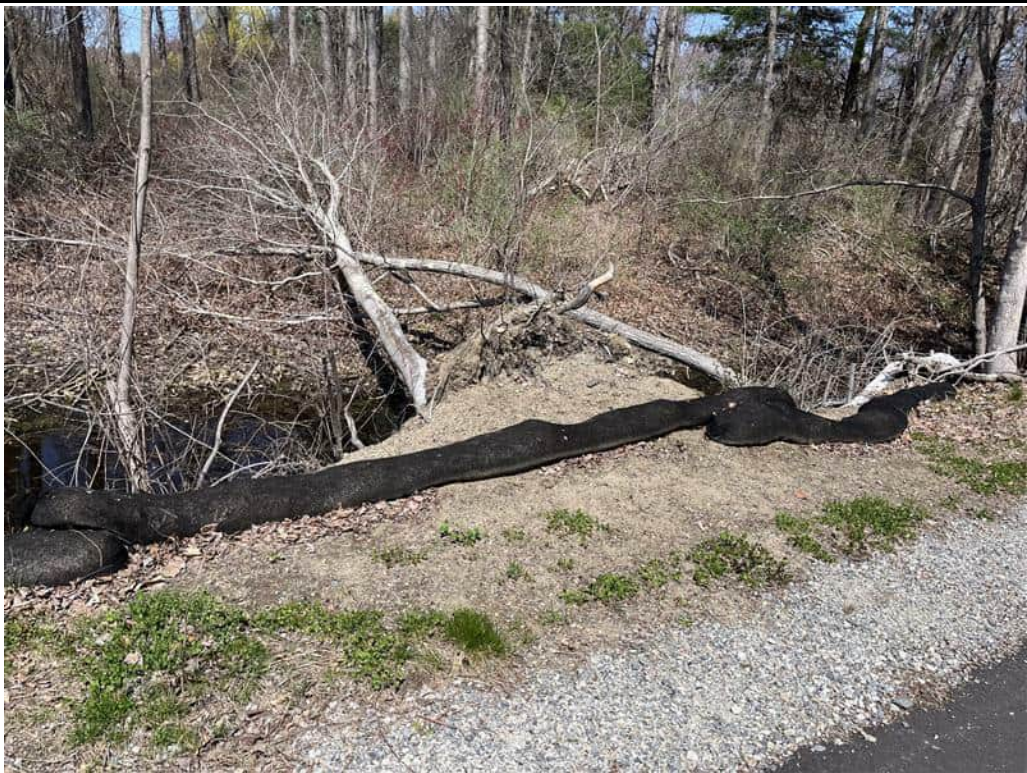
Site Location Bruce Freeman Rail Trail Right-of-Way		BETA Project No. 24.10326.23
Photo No. 15	Date: 4/21/2025

Direction Photo Taken: Toward the West		
Description: View of the location of placed loam that requires stabilization at Station 311+50 per Long Term Compliance Action Item 59.		
Photo No. 16	Date: 4/21/2025

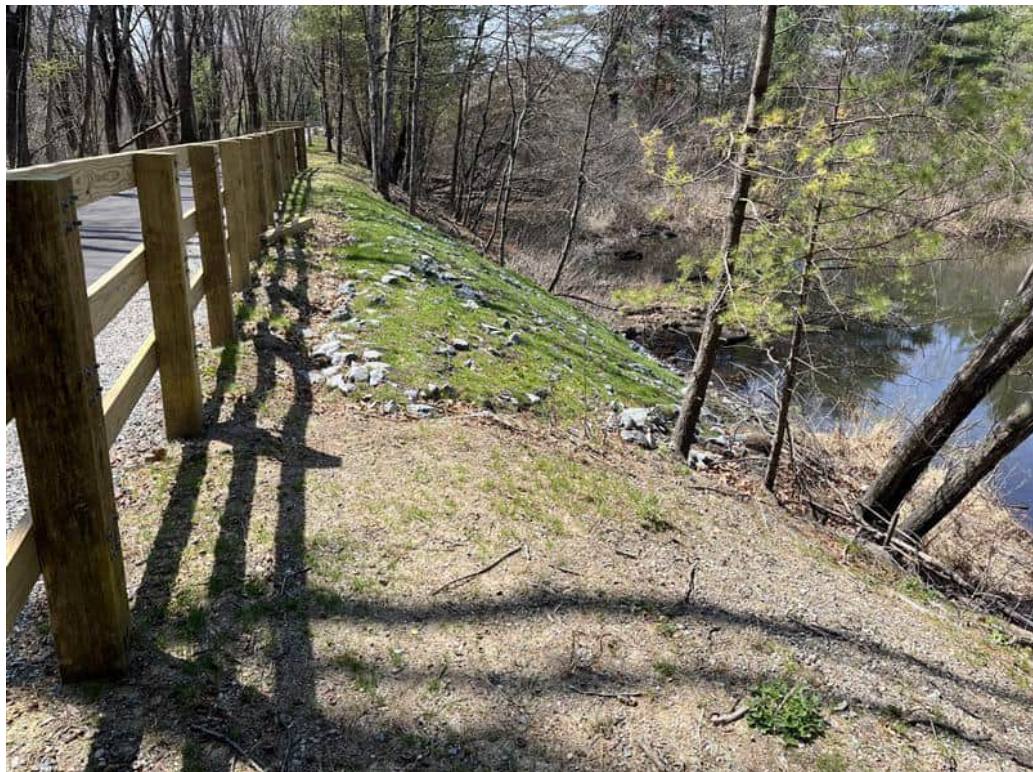
Direction Photo Taken: Toward the South		
Description: View of the location of the riprap slope that extends beyond the limit of work along the WF1 Series wetland and exposed soil requiring stabilization at Station 332+00 per Long Term Compliance Action Item 42 and 59.
