Environmental Monitor Construction Site Inspection Report MassDOT Project #608164 Construction Contract # 119678 EM Report #56						
Project Description: Bruce Freeman Rail Trail Right-of-Way Permit Description(s): Order of Conditions (MGL Chapter 131, Section 40 and 310 CMR 10.00, Mass DEP File No. 301-1362); 2022 EPA NPDES General Permit for Discharges from Construction Areas; U.S. Army Corps of Engineers Permit No NAE-2021-01975.

I. General Project Information						
Project Name:	Bruce Freeman Rail Trail - Phase 2d - Sudbury					
Date of Inspections:	5/16/2025					
Bi Weekly/ Monthly Period Covered:	May Weekly Inspection #3					
Inspector's Name(s):	Anna Haznar					
Inspectors' Contact Information:	ahaznar@beta-inc.com					
II. Weather Information						
	Inspection #1	Inspection #2	Inspection #3	Inspection #4	Inspection #5	Inspection #6
WeatherUnderground	Inspector: Anna Haznar 5/5/2025	Inspector: Anna Haznar 5/12/2025	Inspector: Anna Haznar 5/16/2025	Inspector:	Inspector:	Inspector:
Type of Inspection (i.e. non-storm event, pre-storm event, during-storm event or post-storm event):	Post-storm	Non-storm	Post-storm			
Number of days since last rain event greater than .25"	0	1	1

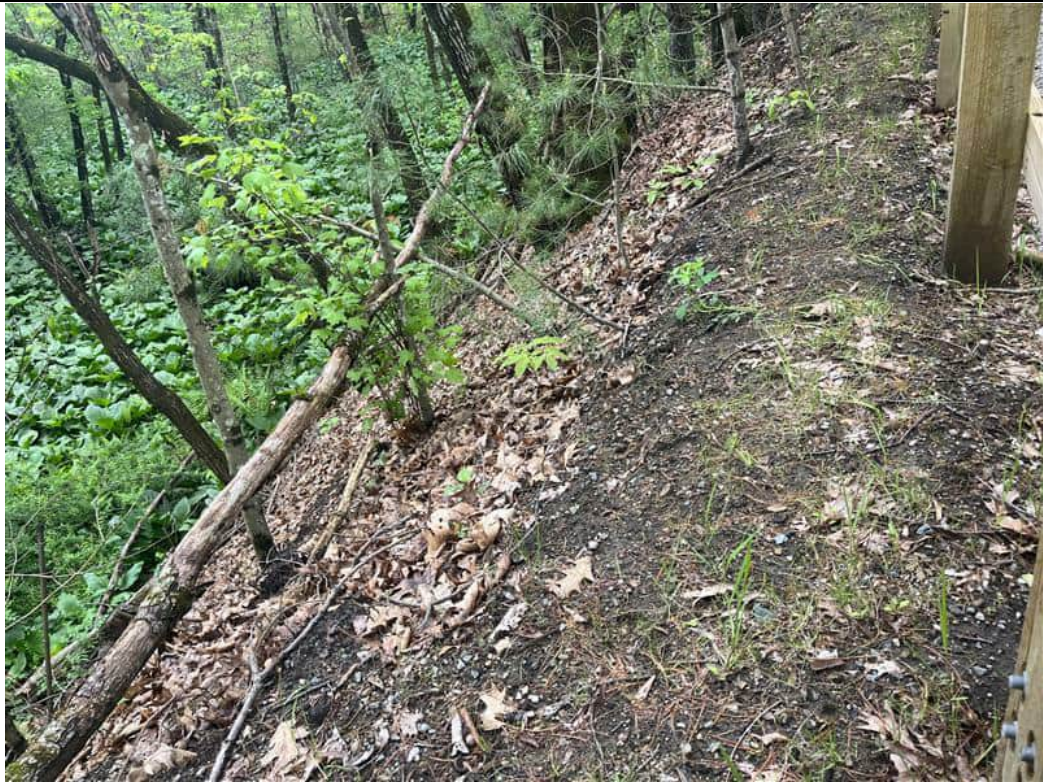
Site Location		Bruce Freeman Rail Trail Right-of-Way	BETA Project No. 24.10326.23
Photo No. 3	Date: 5/16/2025

59	Multiple locations of exposed soils along the Project corridor require stabilization Priority: High	9/3/2024	9/10/2024	The contractor should apply the approved seed mixture to areas of exposed soils and place straw.	<p>4/21/2025 - For readability all previous observations have been removed from the report. Please reference the report from 4/14/2025 to see past observations. Observation remains. Vegetation has begun sprouting in some areas that were hydroseeded; however, most areas are not considered fully stabilized. Multiple areas of exposed soil along the trail still require the application of hydroseed. The seed mix used for stabilization should be submitted to the Conservation Commission.</p> <p>4/28/2025 - Observation remains. See previous update.</p> <p>5/5/2025 - Observation remains. Areas where hydroseed was applied have been observed as being partially or fully stabilized. Areas of exposed soil are still present in multiple locations throughout the trail. Further application of hydroseed should occur. The seed mix used for stabilization should be submitted to the Conservation Commission.</p> <p>5/12/2025 - Observation remains. See previous update.</p> <p>5/16/2025 - Observation remains. Areas of exposed soil are present in multiple locations throughout the trail. Further application of hydroseed should occur. The seed mix used for stabilization should be submitted to the Conservation Commission.</p>

Direction Photo Taken: Toward the North			
Description: View of exposed soil that requires stabilization at Station 161+00 per Long Term Compliance Action item 59.			
Photo No. 4	Date: 5/16/2025

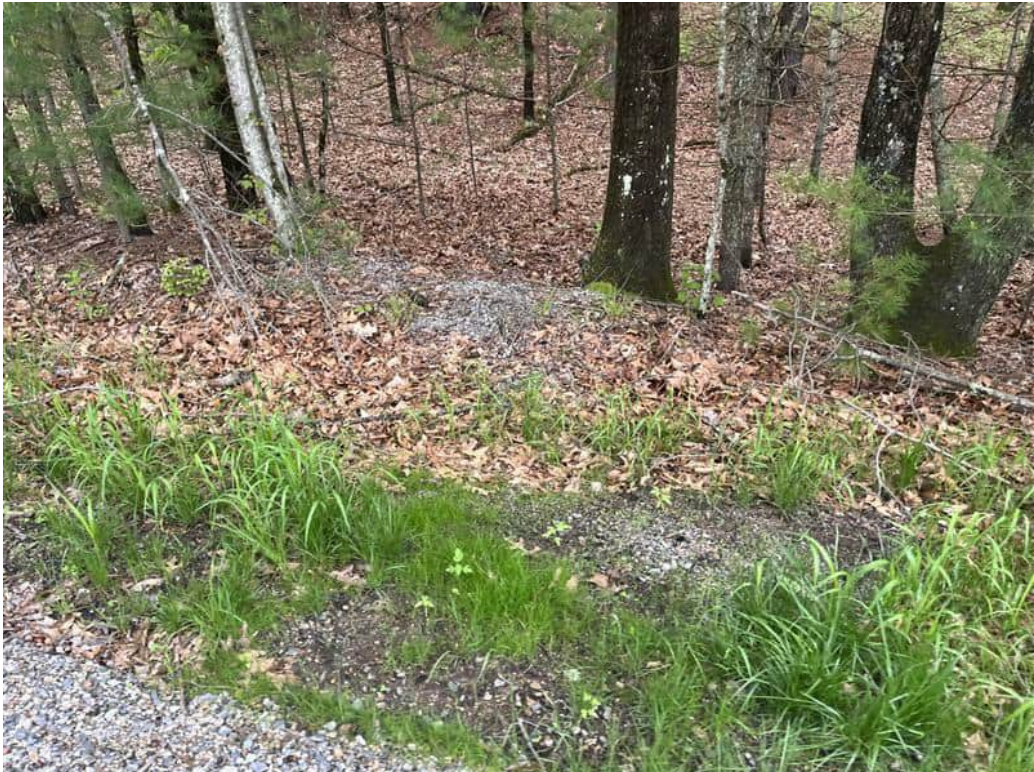
58	Crushed stone used for the dense graded crush stone shoulders has been observed as migrating both onto the path, off the sides of the path, and into the adjacent Resource Areas throughout the Project Priority: High	8/7/2024	8/14/2024	Remove all crushed stone from Resource Areas and develop a plan to cease discharges of stone.	<p>4/21/2025 - For readability all previous observations have been removed from the report. Please reference the report from 4/14/2025 to see past observations. Observation remains. Crushed stone was observed both on and off the trail in multiple locations.</p> <p>4/28/2025 - Observation remains. See previous update.</p> <p>5/5/2025 - Observation remains. See update from 4/21/2025.</p> <p>5/12/2025 - Observation remains. See update from 4/21/2025.</p> <p>5/16/2025 - Observation remains. Crushed stone is present both on and on the side of the trail in multiple locations.</p>

Direction Photo Taken: Toward the East			
Description: View of a location where crushed stone has migrated off of the path at Station 181+00 per Long Term Compliance Action Item 58.

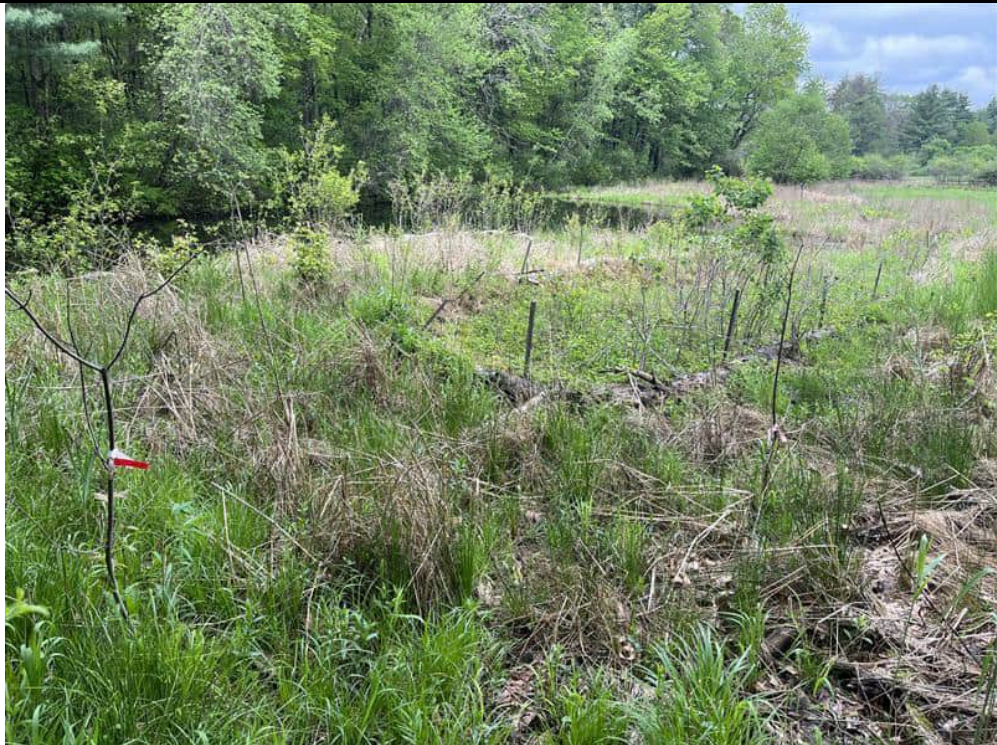
Site Location		Bruce Freeman Rail Trail Right-of-Way	BETA Project No. 24.10326.23
Photo No. 5	Date: 5/16/2025

Item	Location/ Description	Observation Date	Resolution Due Date	Recommended/Discussed Resolution	Comments/Updates
61	Invasive/ non-native vegetation including Japanese knotweed (<i>Reynoutria japonica</i>), bittersweet (<i>Celastrus orbiculatus</i>), bush honeysuckle (<i>Lonicera spp.</i>), burning bush (<i>Euonymus alatus</i>), purple loosestrife (<i>Lythrum salicaria</i>), glossy buckthorn (<i>Frangula alnus</i>) multiflora rose (<i>Rosa multiflora</i>), lesser celandine (<i>Ficaria verna</i>) and garlic mustard (<i>Alliaria petiolata</i>) have been observed throughout the path. Priority: High	10/22/2024	10/29/2024	Invasive Species should be removed by manual and/or chemical removal methods	<p>10/29/2024 - Invasive species are present throughout the trail both within upland and Resource Areas. Populations of glossy buckthorn and purple loosestrife are present within the wetland replication area.</p> <p>11/5/2024 - Observation remains. See update from 10/29/2024.</p> <p>11/12/2024 - Observation remains. Invasive species are still present throughout the trail. Some invasives have been observed with no leaves due to winter die back.</p> <p>11/19/2024 - Observation remains. Further invasive species management will be required during the next growing season.</p> <p>11/22/2024 - Observation remains.</p> <p>11/25/2024 - Observation remains.</p> <p>12/2/2024 - Observation remains.</p> <p>12/6/2024 - Observation remains. This action item has been moved to the Long-Term Compliance Items section because it can only be resolved during the next growing season.</p> <p>12/12/2024 - Observation remains.</p> <p>12/20/2024 - Observation remains.</p> <p>12/26/2024 - Observation remains.</p> <p>12/31/2024 - Observation remains.</p> <p>1/2/2025 - Observation remains.</p> <p>1/9/2025 - Observation remains.</p> <p>1/15/2025 - Observation remains.</p> <p>1/23/2025 - Observation remains.</p> <p>1/30/2025 - Observation remains.</p> <p>2/4/2025 - Observation remains.</p> <p>2/11/2025 - Observation remains.</p> <p>4/2/2025 - Observation remains. Invasive species including, bush honeysuckle, multiflora rose, garlic mustard and buckthorn were observed to be developing buds and leaves throughout the site. In addition, non-invasives but non-native species have been observed along the corridor within areas where the establishment of native species is required.</p> <p>4/7/2025 - Observation remains. See previous update.</p> <p>4/14/2025 - Observation remains. Invasive/non-native species are present throughout the trail.</p> <p>4/21/2025 - Observation remains. Lesser celandine (<i>Ficaria verna</i>) was observed along the trail at Station 312+00. Garlic mustard is present throughout the trail in locations on exposed soil. Invasive species including bittersweet, bush honeysuckle, burning bush, multiflora rose and glossy buckthorn are also present throughout the trail.</p> <p>4/28/2025 - Observation remains. See previous update.</p> <p>5/5/2025 - Observation remains. Multiple Japanese knotweed sprouts have been observed throughout the trail, garlic mustard was observed as flowering, one black locust (<i>Robinia pseudoacacia</i>) sapling was observed along the trail, and other previously listed invasive species have fully leafed out. Management for invasive species should occur prior to the setting of seed to ensure further spread does not occur.</p> <p>5/12/2025 - Observation remains. Invasive species have been observed throughout the path. Japanese knotweed sprouts have germinated in multiple locations, garlic mustard has begun going to seed, bush honeysuckle was observed as being in flower and other invasive species have fully leafed out. Management for invasive species should occur prior to the setting of seed to ensure further spread does not occur.</p> <p>5/16/2025 - Observation remains. Invasive species have been observed throughout the path. See previous update.</p>

Direction Photo Taken: Toward the South			
Description: View of buckthorn within the wetland replication area per Long Term Compliance Action Item 61.			
Photo No. 6	Date: 5/16/2025

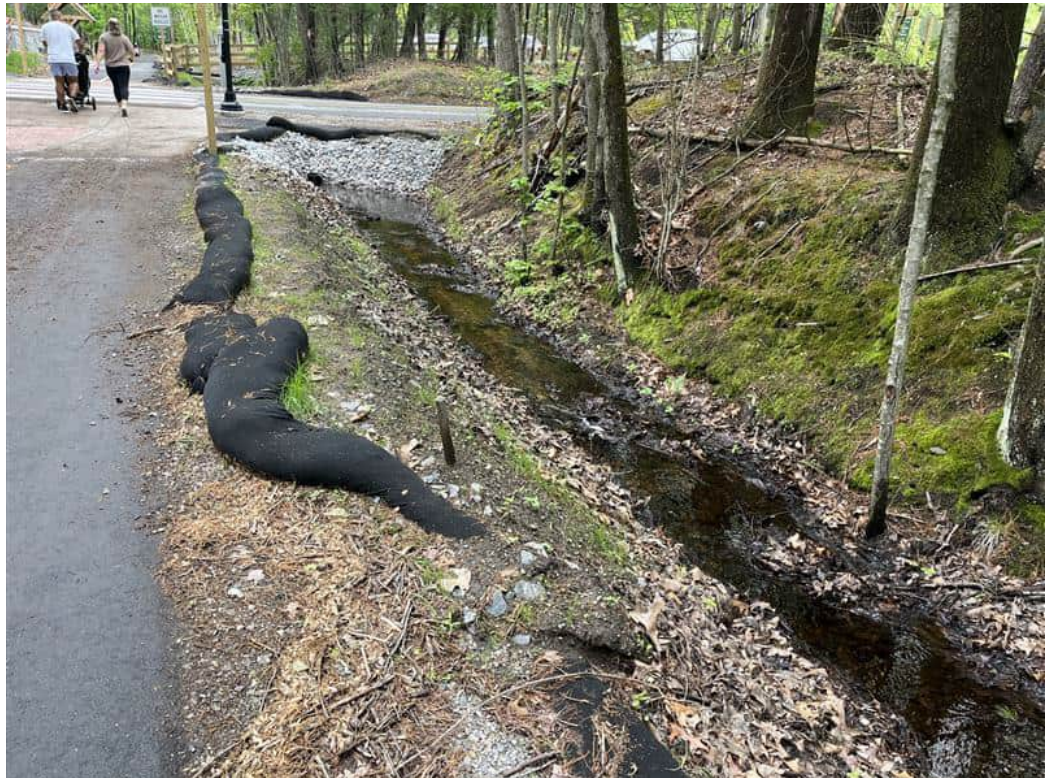
Direction Photo Taken: Toward the West			
Description: View of the location where the stream bank has been regraded beyond the limits of work and exposed soils along the Bank at Station 215+75 per Long Term Compliance Action Items 41 and 62. Note some vegetation has been observed along the Bank.

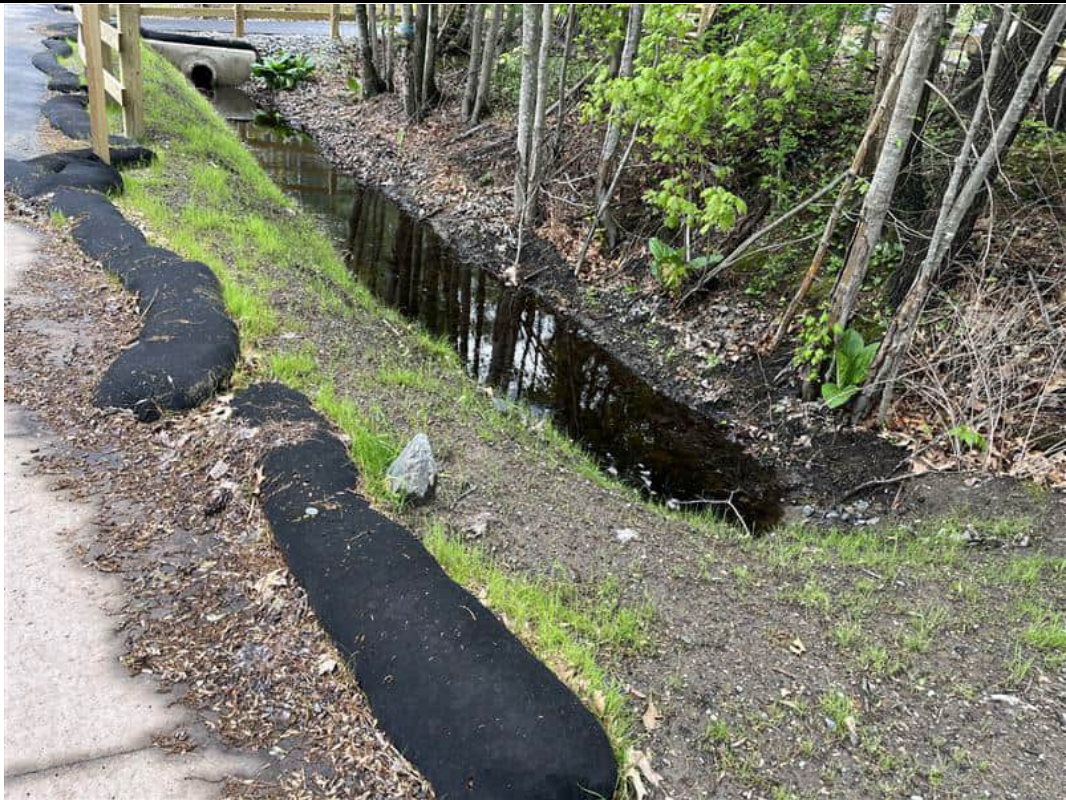
Site Location		Bruce Freeman Rail Trail Right-of-Way	BETA Project No. 24.10326.23
Photo No. 7	Date: 5/16/2025

Item	Location/ Description	Observation Date	Resolution Due Date	Recommended Resolution / Resolution Date	Comments/Updates
62	Loam and seed was applied to the streambank at Station 215+00 to 217+00 and requires further stabilization Priority: High	11/25/2024	12/2/2024	An erosion control blanket should be installed along this slope.	<p>12/2/2024 - Loam and seed have been applied to the streambank at Station 215+00. Stabilization is required at Stations 215+00 to 217+00.</p> <p>12/6/2024 - Observation remains. See previous update.</p> <p>12/12/2024 - Observation remains. Rill erosion was observed within the loam applied to this area from Station 215+00 to 216+00.</p> <p>12/20/2024 - Observation remains. Loam has begun to erode, resulting in a discharge to the stream at Station 216+50.</p> <p>12/26/2024 - Observation remains. No further discharge was observed in this location.</p> <p>12/31/2024 - Observation remains. Additional loam has eroded resulting in a discharge to the stream at Station 216+50.</p> <p>1/2/2025 - Observation remains. No further discharge was observed in this location.</p> <p>1/9/2025 - Observation remains. Straw was observed to have been placed along portions of the streambank; however, this area should be stabilized using an erosion control blanket.</p> <p>1/15/2025 - Observation remains. Erosion causing a discharge of loam and straw into the stream was observed at Station 216+50.</p> <p>1/23/2025 - Observation remains. Snow coverage is present within the stream and on the streambank. No further discharge was observed during this inspection.</p> <p>1/30/2025 - Observation remains. Snow coverage is present within the stream and on the streambank. No further discharge was observed during this inspection.</p> <p>2/4/2025 - Observation remains. Snow coverage is still present over a majority of the stream and on the streambank. No further discharge was observed; however, stabilization is still required.</p> <p>2/11/2025 - Observation remains. Snow coverage is present over the stream and on the streambank.</p> <p>4/2/2025 - Observation remains. Loam was observed to have eroded and discharged into the stream at Station 215+75. Rill erosion was also observed on the streambank at Station 216+25.</p> <p>4/7/2025 - Observation remains. Stone has been installed around the culvert at Station 215+75 to stabilize the Bank. No further discharge in this location was observed; however stabilization still required.</p> <p>4/14/2025 - Observation remains. Some vegetative growth was observed along the Bank of the stream at Station 216+25; however, the area is not considered stabilized. Hydroseed should be applied to the exposed soil.</p> <p>4/21/2025 - Observation remains. No further vegetative growth was observed along the Bank of the stream. Hydroseed should be applied to the exposed soil.</p> <p>4/28/2025 - Observation remains.</p> <p>5/5/2025 - Observation remains. Vegetation has begun stabilization the slope along the stream at Station 215+00 to 216+50; however, these areas are not considered fully stabilized and will continue to be monitored to determine if further stabilization is required. The slope at Station 216+50 to 217+00 currently requires further stabilization as minimal vegetation has germinated on this slope.</p> <p>5/12/2025 - Observation remains. Vegetation has partially stabilized the slope at Station 215+00 to 217+00; however further application of seed is required.</p> <p>5/16/2025 - Observation remains. See previous update.</p>

Direction Photo Taken: Toward the North			
Description: View of exposed soils requiring stabilization at Station 216+00 per Compliance Action Item 62. Note some vegetation has been observed along the Bank.			
Photo No. 8	Date: 5/16/2025	 	
Direction Photo Taken: Toward the North			
Description: View of exposed soils requiring stabilization at Station 217+25 per Long Term Compliance Action item 62.

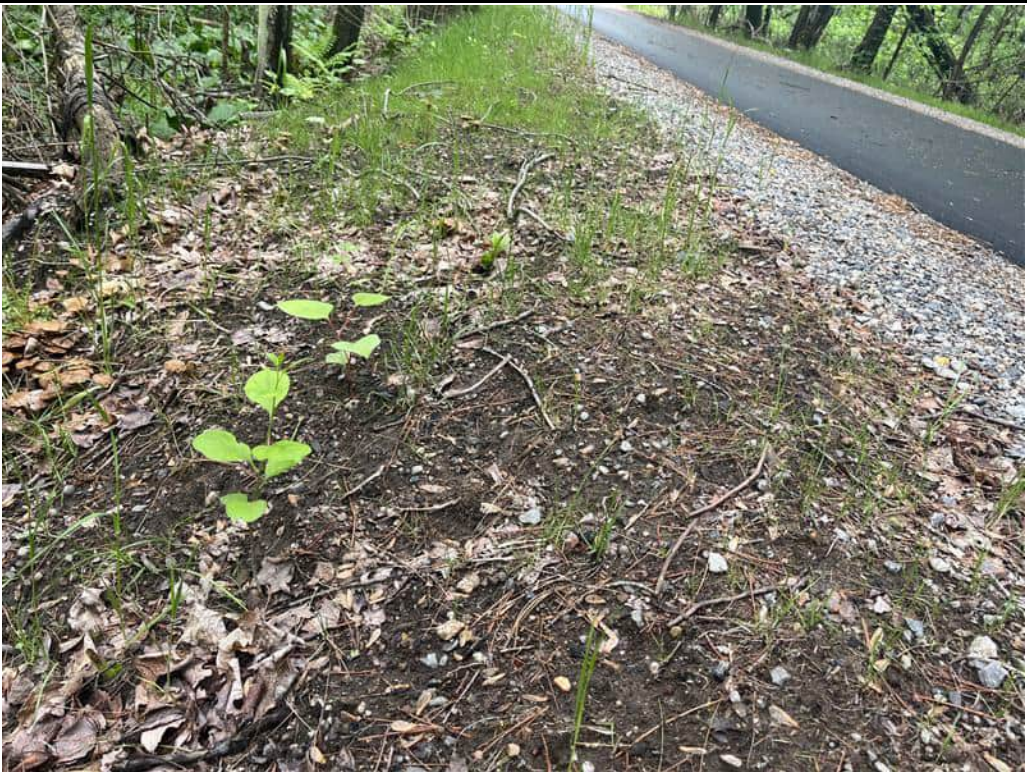
Site Location		Bruce Freeman Rail Trail Right-of-Way	BETA Project No. 24.10326.23
Photo No. 9	Date: 5/16/2025

Direction Photo Taken: Toward the Northwest			
Description: View of bittersweet and Japanese knotweed in an area of exposed soil at Station 224+00 per Long Term Compliance Action Items 59 and 61.			
Photo No. 10	Date: 5/16/2025

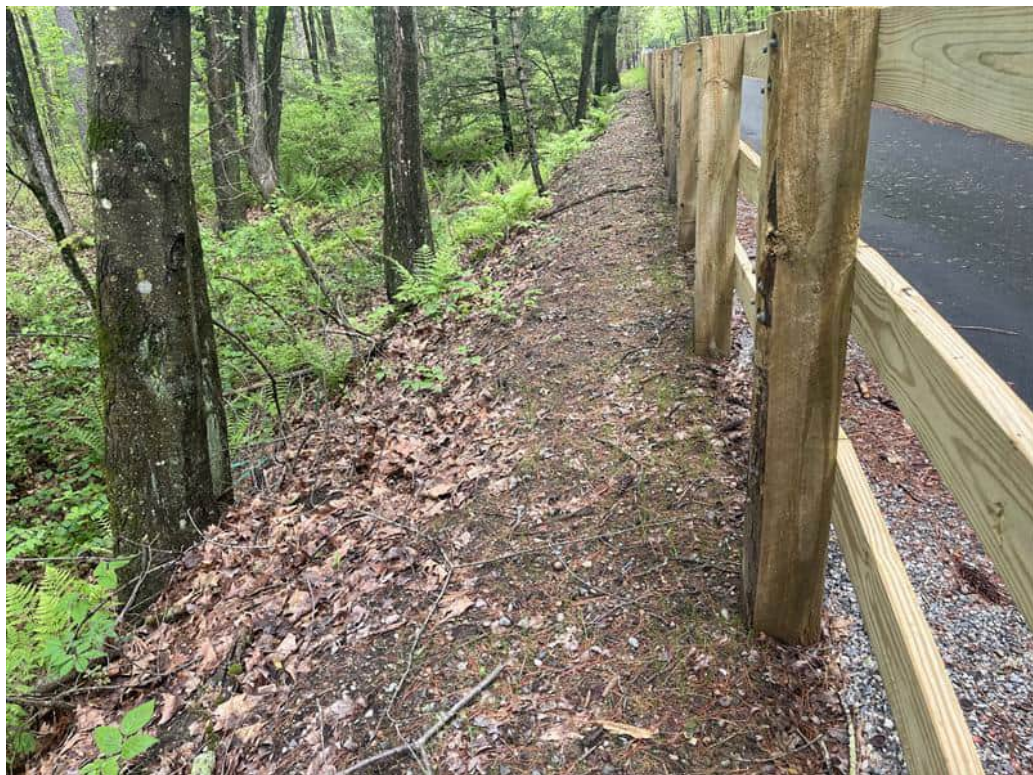
Direction Photo Taken: Toward the North			
Description: View of exposed soil that requires stabilization at Station 233+00 per Long Term Compliance Action Item 59.

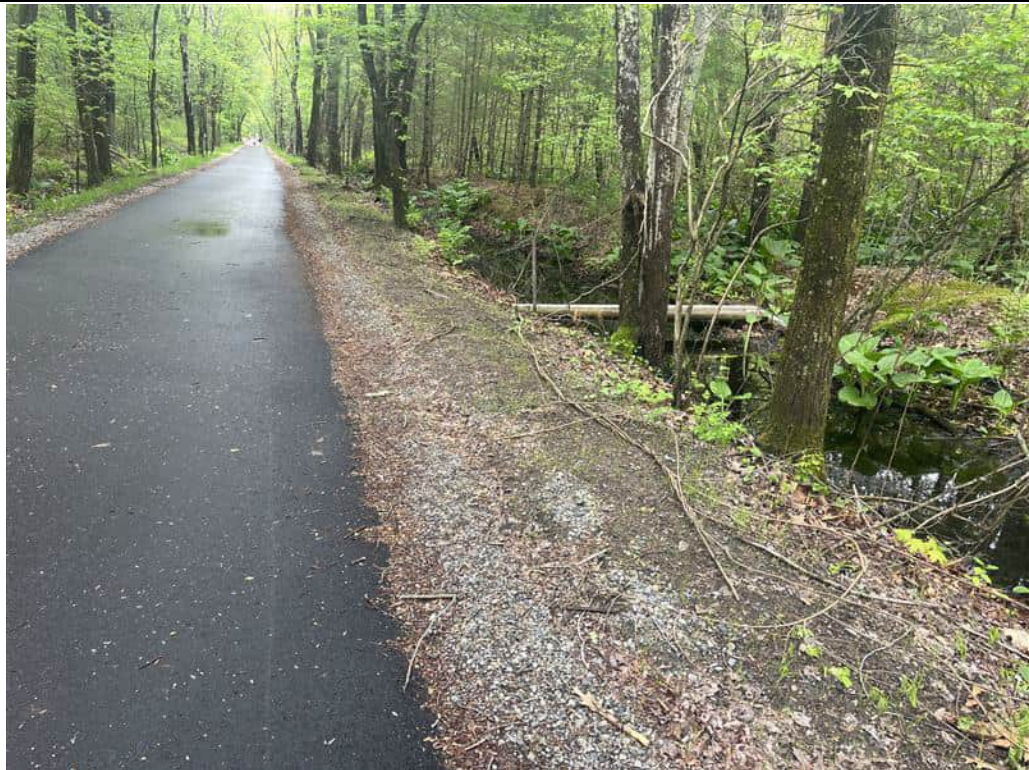
Site Location		Bruce Freeman Rail Trail Right-of-Way	BETA Project No. 24.10326.23
Photo No. 13	Date: 5/16/2025

Direction Photo Taken: Toward the North			
Description: View of exposed soil that requires stabilization at Station 298+00 per Compliance Action Item 59.			
Photo No. 14	Date: 5/16/2025

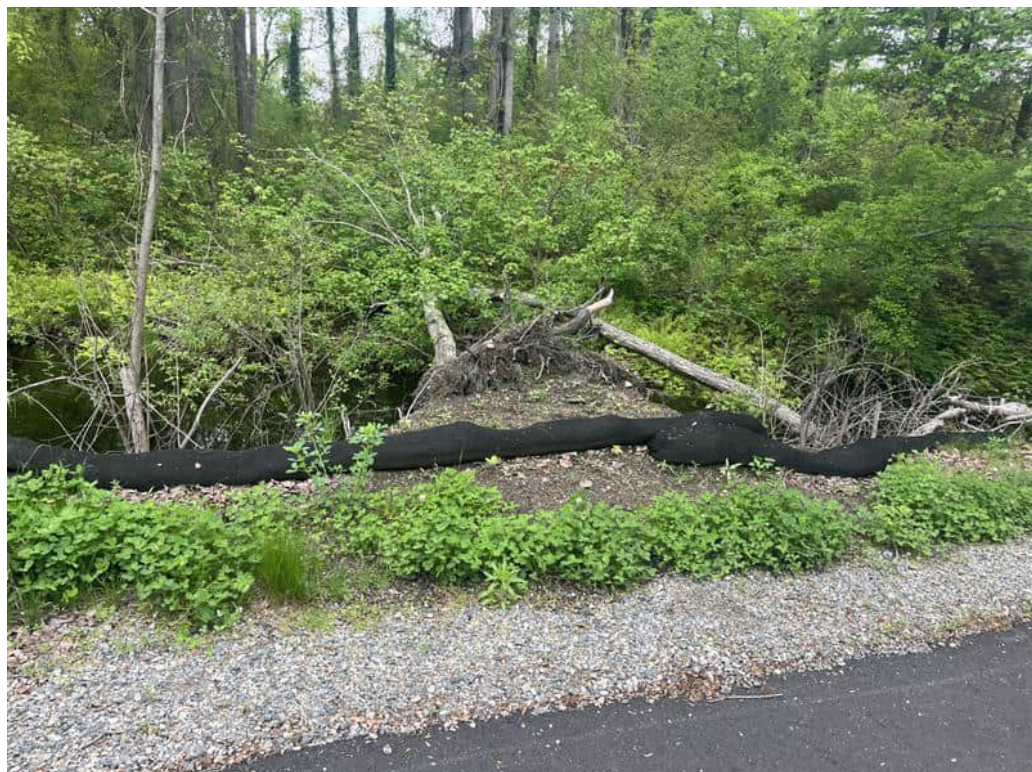
Direction Photo Taken: Toward the North			
Description: View of the location of placed loam that requires stabilization at Station 311+50 per Long Term Compliance Action Item 59.

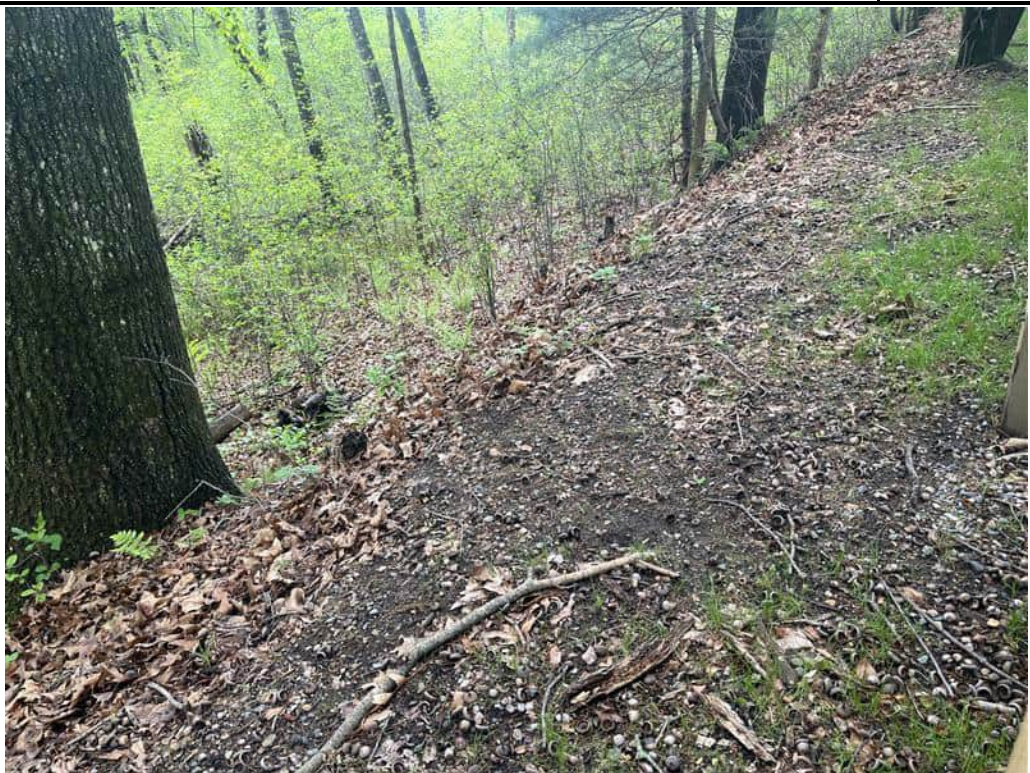
Site Location Bruce Freeman Rail Trail Right-of-Way		BETA Project No. 24.10326.23
Photo No. 15	Date: 5/16/2025

Direction Photo Taken: Toward the West		
Description: View of exposed soil that requires stabilization at Station 328+00 per Long Term Compliance Action Item 59.		
Photo No. 16	Date: 5/16/2025

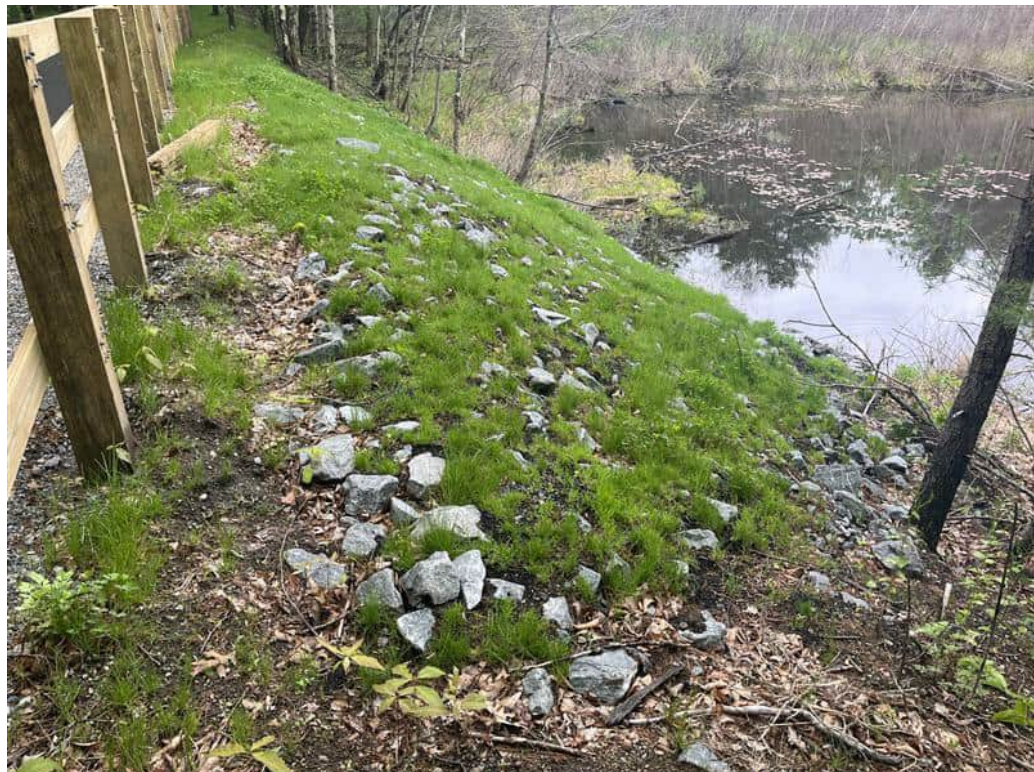
Direction Photo Taken: Toward the South		
Description: View of the location of the riprap slope that extends beyond the limit of work along the WF1 Series wetland and exposed soil requiring stabilization at Station 332+00 per Long Term Compliance Action Item 42 and 59.
