**Environmental Monitor Construction Site Inspection Report**  
**MassDOT Project #608164 Construction Contract # 119678**  
**EM Report #58**

Project Description: Bruce Freeman Rail Trail Right-of-Way  
 Permit Description(s): Order of Conditions (MGL Chapter 131, Section 40 and 310 CMR 10.00, Mass DEP File No. 301-1362); 2022 EPA NPDES General Permit for Discharges from Construction Areas; U.S. Army Corps of Engineers Permit No NAE-2021-01975.

Project Name:	Bruce Freeman Rail Trail - Phase 2d - Sudbury
Date of Inspections:	5/29/2025
Bi Weekly/ Monthly Period Covered:	May Weekly Inspection #5
Inspector's Name(s):	Anna Haznar
Inspectors' Contact Information:	<a href="mailto:ahaznar@beta-inc.com">ahaznar@beta-inc.com</a>

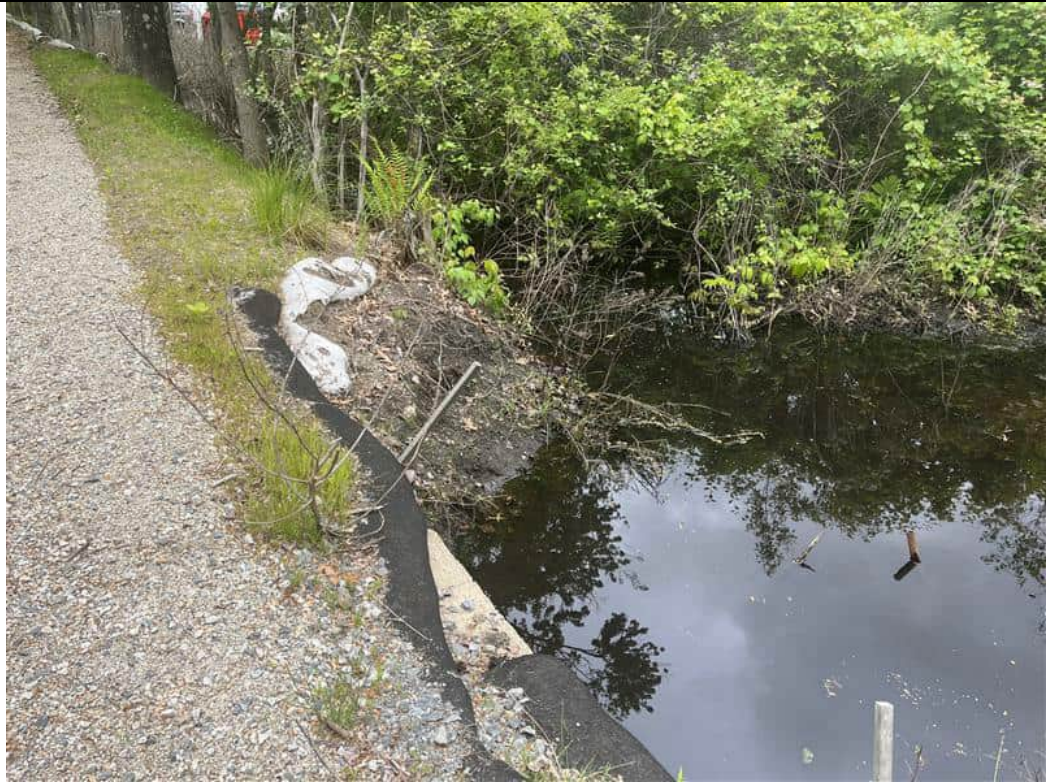
**Photo No. 1**    **Date:**  
5/29/2025

43	<p>Overtopped compost filter tubes and exposed soils beyond the limits of work at Station 105+00  <b>Priority: High</b></p>	6/7/2024	6/14/2024	<p>Stabilize the area with the approved seed mixture and provide interim stabilization such as straw mulch.</p>	<p>6/14/2024 - Observation remains.  6/17/2024 - Observation remains.  6/24/2024 - Observation remains.  6/27/2024 - Observation remains.  7/8/2024 - Observation remains.  7/15/2024 - Observation remains.  7/22/2024 - Observation remains.  7/29/2024 - Observation remains.  8/5/2024 - Observation remains.  8/7/2024 - Observation remains.  8/12/2024 - Observation remains. Some material has migrated off of the compost filter tubes due to erosion.  8/16/2024 - Observation remains.  8/20/2024 - Application of the approved seed mixture is required at this location.  8/27/2024 - Observation remains.  9/3/2024 - Observation remains.  9/10/2024 - Observation remains. Application of the approved seed mixture is required at this location.  9/16/2024 - Observation remains.  9/23/2024 - Observation remains.  9/27/2024 - Observation remains.  10/4/2024 - Hydroseed has been applied here; however, the contractor should provide an update on long-term slope stabilization plans.  10/8/2024 - Observation remains. Germination has not been observed.  10/15/2024 - Observation remains. Germination has not been observed.  10/22/2024 - Observation remains. Some germination has been observed but the area is not considered stabilized.  10/29/2024 - Observation remains. No further germination has been observed since the last inspection.  11/5/2024 - Observation remains. Some germination has been observed but the area is not considered stabilized.  11/12/2024 - Observation remains. Seed has stabilized the area.  11/19/2024 - The area adjacent to the path has become stabilized; however, exposed soil is still present next to the culvert past the limit of work.  11/22/2024 - Observation remains. See previous update.  11/25/2024 - Observation remains. See update from 11/19/2024.  12/2/2024 - Observation remains. See update from 11/19/2024.  12/6/2024 - Observation remains. See update for 11/19/2024.  12/12/2024 - Observation remains. See update from 11/19/2024.  12/20/2024 - Observation remains. See update from 11/19/2024.  12/26/2024 - Observation remains. See update from 11/19/2024.  12/31/2024 - Observation remains. See update from 11/19/2024.  1/2/2025 - Observation remains. See update from 11/19/2024.  1/9/2025 - Observation remains. See update from 11/19/2024.  1/15/2025 - Observation remains. Exposed soils are still present next to the culvert past the limits of work.  1/23/2025 - Observation remains. See previous update.  1/30/2025 - Observation remains. Exposed soils are present next to the culvert past the limits of work.  2/4/2025 - Observation remains. Exposed soils are present next to the culvert past the limits of work.  2/11/2025 - Observation remains. Exposed soils past the limits of work are currently frozen and covered with snow.  4/2/2025 - Observation remains. Exposed soil past the limits of work is present and requires further stabilization.  4/7/2025 - Observation remains. See previous update.  4/14/2025 - Observation remains. Exposed soil past the limits of work is present and requires further stabilization.  4/21/2025 - Observation remains. Exposed soil past the limits of work is present and requires further stabilization.  4/28/2025 - Observation remains. See previous update.  5/5/2025 - Observation remains. Exposed soil past the limits of work is present and requires further stabilization.  5/12/2025 - Observation remains. See previous update.  5/16/2025 - Observation remains. Exposed soil past the limits of work is present and requires further stabilization.  5/23/2025 - Observation remains. See previous update.  5/29/2025 - Observation remains. Exposed soil past the limits of work is present and requires further stabilization.</p>

View of the location of the overtopped compost filter tube and exposed soils beyond the limits of work at Station 105+00 per Compliance Action Item 43.

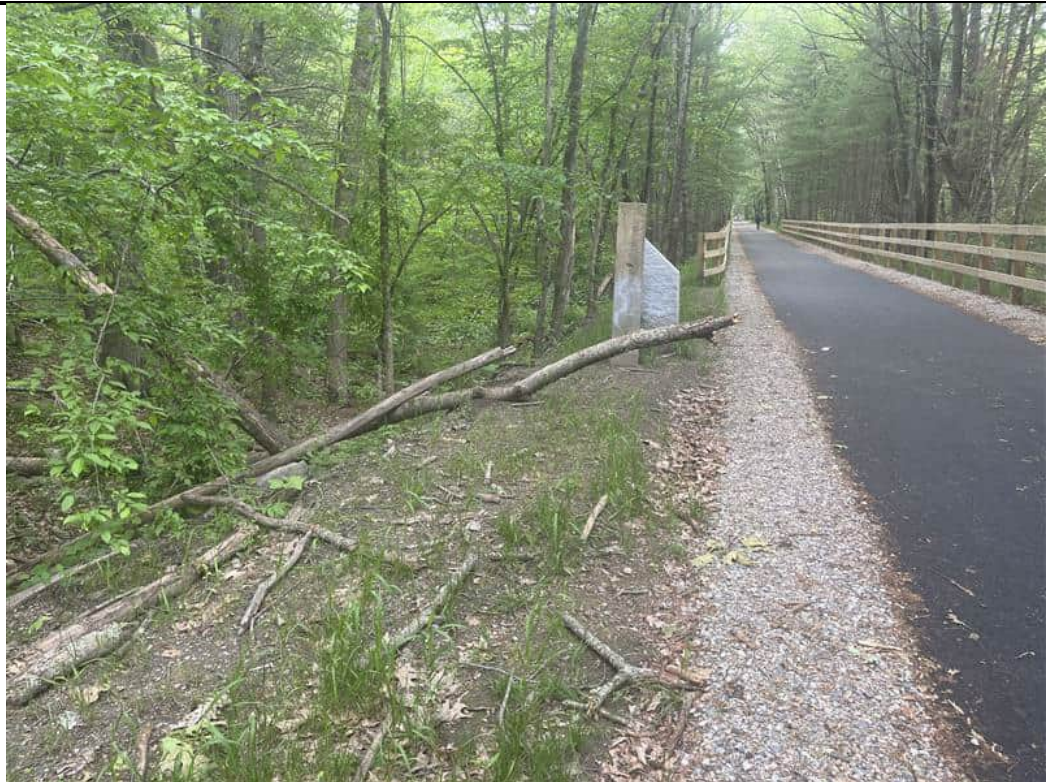
**Photo No. 2**    **Date:**  
5/29/2025

59	Multiple locations of exposed soils along the Project corridor require stabilization <b>Priority: High</b>	9/3/2024	9/10/2024	The contractor should apply the approved seed mixture to areas of exposed soils and place straw.	<p>4/21/2025 - For readability all previous observations have been removed from the report. Please reference the report from 4/14/2025 to see past observations. Observation remains. Vegetation has begun sprouting in some areas that were hydroseeded; however, most areas are not considered fully stabilized. Multiple areas of exposed soil along the trail still require the application of hydroseed. The seed mix used for stabilization should be submitted to the Conservation Commission.</p> <p>4/28/2025 - Observation remains. See previous update.</p> <p>5/5/2025 - Observation remains. Areas where hydroseed was applied have been observed as being partially or fully stabilized. Areas of exposed soil are still present in multiple locations throughout the trail. Further application of hydroseed should occur. The seed mix used for stabilization should be submitted to the Conservation Commission.</p> <p>5/12/2025 - Observation remains. See previous update.</p> <p>5/16/2025 - Observation remains. Areas of exposed soil are present in multiple locations throughout the trail. Further application of hydroseed should occur. The seed mix used for stabilization should be submitted to the Conservation Commission.</p> <p>5/23/2025 - Observation remains. See previous update.</p> <p>5/29/2025 - Observation remains. See update for 5/16/2025.</p>

View of exposed soil that requires stabilization at Station 163+00 per Long Term Compliance Action item 59.

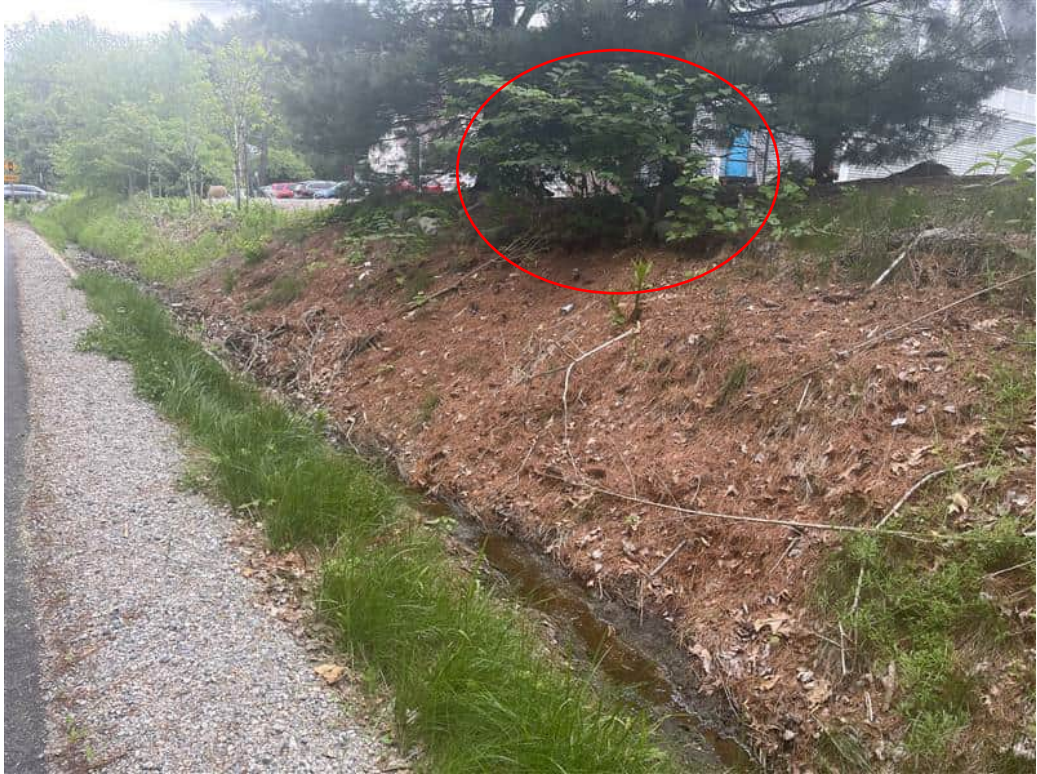
**Photo No. 3**    **Date:**  
5/29/2025

View of Japanese knotweed that require removal in an area of exposed soil at Station 170+00 per Long Term Compliance Action Item 59 and 61.

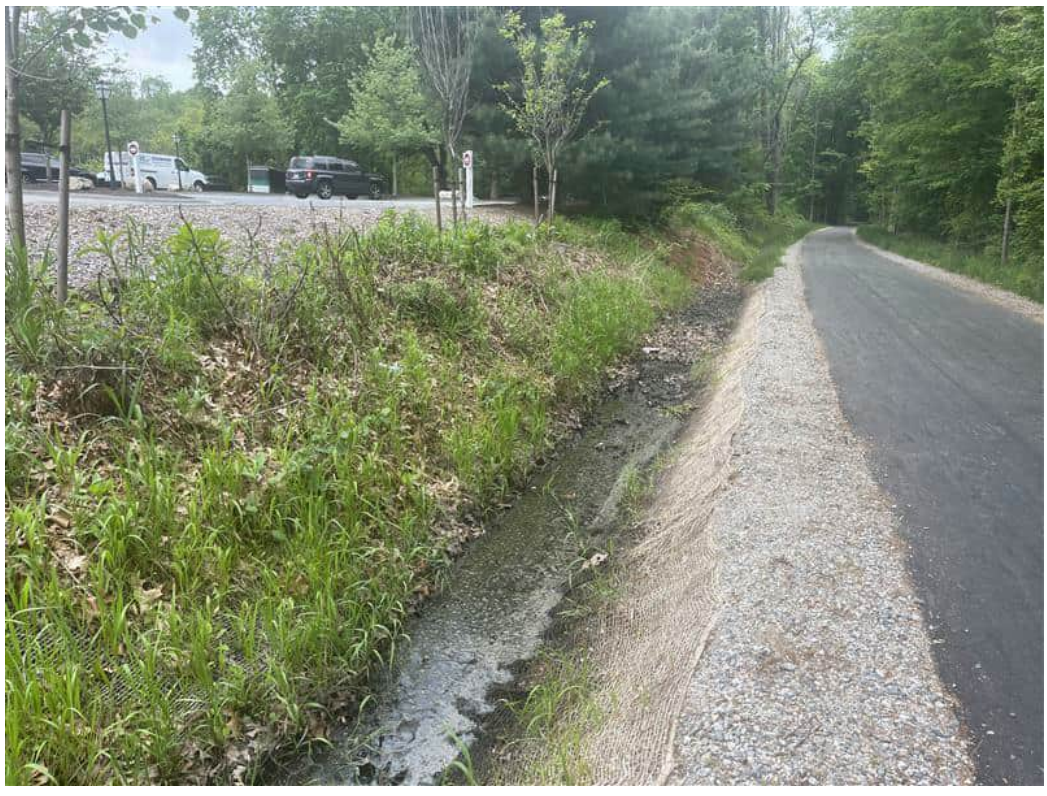
**Photo No. 4**    **Date:**  
5/29/2025

View of the location where stone is present under the leaf litter at Station 172+00 per Compliance Action Item 53.

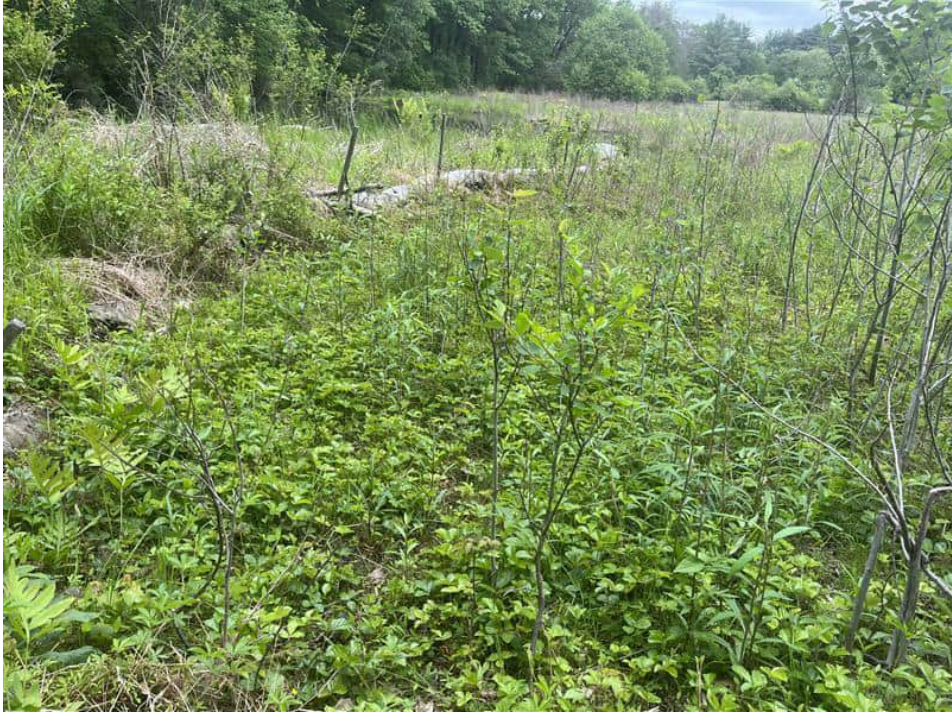
<b>Site Location</b> Bruce Freeman Rail Trail Right-of-Way		<b>BETA Project No.</b> 24.10326.23
<b>Photo No. 5</b>	<b>Date:</b> 5/29/2025

<b>Direction Photo Taken:</b>  Toward the East		
<b>Description:</b>  View of buckthorn within the wetland replication area per Long Term Compliance Action Item 61.		
<b>Photo No. 6</b>	<b>Date:</b> 5/29/2025

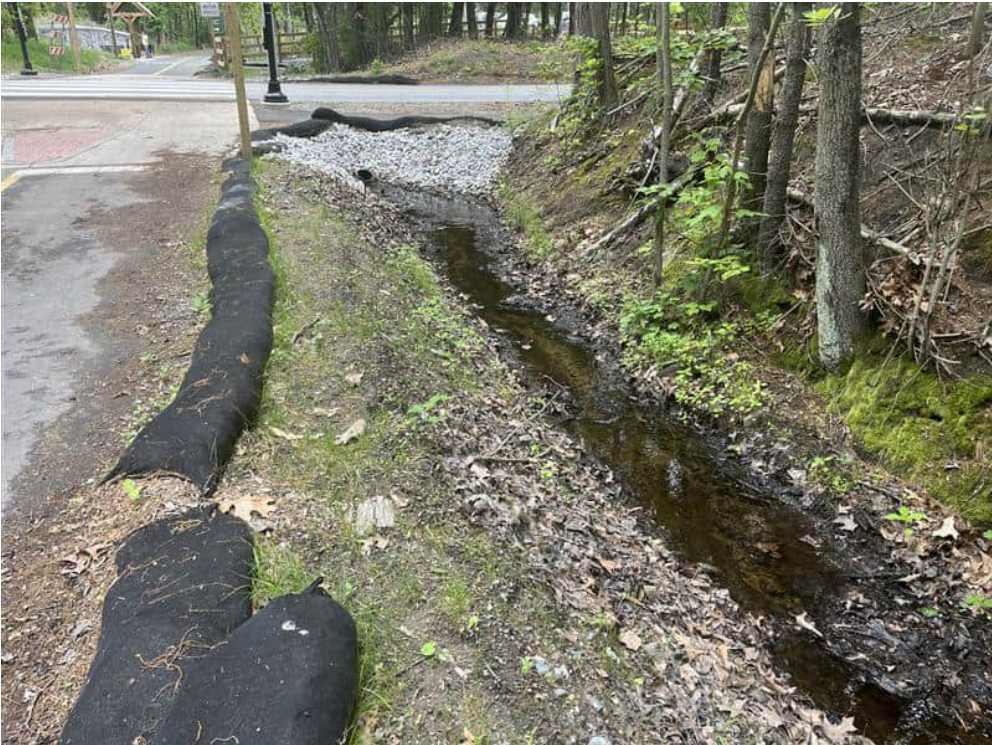
<b>Direction Photo Taken:</b>  Toward the North		
<b>Description:</b>  View of the location where the stream bank has been regraded beyond the limits of work and exposed soils along the Bank at Station 215+75 per Long Term Compliance Action Items 41 and 62. Note some vegetation has been observed along the Bank.

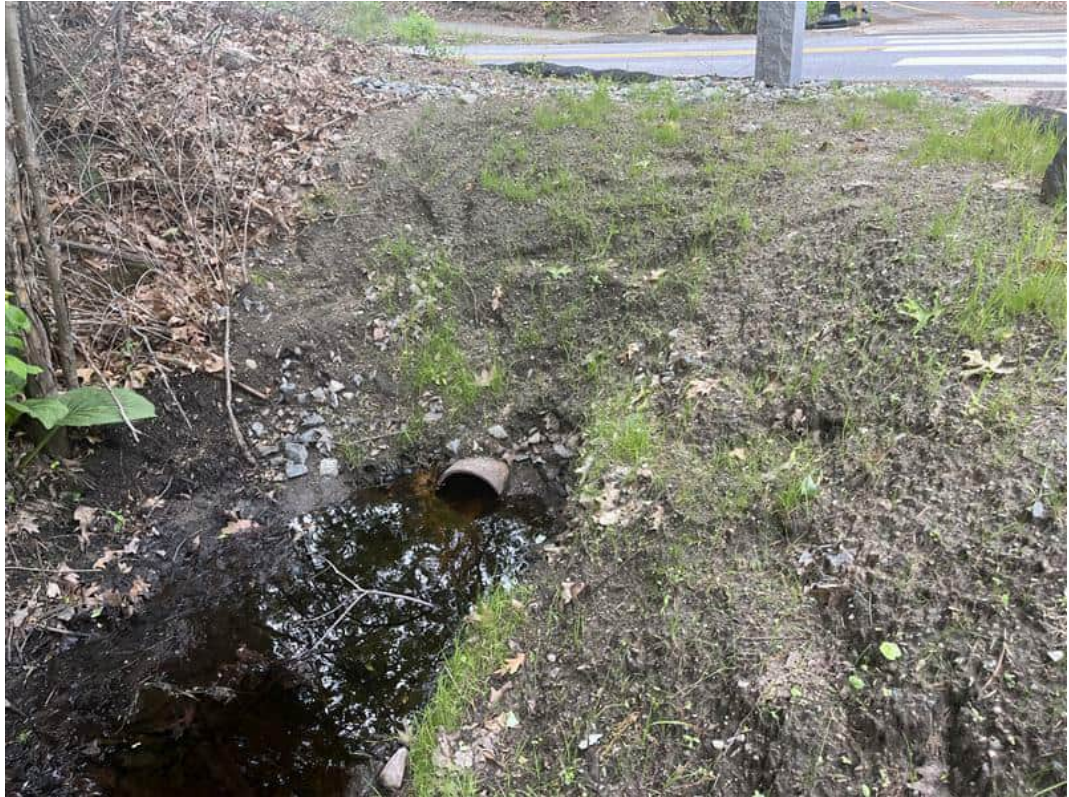
**Photo No. 7**     **Date:**  
5/29/2025

View of exposed soils requiring stabilization and scour erosion at Station 216+00 per Compliance Action Item 62. Note some vegetation has been observed along the Bank.

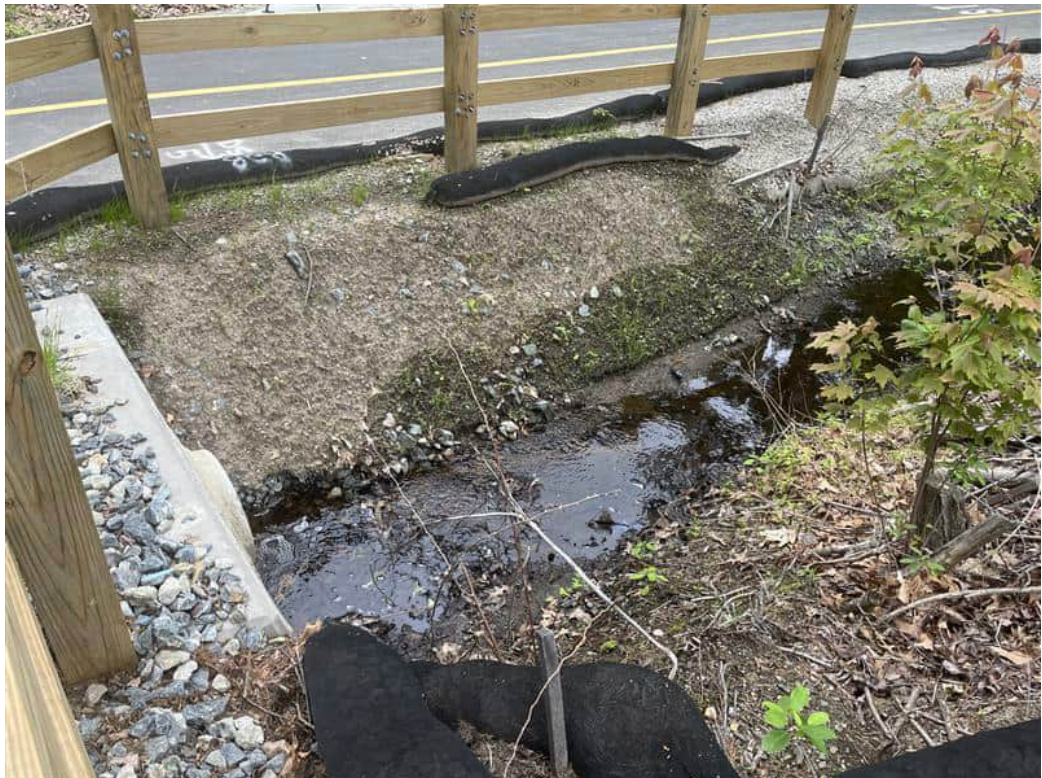
**Photo No. 8**     **Date:**  
5/29/2025

View of exposed soils requiring stabilization and scour erosion at Station 217+25 per Long Term Compliance Action item 62.

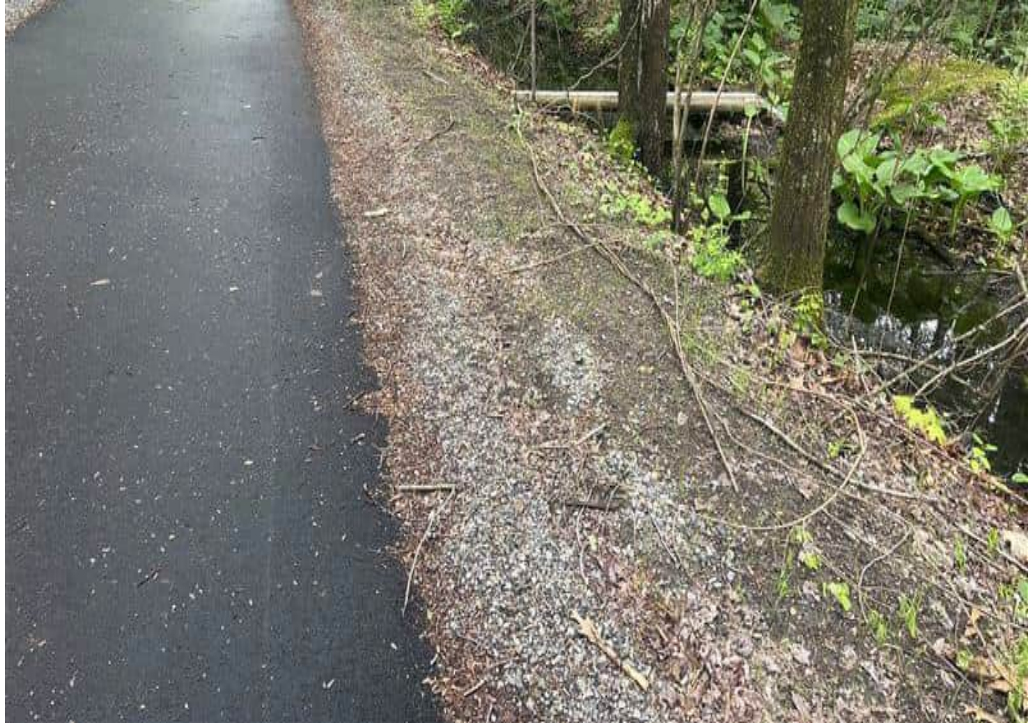
**Photo No. 11**    **Date:**  
5/29/2025

View of exposed soil at Station 294+00 per Long Term Compliance Action Item 61.

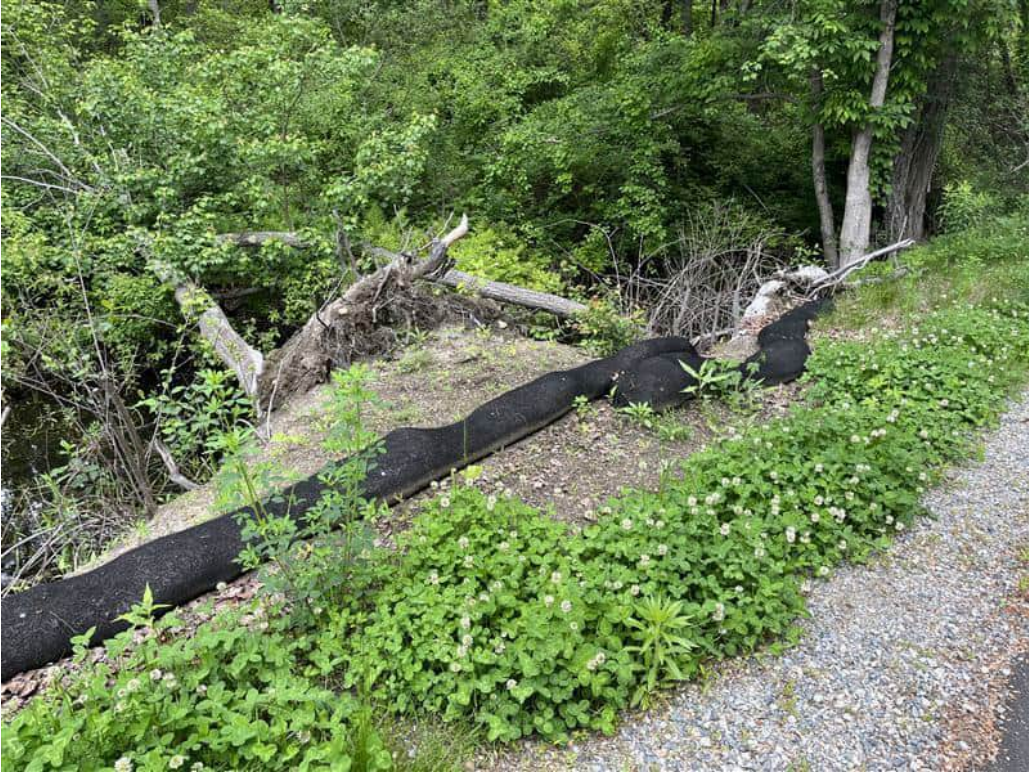
<b>Direction Photo Taken:</b>  Toward the North		
<b>Description:</b>  View of the location of placed loam that requires stabilization at Station 311+50 per Long Term Compliance Action Item 59.		
<b>Photo No. 14</b>	<b>Date:</b> 5/29/2025

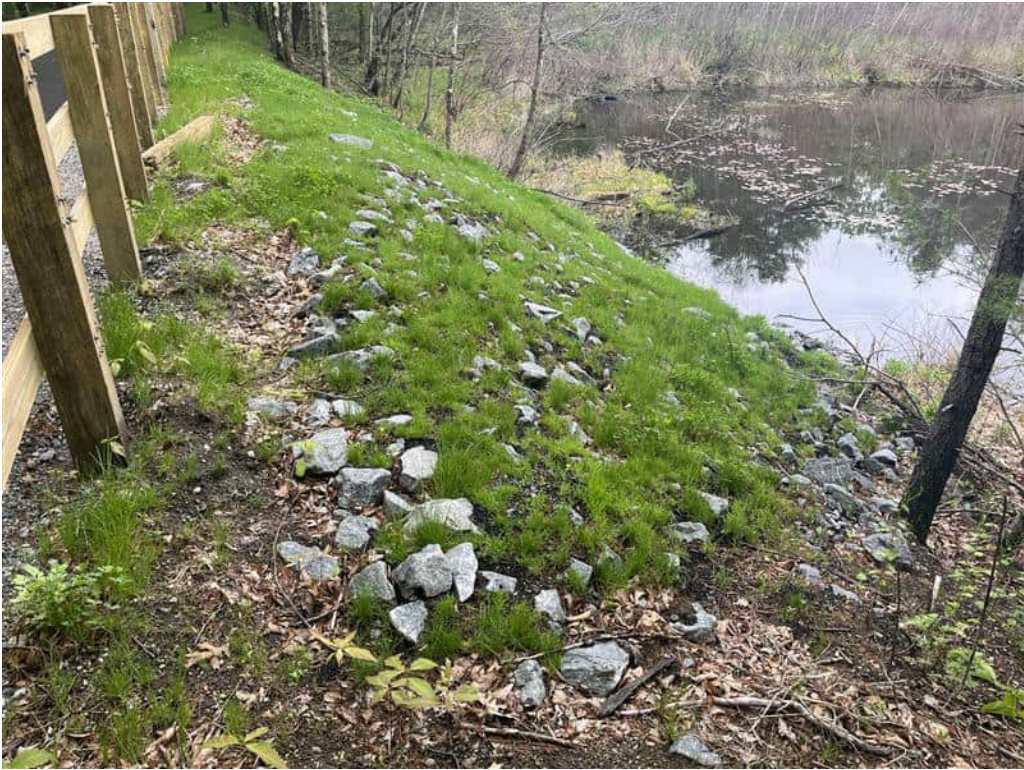
<b>Direction Photo Taken:</b>  Toward the South		
<b>Description:</b>  View of the location of the riprap slope that extends beyond the limit of work along the WF1 Series wetland and exposed soil requiring stabilization at Station 332+00 per Long Term Compliance Action Item 42 and 59.
