Environmental Monitor Construction Site Inspection Report MassDOT Project #608164 Construction Contract # 119678 EM Report #59						
Project Description: Bruce Freeman Rail Trail Right-of-Way Permit Description(s): Order of Conditions (MGL Chapter 131, Section 40 and 310 CMR 10.00, Mass DEP File No. 301-1362); 2022 EPA NPDES General Permit for Discharges from Construction Areas; U.S. Army Corps of Engineers Permit No NAE-2021-01975.

I. General Project Information						
Project Name:	Bruce Freeman Rail Trail - Phase 2d - Sudbury					
Date of Inspections:	6/6/2025					
Bi Weekly/ Monthly Period Covered:	June Weekly Inspection #1					
Inspector's Name(s):	Anna Haznar					
Inspectors' Contact Information:	ahaznar@beta-inc.com					
II. Weather Information						
	Inspection #1	Inspection #2	Inspection #3	Inspection #4	Inspection #5	Inspection #6
WeatherUnderground	Inspector: Anna Haznar 6/6/2025	Inspector:	Inspector:	Inspector:	Inspector:	Inspector:
Type of Inspection (i.e. non-storm event, pre-storm event, during-storm event or post-storm event):	Non-storm					
Number of days since last rain event greater than .25"						
Has there been a storm event since the last inspection?	No					
I

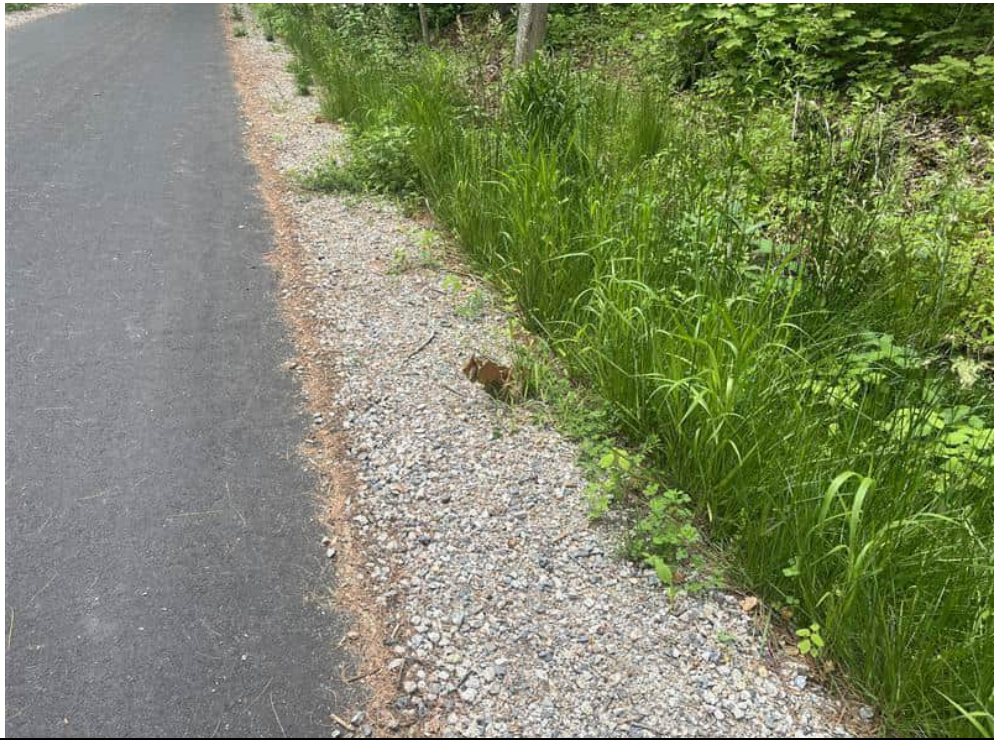
Site Location		Bruce Freeman Rail Trail Right-of-Way	BETA Project No. 24.10326.23
Photo No. 5	Date: 6/6/2025

Direction Photo Taken: Toward the East			
Description: View of Japanese knotweed that was treated at Station 170+00 per Long Term Compliance Action Item 61.			
Photo No. 6	Date: 6/6/2025

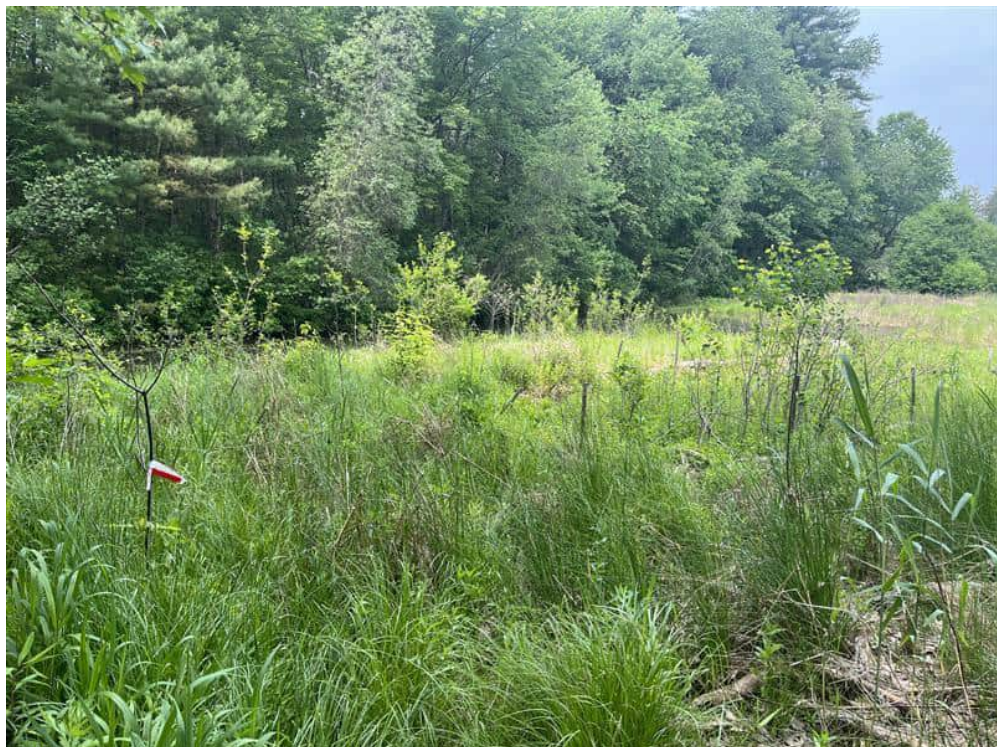
Direction Photo Taken: Toward the North			
Description: View of buckthorn within the wetland replication area per Long Term Compliance Action Item 61.

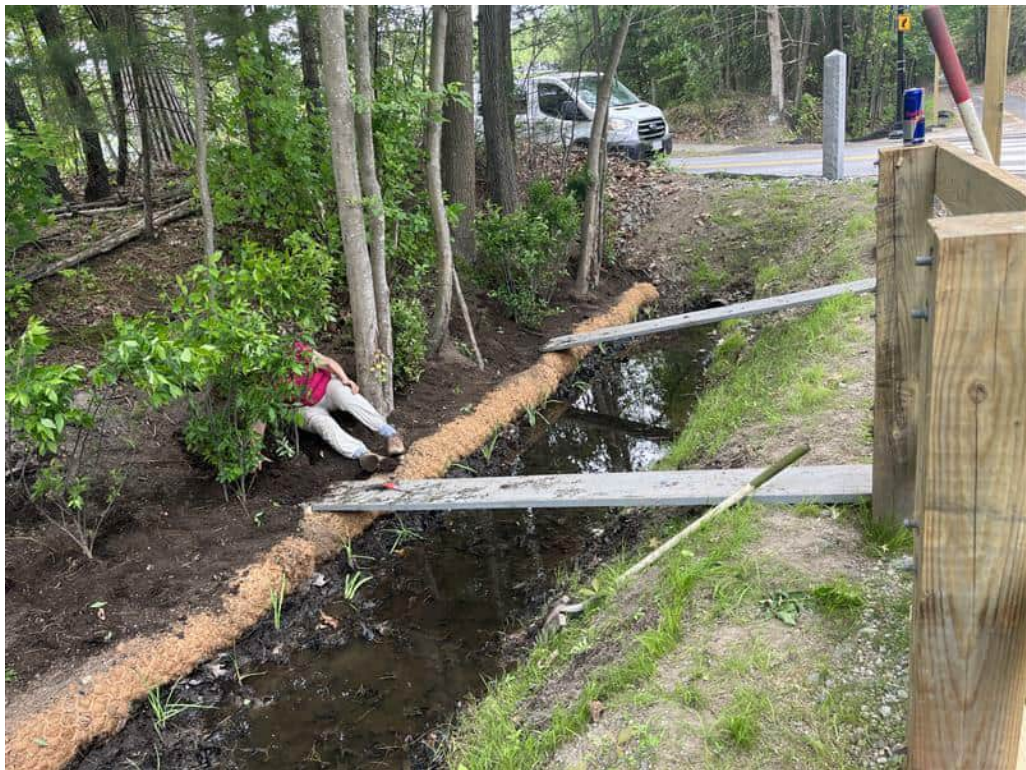
Site Location		Bruce Freeman Rail Trail Right-of-Way	BETA Project No. 24.10326.23
Photo No. 9	Date: 6/6/2025

Direction Photo Taken: Toward the North			
Description: View of exposed soils requiring stabilization and plantings being installed at Station 216+50 per Compliance Action Item 62. Note some vegetation has been observed along the Bank.			
Photo No. 10	Date: 6/6/2025	 	
Direction Photo Taken: Toward the East			
Description: View of exposed soils requiring stabilization at Station 217+25 per Long Term Compliance Action item 62.

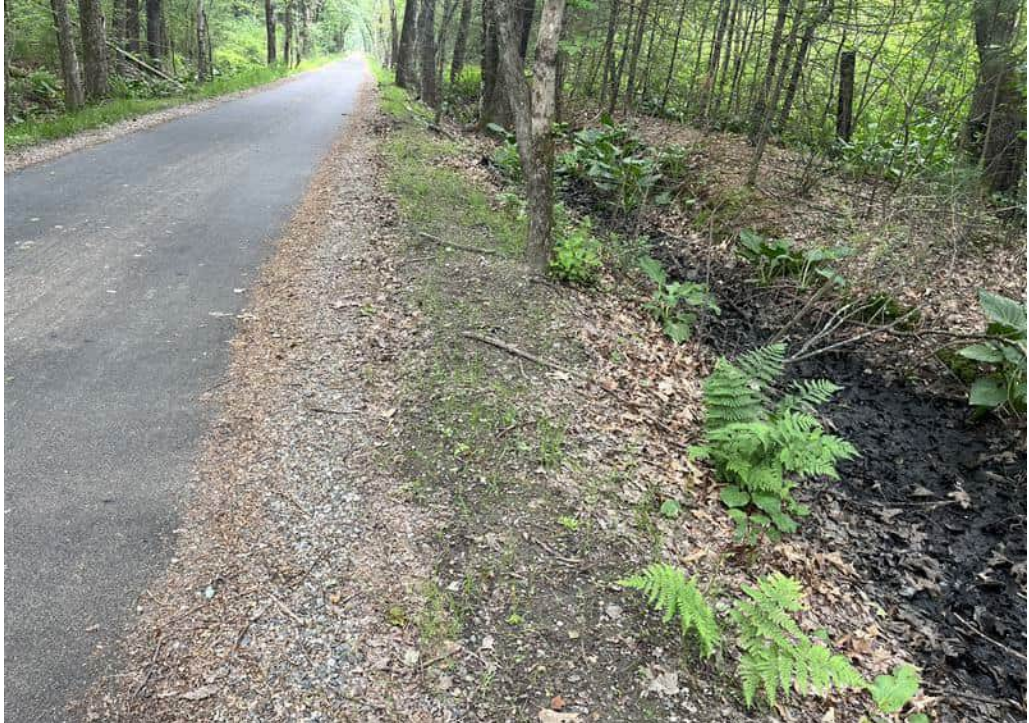
Site Location		Bruce Freeman Rail Trail Right-of-Way	BETA Project No. 24.10326.23
Photo No. 11	Date: 6/6/2025

Direction Photo Taken: Toward the North			
Description: View of exposed soils that require stabilization at Station 252+00 per Long Term Compliance Action Item 59.			
Photo No. 12	Date: 6/6/2025	 	
Direction Photo Taken: Toward the East			
Description: View of the location of placed loam that requires stabilization at Station 311+50 per Long Term Compliance Action Item 59.

59	Multiple locations of exposed soils along the Project corridor require stabilization Priority: High	9/3/2024	9/10/2024	The contactor should apply the approved seed mixture to areas of exposed soils and place straw.	<p>4/21/2025 - For readability all previous observations have been removed from the report. Please reference the report from 4/14/2025 to see past observations. Observation remains. Vegetation has begun sprouting in some areas that were hydroseeded; however, most areas are not considered fully stabilized. Multiple areas of exposed soil along the trail still require the application of hydroseed. The seed mix used for stabilization should be submitted to the Conservation Commission.</p> <p>4/28/2025 - Observation remains. See previous update.</p> <p>5/5/2025 - Observation remains. Areas where hydroseed was applied have been observed as being partially or fully stabilized. Areas of exposed soil are still present in multiple locations throughout the trail. Further application of hydroseed should occur. The seed mix used for stabilization should be submitted to the Conservation Commission.</p> <p>5/12/2025 - Observation remains. See previous update.</p> <p>5/16/2025 - Observation remains. Areas of exposed soil are present in multiple locations throughout the trail. Further application of hydroseed should occur. The seed mix used for stabilization should be submitted to the Conservation Commission.</p> <p>5/23/2025 - Observation remains. See previous update.</p> <p>5/29/2025 - Observation remains. See update for 5/16/2025.</p> <p>6/6/2025 - Observation remains. Further application of hydroseed is required on areas of exposed soils and on areas of sparse vegetation throughout the trail. When hydroseed is applied, leaf litter should be removed to ensure soil to seed contact occurs.</p>
