Environmental Monitor Construction Site Inspection Report MassDOT Project #608164 Construction Contract # 119678 EM Report #60						
Project Description: Bruce Freeman Rail Trail Right-of-Way Permit Description(s): Order of Conditions (MGL Chapter 131, Section 40 and 310 CMR 10.00, Mass DEP File No. 301-1362); 2022 EPA NPDES General Permit for Discharges from Construction Areas; U.S. Army Corps of Engineers Permit No NAE-2021-01975.

I. General Project Information						
Project Name:	Bruce Freeman Rail Trail - Phase 2d - Sudbury					
Date of Inspections:	6/9/2025					
Bi Weekly/ Monthly Period Covered:	June Weekly Inspection #2					
Inspector's Name(s):	Anna Haznar					
Inspectors' Contact Information:	ahaznar@beta-inc.com					
II. Weather Information						
	Inspection #1	Inspection #2	Inspection #3	Inspection #4	Inspection #5	Inspection #6
Weather Underground	Inspector: Anna Haznar 6/6/2025	Inspector: Anna Haznar 6/9/2025	Inspector:	Inspector:	Inspector:	Inspector:
Type of Inspection (i.e. non-storm event, pre-storm event, during-storm event or post-storm event):	Non-storm	Post-storm				
Number of days since last rain event greater than .25"		2				
Has there been a storm event sin

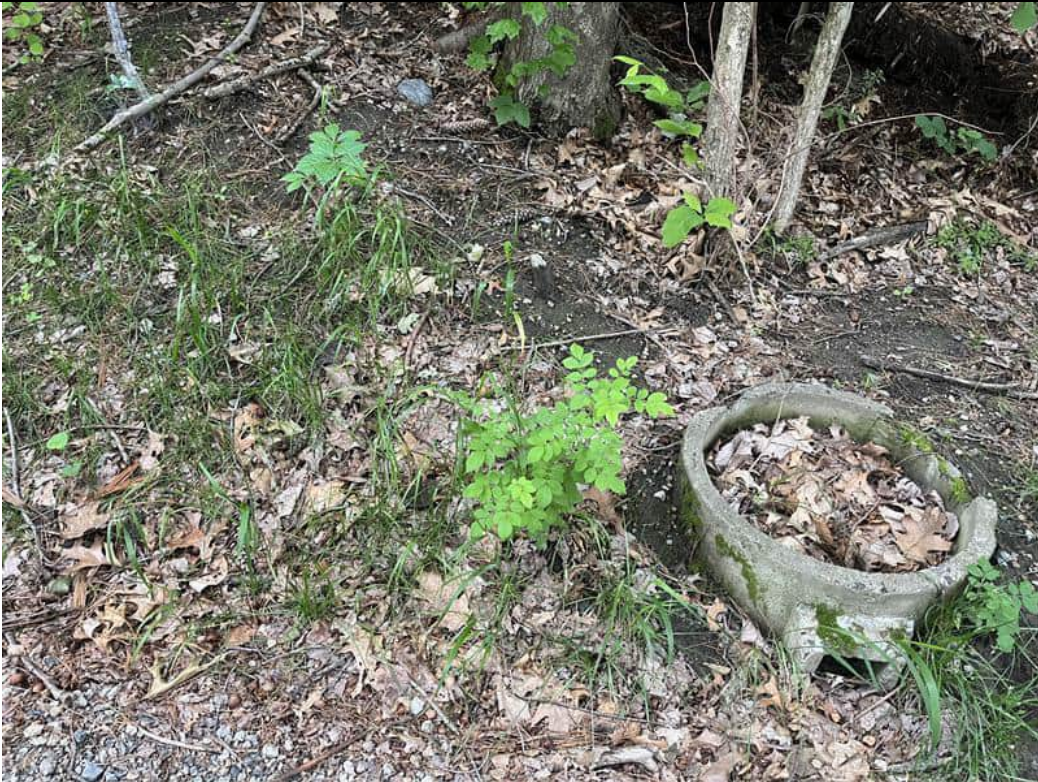
Site Location		Bruce Freeman Rail Trail Right-of-Way	BETA Project No. 24.10326.23
Photo No. 3	Date: 6/9/2025

Direction Photo Taken: Toward the East			
Description: View of exposed soil that requires stabilization and multiflora rose that requires removal at Station 163+00 per Long Term Compliance Action item 59 and 61.			
Photo No. 4	Date: 6/9/2025

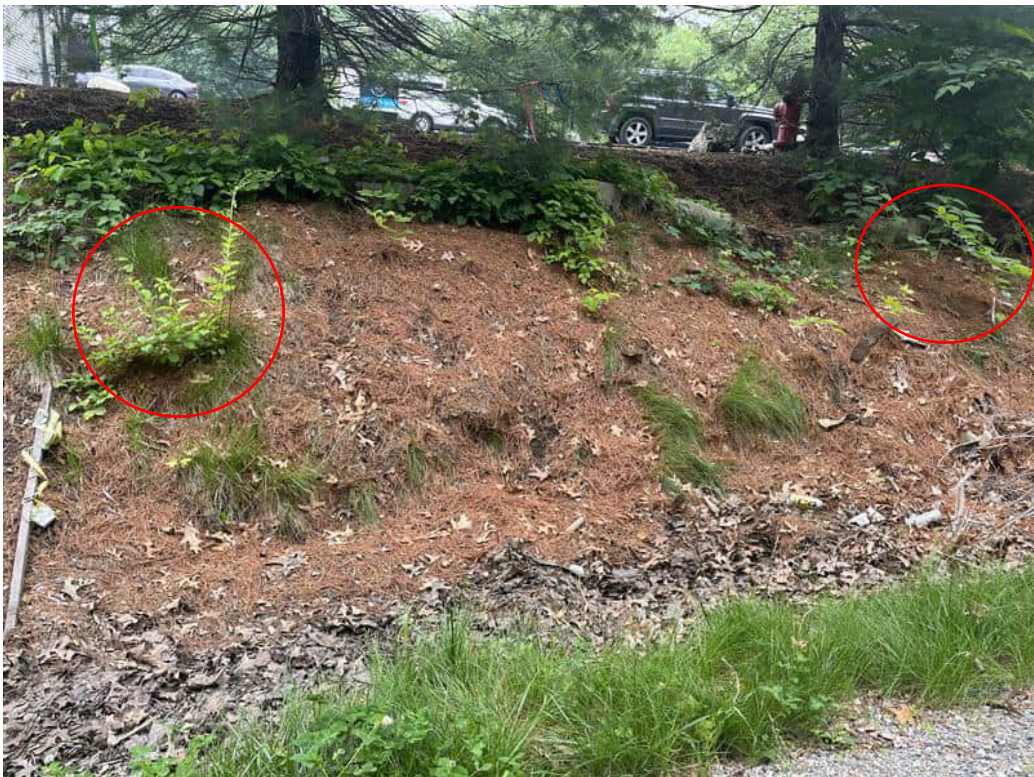
Direction Photo Taken: Toward the East			
Description: View of bittersweet and Japanese knotweed that require removal in an area of exposed soil at Station 172+00 per Long Term Compliance Action Item 59 and 61.

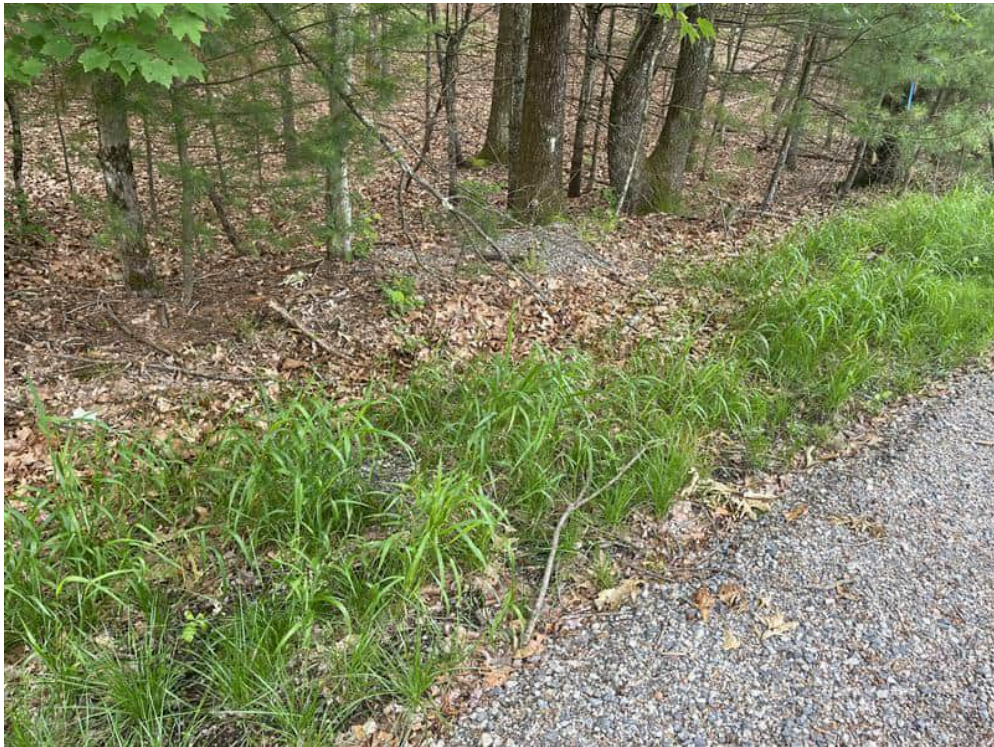
Site Location		Bruce Freeman Rail Trail Right-of-Way	BETA Project No. 24.10326.23
Photo No. 5	Date: 6/9/2025

Direction Photo Taken: Toward the East			
Description: View of a location where crush stone has migrated off of the path at Station 181+00 per Long Term Compliance Action Item 58.			
Photo No. 6	Date: 6/9/2025

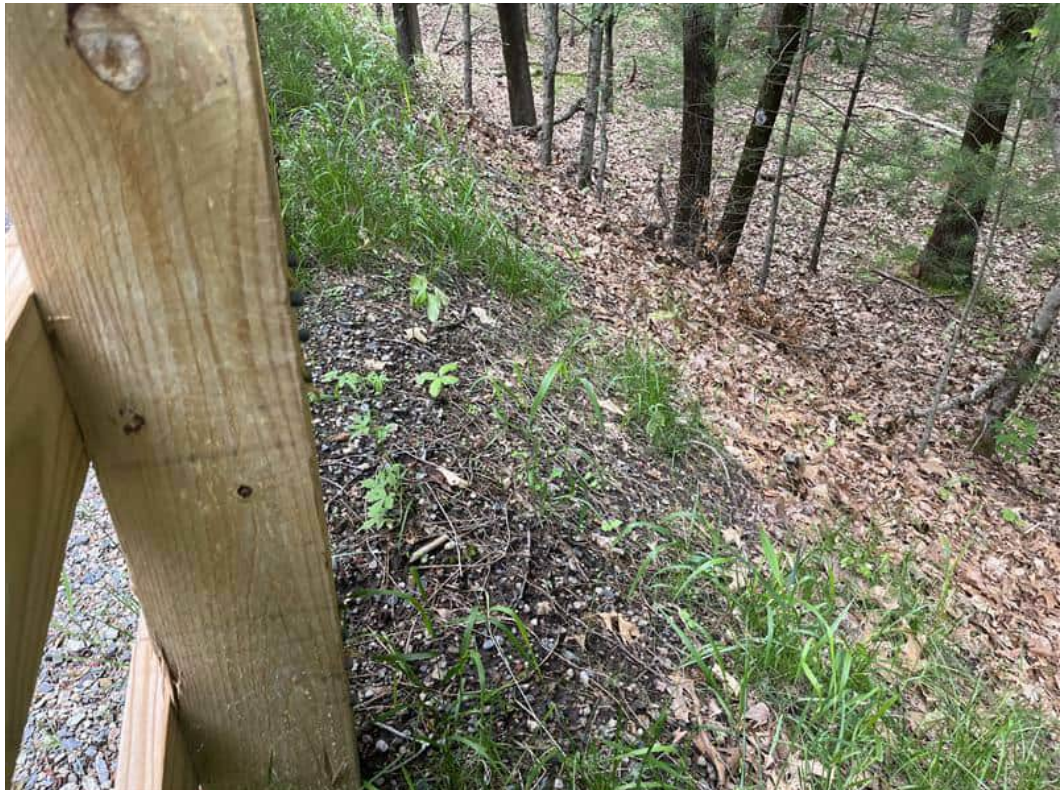
Direction Photo Taken: Toward the North			
Description: View of Japanese hops that require removal within exposed soil that requires stabilization Station 187+00 per Long Term Compliance Action Item 59 and 57-1.

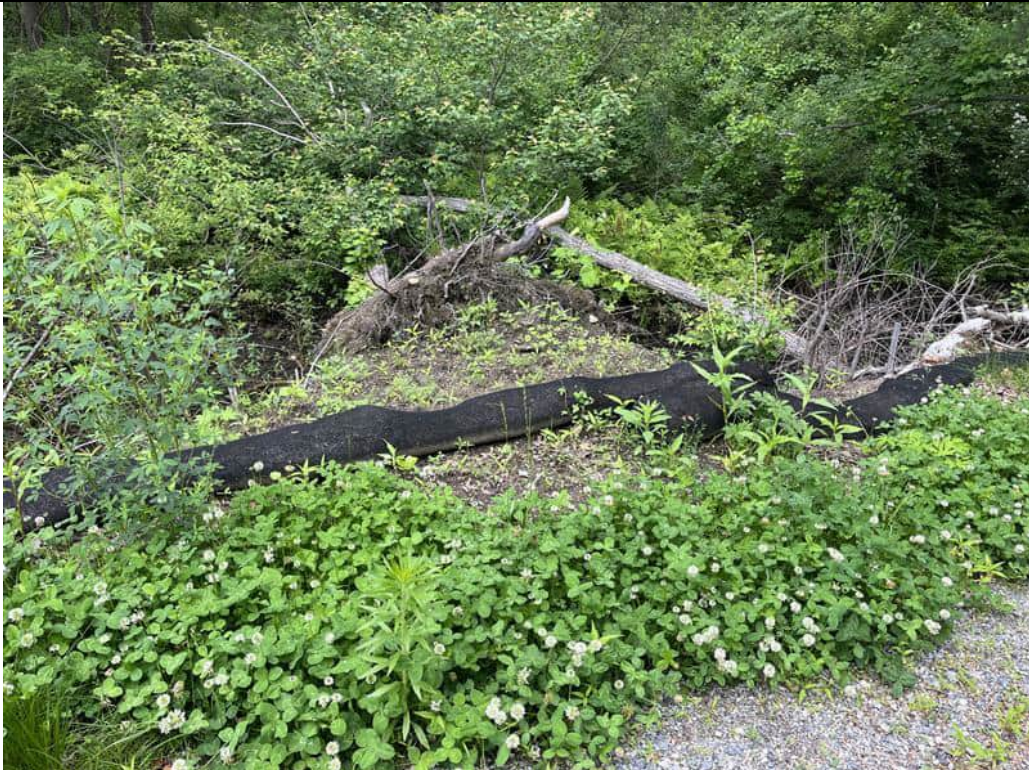
Site Location		BETA Project No.
Bruce Freeman Rail Trail Right-of-Way		24.10326.23
Photo No. 13	Date: 6/9/2025

Direction Photo Taken: Toward the West		
Description: View of the location of placed loam that requires stabilization and Japanese hops within the loam that require removal at Station 311+50 per Long Term Compliance Action Item 59 and 57-1.		
Photo No. 14	Date: 6/9/2025

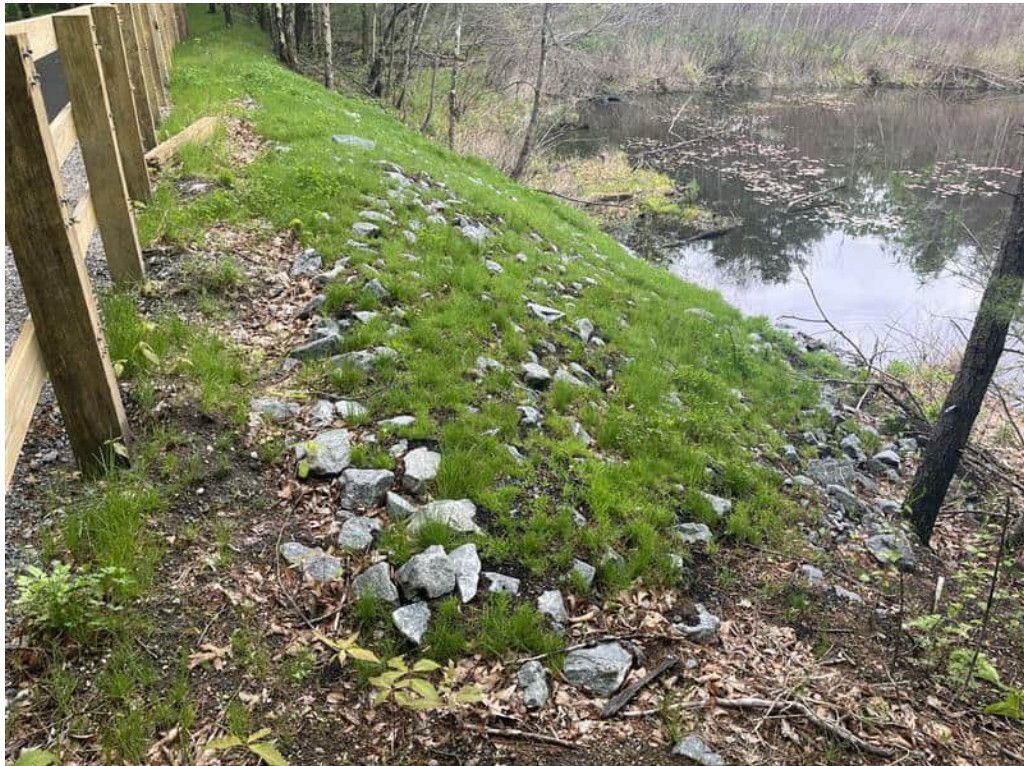
Direction Photo Taken: Toward the South		
Description: View of the location of the riprap slope that extends beyond the limit of work along the WF1 Series wetland and exposed soil requiring stabilization at Station 332+00 per Long Term Compliance Action Item 42 and 59.
