Environmental Monitor Construction Site Inspection Report MassDOT Project #608164 Construction Contract # 119678 EM Report #62						
Project Description: Bruce Freeman Rail Trail Right-of-Way Permit Description(s): Order of Conditions (MGL Chapter 131, Section 40 and 310 CMR 10.00, Mass DEP File No. 301-1362); 2022 EPA NPDES General Permit for Discharges from Construction Areas; U.S. Army Corps of Engineers Permit No NAE-2021-01975.

I. General Project Information						
Project Name:	Bruce Freeman Rail Trail - Phase 2d - Sudbury					
Date of Inspections:	8/8/2025					
Bi Weekly/ Monthly Period Covered:	August Inspection					
Inspector's Name(s):	Anna Haznar					
Inspectors' Contact Information:	ahaznar@beta-inc.com					
II. Weather Information						
	Inspection #1	Inspection #2	Inspection #3	Inspection #4	Inspection #5	Inspection #6
WeatherUnderground	Inspector: Anna Haznar 7/1/2025	Inspector: Anna Haznar 8/8/2025	Inspector:	Inspector:	Inspector:	Inspector:
Type of Inspection (i.e. non-storm event, pre-storm event, during-storm event or post-storm event):	Non-storm	Non-storm				
Number of days since last rain event greater than .25"						
Has there been a storm event since the last

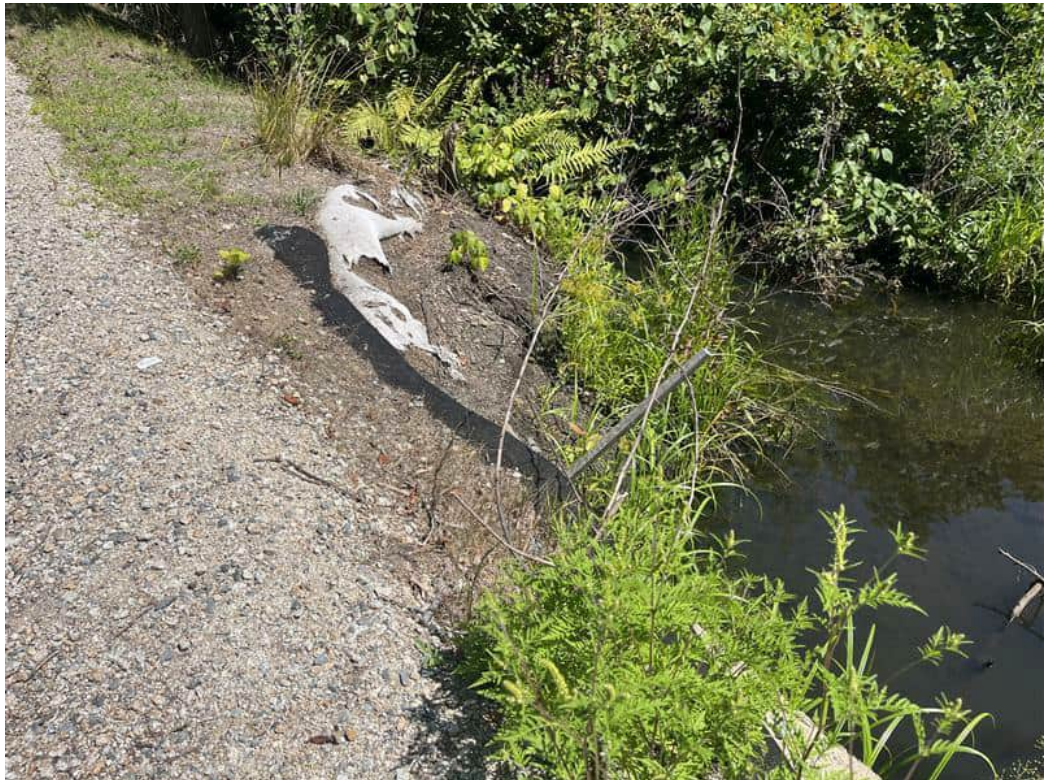
Site Location		Bruce Freeman Rail Trail Right-of-Way	BETA Project No. 24.10326.23
Photo No. 1	Date: 8/8/2025

Direction Photo Taken: Toward the North			
Description: View of the location of the overtopped compost filter tube and exposed soils beyond the limits of work at Station 105+00 per Compliance Action Item 43.			
Photo No. 2	Date: 8/8/2025

43	<p>Overtopped compost filter tubes and exposed soils beyond the limits of work at Station 105+00</p> <p>Priority: High</p>	6/7/2024	6/14/2024	<p>Stabilize the area with the approved seed mixture and provide interim stabilization such as straw mulch.</p>	<p>5/5/2025 - Observation remains. Exposed soil past the limits of work is present and requires further stabilization.</p> <p>5/12/2025 - Observation remains. See previous update.</p> <p>5/16/2025 - Observation remains. Exposed soil past the limits of work is present and requires further stabilization.</p> <p>5/23/2025 - Observation remains. See previous update.</p> <p>5/29/2025 - Observation remains. Exposed soil past the limits of work is present and requires further stabilization.</p> <p>6/6/2025 - Observation remains. See previous update.</p> <p>6/9/2025 - Observation remains. Exposed soil past the limits of work is present and requires further stabilization.</p> <p>7/1/2025 - Observation remains. For readability, observations from 6/14/2024 to 4/28/2025 have been removed - see report #60 for previous observations. Exposed soil past the limits of work is present and requires further stabilization.</p> <p>8/8/2025 - Observation remains. Exposed soil past the limits of work is present and requires further stabilization.</p>

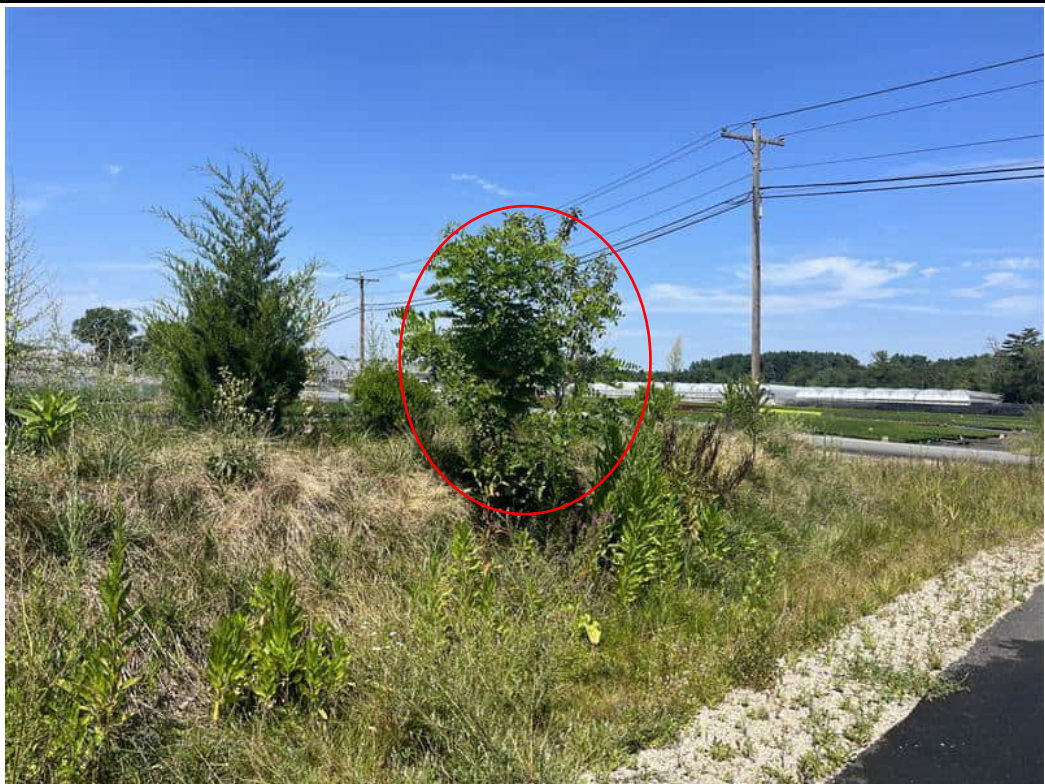
Direction Photo Taken: Toward the Northwest			
Description: View of a black locust that requires removal at Station 115+50 per Long Term Compliance Action item 61.

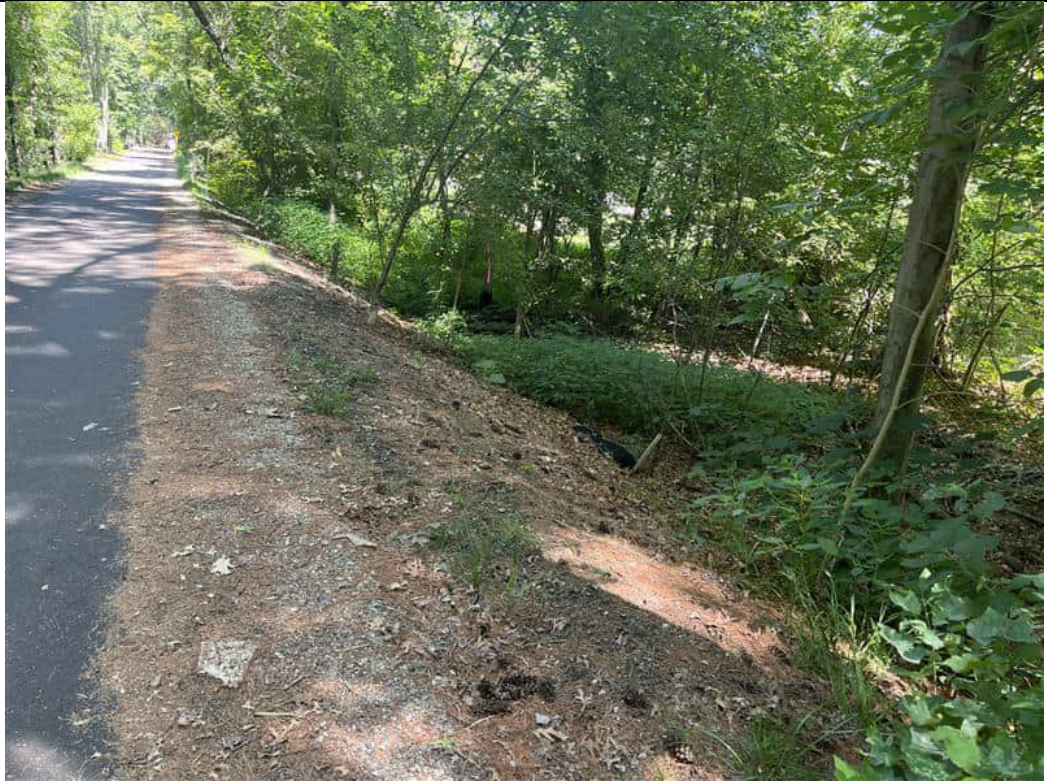
Site Location		Bruce Freeman Rail Trail Right-of-Way	BETA Project No. 24.10326.23
Photo No. 3	Date: 8/8/2025

Direction Photo Taken: Toward the North			
Description: View of exposed soil that requires stabilization at Station 138+00 per Long Term Compliance Action item 59.			
Photo No. 4	Date: 8/8/2025	 	
Direction Photo Taken: Toward the Northeast			
Description: View of Japanese hops within a planted area that require removal at Station 142+50 per Long Term Compliance Action Item 57-1.

59	Multiple locations of exposed soils along the Project corridor require stabilization Priority: High	9/3/2024	9/10/2024	The contractor should apply the approved seed mixture to areas of exposed soils and place straw.	<p>4/21/2025 - For readability all previous observations have been removed from the report. Please reference the report from 4/14/2025 to see past observations. Observation remains. Vegetation has begun sprouting in some areas that were hydroseeded; however, most areas are not considered fully stabilized. Multiple areas of exposed soil along the trail still require the application of hydroseed. The seed mix used for stabilization should be submitted to the Conservation Commission.</p> <p>4/28/2025 - Observation remains. See previous update.</p> <p>5/5/2025 - Observation remains. Areas where hydroseed was applied have been observed as being partially or fully stabilized. Areas of exposed soil are still present in multiple locations throughout the trail. Further application of hydroseed should occur. The seed mix used for stabilization should be submitted to the Conservation Commission.</p> <p>5/12/2025 - Observation remains. See previous update.</p> <p>5/16/2025 - Observation remains. Areas of exposed soil are present in multiple locations throughout the trail. Further application of hydroseed should occur. The seed mix used for stabilization should be submitted to the Conservation Commission.</p> <p>5/23/2025 - Observation remains. See previous update.</p> <p>5/29/2025 - Observation remains. See update for 5/16/2025.</p> <p>6/6/2025 - Observation remains. Further application of hydroseed is required on areas of exposed soils and on areas of sparse vegetation throughout the trail. When hydroseed is applied, leaf litter should be removed to ensure soil to seed contact occurs.</p> <p>6/9/2025 - Observation remains. See previous update.</p> <p>7/1/2025 - Observation remains. Further application of hydroseed is required on areas of exposed soils and on areas of sparse vegetation throughout the trail. When hydroseed is applied, leaf litter should be removed to ensure soil to seed contact occurs.</p> <p>8/8/2025 - Observation remains. Further application of hydroseed was observed along the trail with some vegetative growth. Some areas of exposed soil that were observed during the last inspection have become vegetated; however, populations of non-native species are present throughout these areas. Multiple locations of exposed soil are still present throughout the trail that require further application of seed.</p>

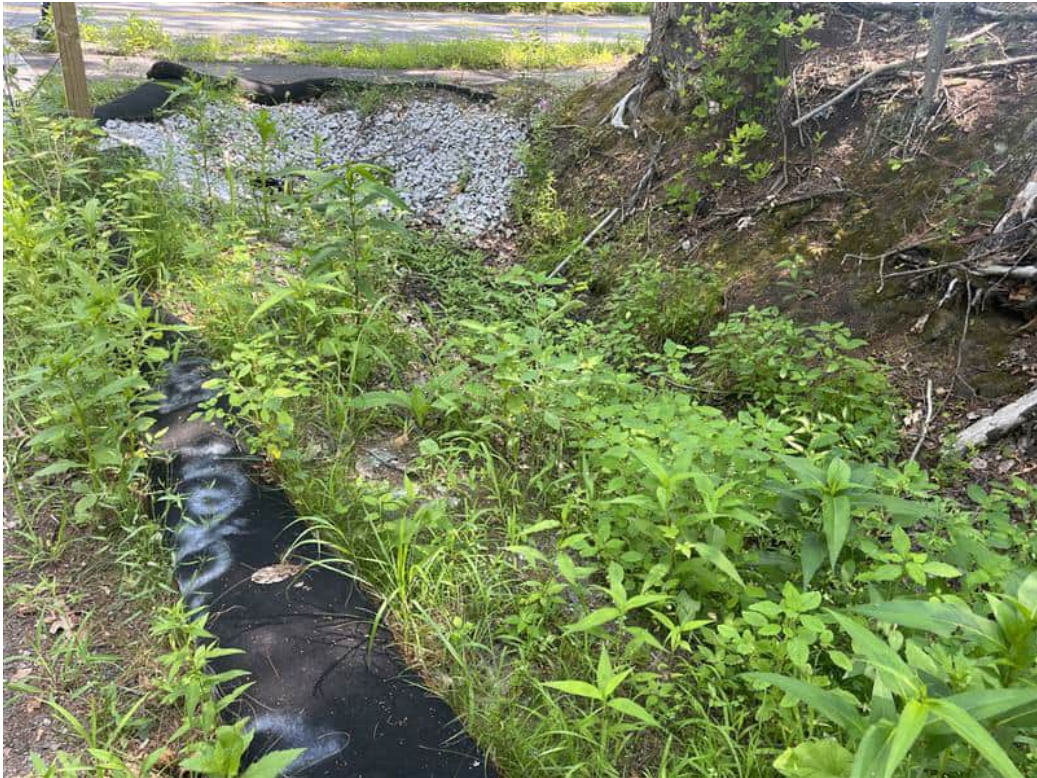
Site Location		Bruce Freeman Rail Trail Right-of-Way	BETA Project No. 24.10326.23
Photo No. 7	Date: 8/8/2025

Direction Photo Taken: Toward the North			
Description: View of the location where the stream bank has been regraded beyond the limits of work at Station 215+75 per Long Term Compliance Action Items 41.			
Photo No. 8	Date: 8/8/2025

41	Stream Bank has been regraded beyond the limit of work at Station 216+00 Priority: High	5/28/2024	6/4/2024	The Contractor should confirm if this work was permitted by the Conservation Commission, as it does not appear to be a part of the approved plans/impacts. MassDOT should be consulted on next steps regarding notification and potential restoration.	5/31/2024 - Observation remains. 6/7/2024 - Observation remains. 6/14/2024 - Observation remains. 6/17/2024 - Observation remains. 6/24/2024 - Observation remains. 6/27/2024 - Observation remains. 7/8/2024- Observation remains. 7/15/2024 - This area could not be assessed due to paving operations ongoing during the inspection. 7/22/2024 - Crushed stone and sediment continue to be discharged to the stream between Stations 215+00 and 217+00 due to overtopped and undermined compost filter tubes. 7/29/2024 - Observation remains. 8/5/2024 - Observation remains. 8/7/2024 - Observation remains. 8/12/2024 - Observation remains. Crushed stone is still present in the streambed at this location. 8/16/2024 - Observation remains. 8/20/2024 - Stone has been removed; however, additional alteration to Resource Areas beyond the limit of work continue. 8/27/2024 - Observation remains. 9/3/2024 - Observation remains. 9/10/2024 - Observation remains. Stone has been observed as discharging into the streambed in this location again. 9/16/2024 - Observation remains. 9/23/2024 - Observation remains. Stone is still present within the streambed at this location. 9/27/2024 - Observation remains. 10/4/2024 - Observation remains. 10/8/2024 - Observation remains. 10/15/2024 - Observation remains. Stone is still present within the streambed at this location. 10/22/2024 - Observation remains. Stone is still present within the streambed at this location. 10/29/2024 - Observation remains. Stone is still present within the streambed at this location. 11/5/2024 - Observation remains. The PVC pipe that was installed at this location was observed to be covered with stone and is no longer visible near Station 215+00. Stone is still present within the streambed at this location. 11/12/2024 - Observation remains. The streambed in this location is covered with leaf litter. See previous update. 11/19/2024 - Observation remains. As discussed with the Conservation Agent in the field, further coordination between the Town and MassDOT will be required to clean/repair the culvert, as the degraded condition of the culvert prompted the contractor to armor the stream banks. Further coordination will also be required for restoration of banks. 7/1/2025 - Observation remains. For readability, observations from 11/22/2025 to 6/9/2025 have been removed - see report #60 for previous observations. See update from 11/19/2024. 8/8/2025 - Observation remains. See update from 11/19/2024.

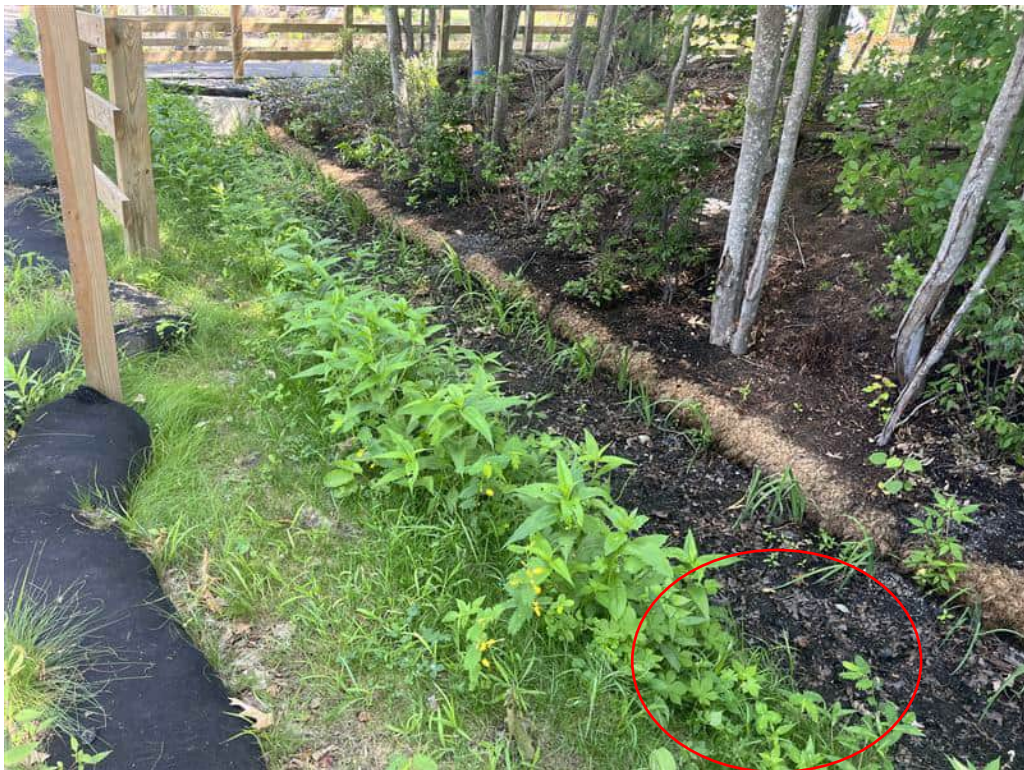
Direction Photo Taken: Toward the North			
Description: View of Japanese hops and garlic mustard requiring removal at Station 216+50 per Compliance Action Item 57-1 and 61.

57-1	<p>Japanese hops (<i>Humulus japonicus</i>) has been observed throughout the Project and requires removal</p> <p>Priority: High</p>	10/22/2024	10/29/2024	<p>The Contractor should manage remaining Japanese hops by hand pulling and the application of herbicide.</p>	<p>10/22/2024 - This Action Item has been reopened due to observations of both dead and living Japanese hops in select locations along the Project. BETA and MassDOT will coordinate further with the Sudbury Conservation Agent to clarify the extents of remaining living vegetation as removal efforts progress.</p> <p>10/29/2024 - Plants that were observed as alive along Route 117 during the last inspection were observed to be wilting due to winter die back.</p> <p>4/14/2025 - Japanese hops were observed within Parkinsons Field and require removal.</p> <p>4/21/2025 - Japanese hops were observed within Parkinsons Field and require removal. Japanese hops have not been observed in other locations throughout the trail.</p> <p>4/28/2025 - Observation remains. See previous update.</p> <p>5/5/2025 - Observation remains. Japanese hops have been observed in multiple locations throughout the trail. Management should occur prior to the setting of seed to ensure further spread does not occur.</p> <p>5/12/2025 - Observation remains. See previous update.</p> <p>5/16/2025 - Observation remains. Japanese hops have been observed throughout the trail in both vegetated areas and areas of exposed soils. Management should occur prior to the setting of seed to ensure further spread does not occur.</p> <p>5/23/2025 - Observation remains. See previous update.</p> <p>5/29/2025 - Observation remains. For readability, observations from 11/5/2024 to 4/7/2025 have been removed. Japanese hops have been observed throughout the trail in both vegetated areas and areas of exposed soils. Management should occur prior to the setting of seed to ensure further spread does not occur.</p> <p>6/6/2025 - Observation remains. Treatment occurred on some plants throughout the trail; however, evidence of treatment was not observed on all plants. Japanese hops will continue to be monitored to evaluate the success of the treatment.</p> <p>6/9/2025 - Observation remains. No further evidence of treatment has been observed on Japanese hops throughout the trail. Multiple populations were observed both in areas of exposed soil and in vegetated areas. Vines were also observed within plantings.</p> <p>7/1/2025 - Observation remains. Japanese hops are present throughout the trail and were observed within areas of minimal vegetation and within plantings.</p> <p>8/8/2025 - Observation remains. Populations of Japanese hops are present throughout the trail. Japanese hops were observed within planted areas climbing plantings in multiple locations.</p>

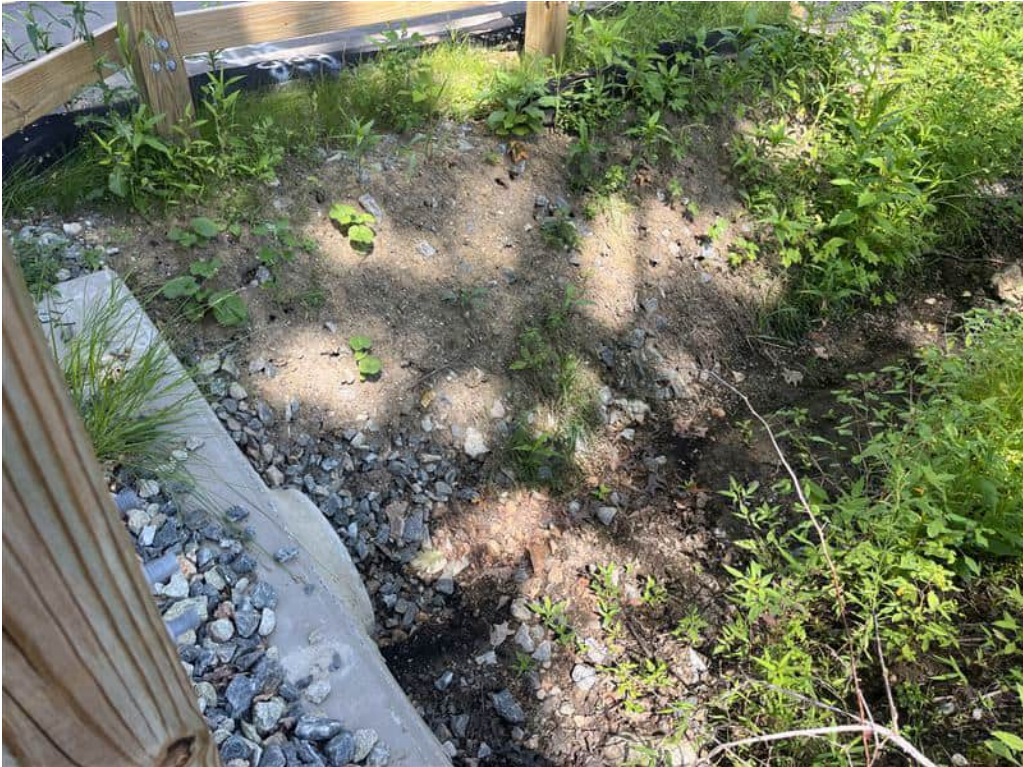
Site Location		Bruce Freeman Rail Trail Right-of-Way	BETA Project No. 24.10326.23
Photo No. 9	Date: 8/8/2025

Direction Photo Taken: Toward the West			
Description: View of exposed soil that requires stabilization and erosion at Station 217+25 per Compliance Action item 62.			
Photo No. 10	Date: 8/8/2025

Item	Location/ Description	Observation Date	Resolution Due Date	Recommended Resolution / Resolution Date	Comments/Updates
62	Loam and seed was applied to the streambank at Station 215+00 to 217+00 and requires further stabilization Priority: High	11/25/2024	12/2/2024	An erosion control blanket should be installed along this slope.	<p>4/2/2025 - Observation remains. Loam was observed to have eroded and discharged into the stream at Station 215+75. Rill erosion was also observed on the streambank at Station 216+25.</p> <p>4/7/2025 - Observation remains. Stone has been installed around the culvert at Station 215+75 to stabilize the Bank. No further discharge in this location was observed; however stabilization still required.</p> <p>4/14/2025 - Observation remains. Some vegetative growth was observed along the Bank of the stream at Station 216+25; however, the area is not considered stabilized. Hydroseed should be applied to the exposed soil.</p> <p>4/21/2025 - Observation remains. No further vegetative growth was observed along the Bank of the stream. Hydroseed should be applied to the exposed soil.</p> <p>4/28/2025 - Observation remains.</p> <p>5/5/2025 - Observation remains. Vegetation has begun stabilization the slope along the stream at Station 215+00 to 216+50; however, these areas are not considered fully stabilized and will continue to be monitored to determine if further stabilization is required. The slope at Station 216+50 to 217+00 currently requires further stabilization as minimal vegetation has germinated on this slope.</p> <p>5/12/2025 - Observation remains. Vegetation has partially stabilized the slope at Station 215+00 to 217+00; however further application of seed is required.</p> <p>5/16/2025 - Observation remains. See previous update.</p> <p>5/23/2025 - Observation remains. Scour erosion as a result of heavy rainfall was observed directly adjacent to the culverts at Station 216+00 and 217+00 . Further seed should be applied to the slopes adjacent to the stream to provide stabilization.</p> <p>5/29/2025 - Observation remains. The slopes from Station 215+50 to Station 216+50 have become partially stabilized due to vegetative growth and the slope at Station 217+00 has minimal vegetative cover. Seed should be applied to these slopes to achieve full stabilization. The seed mix used for stabilization should be submitted to the Conservation Commission.</p> <p>6/6/2025 - Observation remains. See previous update. Plantings were installed along the Bank and the path at Station 216+00 to Station 216+50. Garlic mustard was observed along the slope at Station 216+25, observations regarding invasive species will be addressed in Long Term Compliance Action Item 61.</p> <p>6/9/2025 - Observation remains. See previous update. Further hydroseed should be applied to the Banks so full stabilization can be achieved.</p> <p>7/1/2025 - Observation remains. For readability, observations from 12/2/2024 to 2/11/2025 have been removed - see report #60 for previous observations. These slopes were observed to be partially stabilized; however, some of the vegetation observed includes garlic mustard and Japanese hops that require removal. Further scour erosion that appears to have caused sediment and stone to discharge into the stream was observed adjacent to the culvert at Station 217+00.</p> <p>8/8/2025 - Observation remains. The slopes from 215+00 to 216+50 were observed as being stabilized; however, vegetation along the slopes consists of populations of native and non-native species including lady's thumb (<i>Persicaria maculosa</i>) and Japanese hops (<i>Humulus japonicus</i>). Further erosion that appeared to have caused sediment and stone to discharge into the stream was observed along the slope at Station 217+00; minimal vegetative cover is present along this slope. An erosion control blanket and seed should be installed along this slope to prevent further erosion.</p>

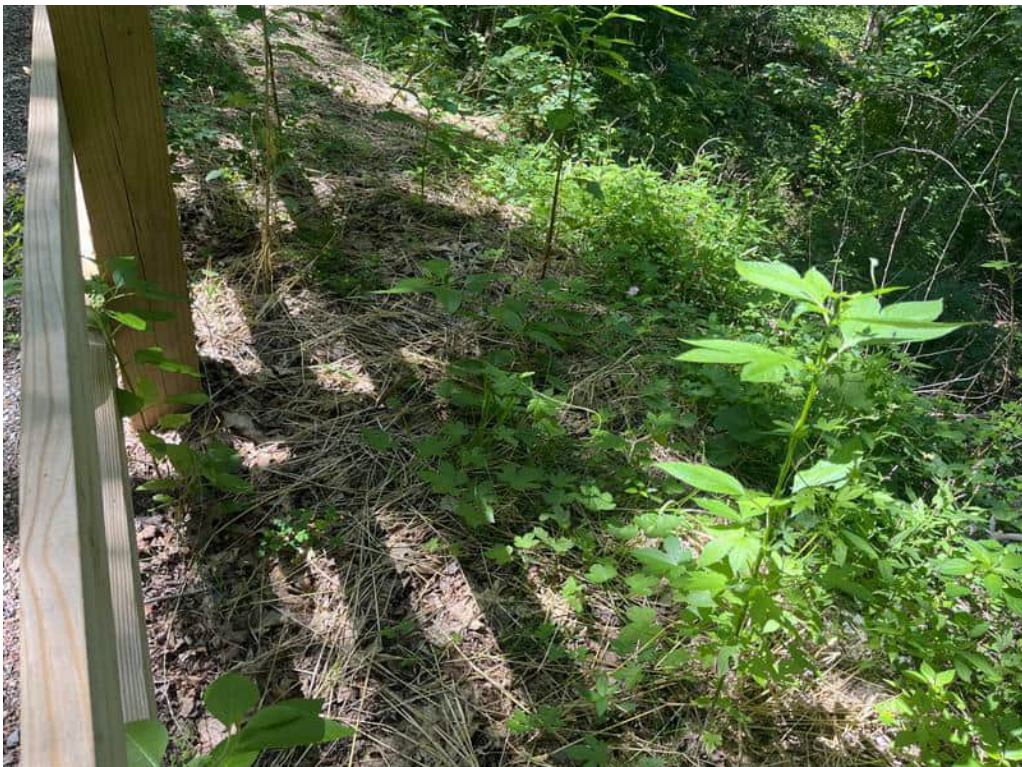
Direction Photo Taken: Toward the South			
Description: View of an area of exposed soil and Japanese hops that requires removal at Station 228+00 per Long Term Compliance Action Item 57-1 and 59.

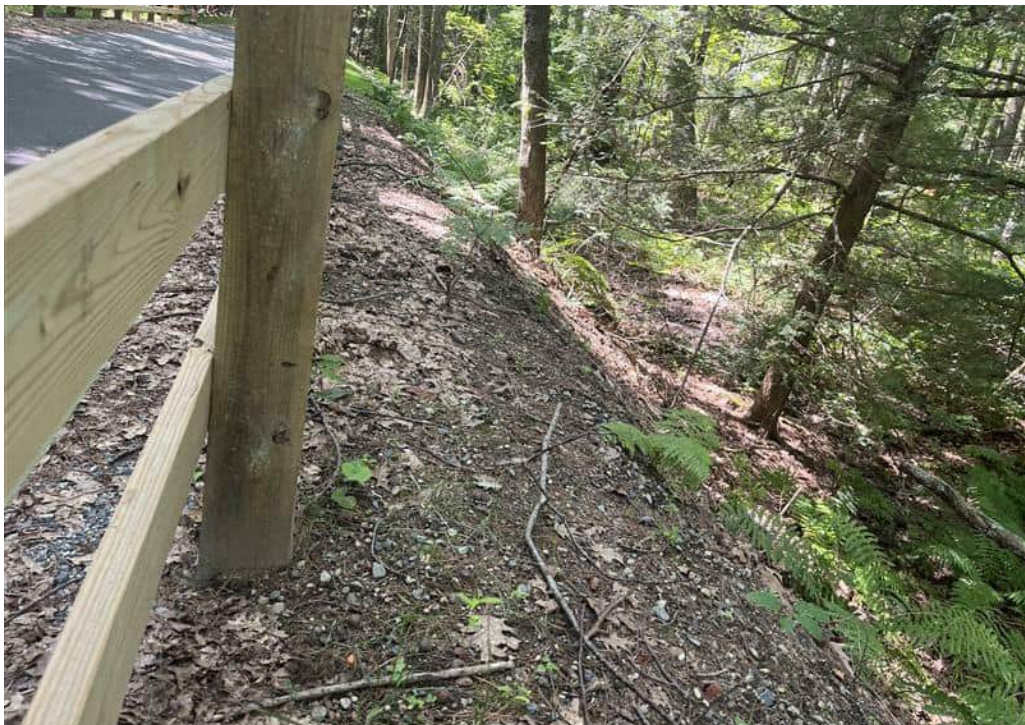
Site Location Bruce Freeman Rail Trail Right-of-Way		BETA Project No. 24.10326.23
Photo No. 11	Date: 8/8/2025

Direction Photo Taken: Toward the South		
Description: View of exposed soils that require stabilization at Station 244+00 per Long Term Compliance Action Item 59.		
Photo No. 12	Date: 8/8/2025

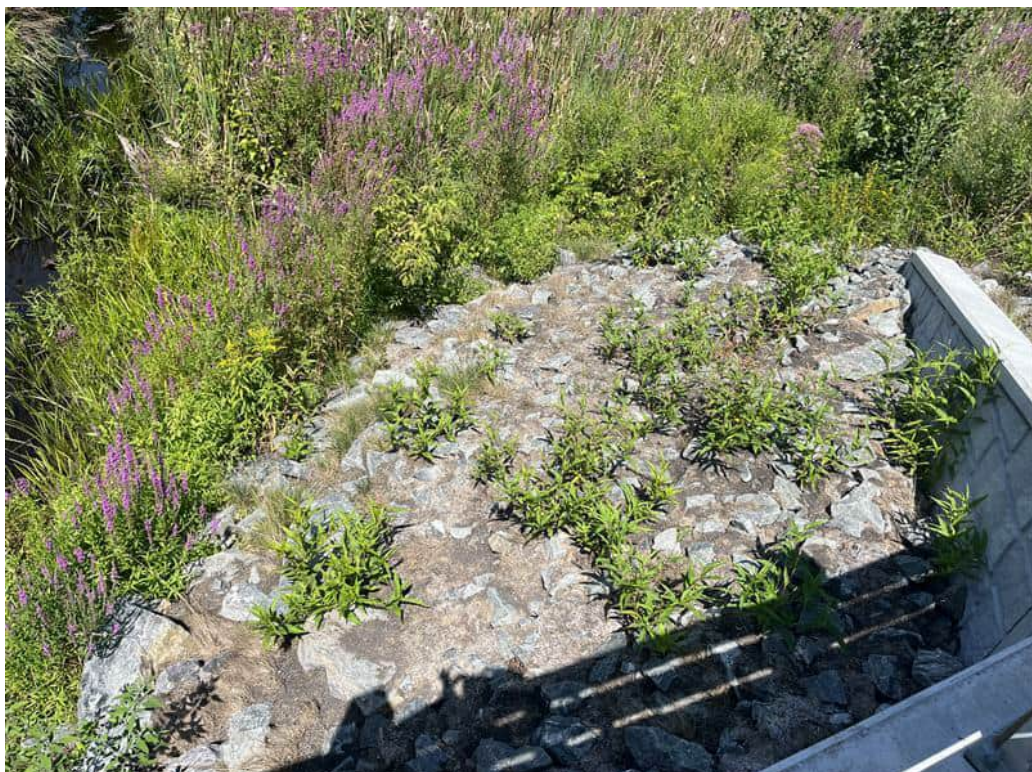
Direction Photo Taken: Toward the West		
Description: View of exposed soils along the Bank of Pantry Brook that requires the application of seed at Station 264+50 per Long Term Compliance Action Item 59.

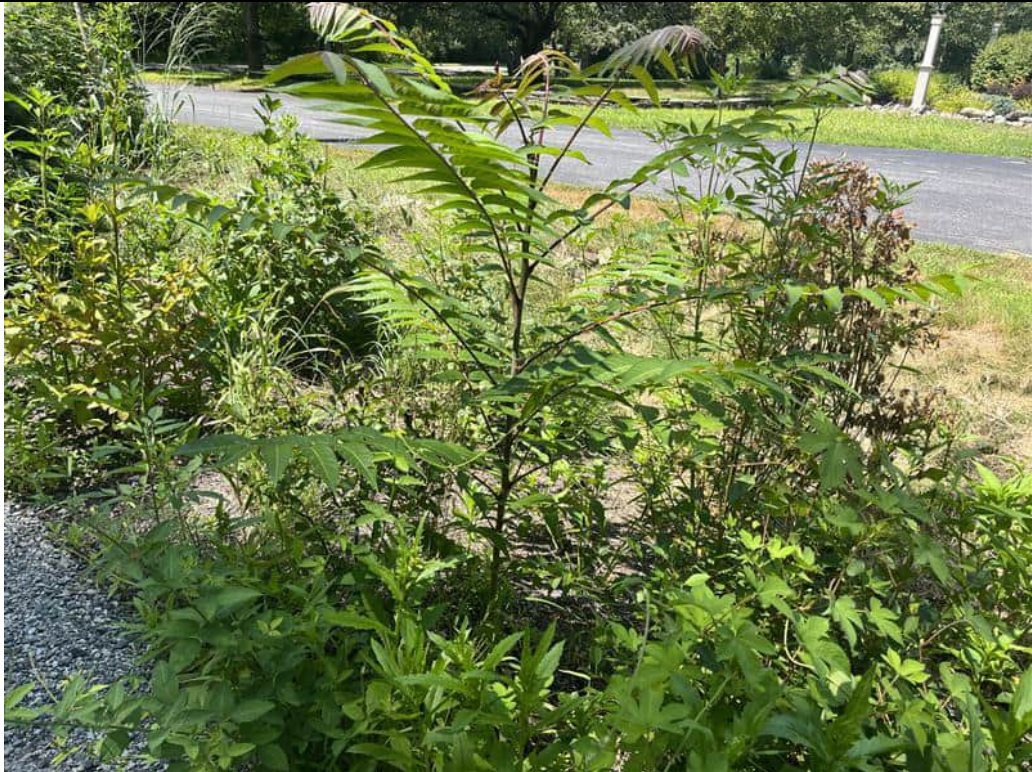
Site Location		Bruce Freeman Rail Trail Right-of-Way	BETA Project No. 24.10326.23
Photo No. 13	Date: 8/8/2025

Direction Photo Taken: Toward the West			
Description: View of tree of heaven and Japanese hops that require removal at Station 278+00 per Long Term Compliance Item 57-1 and 61.			
Photo No. 14	Date: 8/8/2025

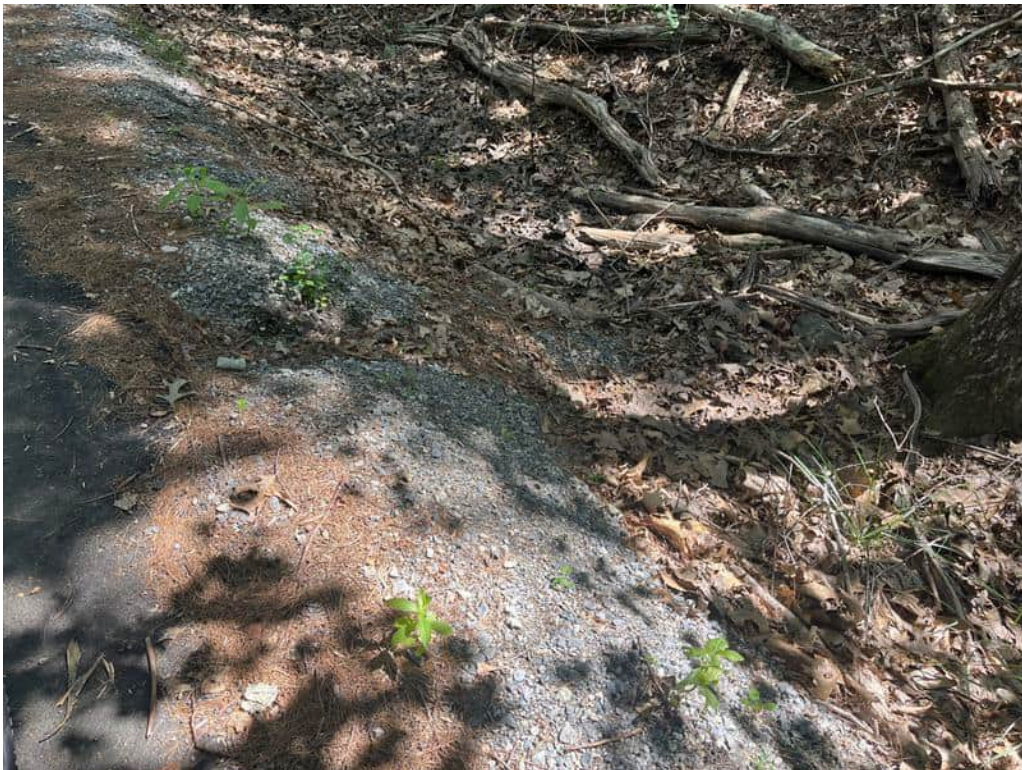
Direction Photo Taken: Toward the Northeast			
Description: View of a location where crushed stone has migrated off of the path at Station 303+00 per Compliance Action Item 58.

58	Crushed stone used for the dense graded crush stone shoulders has been observed as migrating both onto the path, off the sides of the path, and into the adjacent Resource Areas throughout the Project Priority: High	8/7/2024	8/14/2024	Remove all crushed stone from Resource Areas and develop a plan to cease discharges of stone.	<p>4/21/2025 - For readability all previous observations have been removed from the report. Please reference the report from 4/14/2025 to see past observations. Observation remains. Crushed stone was observed both on and off the trail in multiple locations.</p> <p>4/28/2025 - Observation remains. See previous update.</p> <p>5/5/2025 - Observation remains. See update from 4/21/2025.</p> <p>5/12/2025 - Observation remains. See update from 4/21/2025.</p> <p>5/16/2025 - Observation remains. Crushed stone is present both on and on the side of the trail in multiple locations.</p> <p>5/23/2025 - Observation remains. See previous update.</p> <p>5/29/2025 - Observation remains. Crushed stone is present both on and on the side of the trail in multiple locations.</p> <p>6/6/2025 - Observation remains. See previous update.</p> <p>6/9/2025 - Observation remains. Crushed stone is present both on and on the side of the trail in multiple locations.</p> <p>7/1/2025 - Observation remains. Crushed stone is present both on and on the side of the trail in multiple locations.</p> <p>8/8/2025 - Observation remains. Crushed stone is present both on and on the side of the trail in multiple locations.</p>

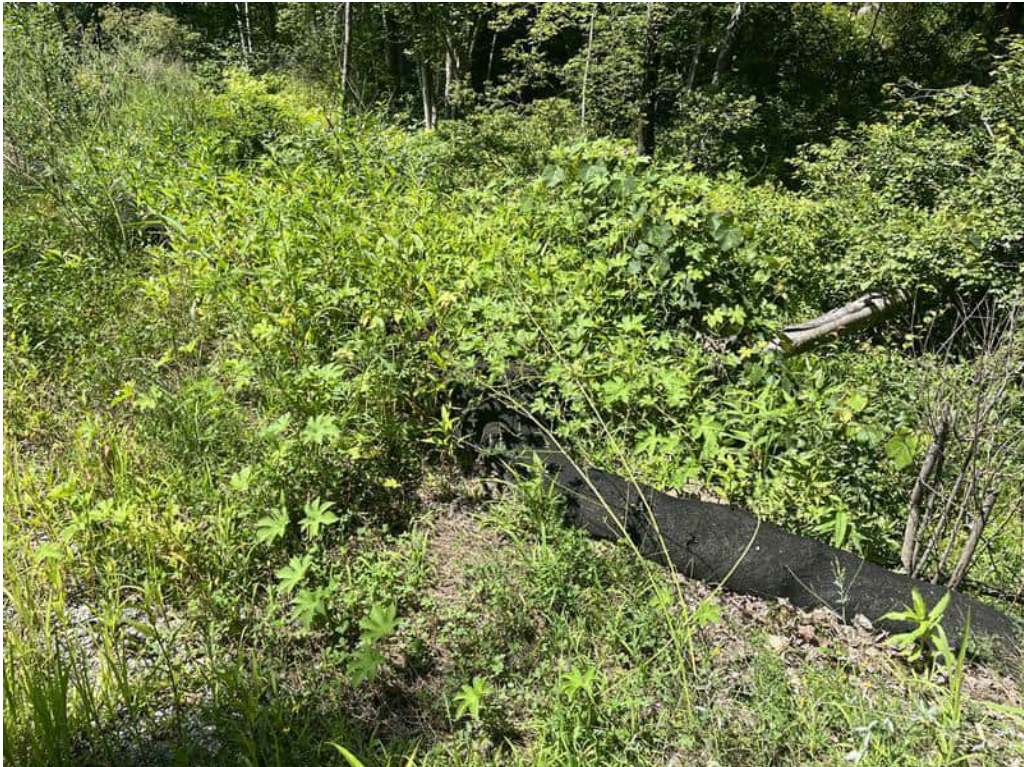
Site Location		Bruce Freeman Rail Trail Right-of-Way	BETA Project No. 24.10326.23
Photo No. 15	Date: 8/8/2025

Direction Photo Taken: Toward the West			
Description: View of the location of placed loam that has become vegetated with Japanese hops that require removal at Station 311+50 per Long Term Compliance Action Item 59 and 57-1.			
Photo No. 16	Date: 8/8/2025

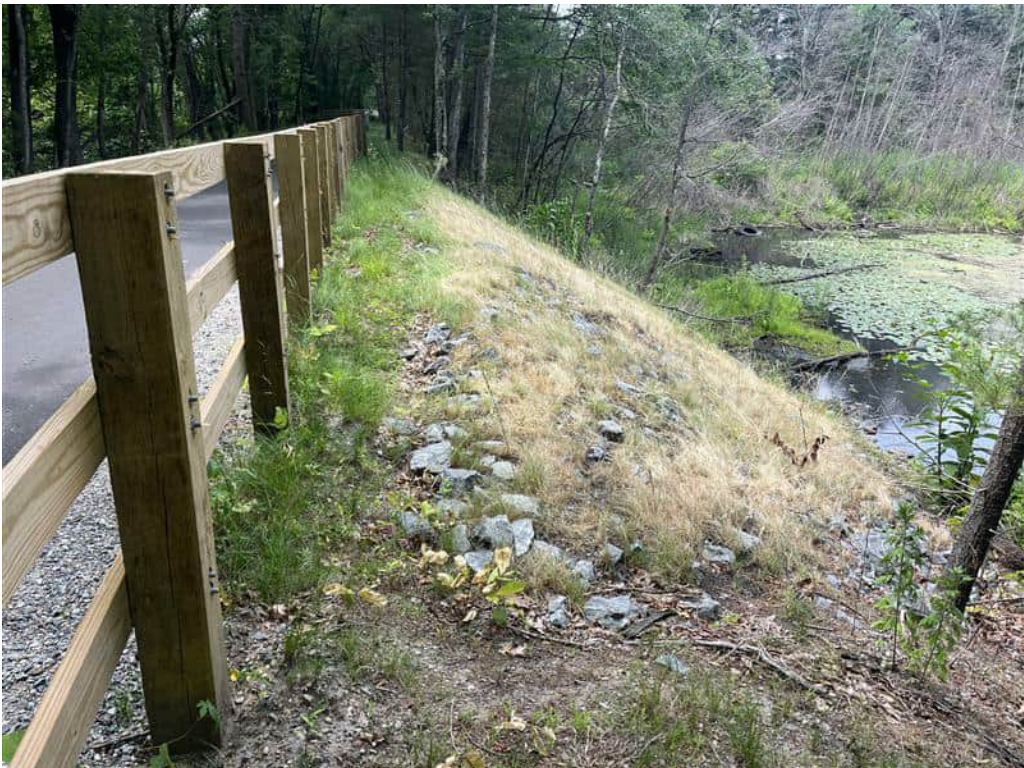
Direction Photo Taken: Toward the South			
Description: View of the location of the riprap slope that extends beyond the limit of work along the WF1 Series wetland at Station 333+00 per Long Term Compliance Action Item 42.

42	Riprap slope extends beyond limits of work along the WF1 Series wetland near flags 103 to 107 Priority: High	5/28/2024	6/4/2024	The Contractor should confirm if this work was permitted by the Conservation Commission, as it does not appear to be a part of the approved plans/impacts. MassDOT should be consulted on next steps regarding notification and potential restoration.	<p>5/31/2024 - Observation remains.</p> <p>6/7/2024 - Observation remains.</p> <p>6/14/2024 - Riprap slope has been altered and active construction is repairing the area.</p> <p>6/17/2024 - During this inspection, additional work in support of the repair/potential replacement of an underlying pipe has was ongoing. It is recommended that the contractor confirm that they have coordinated with the Conservation Commission for this work and provide a restoration plan for the area once work is complete.</p> <p>6/24/2024 - During this inspection, BETA was informed that the existing cast iron pipe was replaced with a new concrete 12-inch reinforced concrete pipe. It appears that riprap was replaced along the side slopes to mirror conditions observed prior to this inspection.</p> <p>6/27/2024 - During this inspection, the area was observed to have been rolled and prepared for paving. Hydroseed was applied and plantings were installed.</p> <p>7/8/2024 - Germination was observed and the area will be monitored for stabilization. See previous updates regarding Conservation Commission coordination.</p> <p>7/15/2024 - This area could not be assessed due to paving operations ongoing during the inspection.</p> <p>7/22/2024 - See previous updates regarding Conservation Commission coordination.</p> <p>11/12/2024 - Observation remains. The timber fence has been installed upgradient of this area.</p> <p>11/19/2024 - Observation remains. As discussed with the Conservation Agent in the field, an as-built should be prepared for this area to quantify any additional impacts that may be addressed through a permit amendment.</p> <p>11/22/2024 - Observation remains. See previous update.</p> <p>11/25/2024 - Observation remains. See update from 11/19/2024.</p> <p>12/2/2024 - Observation remains. See update from 11/19/2024.</p> <p>12/6/2024 - Observation remains. See update from 11/19/2024.</p> <p>12/12/2024 - Observation remains. See update from 11/19/2024.</p> <p>12/20/2024 - Observation remains. See update from 11/19/2024.</p> <p>12/26/2024 - Observation remains. See update from 11/19/2024.</p> <p>12/31/2024 - Observation remains. See update from 11/19/2024.</p> <p>1/2/2025 - Observation remains. Leaf litter that was previously observed at the bottom of the slope has blown away and it appears that exposed soil with no observable germination is present.</p> <p>7/1/2025 - Observation remains. For readability, observations from 7/29/2024 to 11/5/2024 and from 1/9/2025 to 6/9/2025 have been removed - see report #60 for previous observations. See update from 1/2/2025 and 11/19/2024.</p> <p>8/8/2025 - Observation remains. A majority of the exposed soil that was previously observed in this area has become stabilized. See update for 11/19/2024.</p>
