| <b>Environmental Monitor Construction Site Inspection Report</b><br><b>MassDOT Project #608164 Construction Contract # 119678</b><br><b>EM Report #64</b> | | | | | | |
| Project Description: Bruce Freeman Rail Trail Right-of-Way<br>Permit Description(s): Order of Conditions (MGL Chapter 131, Section 40 and 310 CMR 10.00, Mass DEP File No. 301-1362); 2022 EPA NPDES General Permit for Discharges from Construction Areas; U.S. Army Corps of Engineers Permit No NAE-2021-01975. | | | | | | |
| Project Name: | Bruce Freeman Rail Trail - Phase 2d - Sudbury | | | | | |

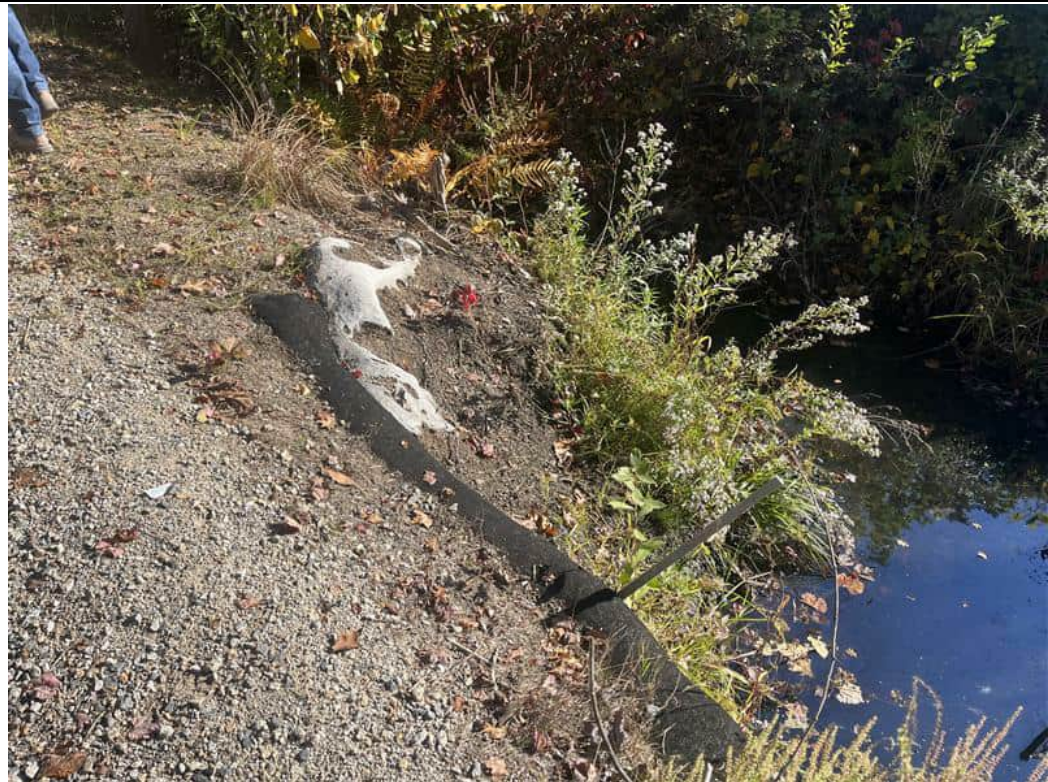
| Photo No. 1 | Date:<br>10/1/2025 | | |

| 43 | <p>Overtopped compost filter tubes and exposed soils beyond the limits of work at Station 105+00</p> <p><b>Priority: High</b></p> | 6/7/2024 | 6/14/2024 | <p>Stabilize the area with the approved seed mixture and provide interim stabilization such as straw mulch.</p> | <p>5/5/2025 - Observation remains. Exposed soil past the limits of work is present and requires further stabilization.</p> <p>5/12/2025 - Observation remains. See previous update.</p> <p>5/16/2025 - Observation remains. Exposed soil past the limits of work is present and requires further stabilization.</p> <p>5/23/2025 - Observation remains. See previous update.</p> <p>5/29/2025 - Observation remains. Exposed soil past the limits of work is present and requires further stabilization.</p> <p>6/6/2025 - Observation remains. See previous update.</p> <p>6/9/2025 - Observation remains. Exposed soil past the limits of work is present and requires further stabilization.</p> <p>7/1/2025 - Observation remains. For readability, observations from 6/14/2024 to 4/28/2025 have been removed - see report #60 for previous observations. Exposed soil past the limits of work is present and requires further stabilization.</p> <p>8/8/2025 - Observation remains. Exposed soil past the limits of work is present and requires further stabilization.</p> <p>9/10/2025 - Observation remains. Exposed soil past the limits of work is present and requires further stabilization.</p> <p>10/1/2025 - Observation remains. Exposed soil past the limits of work is present and requires further stabilization.</p> |

| Description:<br><br>View of the location of the overtopped compost filter tube and exposed soils beyond the limits of work at Station 105+00 per Compliance Action Item 43. | | | |

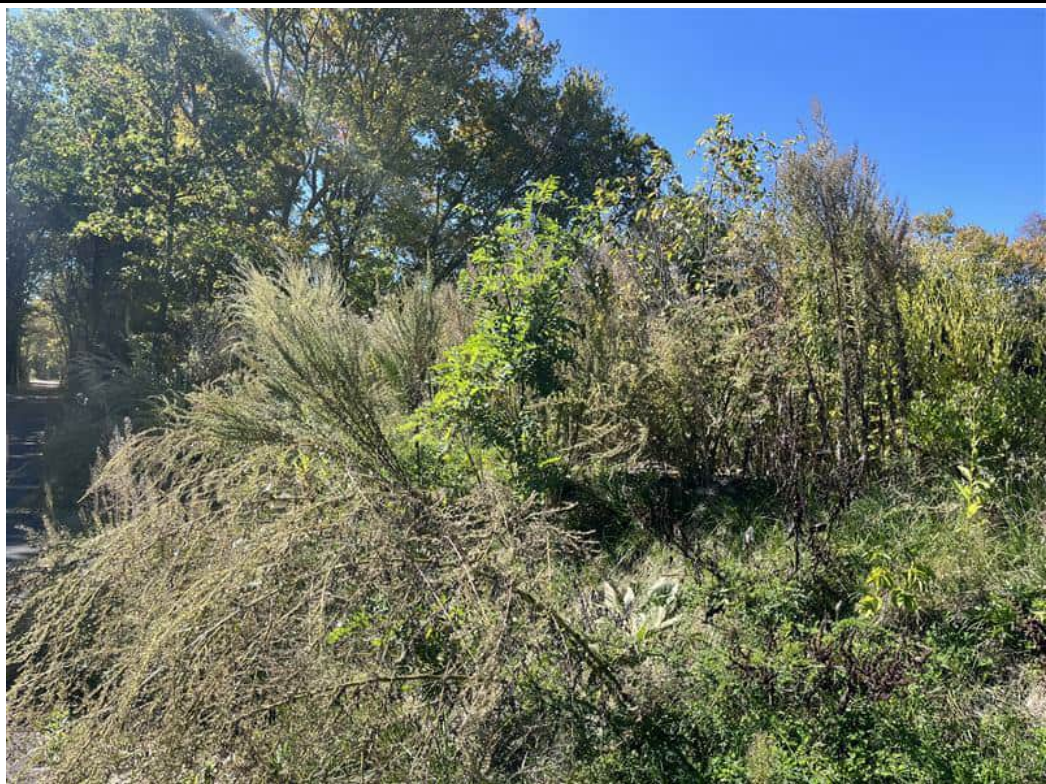
| Photo No. 2 | Date:<br>10/1/2025 | | |

| Description:<br><br>View of a black locust that requires removal at Station 115+00 per Long Term Compliance Action Item 61. | | | |

| V.2. On Going (Longer-Term) Compliance Items | | | | | |
|---|---|---|---|---|---|
| 61 | <p>Invasive/ non-native vegetation including Japanese knotweed (<i>Reynoutria japonica</i>), bittersweet (<i>Celastrus orbiculatus</i>), bush honeysuckle (<i>Lonicera spp.</i>), burning bush (<i>Euonymus alatus</i>), purple loosestrife (<i>Lythrum salicaria</i>), glossy buckthorn (<i>Frangula alnus</i>) multiflora rose (<i>Rosa multiflora</i>), tree of heaven (<i>Ailanthus altissima</i>), lesser celandine (<i>Ficaria verna</i>), barberry (<i>Berberis thunbergii</i>), Japanese stiltgrass (<i>Microstegium vimineum</i>), and garlic mustard (<i>Alliaria petiolata</i>) have been observed throughout the path.</p> <p><b>Priority: High</b></p> | 10/22/2024 | 10/29/2024 | Invasive Species should be removed by manual and/or chemical removal methods | <p>6/6/2025 - Observation remains. Invasive species treatment occurred on June 2, 2025, evidence of treatment on some species along the trail was observed; however, evidence of treatment was not observed on all plants. Invasive species will continue to be monitored to evaluate the success of the treatment.</p> <p>6/9/2025 - Observation remains. No further evidence of treatment has been observed on invasive species throughout the trail. Invasive species including Japanese knotweed, bush honeysuckle, barberry, black locust, multiflora rose, buckthorn, garlic mustard, and burning bush have all been observed to look healthy along the trail.</p> <p>7/1/2025 - Observation remains. For readability, observations from 11/22/2024 to 2/11/2025 have been removed - see report #60 for previous observations. Invasive species in healthy conditions have been observed throughout the trail including Japanese knotweed, bush honeysuckle, barberry, bittersweet, black locust, multiflora rose, buckthorn, garlic mustard, and burning bush.</p> <p>8/8/2025 - Observation remains. Some evidence of treatment of invasive species was observed throughout the trail. Populations of invasive species including bittersweet, multiflora rose, black locust, tree of heaven, buckthorn, garlic mustard, and burning bush are still present throughout the trail.</p> <p>9/10/2025- Observation remains. Less invasive species pressure was observed during this inspection; however, invasive species are still present throughout the trail. A large population of Japanese stiltgrass (<i>Microstegium vimineum</i>) was observed along the trail starting around Station 217+00. This population should be controlled and the area should be revegetated using the approved seed mix. Additionally, continued monitoring and treatment for other invasive species along the trail should continue.</p> <p>10/1/2025 - Observation remains. Comments from 10/29/2024 through 5/29/2025 have been removed for readability, for observations from those dates please see EM Report #63. Invasive species requiring removal are present throughout the corridor. Due to the time of year, hand removal is recommended and treatmetnet should be supplemented with chemical removal in the Spring of 2026.</p> |

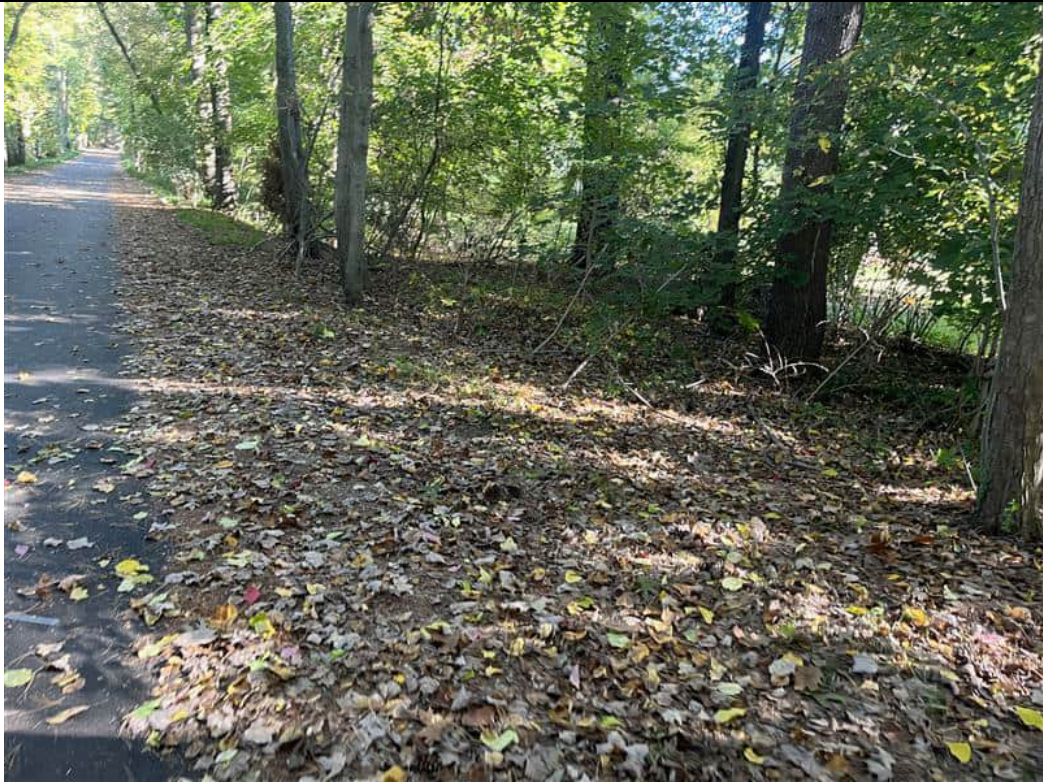
| <b>Photo No. 3</b> | <b>Date:</b><br>10/1/2025 | | |

| <b>Description:</b><br><br>View of exposed soil that requires stabilization at Station 138+00 per Long Term Compliance Action Item 59. | | | |

| 59 | Multiple locations of exposed soils along the Project corridor require stabilization<br><b>Priority: High</b> | 9/3/2024 | 9/10/2024 | The contactor should apply the approved seed mixture to areas of exposed soils and place straw. | <p>4/21/2025 - For readability all previous observations have been removed from the report. Please reference the report from 4/14/2025 to see past observations. Observation remains. Vegetation has begun sprouting in some areas that were hydroseeded; however, most areas are not considered fully stabilized. Multiple areas of exposed soil along the trail still require the application of hydroseed. The seed mix used for stabilization should be submitted to the Conservation Commission.</p> <p>4/28/2025 - Observation remains. See previous update.</p> <p>5/5/2025 - Observation remains. Areas where hydroseed was applied have been observed as being partially or fully stabilized. Areas of exposed soil are still present in multiple locations throughout the trail. Further application of hydroseed should occur. The seed mix used for stabilization should be submitted to the Conservation Commission.</p> <p>5/12/2025 - Observation remains. See previous update.</p> <p>5/16/2025 - Observation remains. Areas of exposed soil are present in multiple locations throughout the trail. Further application of hydroseed should occur. The seed mix used for stabilization should be submitted to the Conservation Commission.</p> <p>5/23/2025 - Observation remains. See previous update.</p> <p>5/29/2025 - Observation remains. See update for 5/16/2025.</p> <p>6/6/2025 - Observation remains. Further application of hydroseed is required on areas of exposed soils and on areas of sparse vegetation throughout the trail. When hydroseed is applied, leaf litter should be removed to ensure soil to seed contact occurs.</p> <p>6/9/2025 - Observation remains. See previous update.</p> <p>7/1/2025 - Observation remains. Further application of hydroseed is required on areas of exposed soils and on areas of sparse vegetation throughout the trail. When hydroseed is applied, leaf litter should be removed to ensure soil to seed contact occurs.</p> <p>8/8/2025 - Observation remains. Further application of hydroseed was observed along the trail with some vegetative growth. Some areas of exposed soil that were observed during the last inspection have become vegetated; however, populations of non-native species are present throughout these areas. Multiple locations of exposed soil are still present throughout the trail that require further application of seed.</p> <p>9/10/2025 - Observation remains. Multiple locations of exposed soil are present throughout the trail that require further application of seed. The seed mix used for stabilization should be submitted to the Conservation Commission.</p> <p>10/1/2025 - Observation remains. Minimal areas of exposed soil are present along the trail. Areas upgradient of Resource Areas should be prioritized for stabilization. The seed mix used for stabilization should be submitted to the Conservation Commission.</p> |

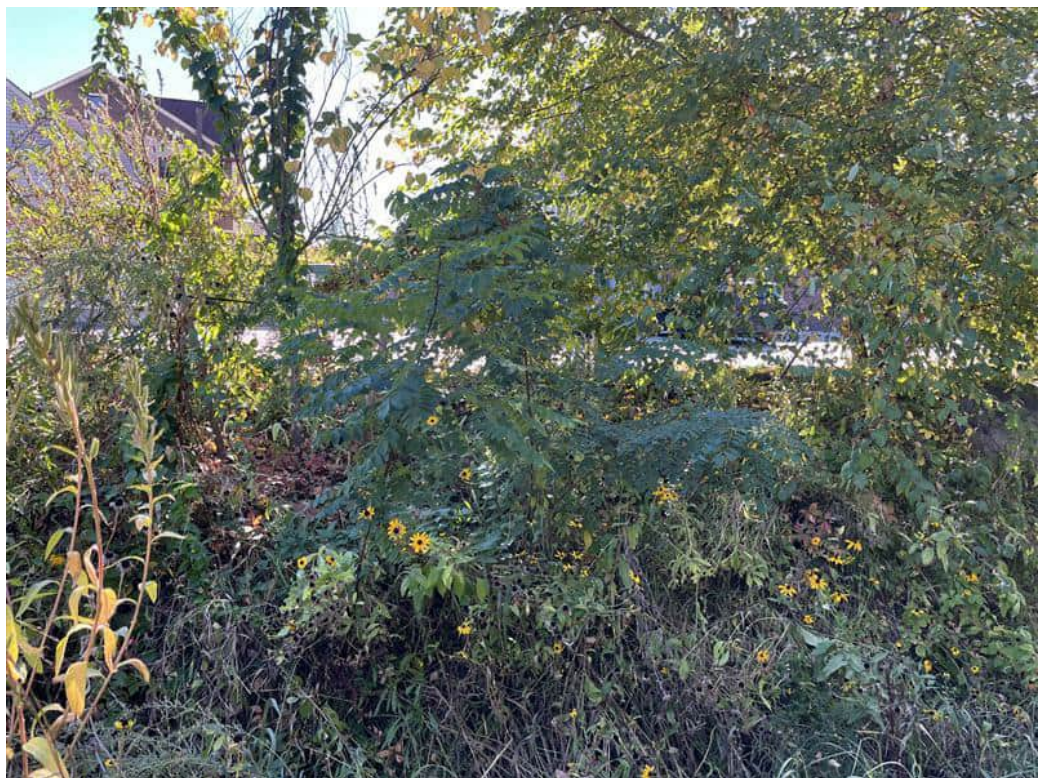
| <b>Photo No. 4</b> | <b>Date:</b><br>10/1/2025 | | |

| <b>Description:</b><br><br>View of a population of bittersweet and black locust that require removal along the slope at Station 173+00 per Long Term Compliance Action Item 61. | | | |

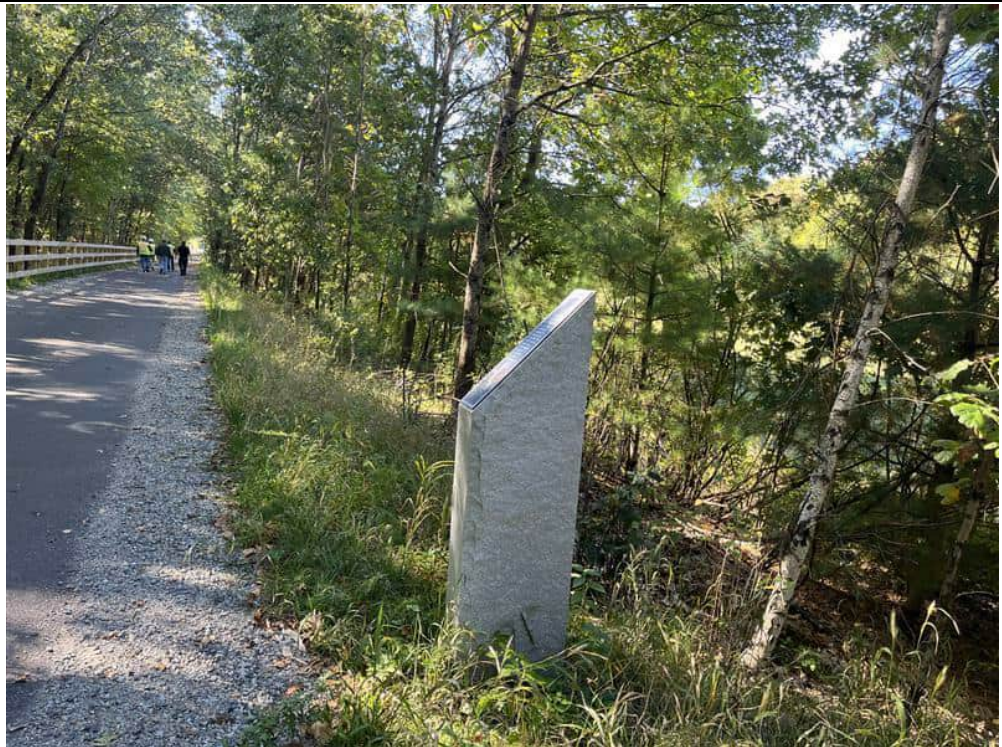
| <b>Photo No. 5</b> | <b>Date:</b><br>10/1/2025 | | |

| <b>Description:</b><br><br>View of a population of Japanese stiltgrass that require removal at Station 192+00 per Long Term Compliance Action Item 61. | | | |

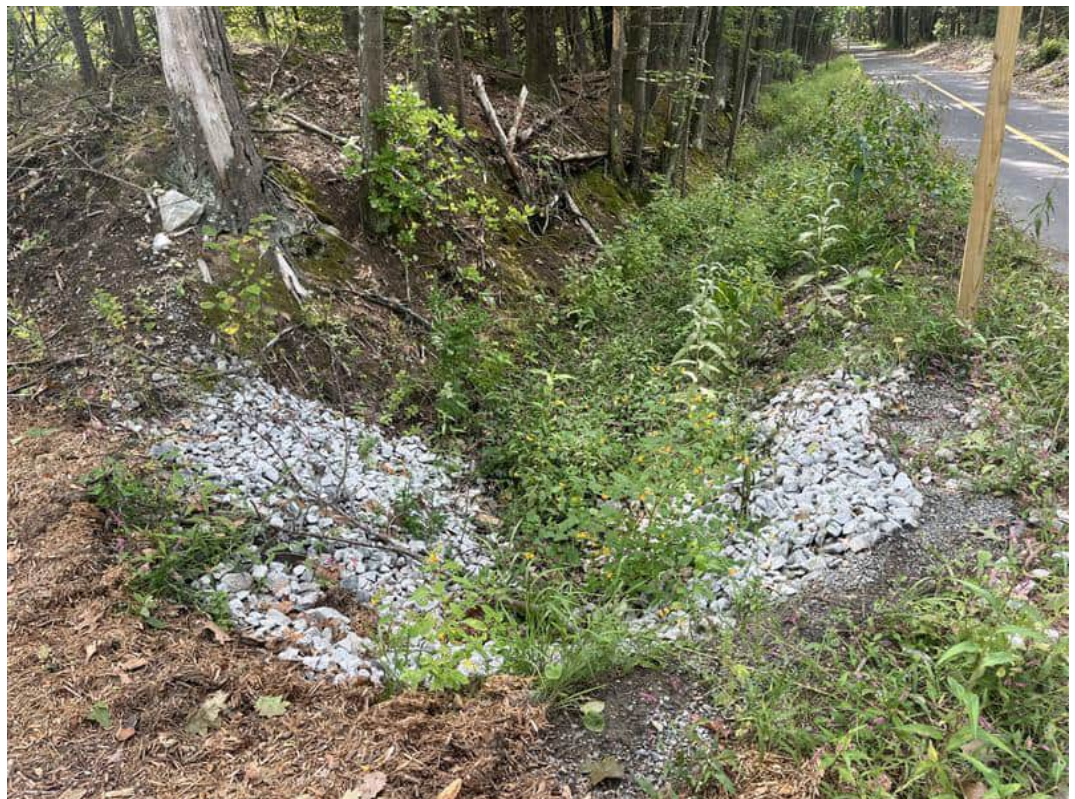
| <b>Photo No. 6</b> | <b>Date:</b><br>10/1/2025 | | |

| 41 | Stream Bank has been regraded beyond the limit of work at Station 216+00<br>Priority: High | 5/28/2024 | 6/4/2024 | The Contractor should confirm if this work was permitted by the Conservation Commission, as it does not appear to be a part of the approved plans/impacts. MassDOT should be consulted on next steps regarding notification and potential restoration. | 5/31/2024 - Observation remains.<br>6/7/2024 - Observation remains.<br>6/14/2024 - Observation remains.<br>6/17/2024 - Observation remains.<br>6/24/2024 - Observation remains.<br>6/27/2024 - Observation remains.<br>7/8/2024- Observation remains.<br>7/15/2024 - This area could not be assessed due to paving operations ongoing during the inspection.<br>7/22/2024 - Crushed stone and sediment continue to be discharged to the stream between Stations 215+00 and 217+00 due to overtopped and undermined compost filter tubes.<br>7/29/2024 - Observation remains.<br>8/5/2024 - Observation remains.<br>8/7/2024 - Observation remains.<br>8/12/2024 - Observation remains. Crushed stone is still present in the streambed at this location.<br>8/16/2024 - Observation remains.<br>8/20/2024 - Stone has been removed; however, additional alteration to Resource Areas beyond the limit of work continue.<br>8/27/2024 - Observation remains.<br>9/3/2024 - Observation remains.<br>9/10/2024 - Observation remains. Stone has been observed as discharging into the streambed in this location again.<br>9/16/2024 - Observation remains.<br>9/23/2024 - Observation remains. Stone is still present within the streambed at this location.<br>9/27/2024 - Observation remains.<br>10/4/2024 - Observation remains.<br>10/8/2024 - Observation remains.<br>10/15/2024 - Observation remains. Stone is still present within the streambed at this location.<br>10/22/2024 - Observation remains. Stone is still present within the streambed at this location.<br>10/29/2024 - Observation remains. Stone is still present within the streambed at this location.<br>11/5/2024 - Observation remains. The PVC pipe that was installed at this location was observed to be covered with stone and is no longer visible near Station 215+00. Stone is still present within the streambed at this location.<br>11/12/2024 - Observation remains. The streambed in this location is covered with leaf litter. See previous update.<br>11/19/2024 - Observation remains. As discussed with the Conservation Agent in the field, further coordination between the Town and MassDOT will be required to clean/repair the culvert, as the degraded condition of the culvert prompted the contractor to armor the stream banks. Further coordination will also be required for restoration of banks.<br>7/1/2025 - Observation remains. For readability, observations from 11/22/2025 to 6/9/2025 have been removed - see report #60 for previous observations. See update from 11/19/2024.<br>8/8/2025 - Observation remains. See update from 11/19/2024.<br>9/10/2025 - Observation remains. See update from 11/19/2024.<br>10/1/2025 - Observation remains. See update from 11/19/2024. |

| <b>Description:</b><br><br>View of the location where the stream bank has been regraded beyond the limits of work at Station 215+75 per Long Term Compliance Action Items 41. | | | |

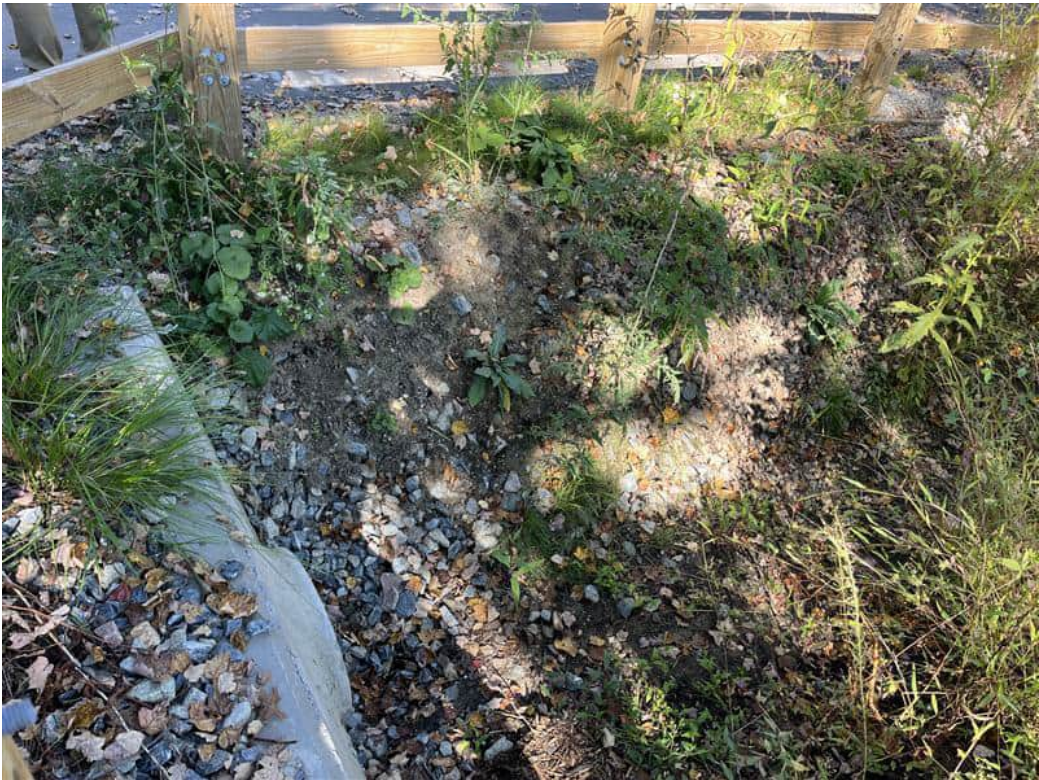
| <b>Photo No. 7</b> | <b>Date:</b><br>10/1/2025 | | |

| <b>Description:</b><br><br>View of erosion and exposed soils that require stabilization and garlic mustard that requires removal at Station 217+00 per Compliance Action item 61 and 62. | | | |

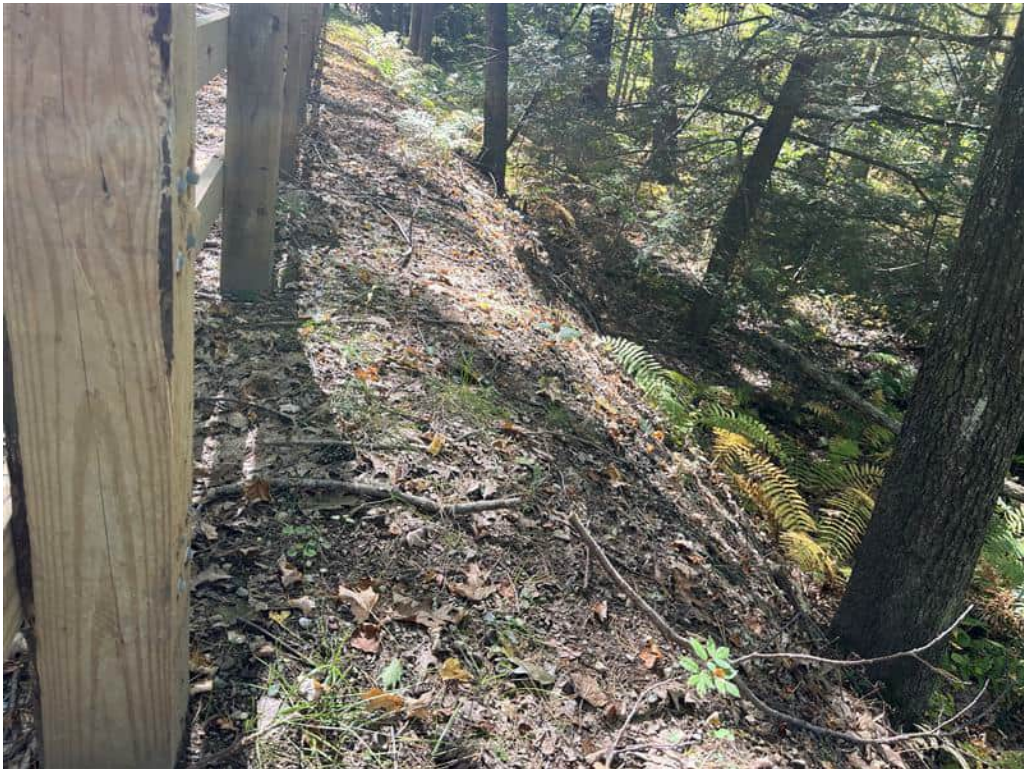
| <b>Photo No. 8</b> | <b>Date:</b><br>10/1/2025 | | |

| <b>Description:</b><br><br>View of exposed soils that require stabilization at Station 231+00 per Long Term Compliance Action Item 59. | | | |

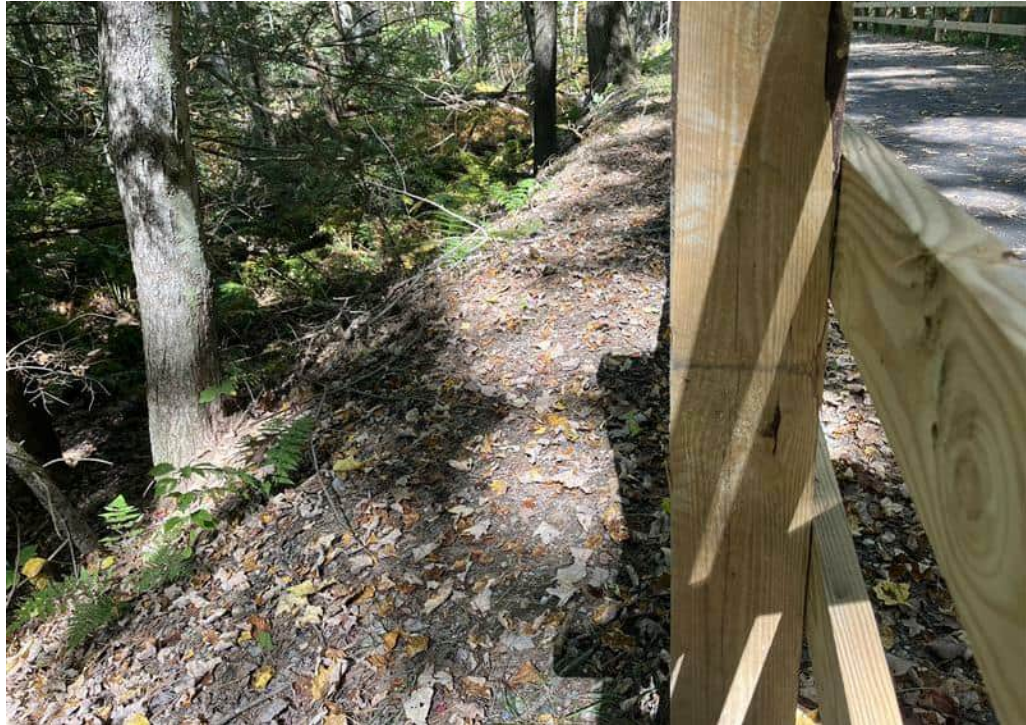
| <b>Photo No. 9</b> | <b>Date:</b><br>10/1/2025 | | |

| <b>Description:</b><br><br>View of exposed soils that require stabilization at Station 244+00 per Long Term Compliance Action Item 59. | | | |

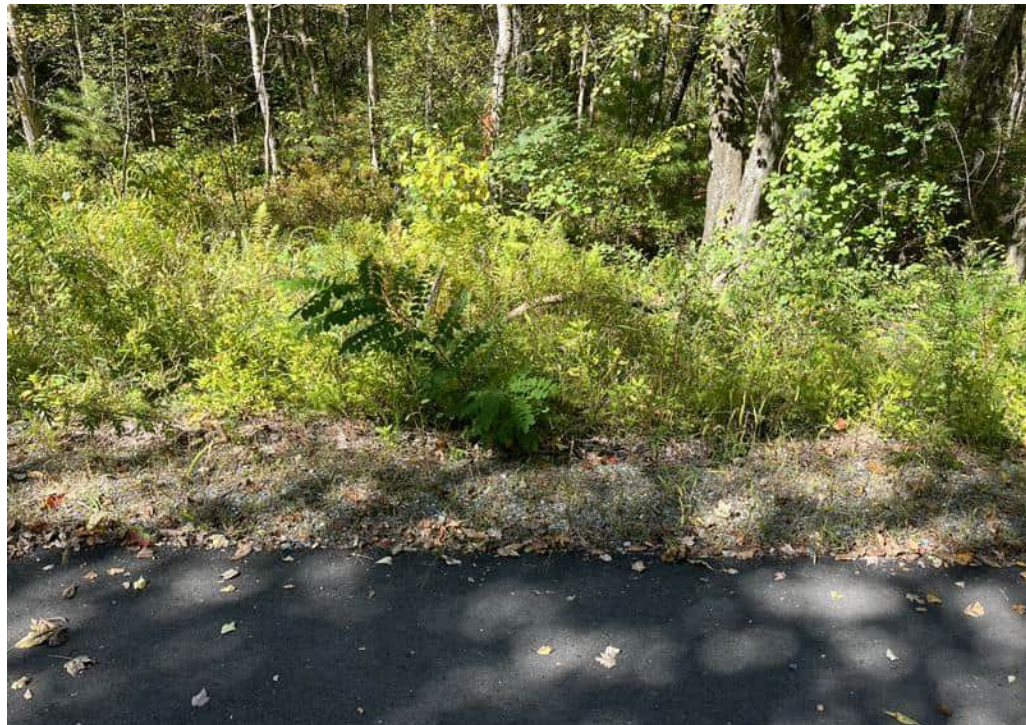
| <b>Photo No. 10</b> | <b>Date:</b><br>10/1/2025 | | |

| <b>Description:</b><br><br>View of black locust and tree of heaven that require removal at Station 289+00 per Long Term Compliance Item 61. | | | |

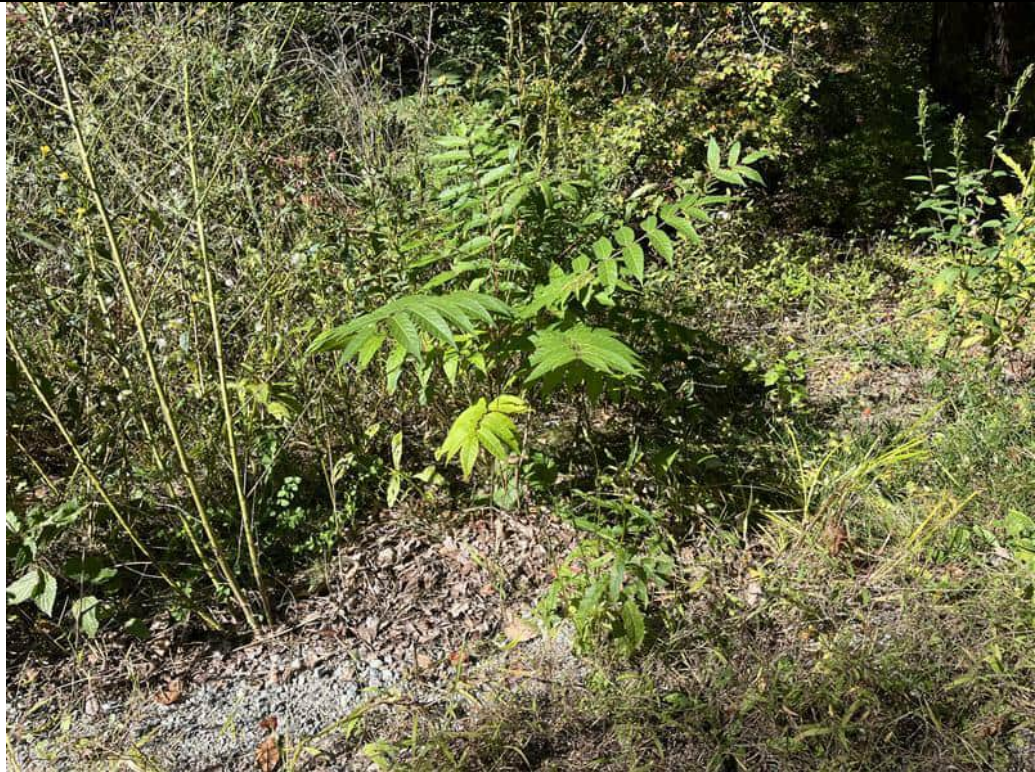
| Photo No. 11 | Date:<br>10/1/2025 | | |

| Description:<br><br>View of tree of heaven that requires removal at Station 291+00 per Long Term Compliance Item 61. | | | |

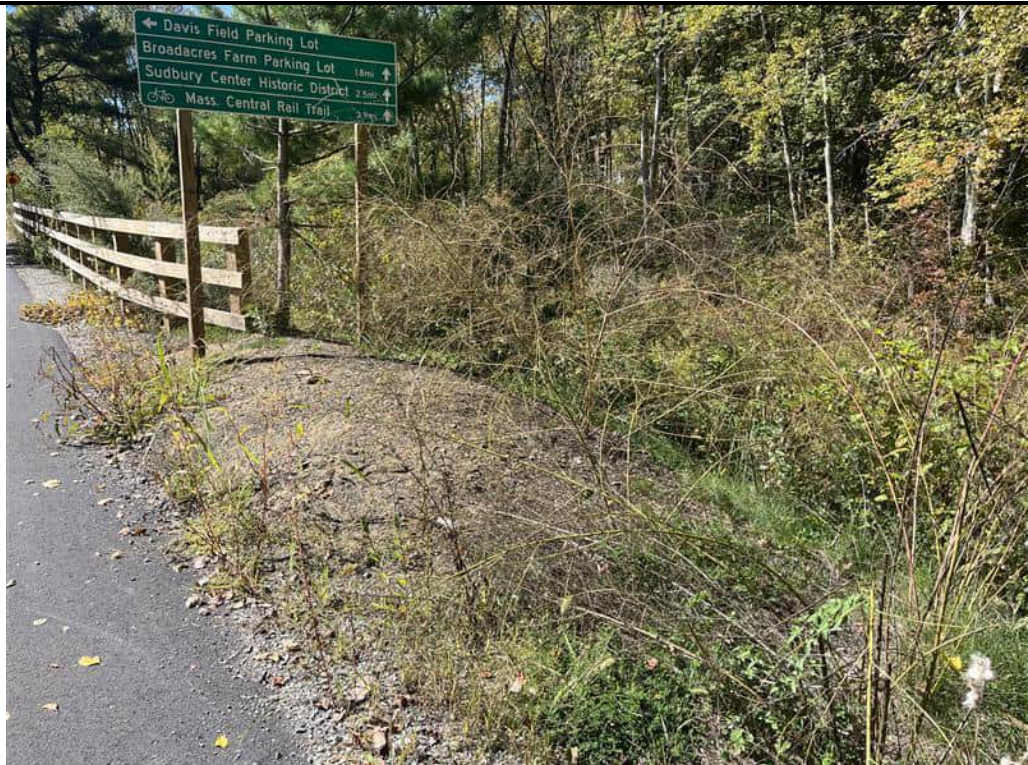
| Photo No. 12 | Date:<br>10/1/2025 | | |

| Description:<br><br>View of exposed soils that require stabilization at Station 310+00 per Long Term Compliance Action Item 59. | | | |

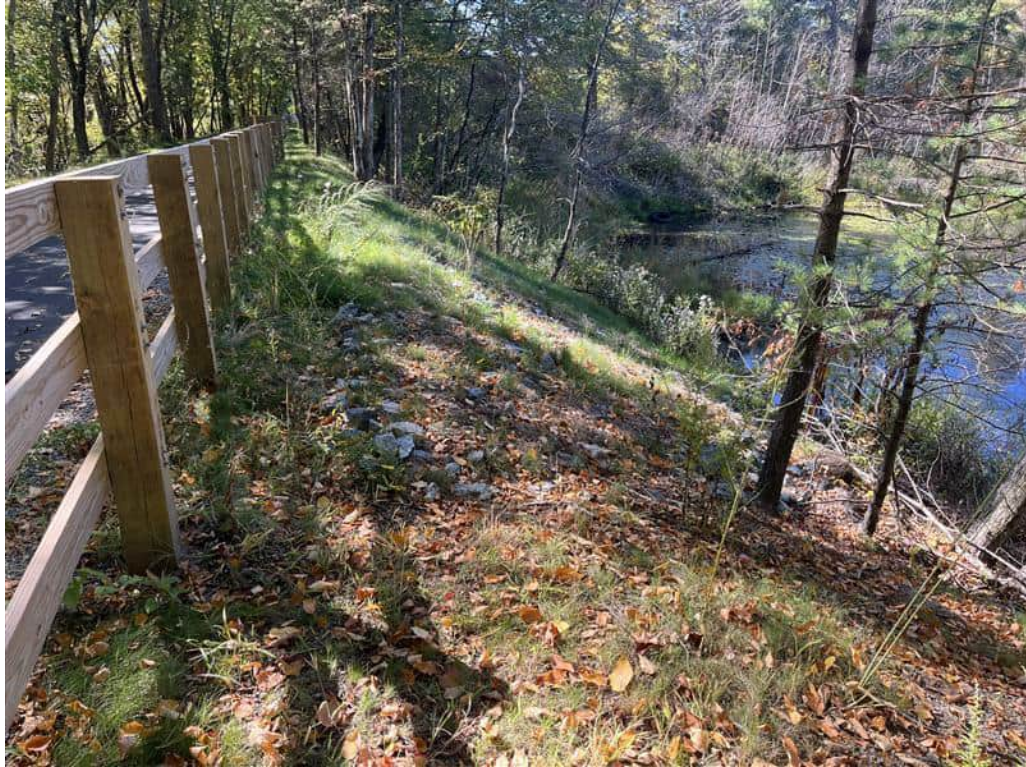
| <b>Photo No. 13</b> | <b>Date:</b><br>10/1/2025 | |

| 42 | Riprap slope extends beyond limits of work along the WF1 Series wetland near flags 103 to 107<br><b>Priority: High</b> | 5/28/2024 | 6/4/2024 | The Contractor should confirm if this work was permitted by the Conservation Commission, as it does not appear to be a part of the approved plans/impacts. MassDOT should be consulted on next steps regarding notification and potential restoration. | <p>5/31/2024 - Observation remains.</p> <p>6/7/2024 - Observation remains.</p> <p>6/14/2024 - Riprap slope has been altered and active construction is repairing the area.</p> <p>6/17/2024 - During this inspection, additional work in support of the repair/potential replacement of an underlying pipe has was ongoing. It is recommended that the contractor confirm that they have coordinated with the Conservation Commission for this work and provide a restoration plan for the area once work is complete.</p> <p>6/24/2024 - During this inspection, BETA was informed that the existing cast iron pipe was replaced with a new concrete 12-inch reinforced concrete pipe. It appears that riprap was replaced along the side slopes to mirror conditions observed prior to this inspection.</p> <p>6/27/2024 - During this inspection, the area was observed to have been rolled and prepared for paving. Hydroseed was applied and plantings were installed.</p> <p>7/8/2024 - Germination was observed and the area will be monitored for stabilization. See previous updates regarding Conservation Commission coordination.</p> <p>7/15/2024 - This area could not be assessed due to paving operations ongoing during the inspection.</p> <p>7/22/2024 - See previous updates regarding Conservation Commission coordination.</p> <p>11/12/2024 - Observation remains. The timber fence has been installed upgradient of this area.</p> <p>11/19/2024 - Observation remains. As discussed with the Conservation Agent in the field, an as-built should be prepared for this area to quantify any additional impacts that may be addressed through a permit amendment.</p> <p>11/22/2024 - Observation remains. See previous update.</p> <p>11/25/2024 - Observation remains. See update from 11/19/2024.</p> <p>12/2/2024 - Observation remains. See update from 11/19/2024.</p> <p>12/6/2024 - Observation remains. See update from 11/19/2024.</p> <p>12/12/2024 - Observation remains. See update from 11/19/2024.</p> <p>12/20/2024 - Observation remains. See update from 11/19/2024.</p> <p>12/26/2024 - Observation remains. See update from 11/19/2024.</p> <p>12/31/2024 - Observation remains. See update from 11/19/2024.</p> <p>1/2/2025 - Observation remains. Leaf litter that was previously observed at the bottom of the slope has blown away and it appears that exposed soil with no observable germination is present.</p> <p>7/1/2025 - Observation remains. For readability, observations from 7/29/2024 to 11/5/2024 and from 1/9/2025 to 6/9/2025 have been removed - see report #60 for previous observations. See update from 1/2/2025 and 11/19/2024.</p> <p>8/8/2025 - Observation remains. A majority of the exposed soil that was previously observed in this area has become stabilized. See update for 11/19/2024.</p> <p>9/10/2025 - Observation remains. See update from 11/19/2024.</p> <p>10/1/2025 - Observation remains. See update from 11/19/2024.</p> |

| <b>Description:</b><br><br>View of the location of the riprap slope that extends beyond the limit of work along the WF1 Series wetland at Station 333+00 per Long Term Compliance Action Item 42. | | |
