HOSMER HOUSE

HISTORIC STRUCTURE REPORT / CULTURAL LANDSCAPE REPORT

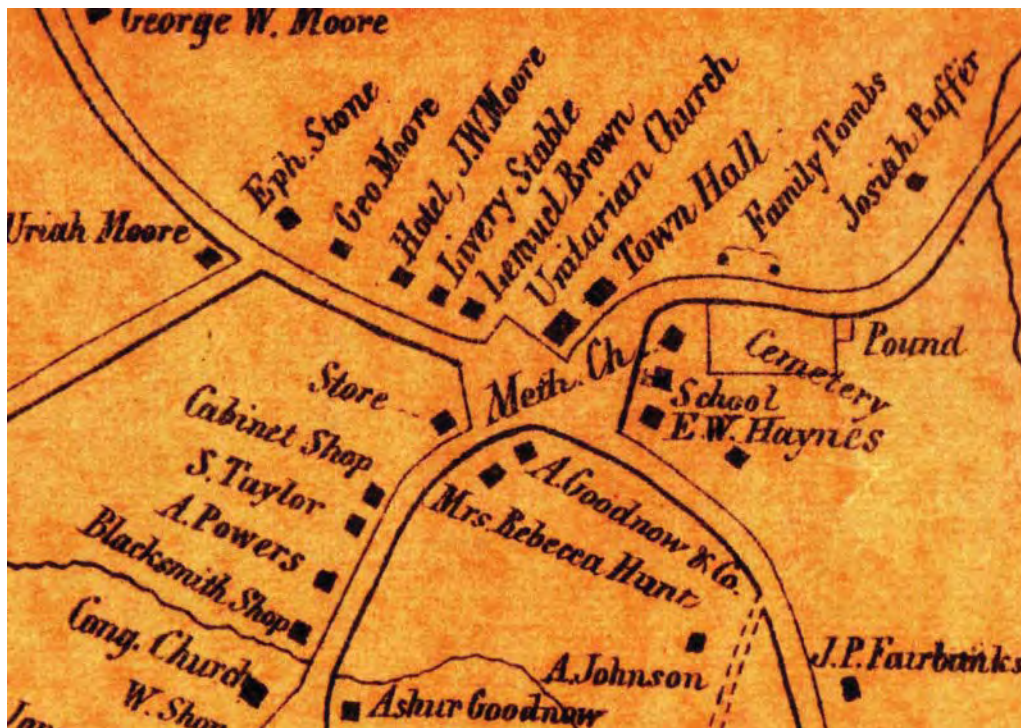
Figure 3.2-2
Map of Middlesex
County - Sudbury
Center Detail

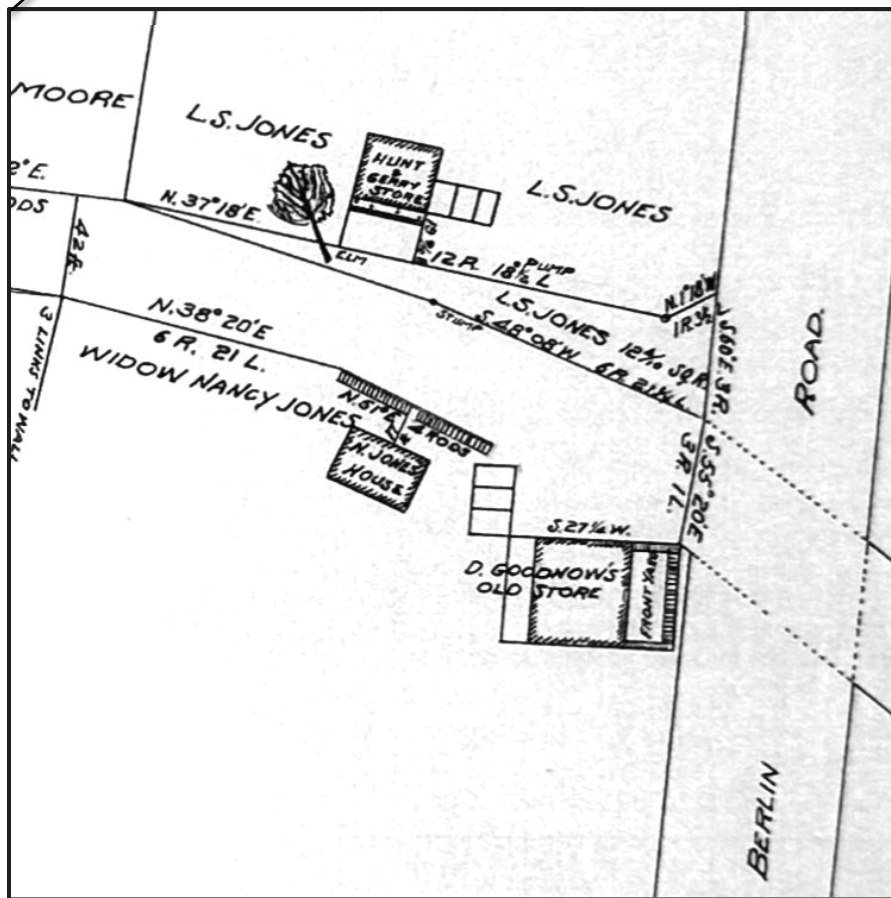
Source: Middlesex South Registry of Deeds

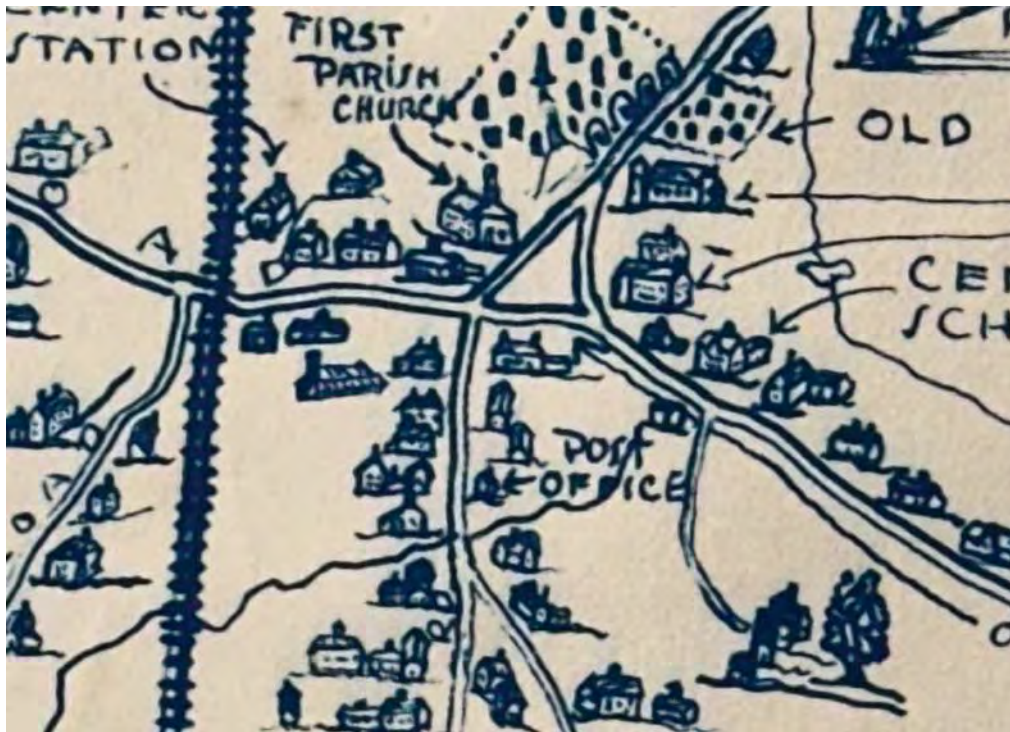
Figure 3.4-1
Sudbury Then and Now

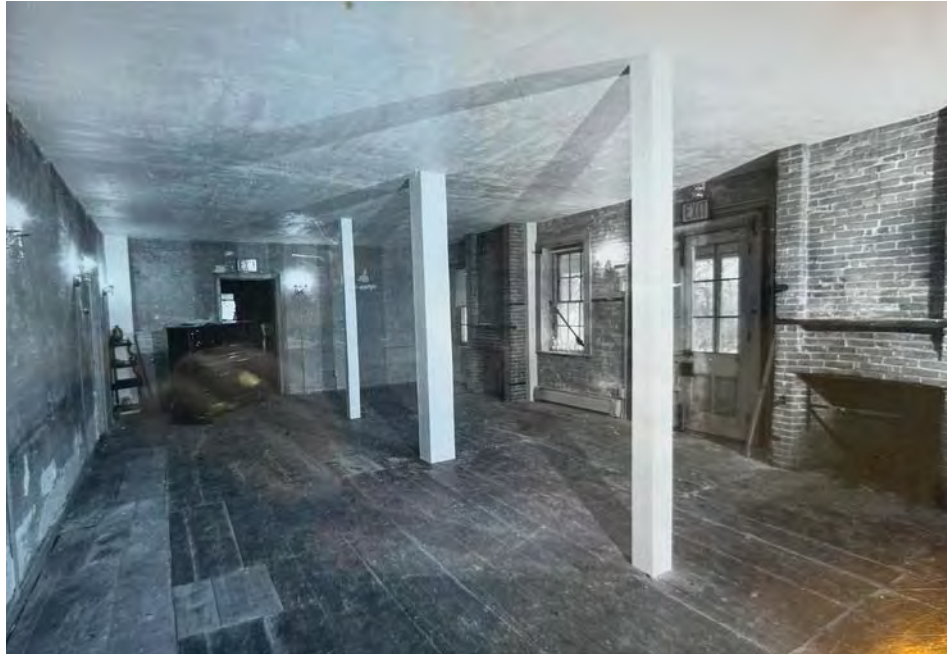
Figure 3.6-4
Images of “General
Store” After
Implementation of
Recommendations in
Hart Report

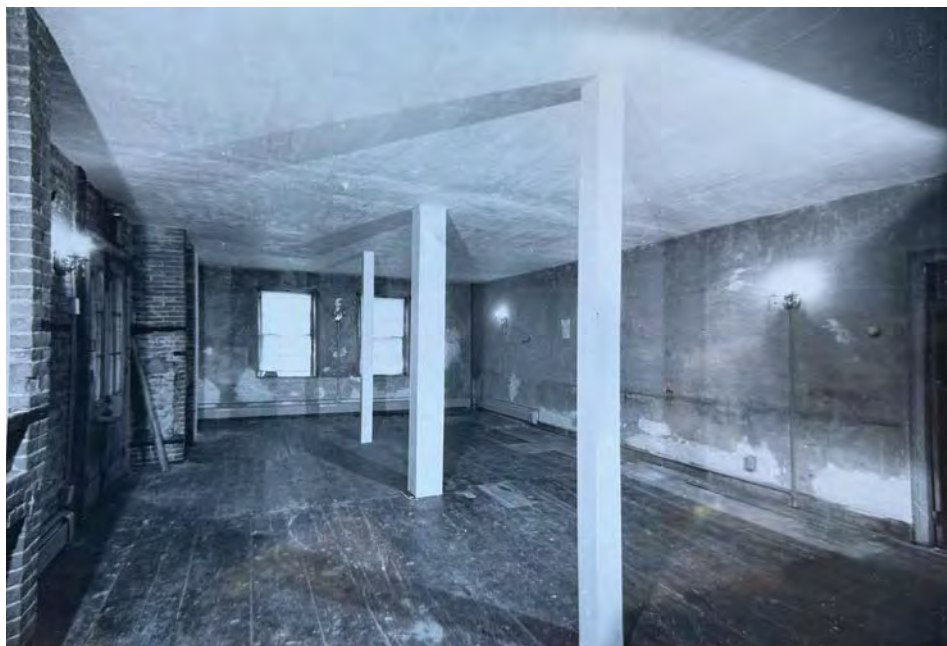
Figure 3.6-5
Images of “General
Store” After
Implementation of
Recommendations in
Hart Report

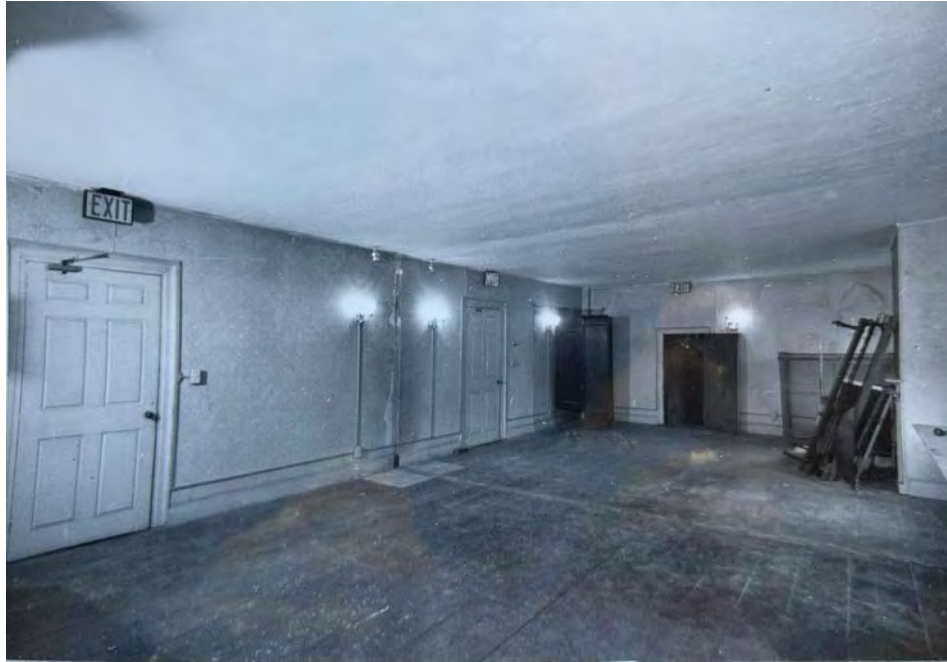
Figure 3.6-8
Images of Ballroom
After Implementation of
Recommendations in
Hart Report

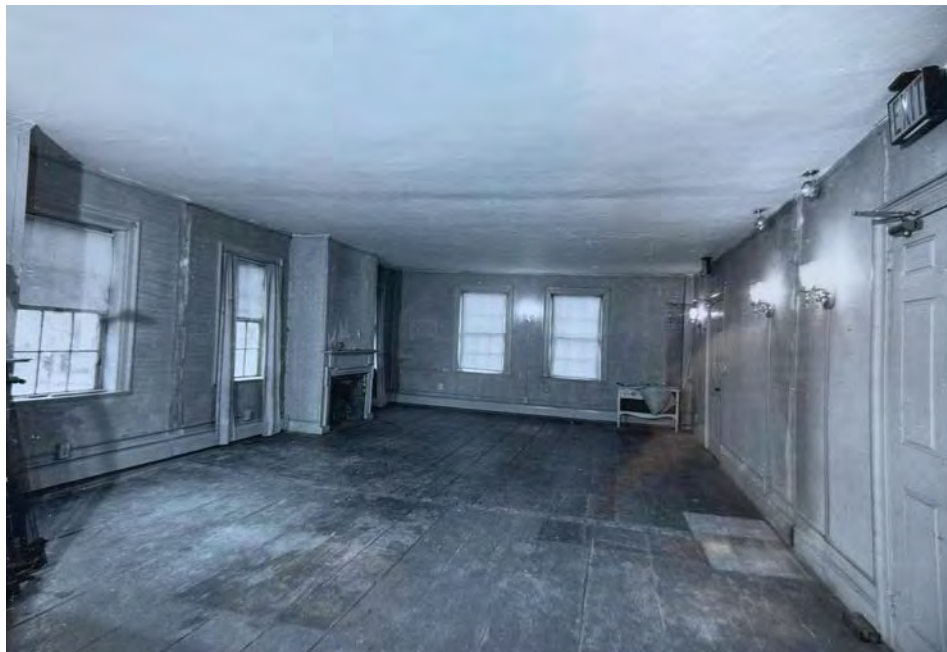
Figure 3.6-9
Images of Ballroom
After Implementation of
Recommendations in
Hart Report

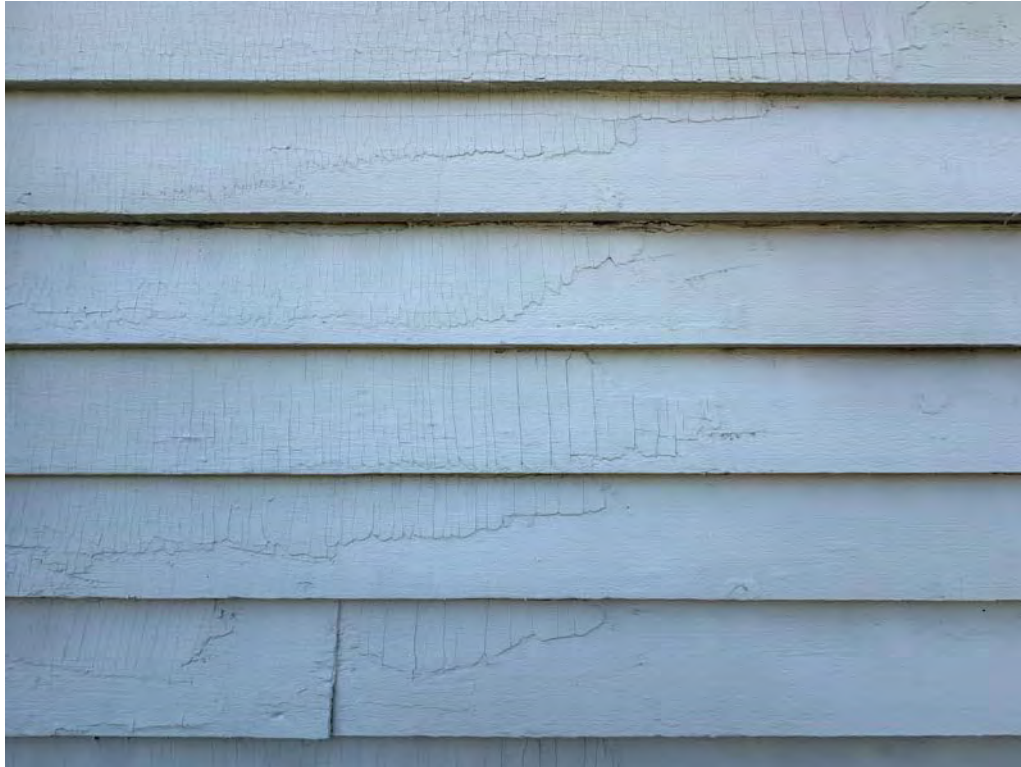
Figure 4.1-1
Clapboard painted a
pale yellow, with an
average exposure of
4".

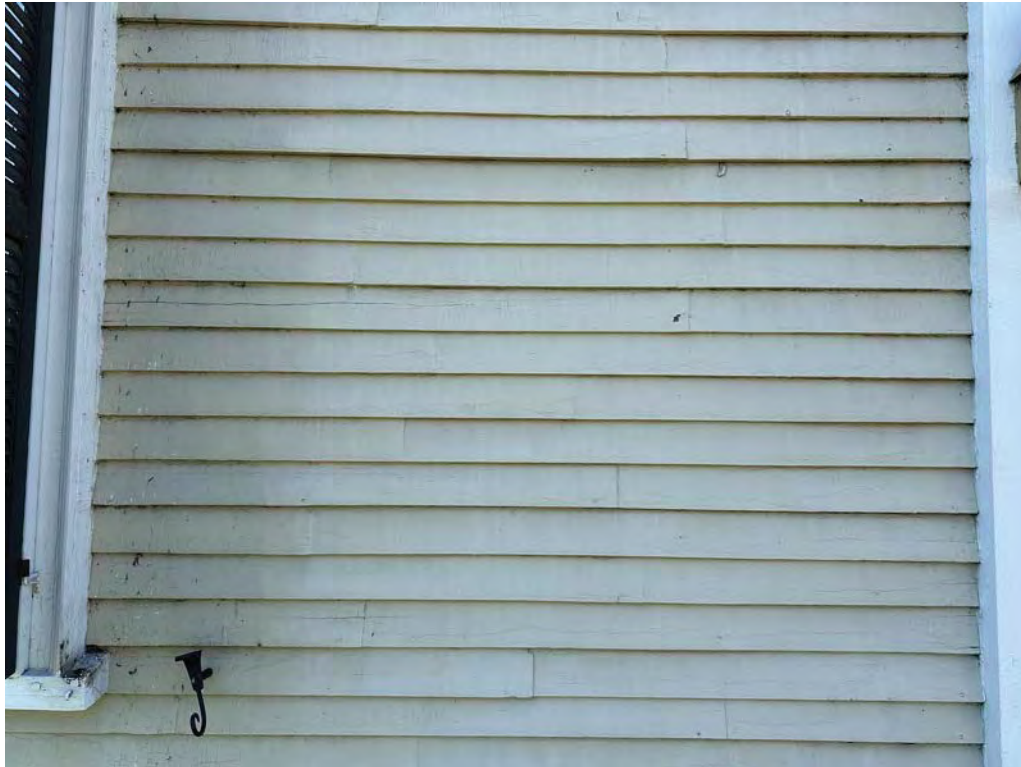
Figure 4.1-4
Large horizontal
cracks visible across
the north elevation.

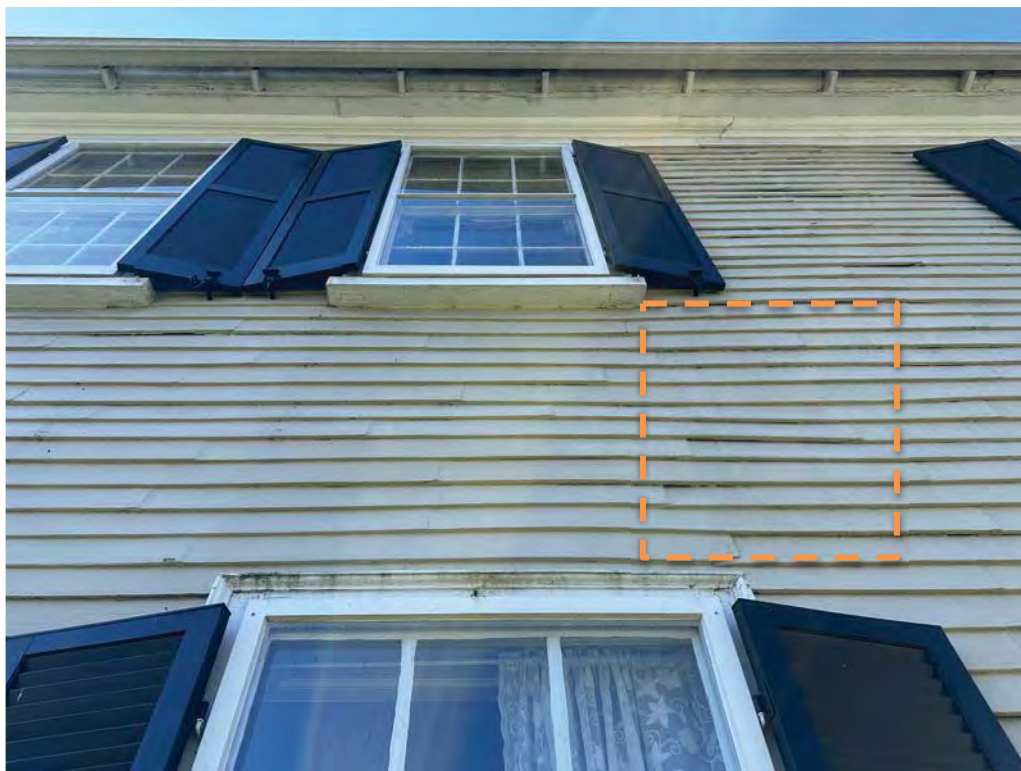
Figure 4.1-5
Depression in the
clapboard,
approximately 4
square feet in size.

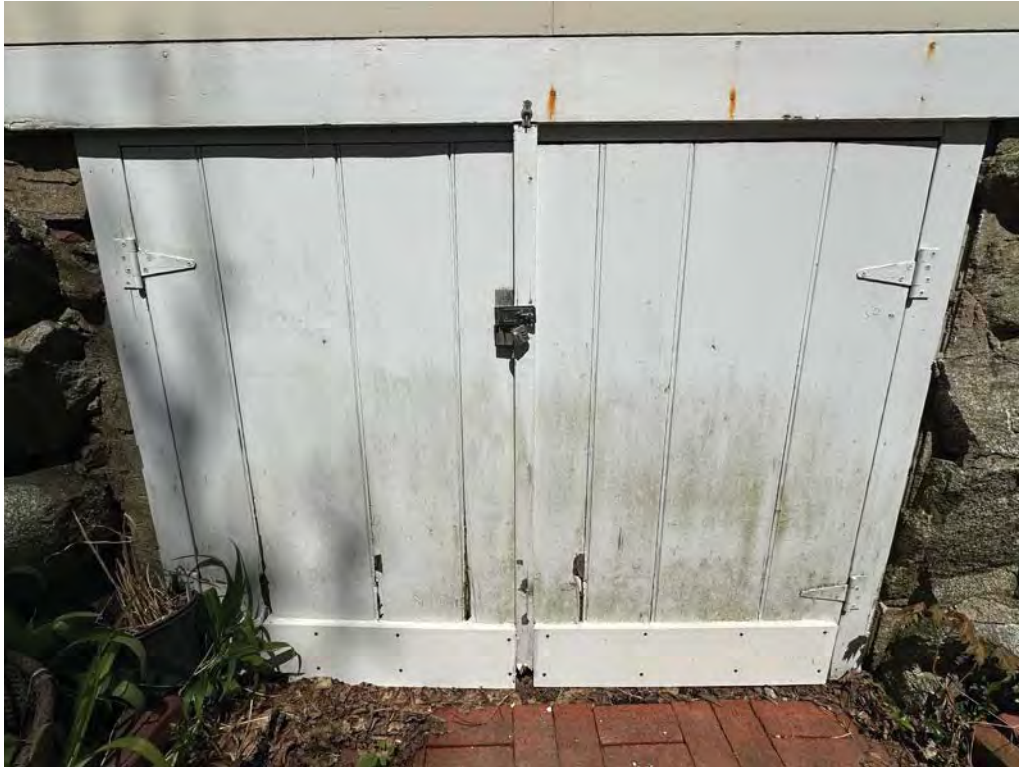
Figure 4.1-11
Fasteners used to
secure the trim,
corner boards and
water tables have
begun to corrode
and stain the wood.

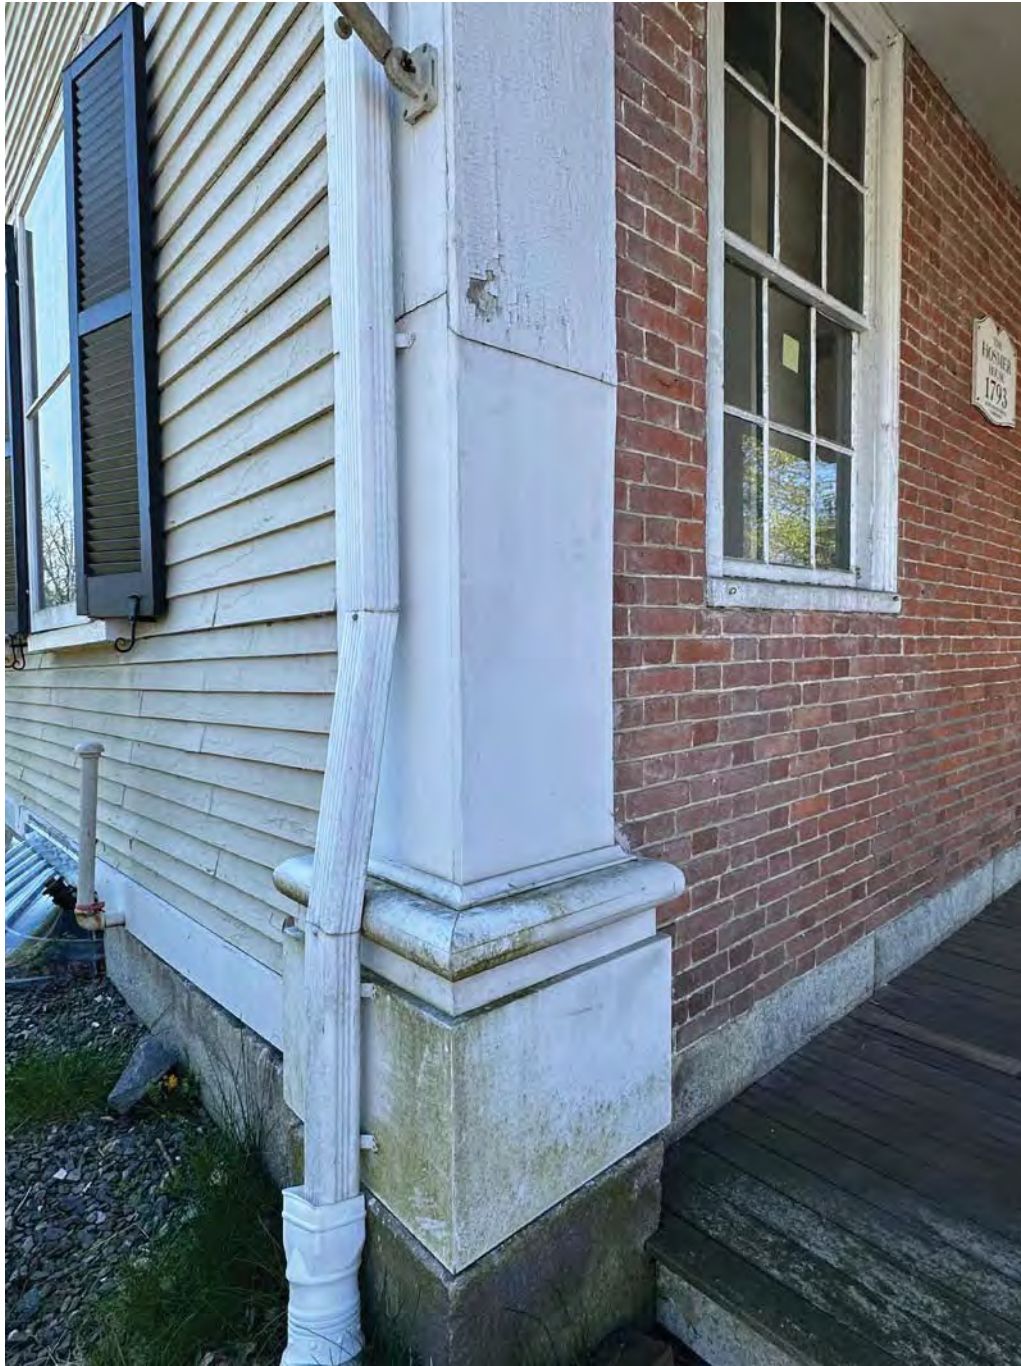
Figure 4.1-12
Bottom 3' of each
pilaster shaft and
both bases have
been replaced.

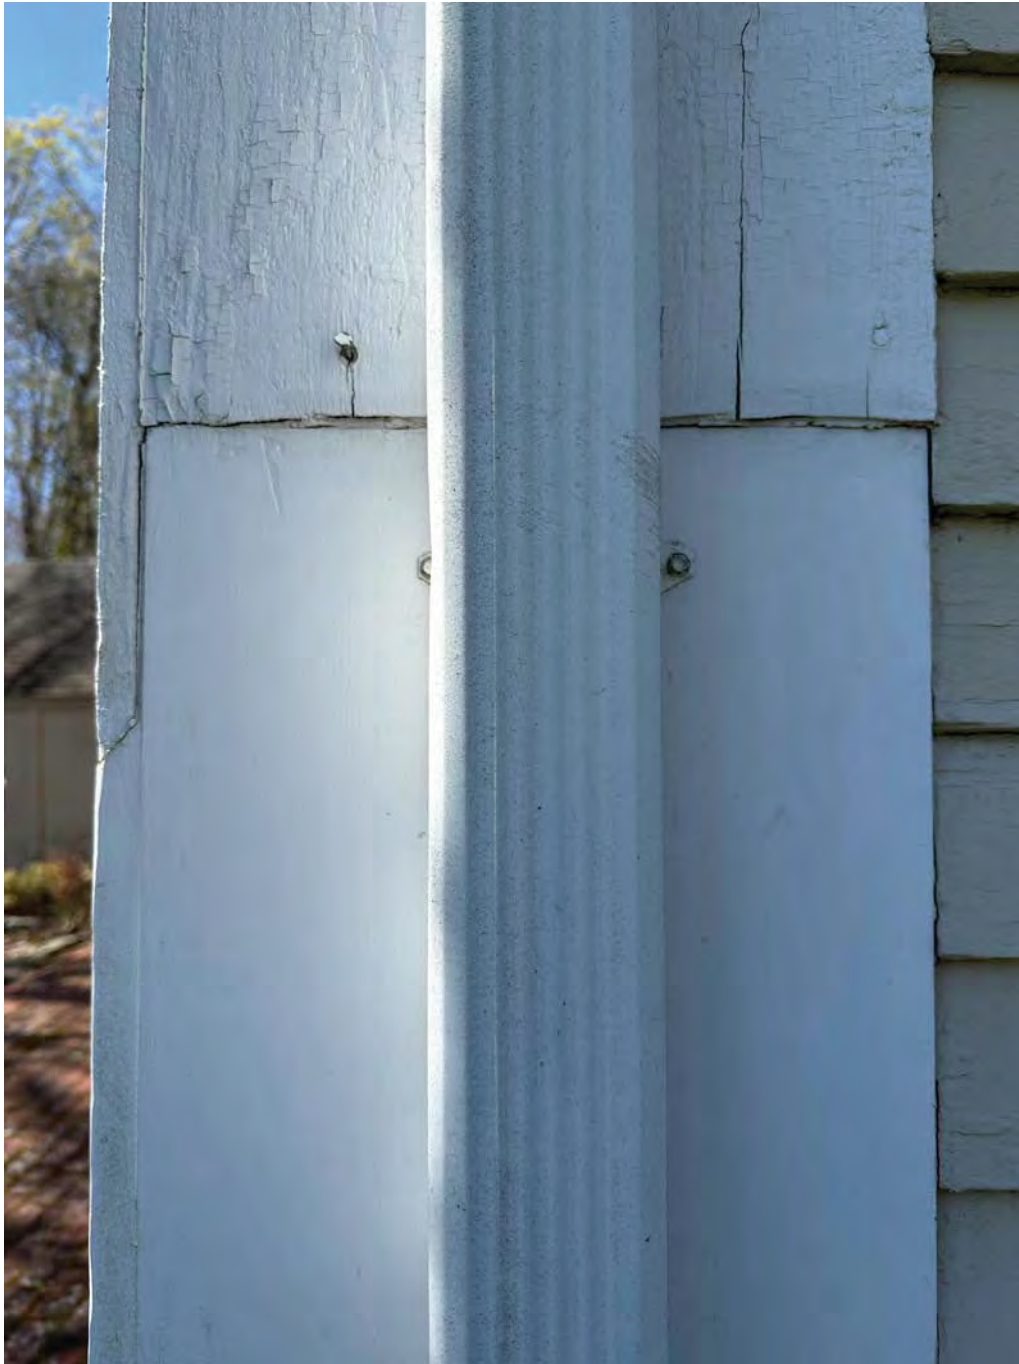
Figure 4.1-13
At the joint of the repaired pilasters, there are several splits in the wood ranging from 8 inches to 2 feet in length.

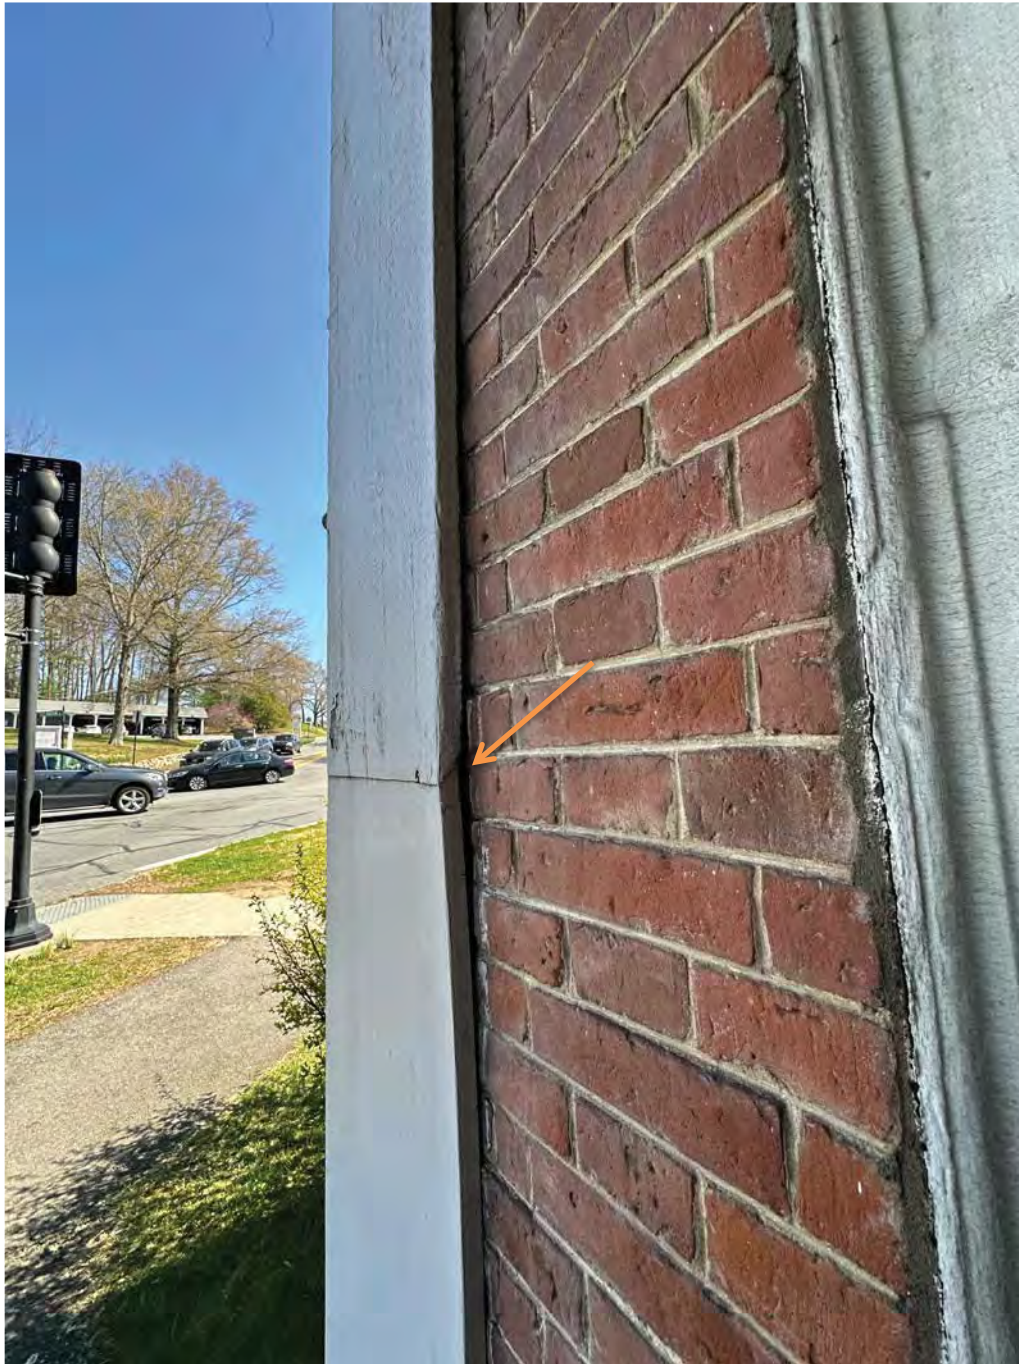
Figure 4.1-14
The pilasters are separating from the brick walls causing gaps between the materials.

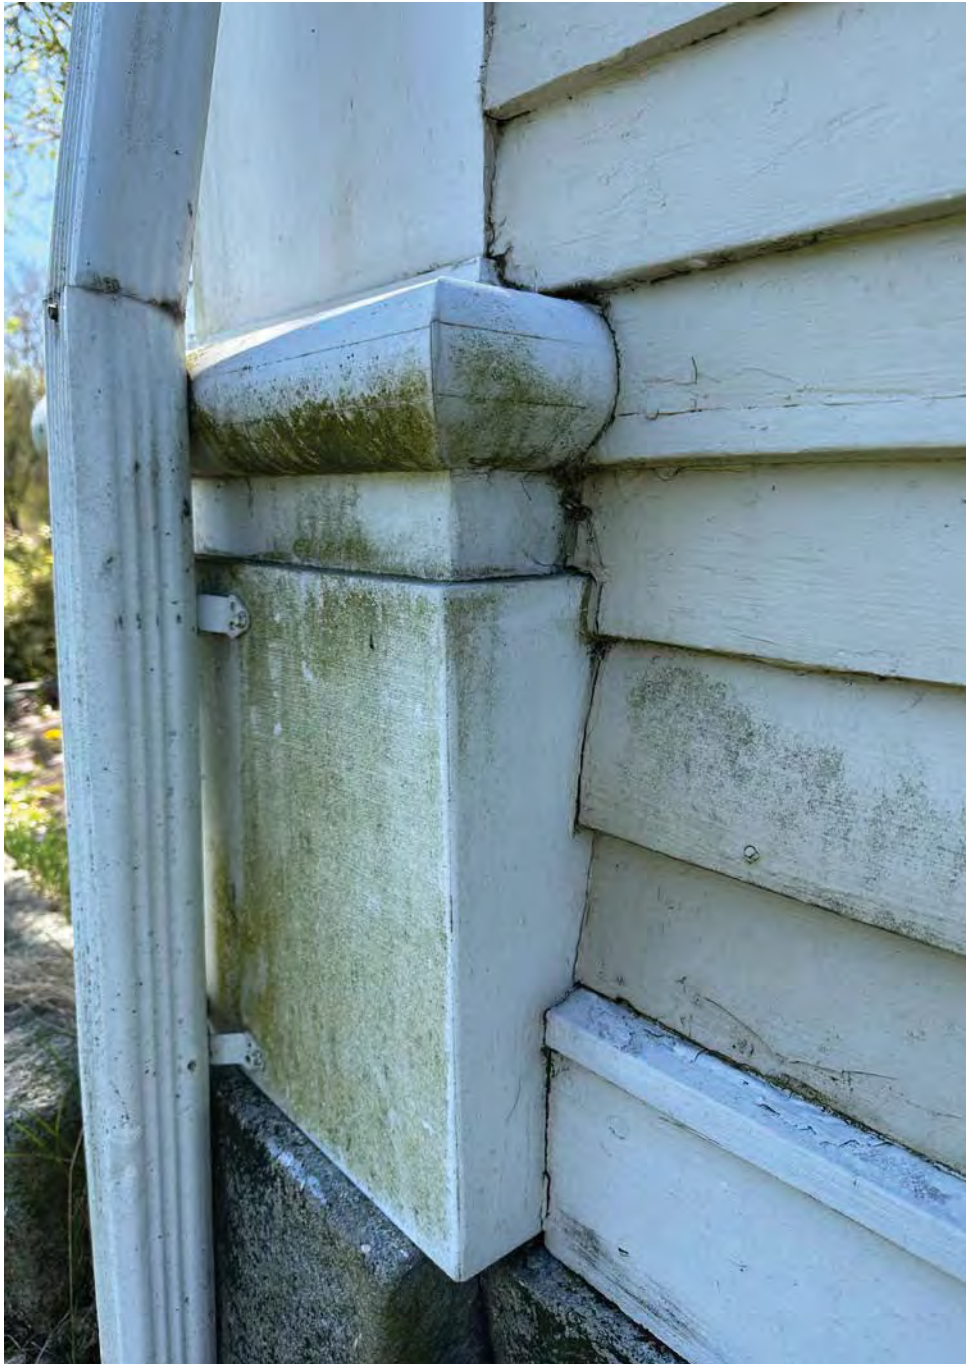
Figure 4.1-15
Both bases of the pilasters are covered in a slight layer of biological growth and mildew due to excessive moisture on the surface of the wood, and the proximity of vegetation to the lower elements of the building.

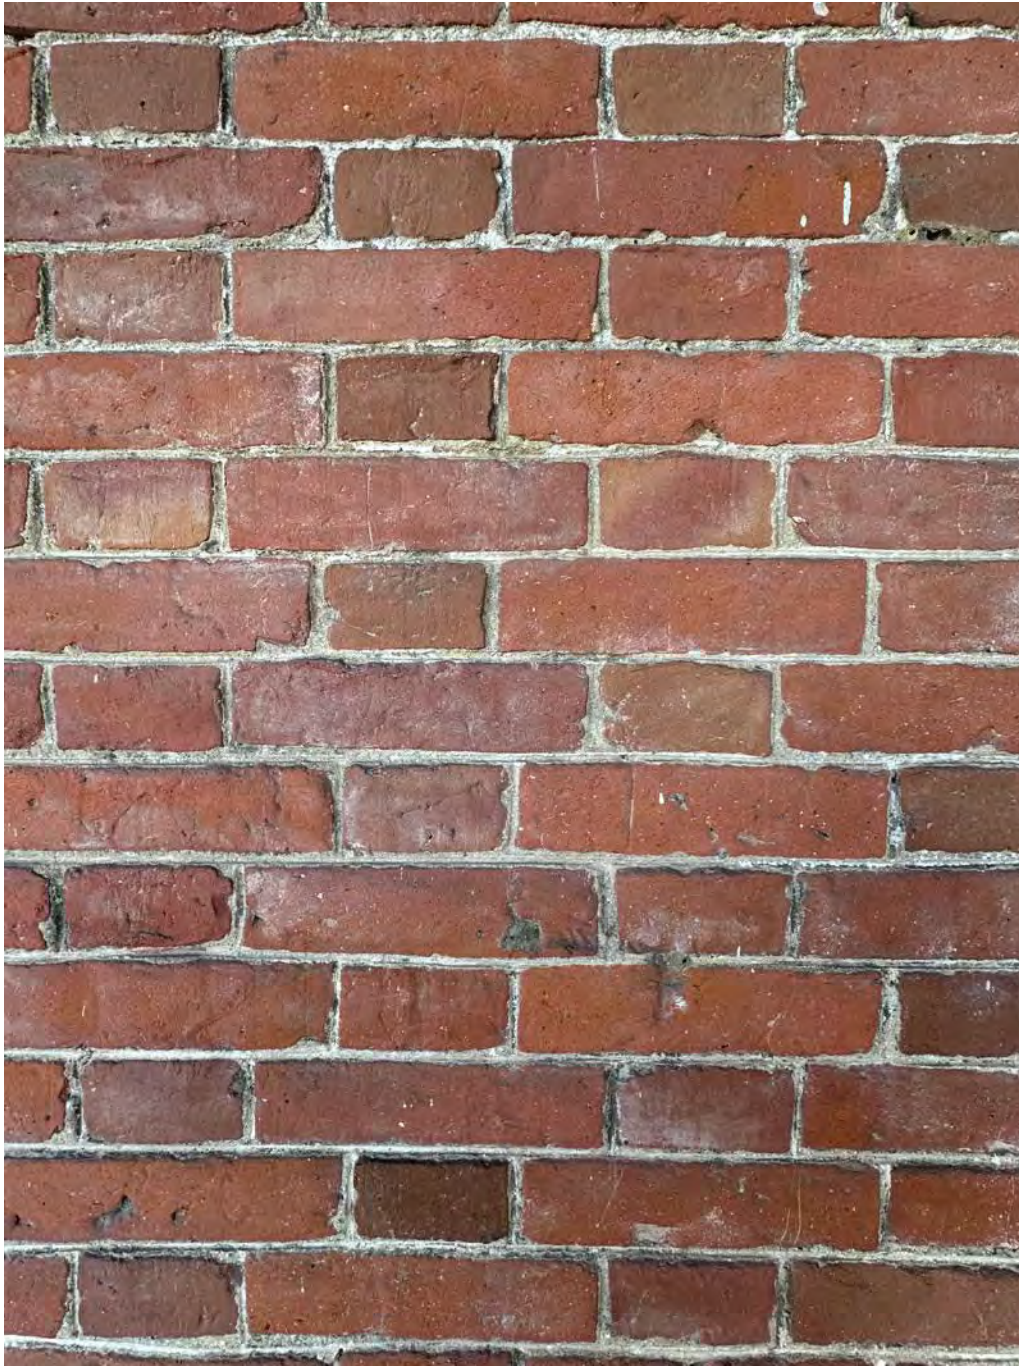
Figure 4.2-1
Bricks laid in Flemish
Bond pattern with
1/4" mortar joints.

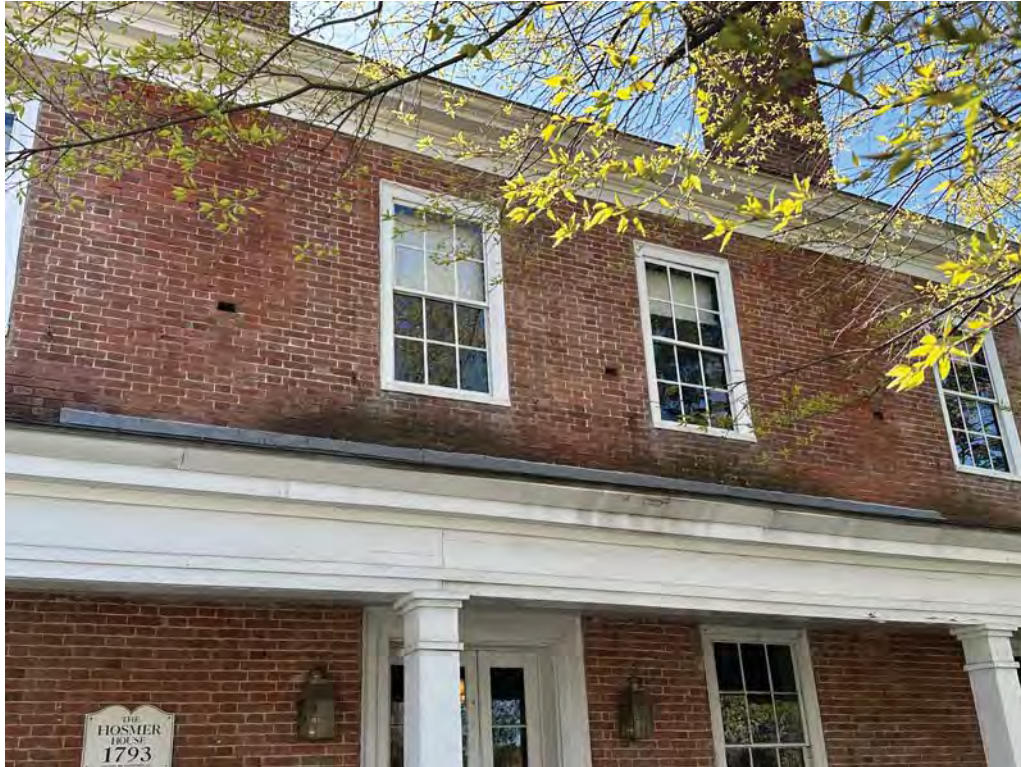
Figure 4.2-2
Discolored bricks due
to water infiltration.
And inadequate
flashing.

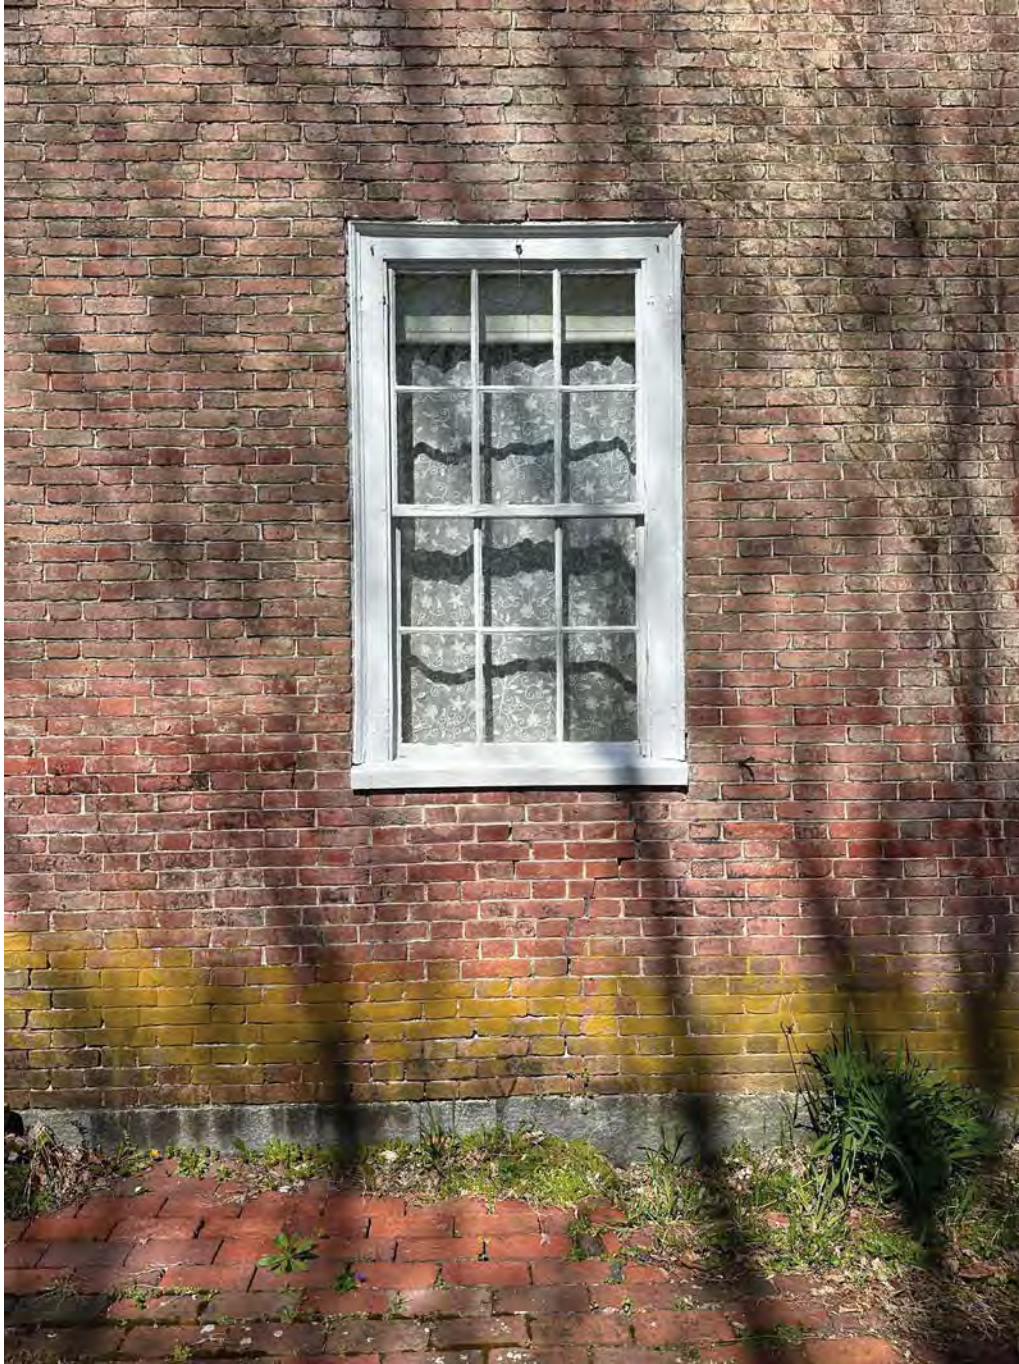
Figure 4.2-3
Extensive biological
growth on the east
elevation along the
entire wall.

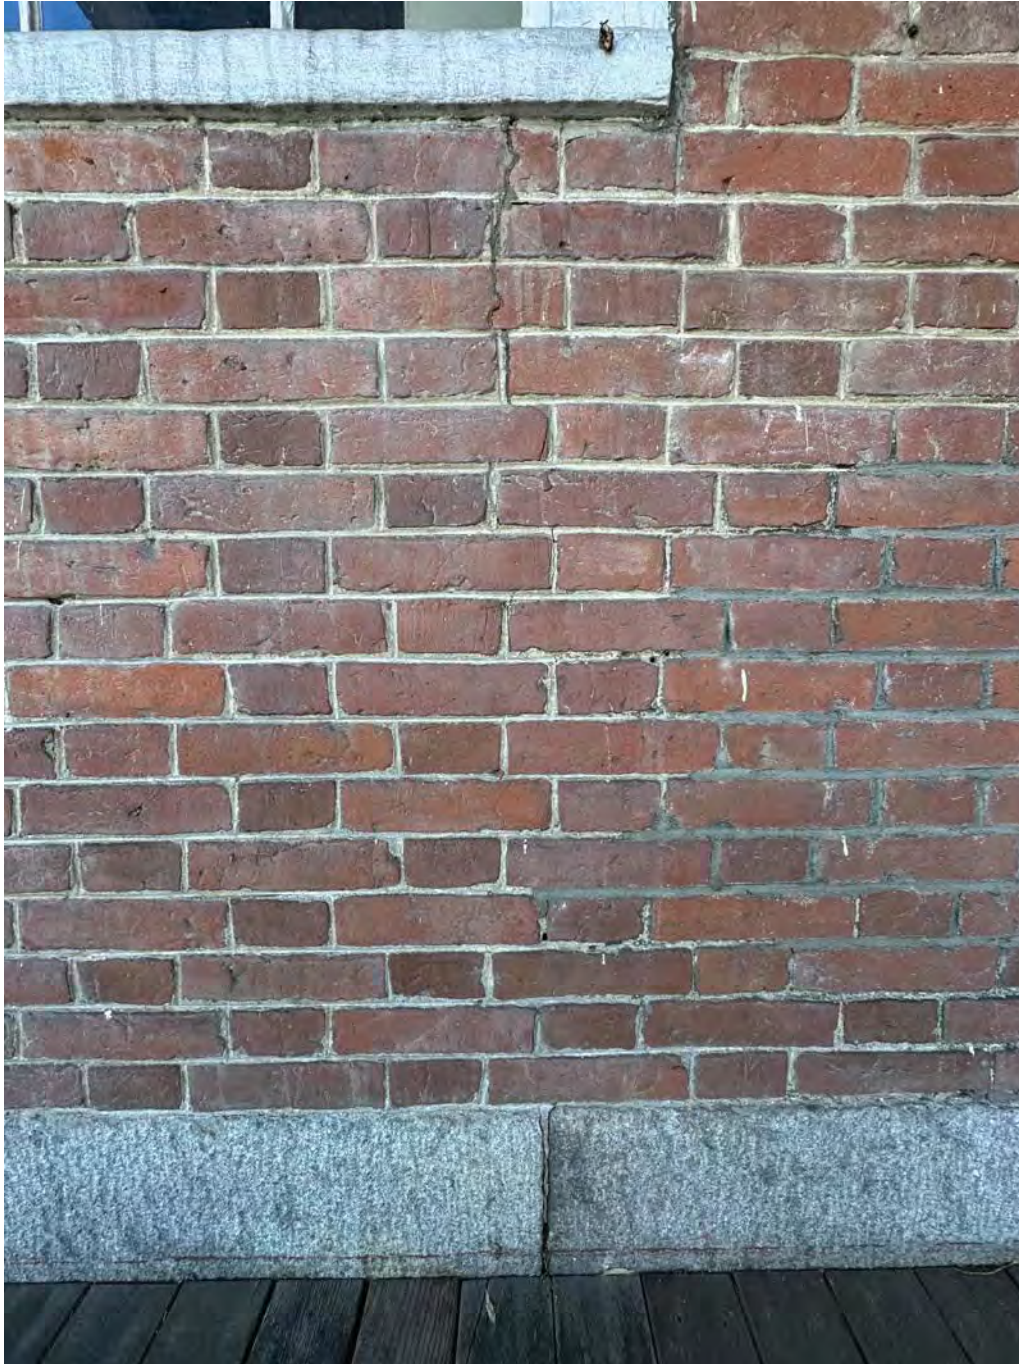
Figure 4.2-4
Crack on the west
elevation below W-23.
Previously improperly
patched.

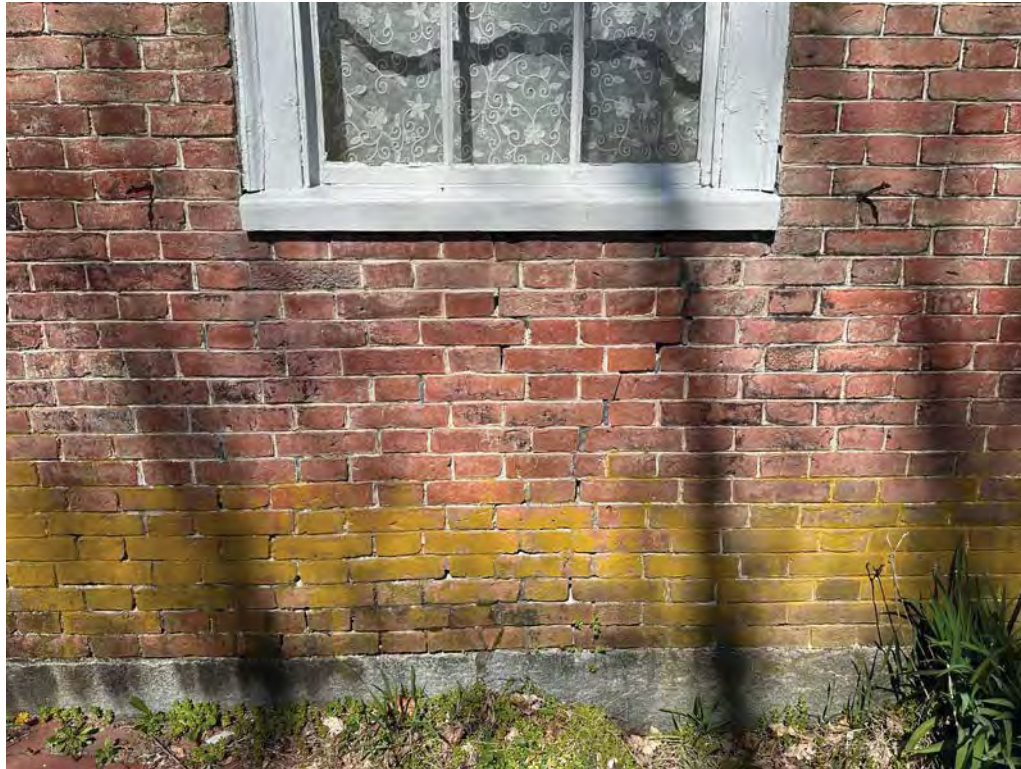
Figure 4.2-5
Crack on the east
elevation below
W-07. Previously
improperly
patched.

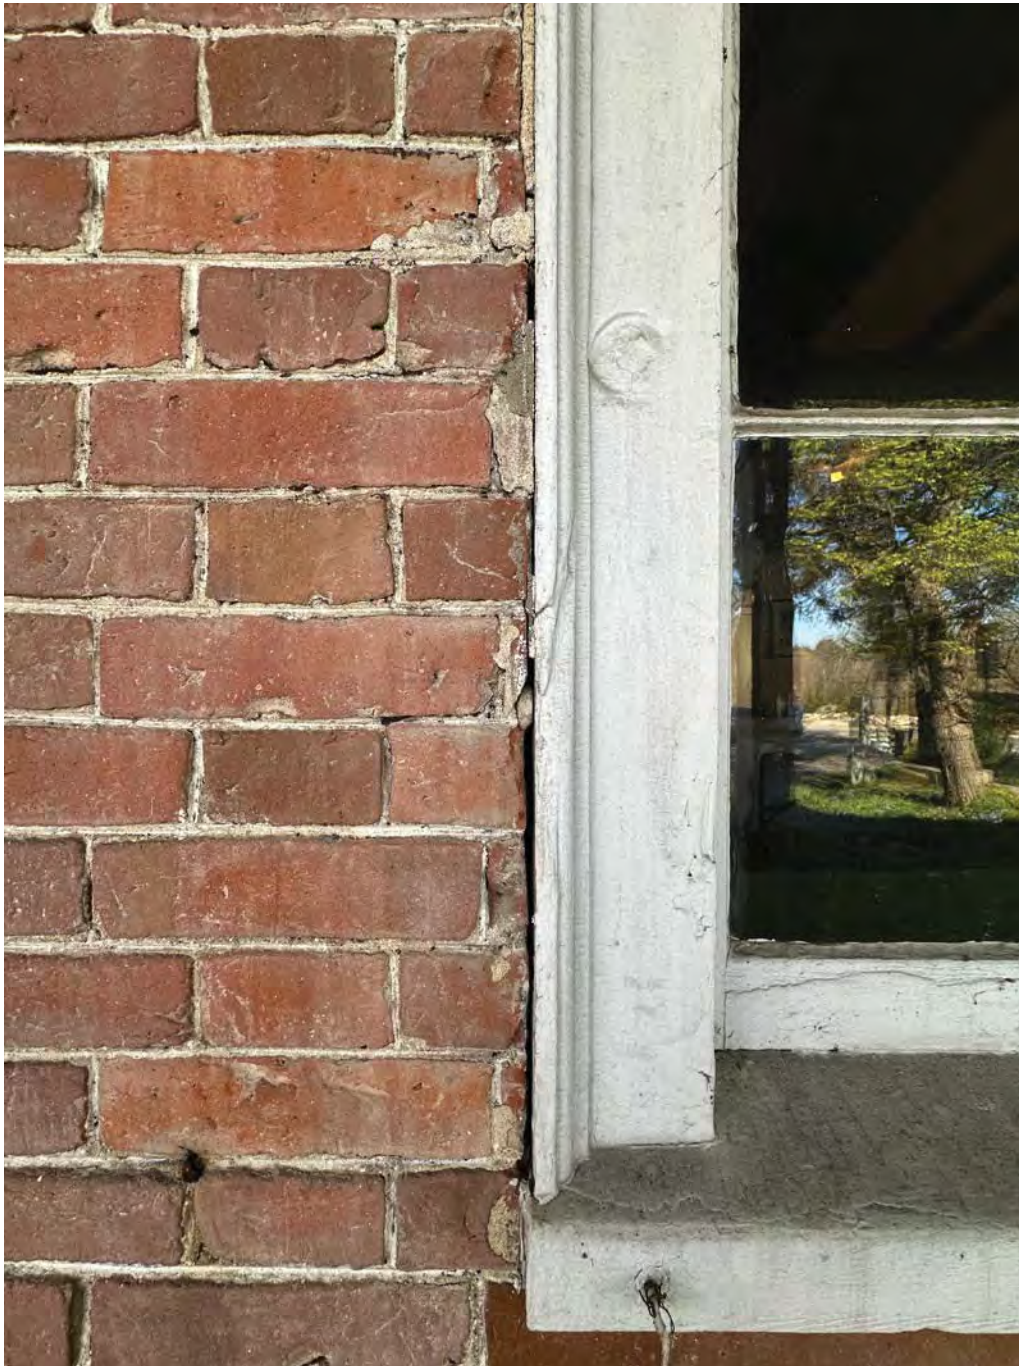
Figure 4.2-6
Several of the bricks
at the outer edge of
the masonry openings
are damaged, missing
pieces, and patched
with mortar.

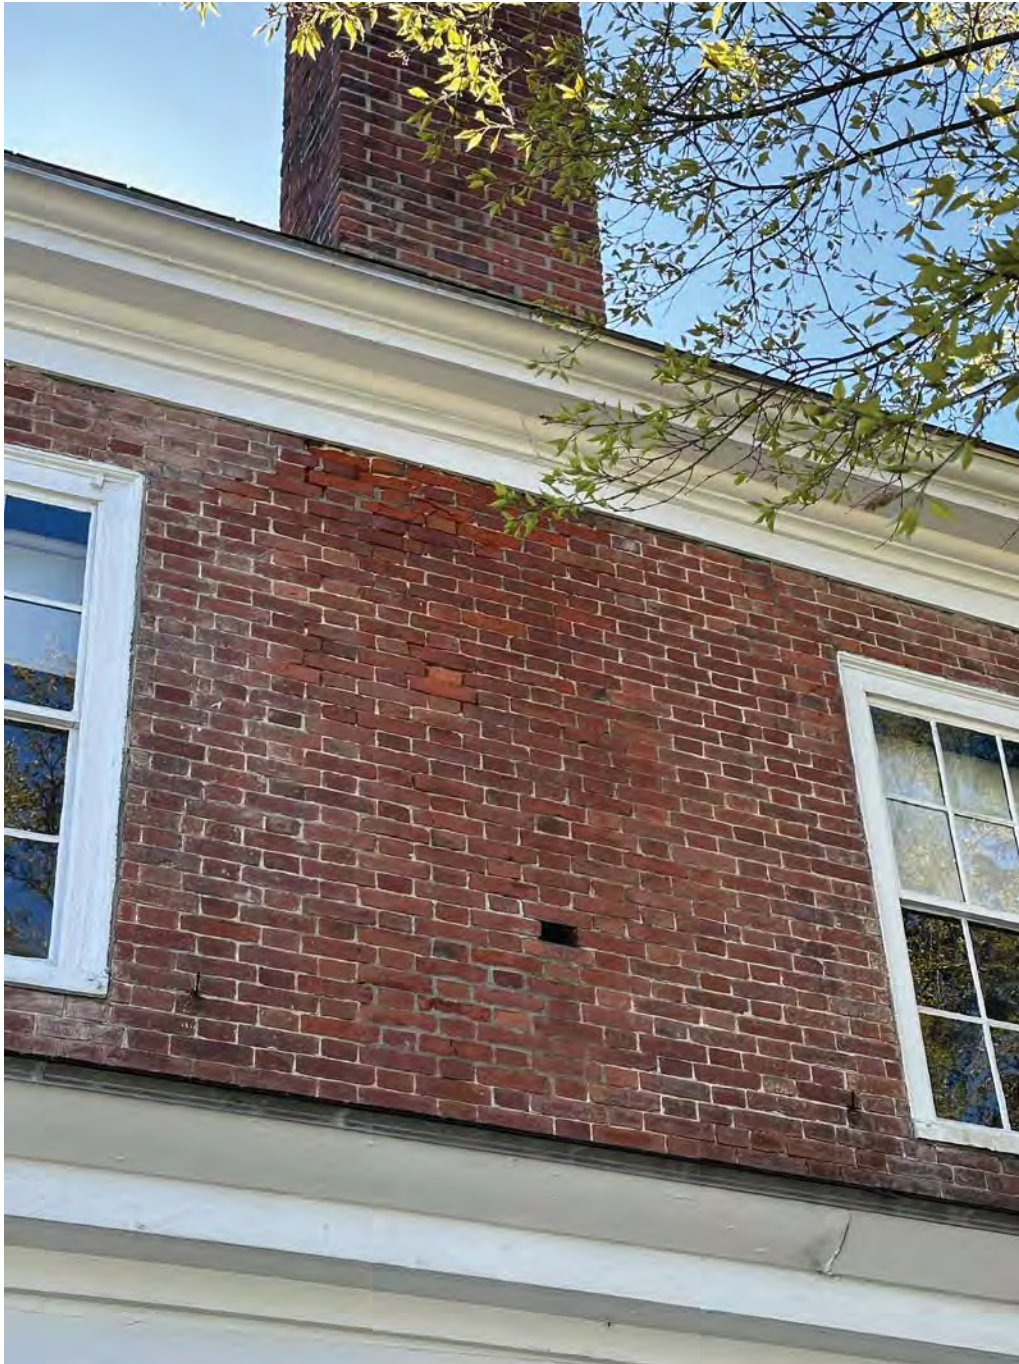
Figure 4.2-7
There are two areas on the west elevation of approximately 3' by 5' between windows W-46 and W-47, which show signs of deterioration. Bricks are missing their fire faces or cracked, and there is extensive mortar loss.
