HOSMER HOUSE

HISTORIC STRUCTURE REPORT / CULTURAL LANDSCAPE REPORT

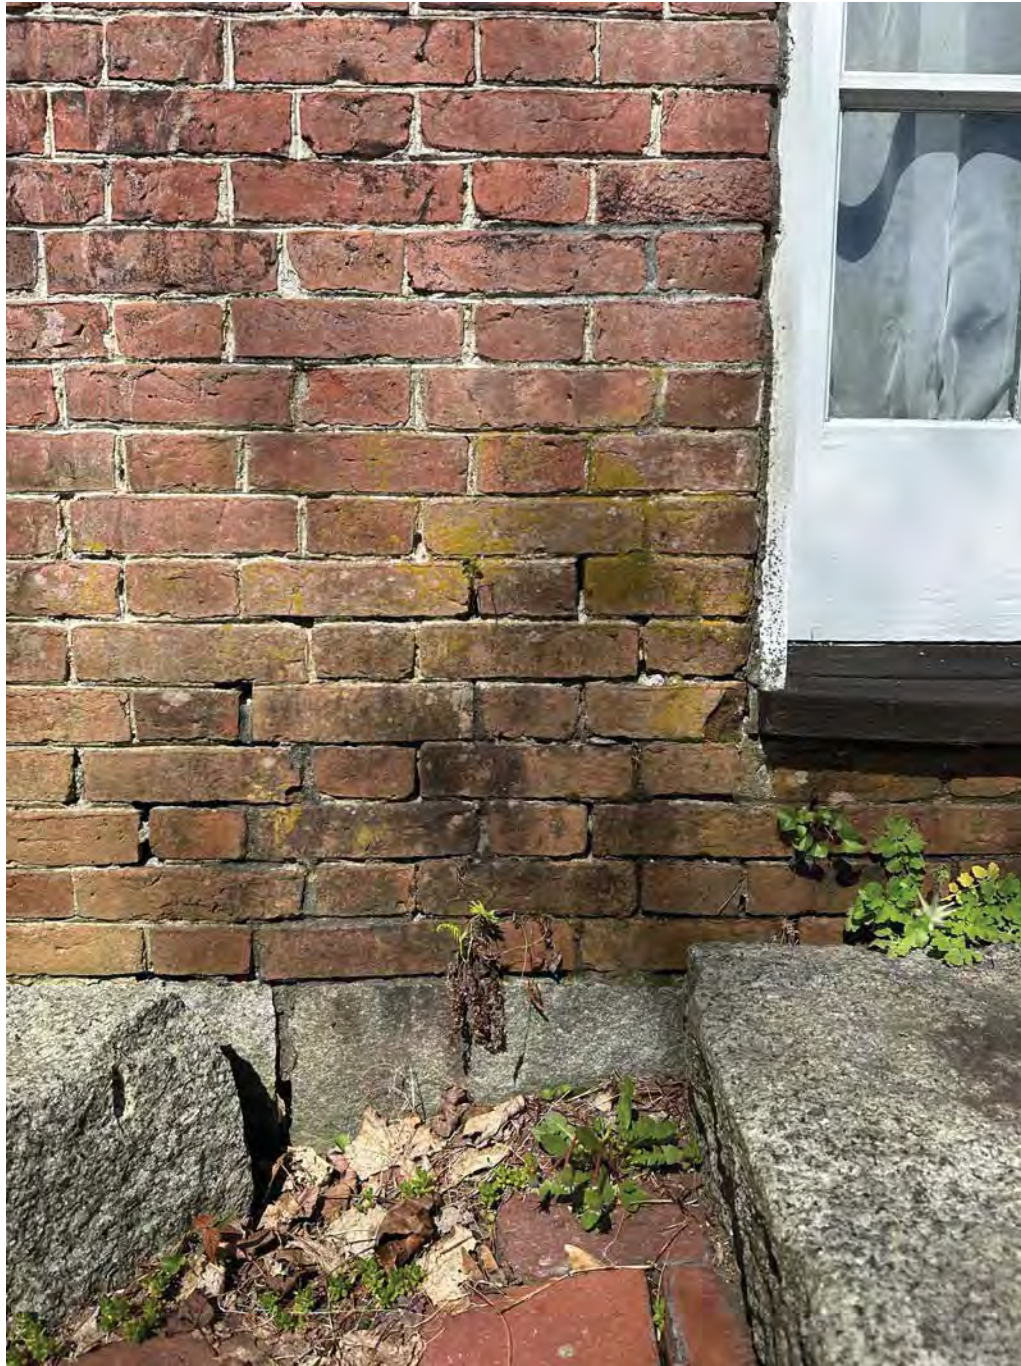
Figure 4.2-8
Several areas along
the base of the
building on the east
elevation in which the
mortar has
deteriorated due to
water infiltration, and
in these gaps, small
plants have taken
root.

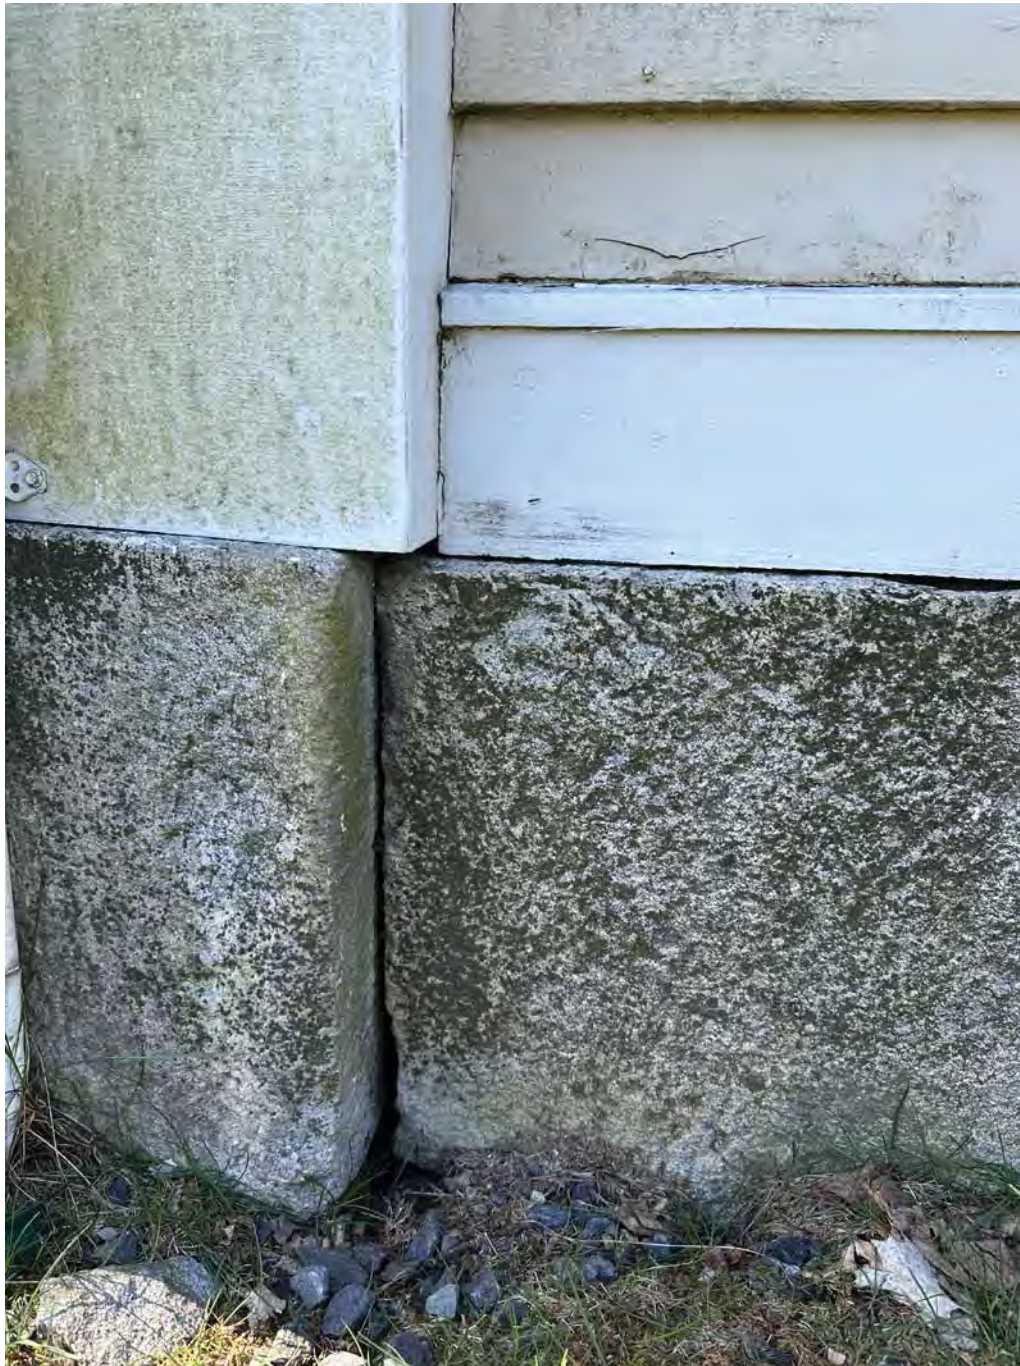
Figure 4.3-1
Along the north, east and west elevations, the base is constructed with a single rectilinear cut stone which sits directly below the exterior cladding system.

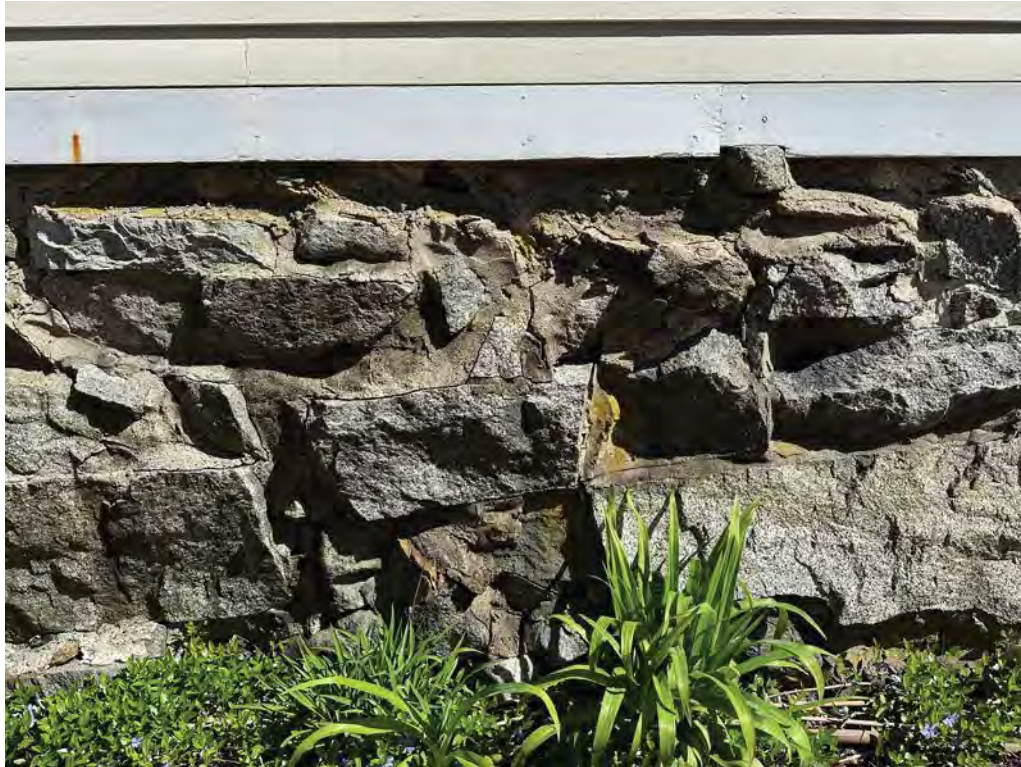
Figure 4.3-2
Foundation below
rooms F-05 and F-
07 is constructed
from ashlar
masonry.

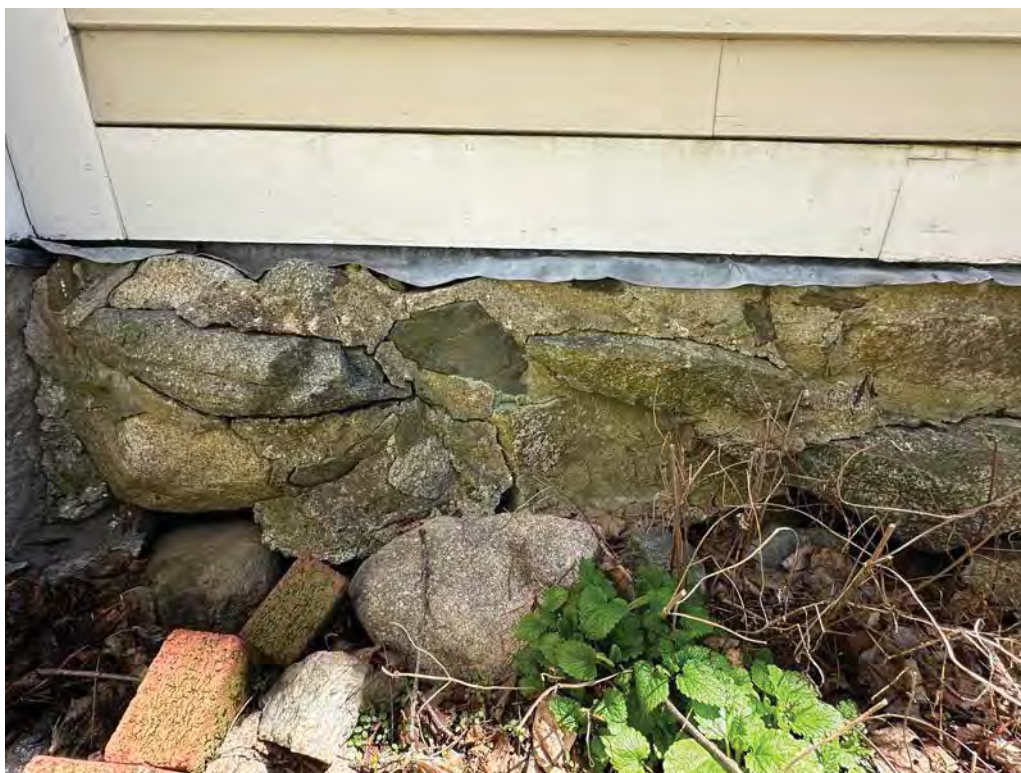
Figure 4.3-3
Base flashing was
found in certain
locations along the
ashlar stone walls;
however it is not
entirely covering the
foundation wall, and
is bent out of shape
in several locations.

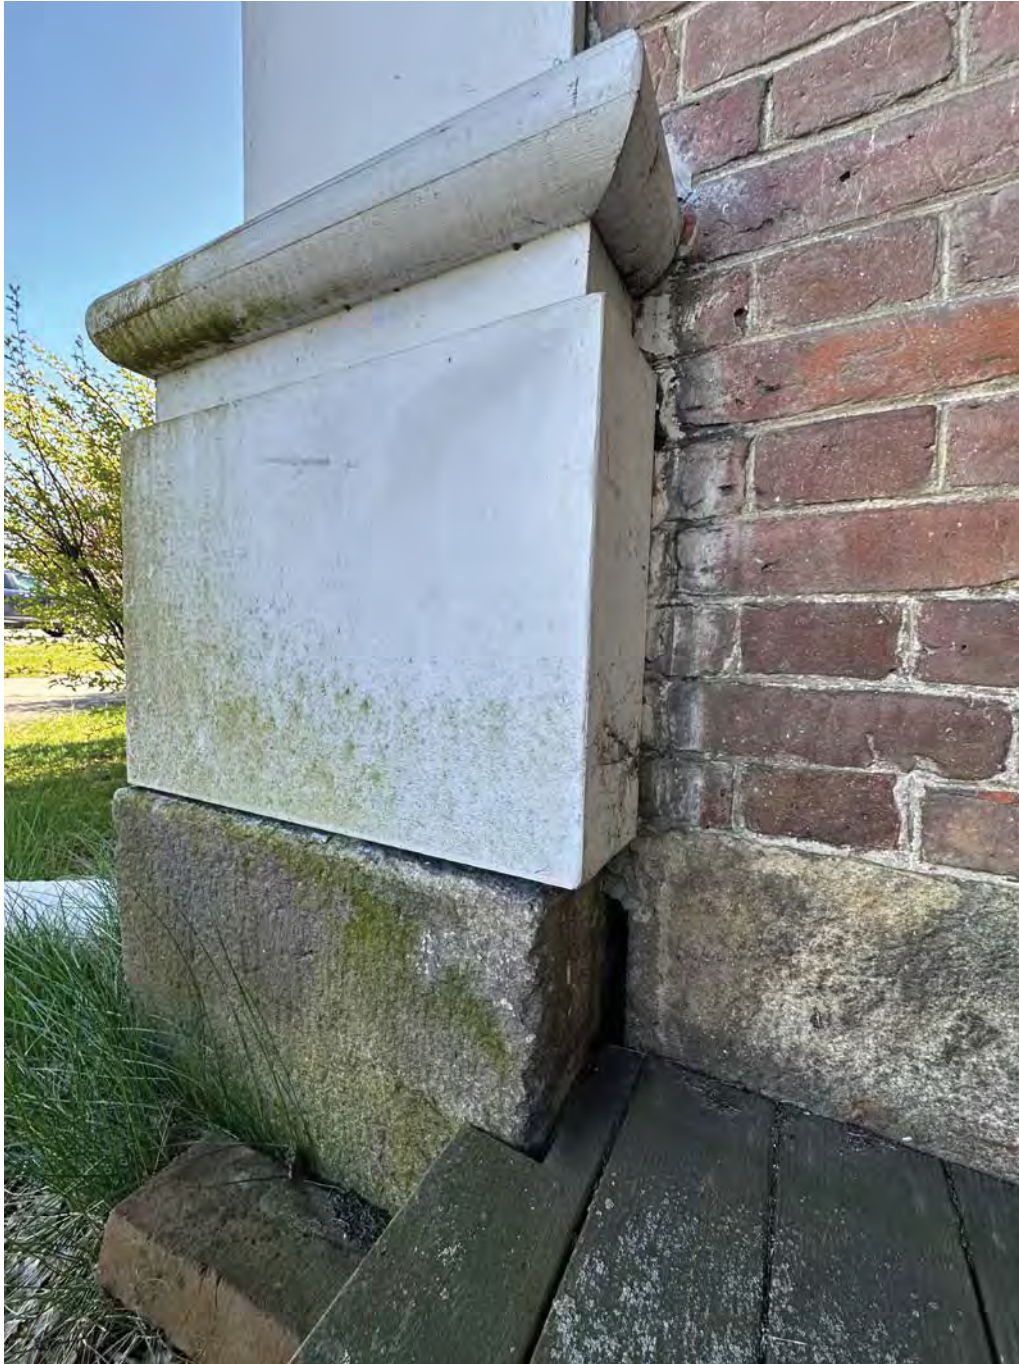
Figure 4.3-4
There is no evident base flashing between the wood pilaster and the granite foundation.

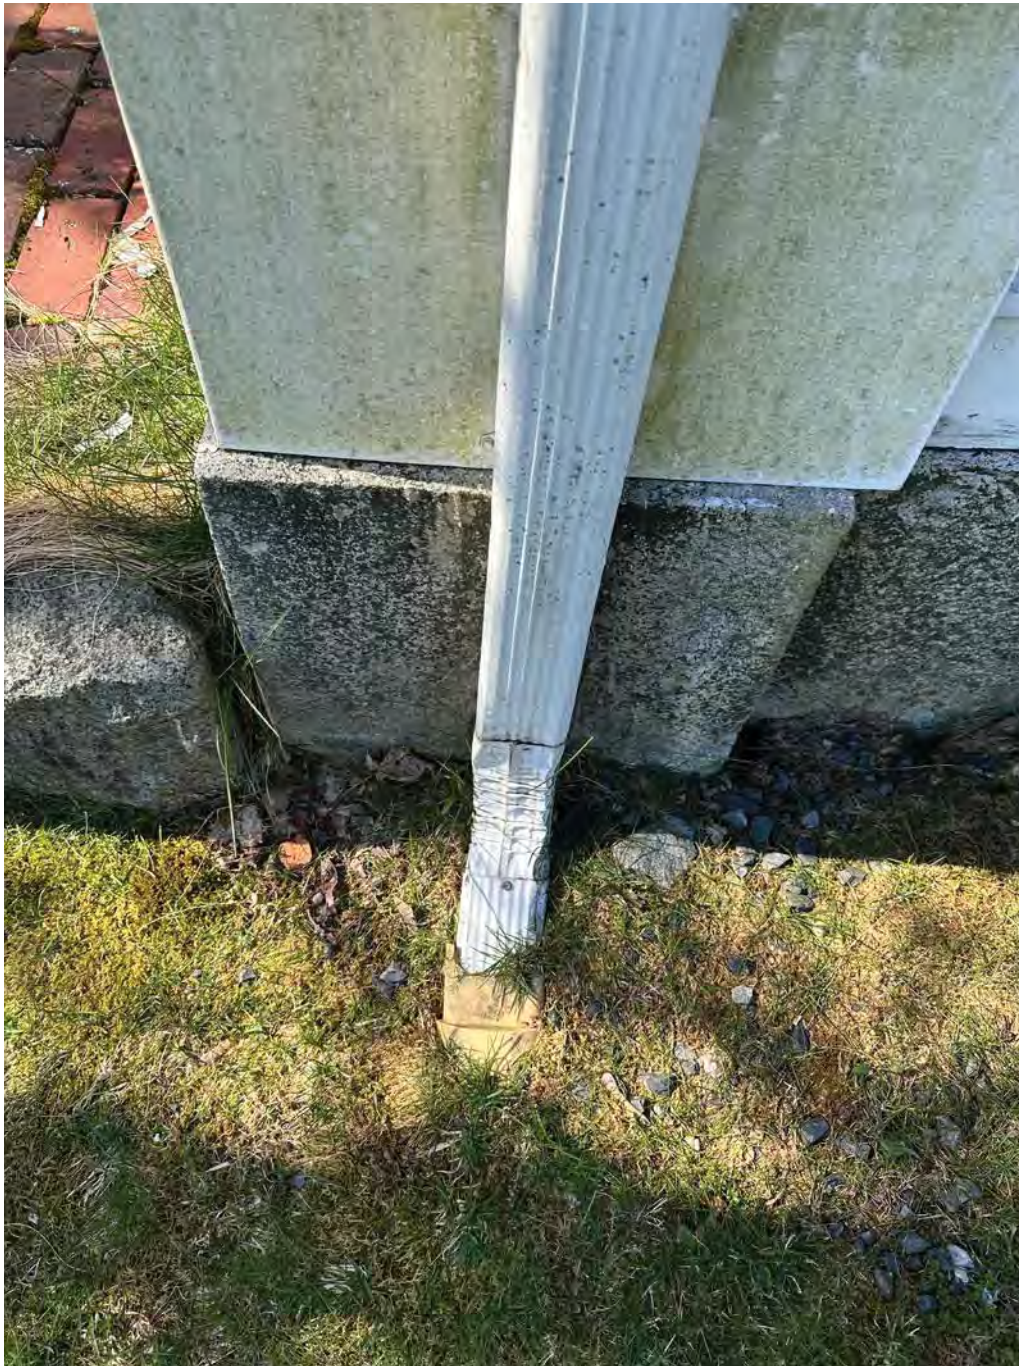
Figure 4.3-5
There is no
evident base
flashing between
the wood pilaster
and the granite
foundation.

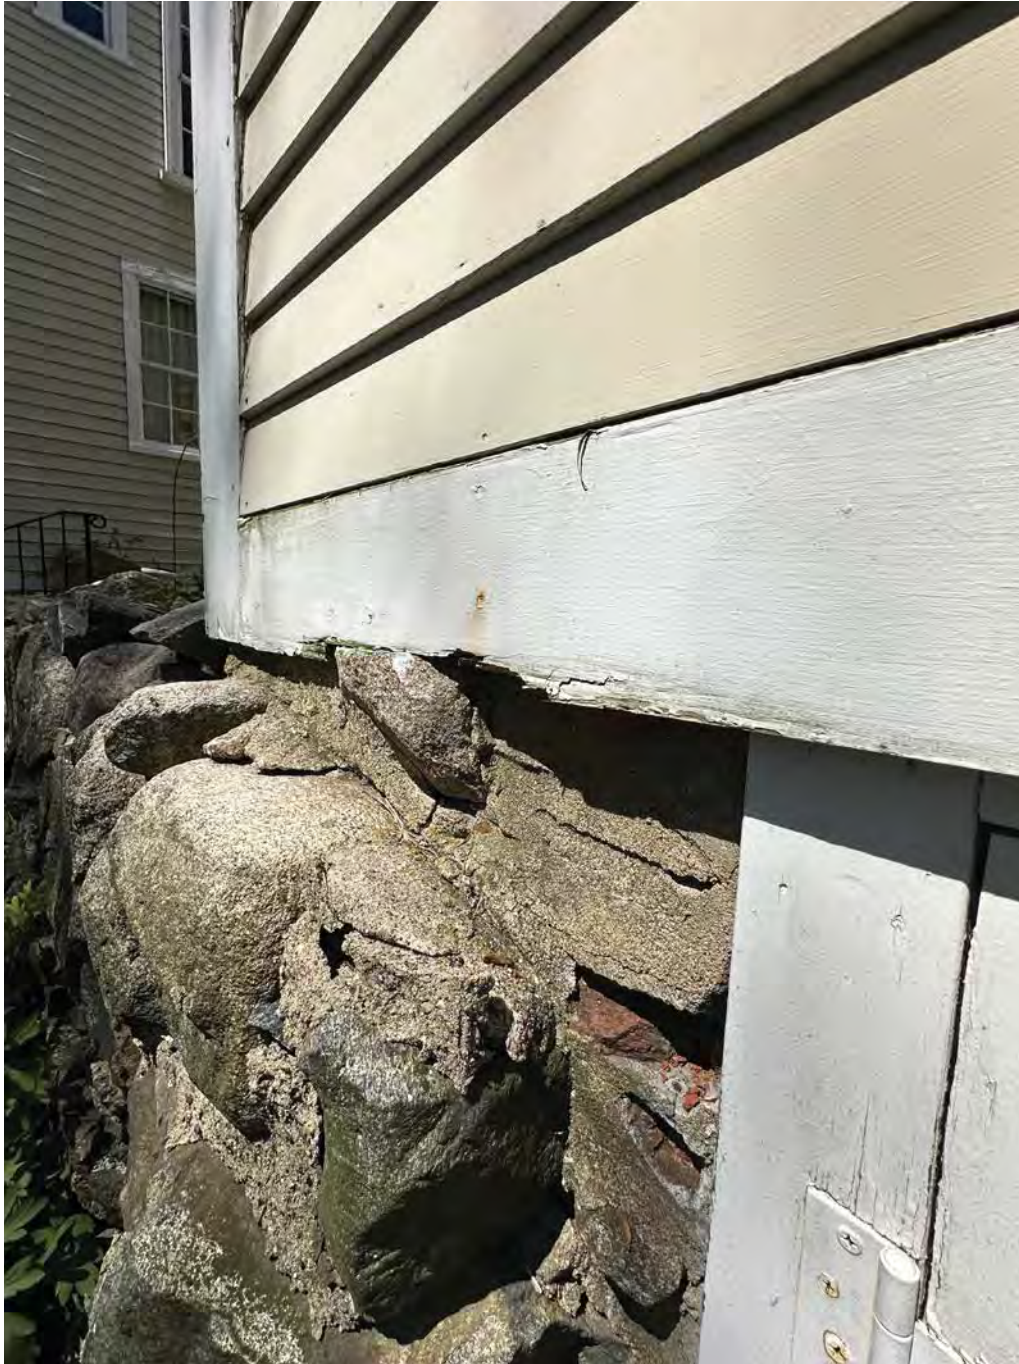
Figure 4.3-6
There is no evident base flashing between the cladding system and the ashlar stone foundation wall.

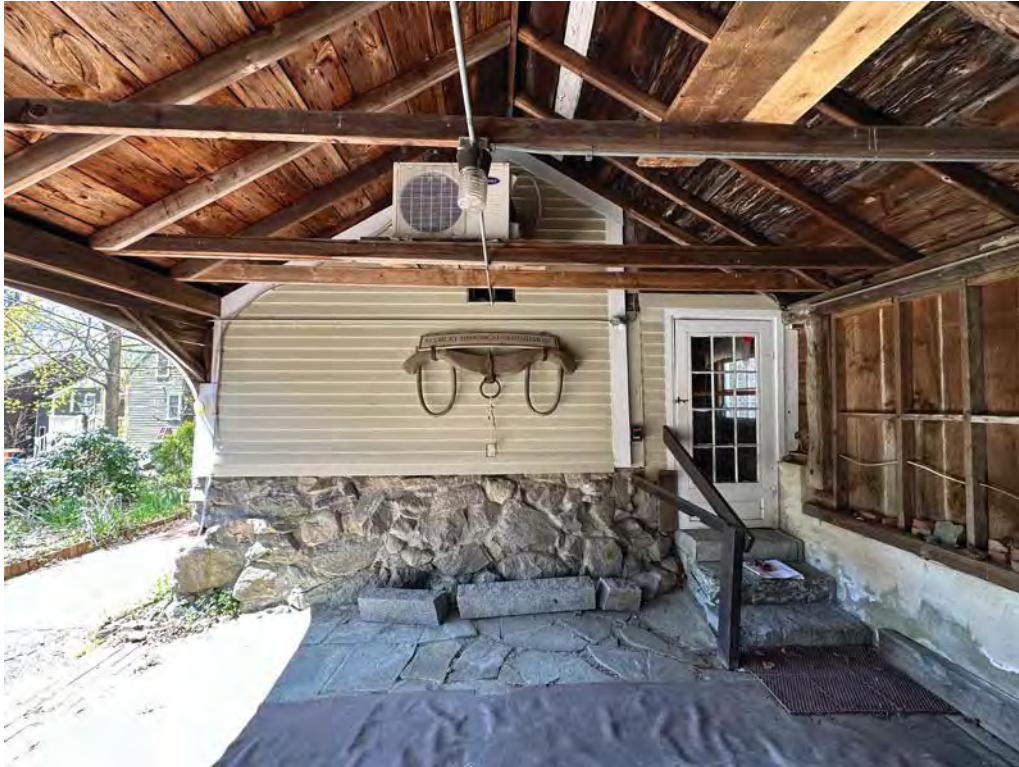
Figure 4.3-7
Ashlar foundation
wall shared by the
east wall of the
southeast addition,
and the carriage
house.

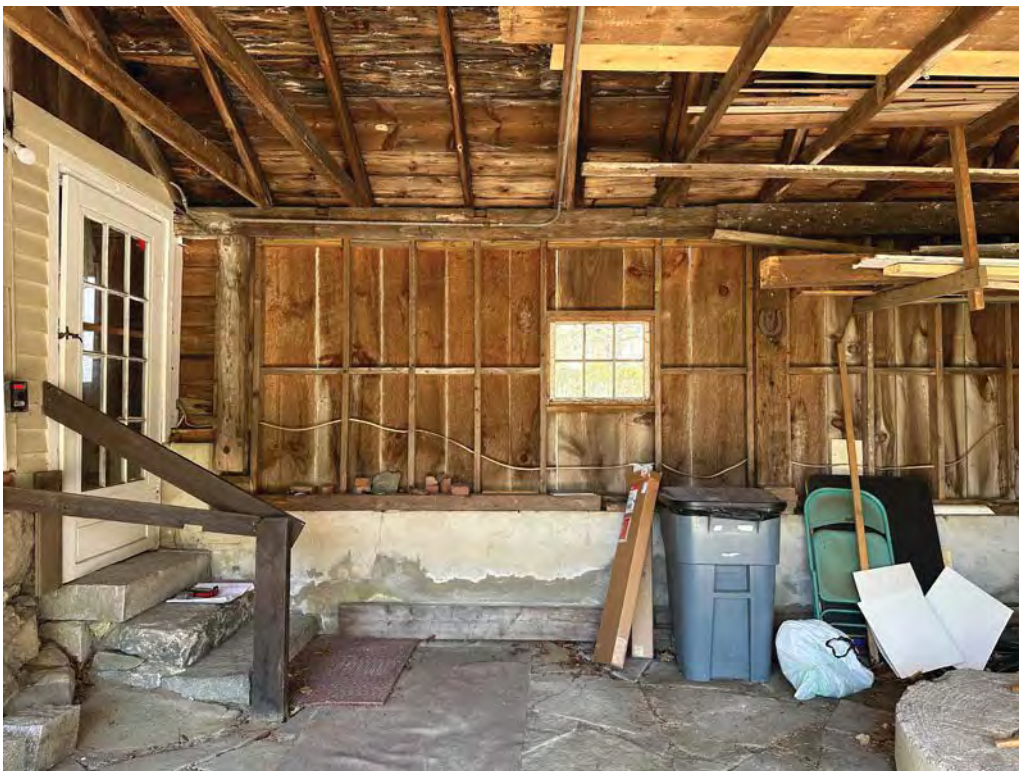
Figure 4.3-8
The foundation along
the northern wall is
constructed of concrete
masonry units (CMU's)
and timber. These
foundations seem to
have been restored in
the recent past and are
in good condition.

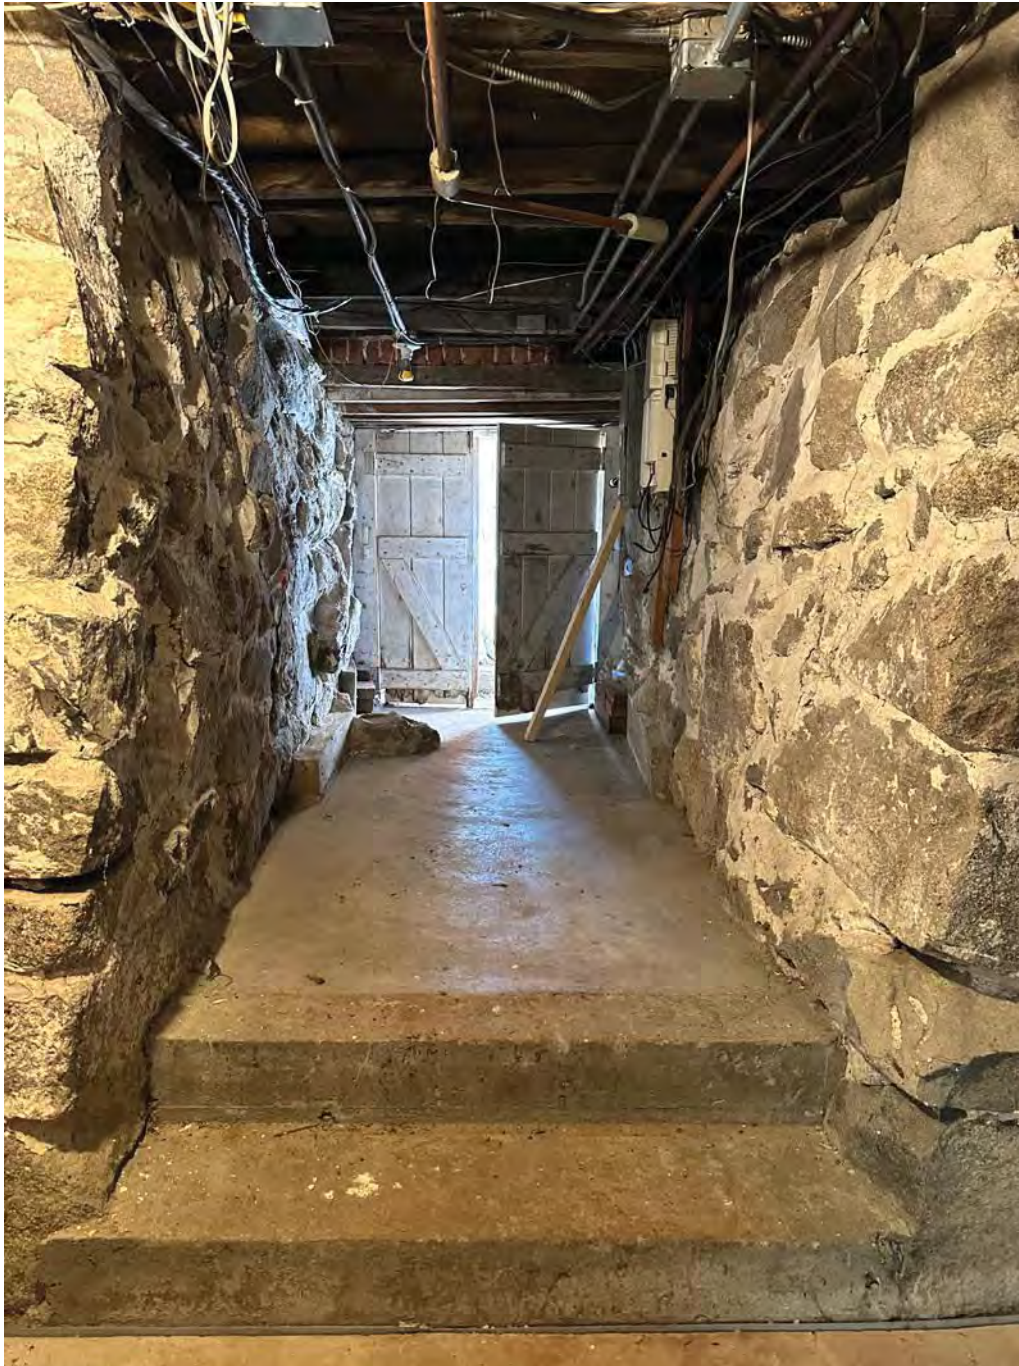
Figure 4.3-9
The basement is partially below-grade with an exterior access door along the south wall of the southwest addition. The foundation walls are constructed of ashlar masonry, which are also exposed in the basement.

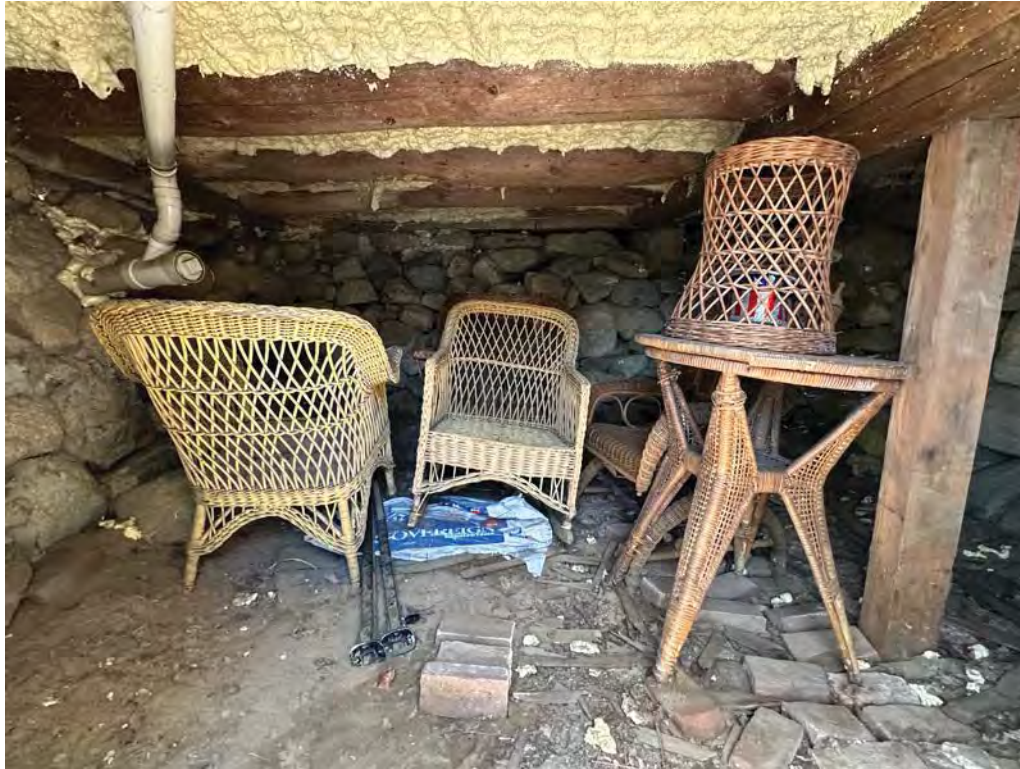
Figure 4.3-10
There is one crawl
space (room B-02)
directly below room F-
05, which is accessed
from outside with no
access to the
basement, and is also
constructed of both
ashlar and loose laid
stone masonry.

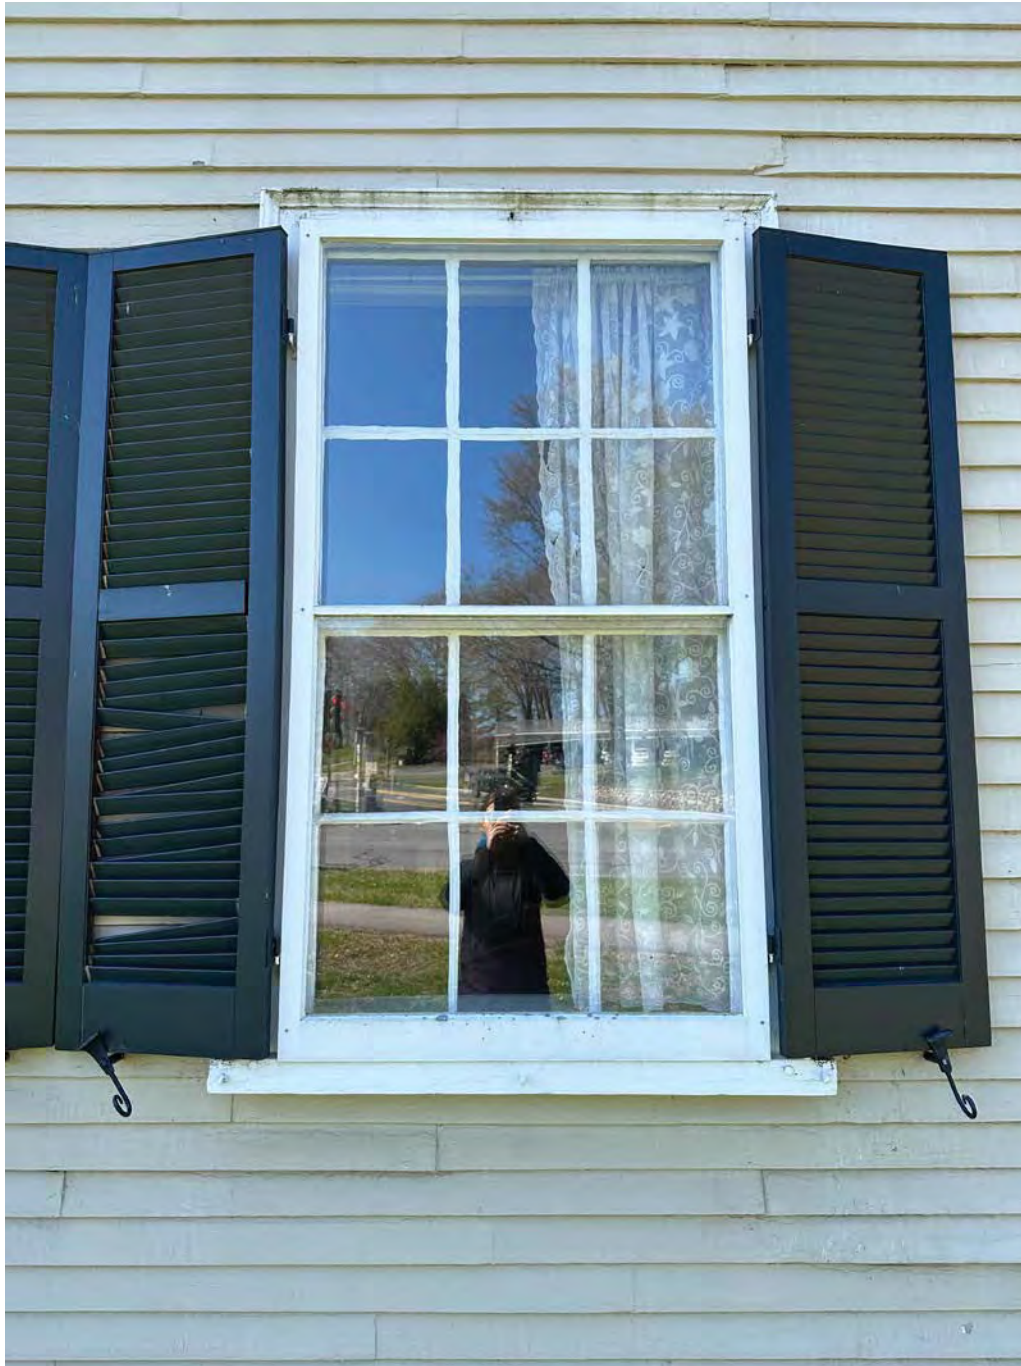
Figure 4.4-1
Double-hung six-over-six
lite window configuration
found typically on the
main house.

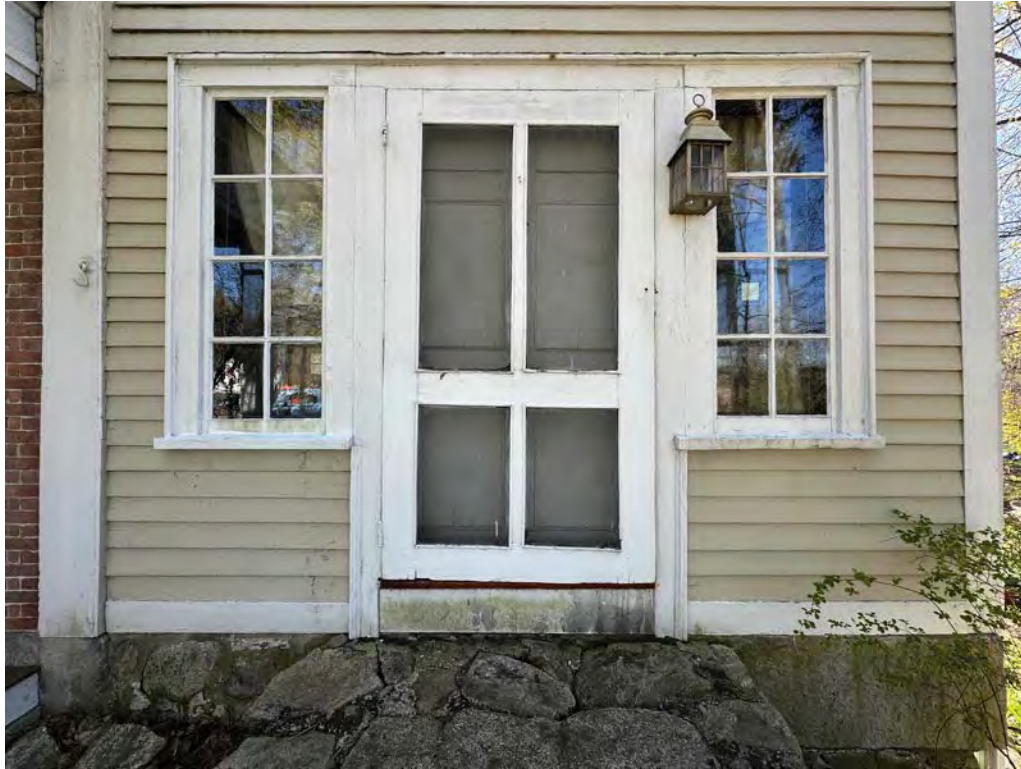
Figure 4.4-2
Two vertical fixed wood
windows flanking the
office entrance door (D-
21). The screen door
was found to be
damaged and
inappropriate in design.

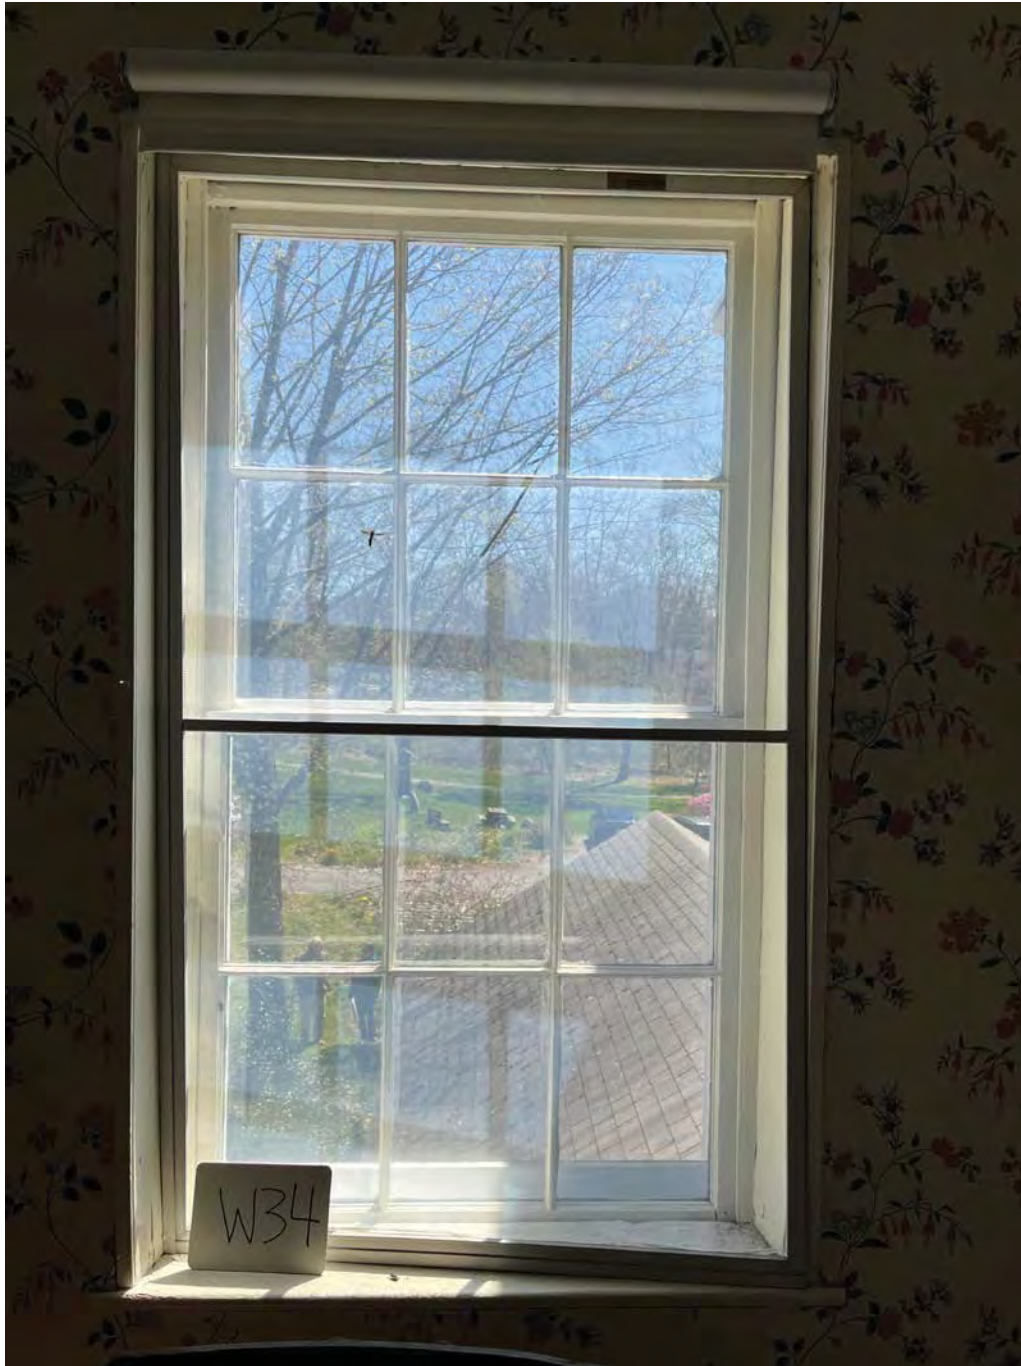
Figure 4.4-3
Window inserts painted
white and installed at the
interior of the windows.

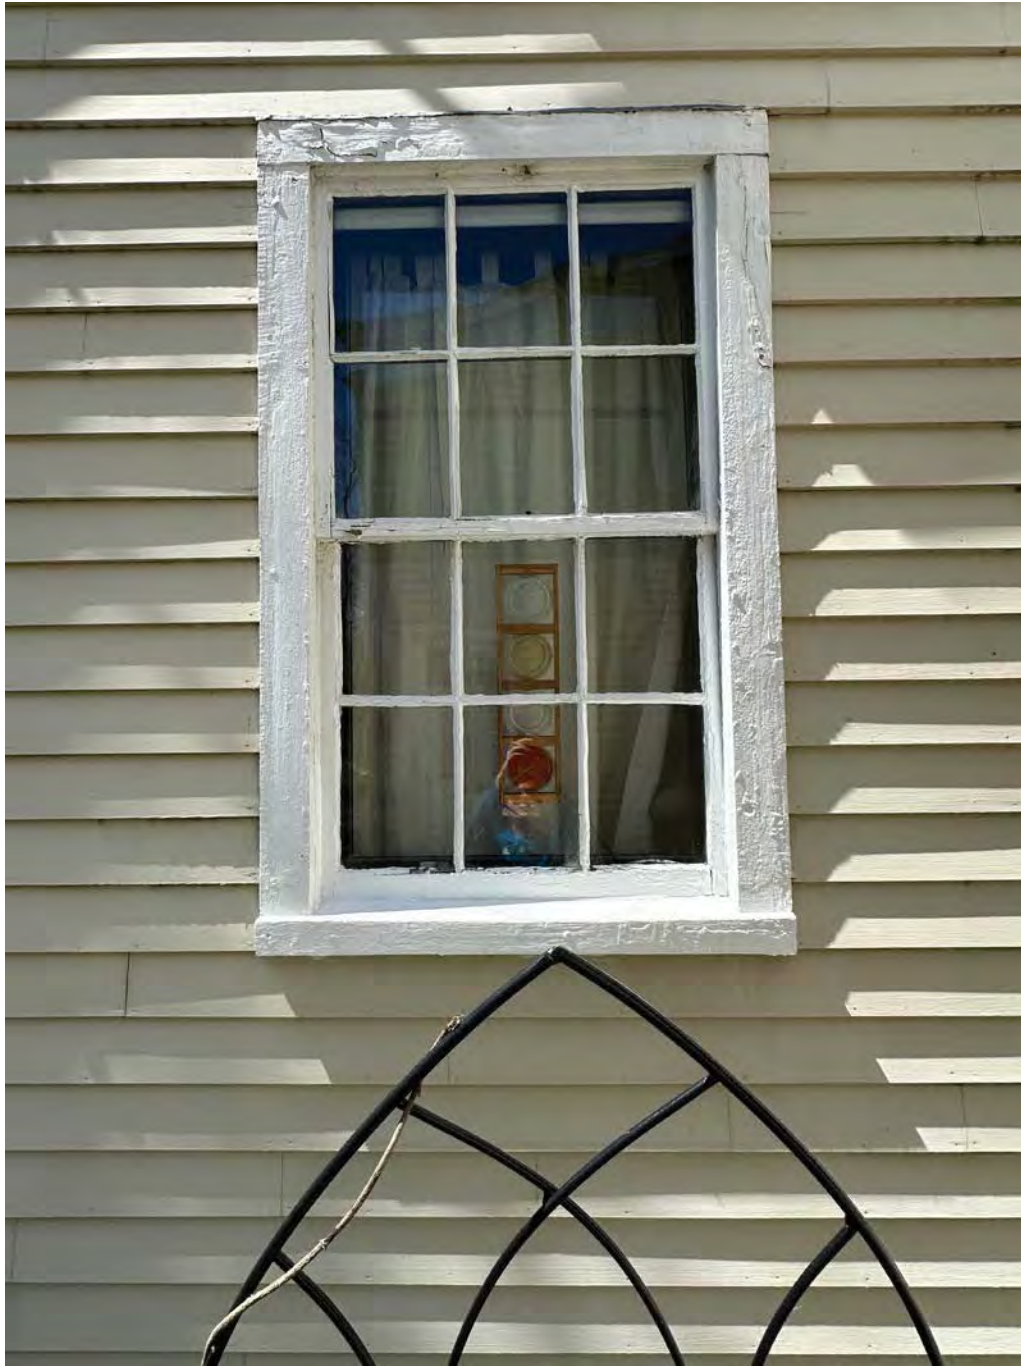
Figure 4.4-6
Minor wood damage and
peeling paint found
typically over all
elevations.

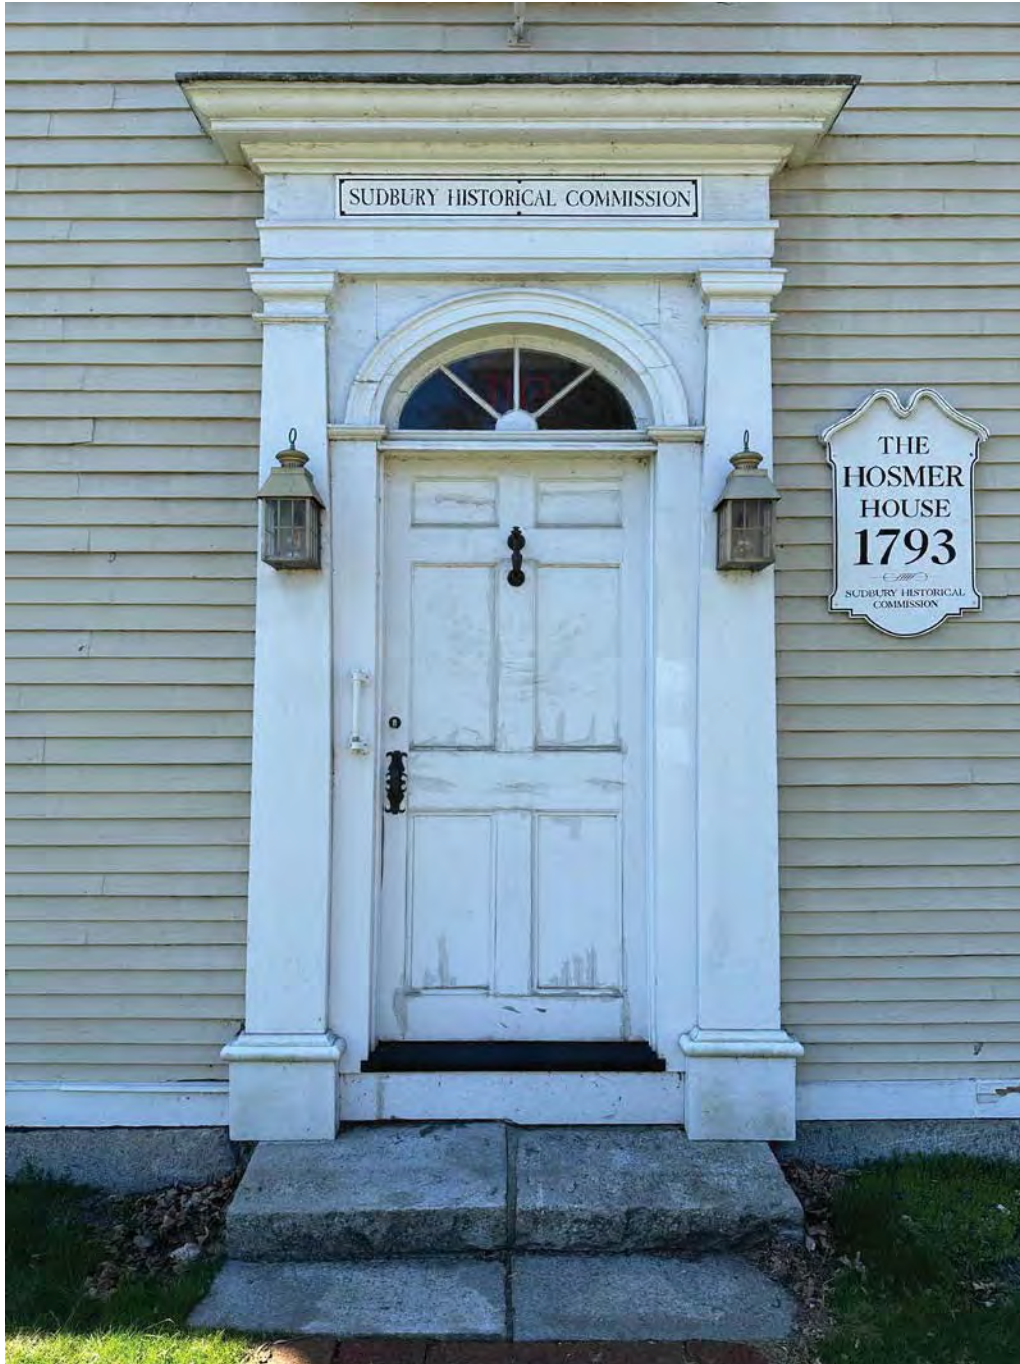
Figure 4.4-7
D-01 in poor-to-fair
condition, showing signs
of wood deterioration,
cracks, and previous
repairs.

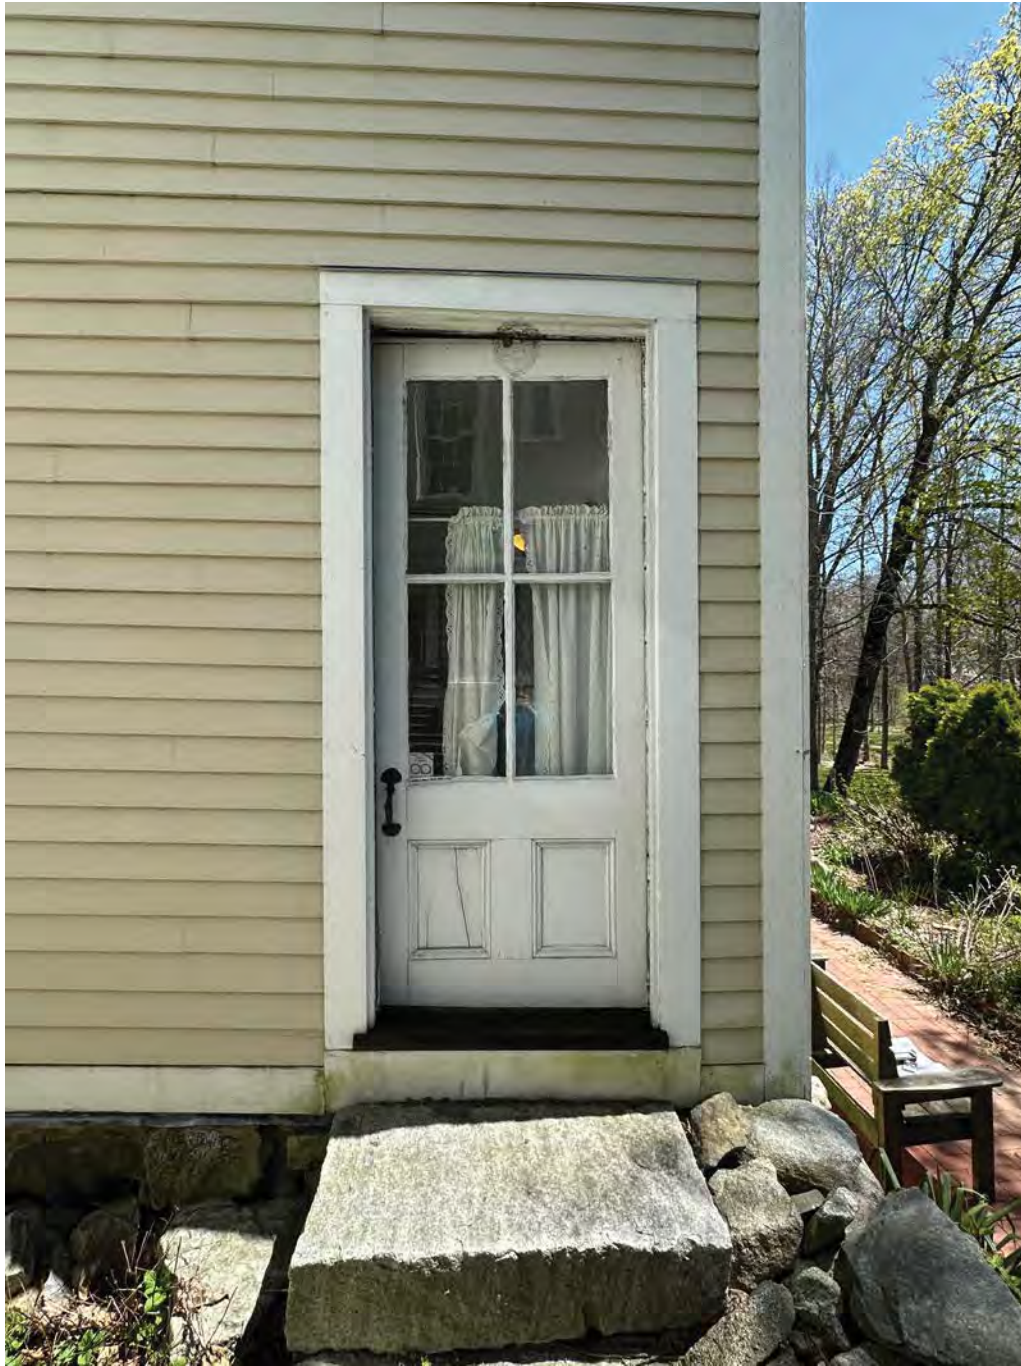
Figure 4.4-8
D-12 in poor-to-fair
condition, showing signs
of wood deterioration,
cracks, and previous
repairs.

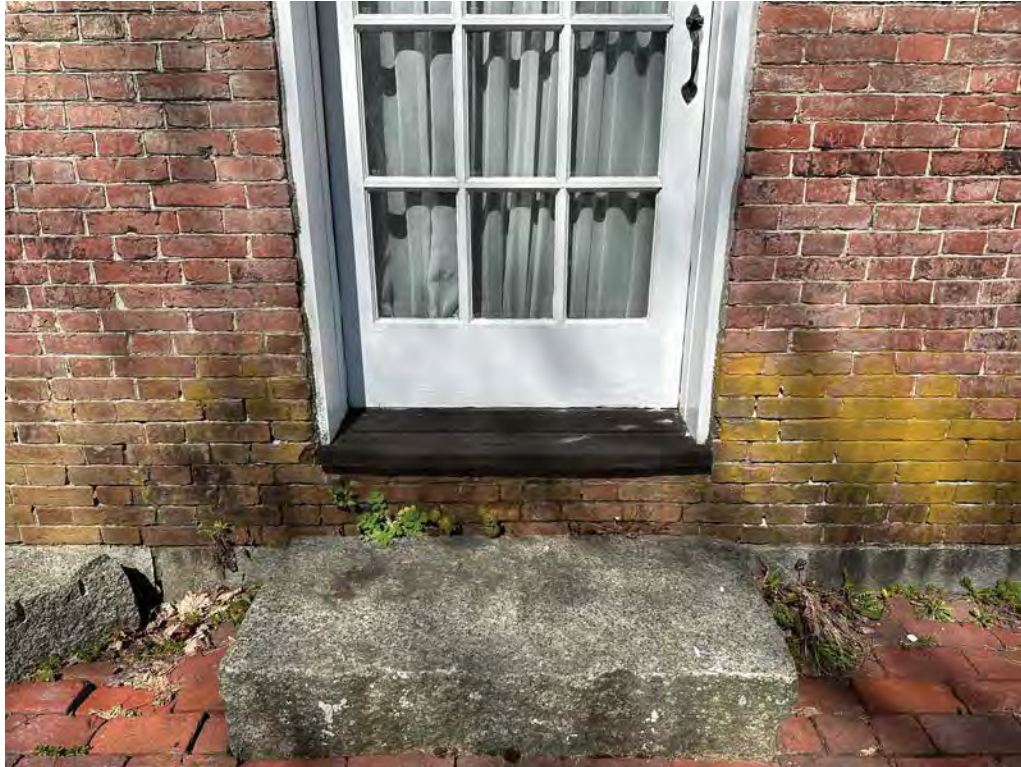
Figure 4.4-9
Door and sill on D-12
and D-06 were found to
be damaged, cupped,
and pitched backward.

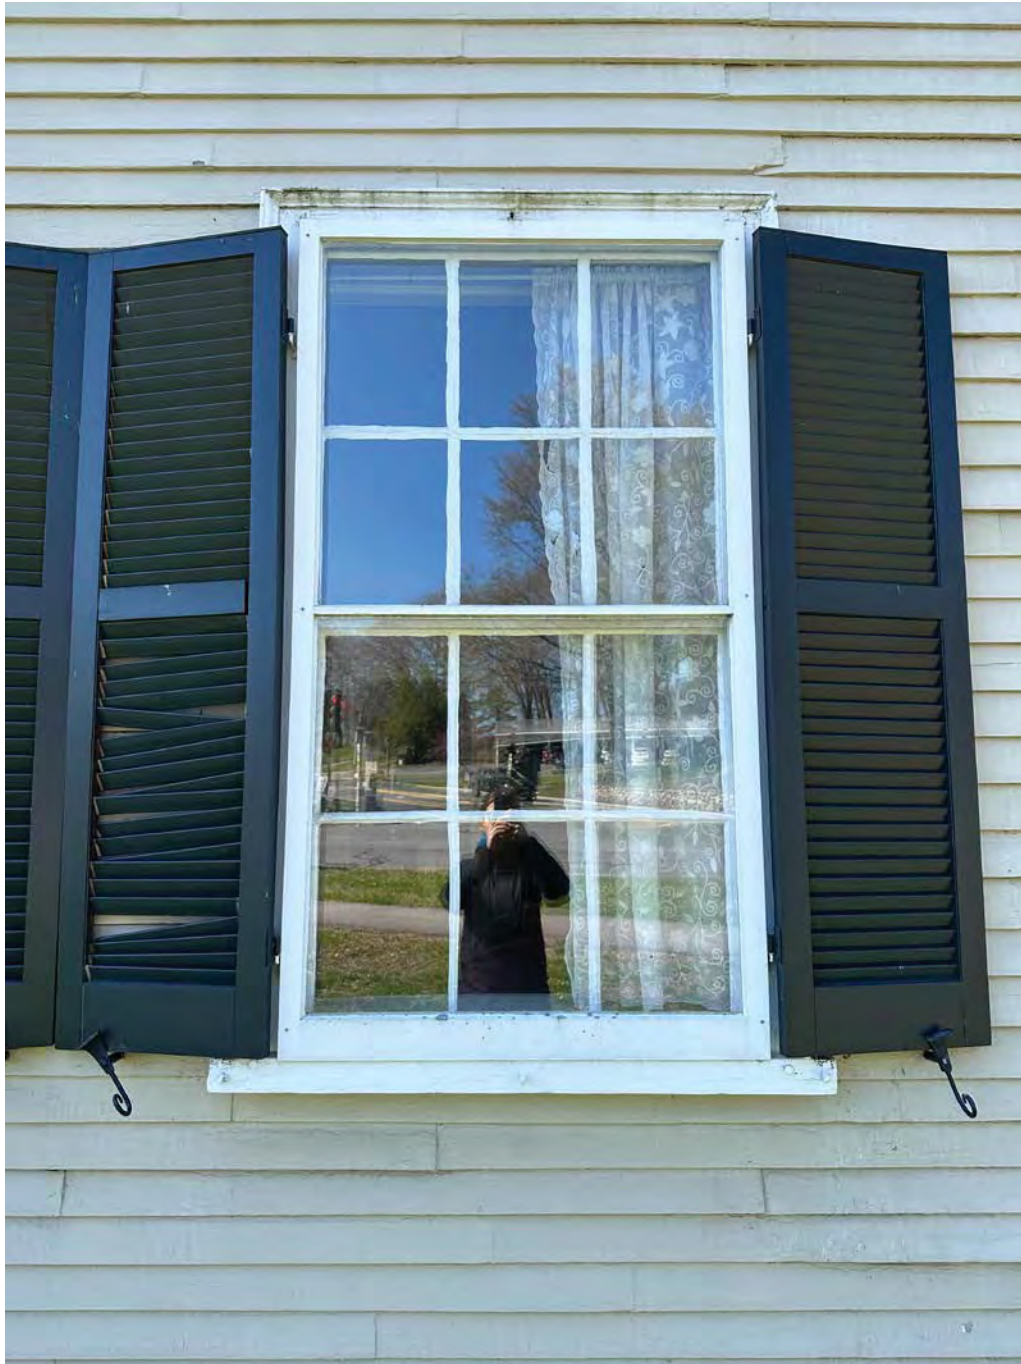
Figure 4.4-10
The storm windows are non-operable and are screwed to the wood casing. One storm window on the north façade (W-05) was installed upside down.
