HOSMER HOUSE

HISTORIC STRUCTURE REPORT / CULTURAL LANDSCAPE REPORT

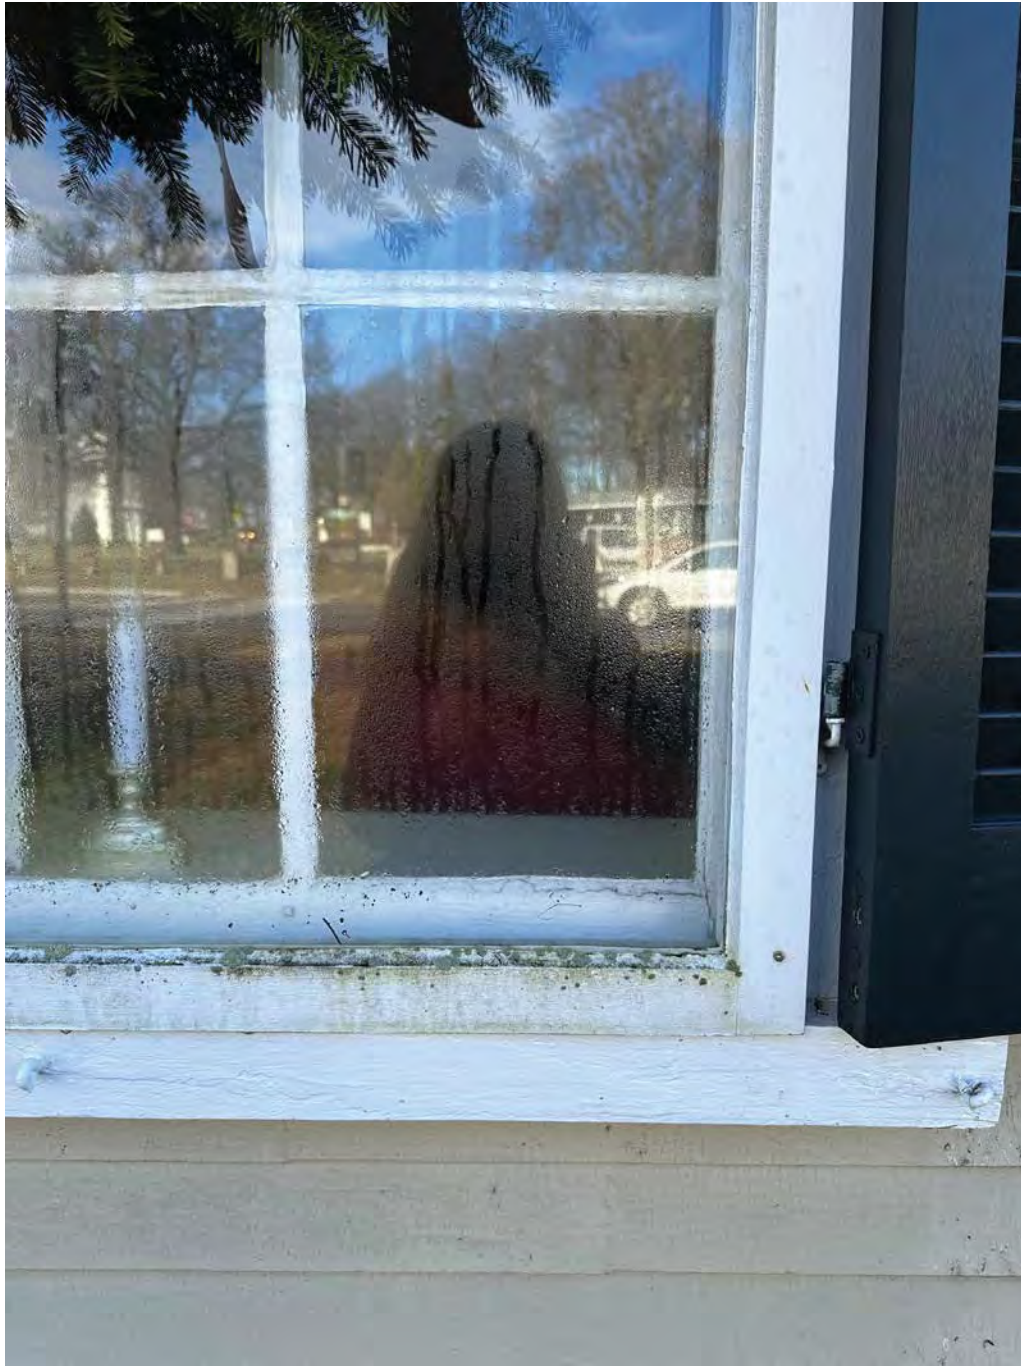
Figure 4.4-11
During the Request for
Proposal process in
December 2023,
condensation was
observed between the
window and storm
window.

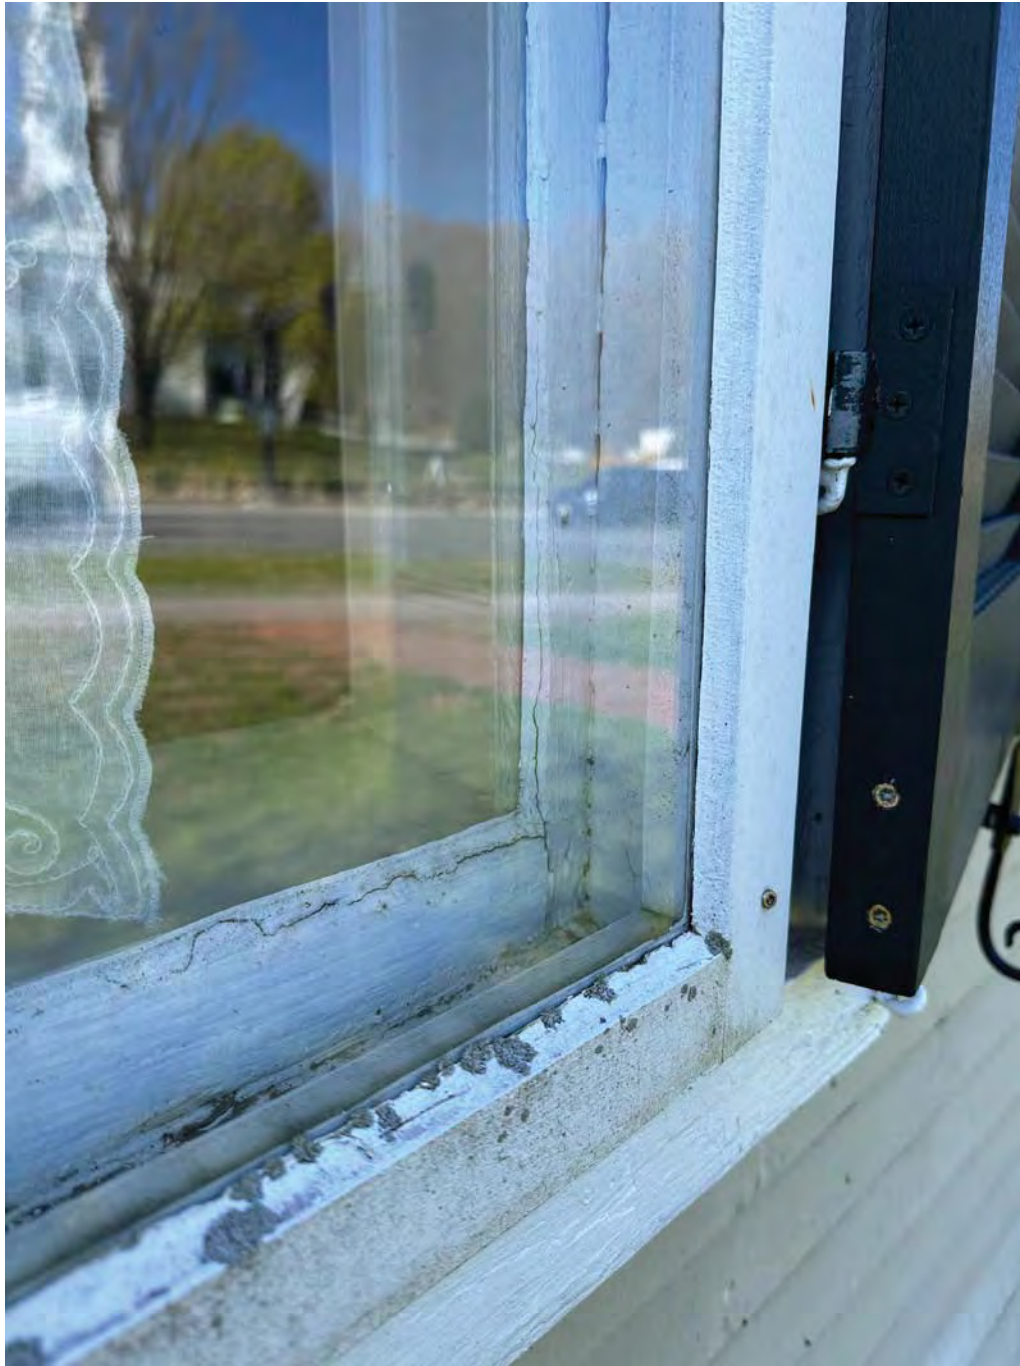
Figure 4.4-12
The perimeter sealant and glazing putty around the windows appear deteriorated, with cracks and gaps in some locations, leading to poor performance.

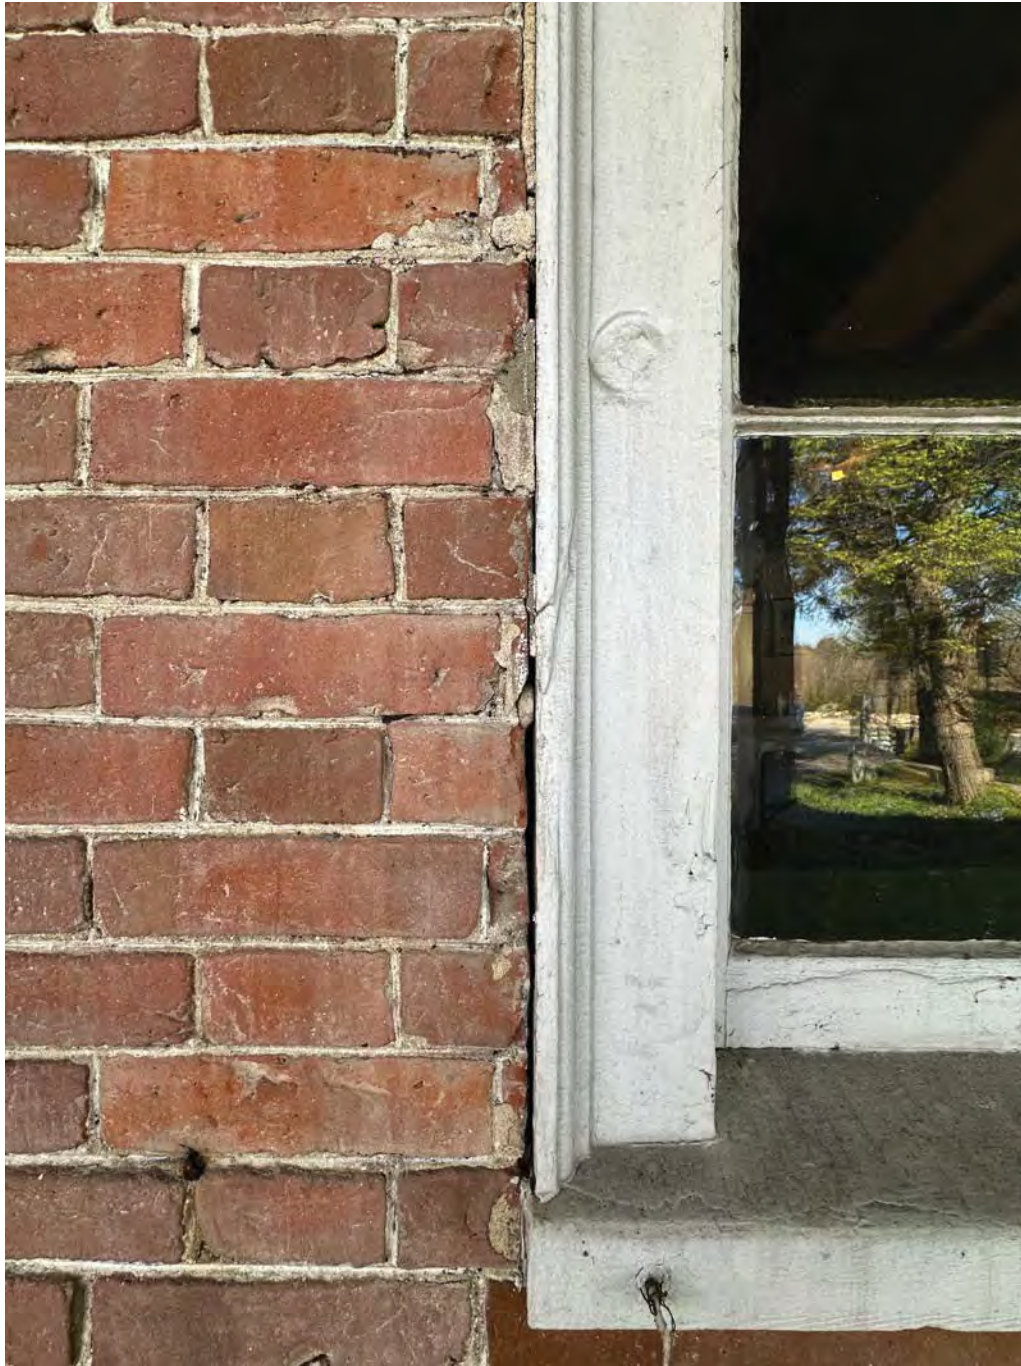
Figure 4.4-13
The perimeter sealant and glazing putty around the windows appear deteriorated, with cracks and gaps in some locations, leading to poor performance.

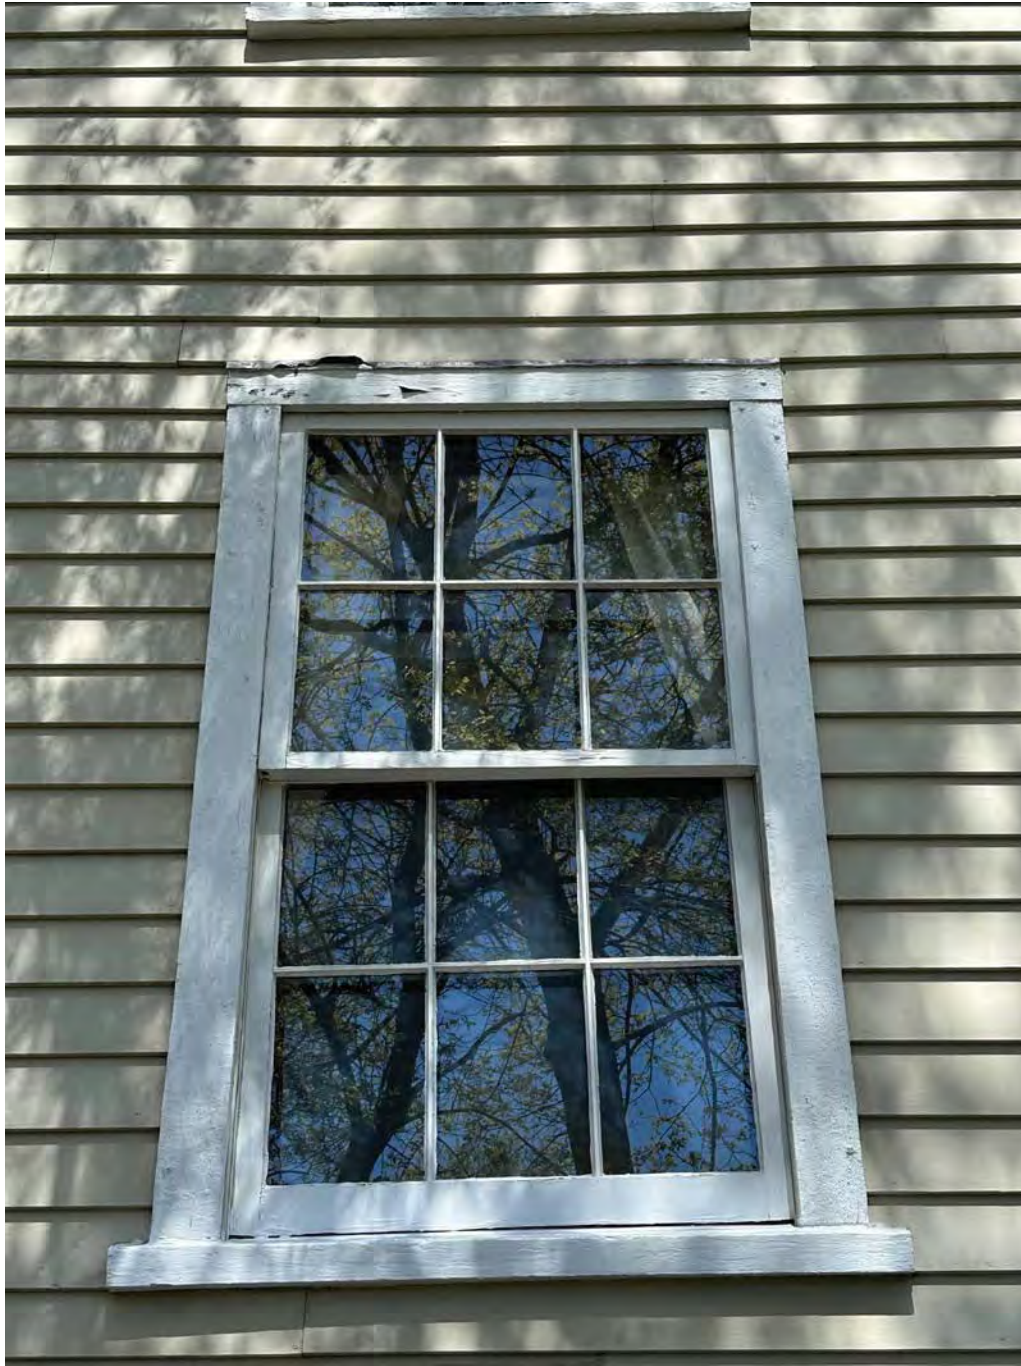
Figure 4.4-14
Metal window head
flashing was noted at
most windows but
appears bent or poorly
installed in some areas.

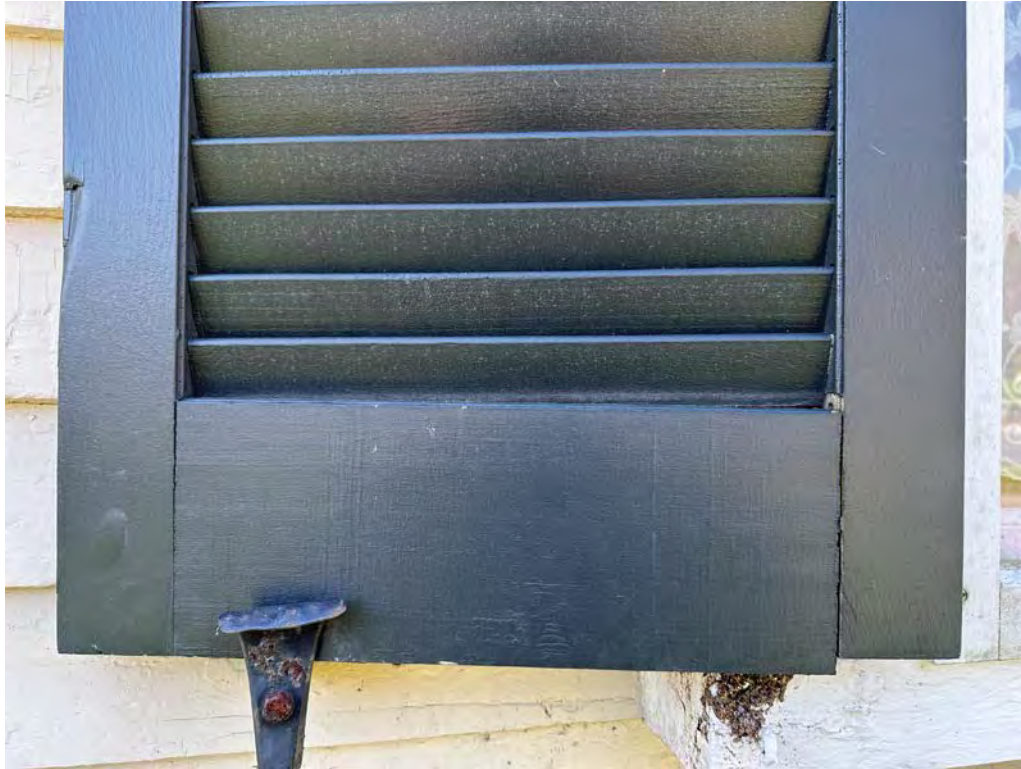
Figure 4.5-1
Loose bottom rail of
a shutter. Typical
conditions seen
throughout.

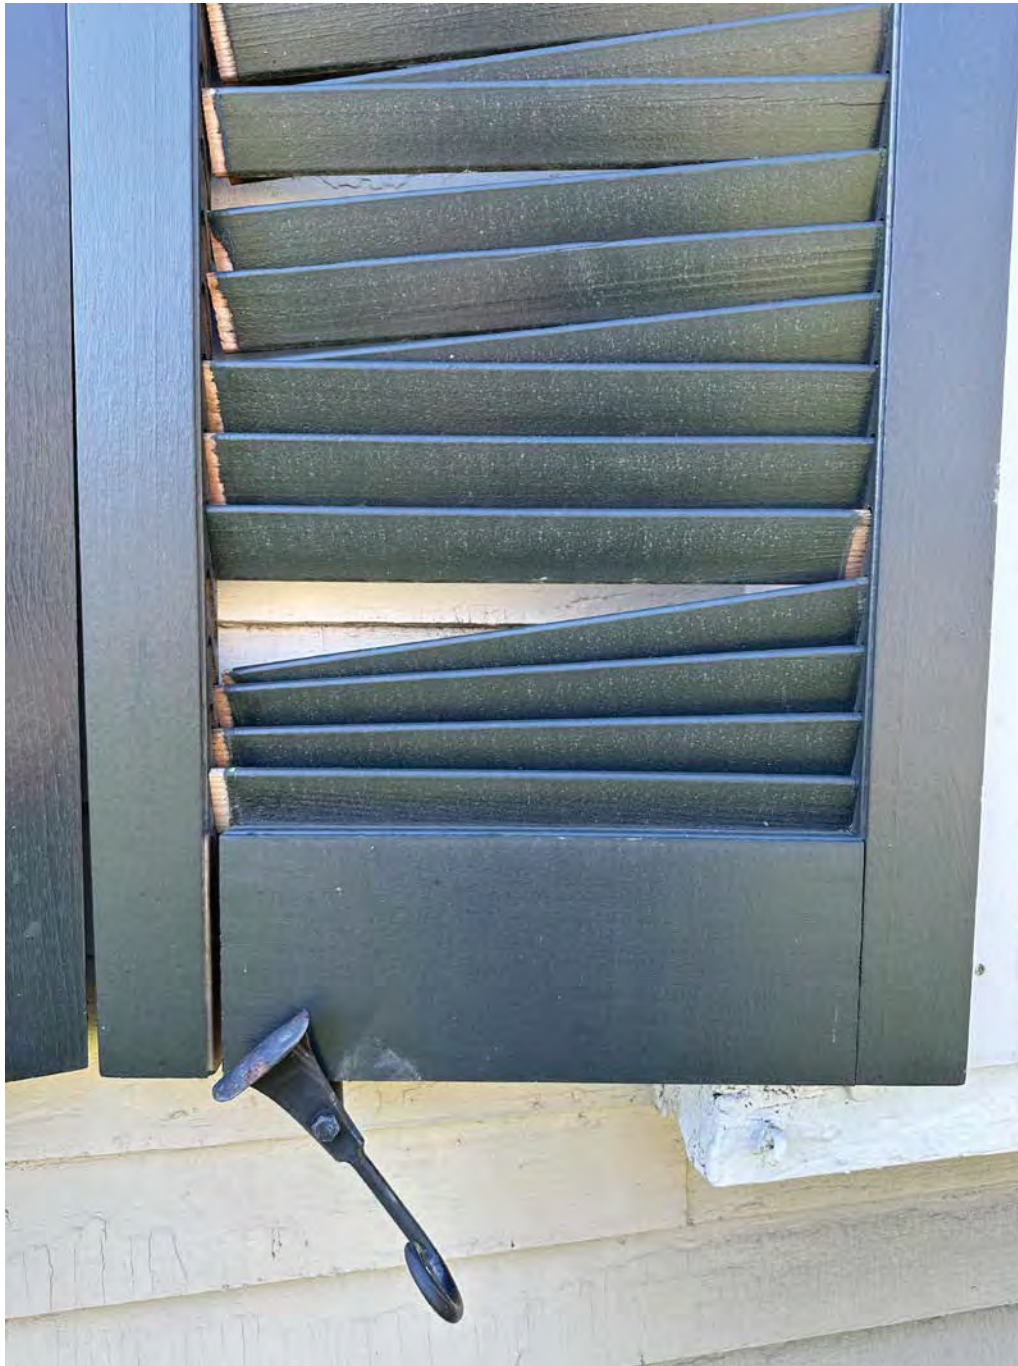
Figure 4.5-2
Louvers which
have fallen out of
place. Typical
condition seen
throughout.

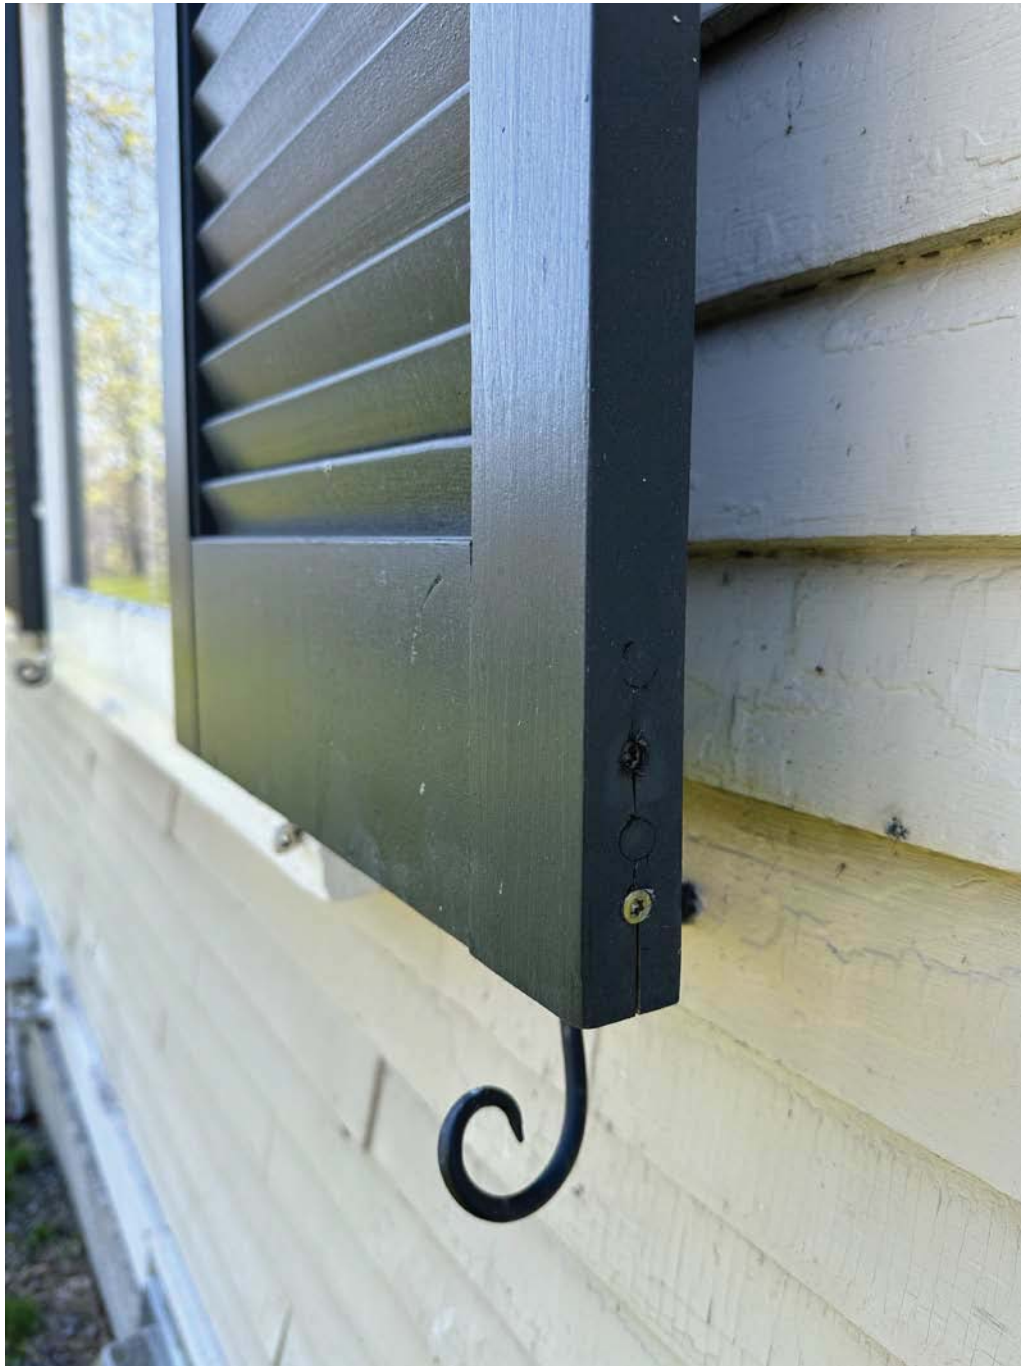
Figure 4.5-3
Instances where the bottom rail of the shutter has become loose. A repair had been made by inserting a screw into the side of the stiles, through to the bottom rail, however this seems to have failed as well, as the wood around the screw is now splitting.

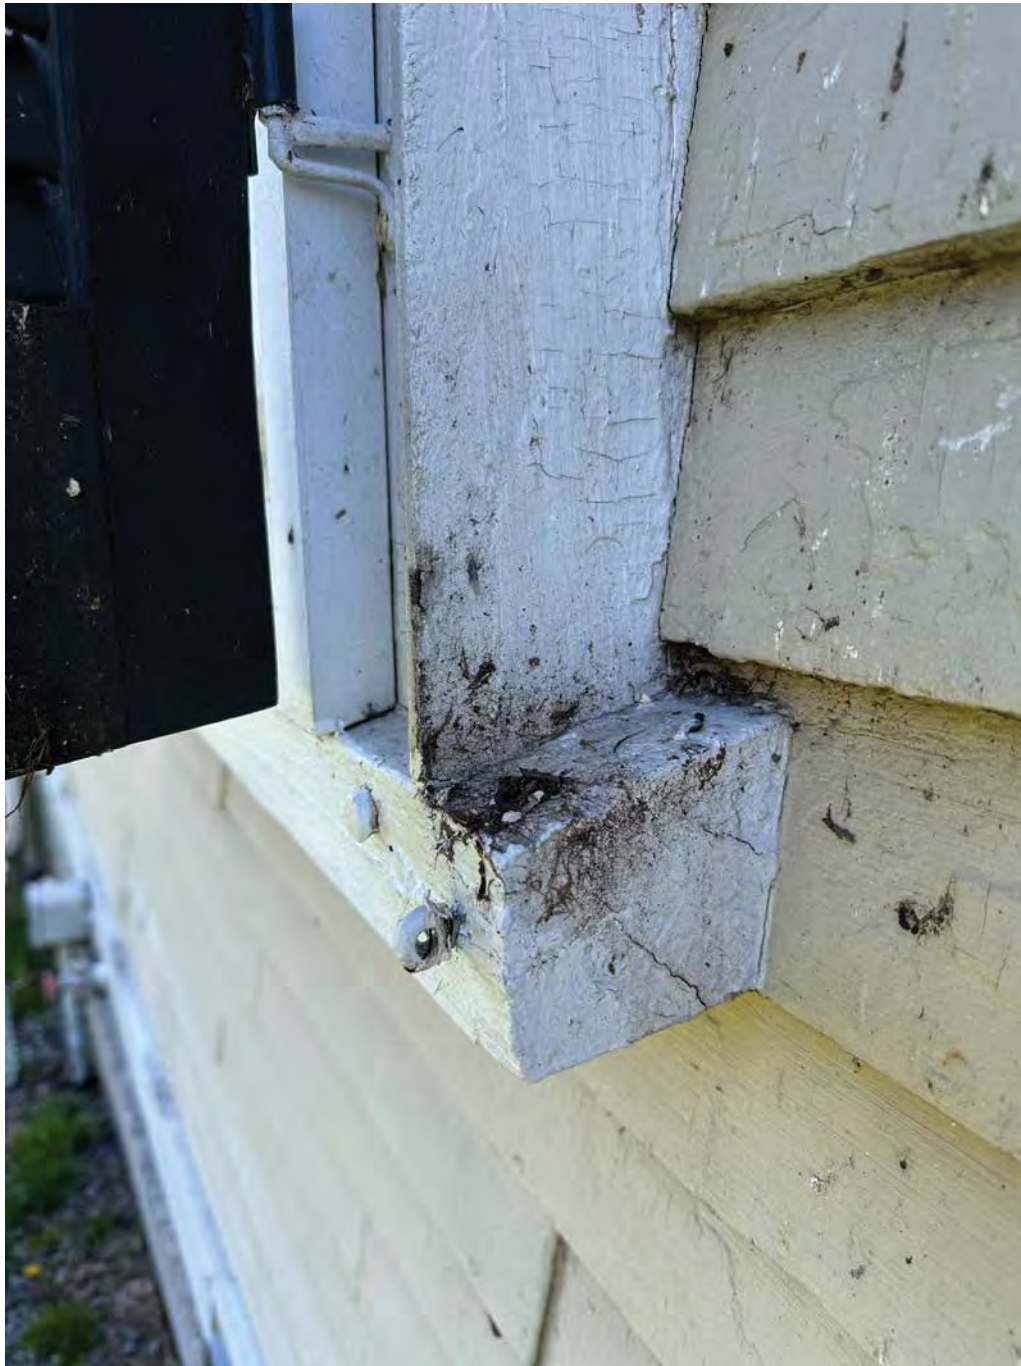
Figure 4.5-4
Evidence of
soiling such as
dust, dirt and
debris piling up.
Typical condition
seen throughout.

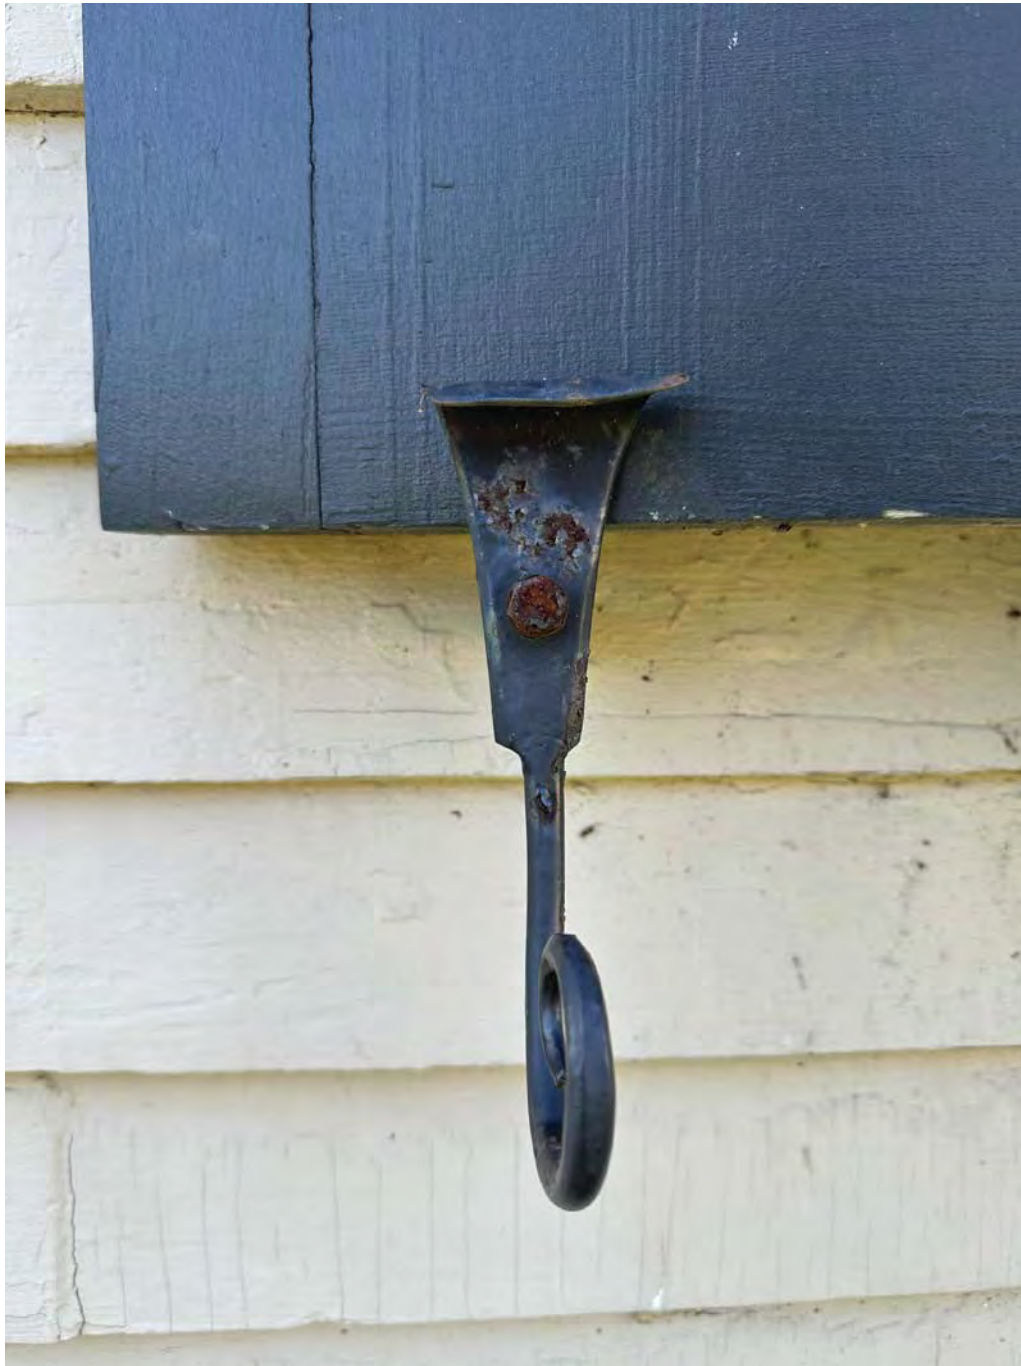
Figure 4.5-5
Less typical
conditions found
were that the
shutters have
been loosely
anchored to the
building, and
many of the
tiebacks are
loosely installed
and are rusting.

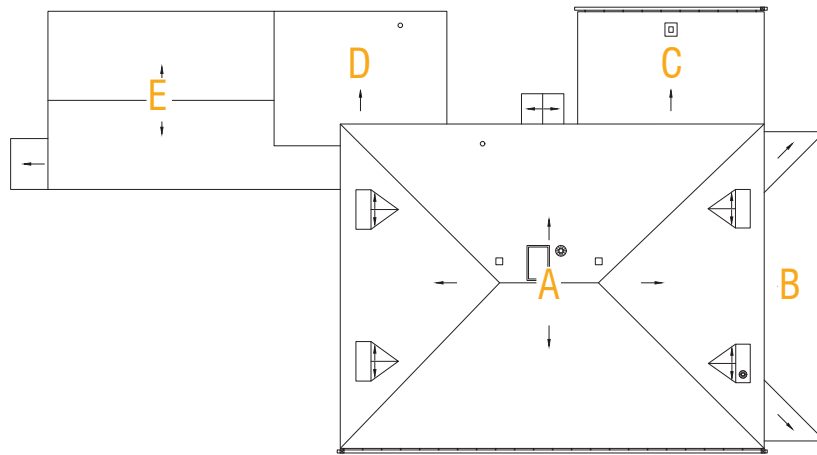
Figure 4.6-1
Roof plan with
identifiers.

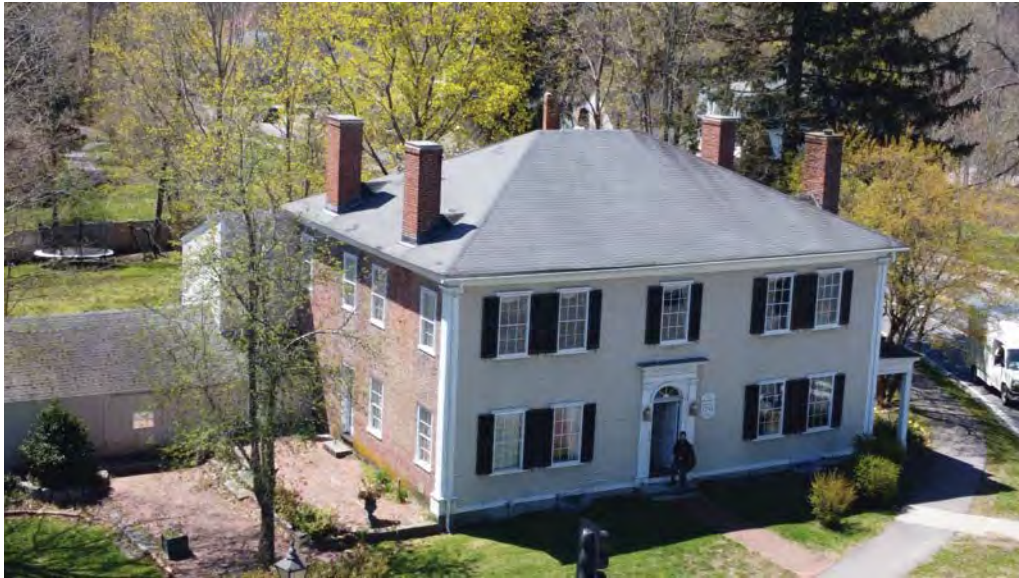
Figure 4.6-2
The main roof of the Hosmer House is a moderately pitched hip roof, finished with asphalt shingles.

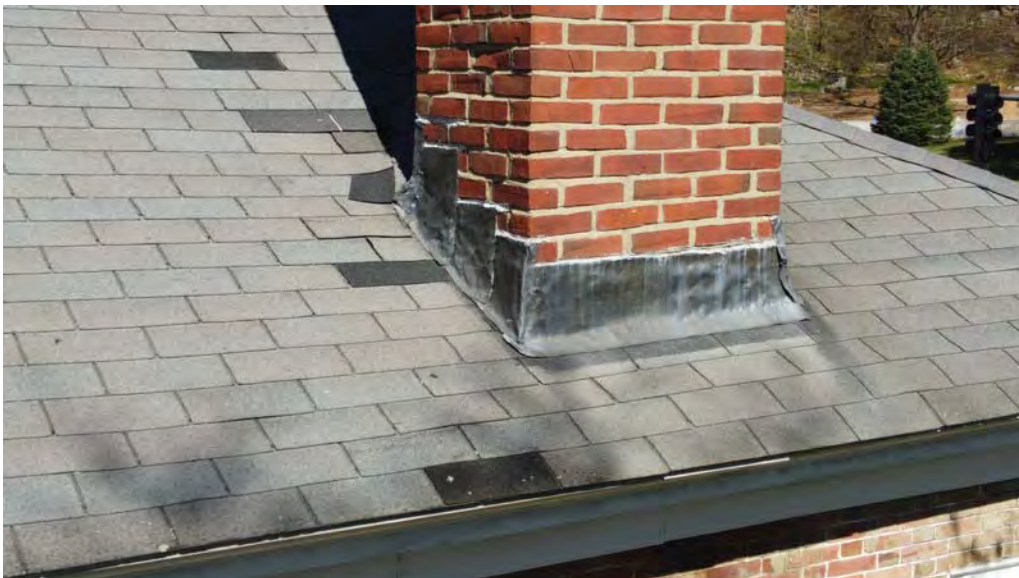
Figure 4.6-3
The step-flashing around the chimneystacks and crickets are in poor condition due to general end-of-life degradation as sections of the flashing are upturned and have become detached from the finished roof surface, or itself.

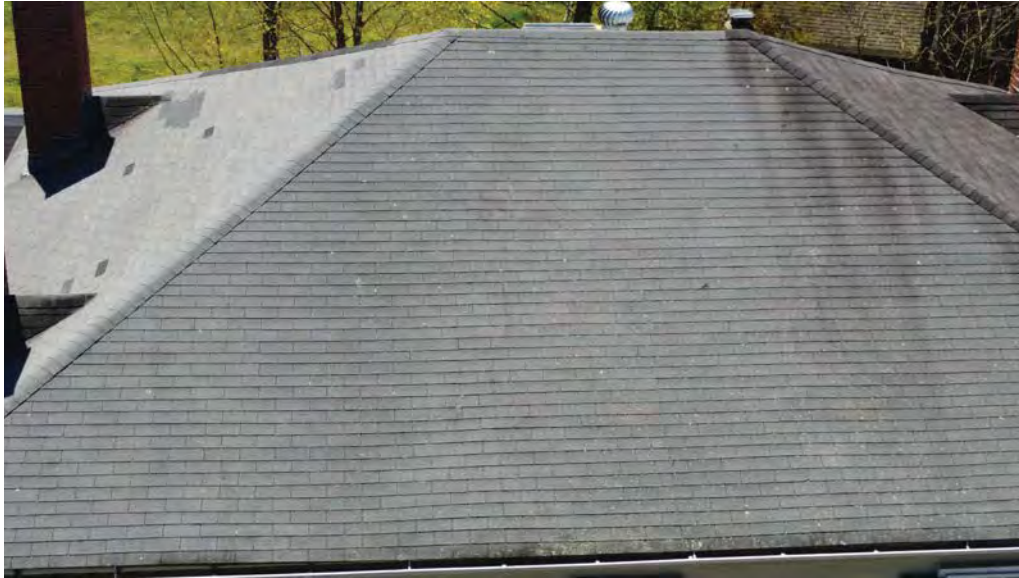
Figure 4.6-4
There are signs of biological growth typical across the entire north slope of the main roof, and edge of the south roof.

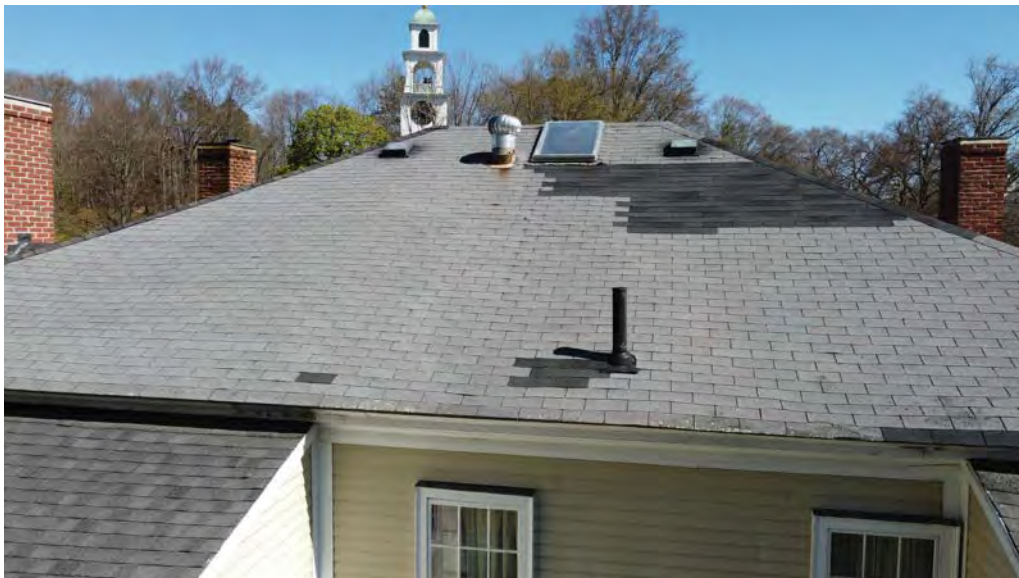
Figure 4.6-5
Selective repairs have been done on a portion of the roof on the south slope, where a large hole was patched.

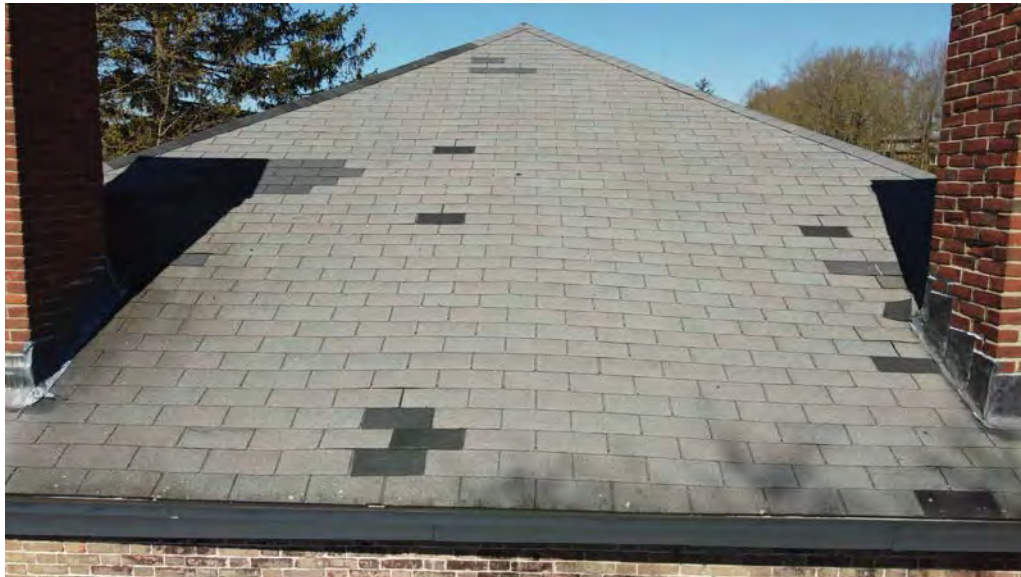
Figure 4.6-6
Selective shingle replacement is visible at several locations on the east slope of the main roof, and south slope near a vent pipe, as well as a portion of the ridge cap shingles along the southeast ridge. Also visible were some shingles which have become dislodged.

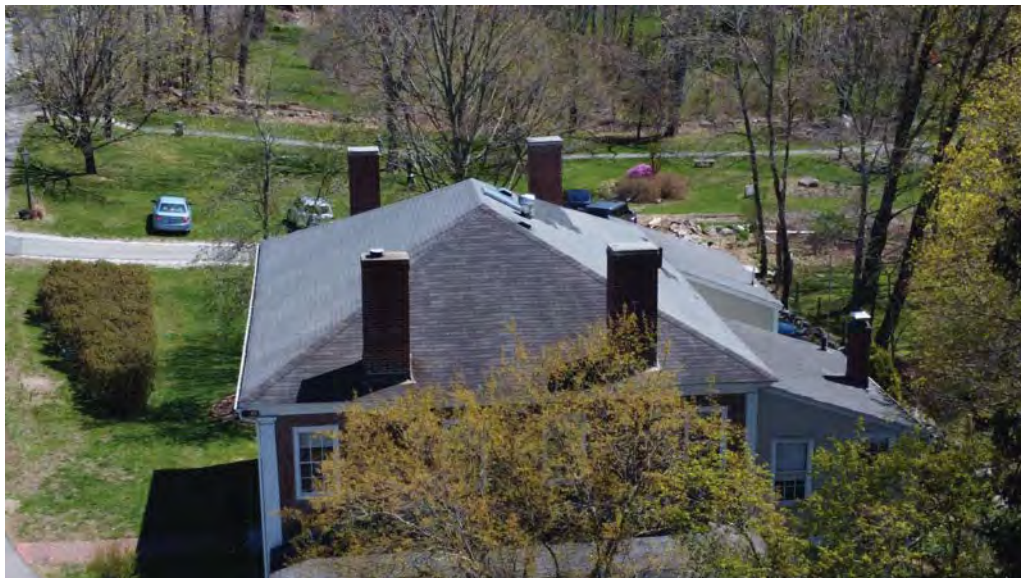
Figure 4.6-7
Along the west slope, there are signs of water damage seen in the form of discoloration, evident near the chimneys.

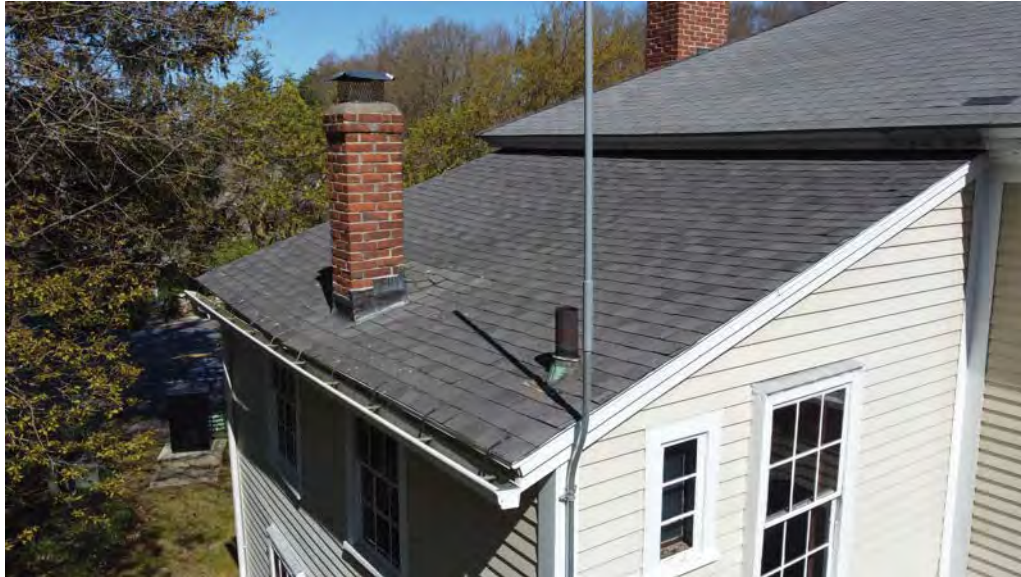
Figure 4.6-8
Both roofs of the
additions are in the
style of a shed roof, in
fair condition.

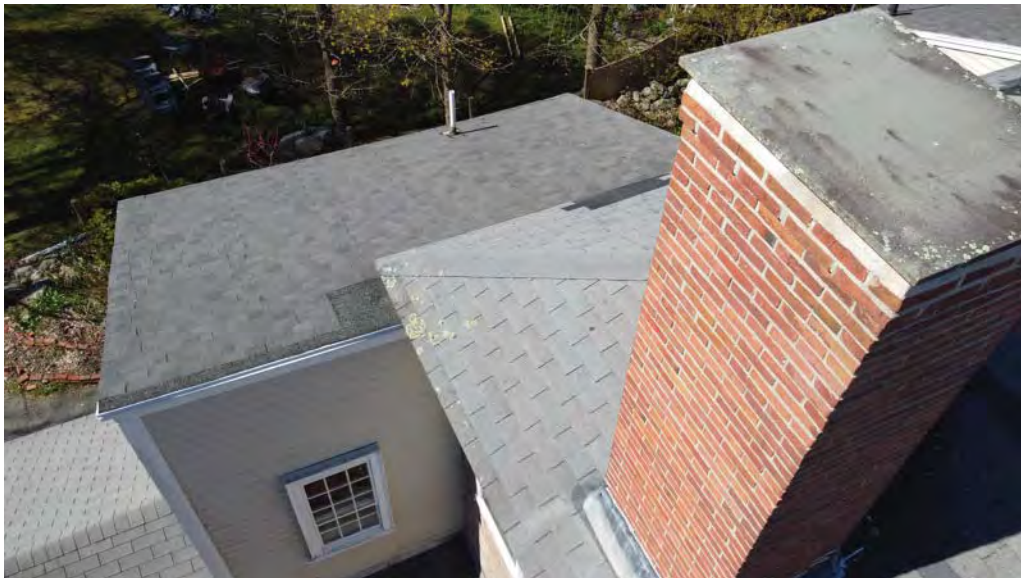
Figure 4.6-9
Both roofs of the
additions are in the
style of a shed roof, in
fair condition.

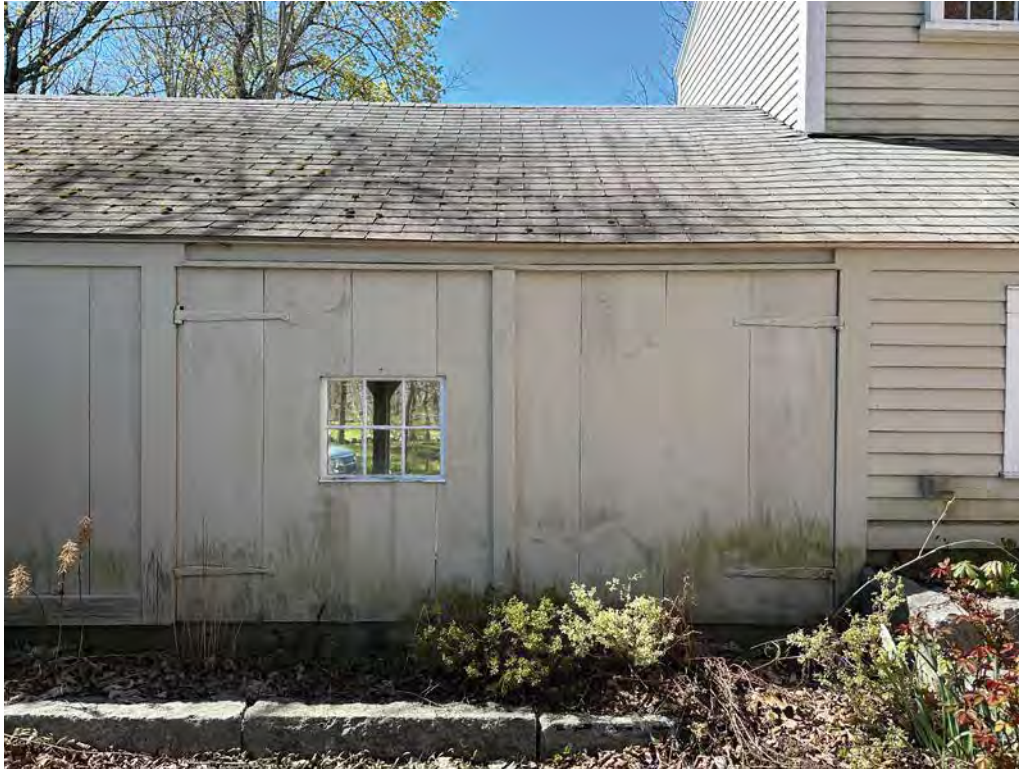
Figure 4.6-10
The carriage house roof is an open gable roof structure which slopes north and south on the site, and has no penetrations. Along the north-facing slope, there is extensive biological growth in the form of moss growing sporadically over the entire surface.

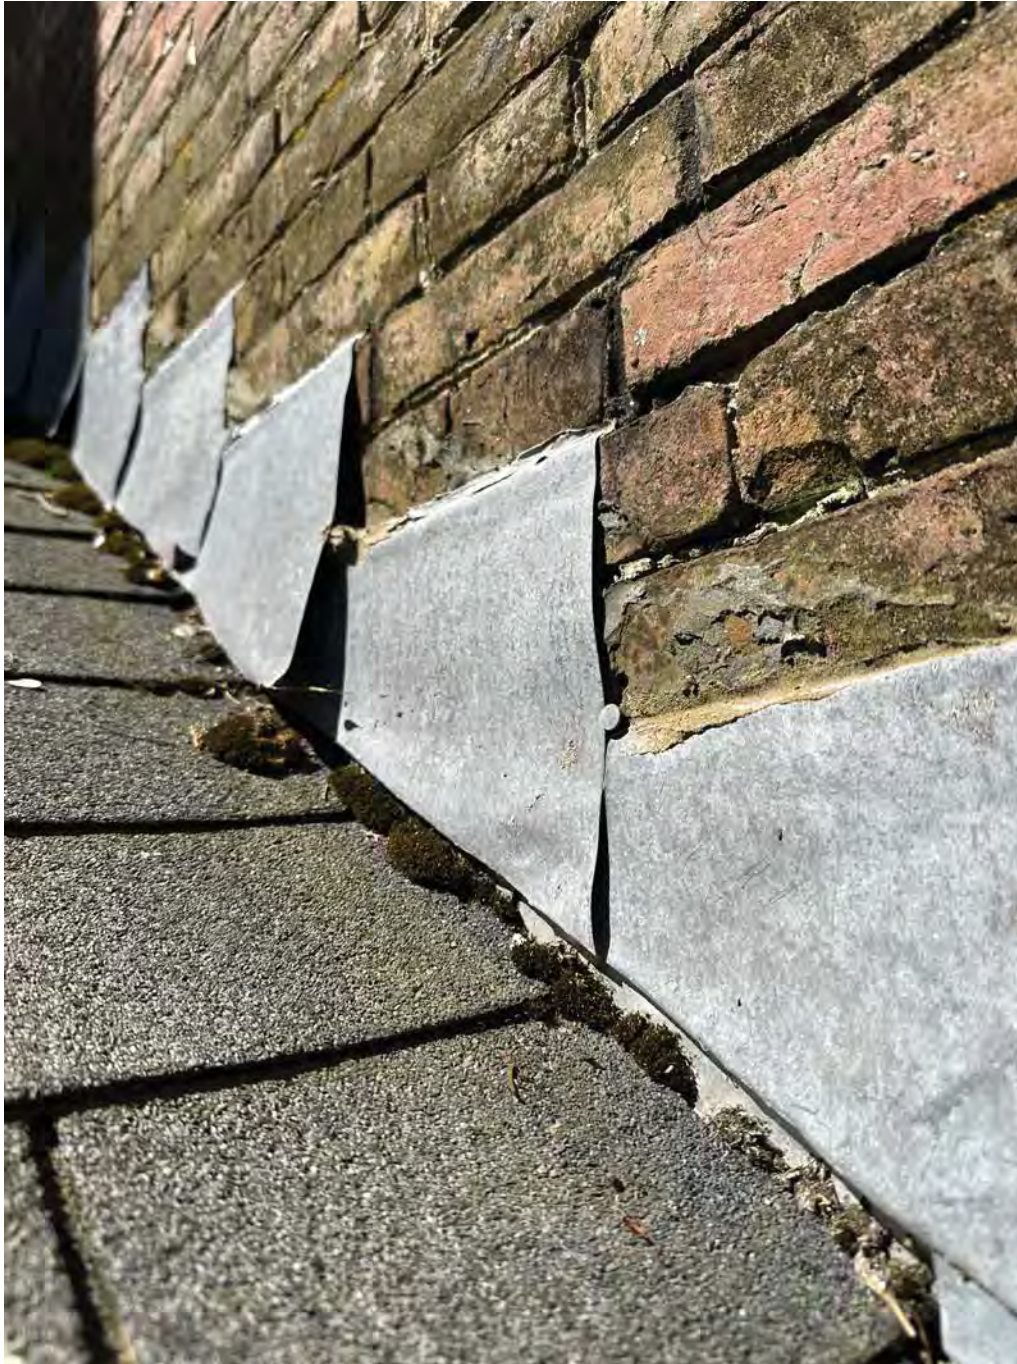
Figure 4.6-12
The step-flashing at the building joint of the north-facing slope along the east elevation of the house is in need of replacement. Portions have become unattached from the brick wall and roof, and are deflected in many places.

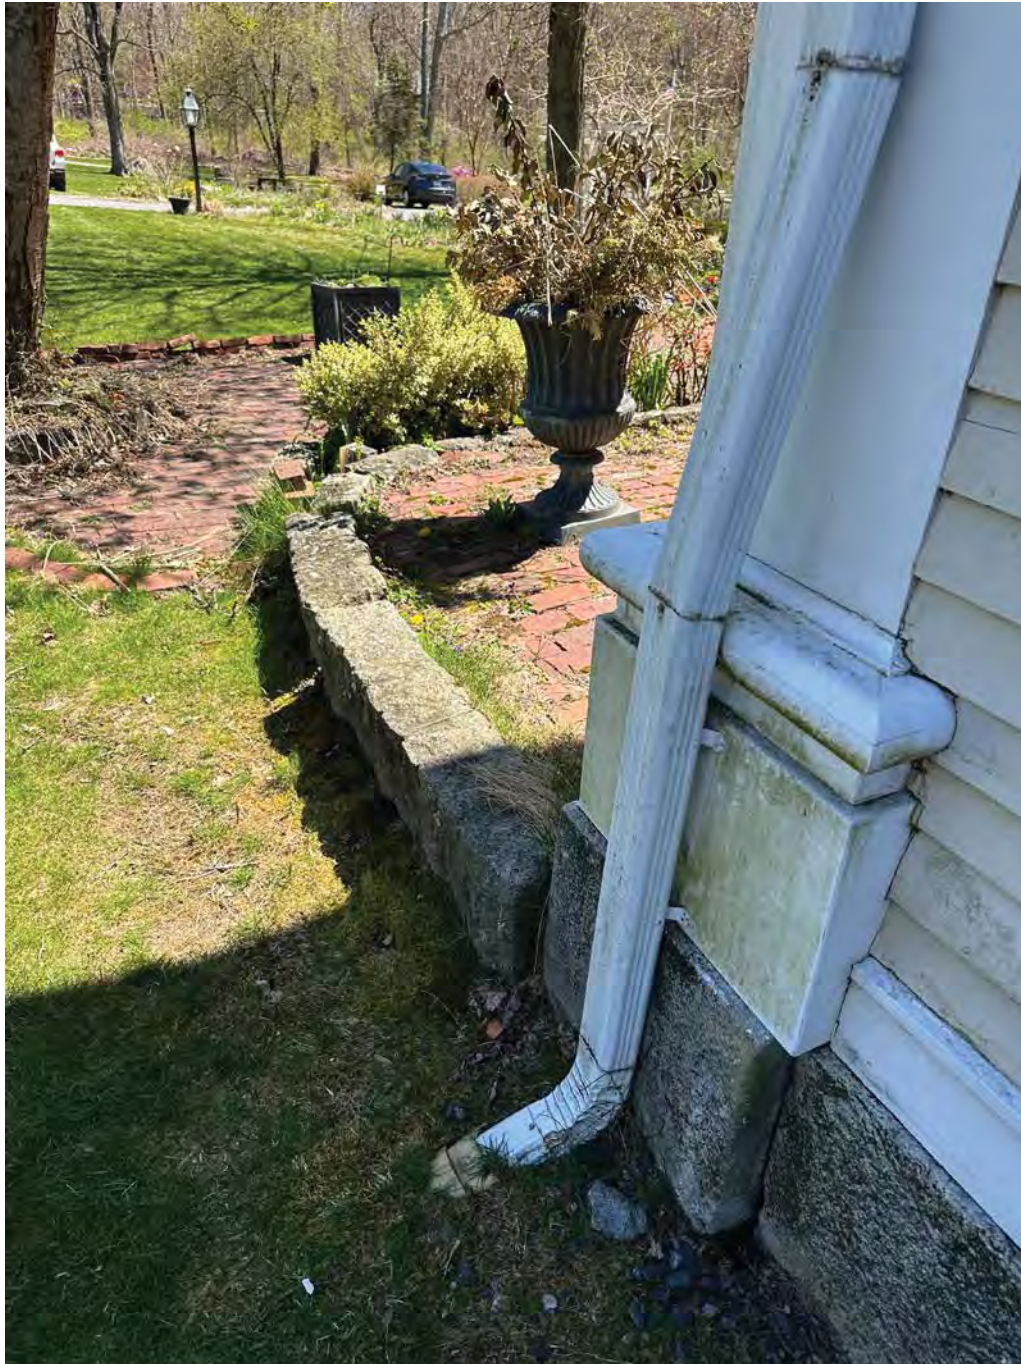
Figure 4.7-1
Located at the northeast corner of the house is a downspout missing an elbow to help expel water away from the immediate perimeter of the house, below grade.

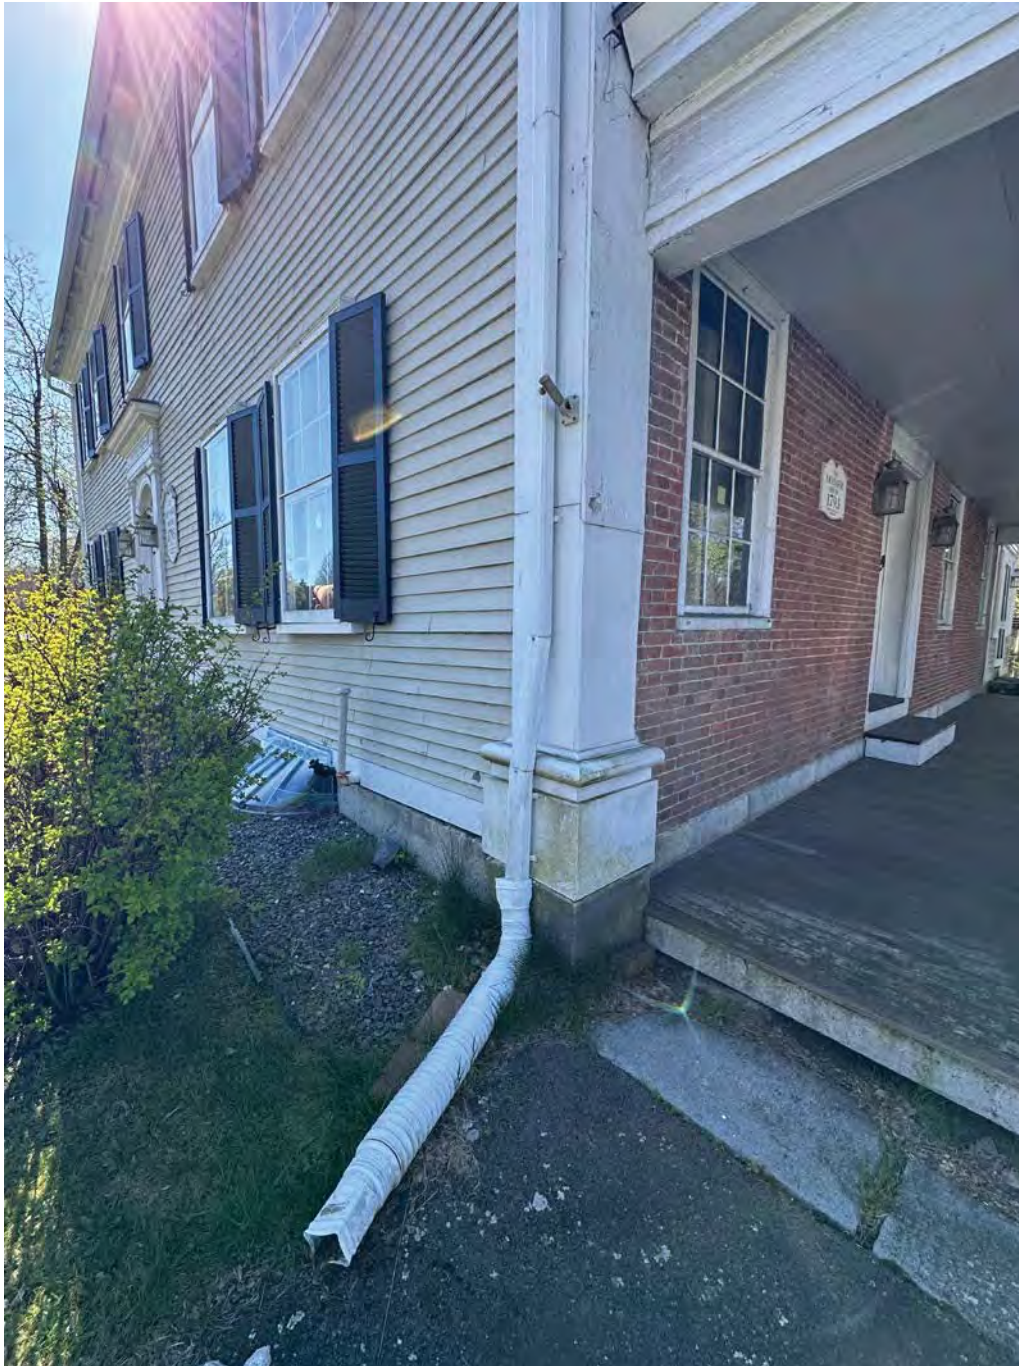
Figure 4.7-2
Located at the northwest corner of the house is a downspout that expels water through a downspout extension above grade, away from the house's foundation walls.
