HOSMER HOUSE

HISTORIC STRUCTURE REPORT / CULTURAL LANDSCAPE REPORT

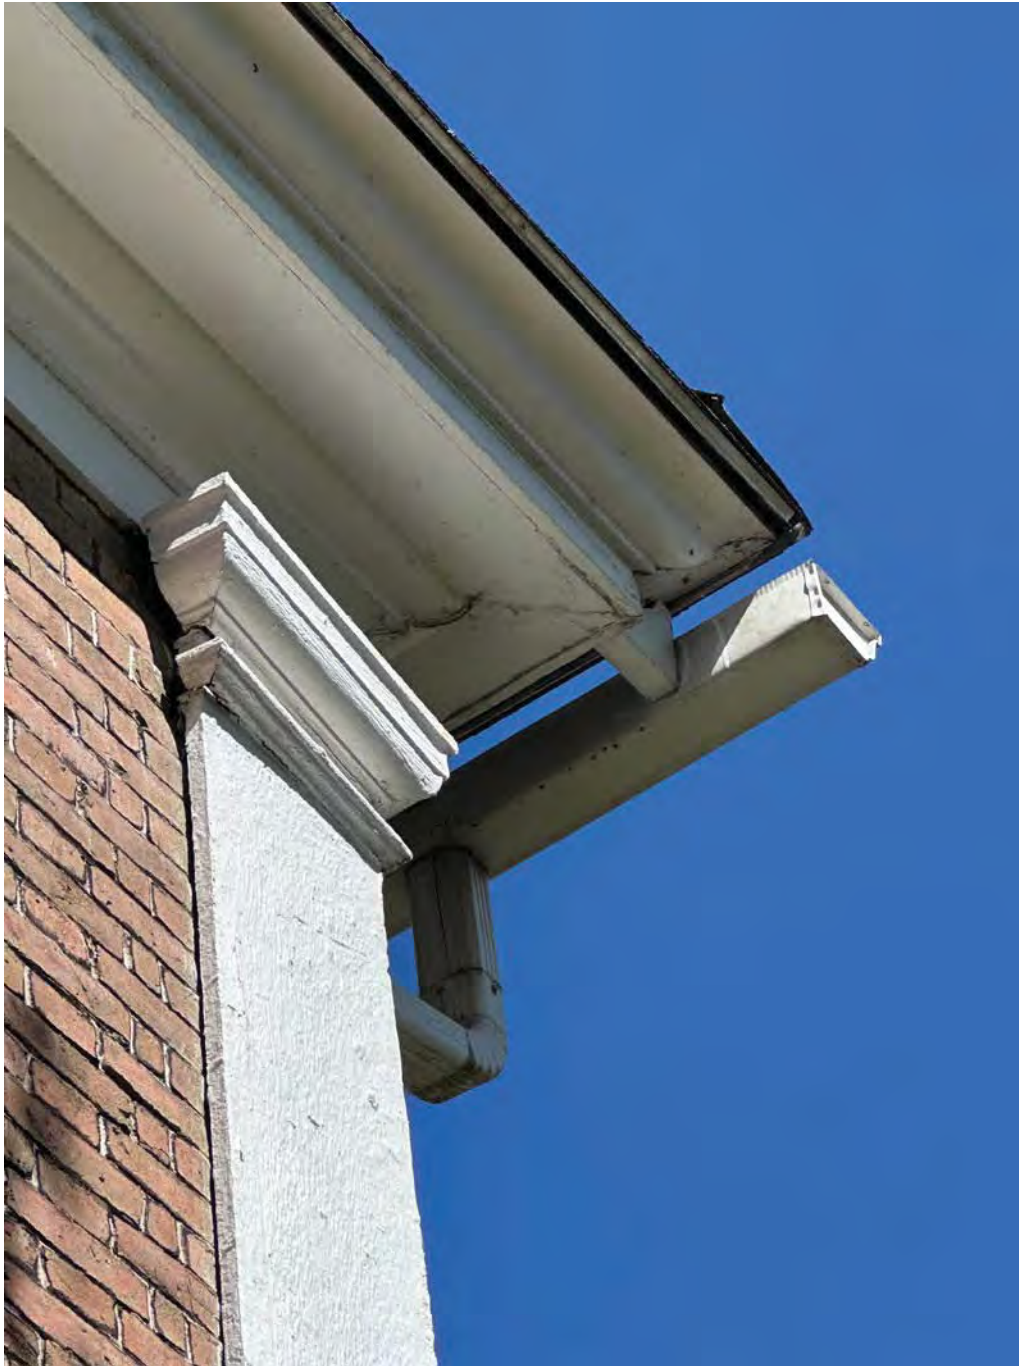
Figure 4.7-3
Along the north
elevation, a gutter
was installed
along the roofline,
supported by
wood blocking.

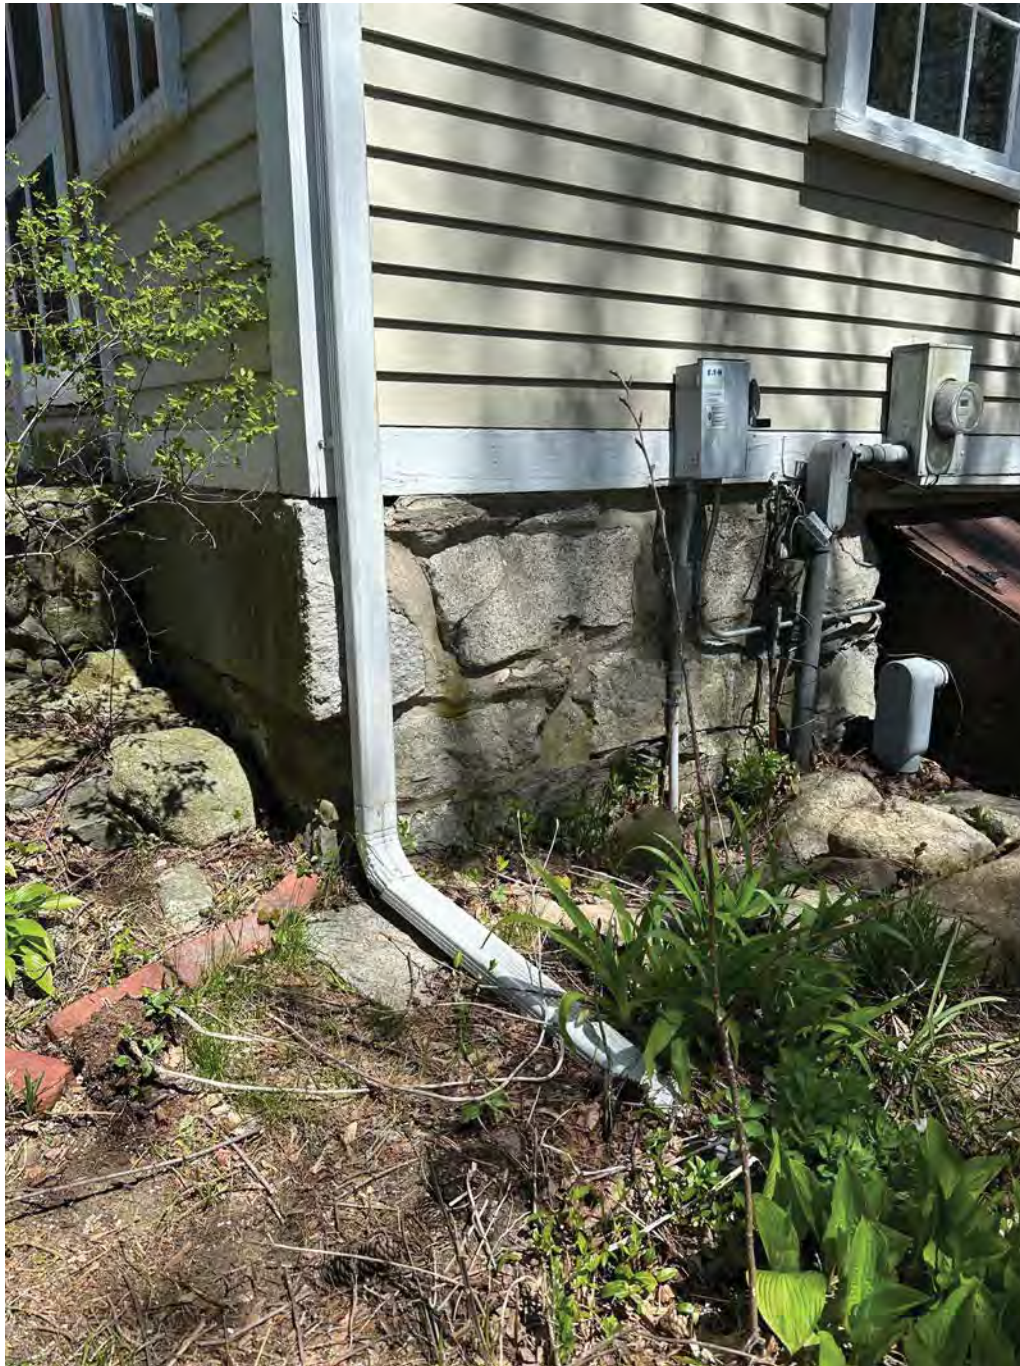
Figure 4.7-8
This downspout terminates an appropriate distance from the house's foundation, and expels water above grade, however is visibly clogged at its termination.

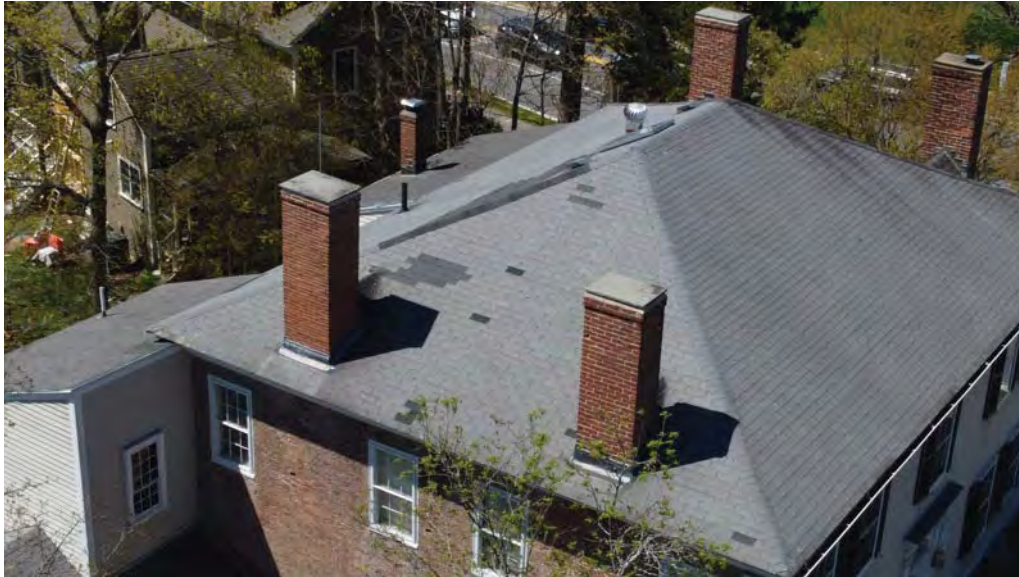
Figure 4.8-1
Four tall, brick-masonry chimneys are situated in pairs along the east and west elevations of the main house, slightly set back from the hipped roofline. The fifth chimney is located in the southwest addition.

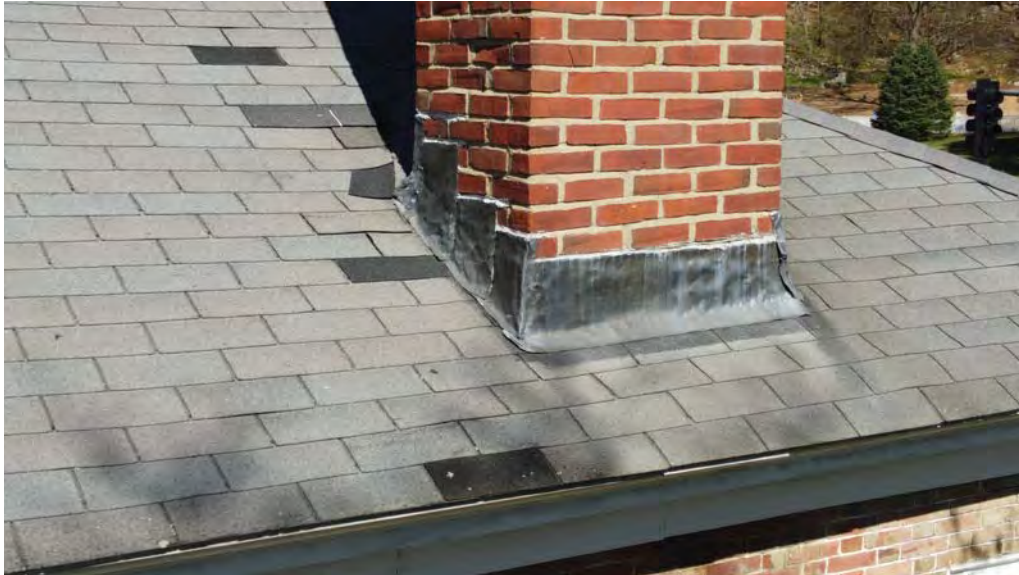
Figure 4.8-3
The step-flashing around the chimneystacks and crickets is in poor condition due to general end-of-life degradation as edges of the flashing are upturned and portions of the step-flashing are separating.

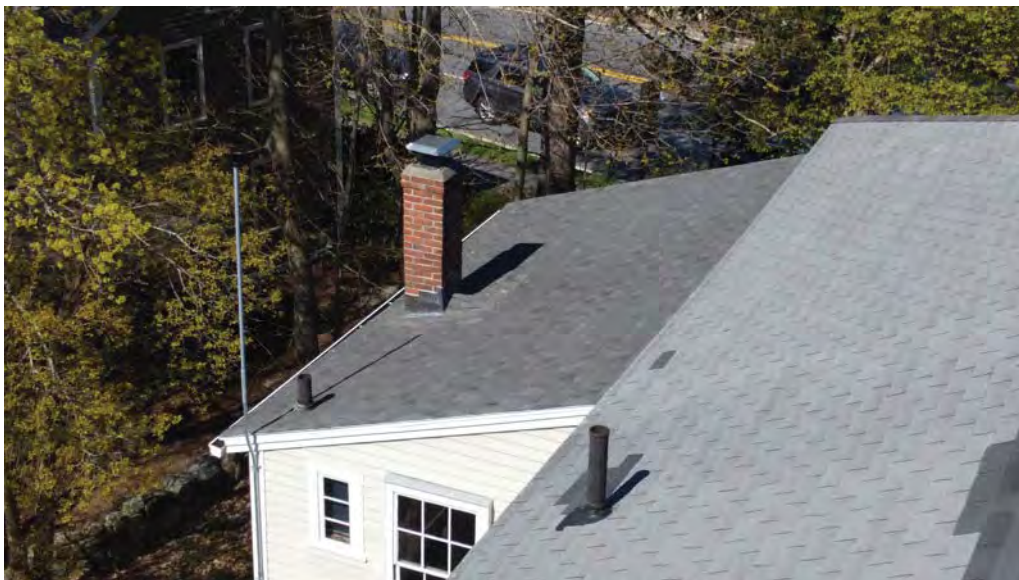
Figure 4.8-4
The fifth chimney, located in the southwest addition, is topped with a vent cap.

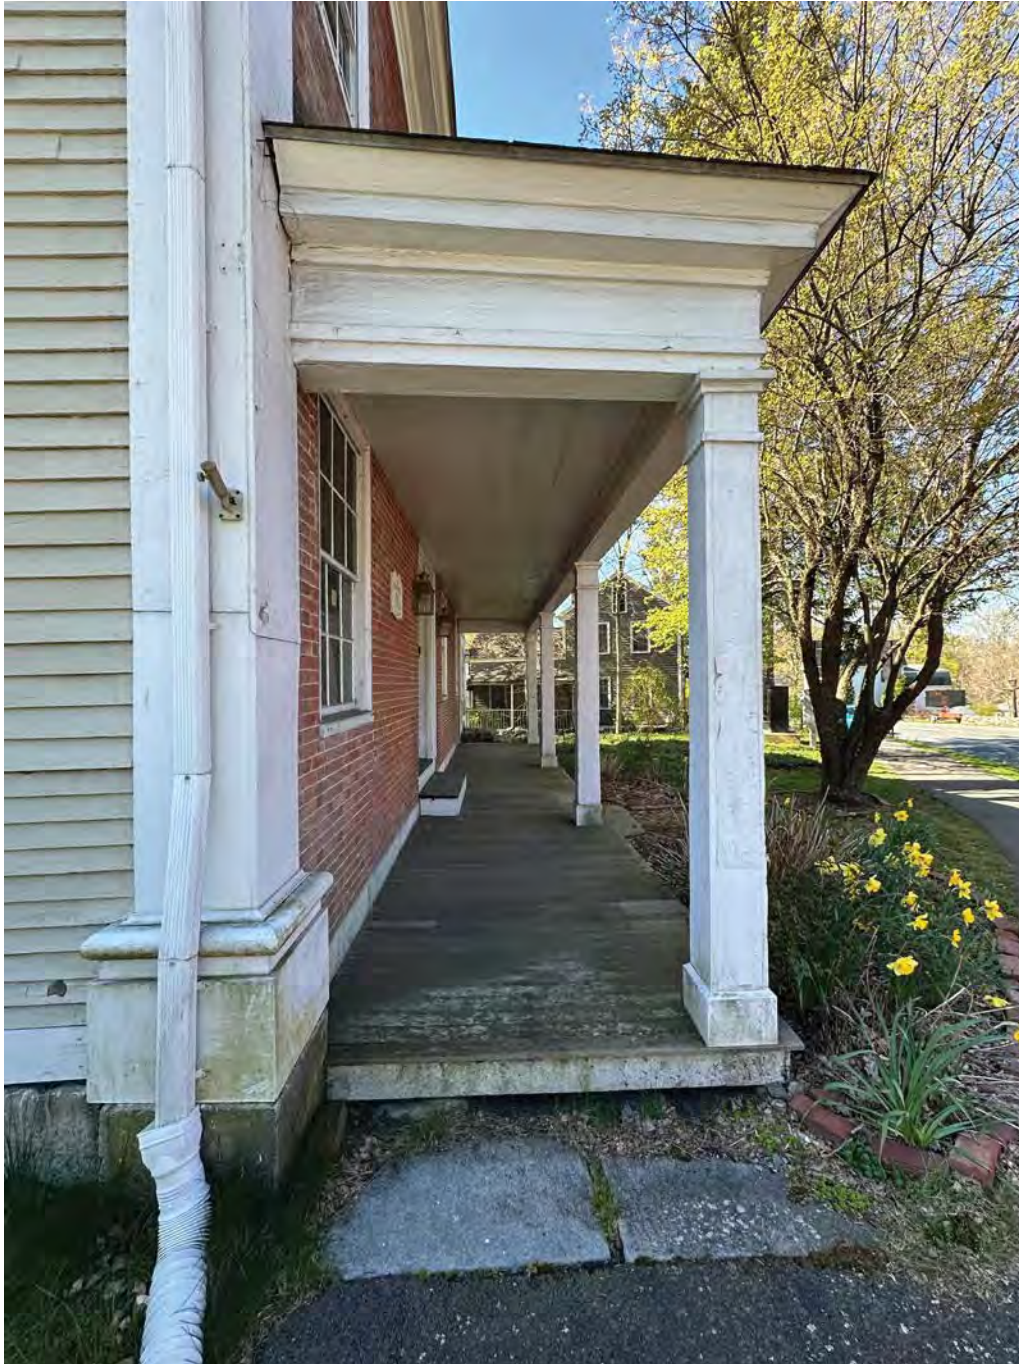
Figure 4.9-1
A single-story open porch extends along the entire length of the west elevation. It is constructed of a wood deck, wood columns and a shingled hip roof.

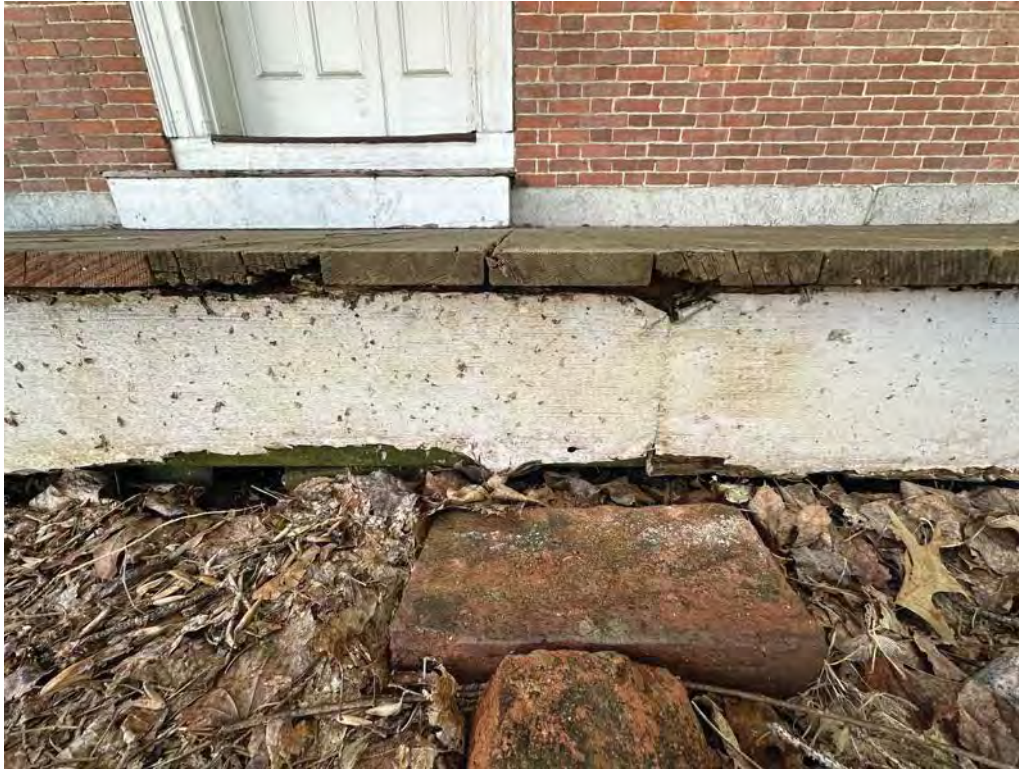
Figure 4.9-2
There is extensive mildew and mold on the deck fascia, most likely due to its proximity to the earth and surrounding vegetation and the section of fascia between the second and third columns is rotted through, the wood is cracked, and a portion of the fascia has fallen off.

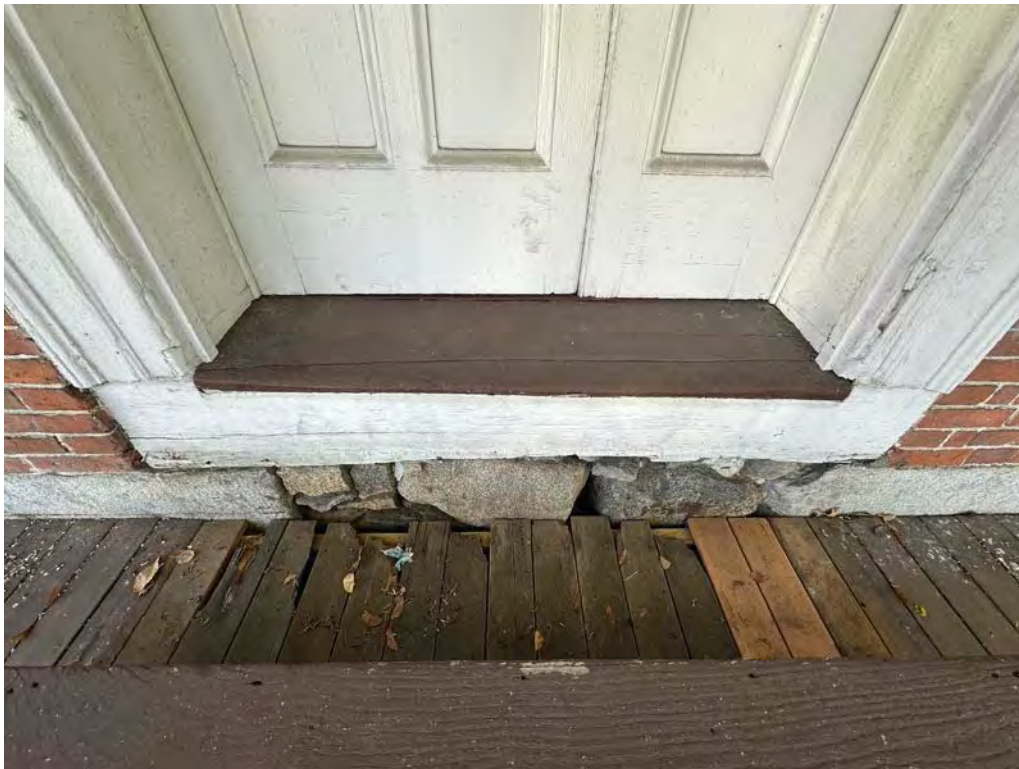
Figure 4.9-3
The decking planks directly below the door threshold are rotted, and are exhibit the most severe deterioration of the deck.

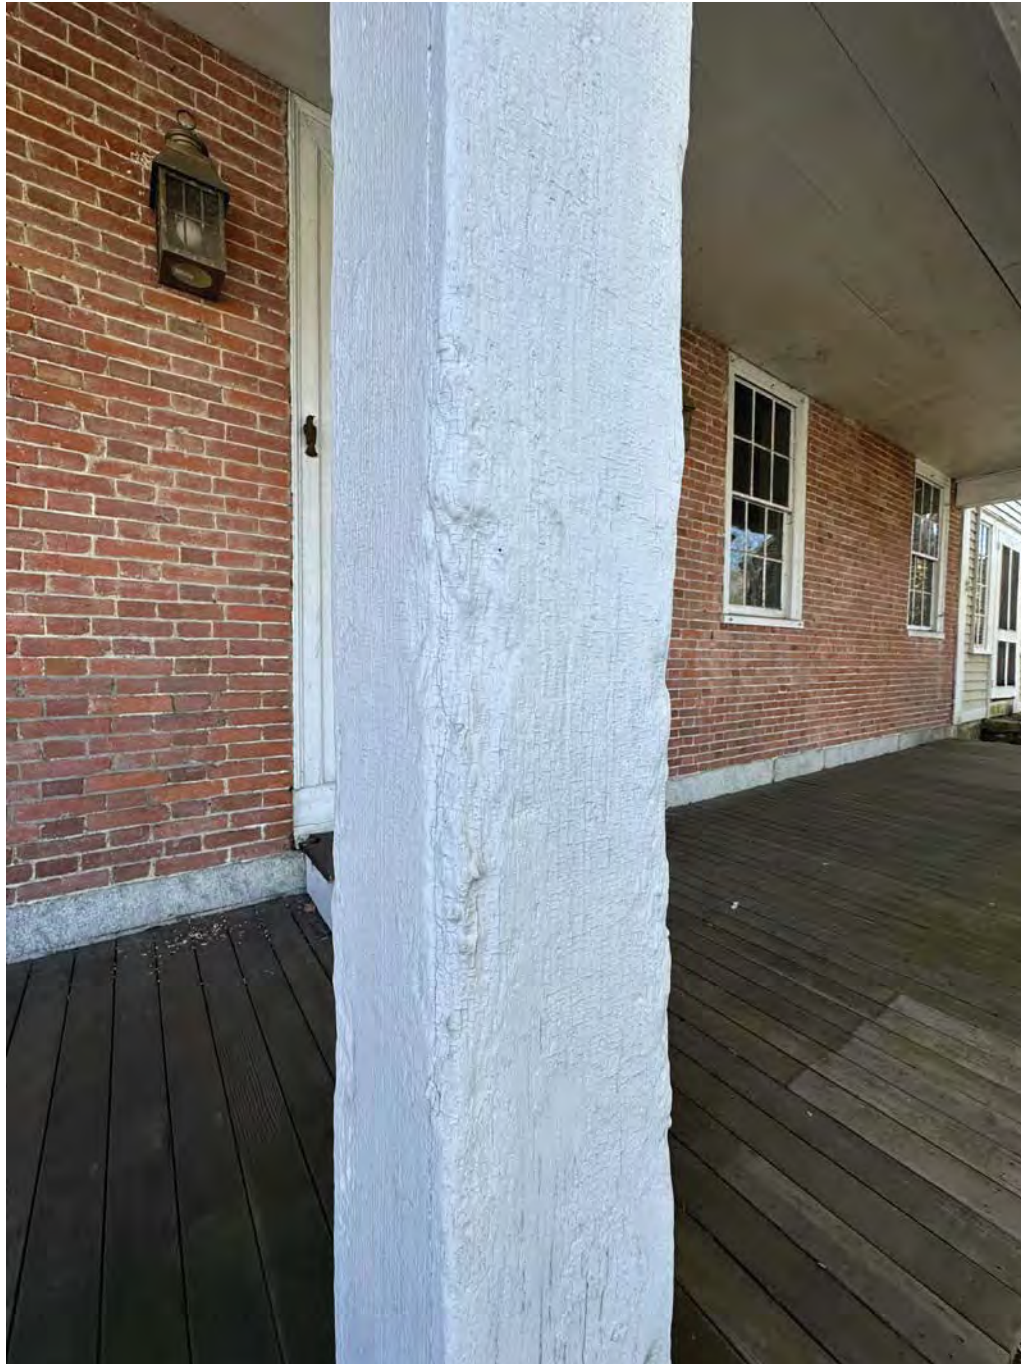
Figure 4.9-4
The 4 columns
which support the
porch roof are in
poor-to-fair
condition. The
shaft of the
columns have
degraded over
time, and have
lost material
mass at various
locations.

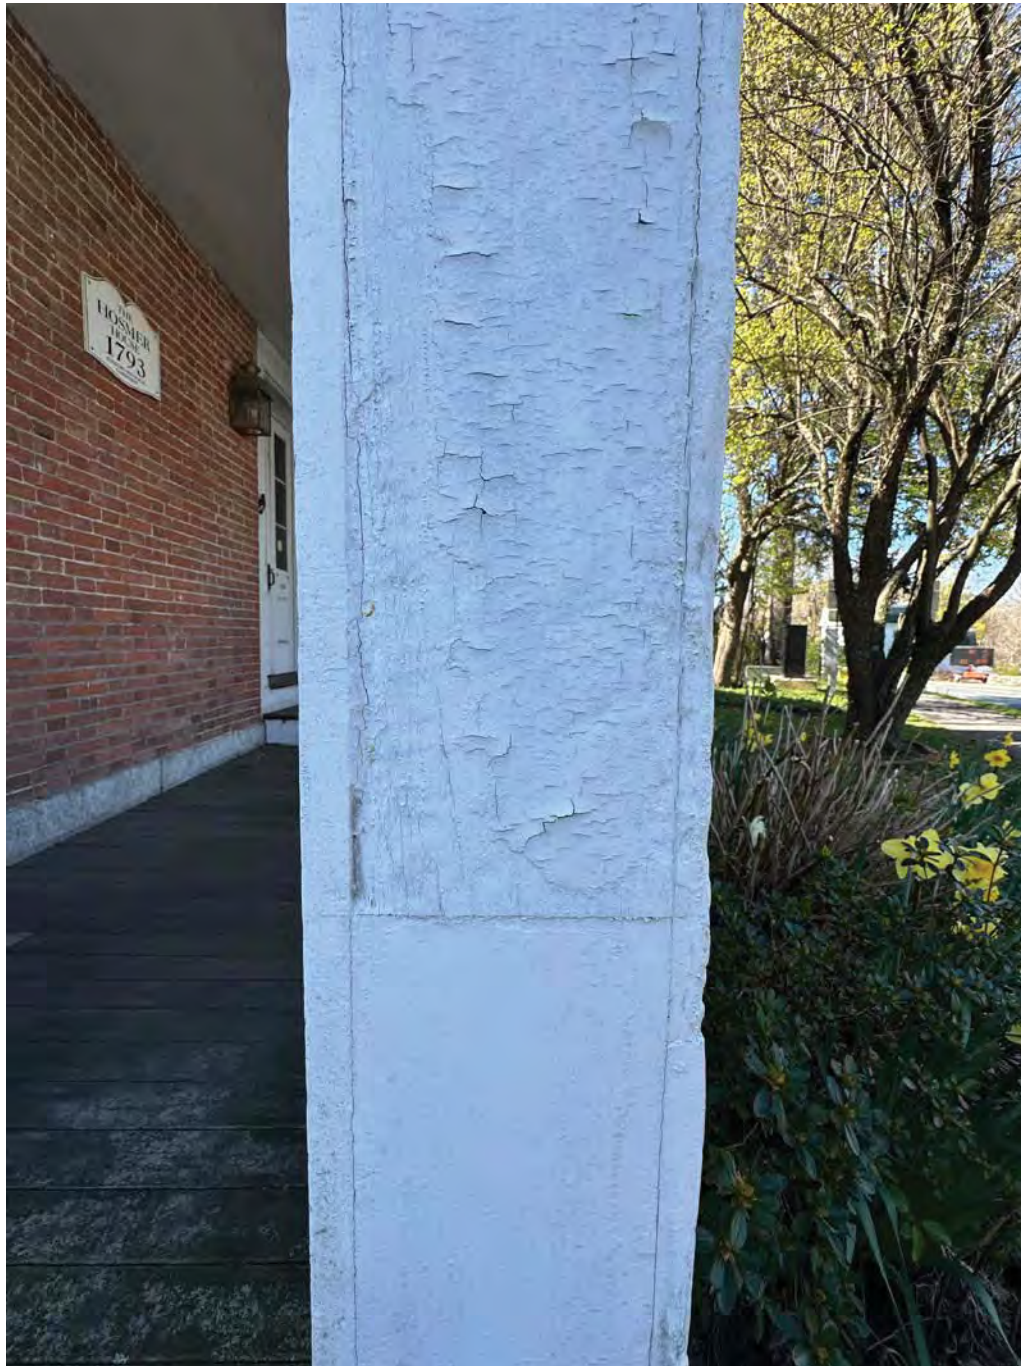
Figure 4.9-5
Between 12" to
14" of the shafts
of the two
columns at either
end of the porch
have been
replaced along
with all 4 column
capitals and
bases.

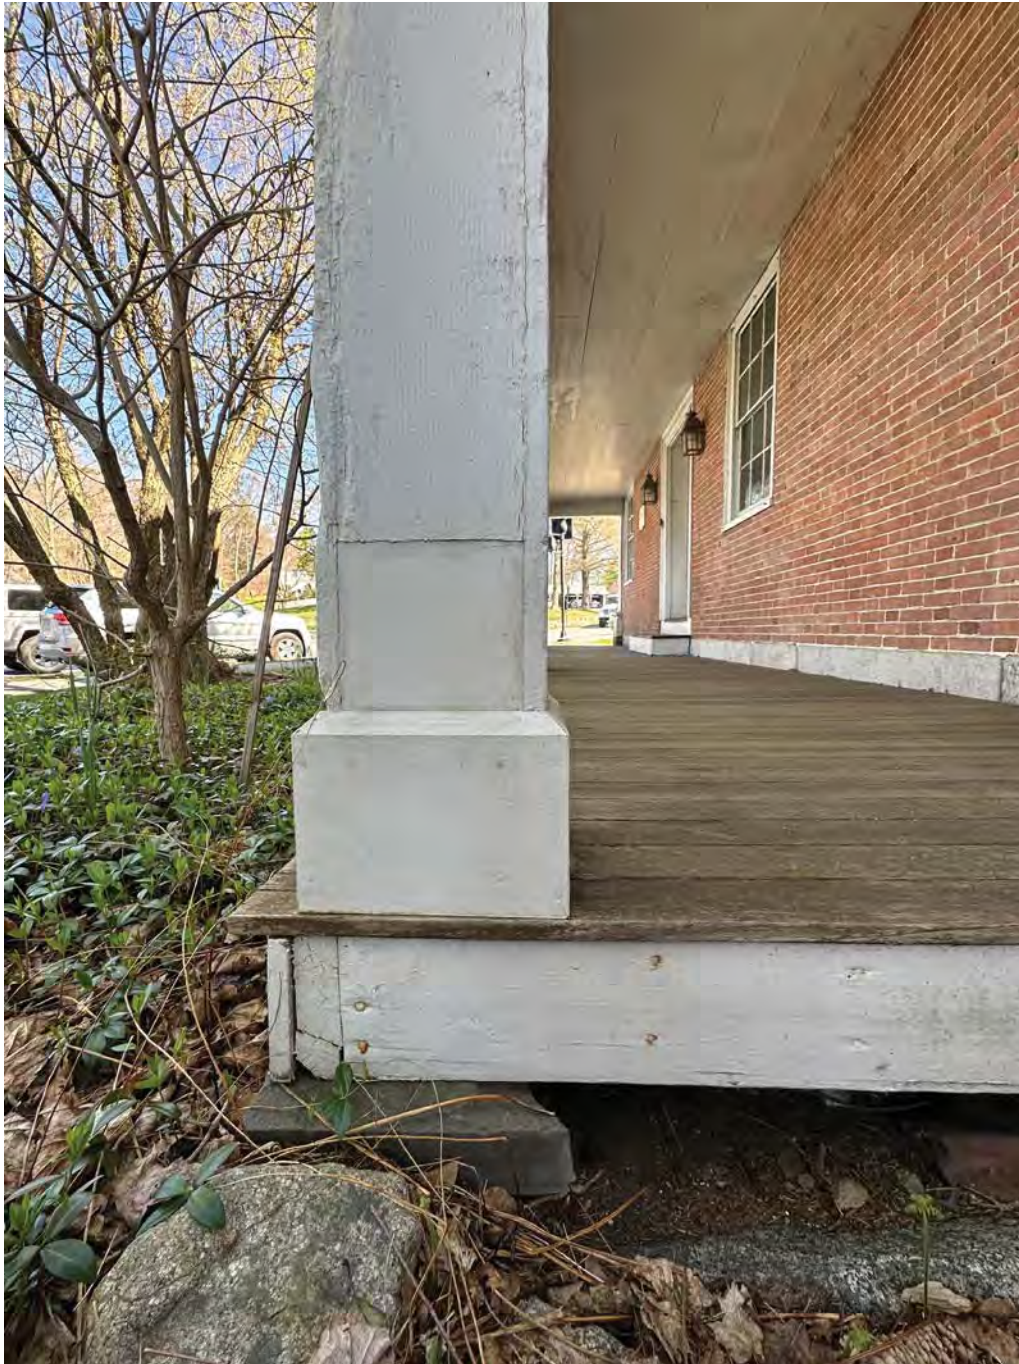
Figure 4.9-6
Between 12" to
14" of the shafts
of the two
columns at either
end of the porch
have been
replaced along
with all 4 column
capitals and
bases.

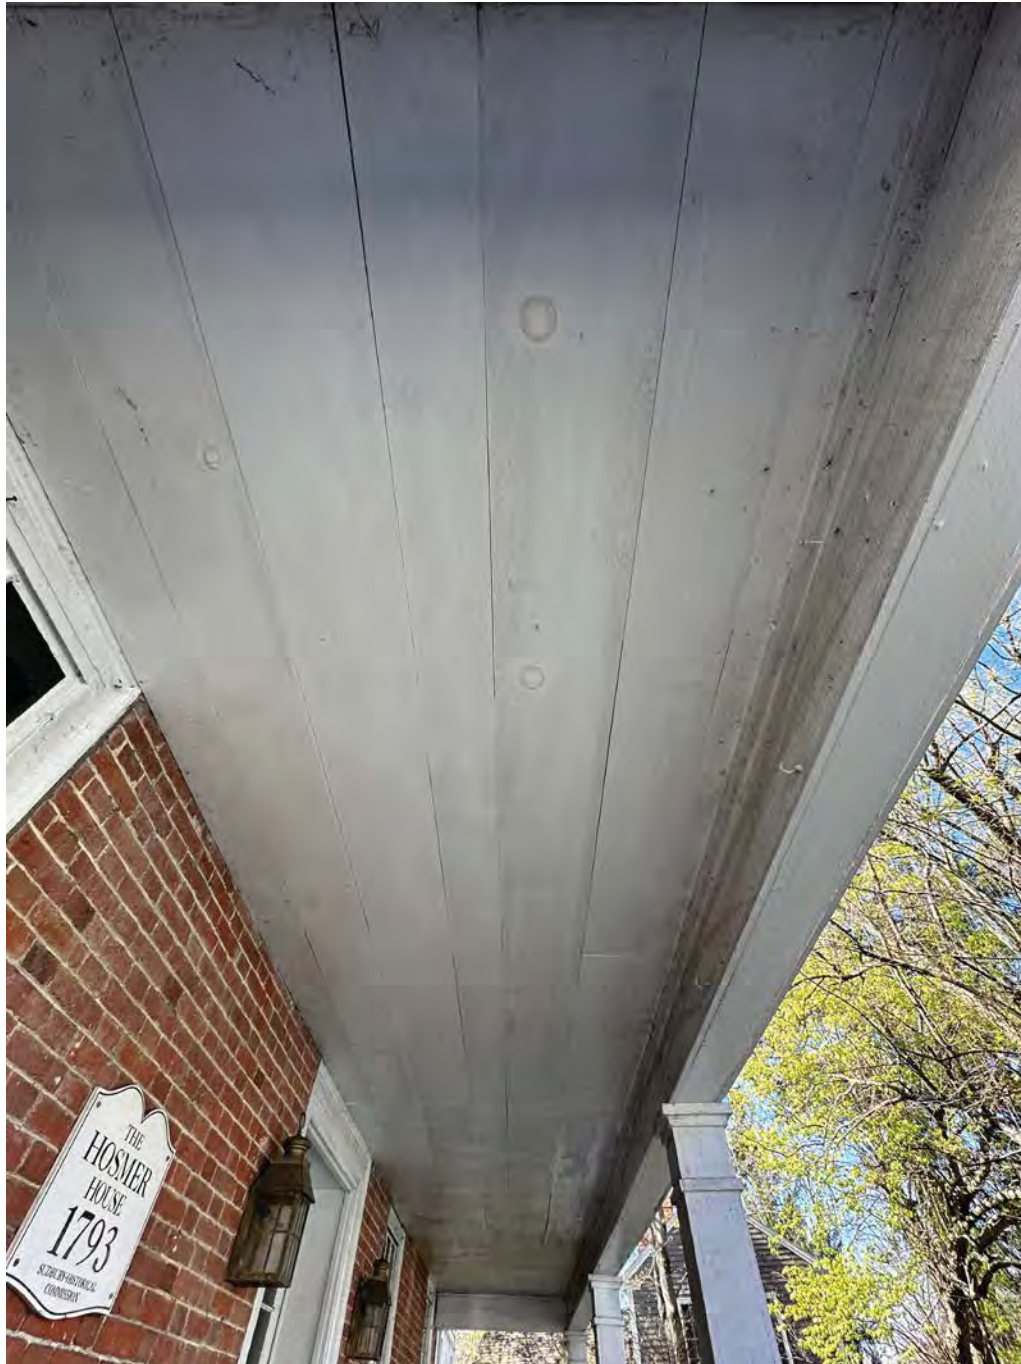
Figure 4.9-7
The porch ceiling is in good condition. The ceiling board at the underside of the roof is relatively new, however, oils are being drawn out from the knots in the wood, creating brown rings which telegraph through the white paint, typical throughout.

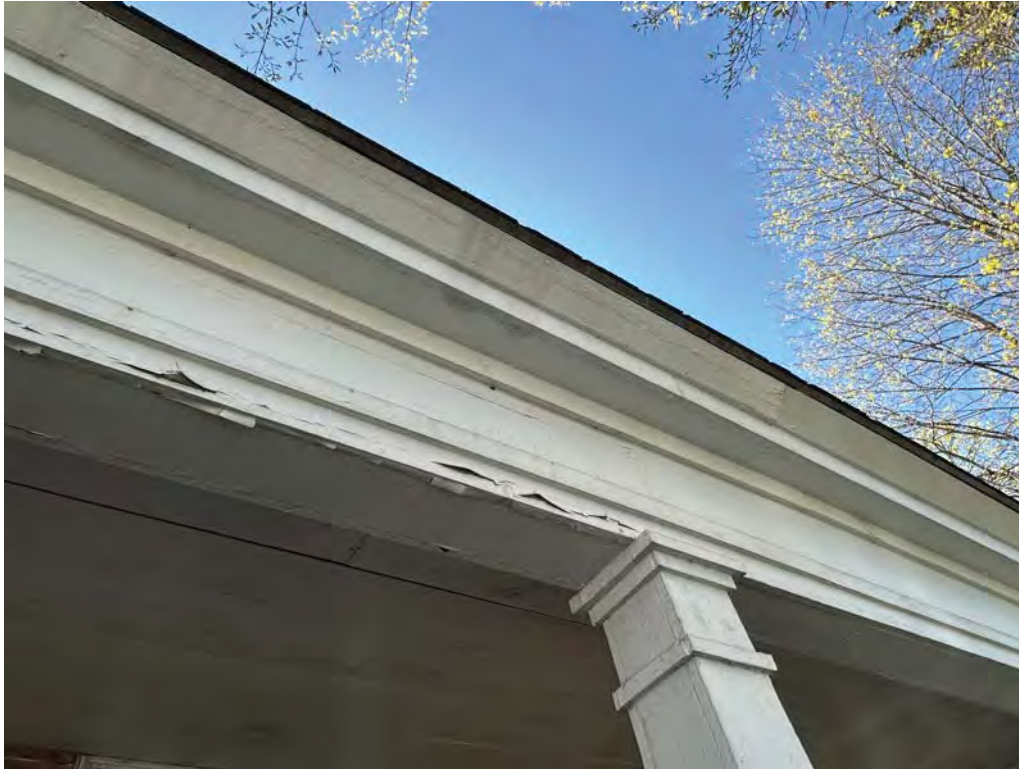
Figure 4.9-8
The frieze board and
fascia of the porch
roof have as well
been replaced.

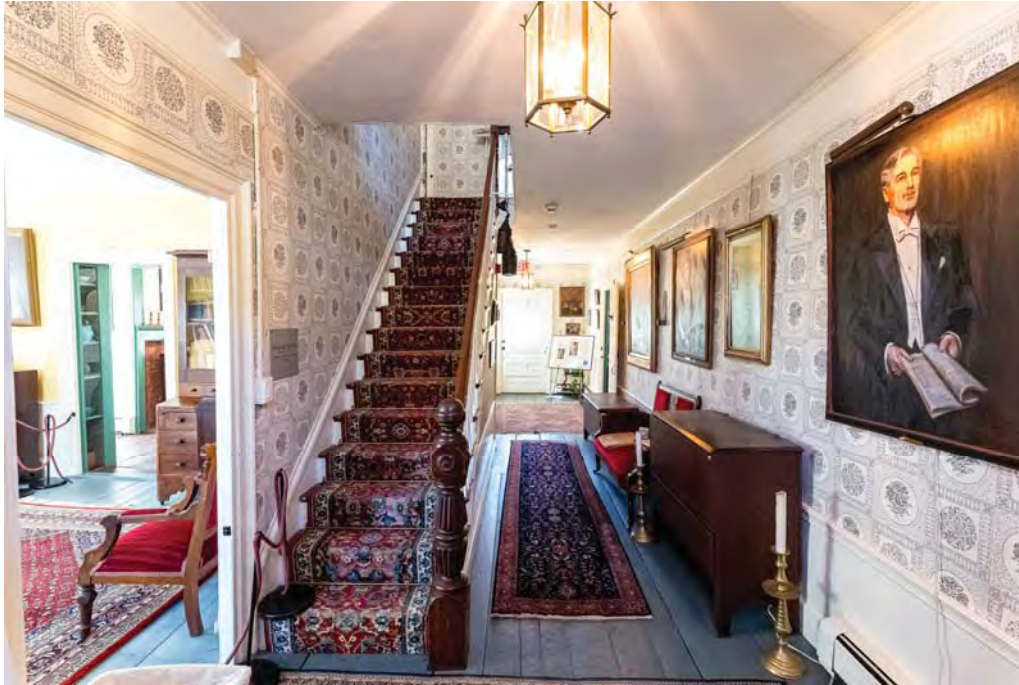
Figure 4.10-1
F-01 is a central
corridor on the first
floor giving access
into almost all
rooms.

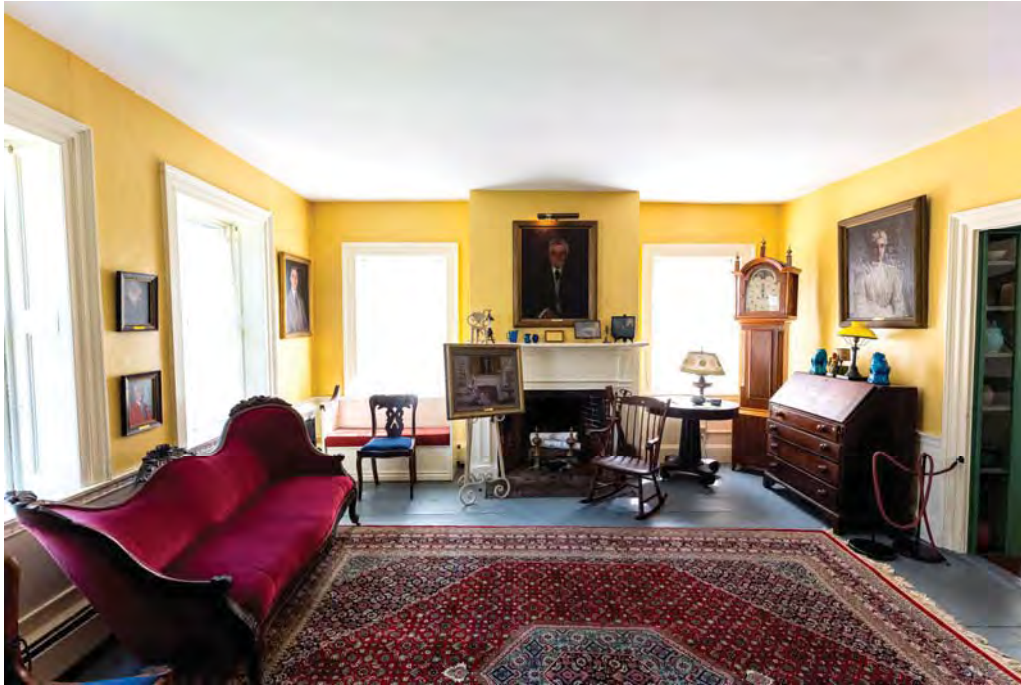
Figure 4.10-6
Room F-02 is
accessed through
room F-01 and F-03,
and is currently
displayed as the
Hosmer's parlor.

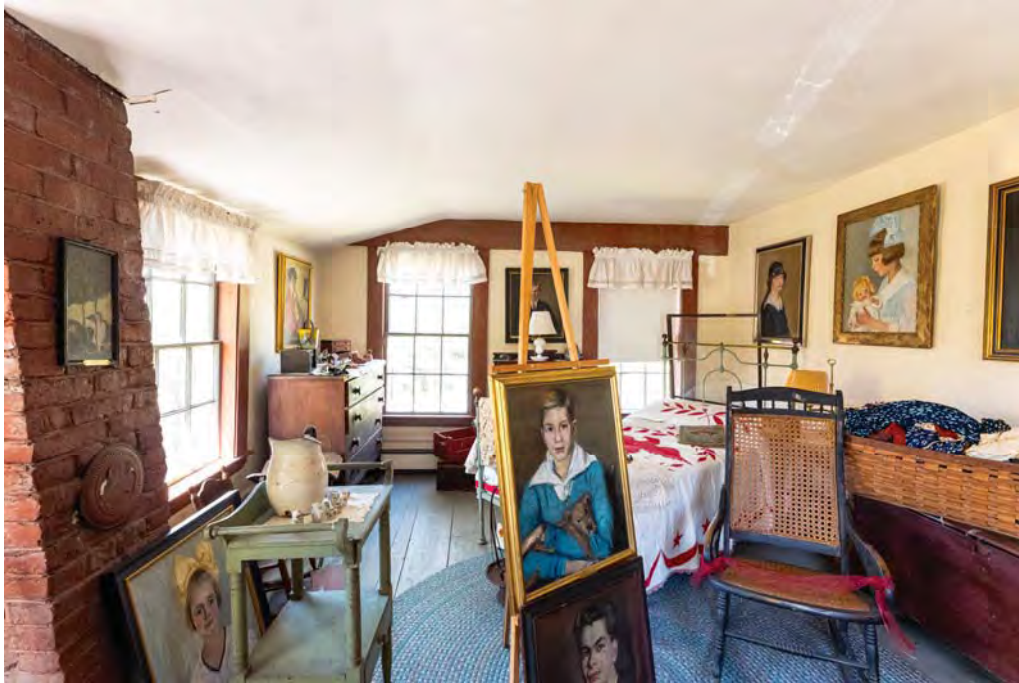
Figure 4.10-16
Accents in room S-08 are a deep burnt-red color.

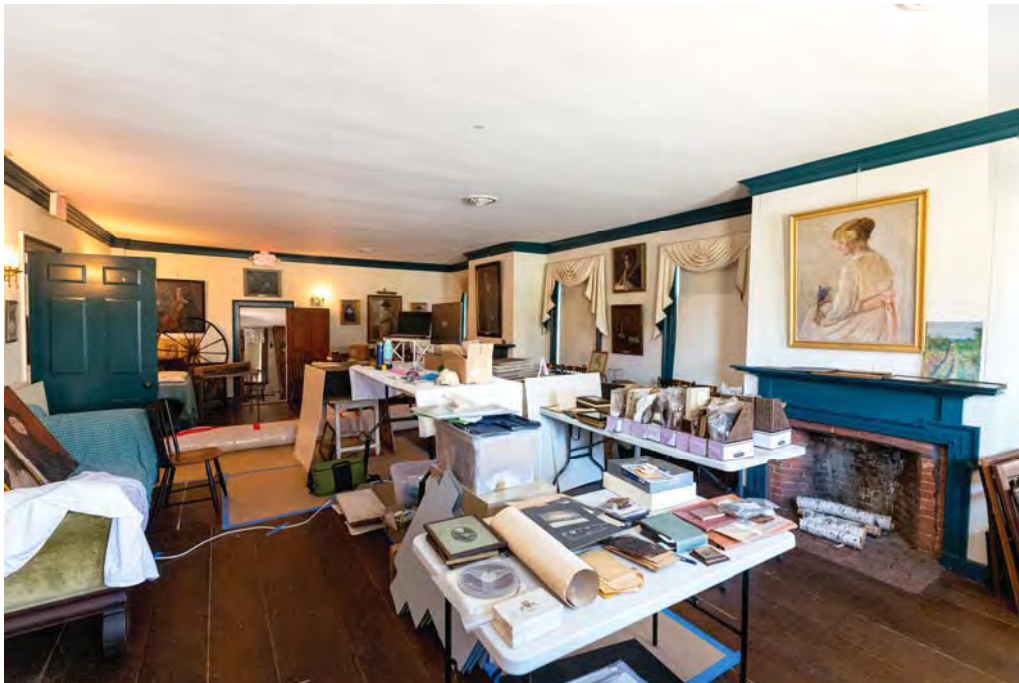
Figure 4.10-17
The largest room on the second floor is room S-09, painted a creamy white, with crown molding and window and door trims in a deep teal.

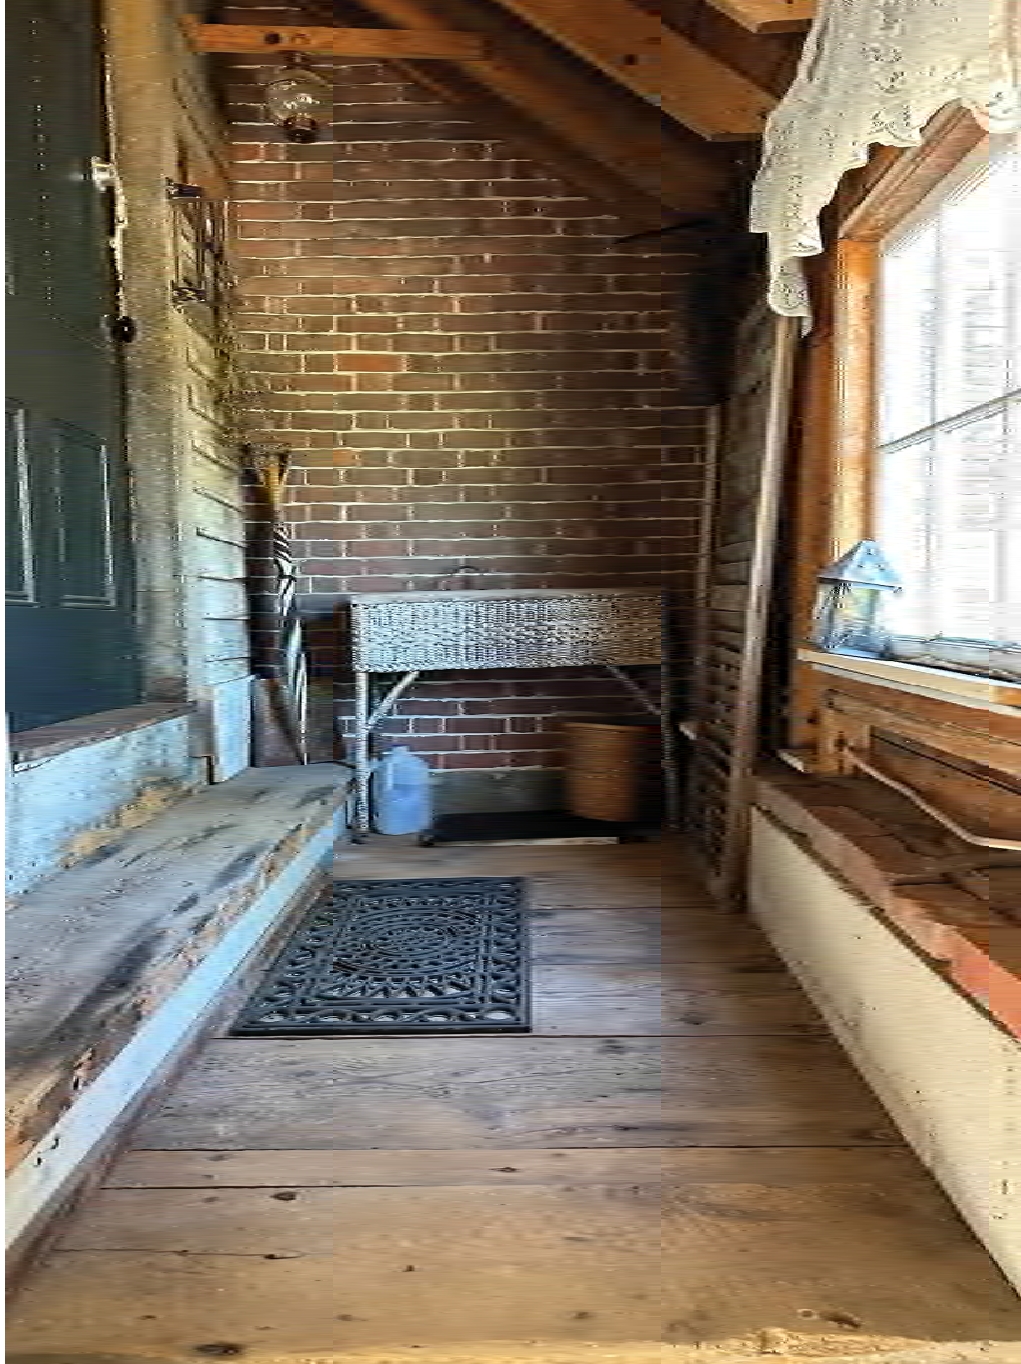
Figure 4.10-18
Interstitial space,
which acts as a
mudroom,
between the
open-air carriage
house and room
F-05, which
currently houses
the kitchen.

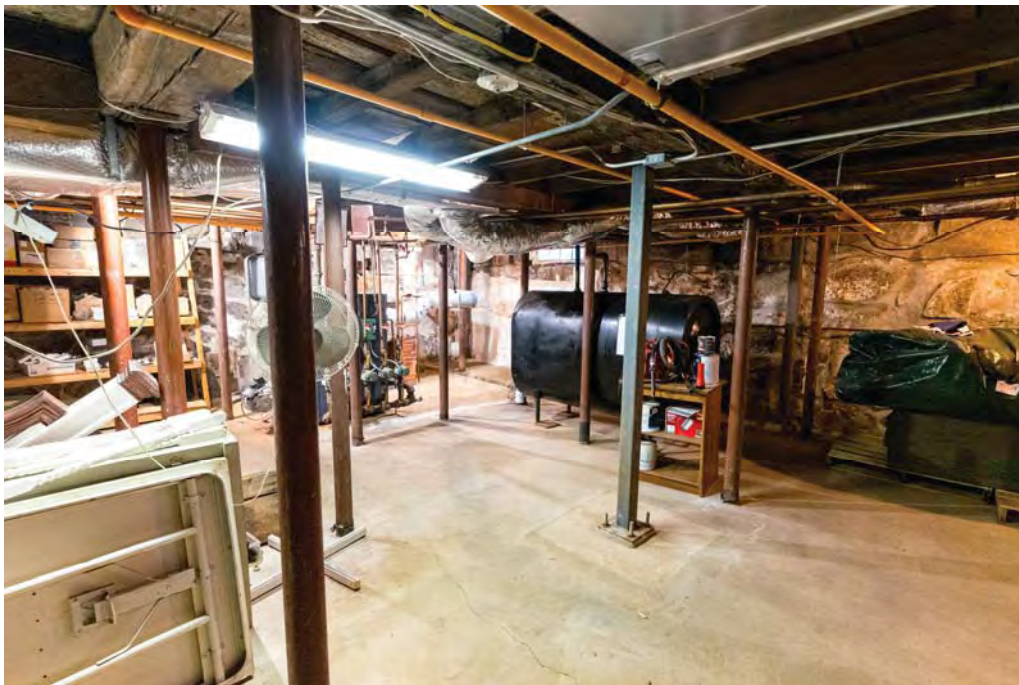
Figure 4.11-1
Poured concrete
floor of B-01.

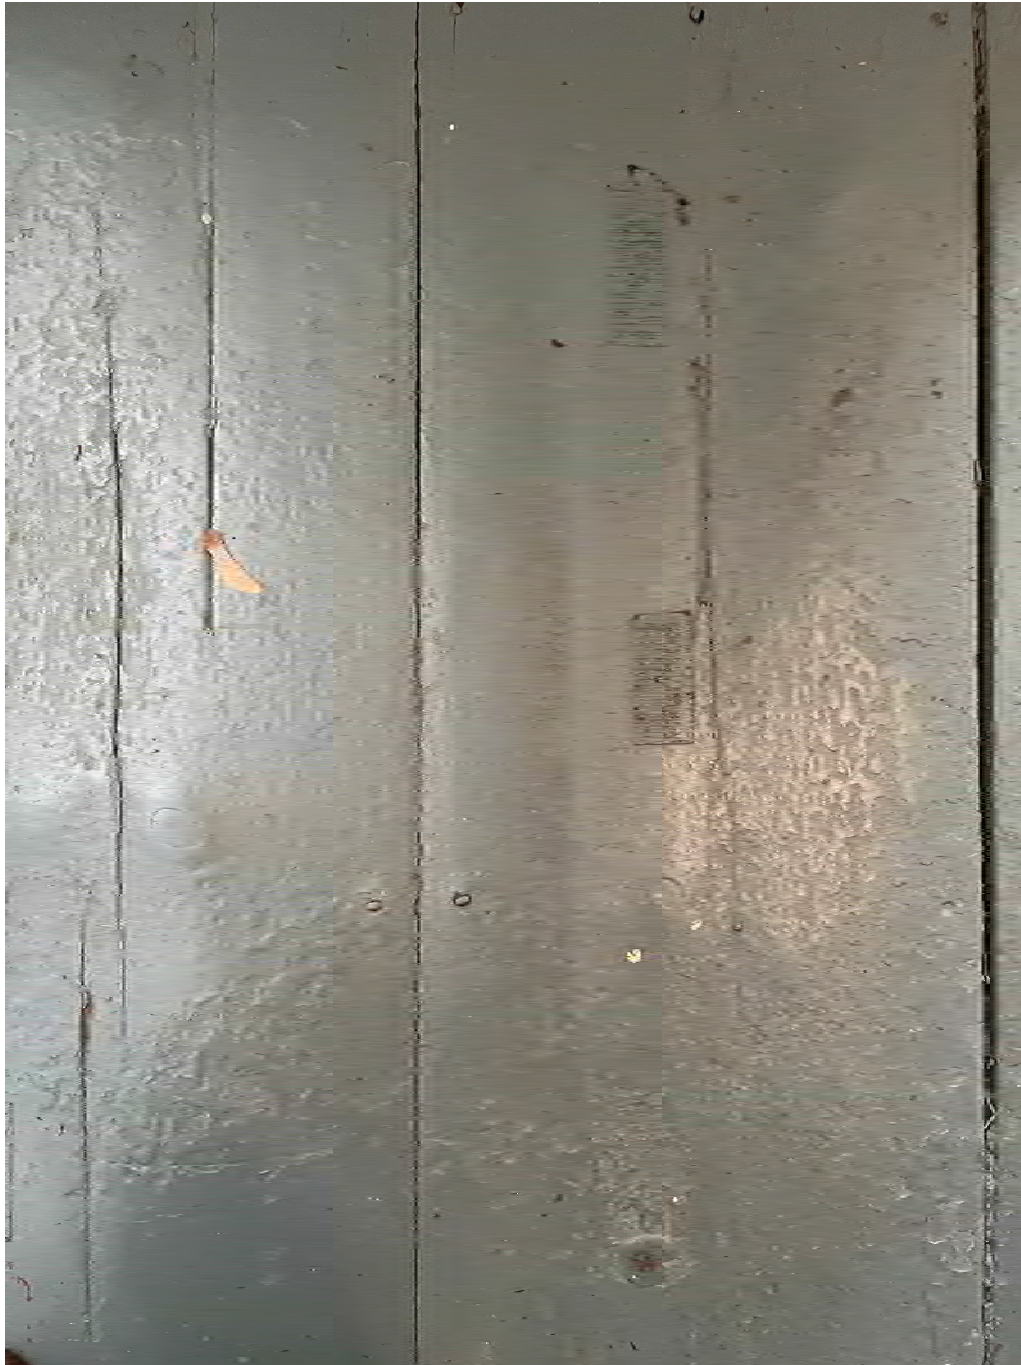
Figure 4.11-2
Floorboards vary
in width, and are
painted a dusty
blue. Signs of
cracking and
paint loss were
observed.

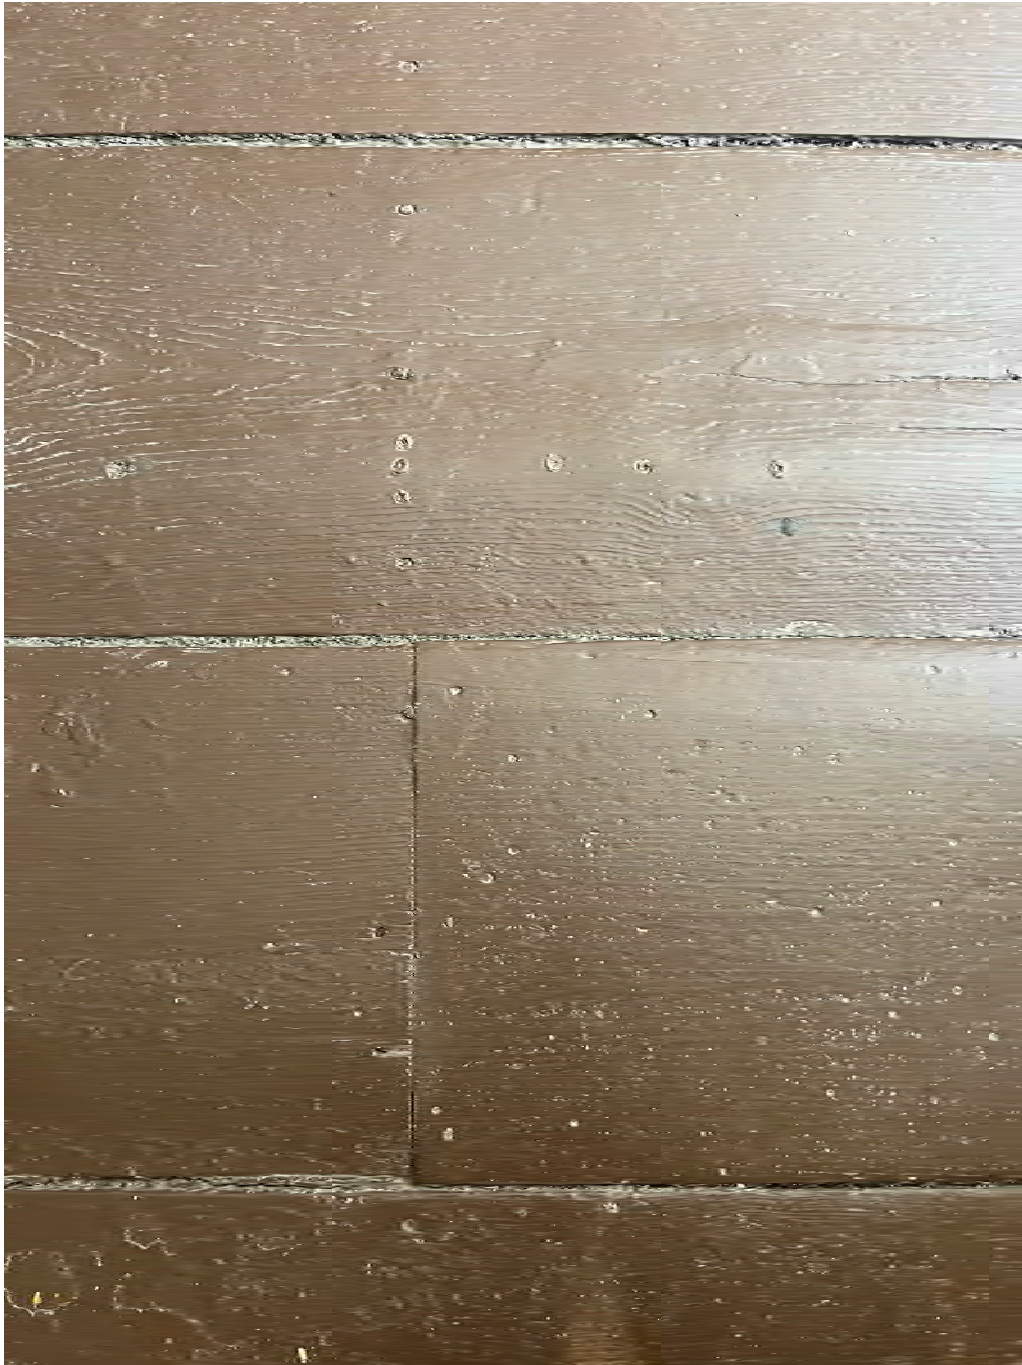
Figure 4.11-3
Planks run in a
north-south
orientation, and
are painted a
deep brown.
