HOSMER HOUSE

HISTORIC STRUCTURE REPORT / CULTURAL LANDSCAPE REPORT

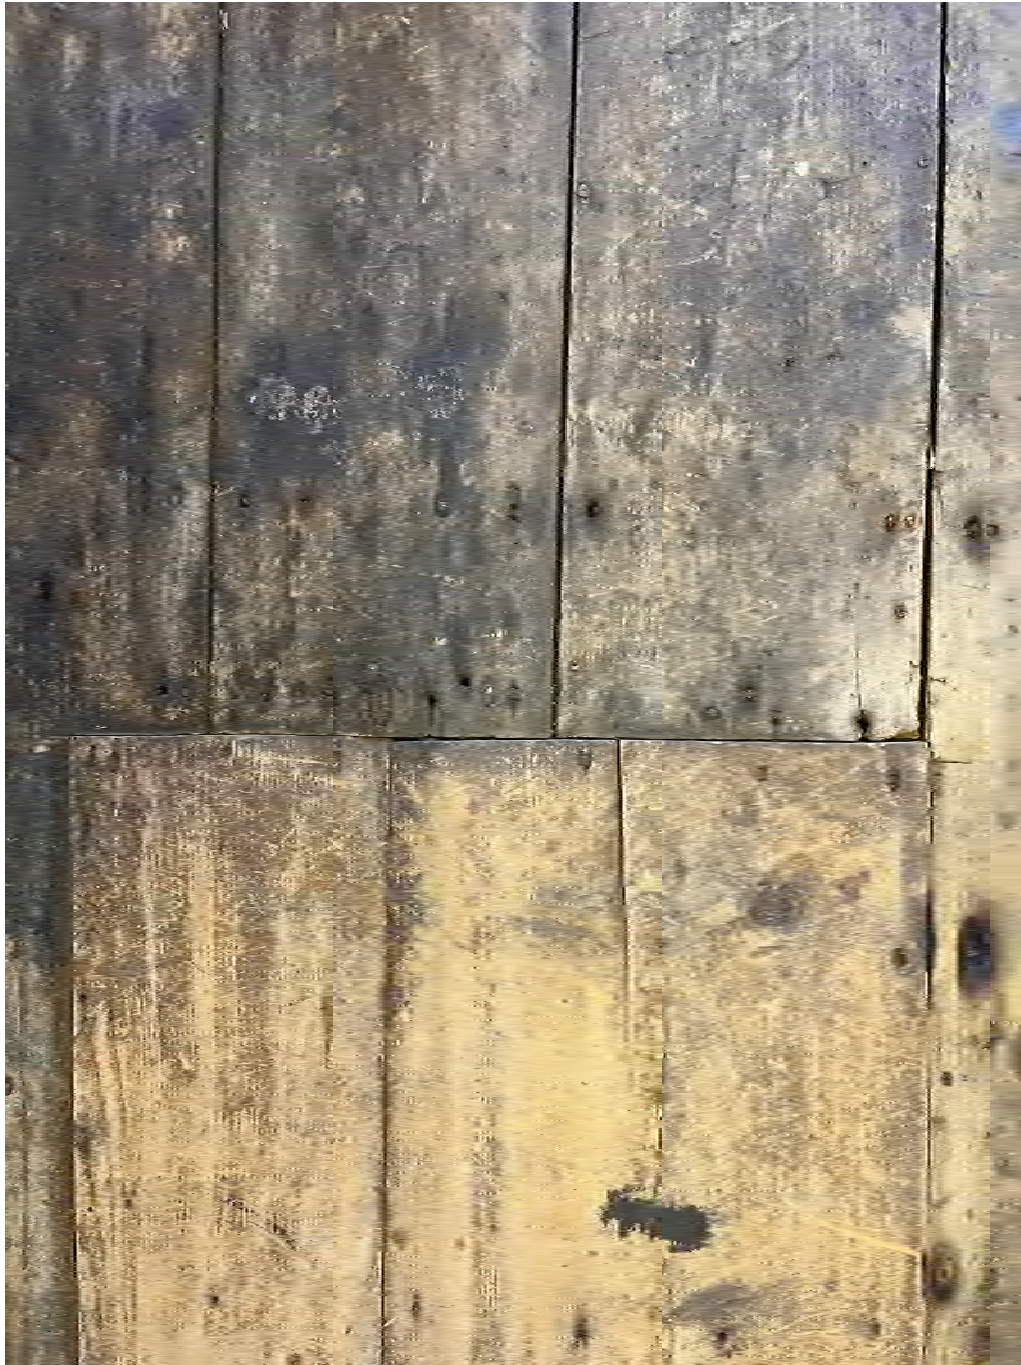
Figure 4.11-4
Planks run in a
north-south
orientation and
have large
variations in their
width. Floor
finishes are
visibly worn, as
depicted here.

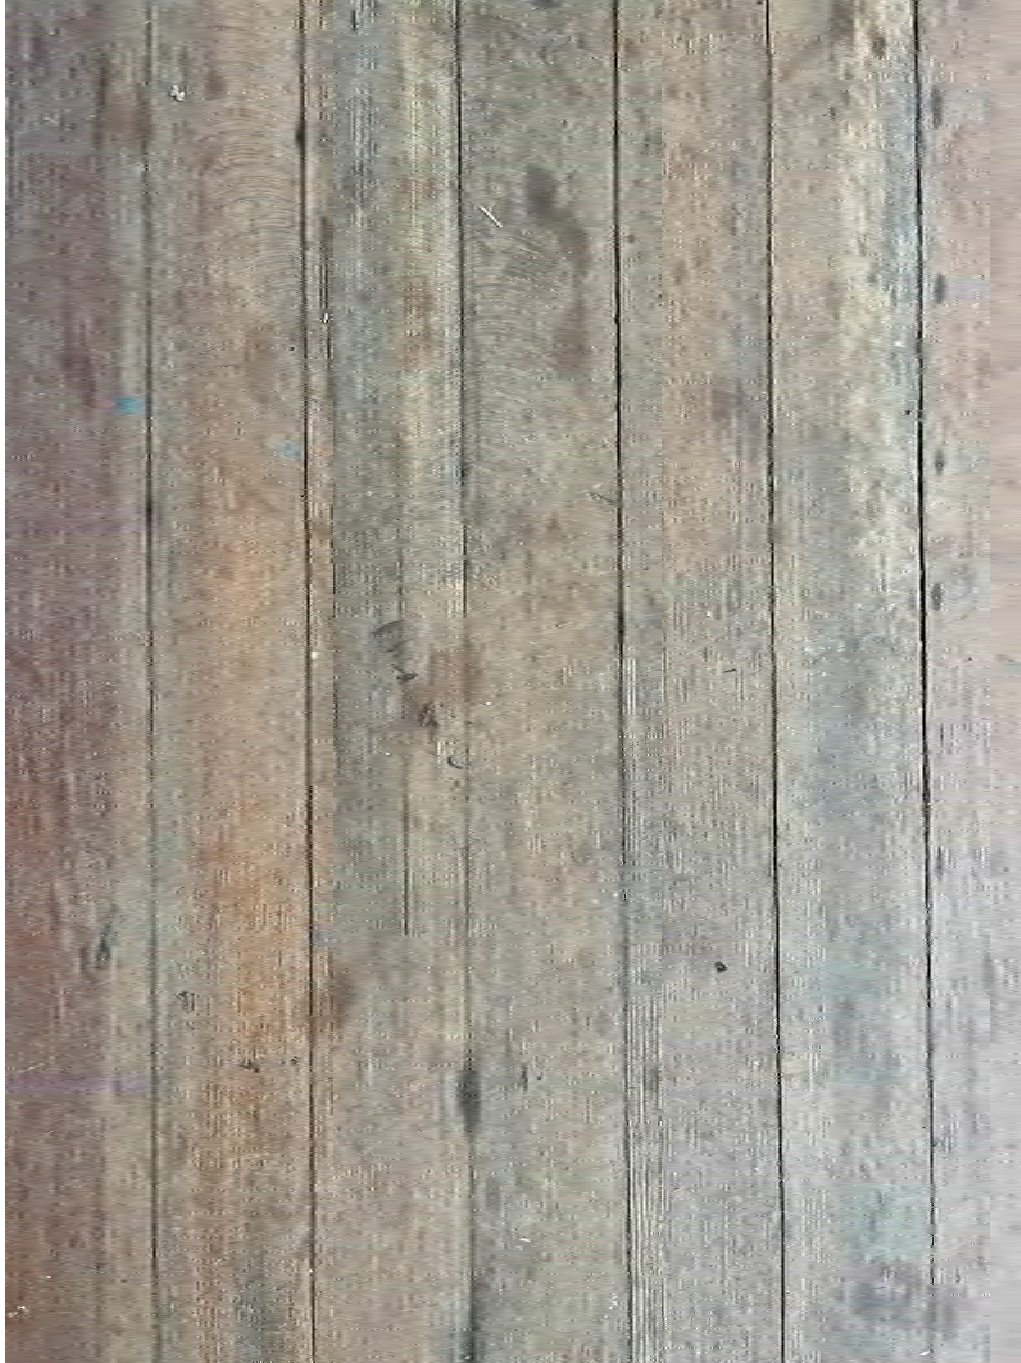
Figure 4.11-5
Thinner
floorboards and
more uniform
width indicate
that these planks
are from a
different period.

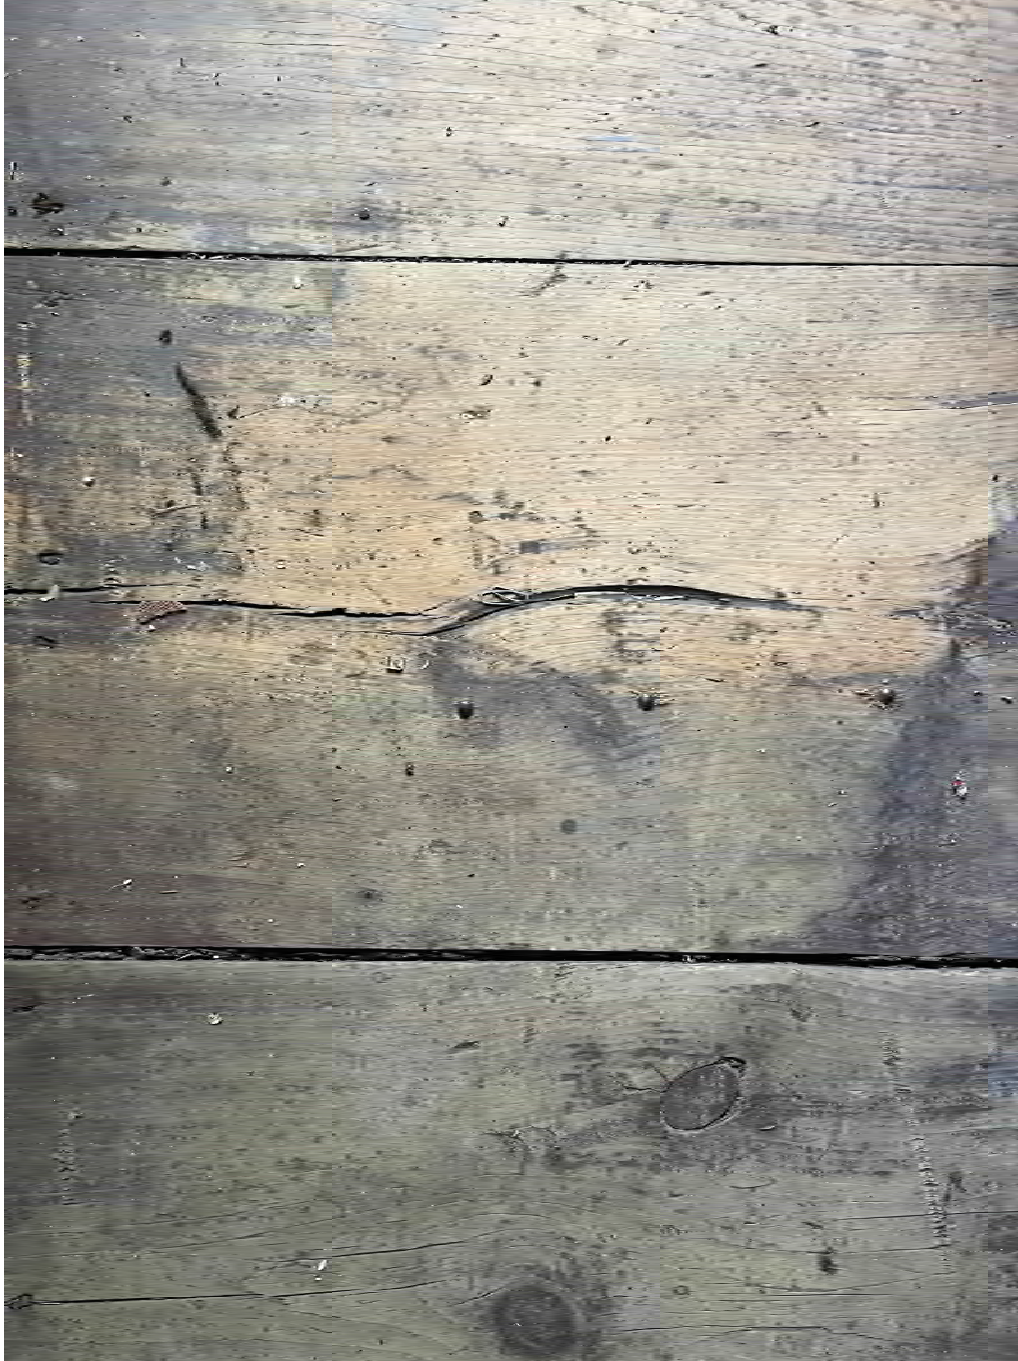
Figure 4.11-7
Splits in the wood
were observed in
room F-05, as
well as evidence
of past repairs,
where wood has
weakened due to
water damage.

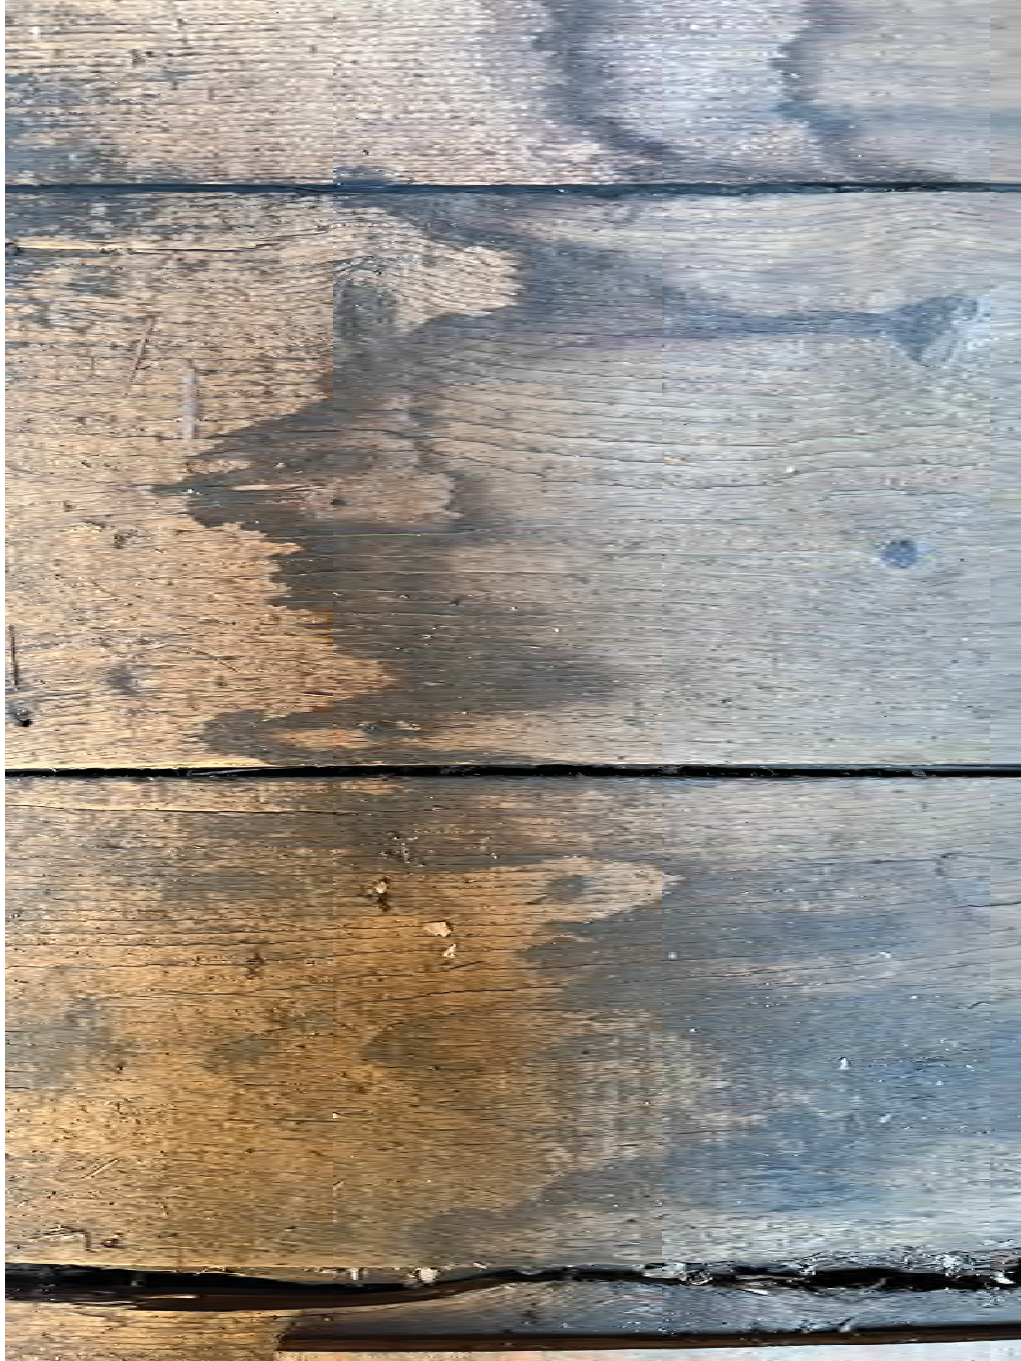
Figure 4.11-8
Splits in the wood
were observed in
room A-01, as
well as evidence
of past repairs,
where wood has
weakened due to
water damage.

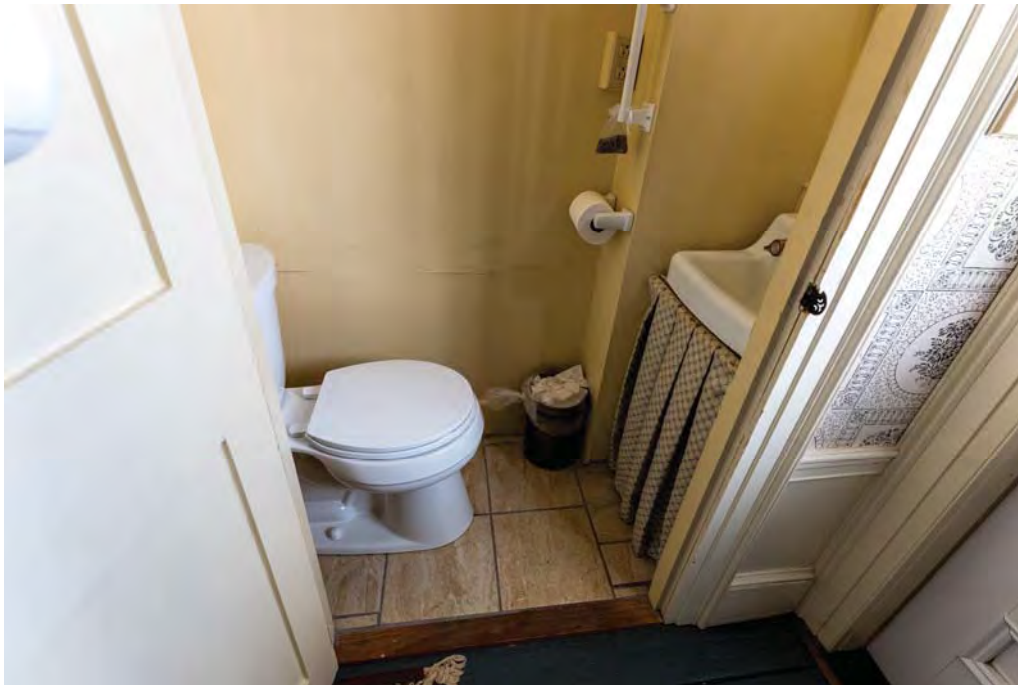
Figure 4.11-9
Modern tiling in
room F-06 is in good
condition, however it
is not historically
accurate to the
house.

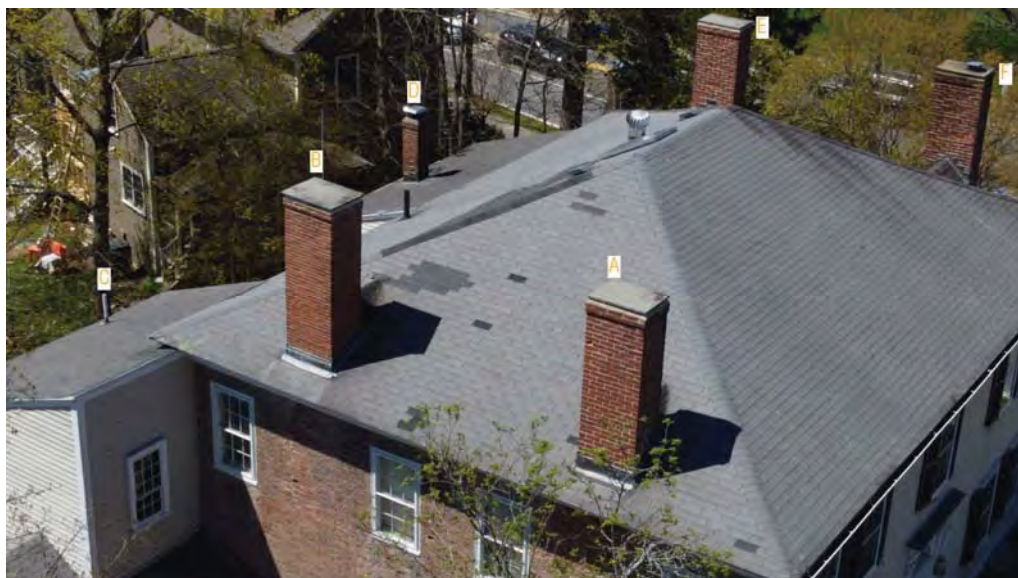
Figure 4.12-1
Chimney A services:
FP-01 & FP-07

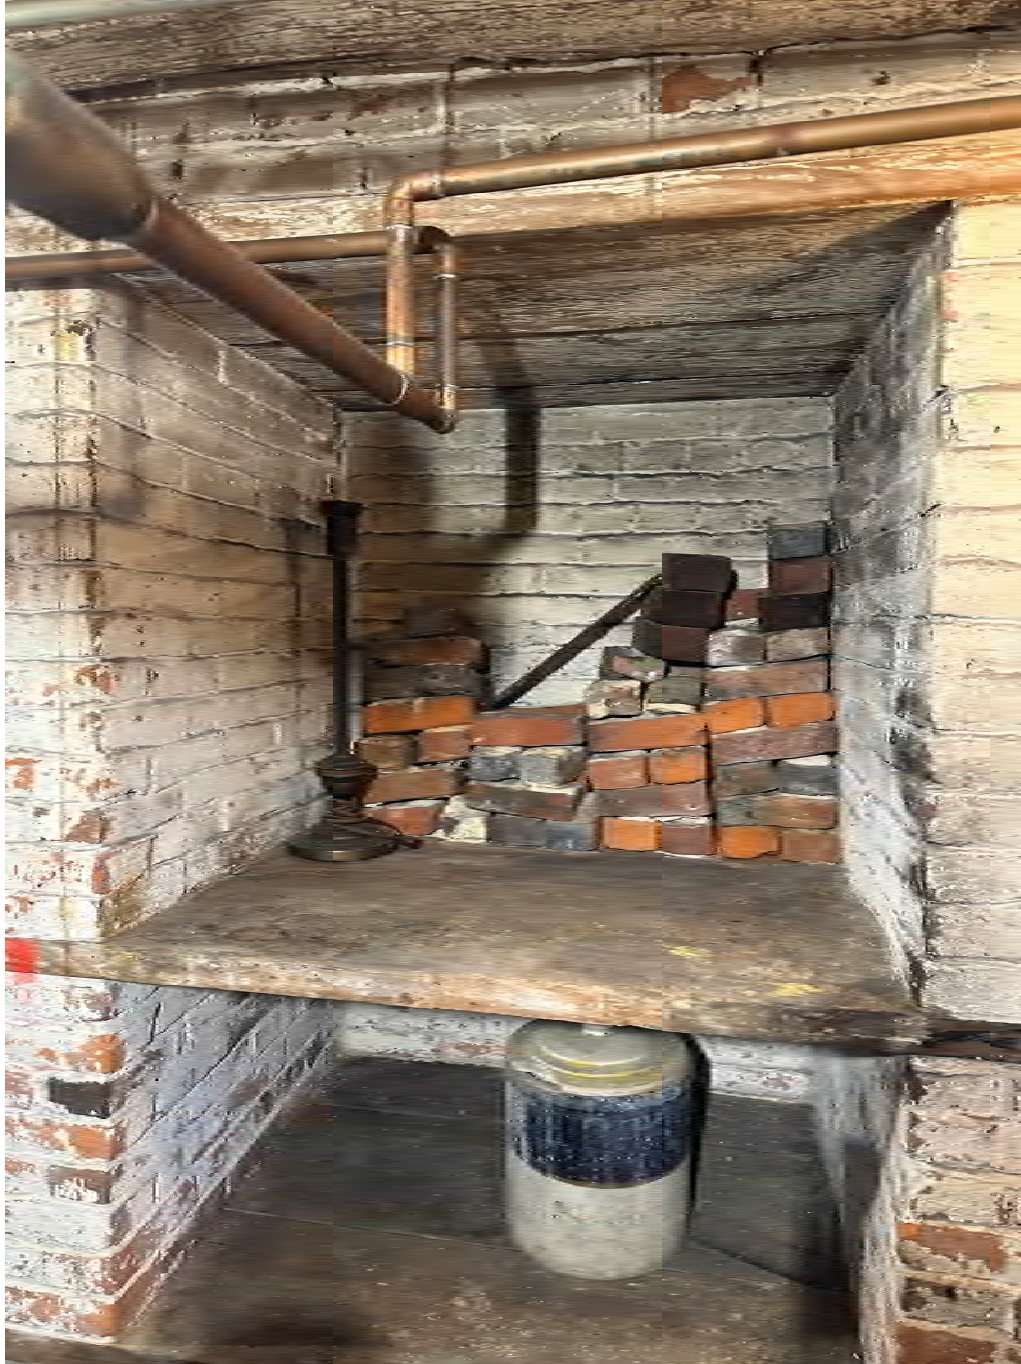
Figure 4.12-2
Fireplaces FP-05
and FP-09, and
FP-06 and FP-10
each share a
chimneystack
with two flutes,
with foundations
and footings
visible in the
basement. Visible
are cracked
bricks, and loss
of masonry
coating.

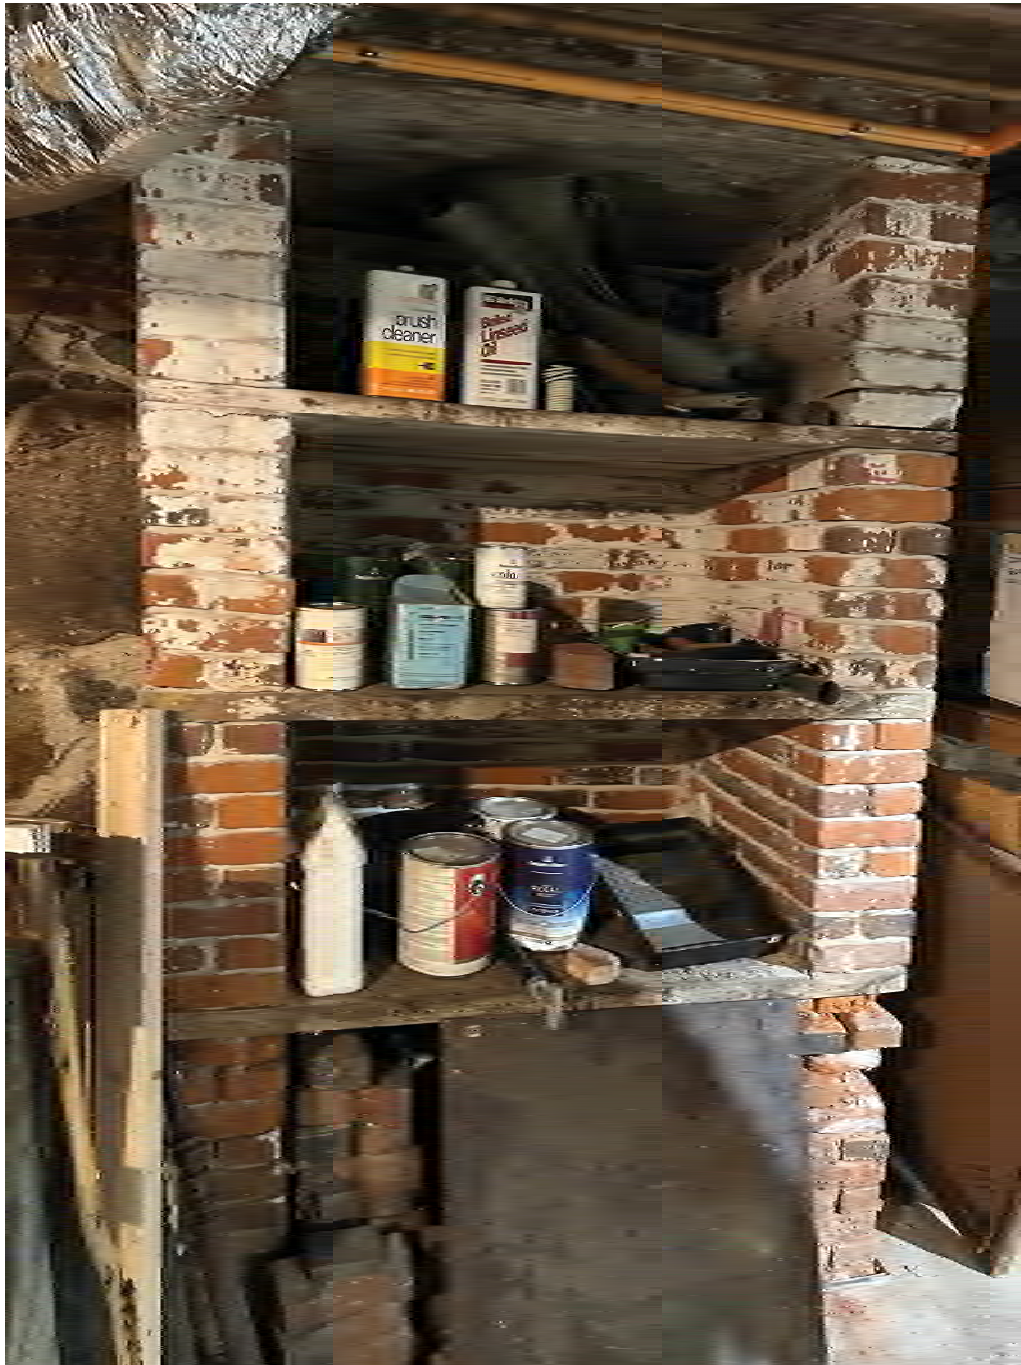
Figure 4.12-3
Fireplaces FP-05
and FP-09, and
FP-06 and FP-10
each share a
chimneystack
with two flutes,
with foundations
and footings
visible in the
basement. Visible
are cracked
bricks, loss of
masonry coating
and loss of
mortar.

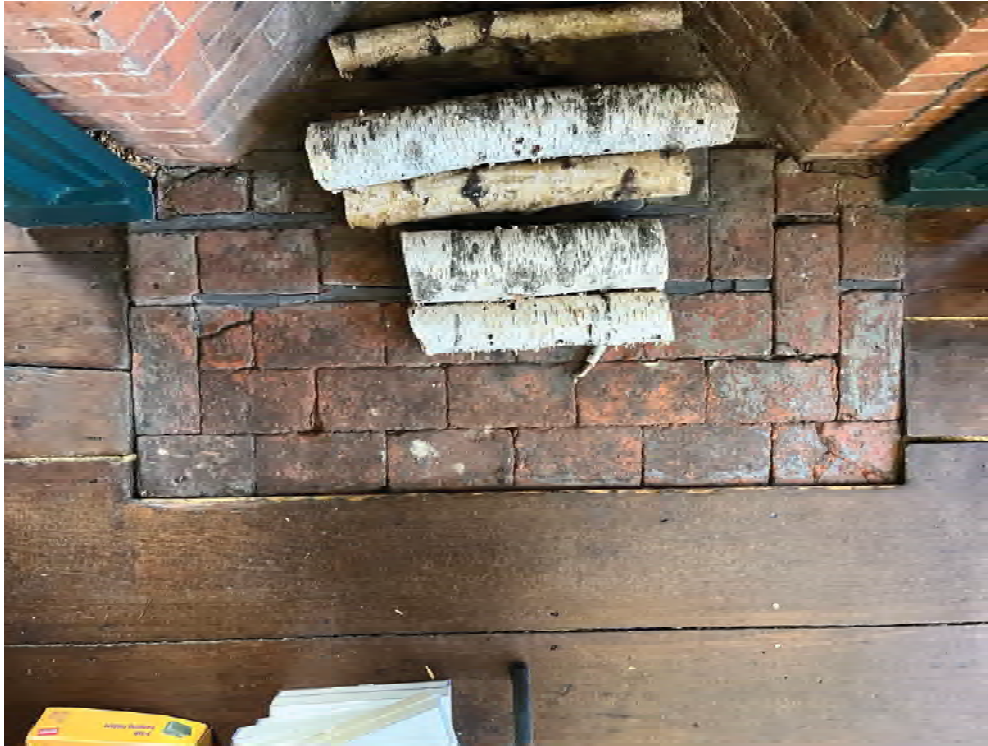
Figure 4.12-4
Standard bricks used
to build the fireplace
hearth in S-09.

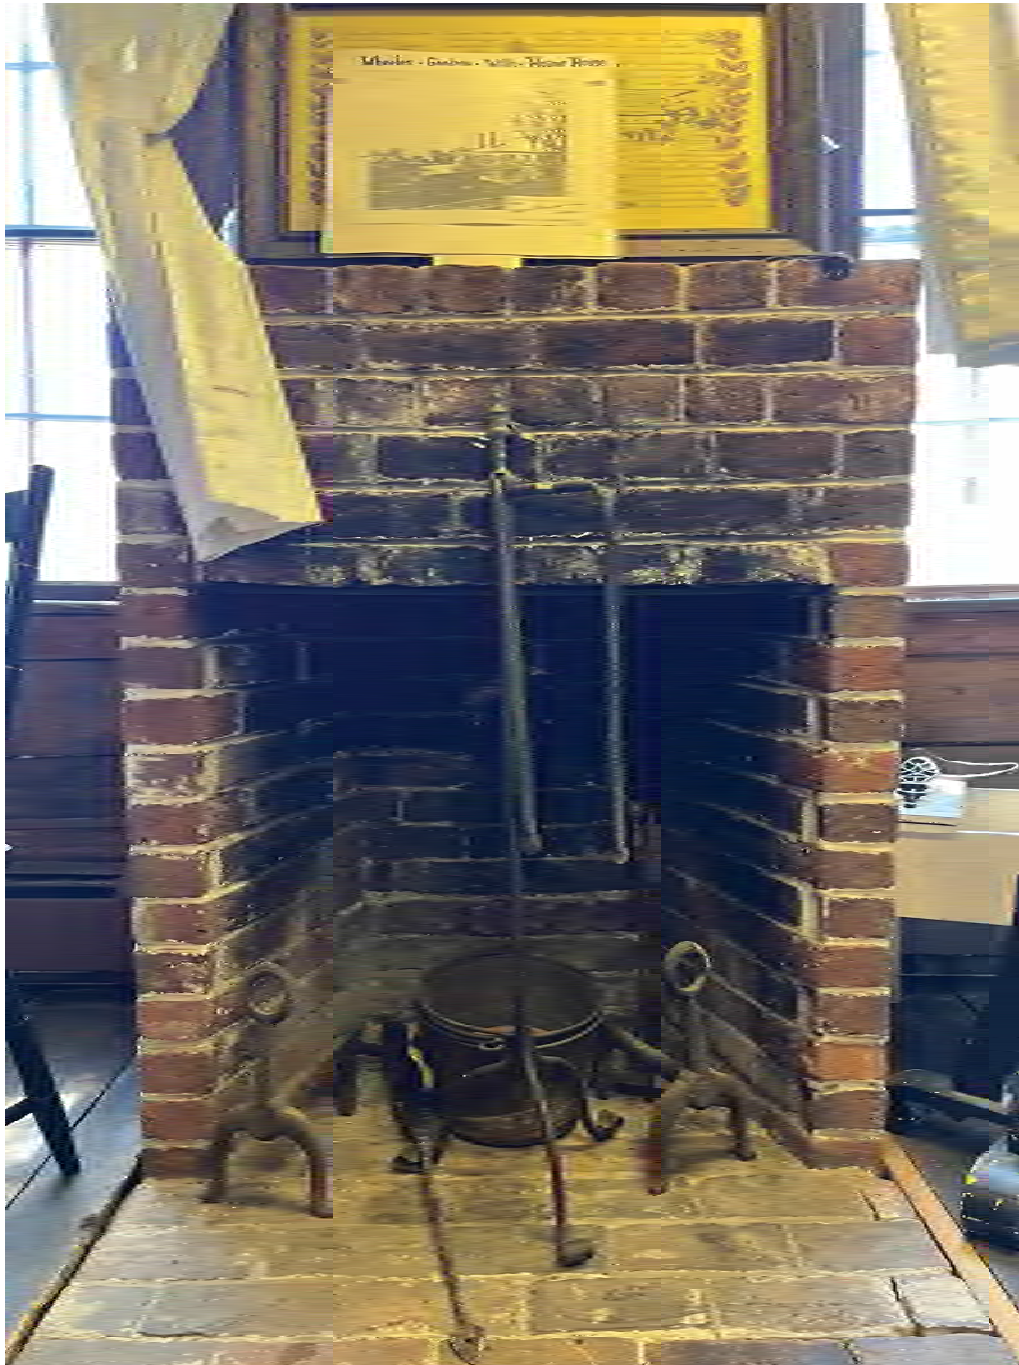
Figure 4.12-9
Corroded
fireplace lintel in
room F-07.

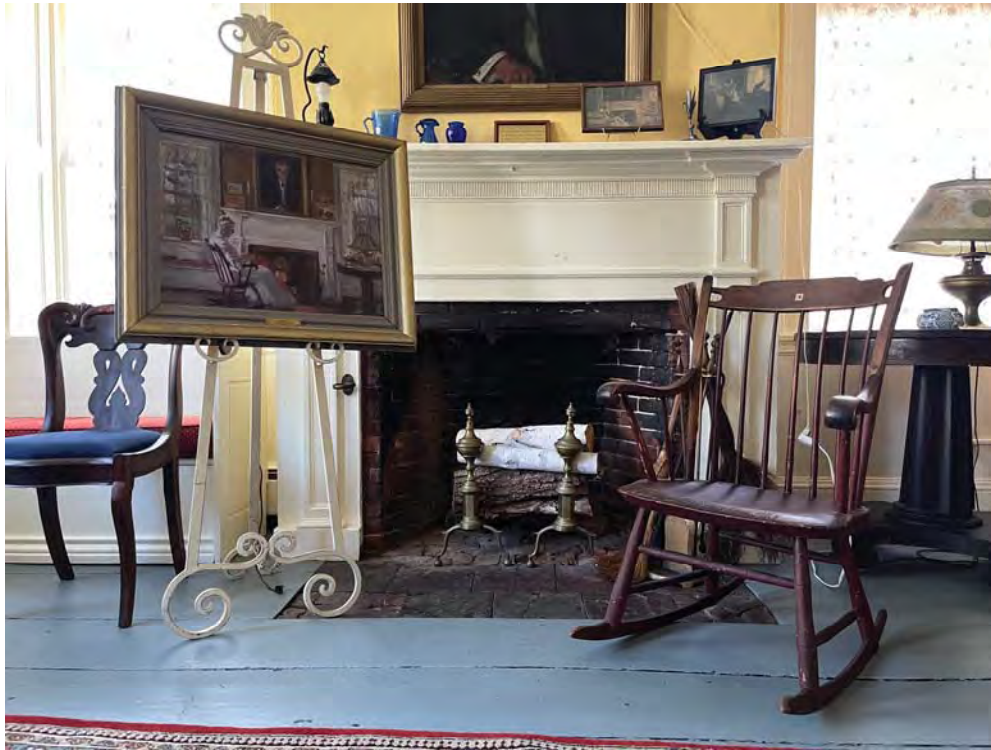
Figure 4.12-10
Painted decorative
wooden mantel in
room F-02.

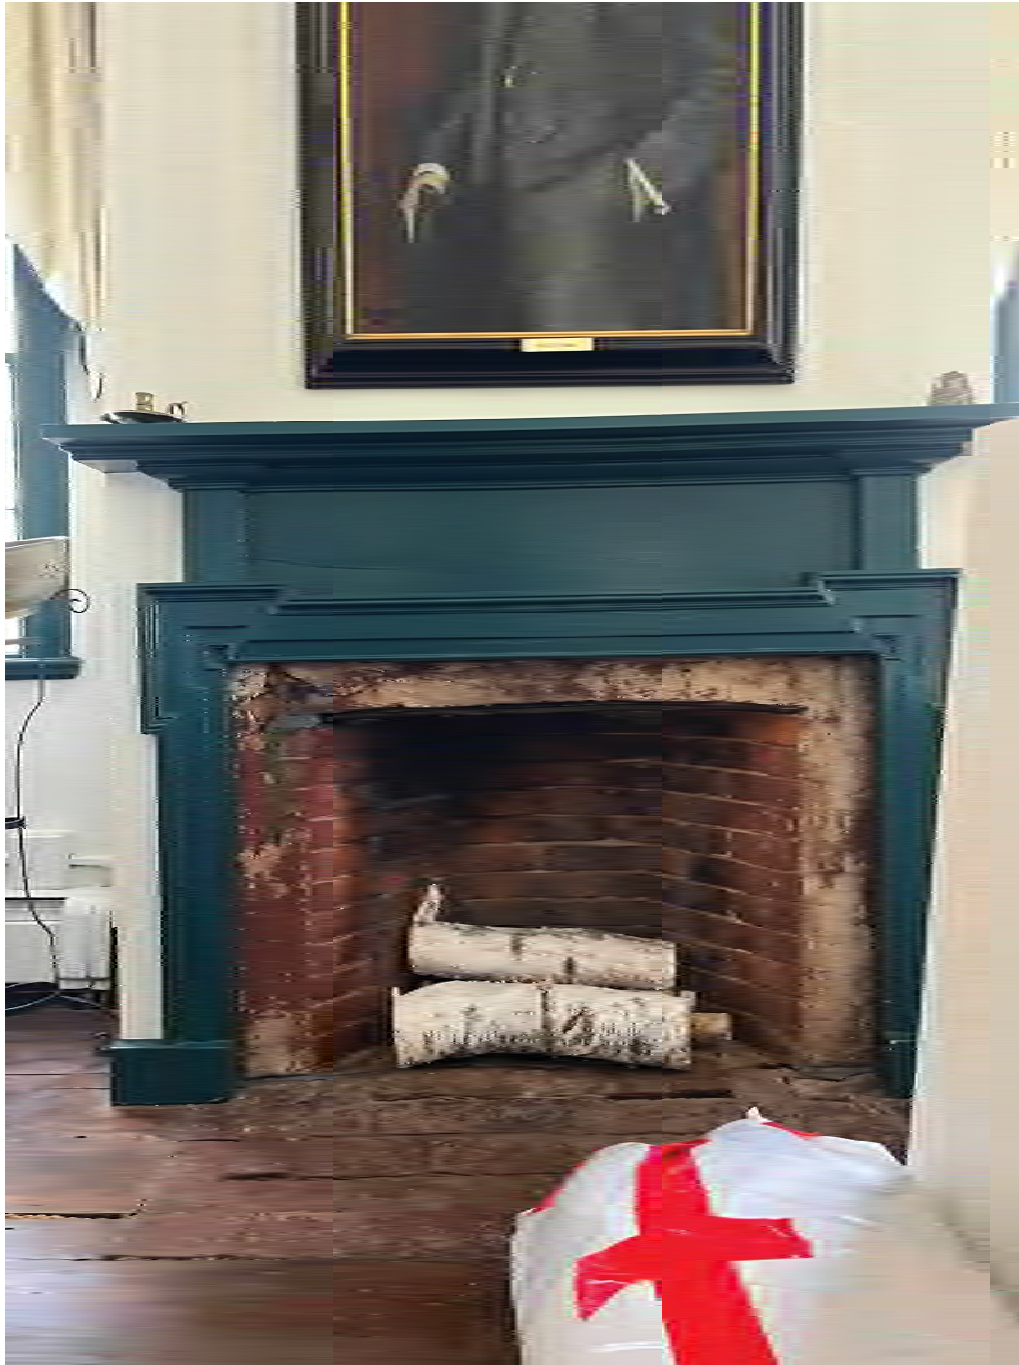
Figure 4.12-11
Painted
decorative
wooden mantel in
room S-09. Lintel
shows signs of
corrosion.

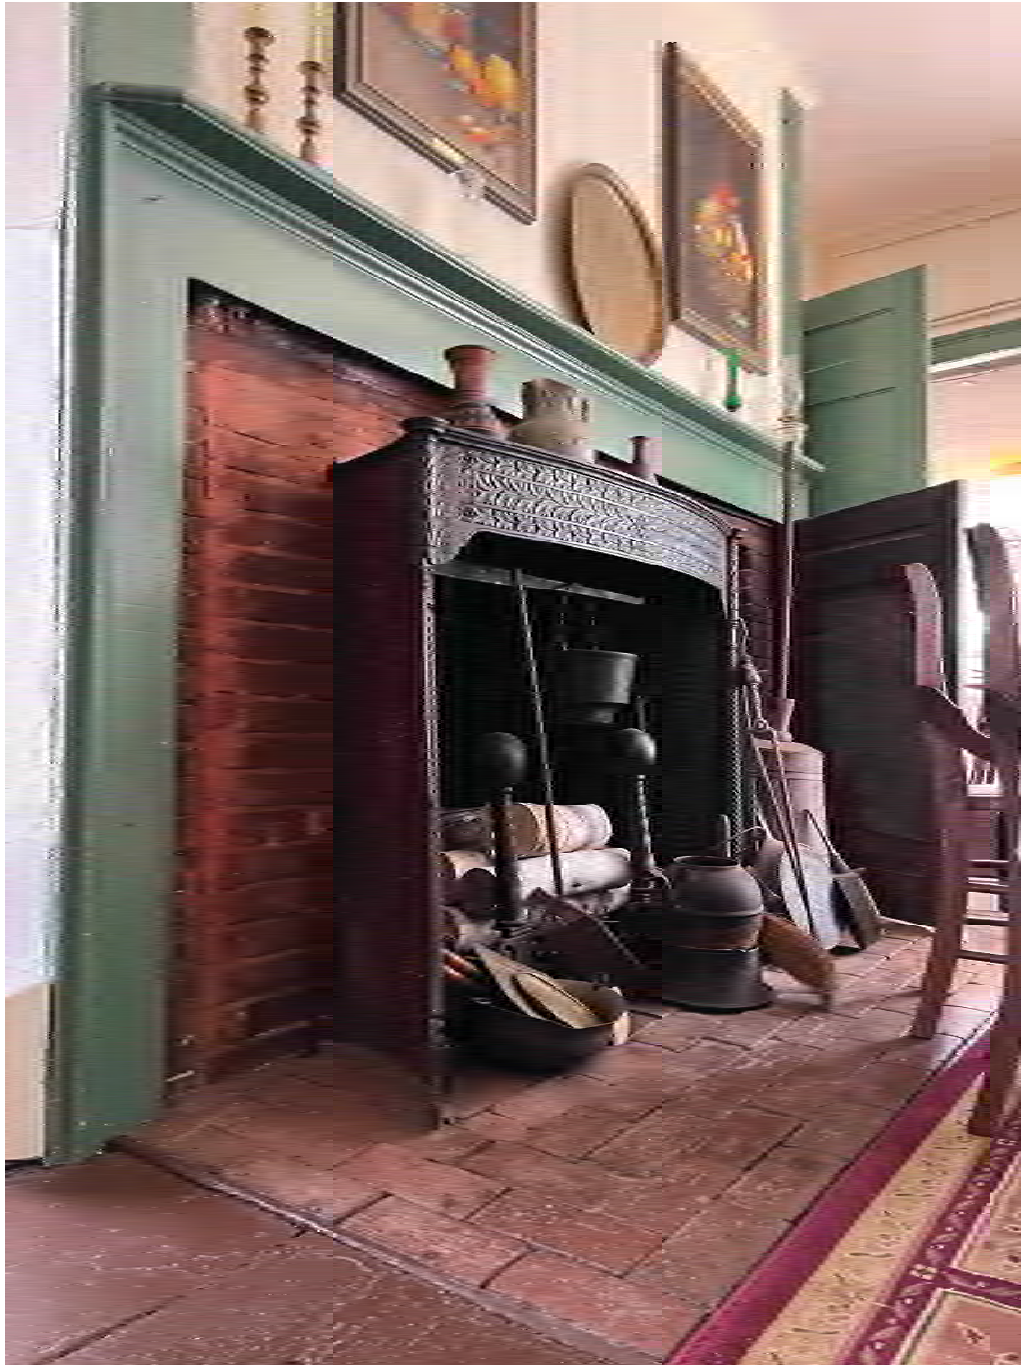
Figure 4.12-12
Located in room
F-03, the original
kitchen hearth,
with a simple
wooden painted
mantel.

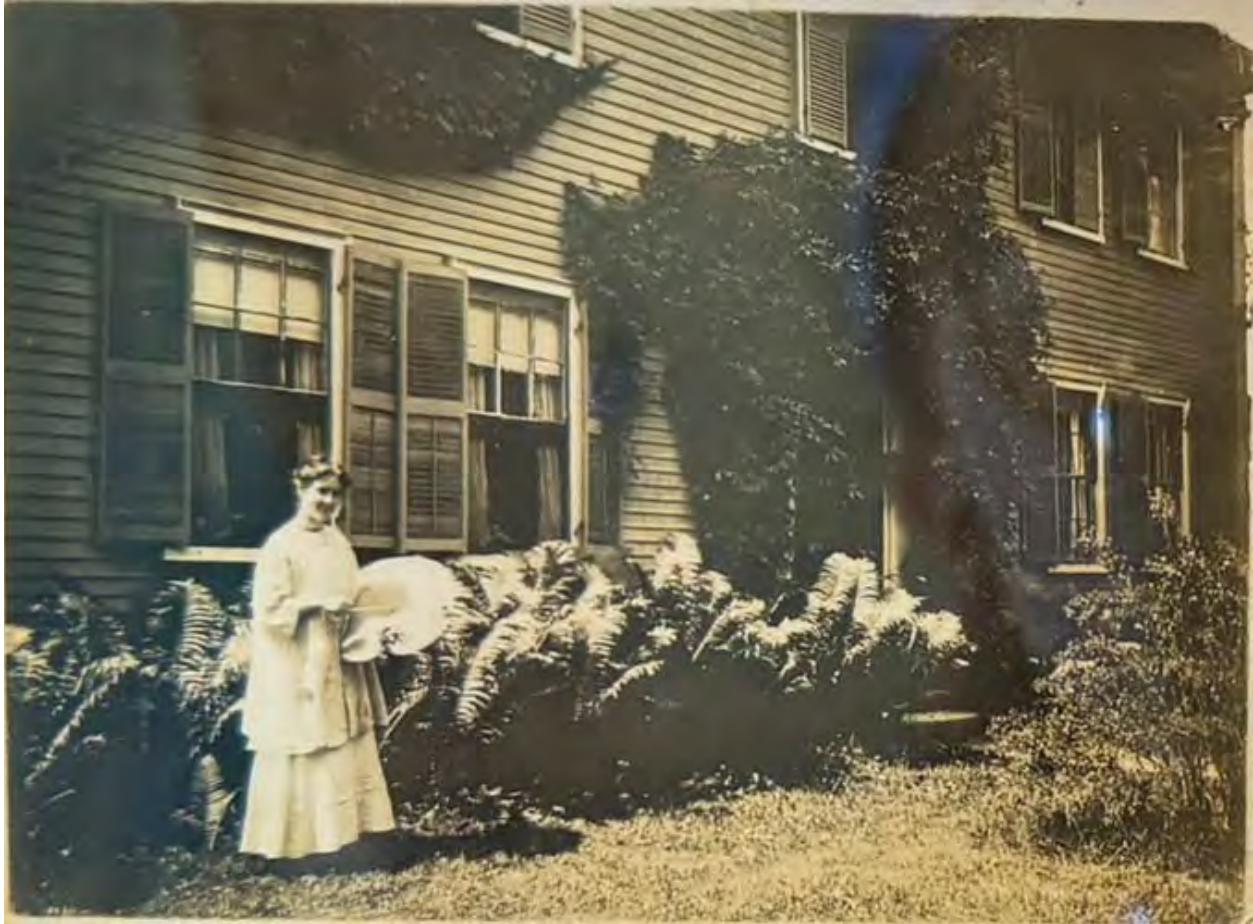
Figure 7.2-13. A 1910s photograph of Florence Hosmer standing with paint palette at north side of Hosmer House. Dense vines grow on the north façade framing the entry door. Two to three foot tall ostrich fern (*Matteucia struthiopteris*) lines the house foundation. An arching shrub form, possibly bridalwreath (*Spirea vanhouttei*), appears at the right side of the image. Courtesy Hosmer House Collections.

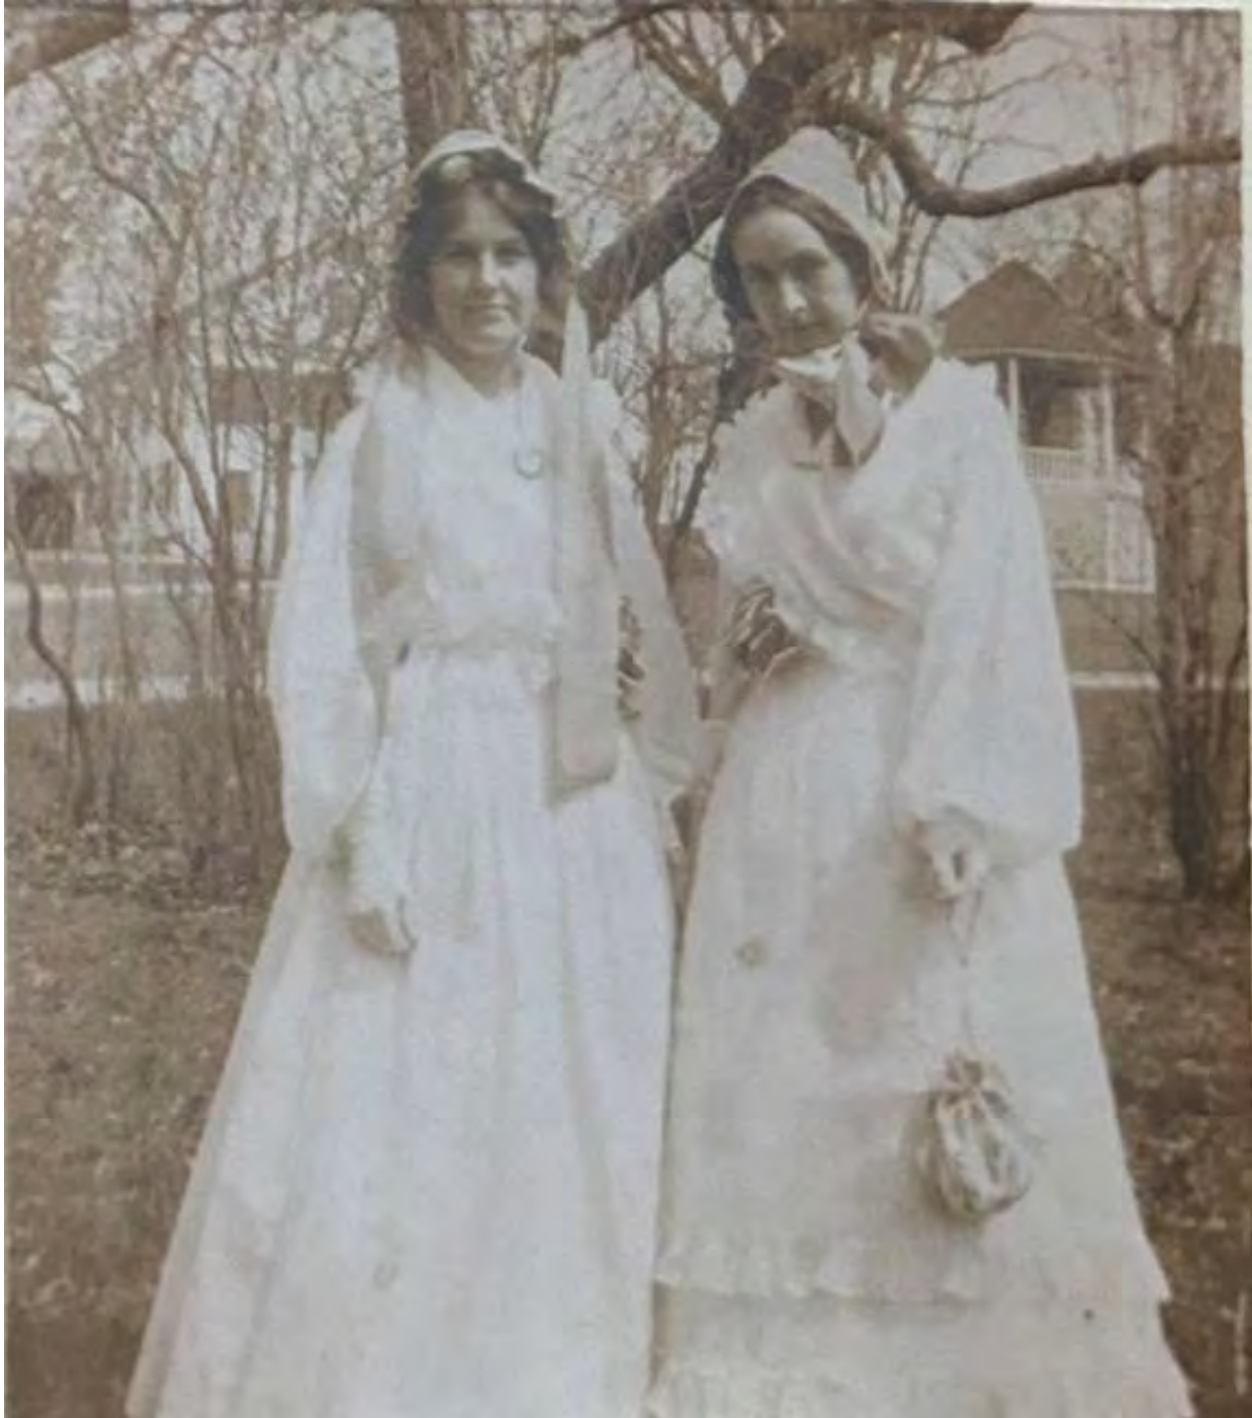
Figure 7.2-14. This 1910s photograph of Florence Ames Hosmer and an unidentified woman captures a north-facing view from the Hosmer House property. Beyond a grouping of leaf-off shrubs and a large deciduous tree, the Old Bandstand appears in Sudbury Common on the opposite side of the street. To the left of the Bandstand is the original Town Hall. Courtesy Hosmer House Collections.

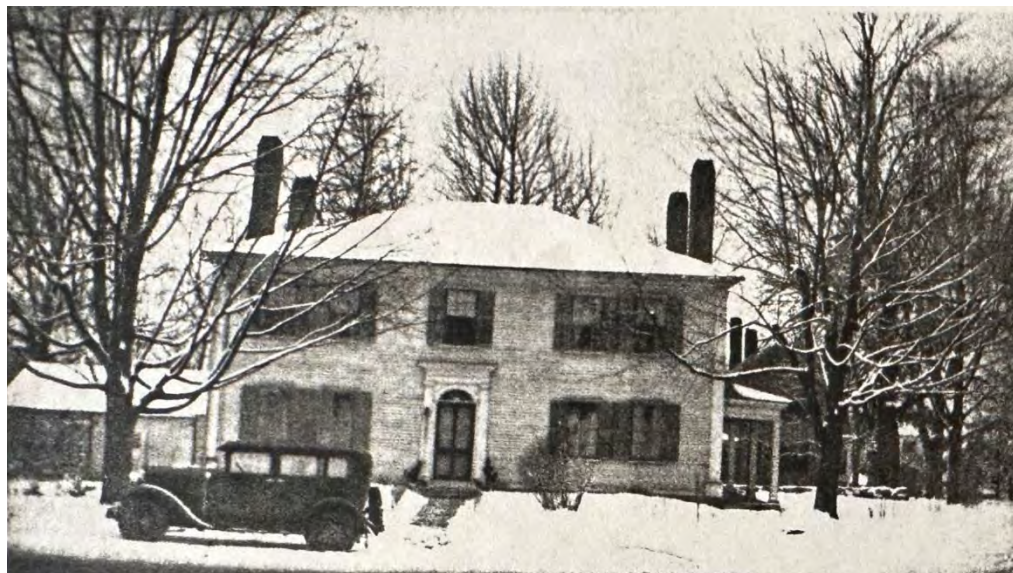
Figure 7.2-22. This circa 1937 winter view shows leaf-off deciduous trees framing the north façade, with the branches of trees behind the Hosmer House appearing over the roofline. A woody shrub is present in the lawn on the west side of the entry walk to the front door. Courtesy Sudbury Historical Society.

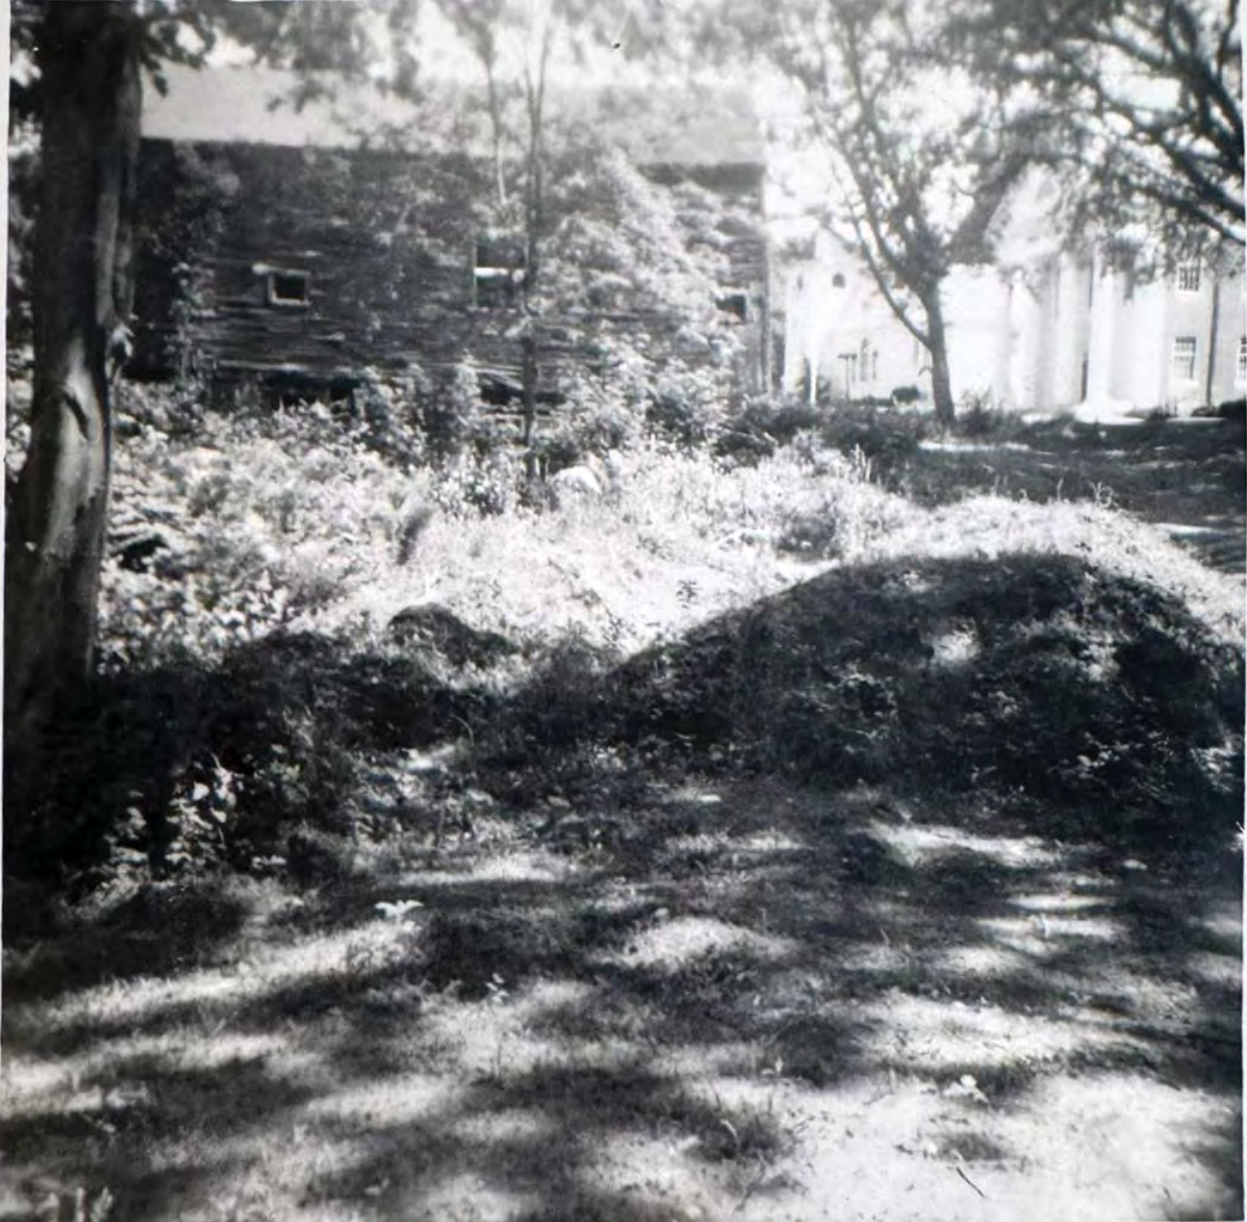
Figure 7.2-57. This 1975 north-facing photograph of the Barn, with deteriorated siding evident, and landscape captures an overgrown area of volunteer vegetation on the south side of the barn, with a pile on the right side of the image. Deciduous tree canopy overhead creates dappled light patterns on the ground. In the background, the Town Hall white columns and brick façade appears across the street. Courtesy Hosmer House Collections.

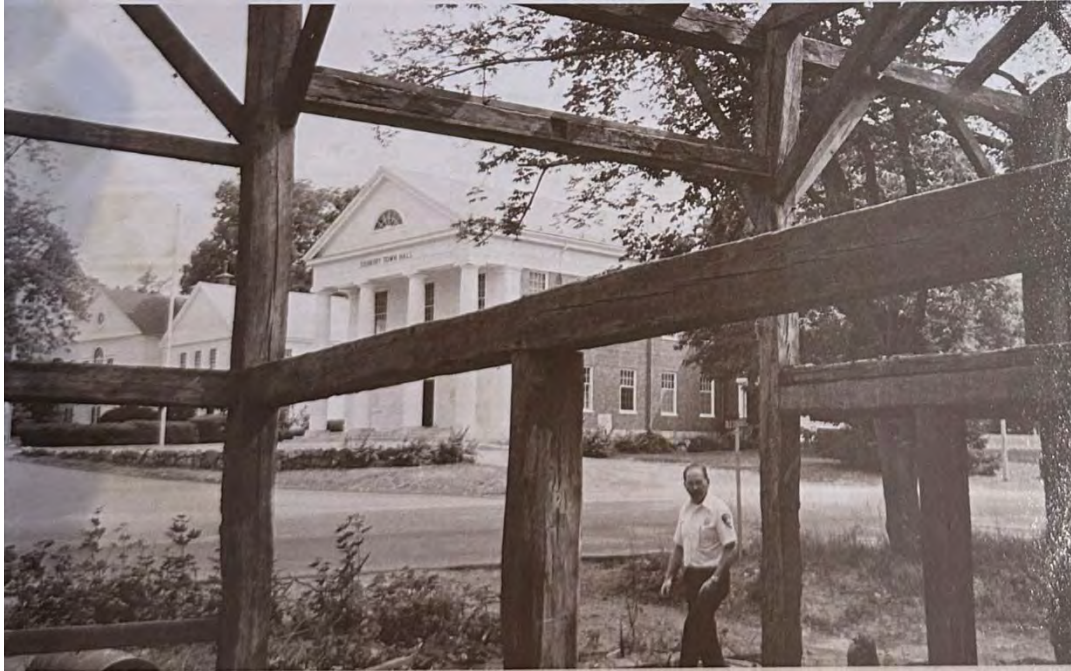
Figure 7.2-58. This circa 1970s photograph documents the timber frame of the Barn without siding or windows. The nearby Hosmer property street front landscape appears untended with scattered plants and unmown turf. Sudbury Town Hall appears through the frame on the opposite side of Old Sudbury Road. Courtesy Sudbury Historical Society.

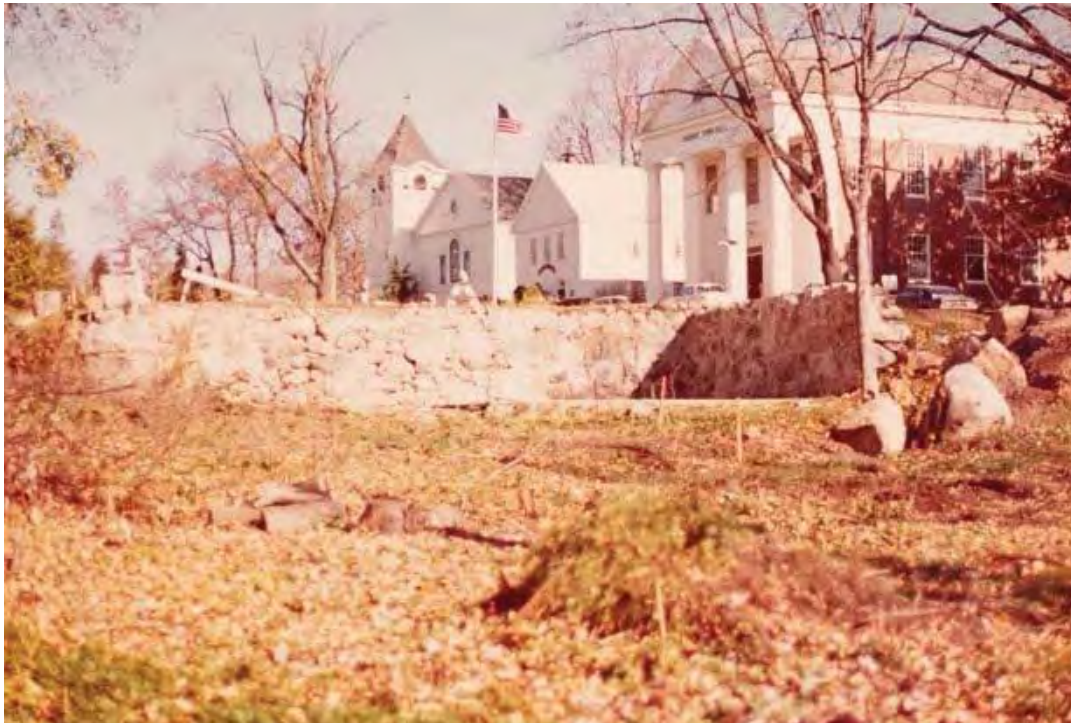
Figure 7.2-59. This circa 1970s view captures the barn foundation after the structure removal. The obverse of the photograph reads, 'The barn was torn down and some of its foundation buried when Heritage Park was created.' Courtesy Sudbury Historical Society.
