HOSMER HOUSE

HISTORIC STRUCTURE REPORT / CULTURAL LANDSCAPE REPORT

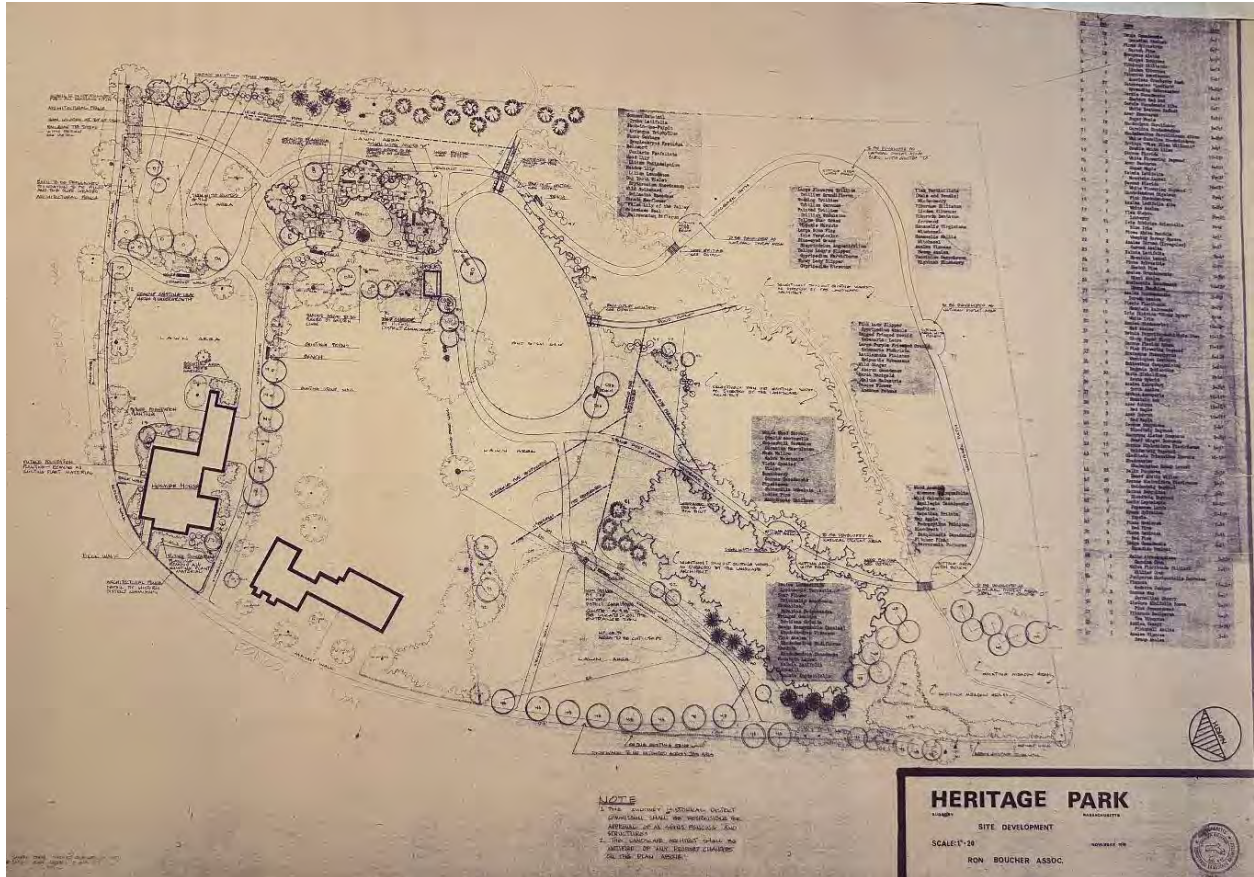
Figure 7.2-60. Dated November 1973 "Site Development" plan for Heritage Park, Ron Boucher Associates, Landscape Architecture firm, Sudbury, Massachusetts. Courtesy Sudbury Historical Society.

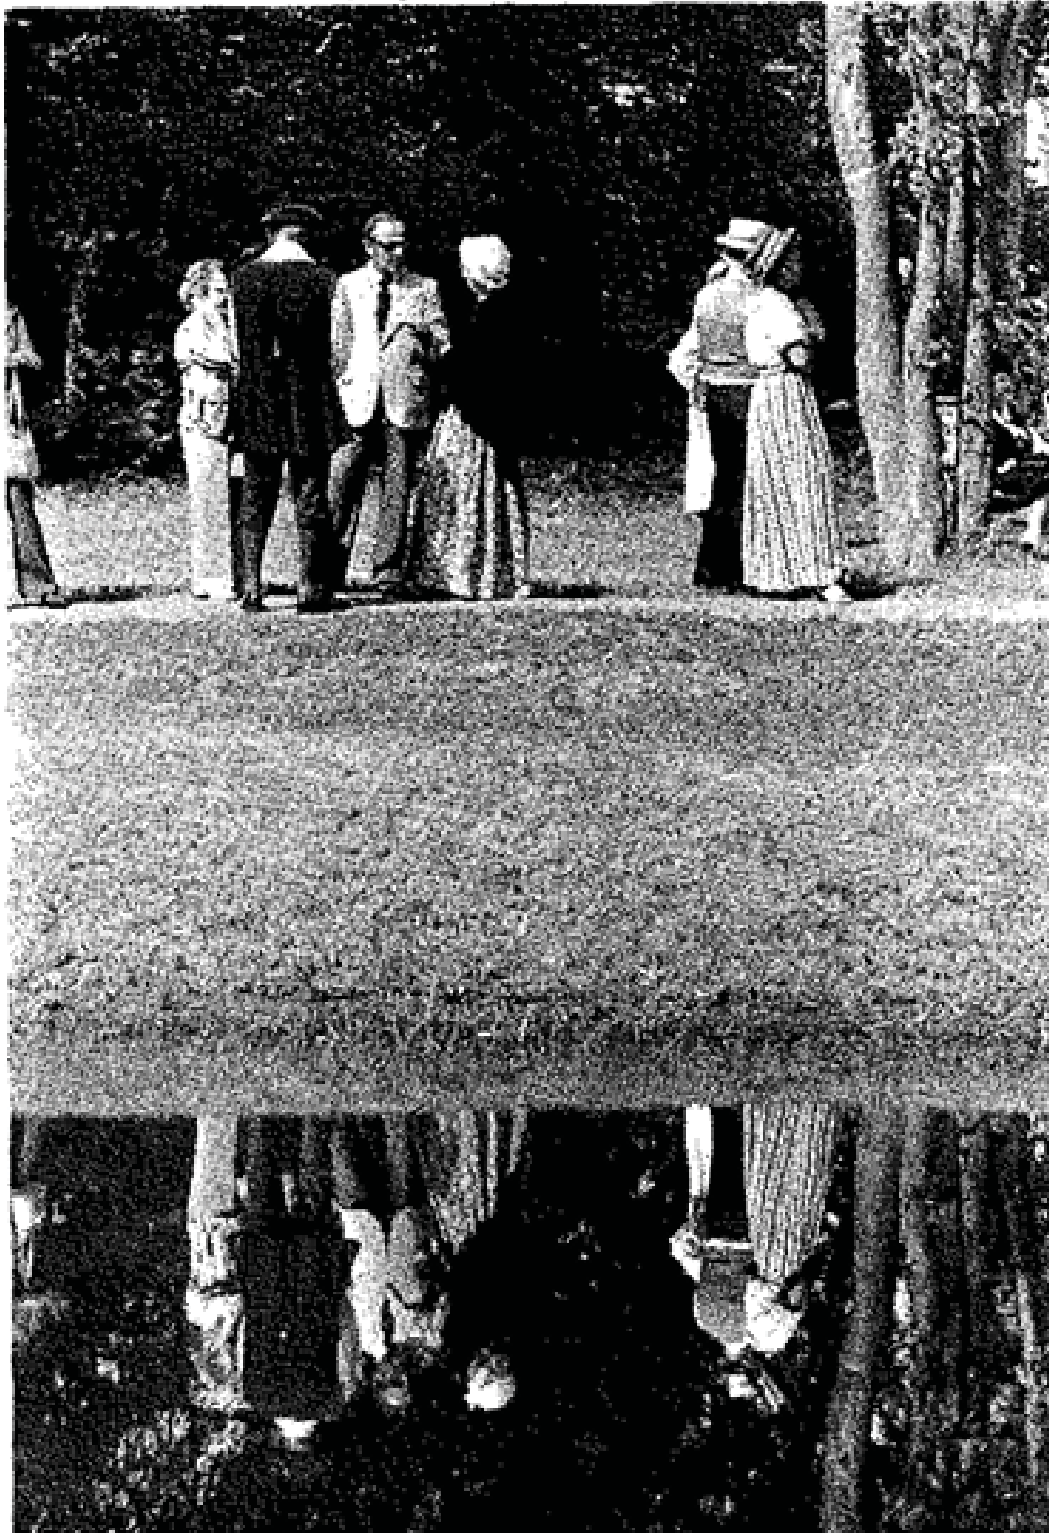
Figure 7.2-63. Reproduction of a Sudbury Town Crier photograph in the 1975 Town Report shows people gathered on a gravel path near Cricket Pond at the dedication of Heritage Park. Some women appear to wear colonial-era attire. Mown turf extends to the edge of the pond.

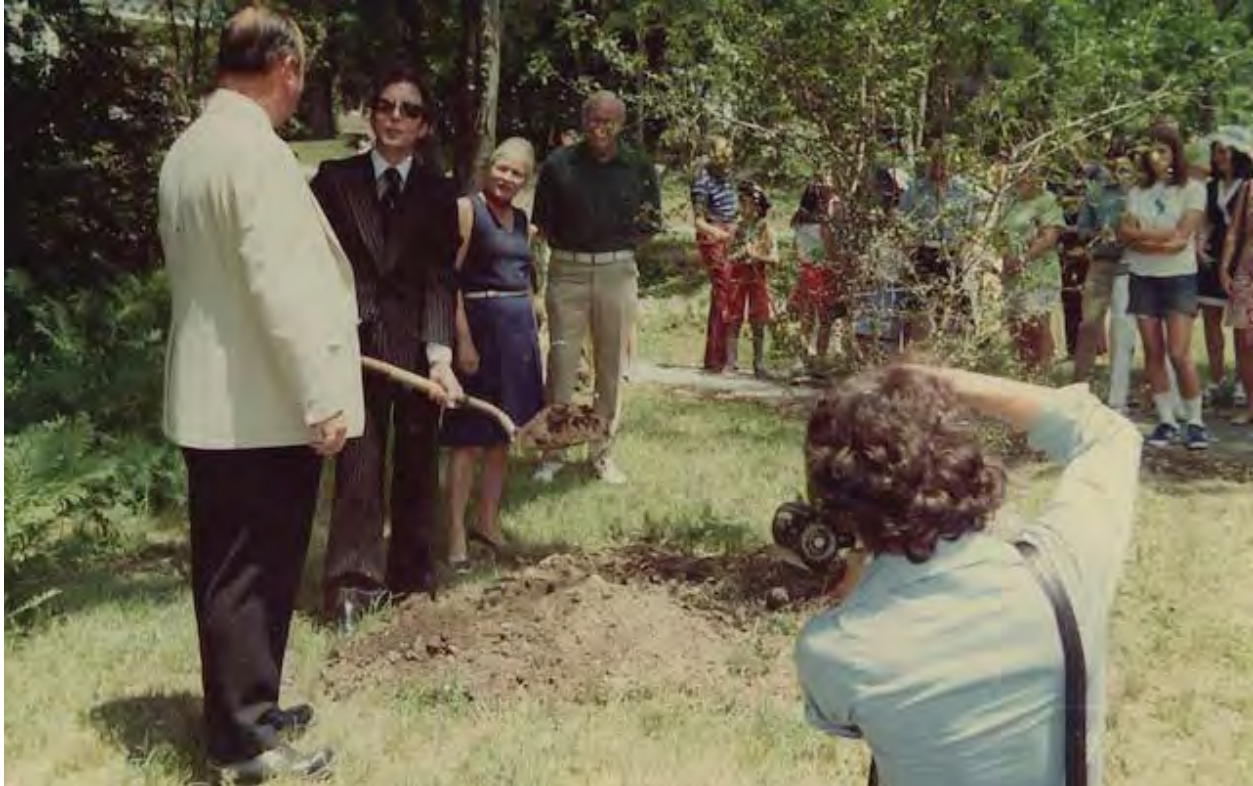
Figure 7.2-64. Photograph of John C. Powers (left in white) and Anthony Moore, Mayor of Sudbury in Suffolk, England (right, holding shovel) at a ceremonial tree planting during the dedication of Heritage Park in 1975. Courtesy Sudbury Historical Society.

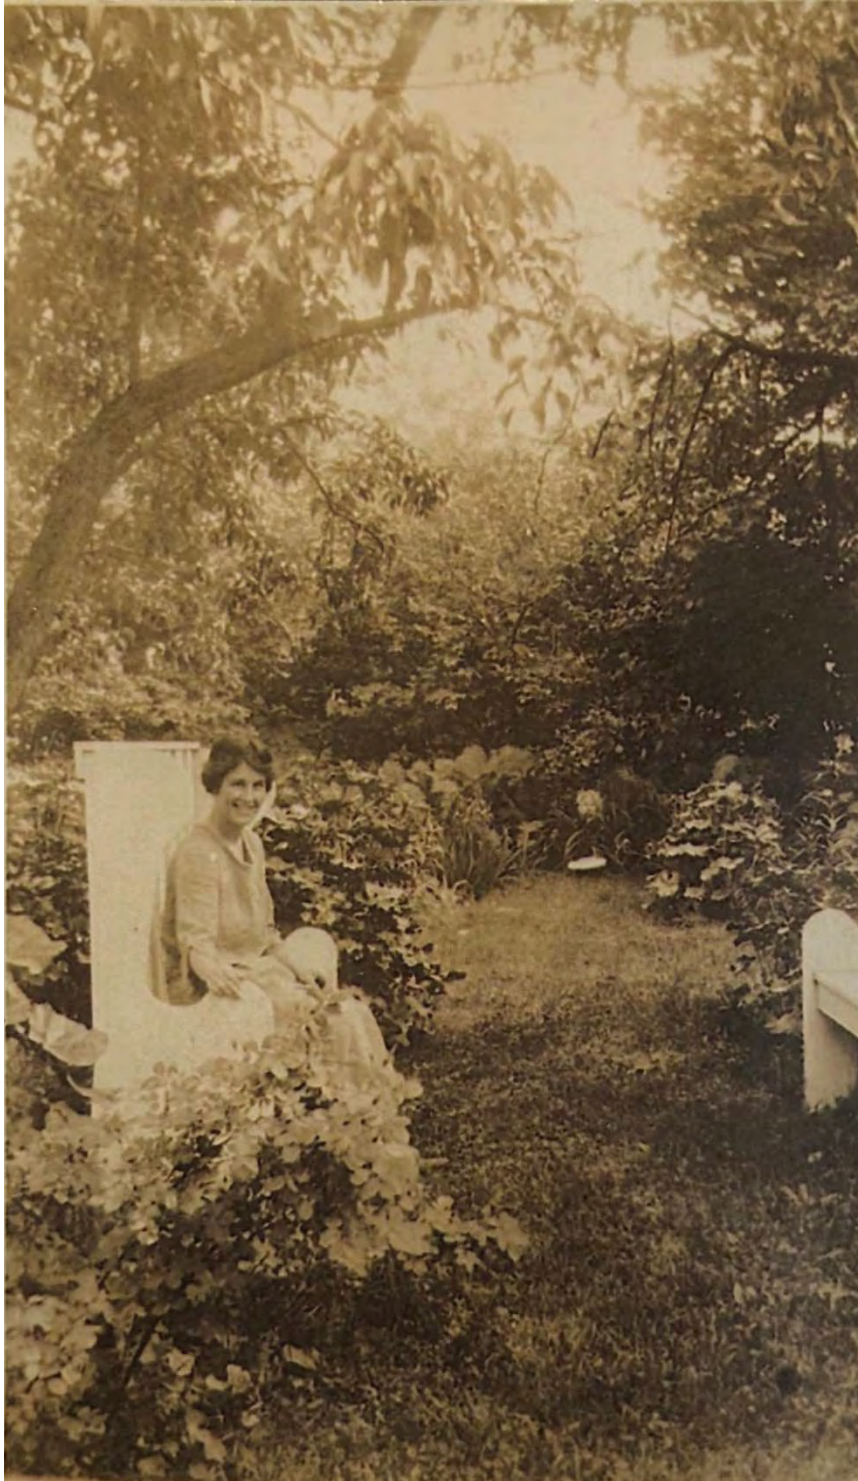
Figure 7.2-65 Volunteer docent Harriet Ritchie sits on one of the high-backed garden benches, with the second bench opposite in this undated circa 1983 to 1999 photograph. Trees behind each bench form a loose arch overhead. The benches frame a mown turf axial walk that is bordered by what appears to be a well-tended flower plant border. Courtesy Hosmer House Collections.

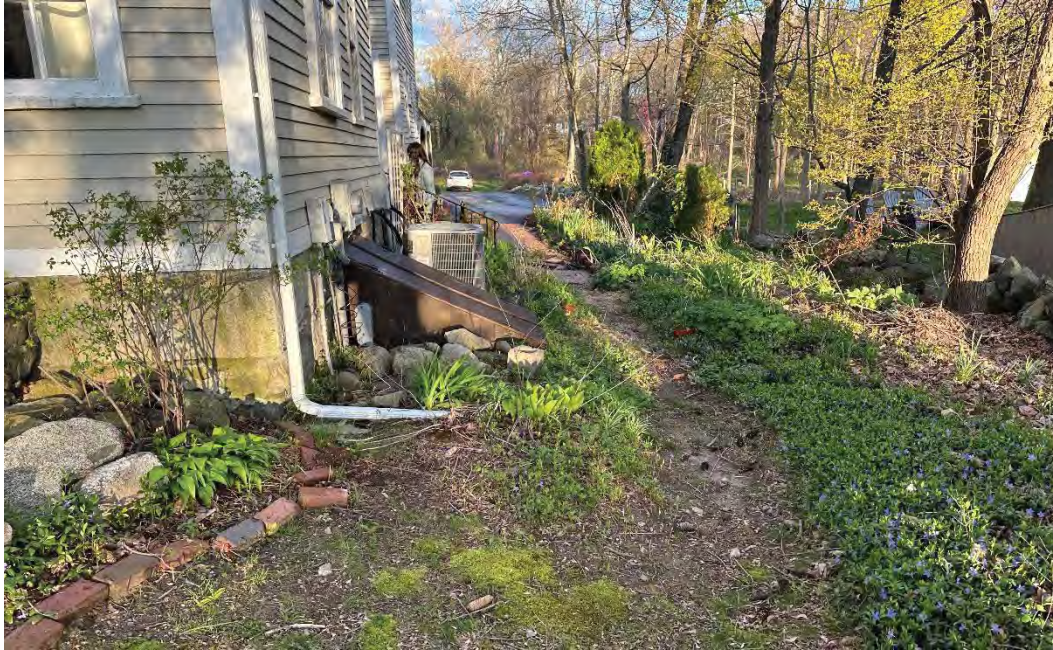
Figure 7.3-3 View along the south side of the Hosmer House. A worn dirt path leads around the southwest corner and meets a partial brick walk, which continues to the end of the driveway. A line of mature deciduous trees, along with a stone wall and fence, divide the property from the neighboring residence. HL 2024.

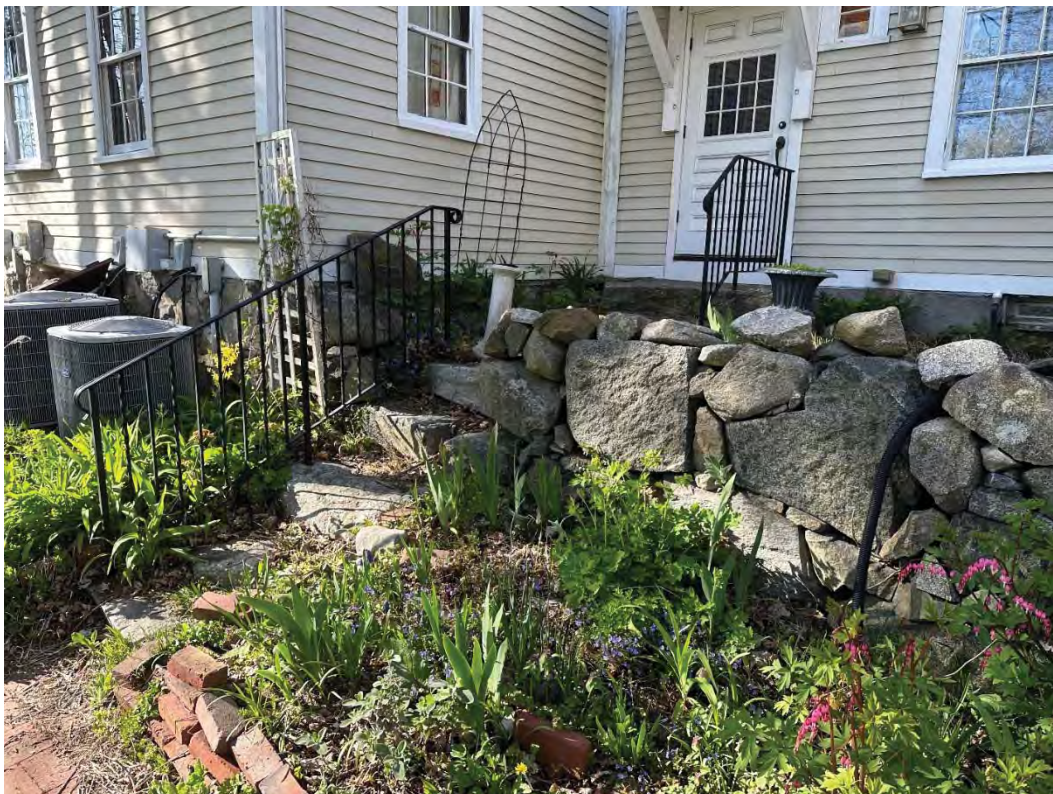
Figure 7.3-4 The raised courtyard set between two building appendages on the south side of the Hosmer House. The door on the left leads into the entry hallway and a door to the right opens into the kitchen. HL 2024.

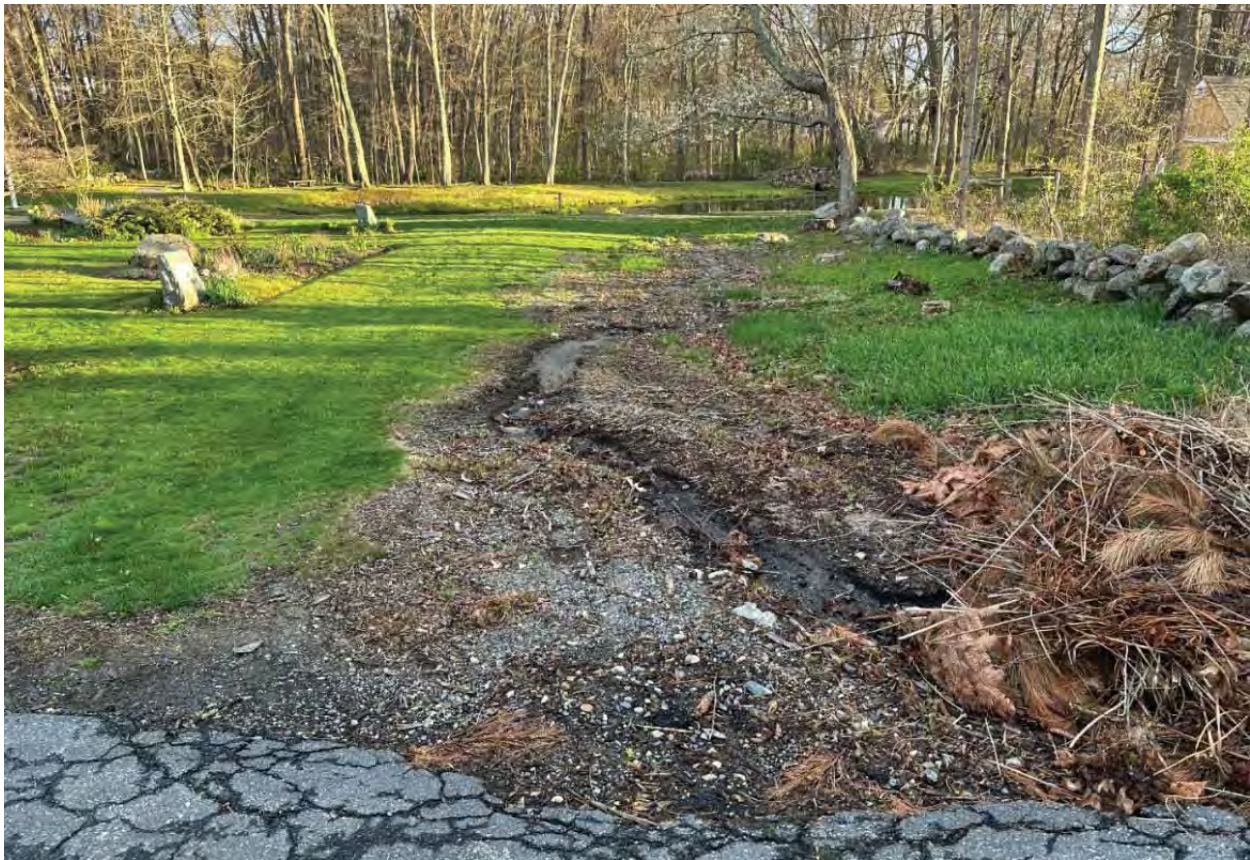
Figure 7.3-8 Soil washout and erosion extending downslope from the edge of the asphalt driveway and parking area. HL 2024.

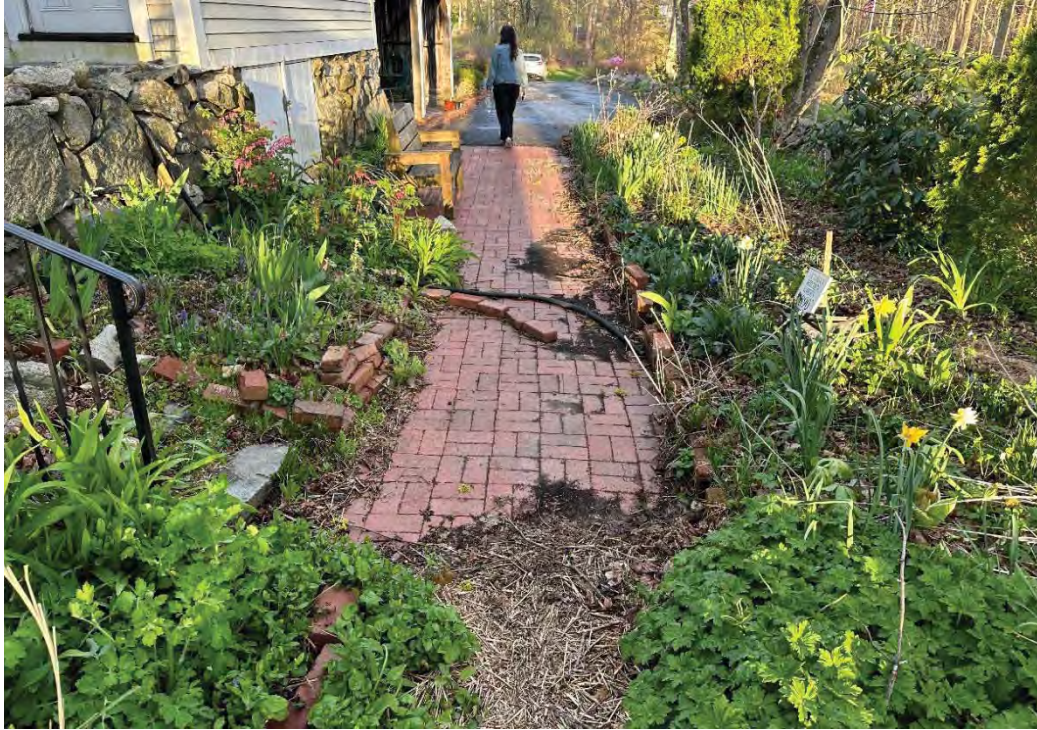
Figure 7.3-14 Mixed beds flank the sides of a partial and deteriorated brick walk stone wall and stone steps in the South Yard. To the south (right) are redbud, rhododendron, arborvitae, strawberries, dill, phlox, iris, daylily, daffodil mayapple, and periwinkle. To the north (left) a bed against the base of the stone wall bed features bleeding heart, celandine, iris, yucca, dock, sage, and lungwort. HL 2024.

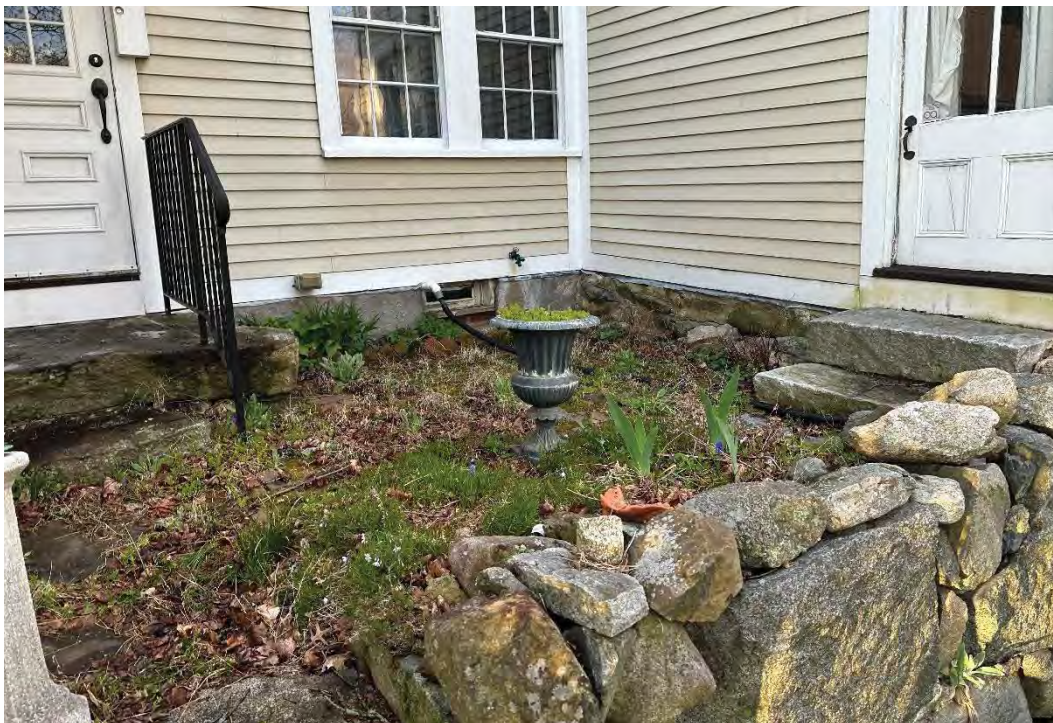
Figure 7.3-15 The raised courtyard is flanked by two pairs of granite steps, a mosaic flagstone walk and small perennial plants bleeding heart, lily, sedum, hosta, mint, iris, periwinkle, and more. HL 2024.

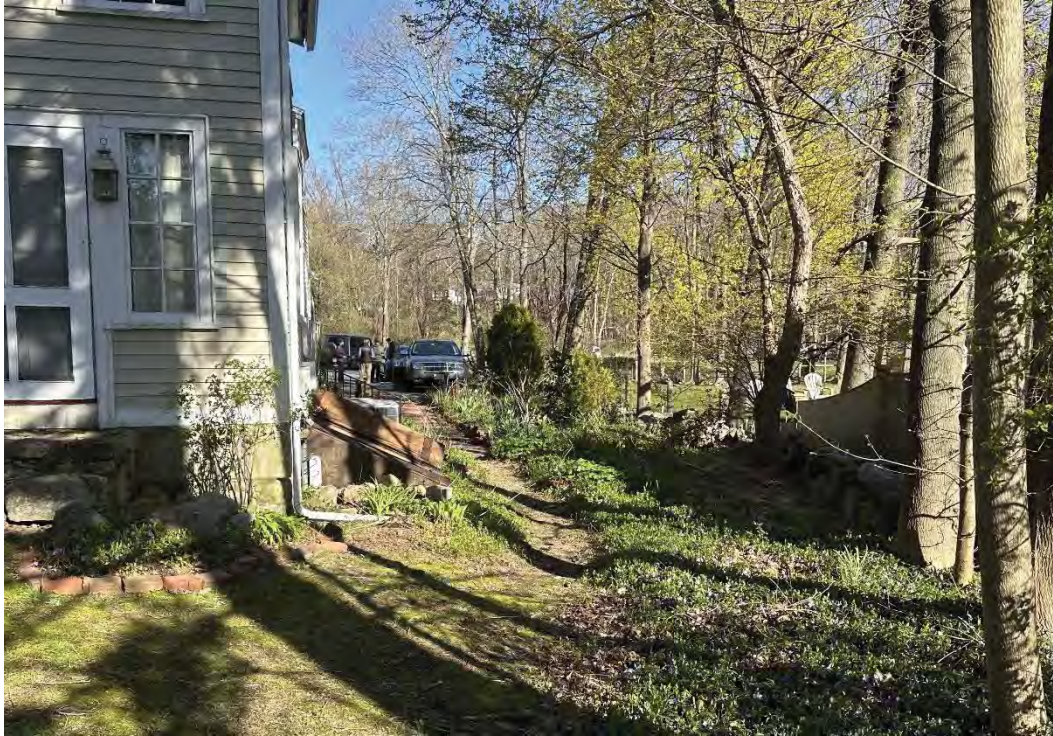
Figure 7.3-16 Foundation plantings around the cellar door and the southwest corner of the house comprise periwinkle, celandine, a cherry seedling, false phlox, sedum, and mayapple. Beds framing the steps to the apartment contain bridalwreath, Hosta, periwinkle, lily of the valley, and ferns. HL 2024.

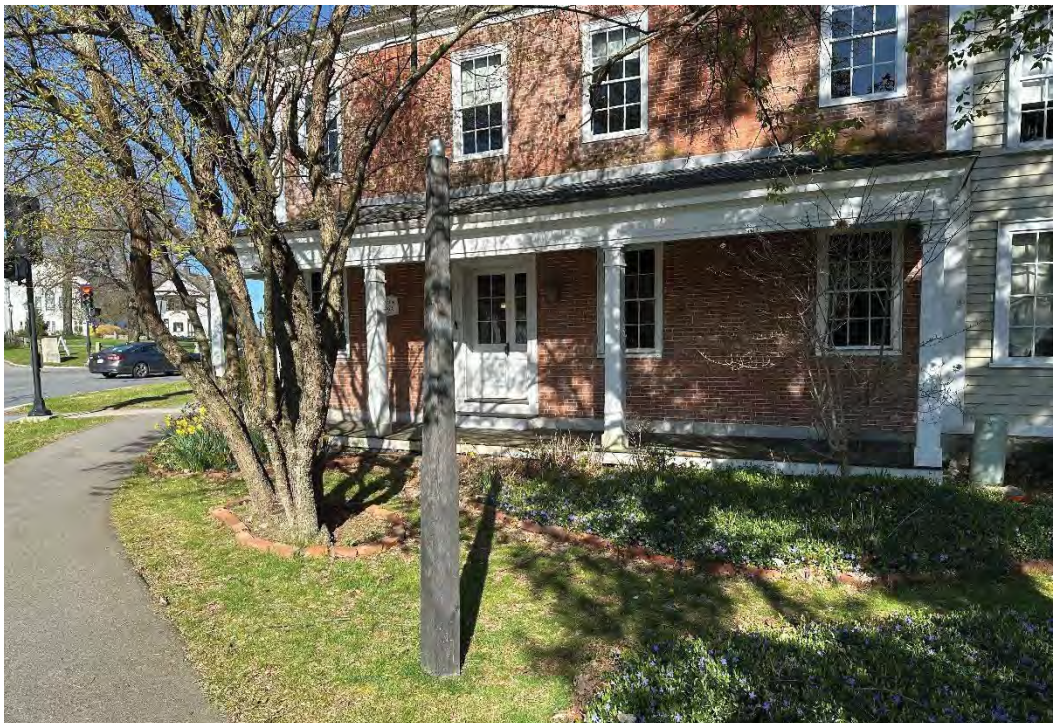
Figure 7.3-17 Planted beds of the West Yard include daffodils, daylilies, shrub and tree forms of hydrangea, azalea, English ivy, periwinkle, and two mature Japanese tree lilacs. A wood lamp post without a lantern appears in the foreground. HL 2024.

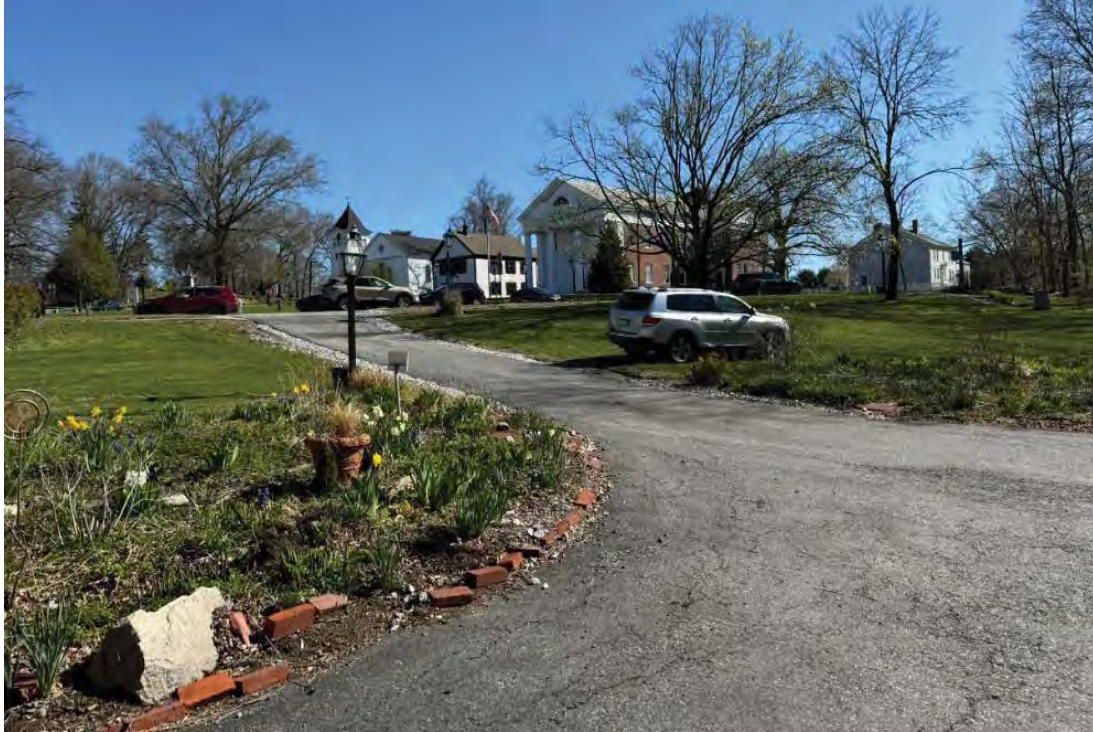
Figure 7.3-18 The asphalt driveway enters from Old Sudbury Road and proceeds south down the gentle slope, where it splits into two parking areas: one facing Heritage Park and the other alongside the Carriage House. One lamppost is visible. HL 2024.

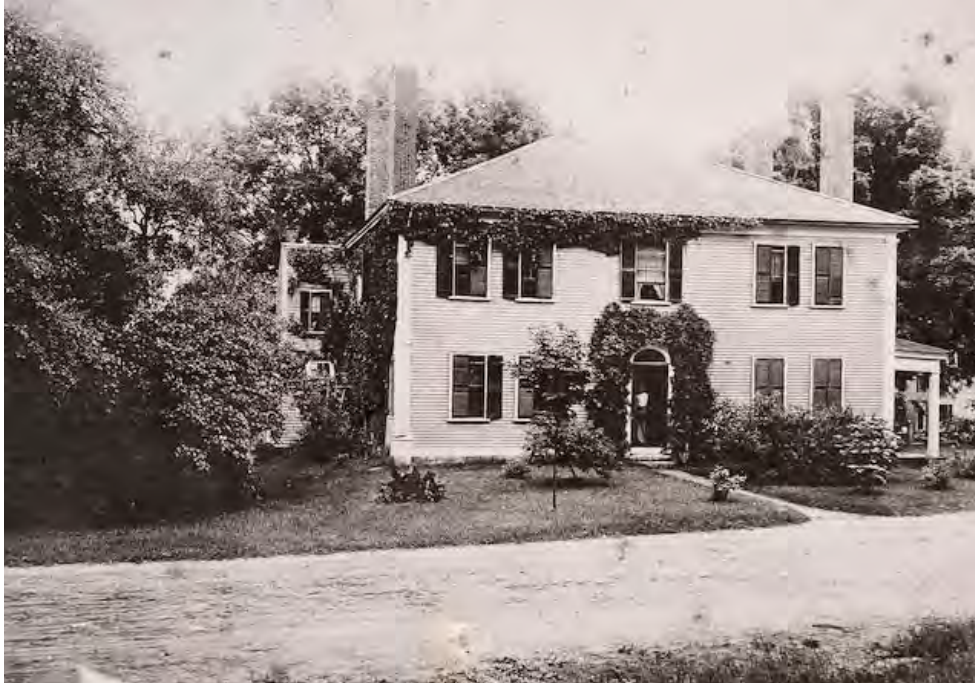
Figure 7.5-1a. Circa 1900 photograph of the North Yard captures shrubs and small trees in lawn on either side of the entry walk, as well as ivy on the façade and a tall shrub mass obscuring views of the East Yard. Courtesy Sudbury Historical Society.

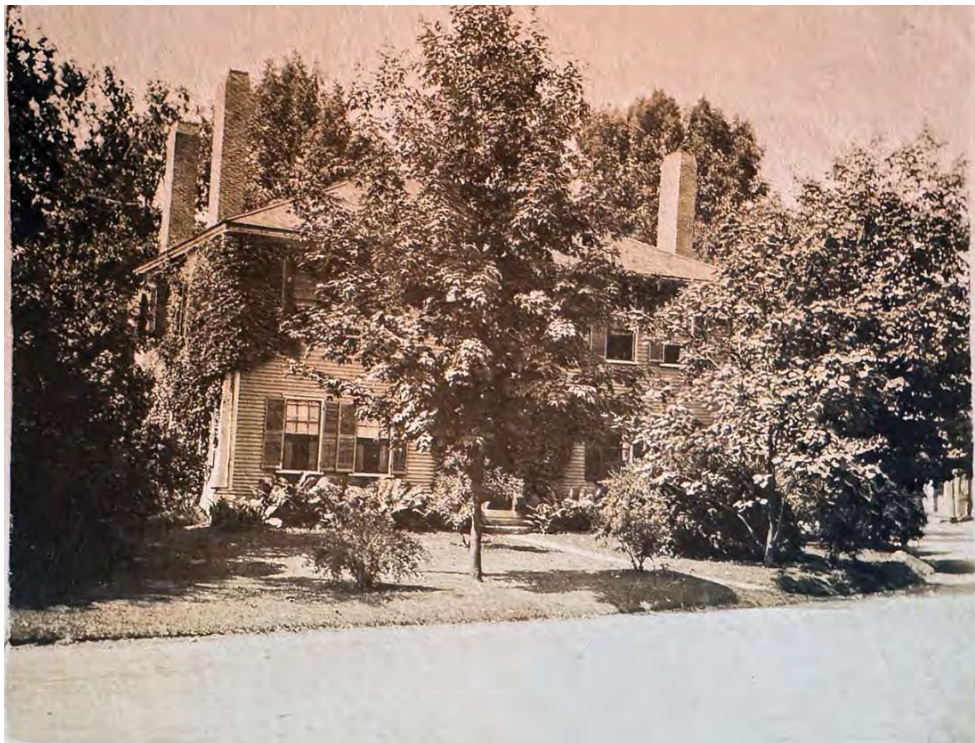
Figure 7.5-1b. This undated photograph shows larger plantings in the North Yard perhaps 15 years later. Shrubs and trees have grown to partially obscure the north façade. Ostrich ferns line the foundation, and vines climb the hose façades. Courtesy Hosmer House Collections.

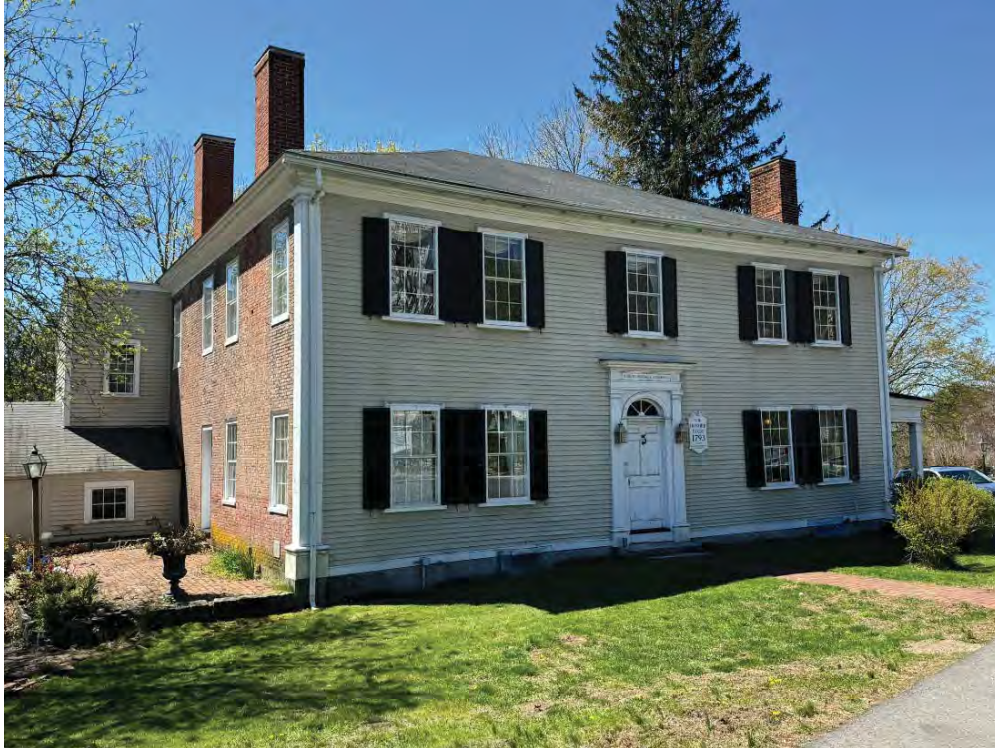
Figure 7.5-1c. The North Yard displays limited plantings today, with three bridal-wreath shrubs to the wet of the front door paths. No north façade vines, trees or individual shrubs are seen. The ground plane is covered with mown turf. The lack of street front trees may be due to road widening. HL 2024.

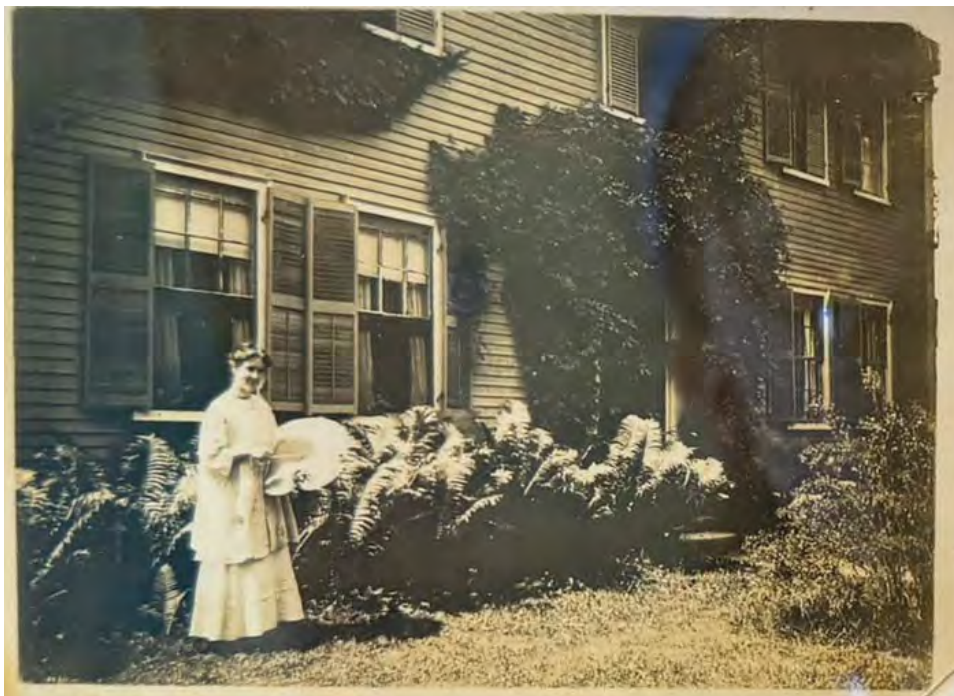
Figure 7.5-2a. 1910s photograph of Florence Hosmer in the North Yard. Note the ivy on the north façade and the tall ostrich ferns along the foundation. The shrub at the right side of the image, possibly bridal-wreath, exhibits an arching form. Courtesy Hosmer House Collections.

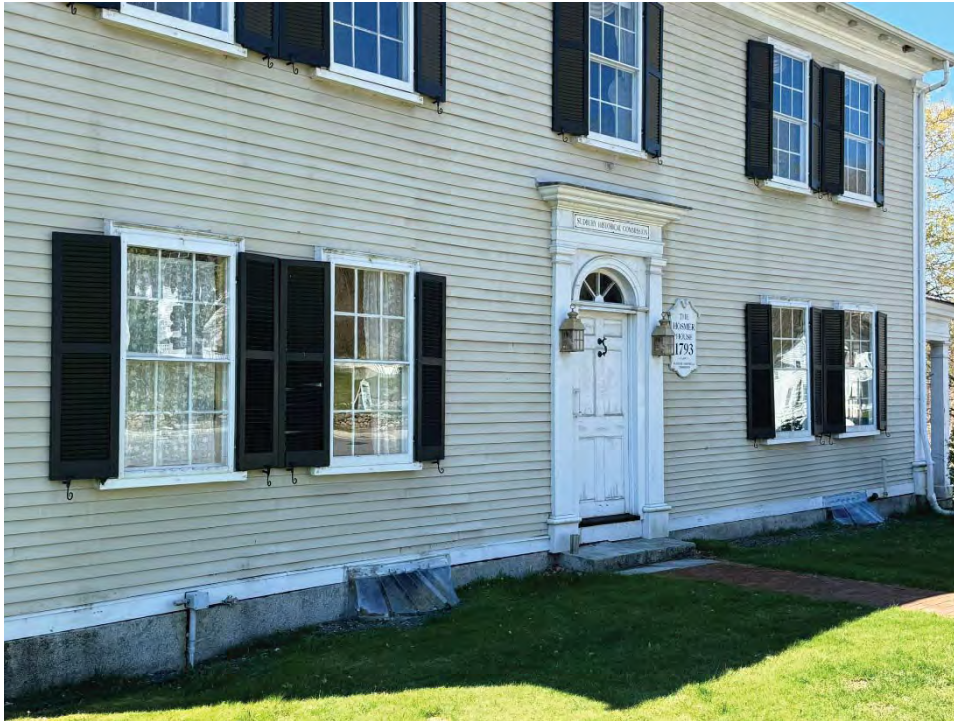
Figure 7.5-2b. Similar oblique view of the north façade shows no foundation plantings today. A thin strip of gravel divides the foundation from the lawn. HL 2024.

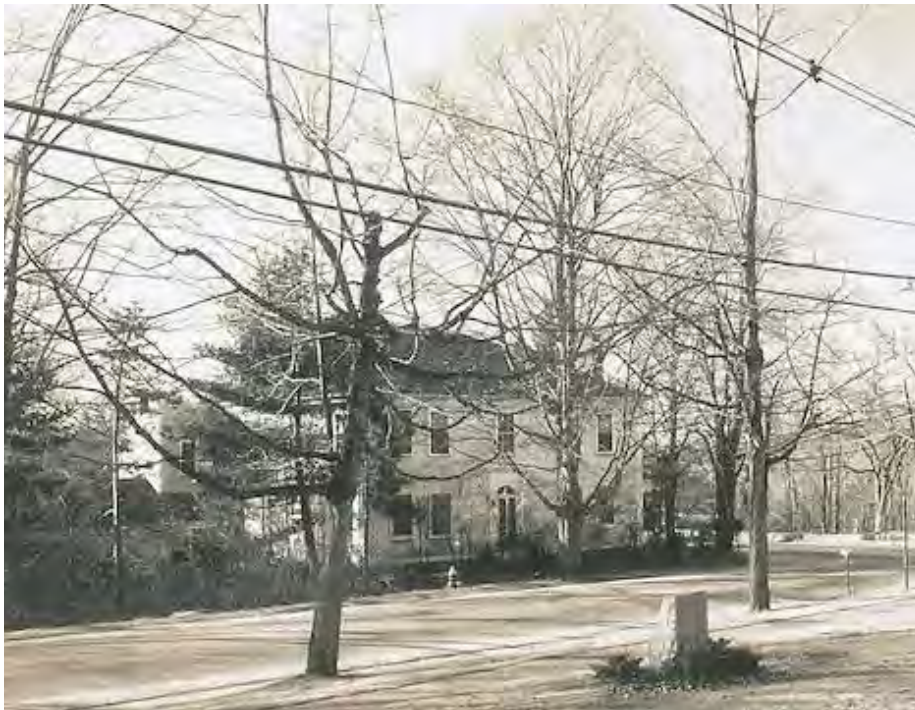
Figure 7.5-3a. This detail of a circa 1970 photograph shows a view of the Hosmer House from the north side of Old Sudbury Road. Woody shrubs screen the East Yard and north façade. Mature deciduous trees stand at the north façade, northwest corner, and the west façade. Tall pine trees are present in the East Yard. Courtesy Sudbury Historical Society.

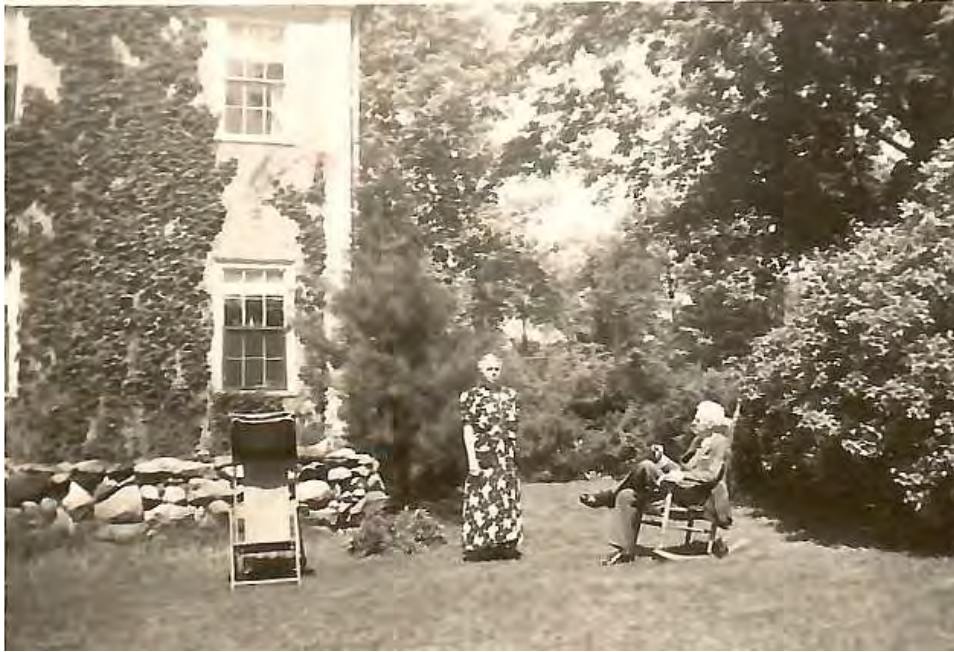
Figure 7.5-6a. This undated photograph captures the transition between the North and East Yards. The retaining stone wall of the east patio appears on the left side of the image. Dense shrubs and trees obscure Old Sudbury Road, to the right, and the North Yard in the background. Courtesy Hosmer House Collections.

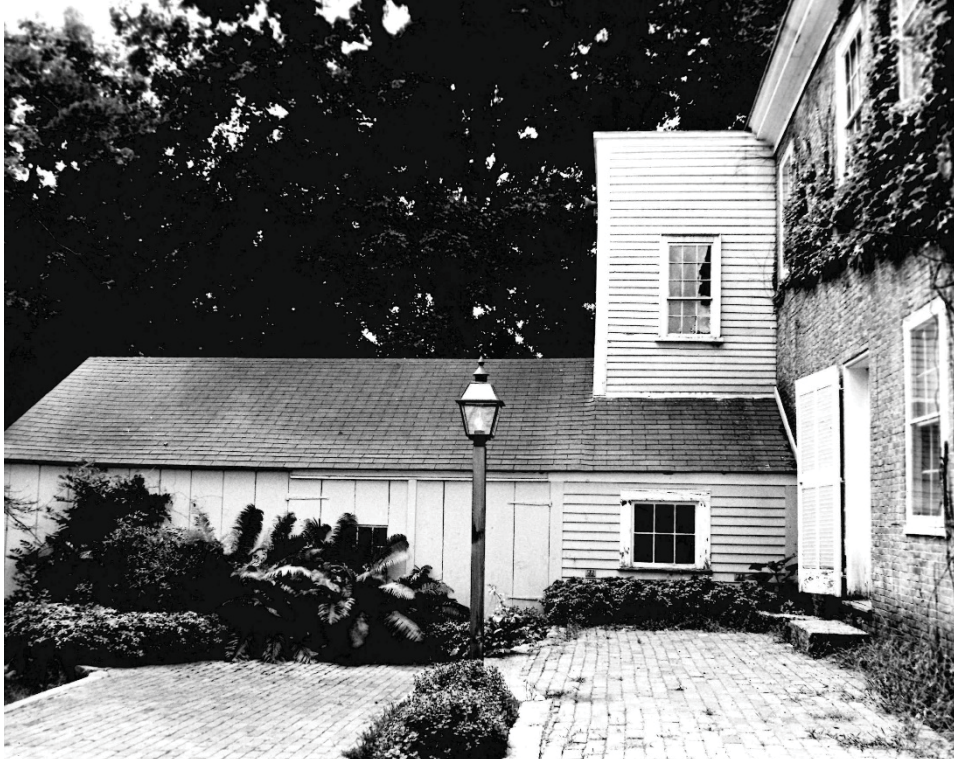
Figure 7.5-8a. South-facing 1983 capture shows both levels of the brick-paved east patio. Tall ostrich ferns and other foundation plantings line the north side of the Carriage House. Planted beds divide the two patio levels. A lantern lamp post stands beside the steps that descend from the upper patio level to the lower level. Courtesy Town of Sudbury Archives.

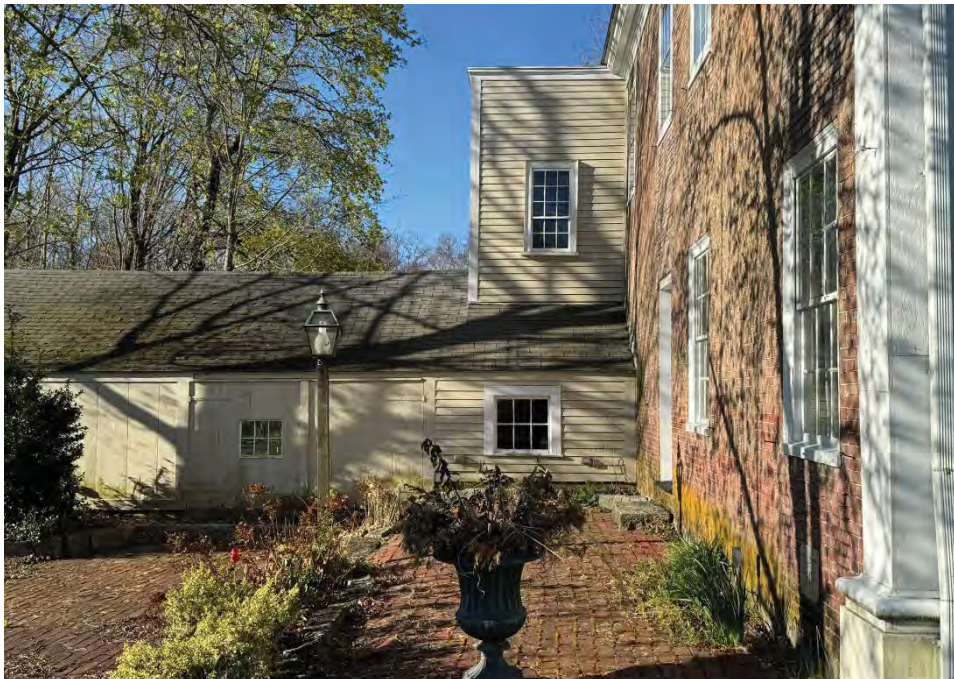
Figure 7.5-8b. Repeat view in 2024 shows the Hosmer House and Carriage House relatively unchanged. HL 2024.

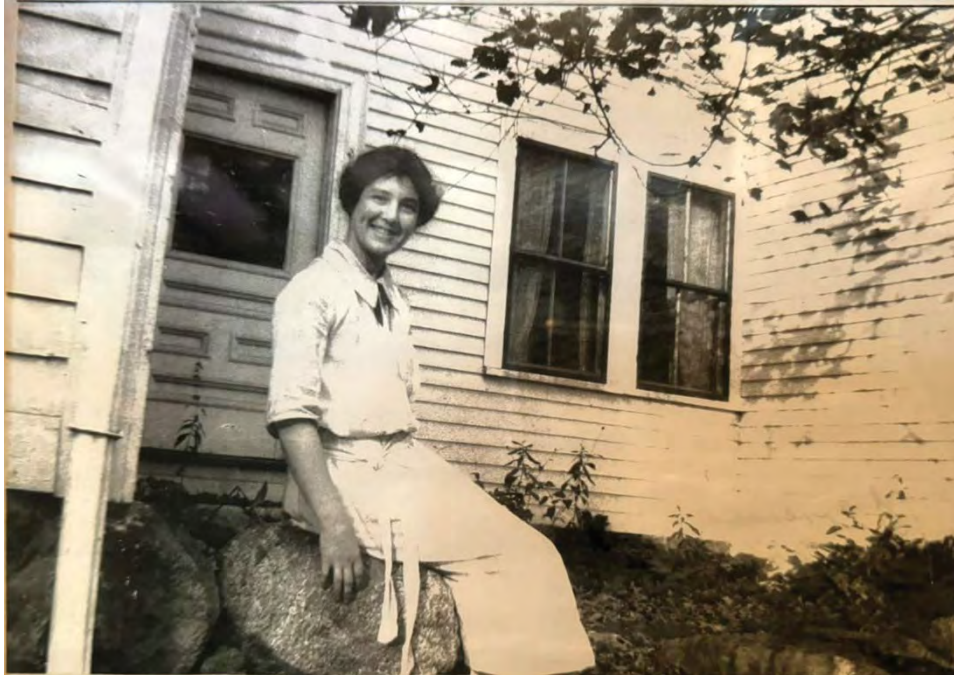
Figure 7.5-17a. This undated photograph of Florence Hosmer seated on a retaining wall boulder at the raised courtyard shows a few plantings along the house foundation and the overarching tree canopy. Courtesy Hosmer House Collections.

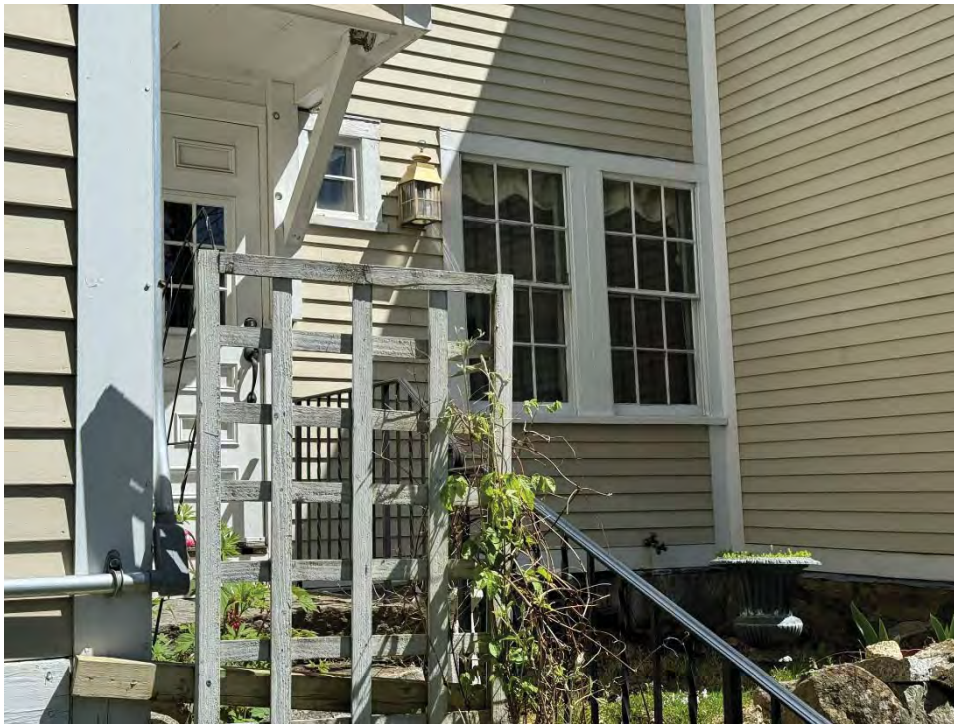
Figure 7.5-17b. Current view of the raised courtyard captures a white wooden trellis against the retaining wall, as well as safety railings along the steps to the courtyard and to the door. An urn planter sits in the courtyard, which features mixed species groundcover over and between flagstone paving. HL 2024.

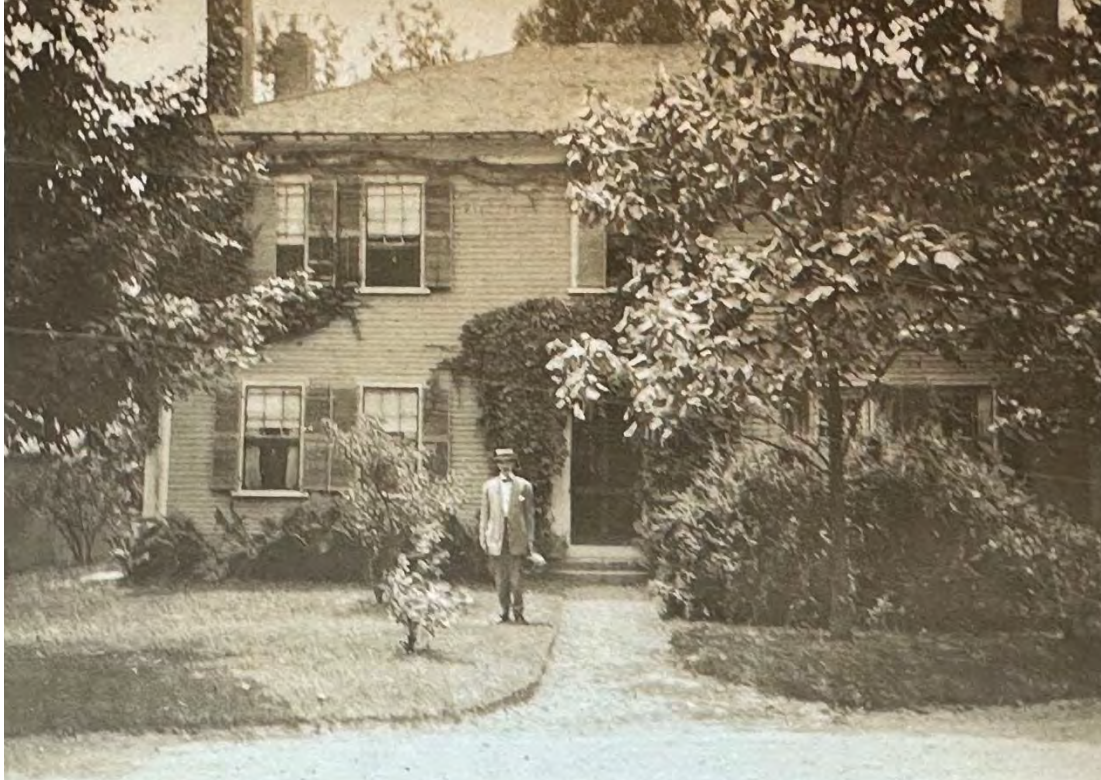
Figure 7.9-3 An undated photograph captures plantings in the North Yard, including ferns along the house foundation, shrubs of varying height, and young deciduous trees. Courtesy Hosmer House Collections.

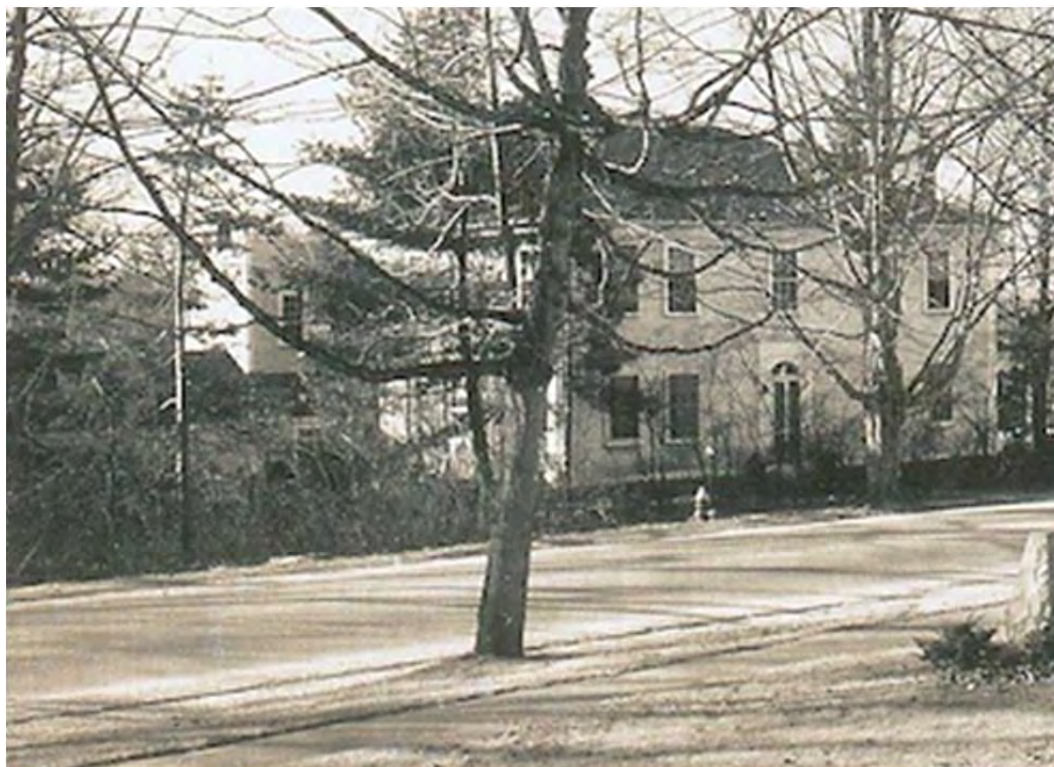
Figure 7.9-4 Detail of a circa 1970 view toward the Hosmer House from Sudbury Common. On the left side of the image, the lilac hedge lines the Hosmer property boundary along Old Sudbury Road. Courtesy Sudbury Historical Society.
