HOSMER HOUSE

HISTORIC STRUCTURE REPORT / CULTURAL LANDSCAPE REPORT

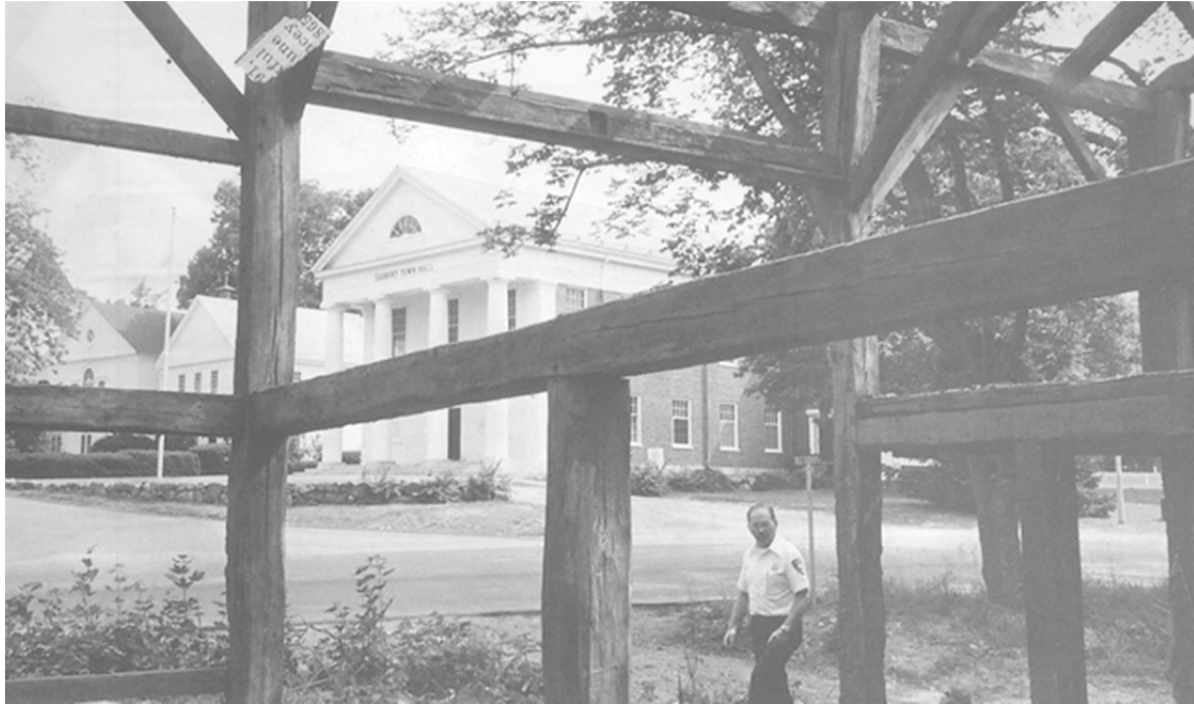
Figure 7.9-6 Circa 1970s photograph captures the spatial relationship between the Barn, reduced to a timber frame, and the edge of Old Sudbury Road in the background. Courtesy Sudbury Historical Society.

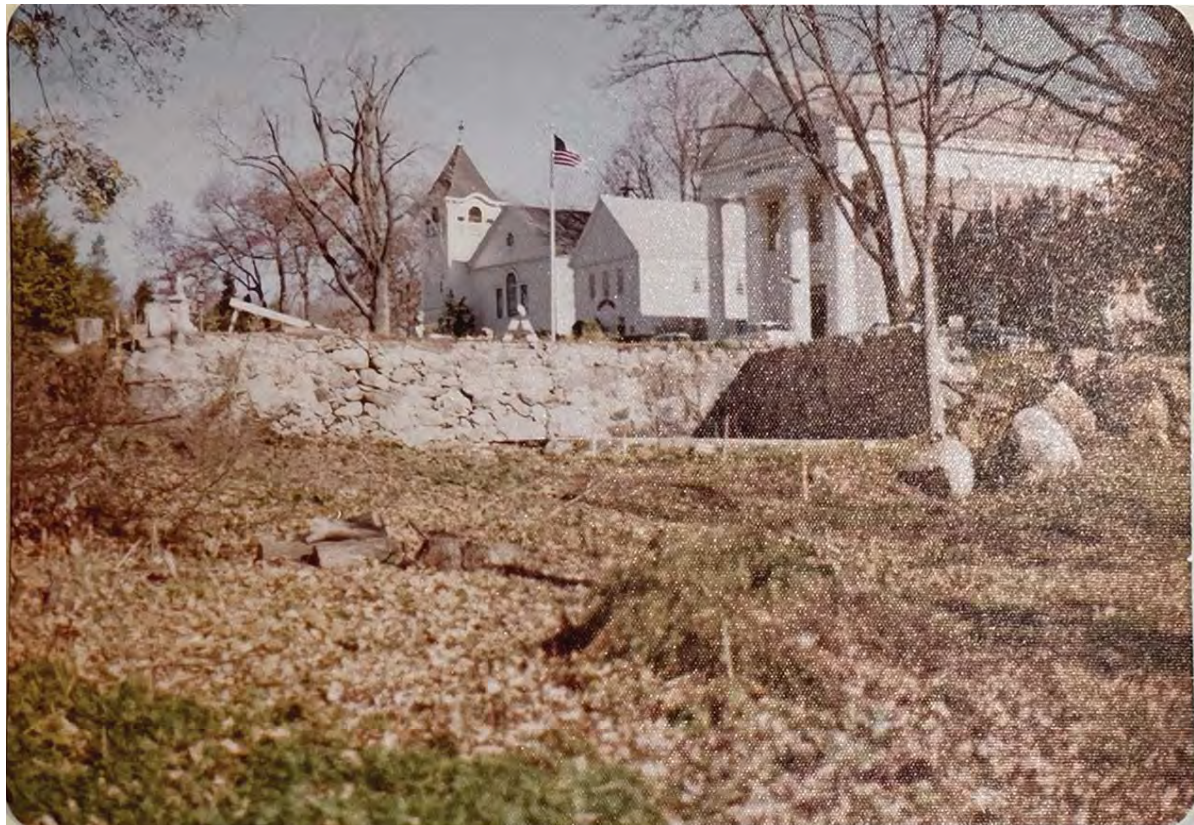
Figure 7.9-7 Circa 1970s view of the barn foundation. Courtesy Sudbury Historical Society.

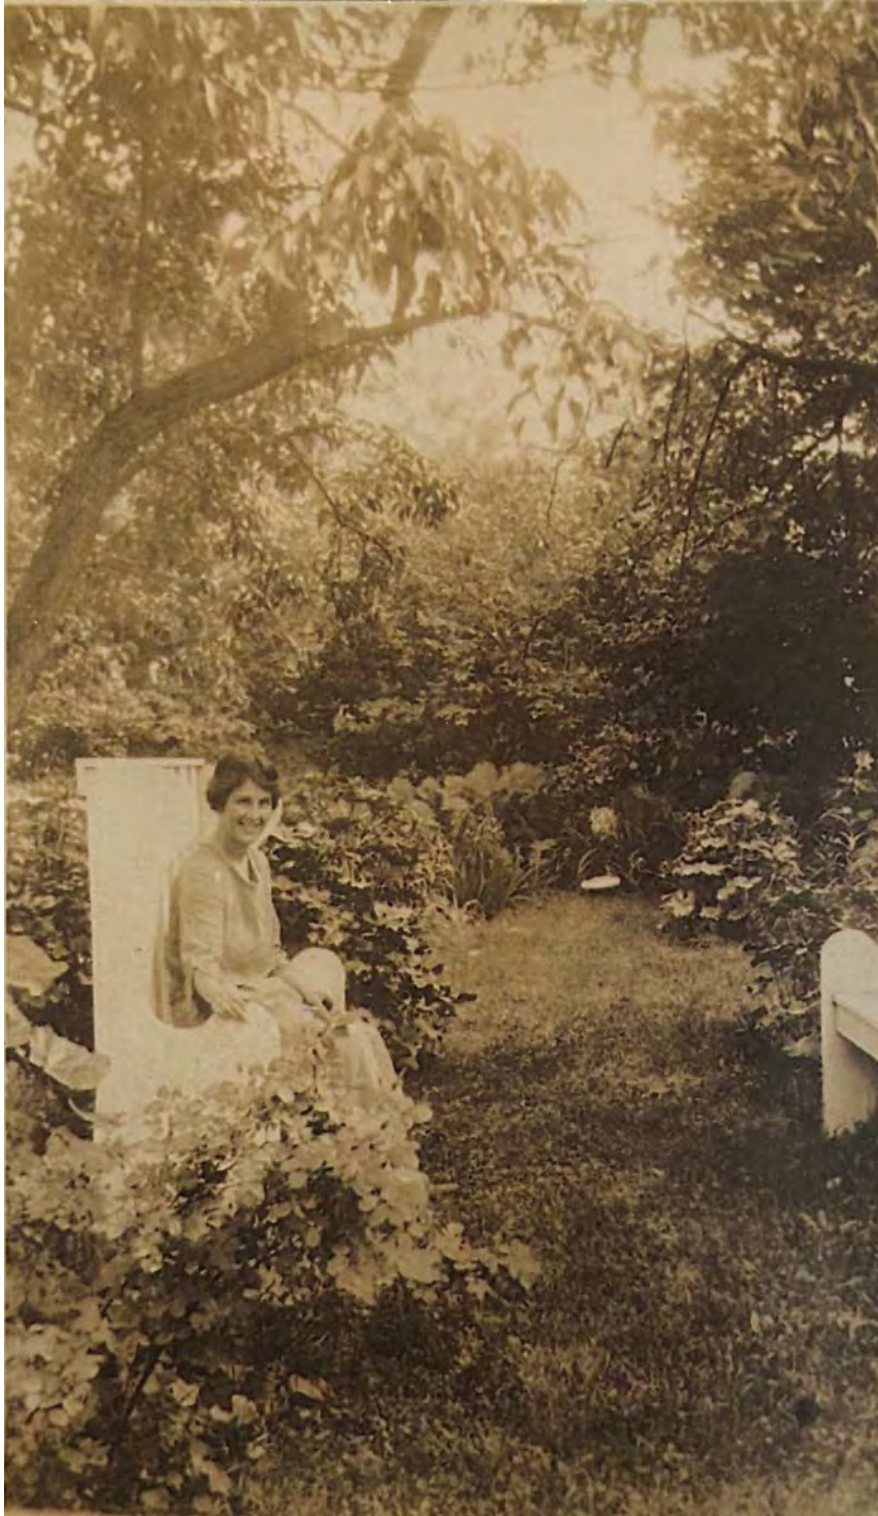
Figure 7.9-11 Circa 1983-99 photograph of volunteer docent Harriet Ritchie seated on one of the high-backed garden benches, with the second bench opposite. Trees behind each bench form a loose arch overhead. The benches frame a mown turf axial walk that is bordered by a flowering border. Courtesy Hosmer House Collections.

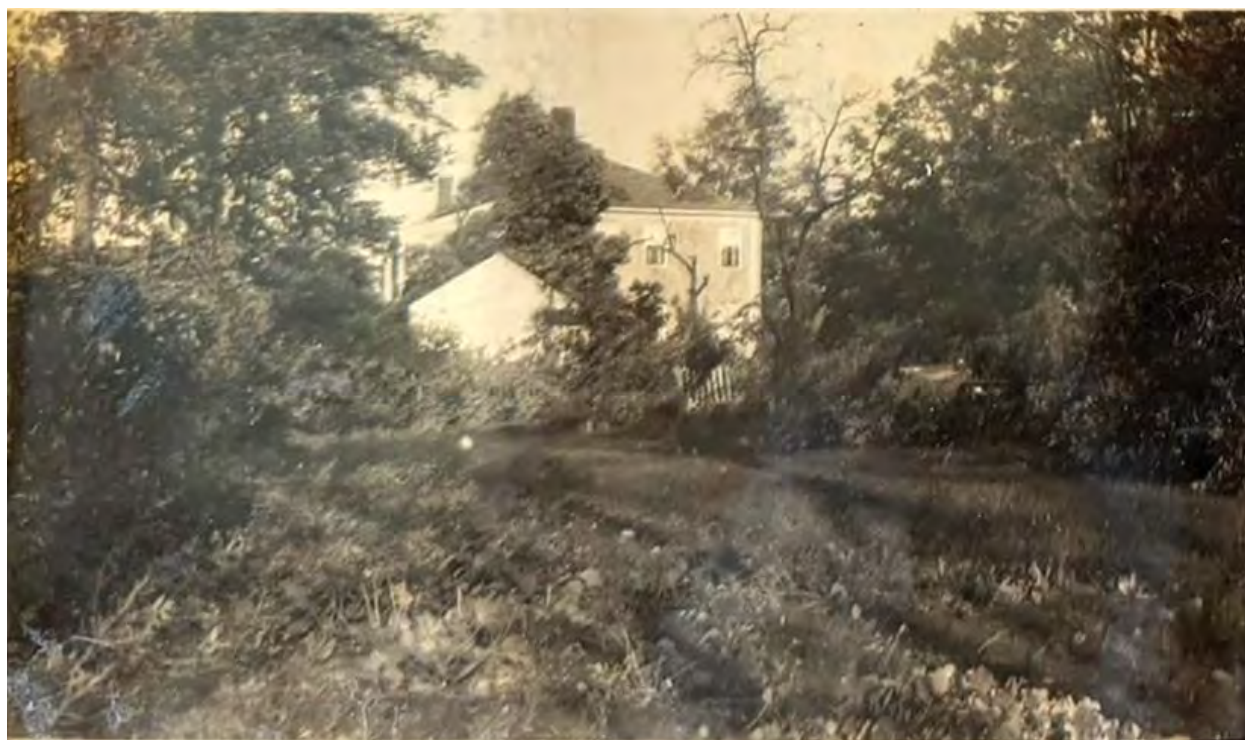
Figure 7.9-12 Undated photograph captures the landscape east of the Carriage House, with an open area of irregular turf in the foreground framed by mixed vegetation on both sides. The existing drive and parking area today is located roughly where the vertical slats of the white high-backed bench appear in the midground of this image. Courtesy Hosmer House Collections.

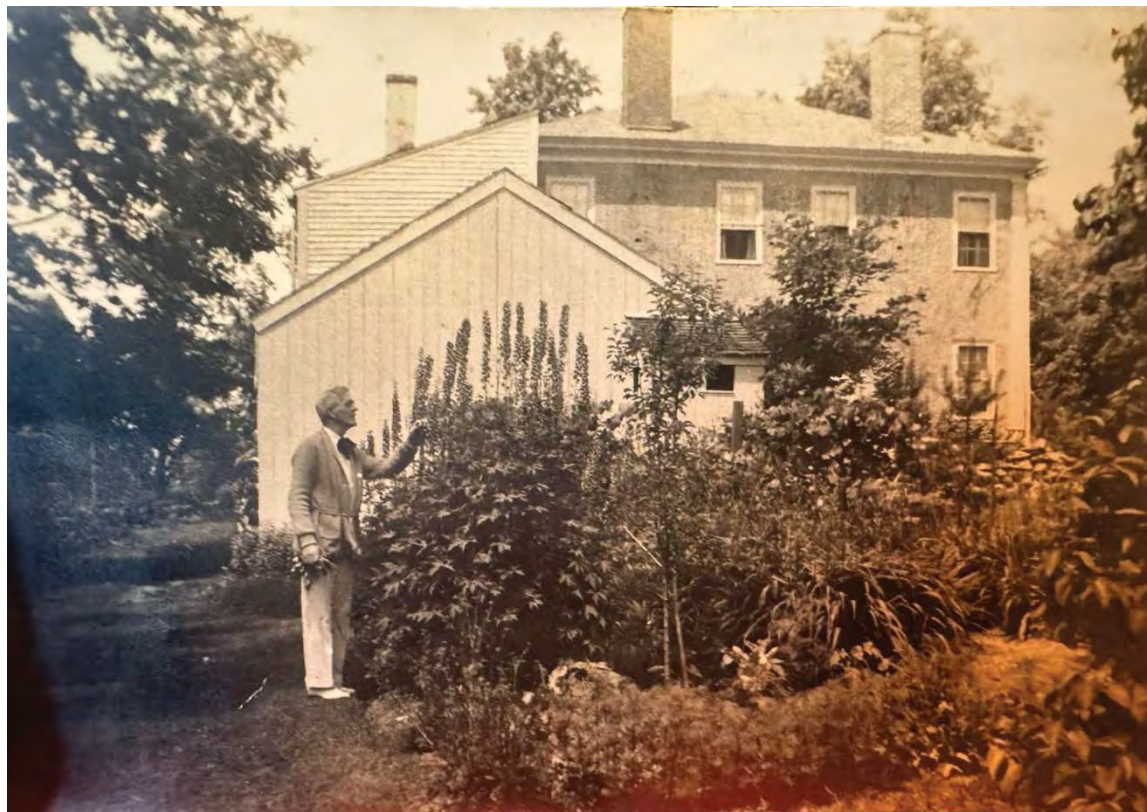
Figure 7.9-13 1940 photograph of Burt Hosmer standing beside the Fairy Garden. The garden is contained within a defined bed, distinct from the turf lawn where Burt stands, although the exact shape and dimensions of the garden cannot be determined from this image. The Fairy Garden includes tall delphinium, daylily, and other perennials. Young deciduous and pine trees appear on the north side of the bed. An open grassy area extends along the south side of the Carriage House. An edge of turf grass in the foreground, at the lower right corner of the image, could indicate a path through the garden bed or mark the end of the Fairy Garden. Courtesy Hosmer House Collections.

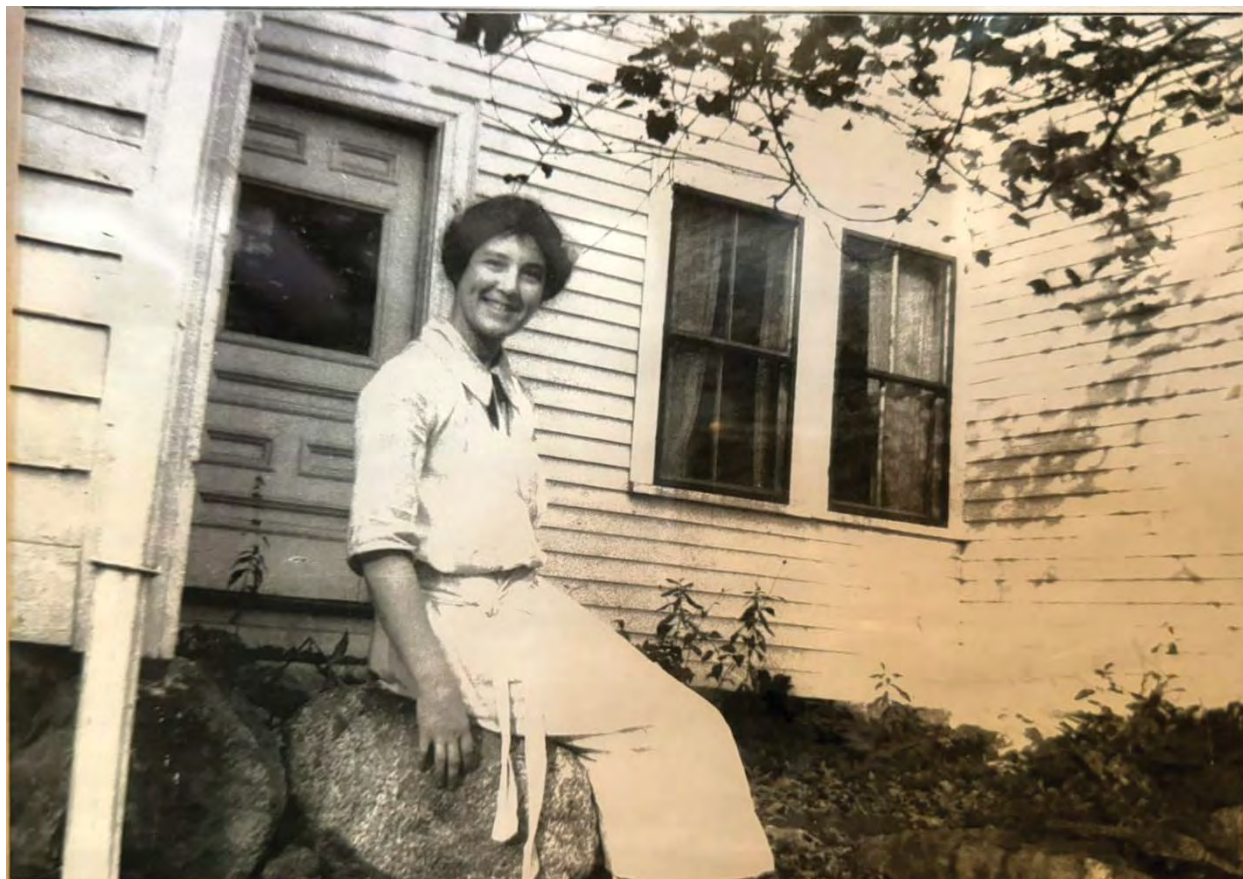
Figure 7.9-14 Undated photograph of Florence Hosmer seated on the stone retaining wall of the raised courtyard on the south side of the Hosmer House. Courtesy Hosmer House Collections.

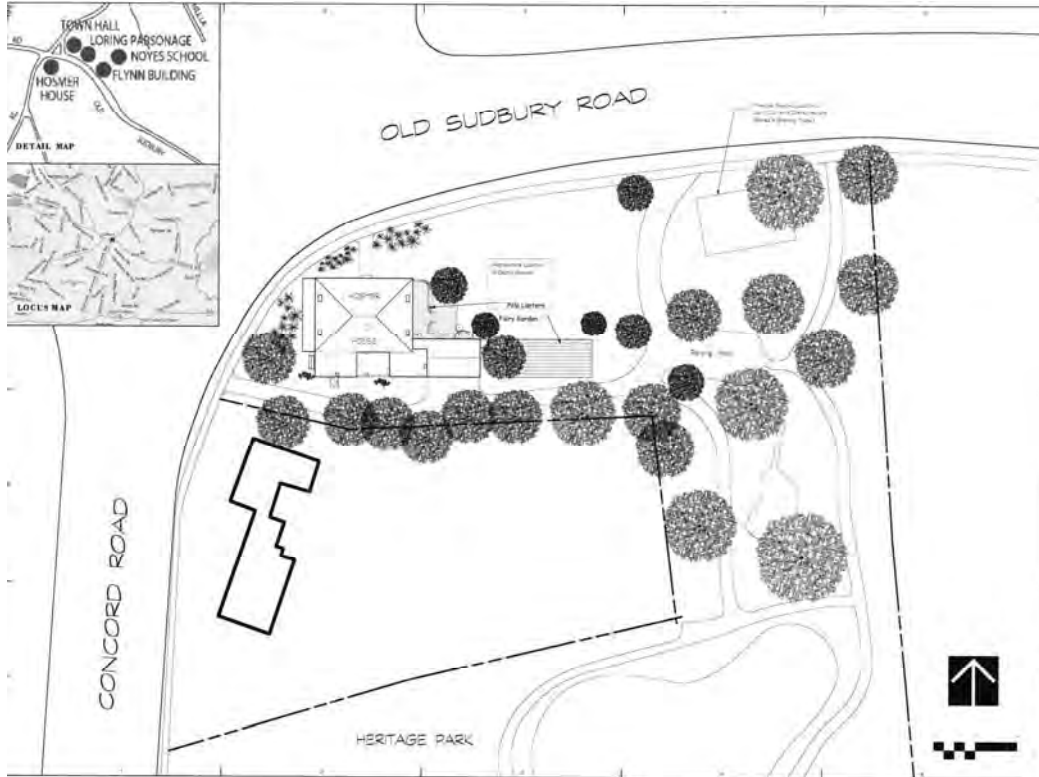
Figure 8.1-1
Site Plan of Hosmer
House (Existing
Conditions Survey-
Latady Design
Associates, 2004)

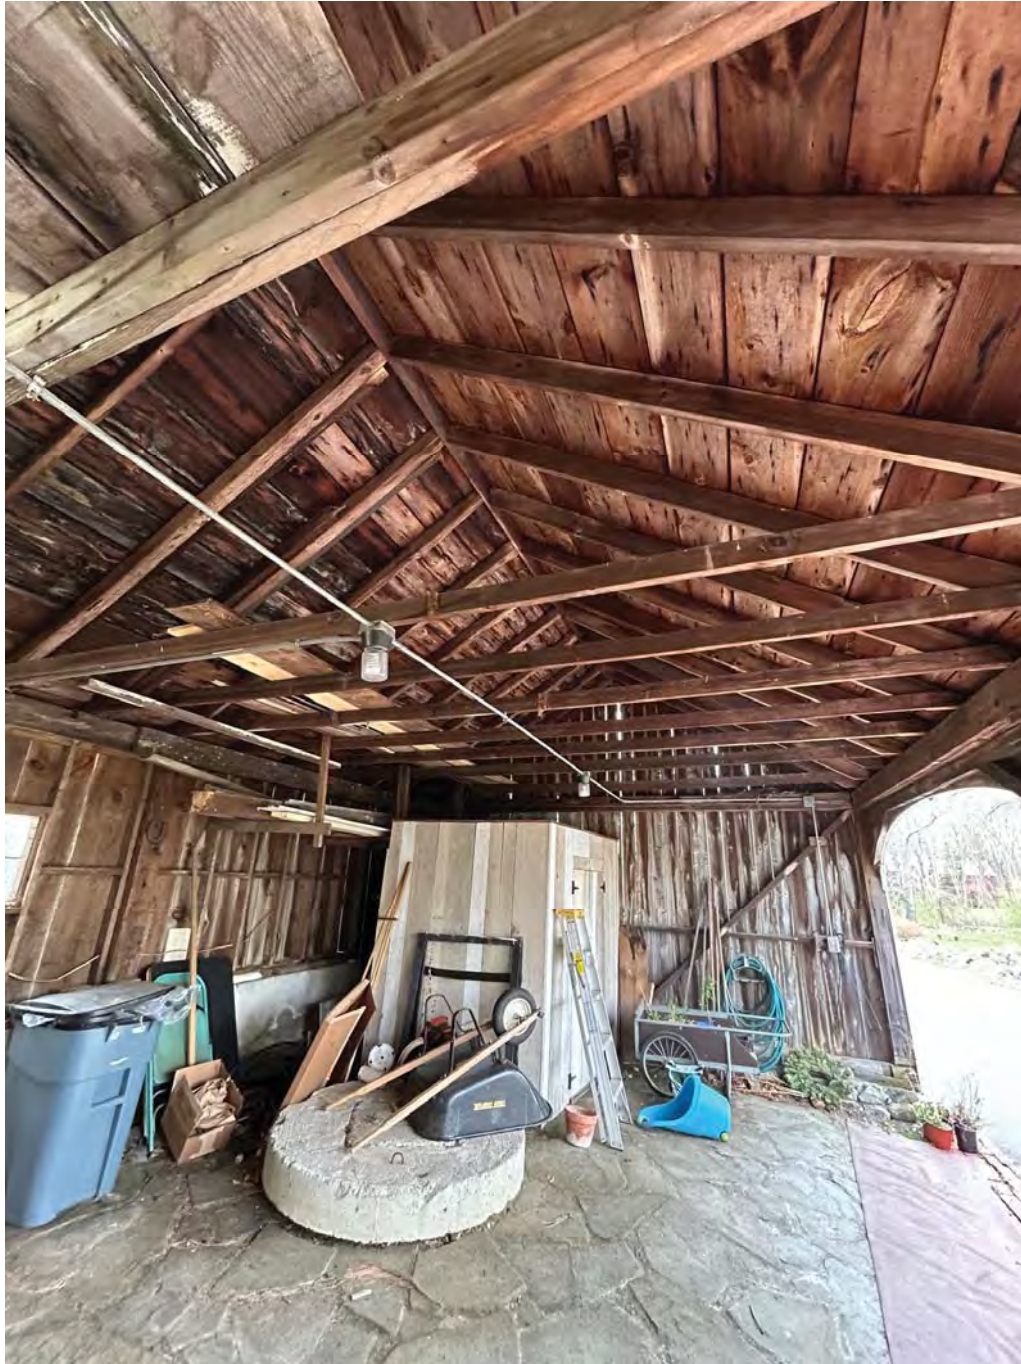
Figure 8.2-15
Carriage house roof
framing.

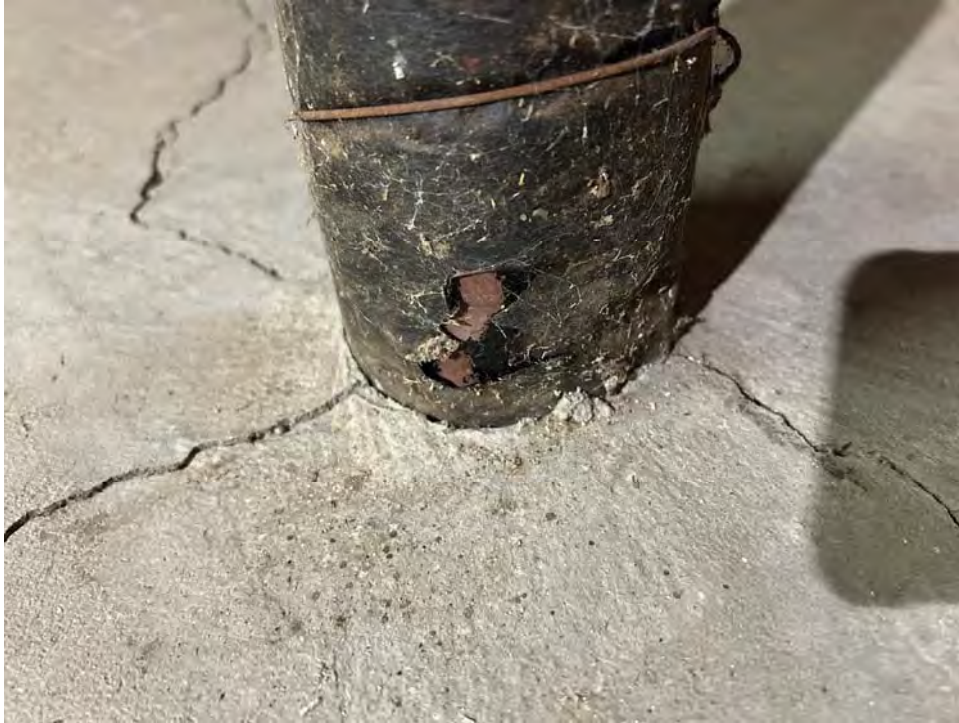
Figure 8.3-1
Failed post waterproofing.

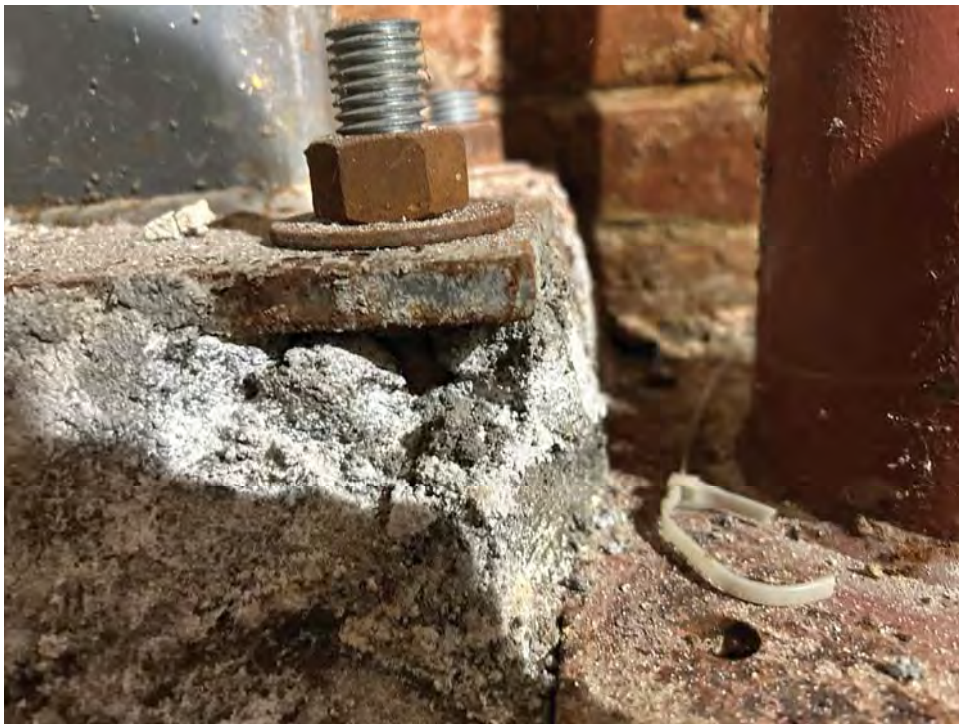
Figure 8.3-2
Spalled grout at HSS post anchorage.

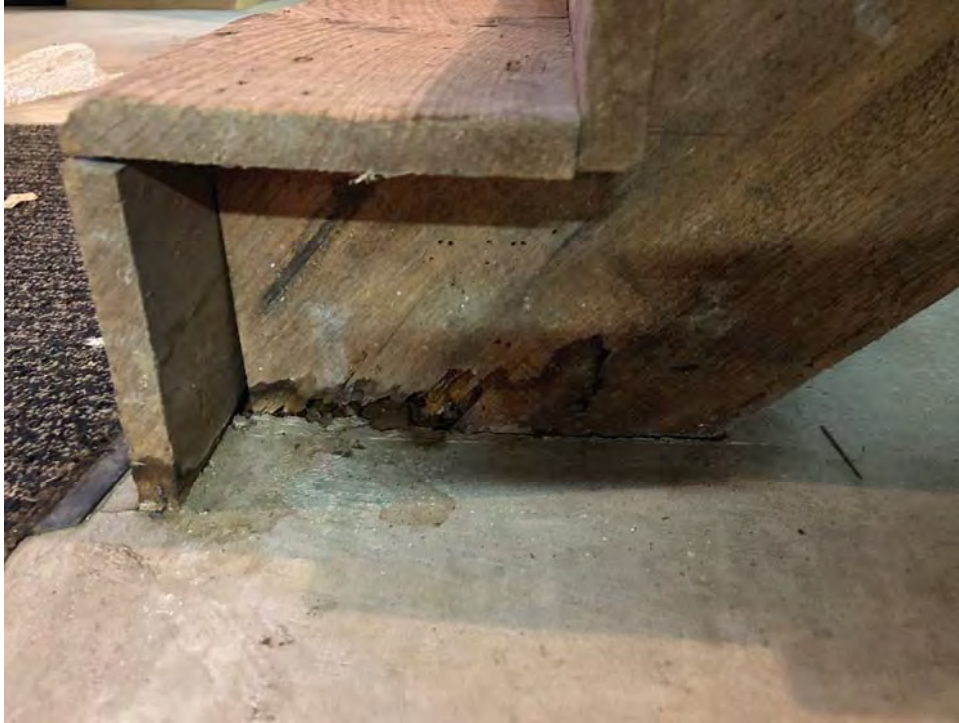
Figure 8.3-3
Deteriorated stringer
bearing.

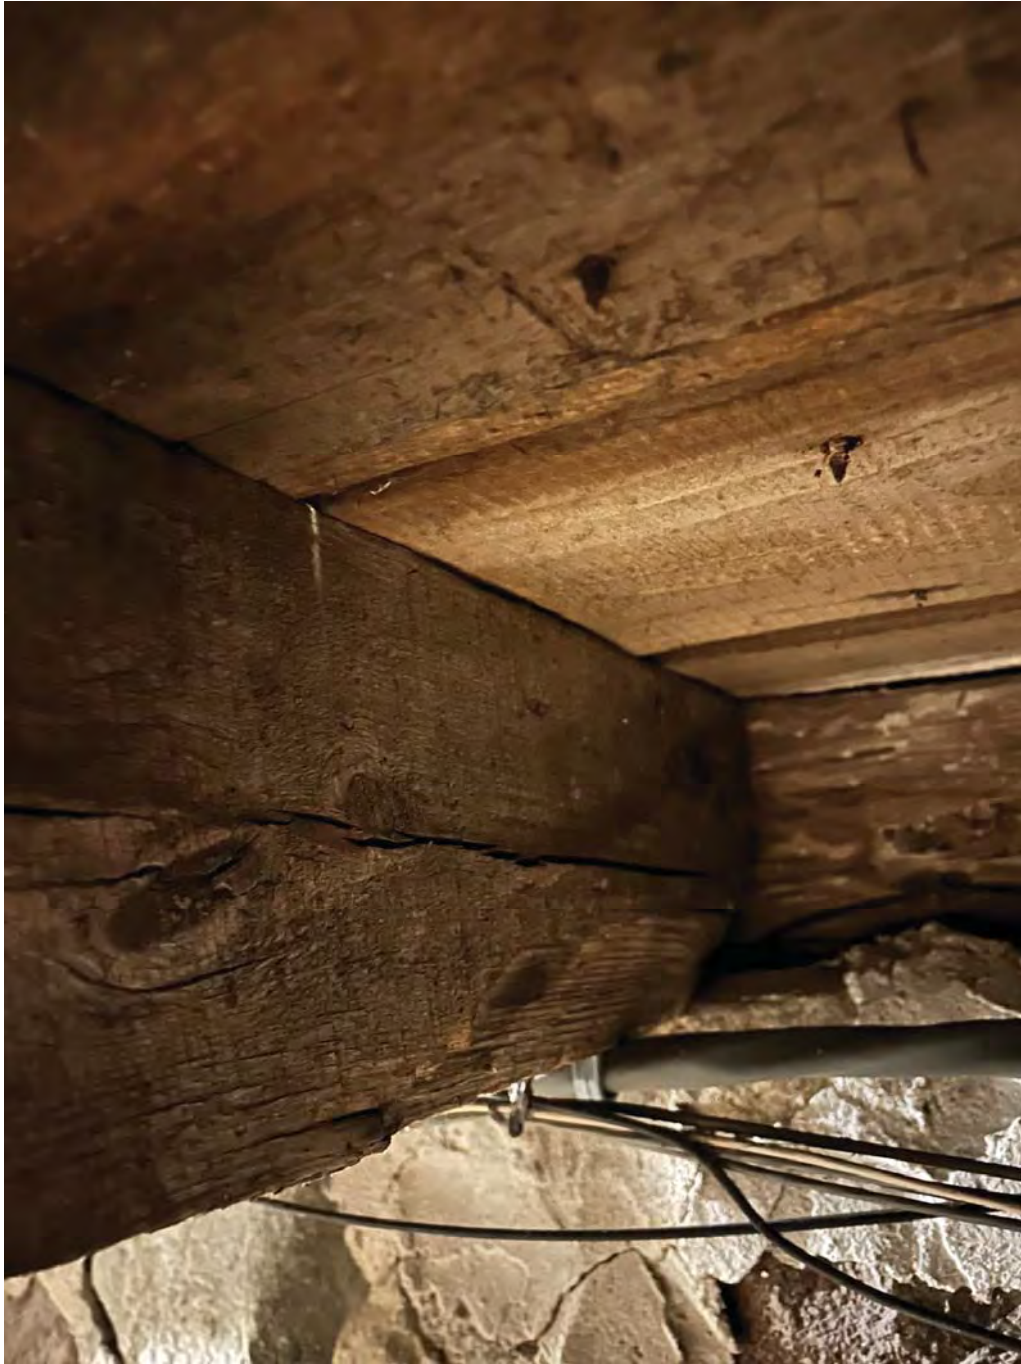
Figure 8.3-4
Fill length split in sister.

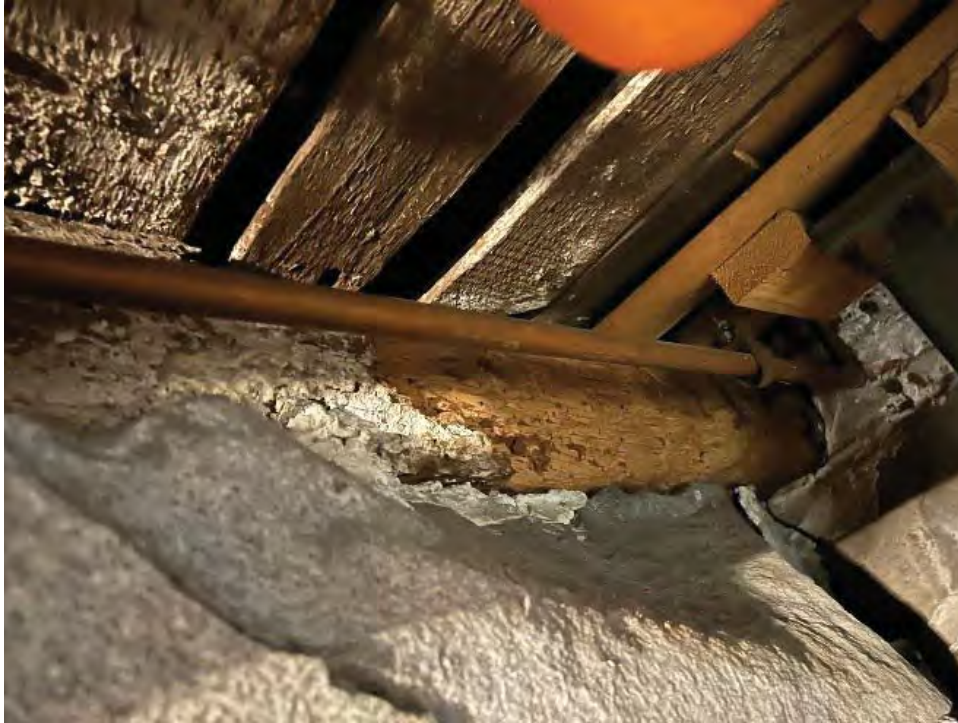
Figure 8.3-5
Deterioration at sill
southwest corner.

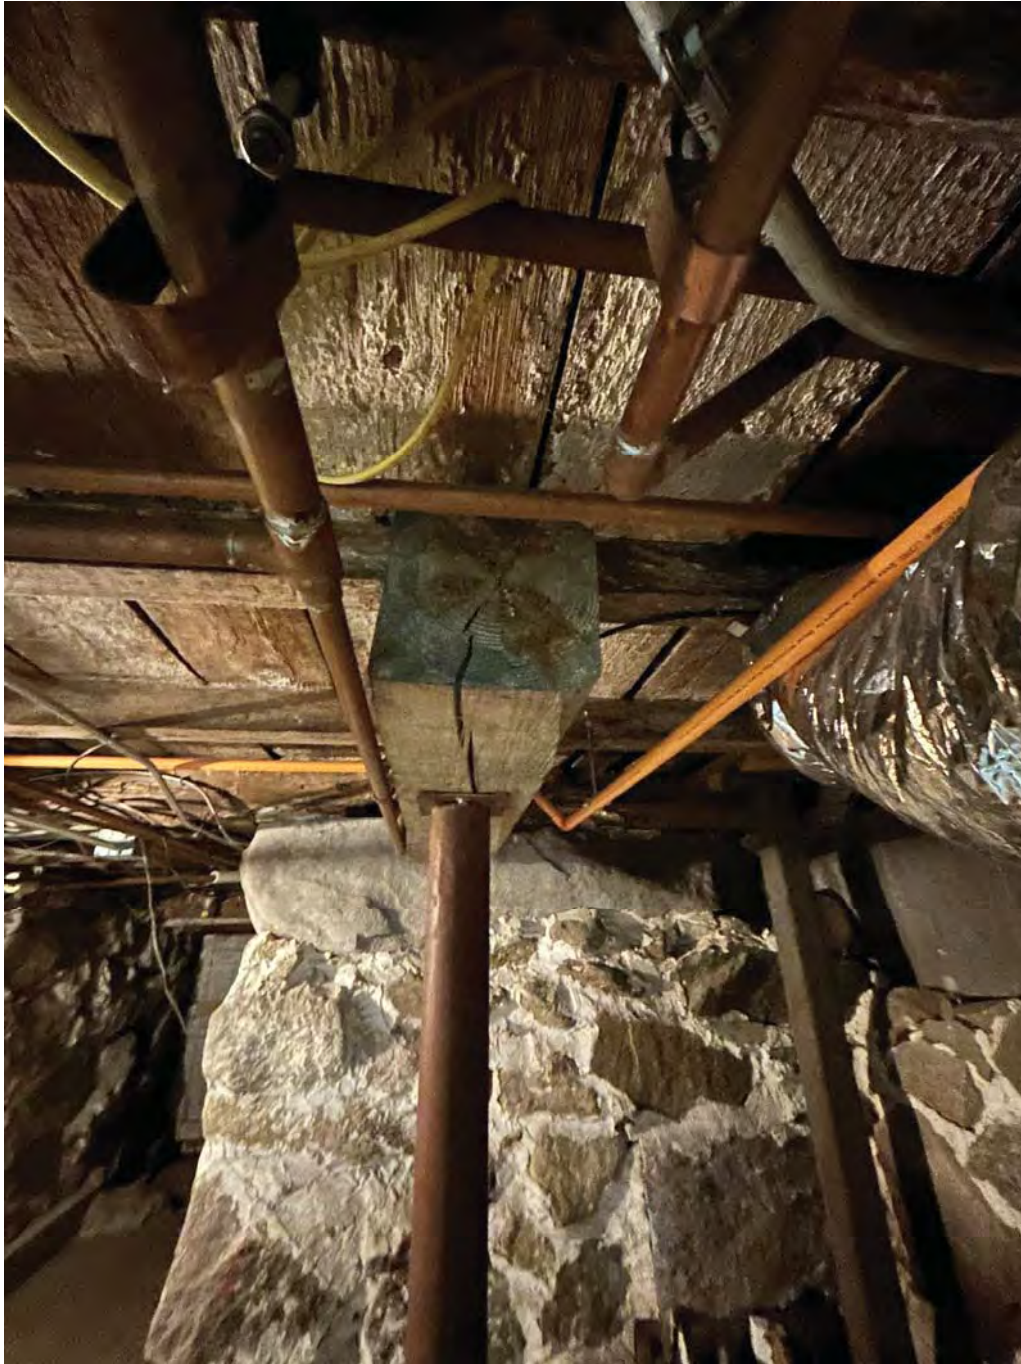
Figure 8.3-6
Through section check at
low beam.

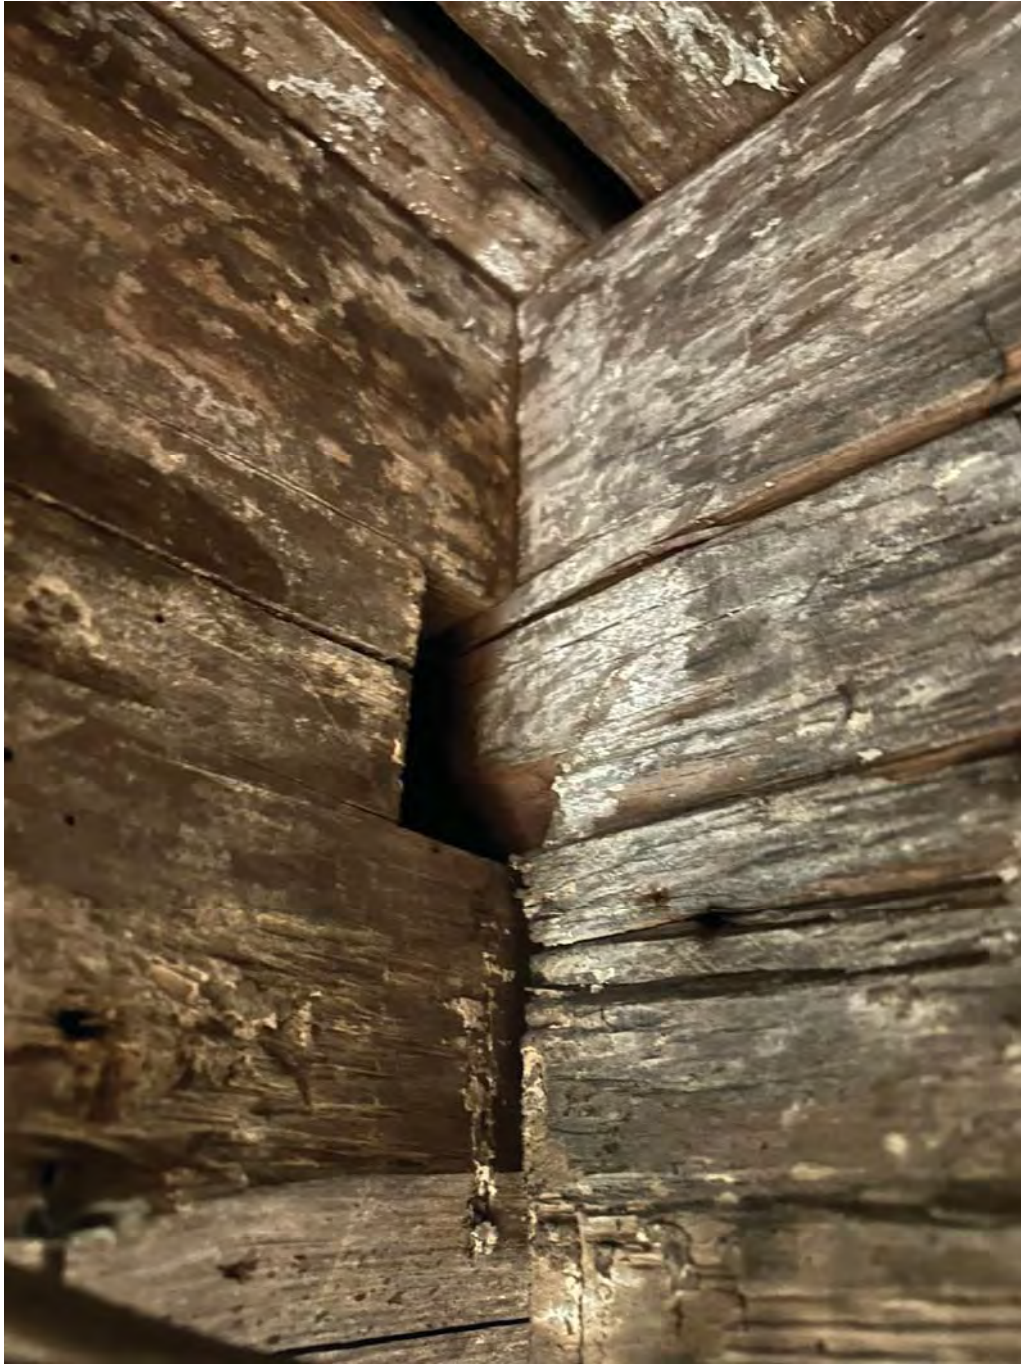
Figure 8.3-8
Wood deterioration at
header to trimmer
connection.

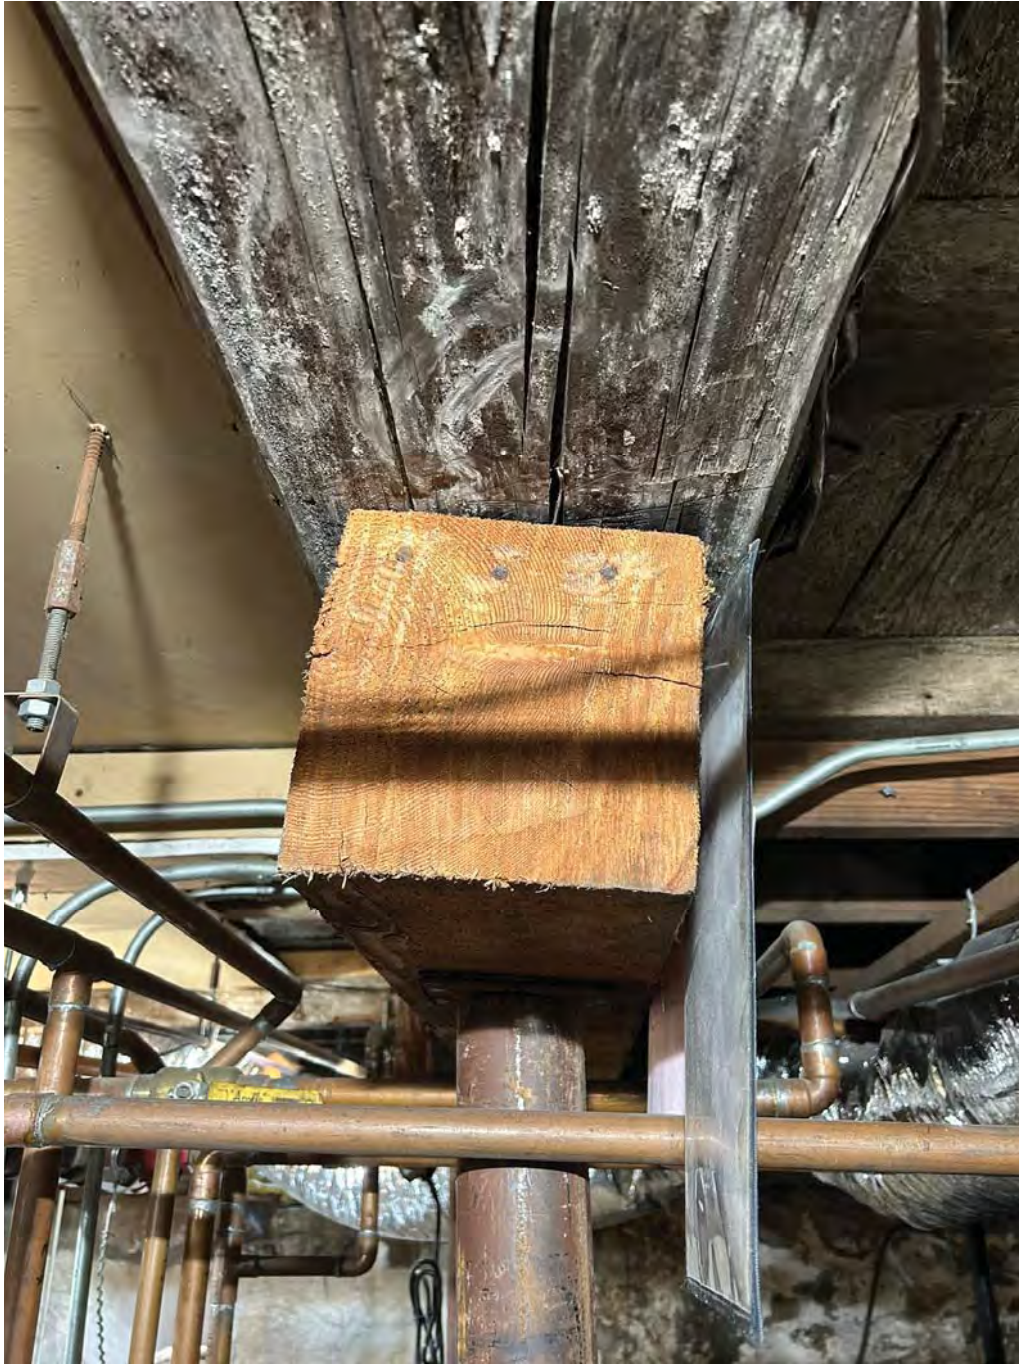
Figure 8.3-9
Rotated low support
beam with torsional
cracking.

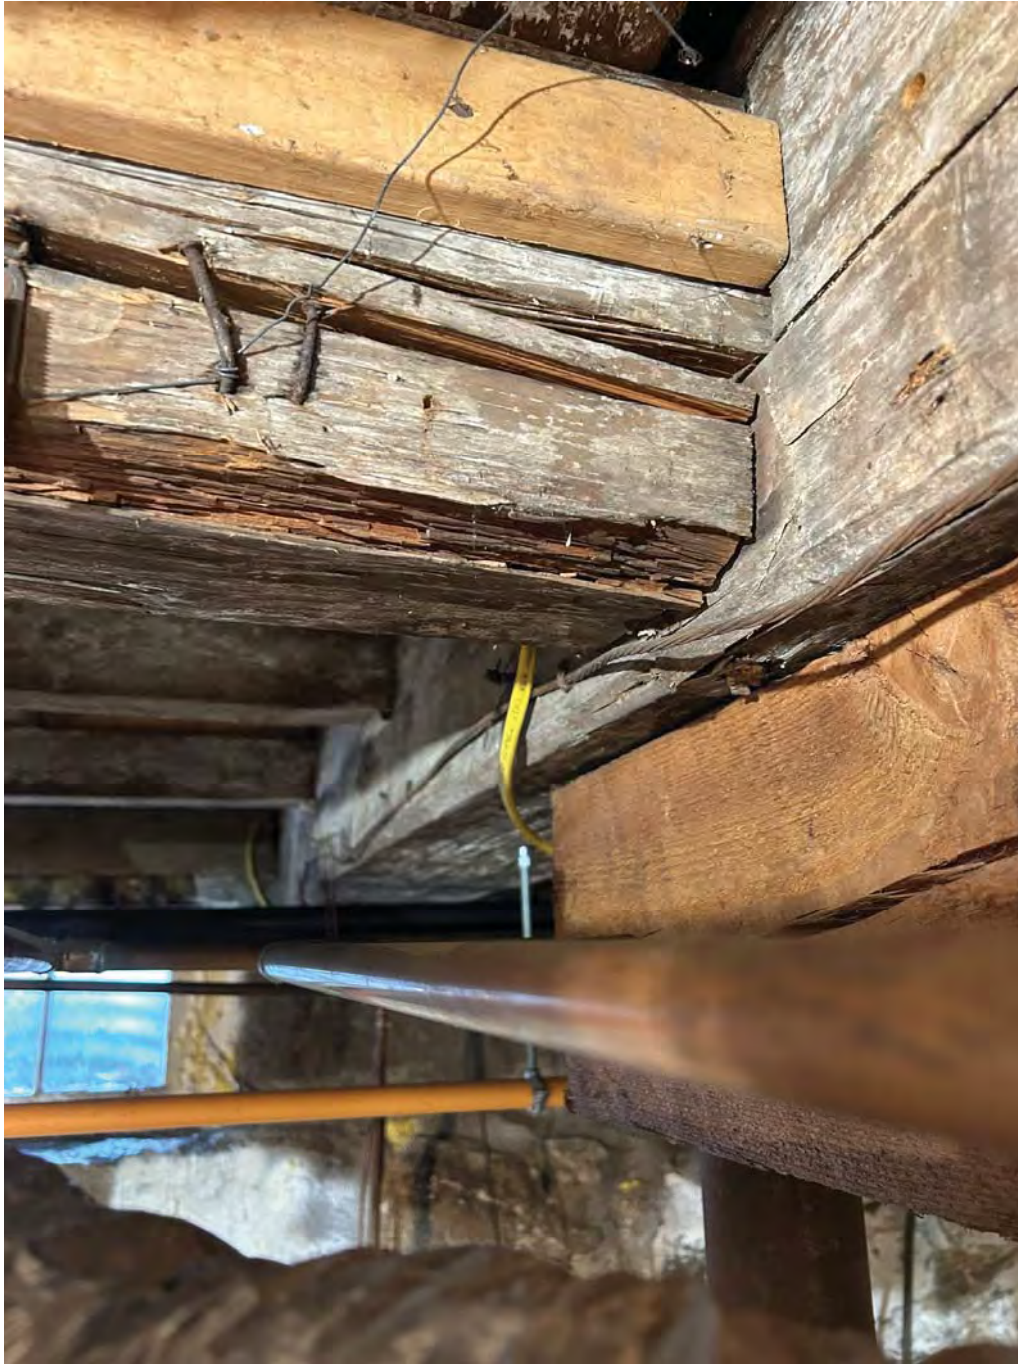
Figure 8.3-10
Deteriorated trimmer east
end connection.

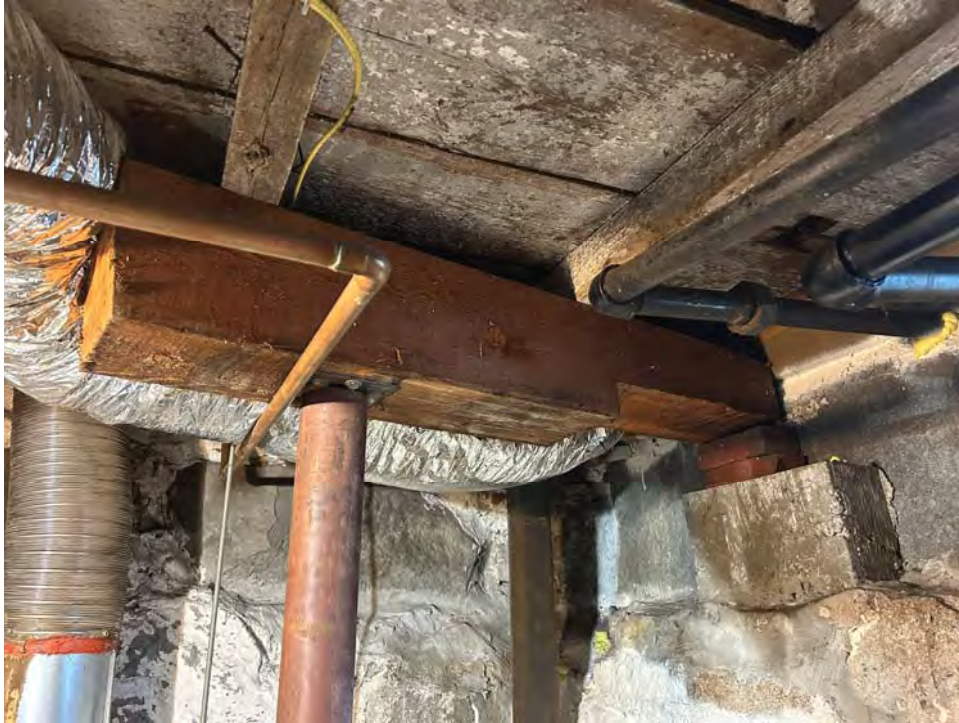
Figure 8.3-11
Low beam notched
bearing.

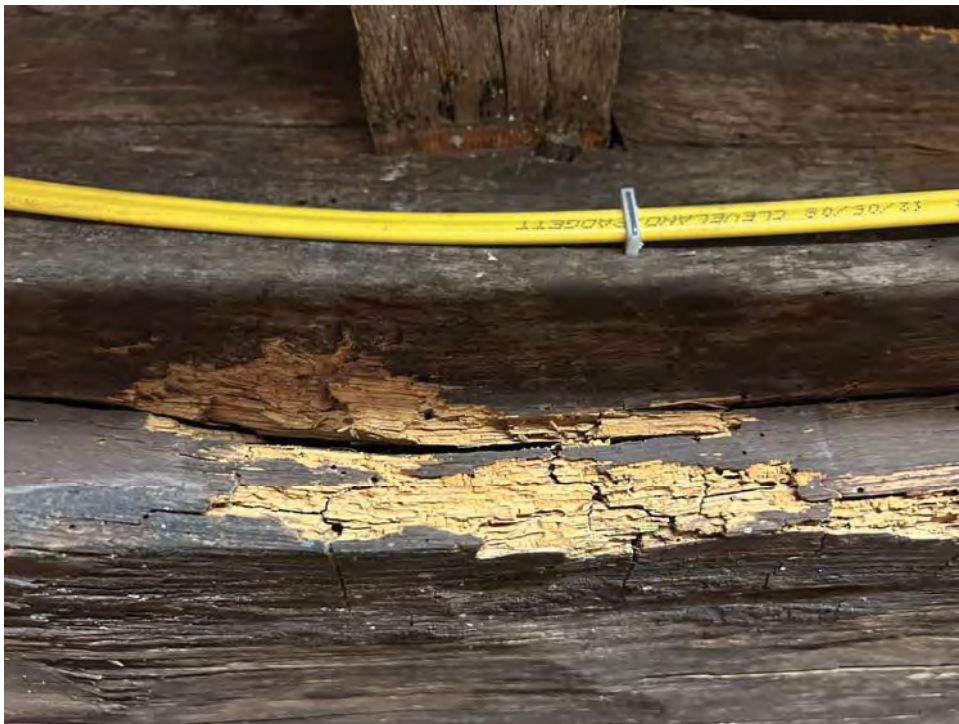
Figure 8.3-12
Deteriorated original timber
beam.

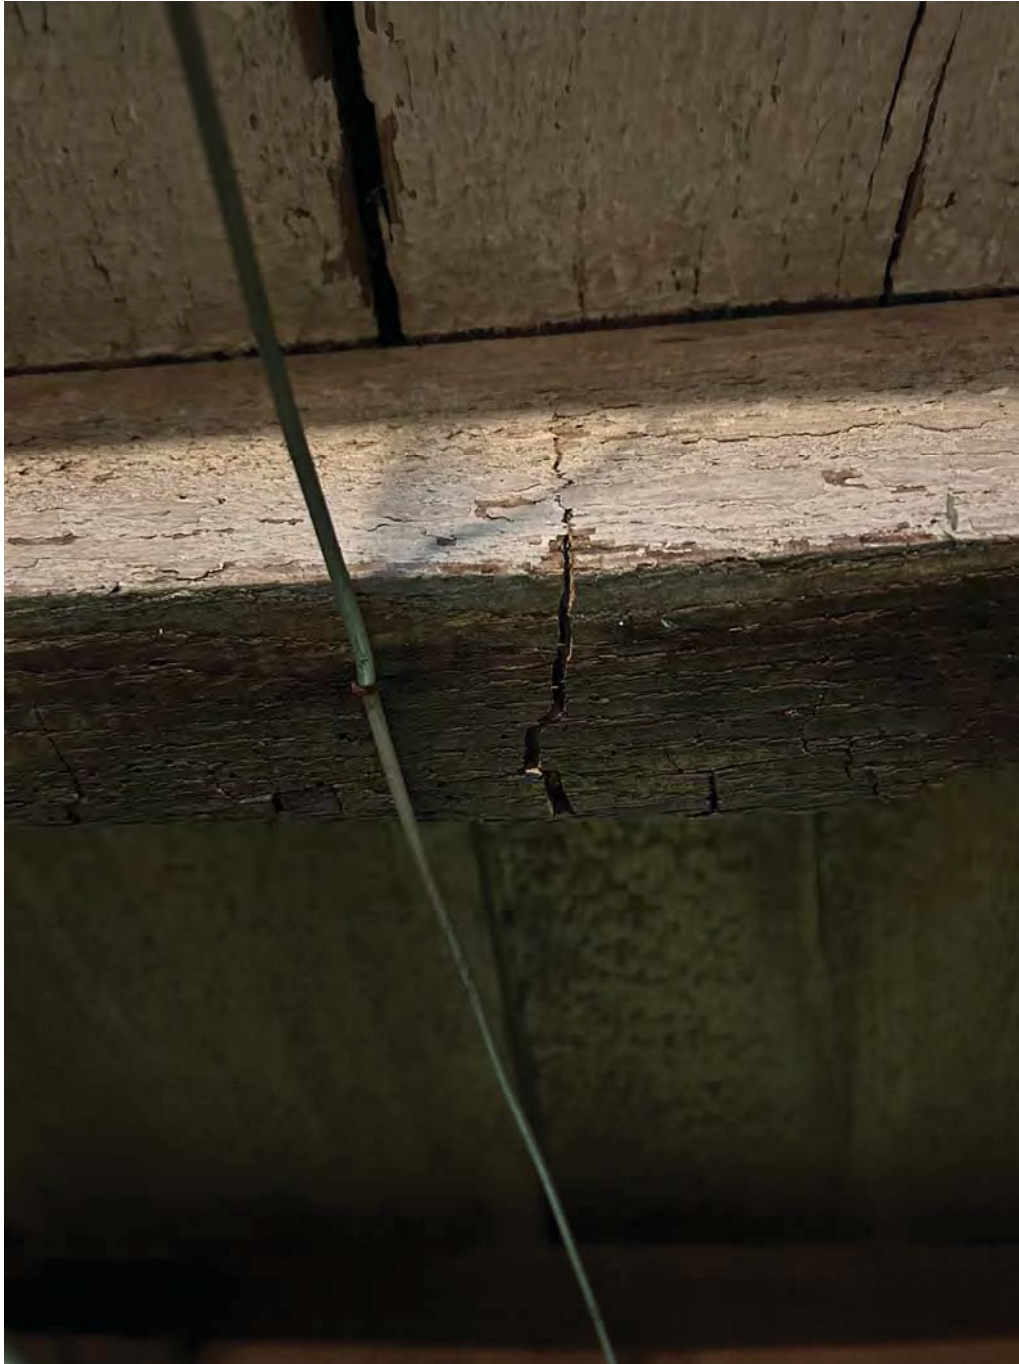
Figure 8.3-13
Cracked joist below
parlor.

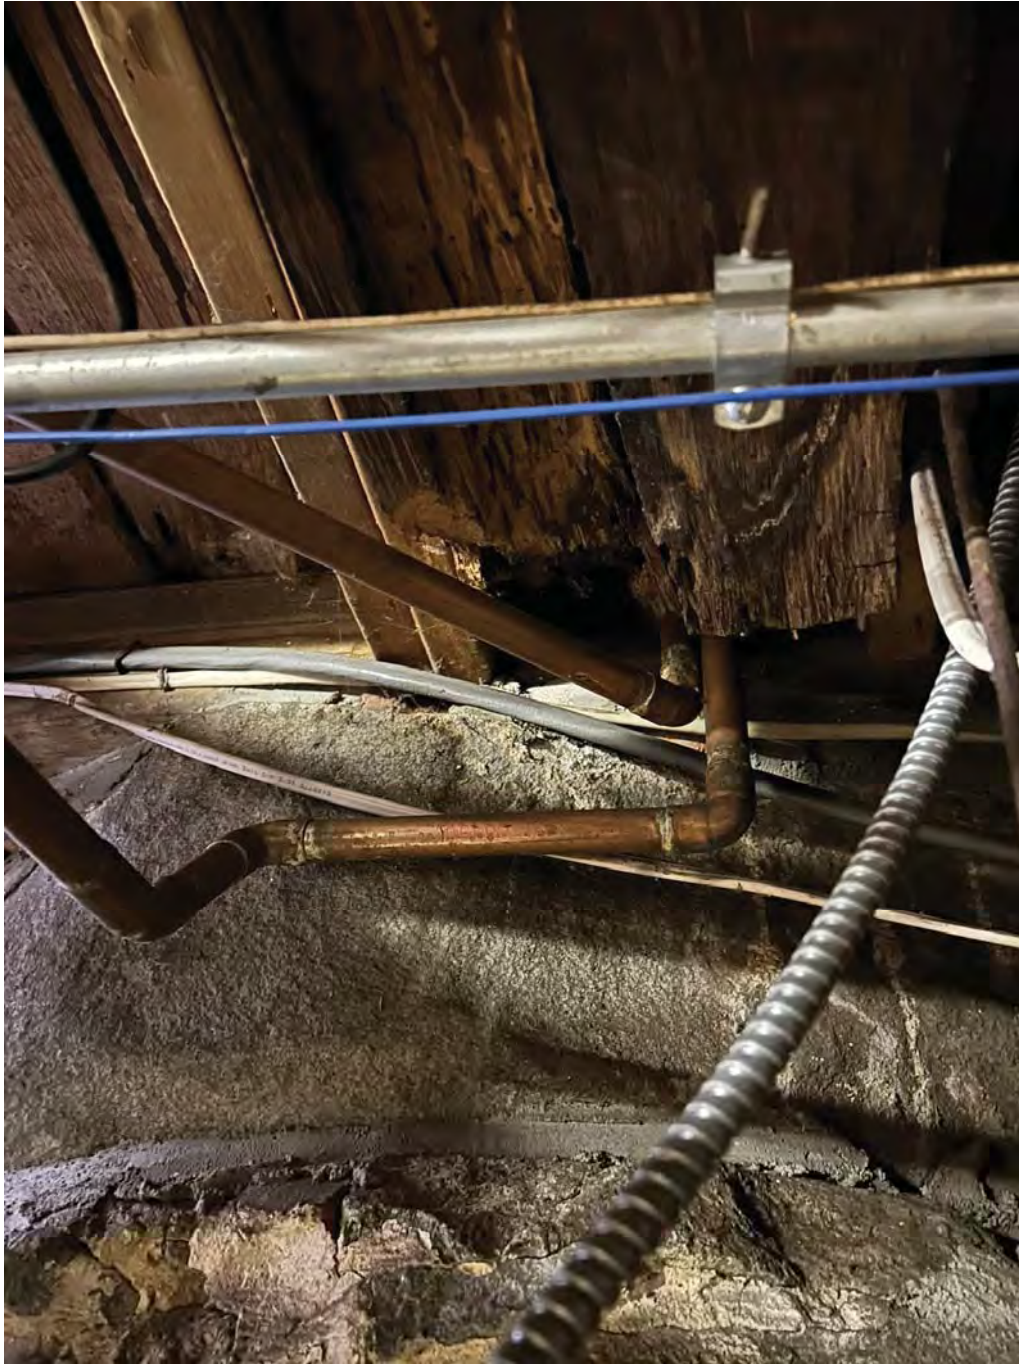
Figure 8.3-14
Void at previous beam
bearing along south wall.
