HOSMER HOUSE

HISTORIC STRUCTURE REPORT / CULTURAL LANDSCAPE REPORT

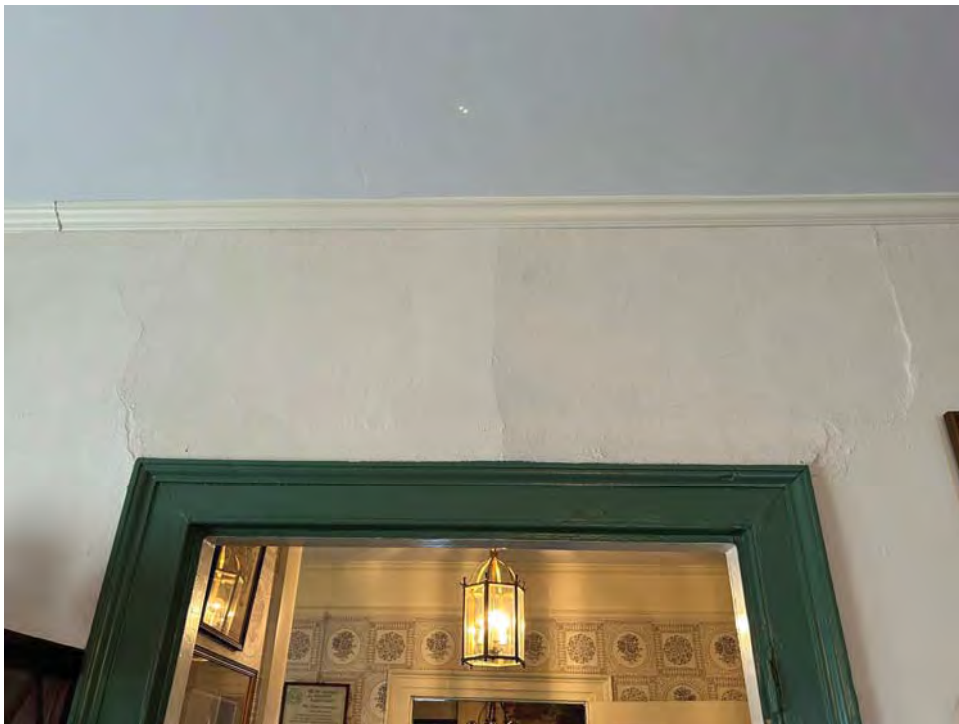
Figure 8.3-16
Diagonal cracking above
opening to dining room.

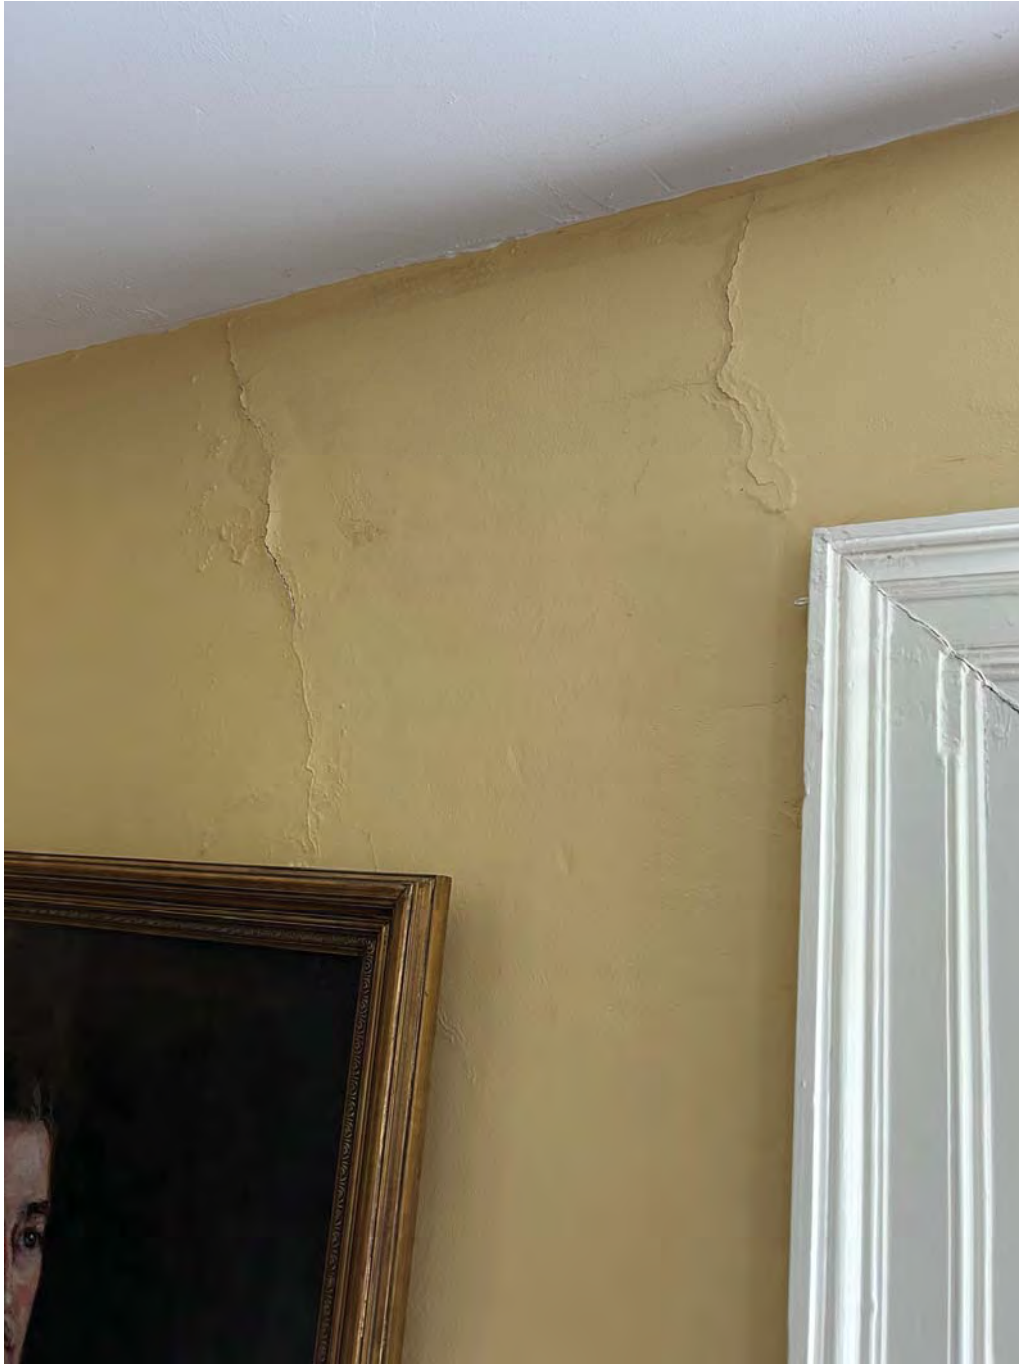
Figure 8.3-17
Cracking in north wall of
parlor.

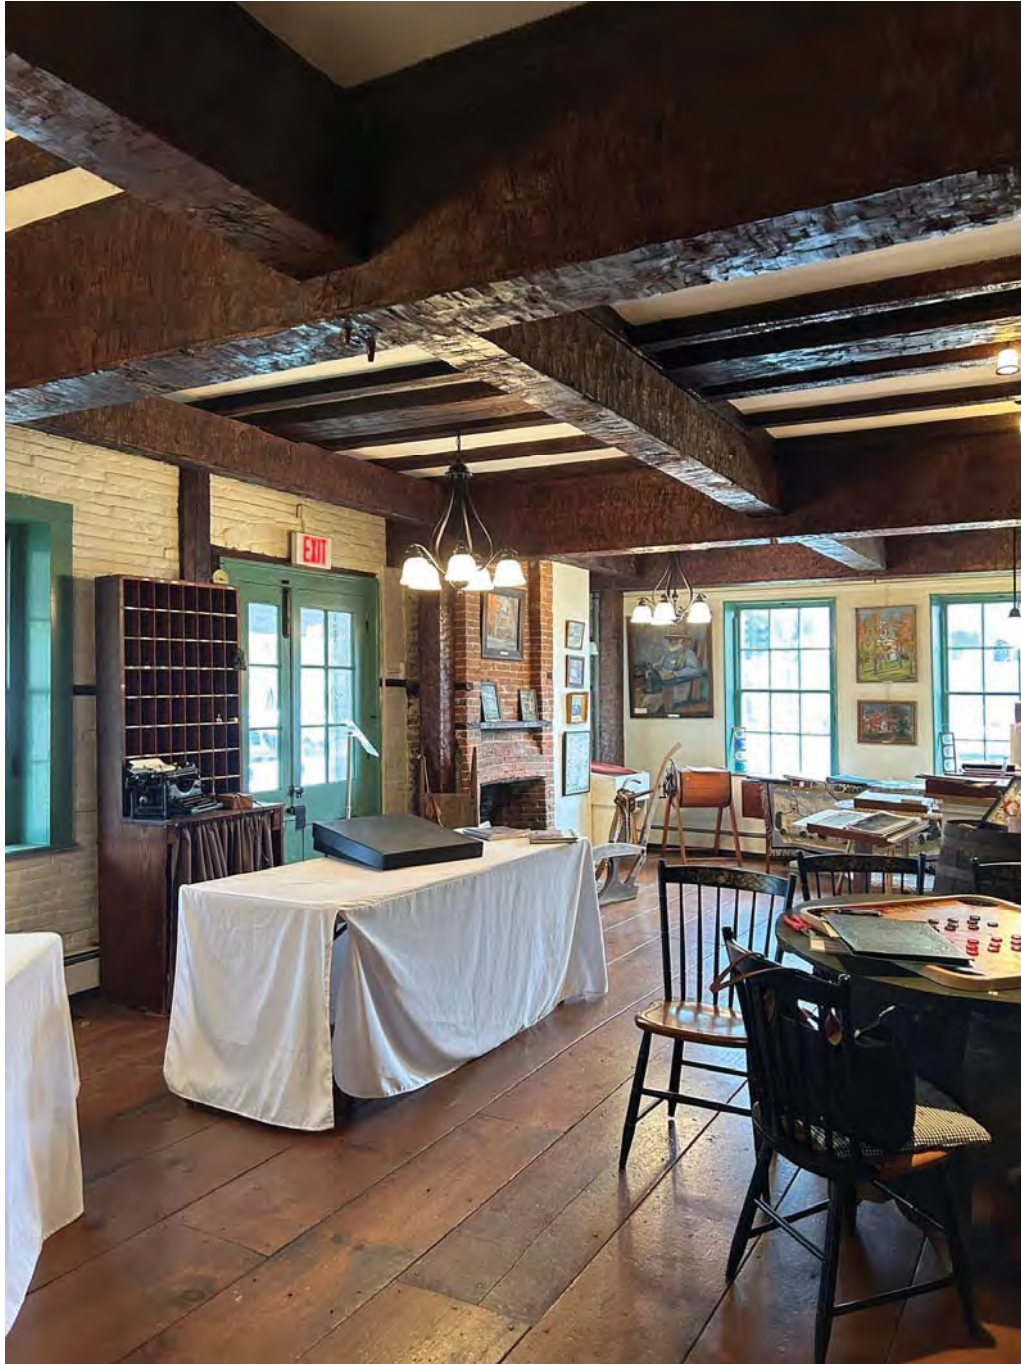
Figure 8.3-18
Ballroom floor framing.

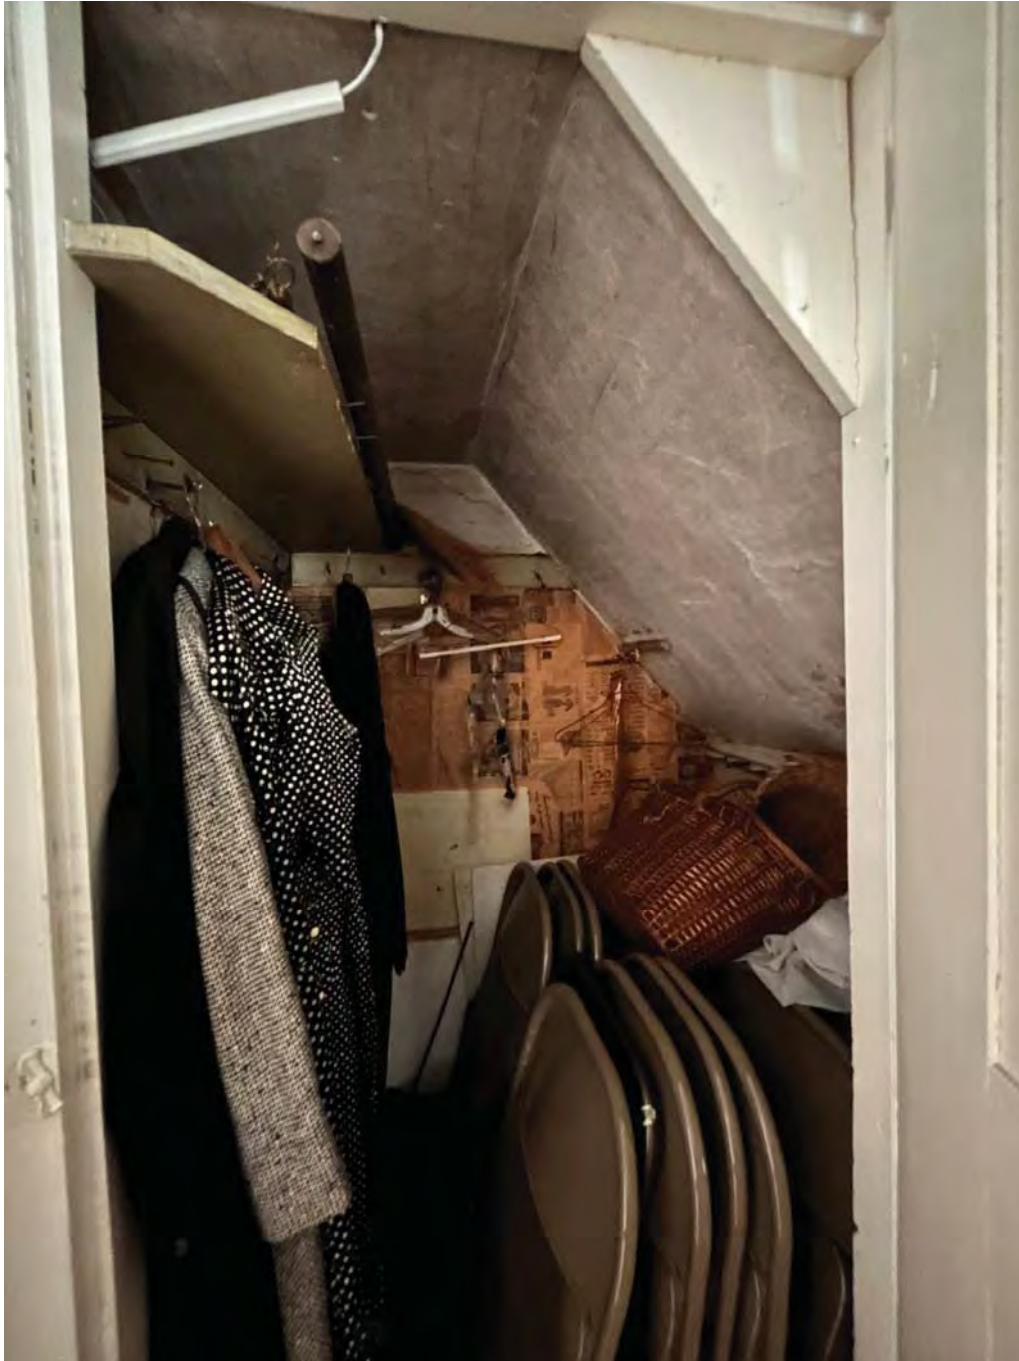
Figure 8.3-19
Cracking in ceiling under
stair to attic.

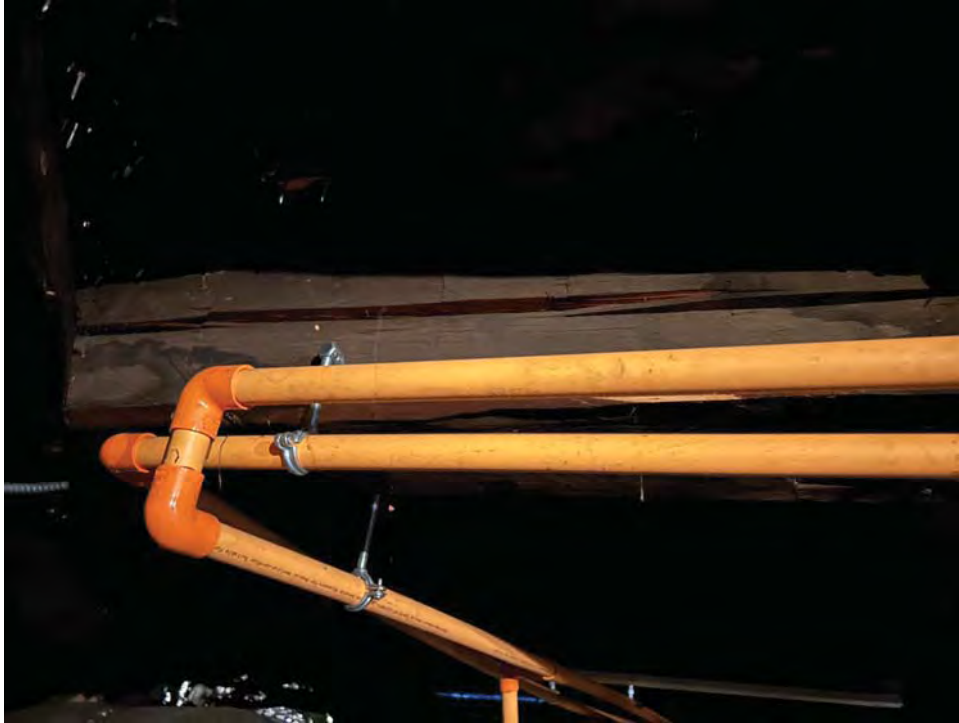
Figure 8.3-20
Large checks in roof purlin,
southeast corner.

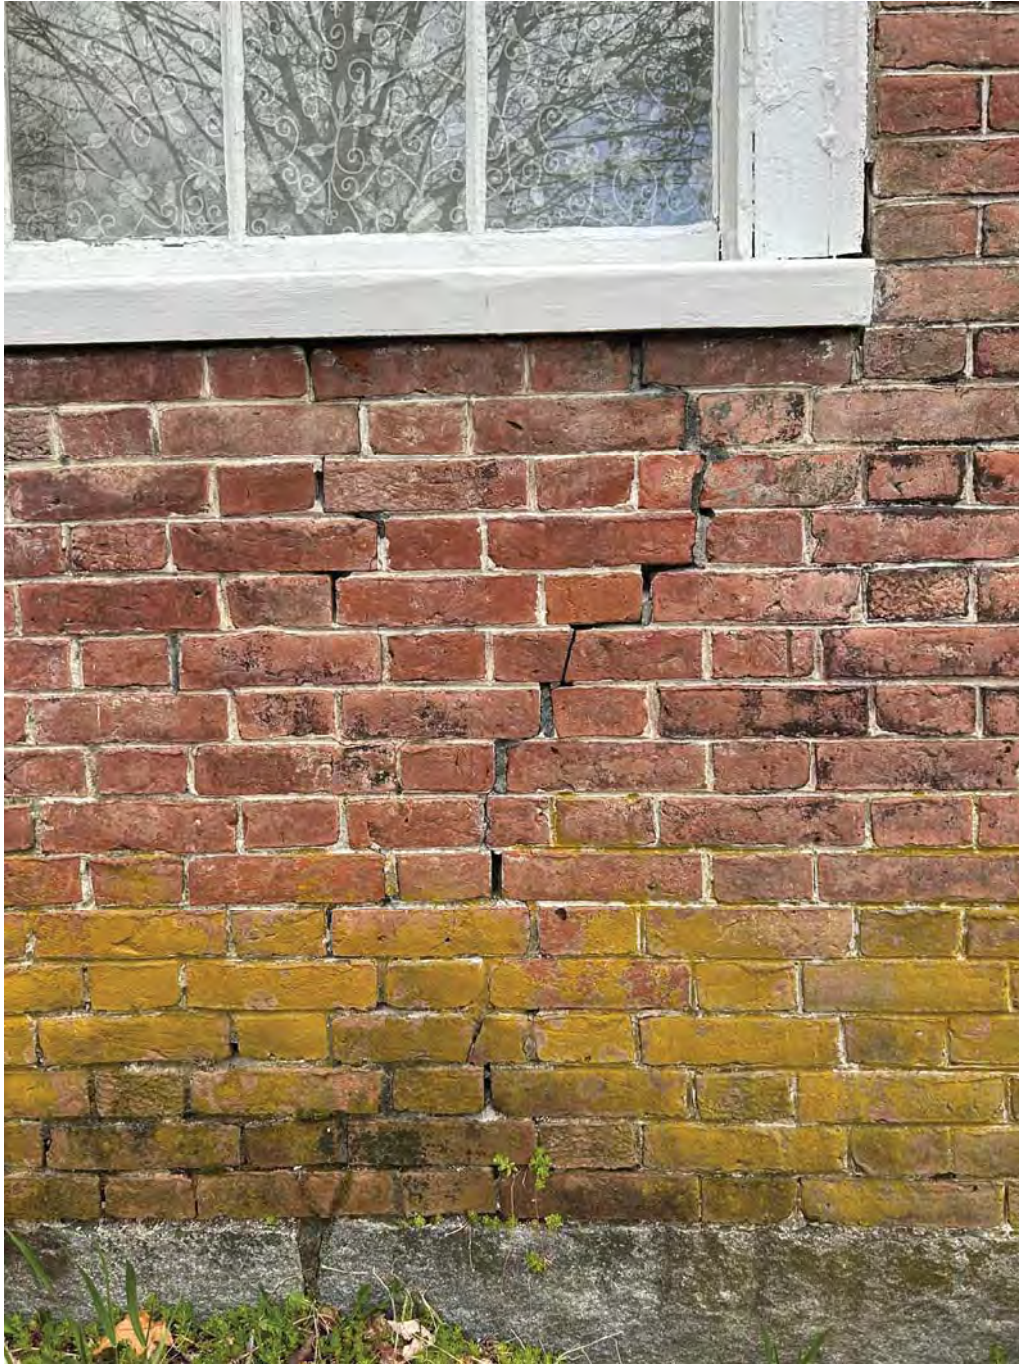
Figure 8.3-22
Masonry cracking in east
wall.

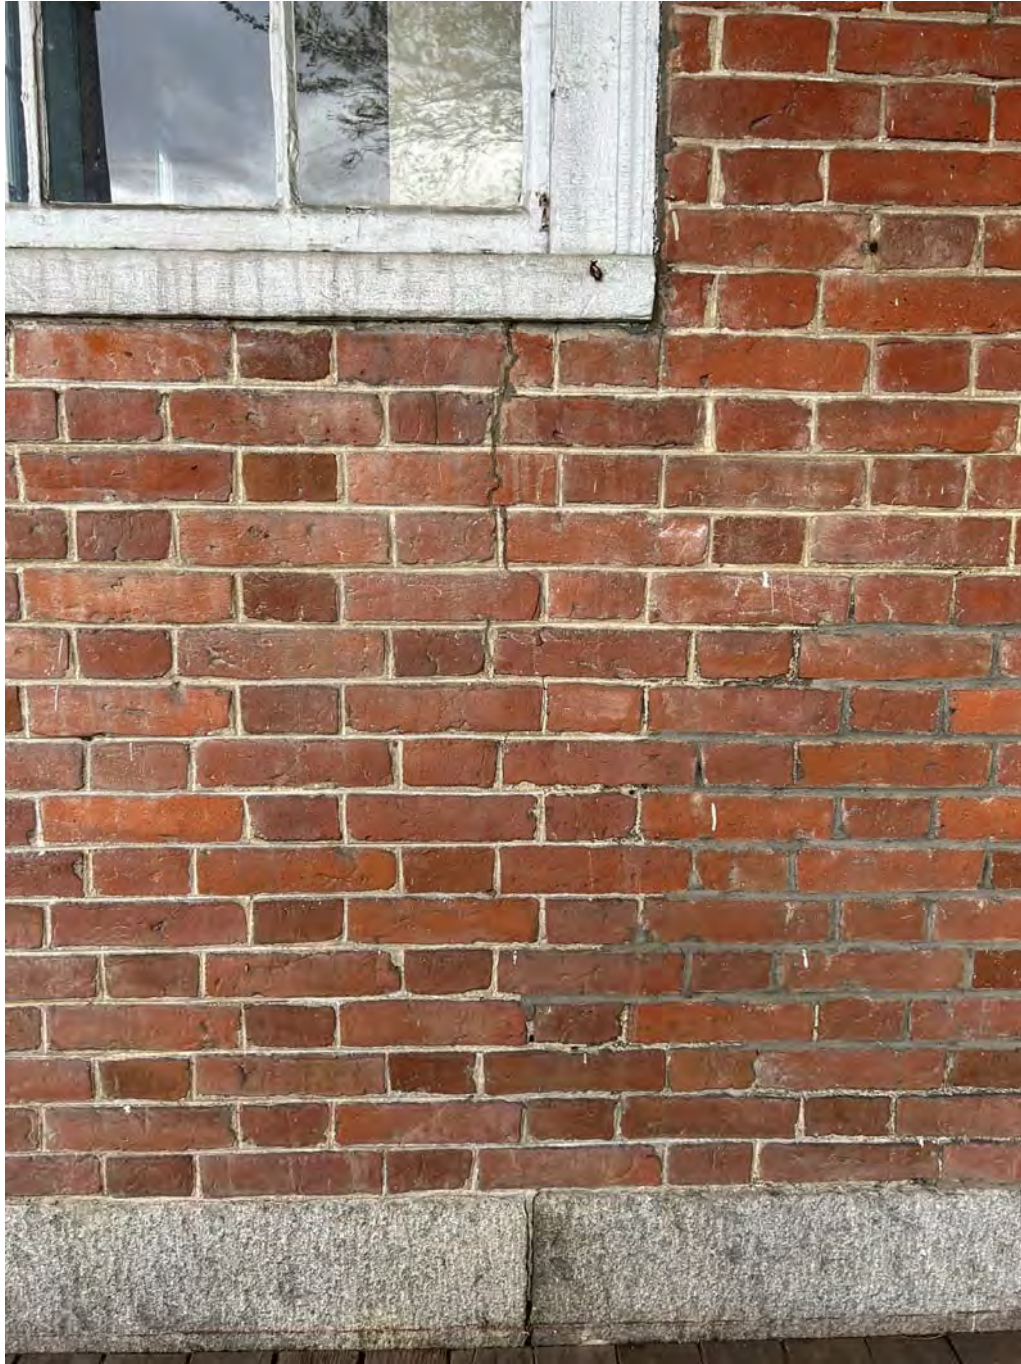
Figure 8.3-23
Cracked in west masonry
wall.

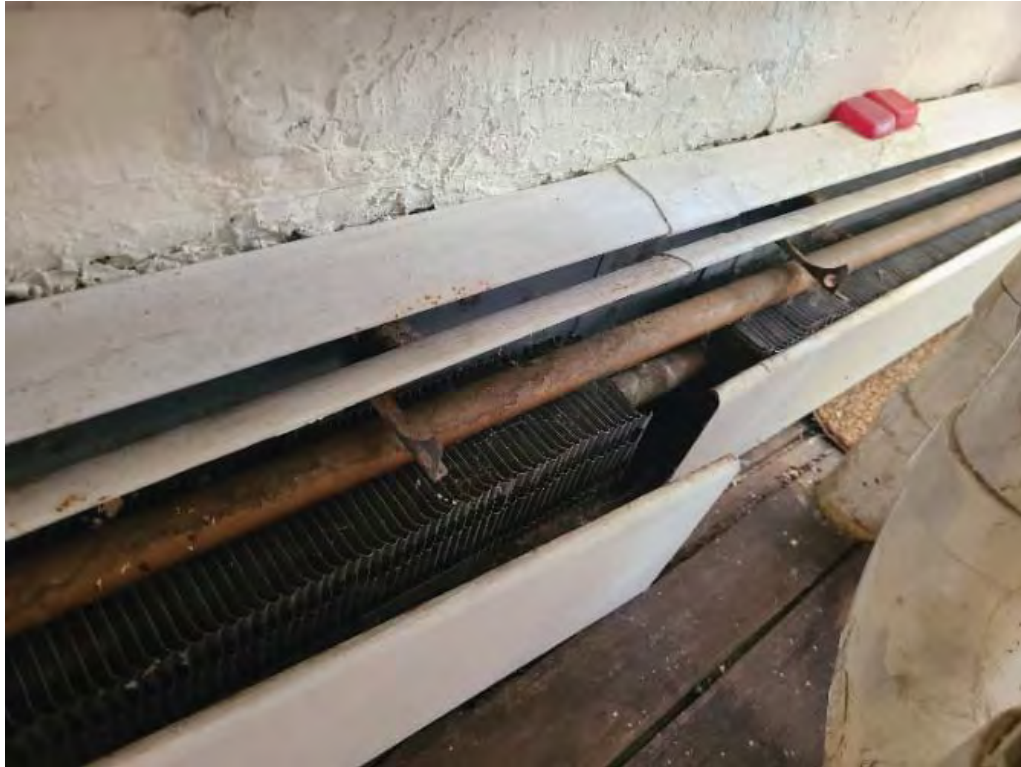
Figure 9.1-1
Typical Fin Tube
Radiator.

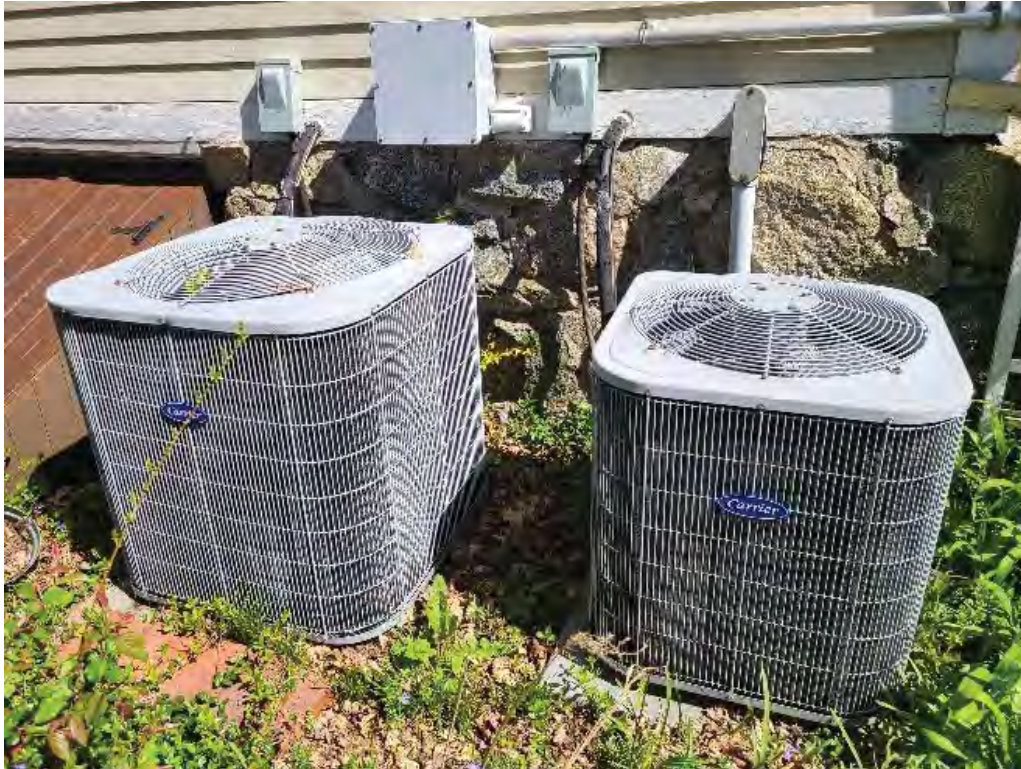
Figure 9.2-1
First Floor (Right)
and Second Floor (Left)
Outdoor
Condensing Units.

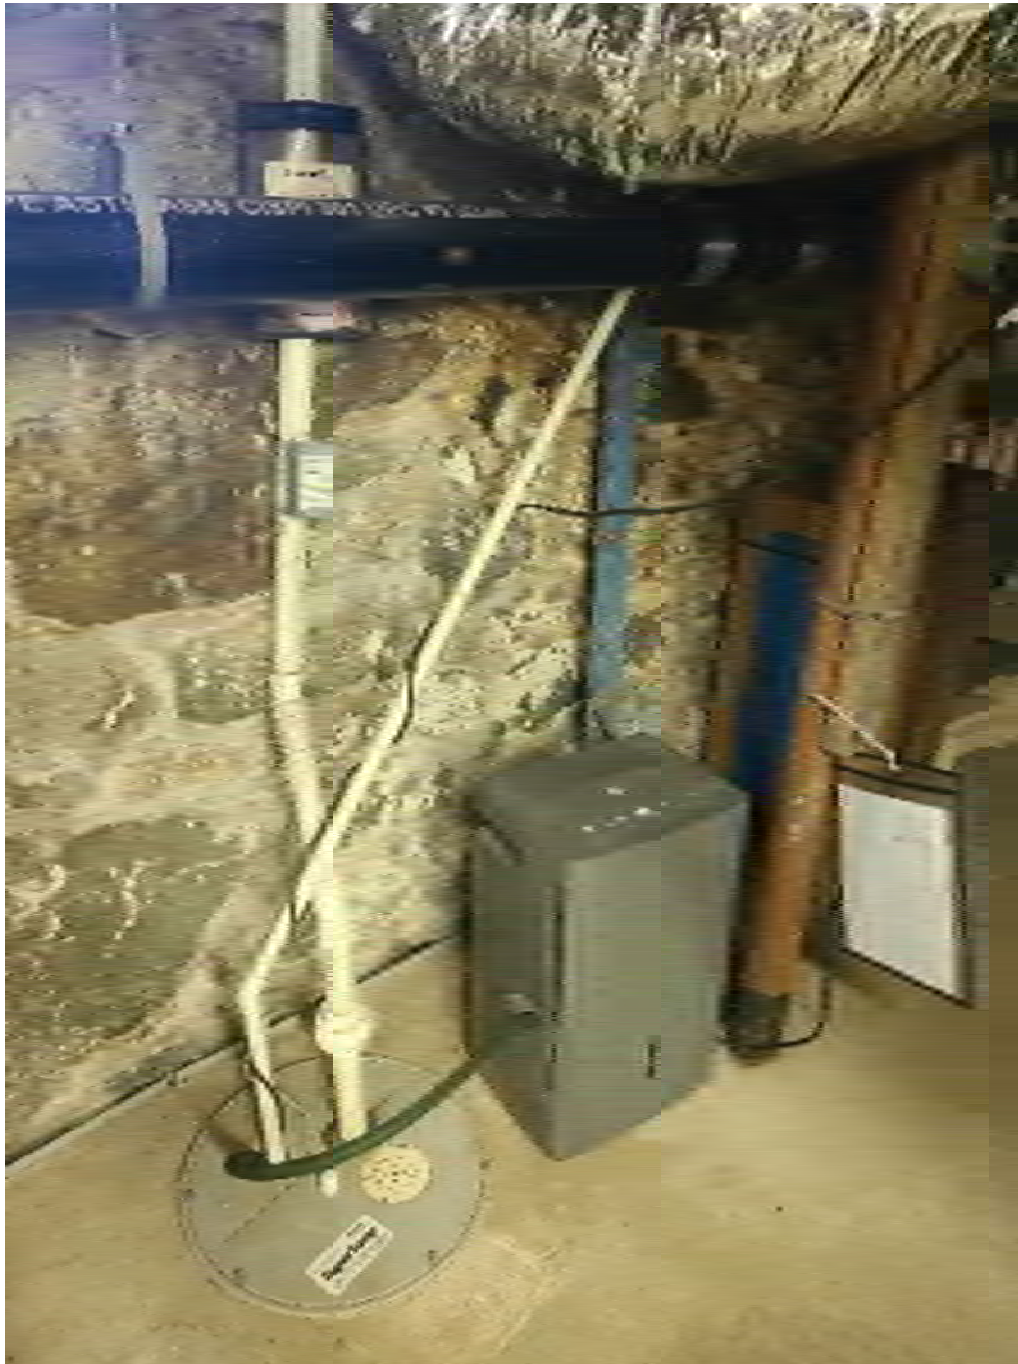
Figure 9.2-7
Basement (B-01)
Dehumidifier tied to
Sump Pump Pit.

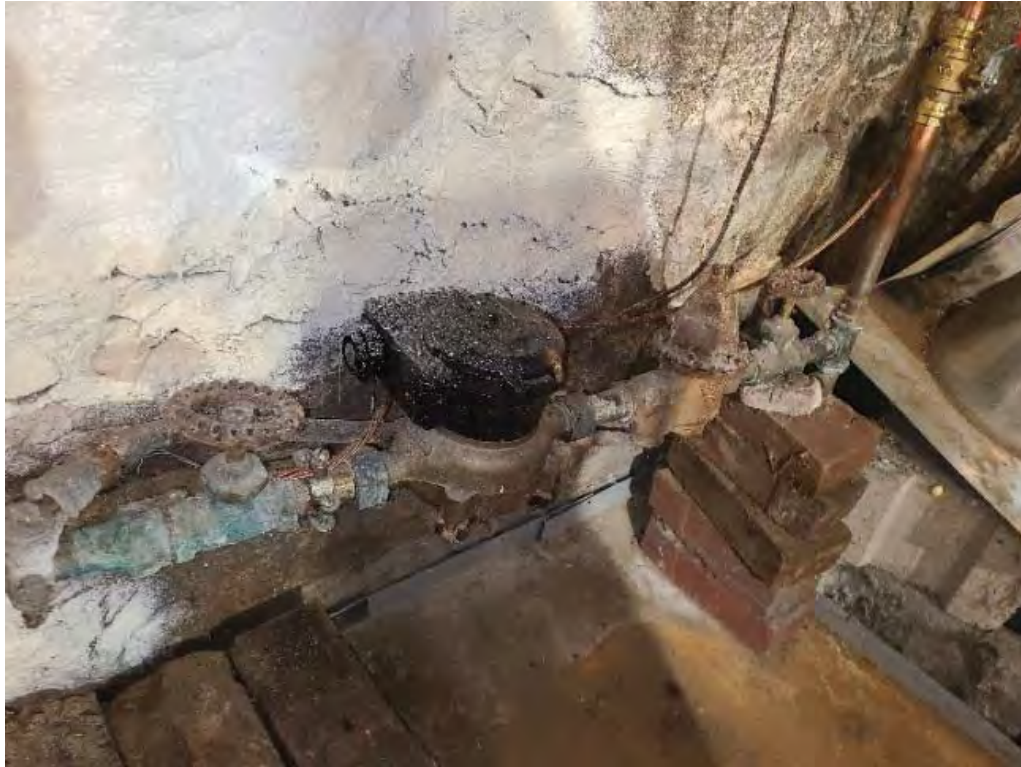
Figure 9.3-1
Domestic Water
Service.

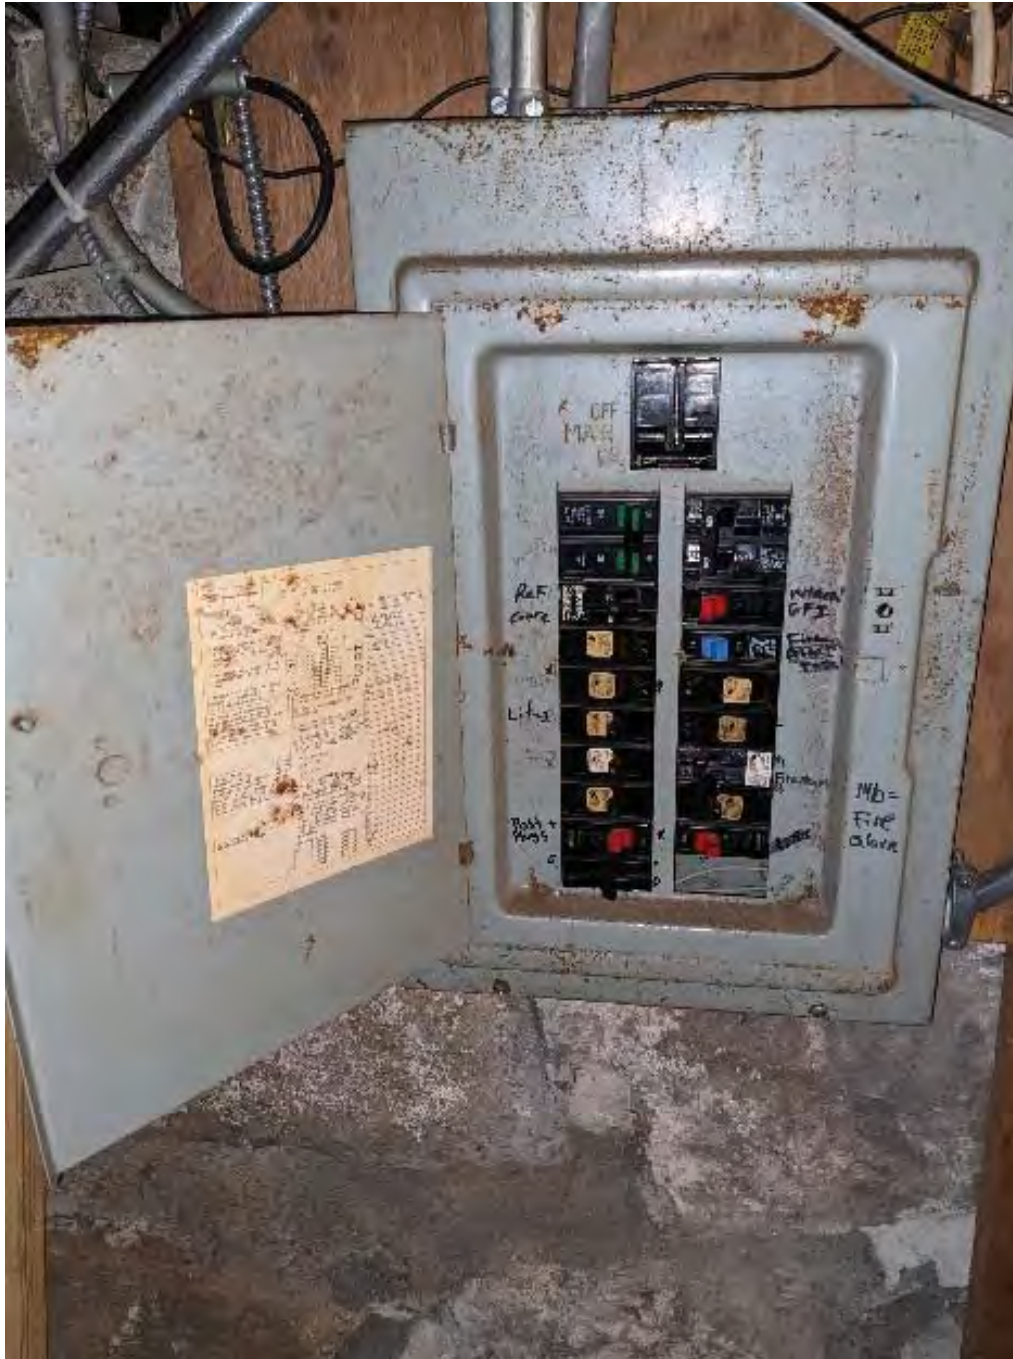
Figure 9.7-1
100A, 120/240V,
single phase panel
with rust damage.

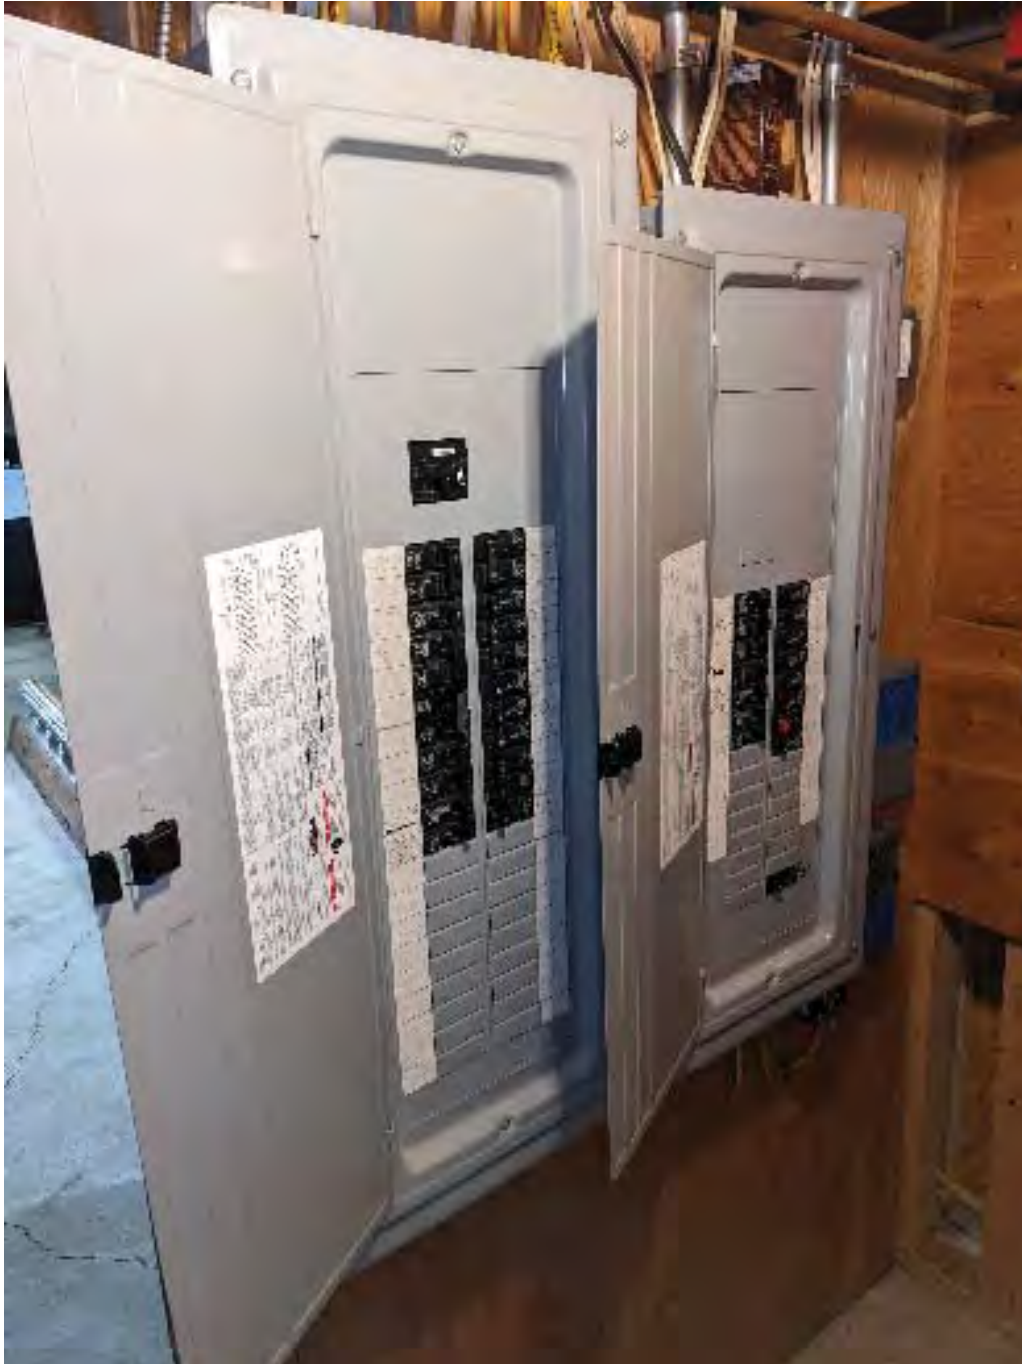
Figure 9.7-2
Newer 200A,
120/240V, single
phase panels.

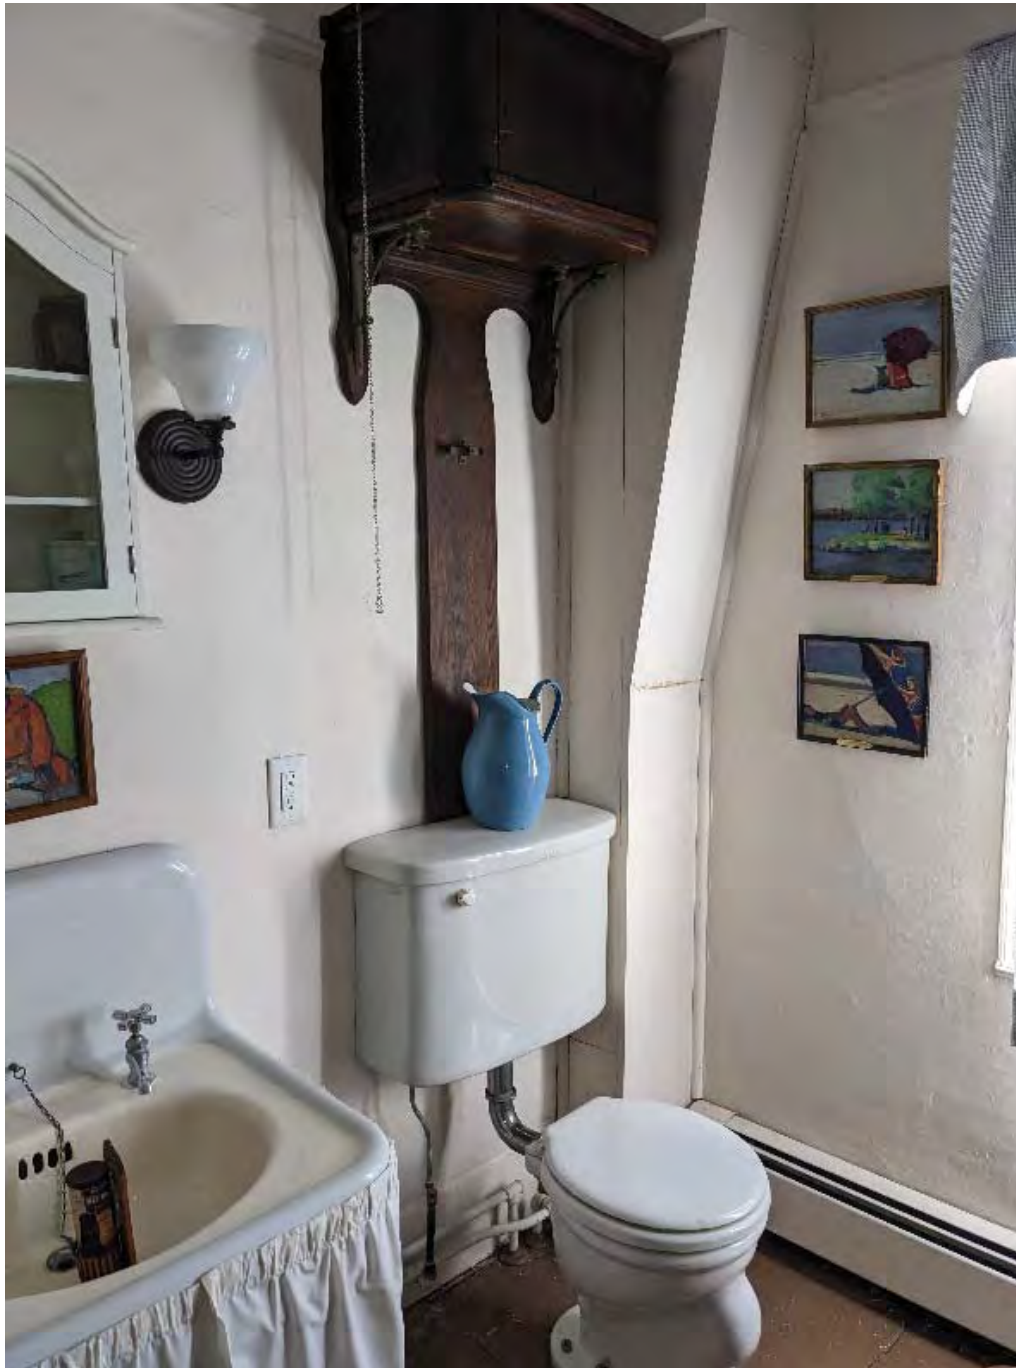
Figure 9.8-1
GFCI receptacle
located in the
upstairs bathroom.

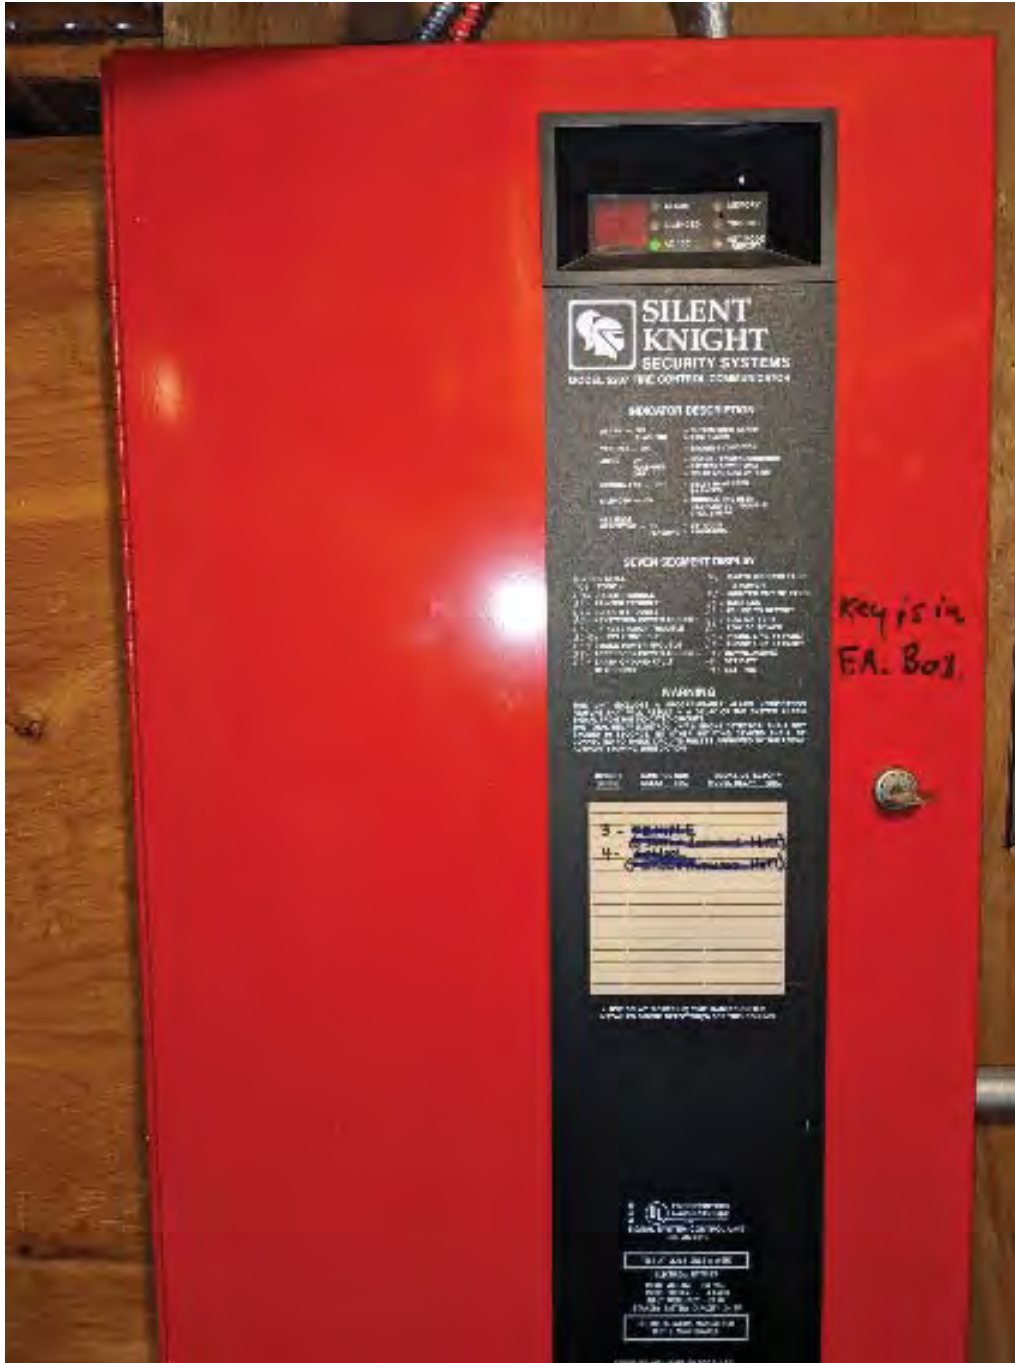
Figure 9.9-1
Silent Knight Fire
Alarm Control
Panel.

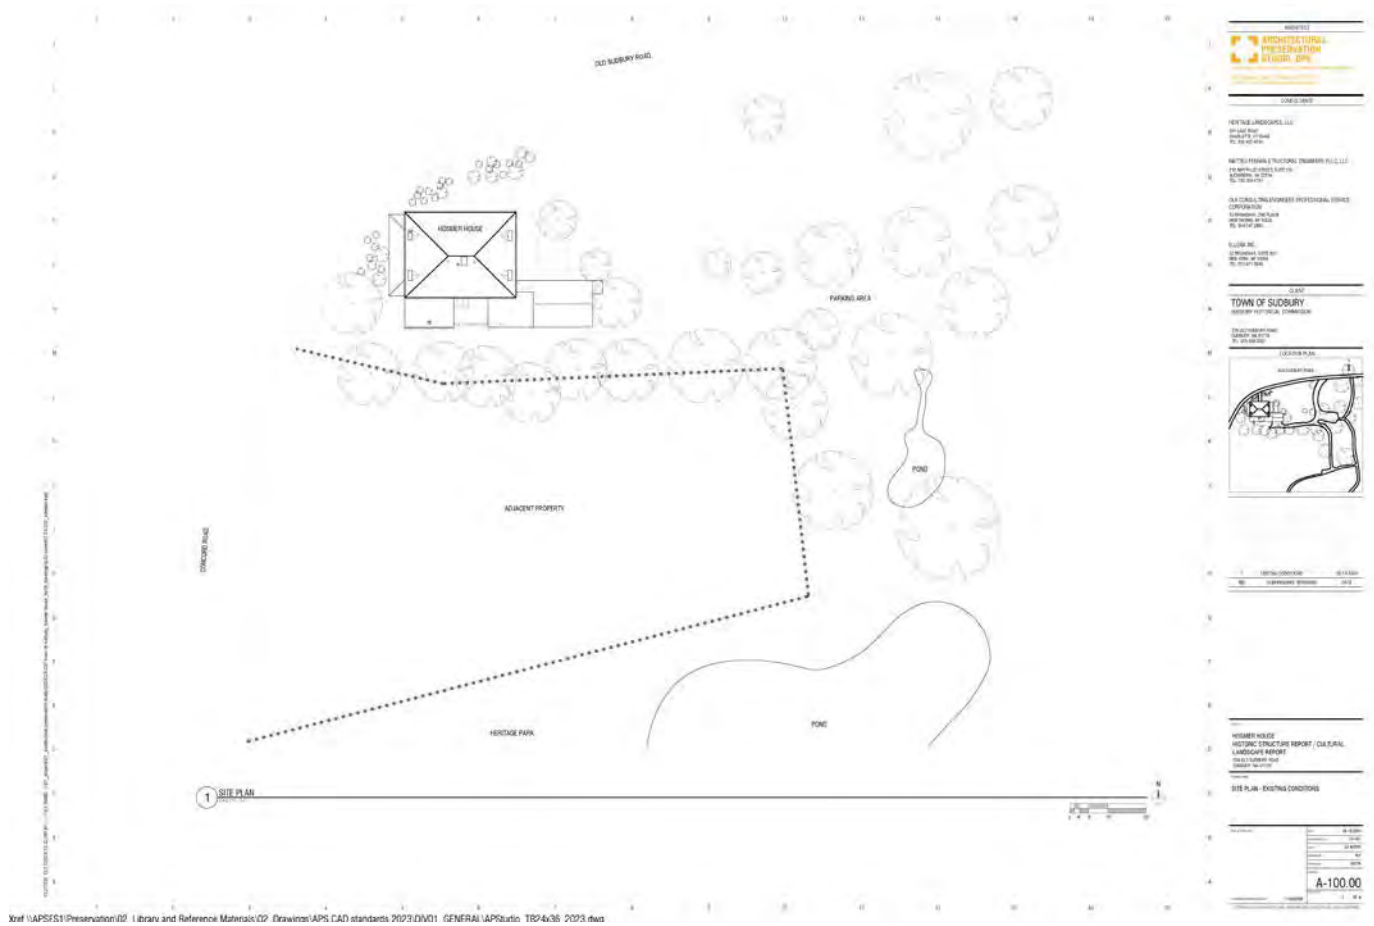
Figure 11.1-1
Site Plan – Existing Conditions

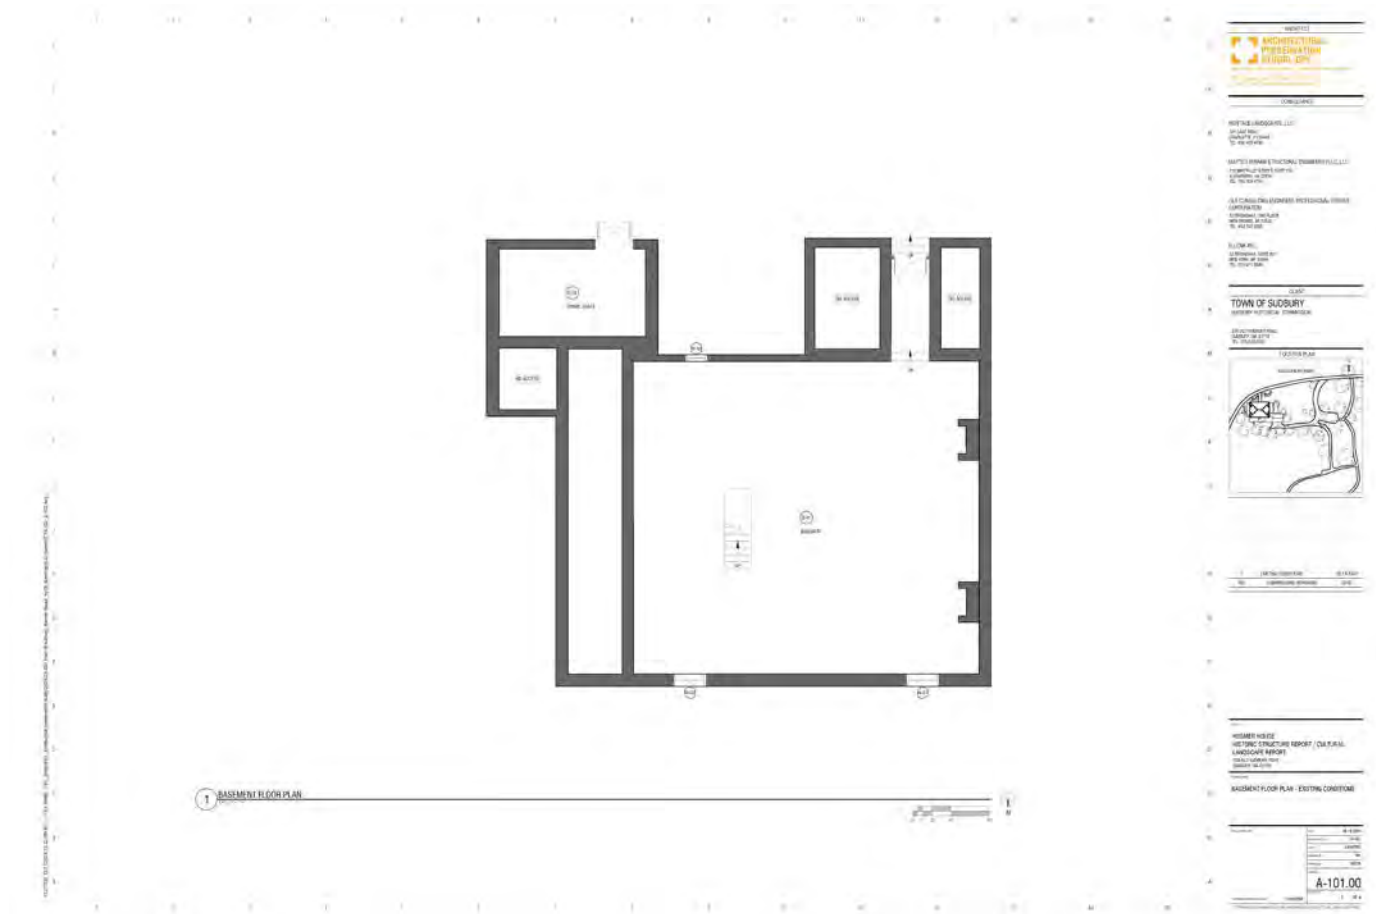
Figure 11.2-1
Basement Floor Plan – Existing Conditions

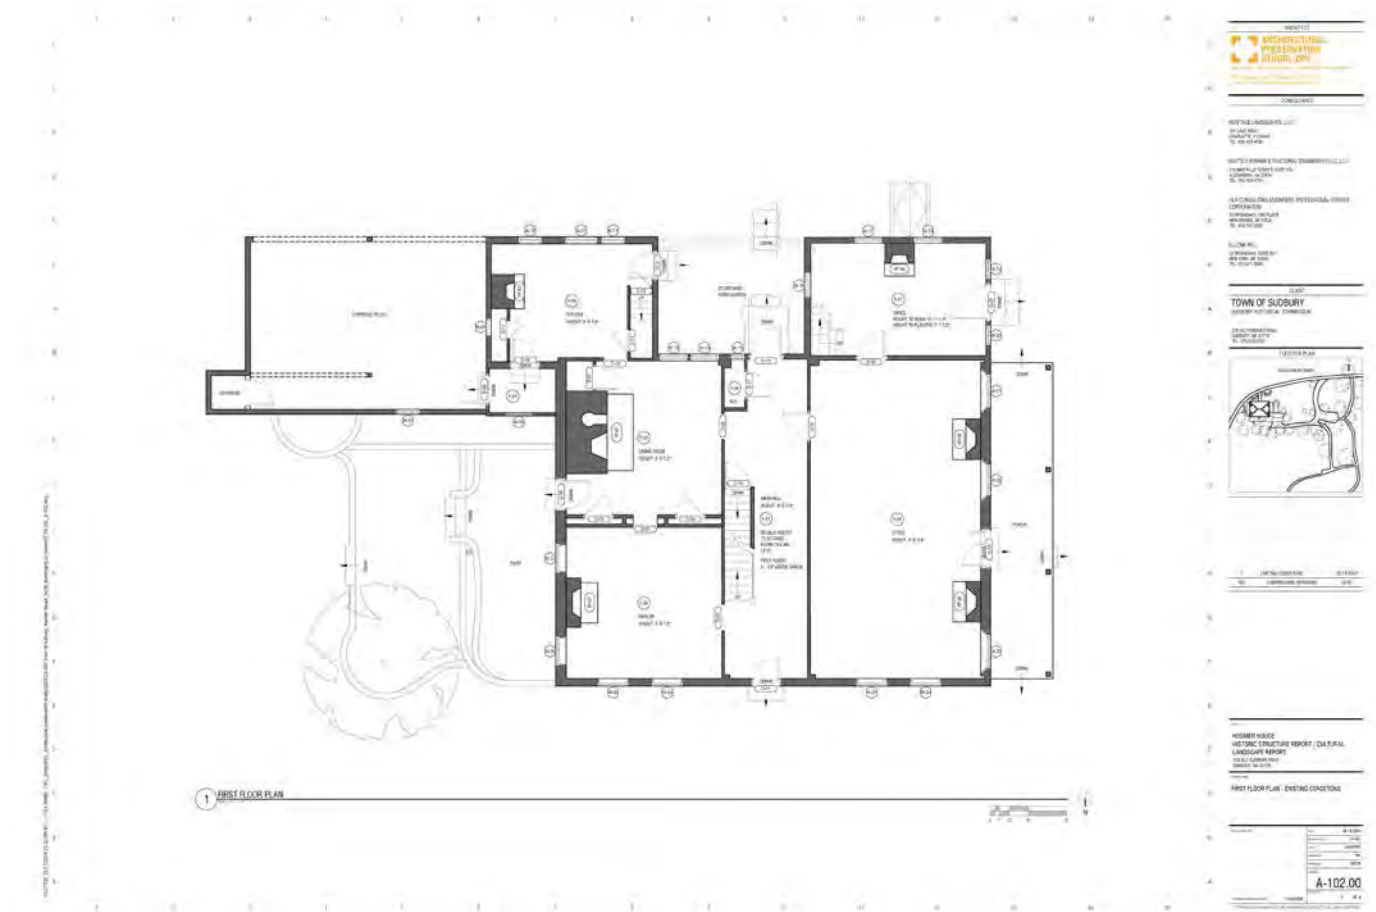
Figure 11.2-2
First Floor Plan – Existing Conditions

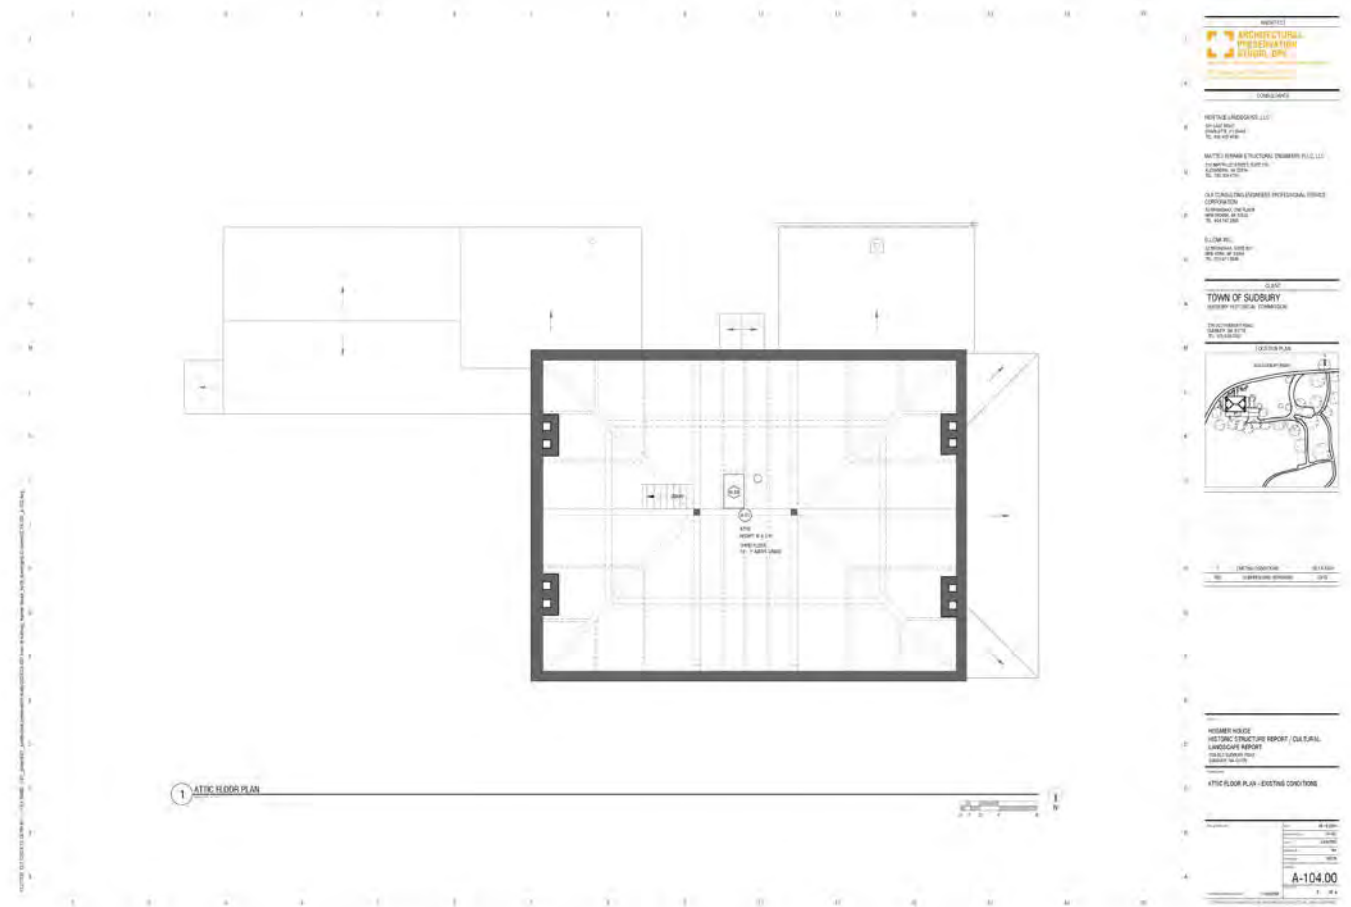
Figure 11.2-4
Attic Floor Plan – Existing Conditions
