HOSMER HOUSE

HISTORIC STRUCTURE REPORT / CULTURAL LANDSCAPE REPORT

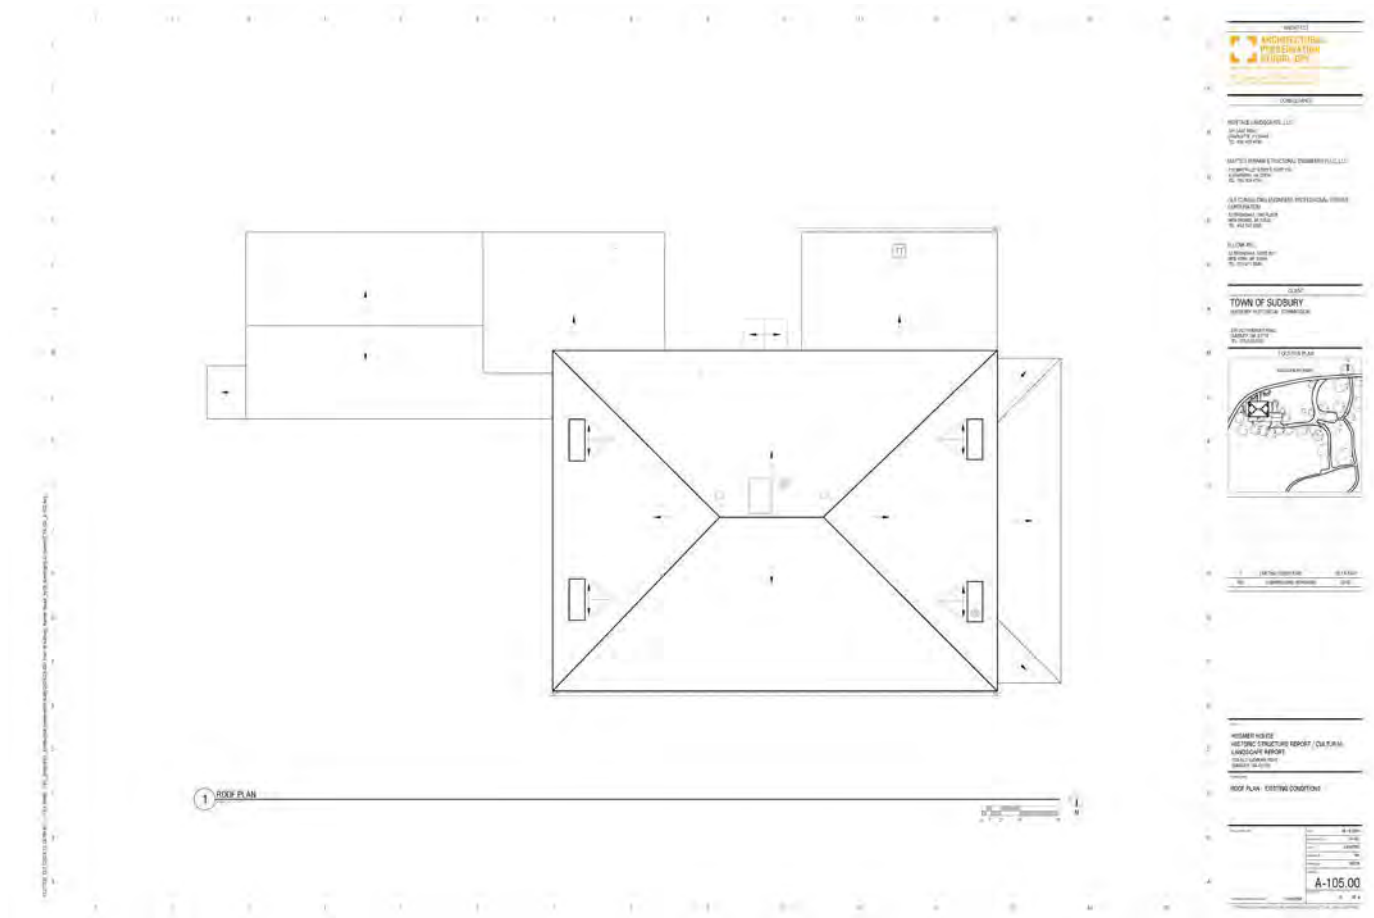
Figure 11.2-5
Roof Plan – Existing Conditions

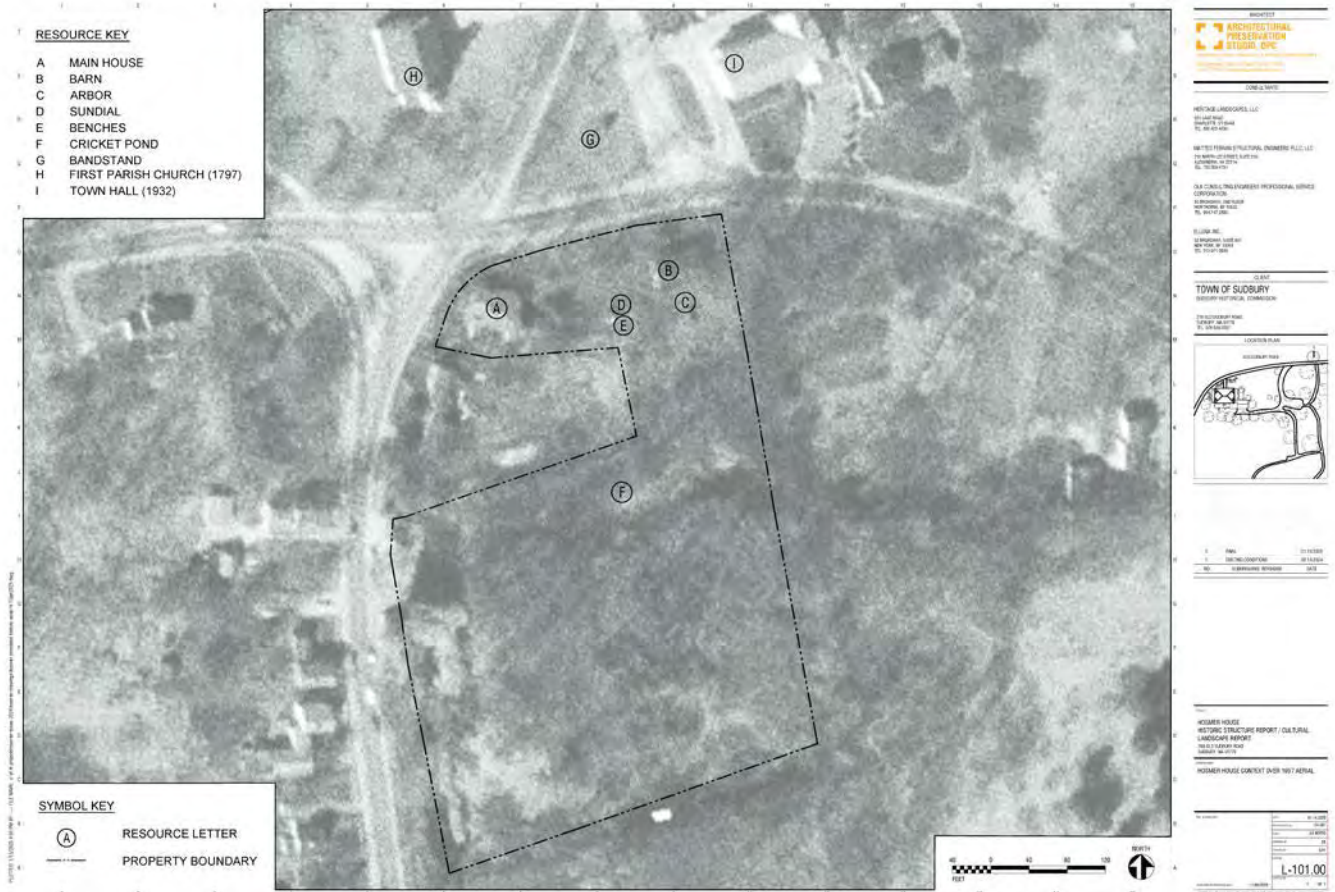
Figure 11.3-1
Hosmer House Context Over 1957 Aerial

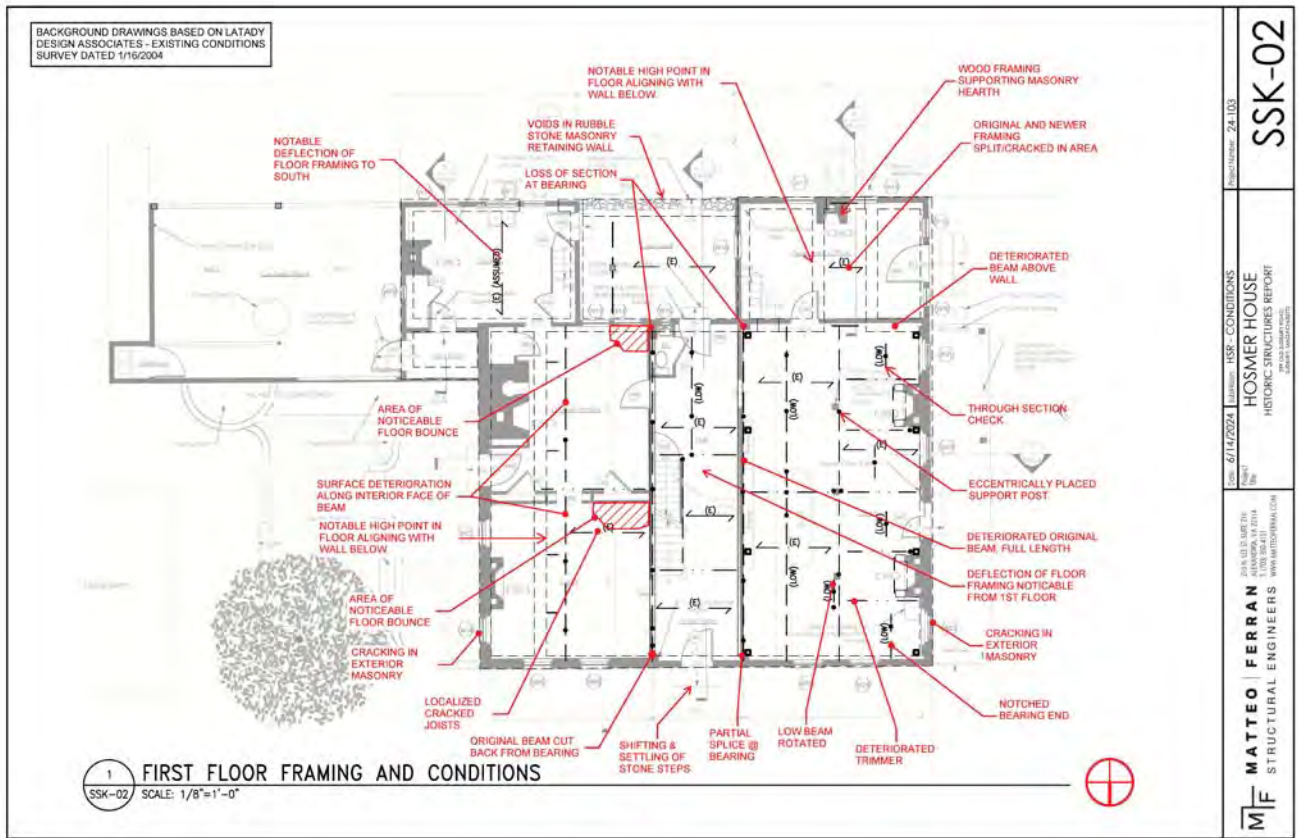
Figure 11.7-2
 First Floor Framing And Conditions

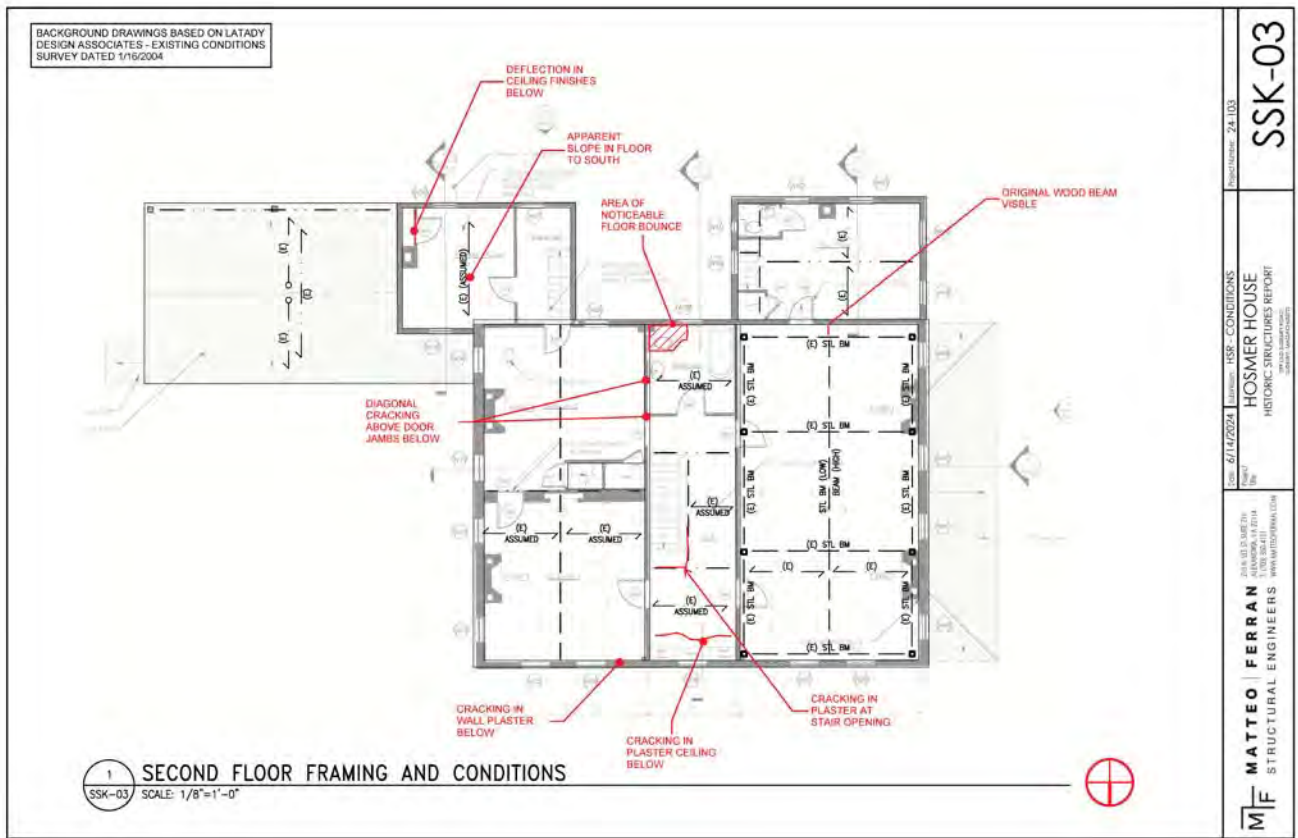
Figure 11.7-3
Second Floor Framing And Conditions

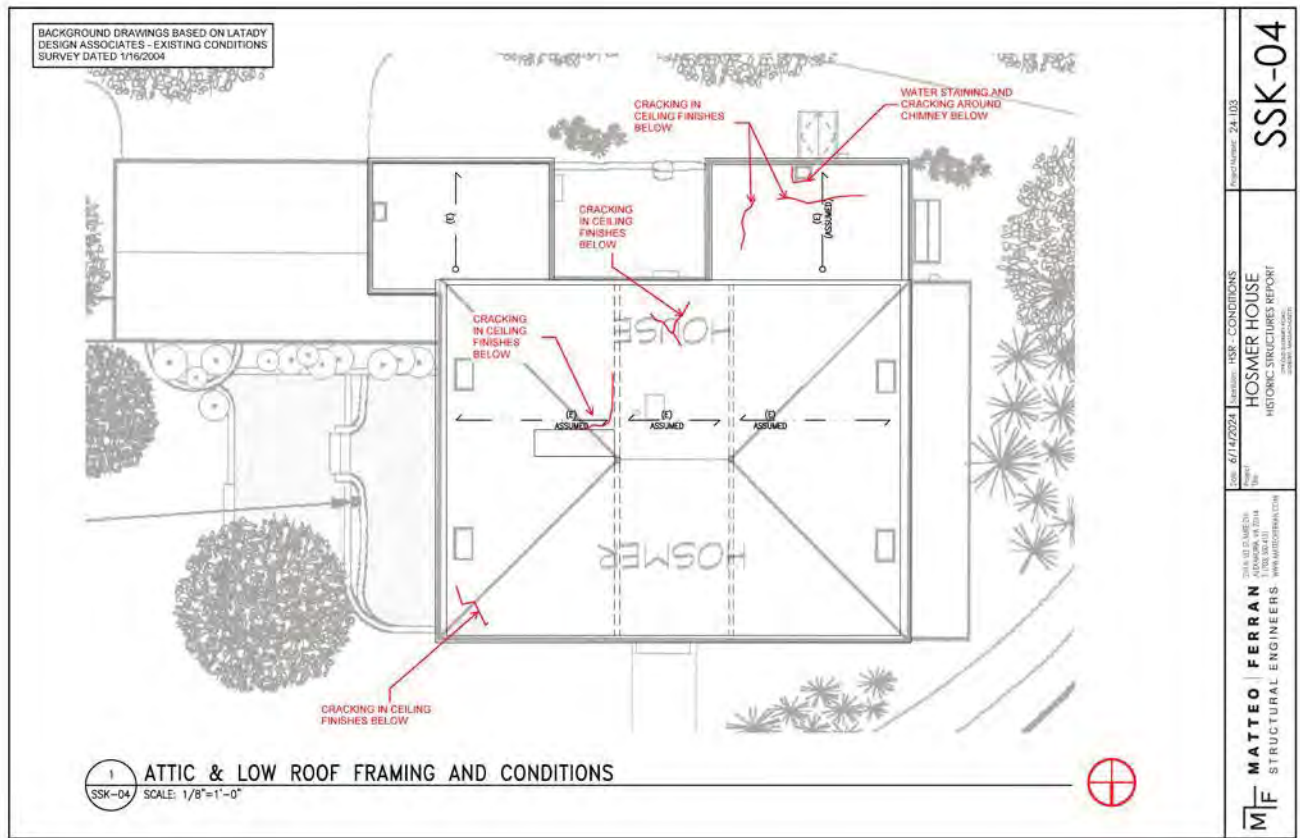
Figure 11.7-4
Attic & Low Roof Framing And Conditions

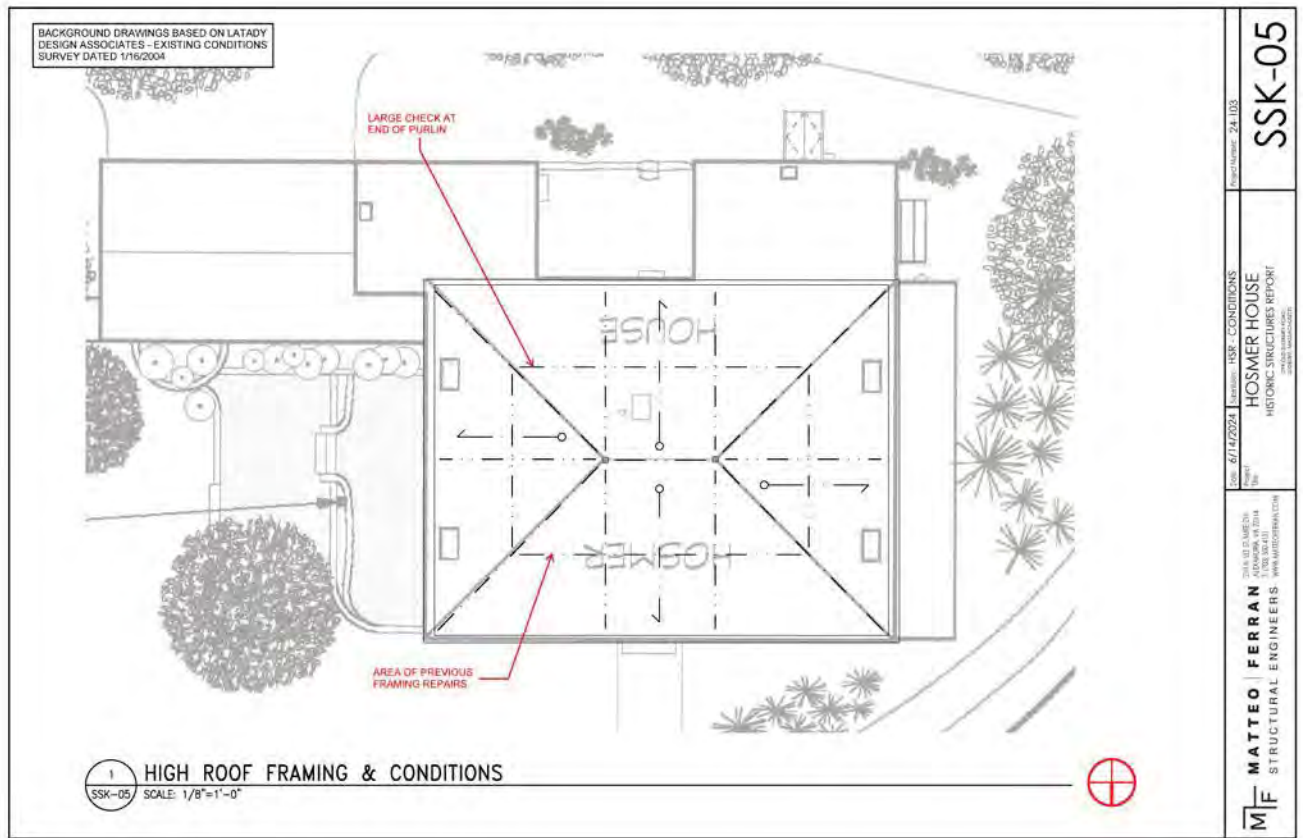
Figure 11.7-5
High Roof Framing & Conditions
