# Broadacres Farm

## Town of Sudbury ADA Transition Plan

September 2020

Institute for Human Centered Design

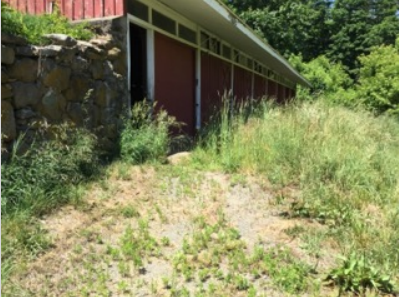
| ID | Location | Floor | Room | Element | Type | Photo | Issues | Current Measure | Recommendations | Quantity | Price | Cost Estimation |
|---|--|---|---|---|---|--|---|---|--|---|---|---|
| 1 | Path Between Horse Riding Practice Building and Horse Barn | Ext. | | Exterior Access Route | Walkway | | Running slope > 1:20 (5%)<br>Surface is not stable, firm, and slip-resistant<br>Accessible route not provided | 7.3%<br>-<br>250' | Ensure an accessible route is provided with a slope no greater than 1:20 (5.00%).<br>(Cost estimate for a 250' long 4' wide stone dust walkway.) | 1 | 8000 | \$8000 |

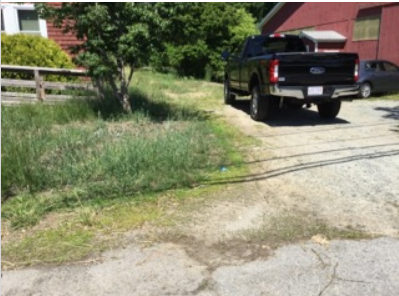
| ID | Location | Floor | Room | Element | Type | Photo | Issues | Current Measure | Recommendations | Quantity | Price | Cost Estimation |
|---|--|---|---|---|---|--|---|---|--|---|---|---|
| 2 | House Entrance | Ext. | | Exterior Access Route | Walkway | | Level changes > 1/4" | 2" | Alter change in level to be 1/4" high max. (Cost estimate for a 4' by 4' asphalt area.) | 1 | 160 | \$160 |

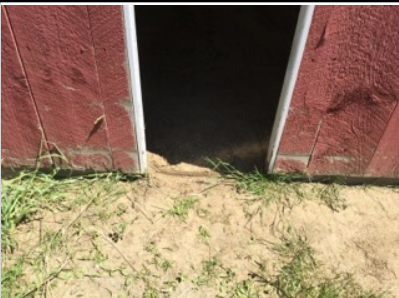
| ID | Location | Floor | Room | Element | Type | Photo | Issues | Current Measure | Recommendations | Quantity | Price | Cost Estimation |
|---|--|---|---|---|---|--|---|---|--|---|---|---|
| 3 | Horse Riding Practice Building | Ext. | | Exterior Access Route | Walkway | | Accessible route not provided | - | Ensure an accessible route is provided to the new main entrance door. (Cost estimate for a 10' long 4' wide stone dust walkway.) | 1 | 320 | \$320 |

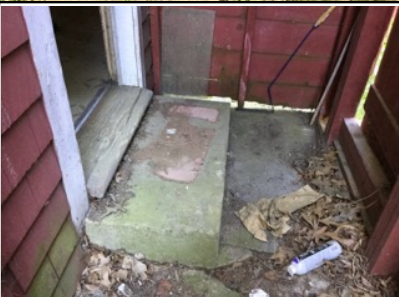
| ID | Location | Floor | Room | Element | Type | Photo | Issues | Current Measure | Recommendations | Quantity | Price | Cost Estimation |
|---|--|---|---|---|---|--|---|---|--|---|---|---|
| 4 | Kitchen Egress to Outdoor Office | Ext. | | Exterior Access Route | Exterior | | Accessible route not provided | - | Due to lack of space an accessible route may not be technically feasible to the outdoor office. | 1 | - | \$0 |

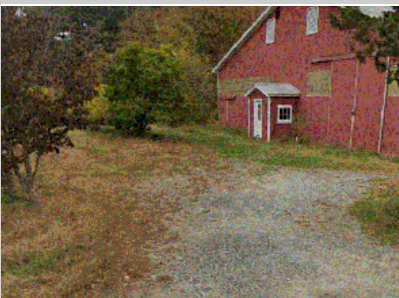
| ID | Location | Floor | Room | Element | Type | Photo | Issues | Current Measure | Recommendations | Quantity | Price | Cost Estimation |
|---|--|---|---|---|---|--|---|---|--|---|---|---|
| 5 | Parking Area | Ext. | | Off-Street Parking Lot or Garage | Visitor | | Total # of parking<br>Total # of designated van accessible spaces | 3<br>0 | Provide one van accessible parking space. | 1 | 1850 | \$1850 |

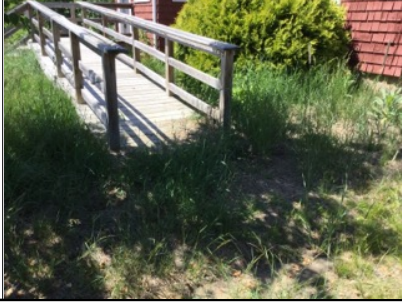
| ID | Location | Floor | Room | Element | Type | Photo | Issues | Current Measure | Recommendations | Quantity | Price | Cost Estimation |
|---|--|---|---|---|---|--|---|---|--|---|---|---|
| 6 | House - Main Entrance | Ext. | | Exterior Ramp | N/A | | No lower handrail 18"-20" high provided<br>Ramp < 48" wide<br>Handrails do not extend 12" past top & bottom<br>Handrails have non-compliant cross section<br>Ramp is not located on an accessible route | -<br>35"<br>-<br>- | Rebuild ramp so that there is 48" inches clear. Provide a lower handrail between 18" to 20" high on each side. Provide handrails that extend horizontally above the landing for 12" min. beyond the top and bottom of ramp runs. Provide handrails with 1-1/4" to 1-1/2" circular cross sections. (Cost estimate for a new 30' pressure treated wood ramp.). | 1 | 7843 | \$7843 |

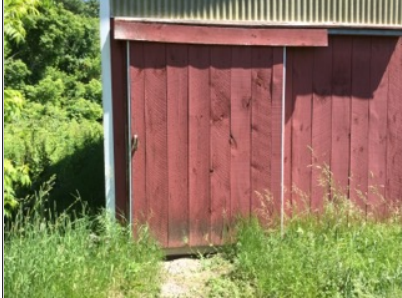
| ID | Location | Floor | Room | Element | Type | Photo | Issues | Current Measure | Recommendations | Quantity | Price | Cost Estimation |
|---|--|---|---|---|---|--|---|---|--|---|---|---|
| 7 | Horse Riding Practice Building Inaccessible Door | Ext. | | Entrance | Secondary Entrance | | Entrance not on an accessible route<br>Directional sign to accessible entrance not provided | 5"<br>- | Provide a directional sign indicating the location of the nearest accessible entrance. | 1 | 346 | \$346 |

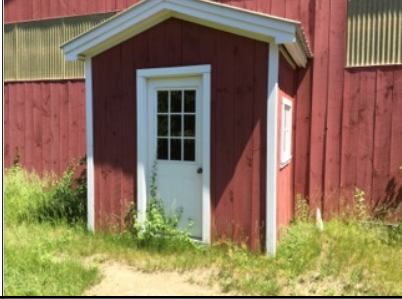
| ID | Location | Floor | Room | Element | Type | Photo | Issues | Current Measure | Recommendations | Quantity | Price | Cost Estimation |
|---|--|---|---|---|---|--|---|---|--|---|---|---|
| 8 | Horse Riding Practice Building Observation Area | Ext. | | Entrance | Secondary Entrance | | Entrance not on an accessible route<br>Threshold > 1/2" high<br>Hardware not operable with a closed fist<br>International Symbol of Accessibility not provided | -<br>5"<br>- | After the entrance is made accessible, provide a sign with the International Symbol of Accessibility (ISA). Provide hardware that can be operable with one hand and not require tight grasping, pinching, or twisting of the wrist. Provide a sloped walkway with a 5' by 5' level platform at the door. (Cost estimate includes a 15' long concrete route to the door, door hardware and sign.) | 1 | 2030 | \$2030 |

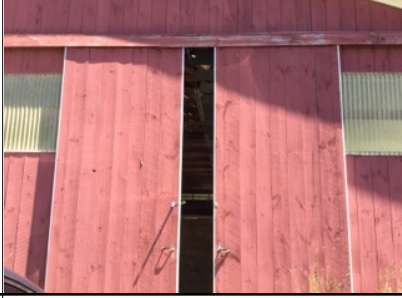
| ID | Location | Floor | Room | Element | Type | Photo | Issues | Current Measure | Recommendations | Quantity | Price | Cost Estimation |
|---|--|---|---|---|---|--|---|---|--|---|---|---|
| 9 | Horse Riding Practice Building Main Entrance | Ext. | | Entrance | Main Entrance | | International Symbol of Accessibility not provided | -<br>- | Provide a sign with the International Symbol of Accessibility (ISA) at the new accessible entrance door. | 1 | 346 | \$346 |

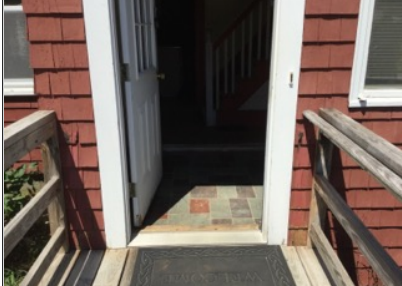
| ID | Location | Floor | Room | Element | Type | Photo | Issues | Current Measure | Recommendations | Quantity | Price | Cost Estimation |
|---|--|---|---|---|---|--|---|---|--|---|---|---|
| 10 | House - Main Entrance | Ext. | | Entrance | Main Entrance | | Threshold > 1/2" high<br>Hardware not operable with a closed fist | 1"<br>- | Alter threshold to be 1/2" high max. Provide hardware that can be operable with one hand and not require tight grasping, pinching, or twisting of the wrist. | 1 | 634 | \$634 |

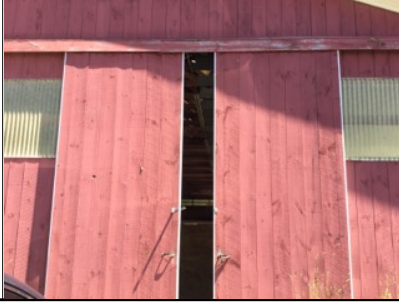
| ID | Location | Floor | Room | Element | Type | Photo | Issues | Current Measure | Recommendations | Quantity | Price | Cost Estimation |
|---|--|---|---|---|---|--|---|---|---|---|---|---|
| 11 | Horse Riding Practice Building Main Entrance | Ext. | | Entrance | Main Entrance | | Door requires > 15 lbs. of force to open | - | Provide an accessible door into the facility. (Cost estimate for installing a solid core wood door.) | 1 | 2972 | \$2972 |

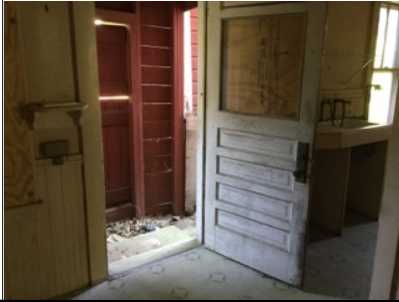
| ID | Location | Floor | Room | Element | Type | Photo | Issues | Current Measure | Recommendations | Quantity | Price | Cost Estimation |
|---|--|---|---|---|---|--|---|---|---|---|---|---|
| 12 | Kitchen Egress | 1 | | Emergency Exit | N/A | | Tactile sign not provided at exit<br>Directional sign to accessible emergency exit not provided | -<br>- | Provide tactile exit signs with raised characters and braille at exit doors. Mount signs between 48"- 60" above the finished floor located on the latch side of the door.<br>Provide a directional sign indicating the location of the nearest accessible emergency exit. | 1 | 464 | \$464 |

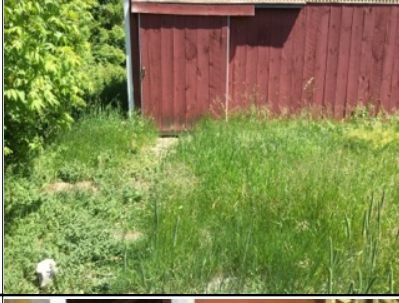
| ID | Location | Floor | Room | Element | Type | Photo | Issues | Current Measure | Recommendations | Quantity | Price | Cost Estimation |
|---|--|---|---|---|---|--|---|---|---|---|---|---|
| 13 | Horse Riding Practice Building Inaccessible Door | Ext. | | Emergency Exit | N/A | | Tactile sign not provided at exit<br>Directional sign to accessible emergency exit not provided | -<br>- | At the interior of the exit door: provide tactile exit signs with raised characters and braille at exit doors. Mount signs between 48"- 60" above the finished floor located on the latch side of the door.<br>Provide a directional sign indicating the location of the nearest accessible emergency exit. | 1 | 464 | \$464 |

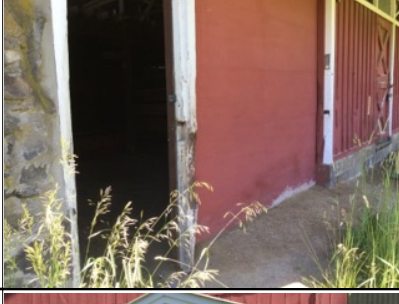
| ID | Location | Floor | Room | Element | Type | Photo | Issues | Current Measure | Recommendations | Quantity | Price | Cost Estimation |
|---|--|---|---|---|---|--|---|---|---|---|---|---|
| 14 | Horse Barn Exit | 1 | | Emergency Exit | N/A | | Tactile sign not provided at exit<br>Illuminated Int. Symbol of Acc. not provided (MAAB) | -<br>- | Provide tactile exit signs with raised characters and braille at exit doors. Mount signs between 48"- 60" above the finished floor located on the latch side of the door.<br>Provide an illuminated sign with the International Symbol of Accessibility. | 1 | 1116 | \$1116 |

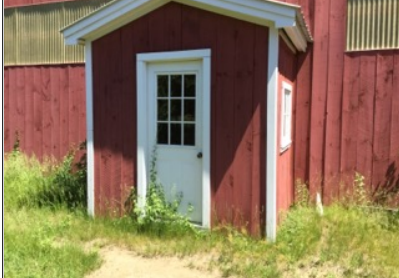
| ID | Location | Floor | Room | Element | Type | Photo | Issues | Current Measure | Recommendations | Quantity | Price | Cost Estimation |
|---|--|---|---|---|---|--|---|---|---|---|---|---|
| 15 | Horse Riding Practice Building Observation Area | Ext. | | Emergency Exit | N/A | | Tactile sign not provided at exit<br>Illuminated Int. Symbol of Acc. not provided (MAAB) | -<br>-<br>- | Provide a tactile exit signs with raised characters and braille at the interior. Mount signs between 48"- 60" above the finished floor located on the latch side of the door.<br>After the door is made accessible, provide an illuminated sign with the International Symbol of Accessibility on the interior of the door. | 1 | 1116 | \$1116 |

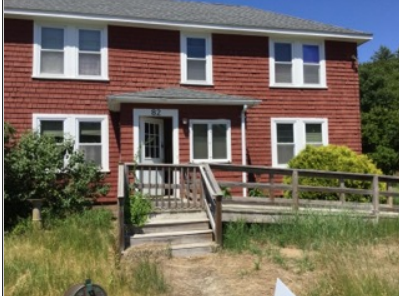
| ID | Location | Floor | Room | Element | Type | Photo | Issues | Current Measure | Recommendations | Quantity | Price | Cost Estimation |
|---|--|---|---|---|---|--|--|---|---|---|---|---|
| 16 | House - Main Entrance | Ext. | | Emergency Exit | N/A | | Tactile sign not provided at exit<br>Illuminated Int. Symbol of Acc. not provided (MAAB) | -<br>- | Provide a tactile exit sign with raised characters and braille at the interior of the exit door. Mount sign between 48"- 60" above the finished floor located on the latch side of the door.<br>After the exit is made accessible, provide an illuminated sign with the International Symbol of Accessibility. | 1 | 1116 | \$1116 |

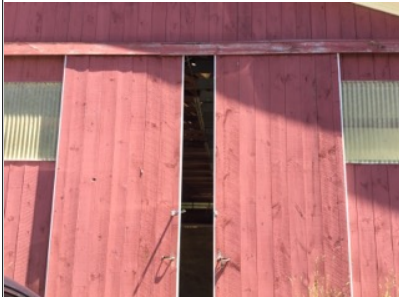
| ID | Location | Floor | Room | Element | Type | Photo | Issues | Current Measure | Recommendations | Quantity | Price | Cost Estimation |
|---|--|---|---|---|---|--|--|---|---|---|---|---|
| 17 | Horse Riding Practice Building Main Entrance | Ext. | | Emergency Exit | N/A | | Tactile sign not provided at exit<br>Illuminated Int. Symbol of Acc. not provided (MAAB)<br>Directional sign to accessible emergency exit not provided | -<br>-<br>-<br>- | At the interior of the exit door: provide tactile exit signs with raised characters and braille at the existing main exit door and the new accessible main exit door. Provide a directional sign indicating the location of the nearest accessible emergency exit at the inaccessible exit. Provide an illuminated sign with the International Symbol of Accessibility at the accessible exit door. | 1 | 1580 | \$1580 |

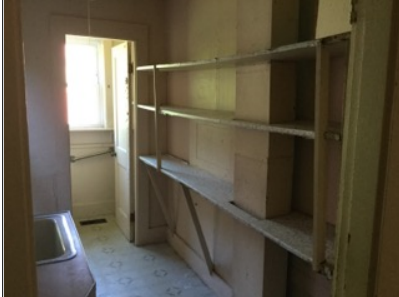
| ID | Location | Floor | Room | Element | Type | Photo | Issues | Current Measure | Recommendations | Quantity | Price | Cost Estimation |
|---|--|---|---|---|---|--|--|---|---|---|---|---|
| 18 | Kitchen Storage and Bathroom | 1 | | Interior Access Route | N/A | | Route < 36" wide | 31" | Ensure that a clear width of 36" min. is maintained at the accessible route. Remove shelves. Route is allowed to narrow to 32 inches for a depth of 24 inches. | 1 | Labor | \$0 |

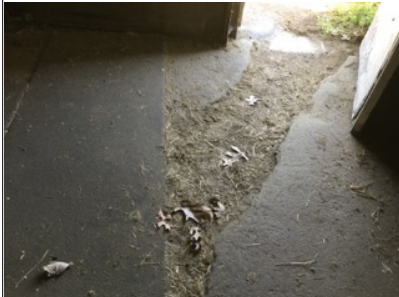
| ID | Location | Floor | Room | Element | Type | Photo | Issues | Current Measure | Recommendations | Quantity | Price | Cost Estimation |
|---|--|---|---|---|---|--|--|---|---|---|---|---|
| 19 | Horse Barn Entrance | 1 | | Interior Access Route | N/A | | Level changes > 1/4" | 2" | Alter change in level to be 1/4" high max. | 1 | 144 | \$144 |

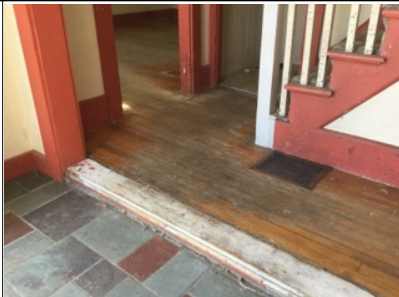
| ID | Location | Floor | Room | Element | Type | Photo | Issues | Current Measure | Recommendations | Quantity | Price | Cost Estimation |
|---|--|---|---|---|---|--|--|---|---|---|---|---|
| 20 | House - Main Entrance | 1 | | Interior Access Route | N/A | | Level changes > 1/4" | 3" | Alter change in level to be 1/4" high max. | 1 | 432 | \$432 |

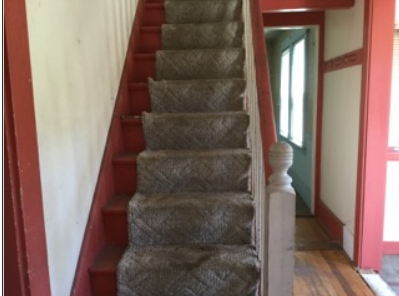
| ID | Location | Floor | Room | Element | Type | Photo | Issues | Current Measure | Recommendations | Quantity | Price | Cost Estimation |
|---|---|---|---|---|---|--|---|---|---|---|---|---|
| 21 | Stair | 1 | | Interior Access Route | N/A | | Accessible route not provided | - | Consider locating all public programs on the first floor of the building. | 1 | - | \$0 |

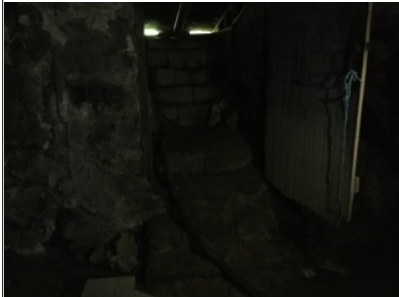
| ID | Location | Floor | Room | Element | Type | Photo | Issues | Current Measure | Recommendations | Quantity | Price | Cost Estimation |
|---|---|---|---|---|---|--|---|---|---|---|---|---|
| 22 | Basement | B | | Interior Access Route | N/A | | Vertical clearance < 80" above finished floor | 62.5" | The basement is unfinished with tripping hazards, no lighting, and has vertical clearance less than 80" above the floor in some areas. IHCD recommends not providing public programs in this area. | 1 | - | \$0 |

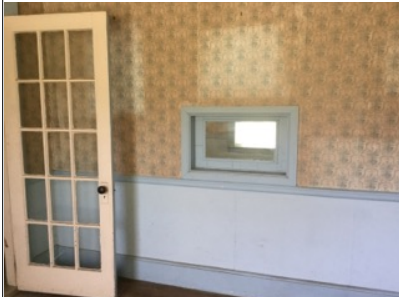
| ID | Location | Floor | Room | Element | Type | Photo | Issues | Current Measure | Recommendations | Quantity | Price | Cost Estimation |
|---|---|---|---|---|---|--|---|---|---|---|---|---|
| 23 | Dining Room | 1 | | Doors, Doorways, & Gates | Other | | Hardware not operable with a closed fist | - | Provide hardware that can be operable with one hand and not require tight grasping, pinching, or twisting of the wrist. | 1 | 484 | \$484 |

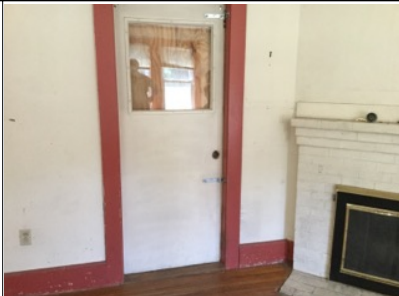
| ID | Location | Floor | Room | Element | Type | Photo | Issues | Current Measure | Recommendations | Quantity | Price | Cost Estimation |
|---|---|---|---|---|---|--|---|---|---|---|---|---|
| 24 | Access to Porch From the Living Room | 1 | | Doors, Doorways, & Gates | Other | | Hardware not operable with a closed fist | - | Provide hardware that can be operable with one hand and not require tight grasping, pinching, or twisting of the wrist. | 1 | 484 | \$484 |

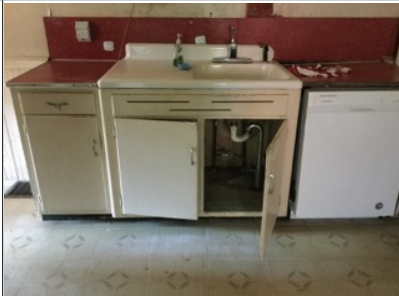
| ID | Location | Floor | Room | Element | Type | Photo | Issues | Current Measure | Recommendations | Quantity | Price | Cost Estimation |
|---|---|---|---|---|---|--|---|---|---|---|---|---|
| 25 | Kitchen | 1 | | Kitchens and Kitchenettes | N/A | | Knee/toe clearance not provided at sink<br>Sink > 34" high<br>Countertop > 34" high | -<br>-<br>- | Provide a sink with knee and toe clearance positioned for a forward approach.<br>Lower sink to be no higher than 34" positioned for a forward approach.<br>Lower countertop to provide a work surface no higher than 34" positioned for a forward approach. | 1 | 3974 | \$3974 |

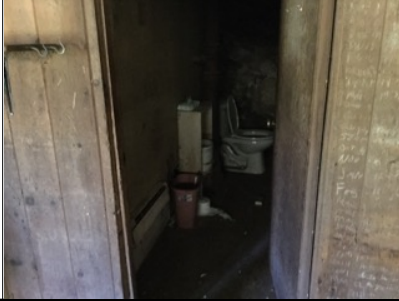
| ID | Location | Floor | Room | Element | Type | Photo | Issues | Current Measure | Recommendations | Quantity | Price | Cost Estimation |
|---|---|---|---|---|---|--|---|---|--|---|---|---|
| 26 | Horse Barn Toilet Room | 1 | | Overall Access | Toilet Room | | Turning space not provided<br>Accessible plumbing fixtures or stalls not provided | 40"<br>- | Add an accessible single-user toilet room. | 1 | 24604 | \$24604 |

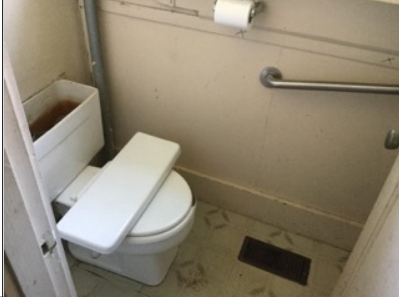
| ID | Location | Floor | Room | Element | Type | Photo | Issues | Current Measure | Recommendations | Quantity | Price | Cost Estimation |
|---|---|---|---|---|---|--|---|---|--|---|---|---|
| 27 | Kitchen Bathroom in the House | 1 | | Overall Access | Toilet Room | | Turning space not provided<br>Accessible plumbing fixtures or stalls not provided | 31"<br>- | Provide an accessible single-user toilet room. | 1 | 24604 | \$24604 |

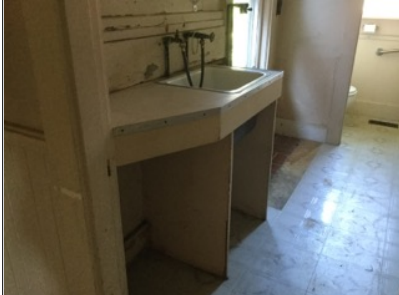
| ID | Location | Floor | Room | Element | Type | Photo | Issues | Current Measure | Recommendations | Quantity | Price | Cost Estimation |
|---|---|---|---|---|---|--|---|---|--|---|---|---|
| 28 | Kitchen Storage Area | 1 | | Sink | Other | | Toe and knee clearances not provided<br>Rim or counter > 34"<br>Non-compliant faucets | 24"<br>37"<br>- | Ensure there is a 27" knee clearance positioned for a forward approach.<br>Relocate sink with the front of the rim or counter no higher than 34".<br>Install faucets that do not require tight grasping, pinching, or twisting of the wrist. | 1 | 4080 | \$4080 |
