Davis Field

Town of Sudbury ADA Transition Plan

December 2020

Institute for Human Centered Design

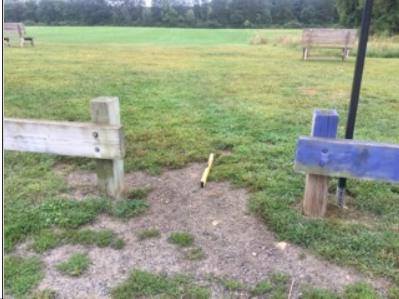
Running slope > 1:20 (5%) Accessible route not provided	7.4% -	Reduce running slope to be no steeper than 1:20 (5%). Ensure an accessible route is provided. (Cost estimate for a 6' long, 4' wide stone dust route.)	1	192	\$192
2	Center Entrance to Wayside	Ext.		Exterior Access Route	Exterior

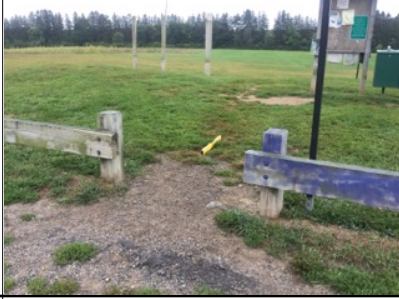
Running slope > 1:20 (5%) Accessible route not provided	9.8% -	Reduce running slope to be no steeper than 1:20 (5%). Ensure an accessible route is provided. (Cost estimate for a 4' wide 14' long stone dust route.)	1	448	\$448
3	Wayside and Trash Container	Ext.		Exterior Access Route	Exterior

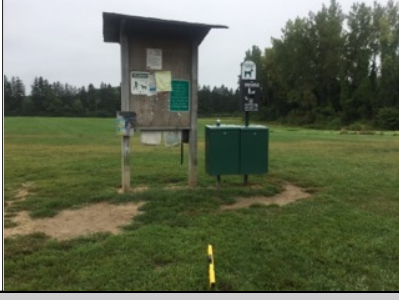
Accessible route not provided	-	Ensure an accessible route is provided. (Cost estimate for a 4' wide 13' long stone dust route.)	1	416	\$416

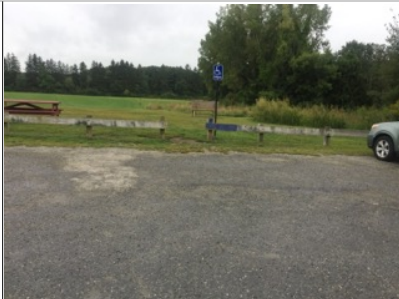
Off-Street Parking Lot or Garage												
4	Parking Lot	Ext.		Off-Street Parking Lot or Garage	Visitor

Total # of parking Total # of designated accessible parking spaces	175 est. 3	Parking lot has 175-200 spaces estimated. Provide three additional accessible spaces.	3	800	\$2400
5	Parking Lot Near Picnic Table on West Side	Ext.		Off-Street Parking Lot or Garage	Visitor

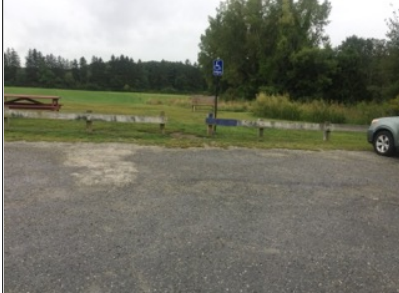
Access aisle not provided	-	Provide a marked access aisle that is at least 60" wide.	1	300	\$300

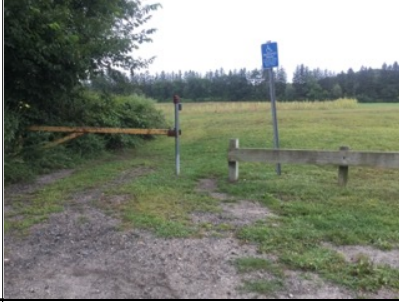
ID	Location	Floor	Room	Element	Type	Photo	Issues	Current Measure	Recommendations	Quantity	Price	Cost Estimation
6	Parking Lot Near Gate Opening on East Side	Ext.		Off-Street Parking Lot or Garage	Visitor

Access aisle not provided	-	Provide a marked access aisle that is at least 60" wide and a marked vehicle space that is 96" wide min.	1	300	\$300
7	Parking Lot Near Wayside Opening in Center	Ext.		Off-Street Parking Lot or Garage	Visitor

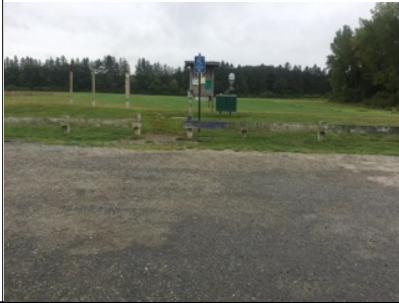
Access aisle not provided Sign does not have the designation "Van Accessible"	- -	Provide a marked access aisle that is at least 96" wide. Add the designation "Van Accessible" to the sign located at the van accessible space.	1	800	\$800
Access to Goods and Services												
Operable Parts												
8	Lost and Found on Back of Wayside	Ext.		Operable Parts	Lost and Found	 	Element not on an accessible route Side reach > 54"	- 58"	Provide an accessible route to the lost and found area. Relocate lost and found between 15" - 48" above the finished floor. (Cost estimate for a 20' long 4' wide stone dust route.)	1	640 Labor	\$640

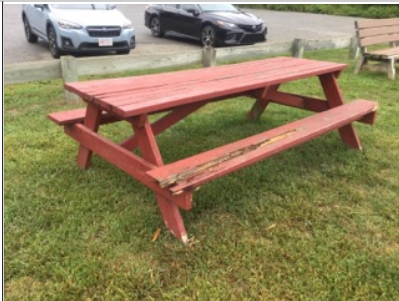
Picnic Tables												
9	Picnic Table Near Parking Lot	Ext.		Picnic Tables	N/A

Toe or knee clearance at table not provided Picnic table not on an accessible route	- -	Provide at least one picnic table with top between 28"- 34" above the ground and 27" clear height underneath. Ensure that the dining surface is connected to an accessible route. (Cost estimate for an accessible picnic table and a 37" long by 4' wide stone dust path from the entrance to the table.)	1	2584	\$2584

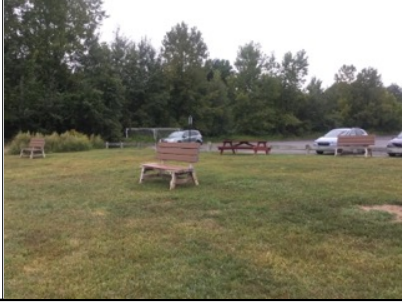
ID	Location	Floor	Room	Element	Type	Photo	Issues	Current Measure	Recommendations	Quantity	Price	Cost Estimation
Benches												
10	Bench Near Parking Lot	Ext.		Benches	N/A

No accessible route to one bench in this area	-	Provide an accessible route to at least one bench in this area. (Cost estimate for a 30' long, 4' wide stone dust route).	1	960	\$960
Play and Sport Areas												
Field												
11	Soccer Nets by Parking Lot and Benches	Ext.		Field	Soccer

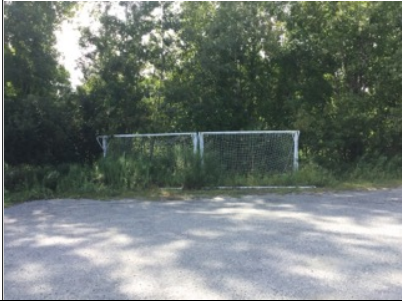
Not connected to an accessible-route	-	Provide an accessible route to the field. (Cost estimate for 10' long, 4' wide stone dust route.)	1	320	\$320
Best Practice												
12	Picnic Table Near Parking Lot	Ext.

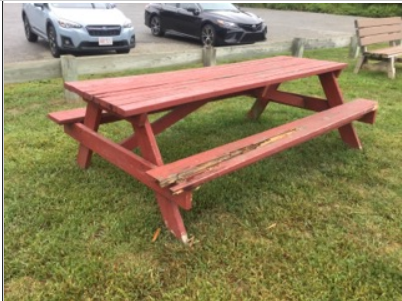
-	Recommend providing a 48" wide min. stable, firm and slip resistant surface under and around an accessible picnic table once it is placed in the picnic area and connected to an accessible route.	1	-	\$0
13	Bench Near Parking Lot	Ext.

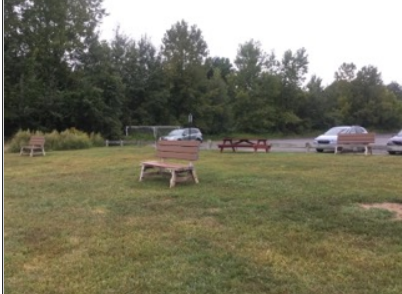
-	Recommend providing clear floor space of 36" wide minimum by 48" deep alongside one bench so that a wheelchair user can sit alongside someone sitting on the bench.	1	-	\$0
