# Featherland Park

## Town of Sudbury ADA Transition Plan

December 2020

Institute for Human Centered Design

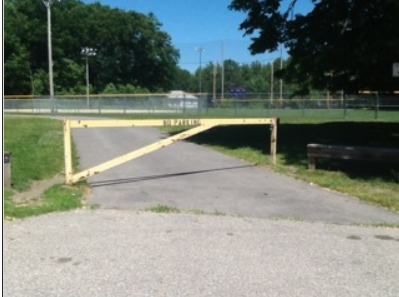
ID	Location	Floor	Room	Element	Type	Photo	Issues	Current Measure	Recommendations	Quantity	Price	Cost Estimation
<b>Approach and Entrance</b>												
<b>Exterior Access Route</b>												
1	Path Between Baseball Field 1 and Softball Field 2 (Gate Closed)	Ext.		Exterior Access Route	Walkway

Exterior route < 48" wide	-	Ensure that gate is opened during operating hours.	1	Labor	\$0
2	Asphalt Path to Entrance to Baseball Field 3	Ext.		Exterior Access Route	Walkway

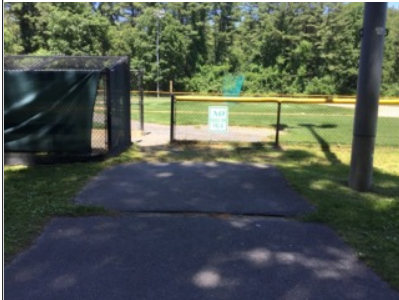
Level changes > 1/4"	1"	Alter change in level to be 1/4" high max.	1	320	\$320
3	Ice Rink Entrance	Ext.		Exterior Access Route	Exterior

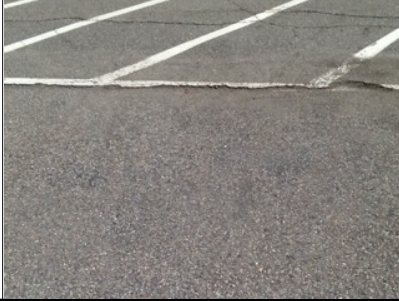
Level changes > 1/4" Route not maintained in operable working condition	1" -	Alter change in level to be 1/4" high max. Ensure the accessible route is maintained in operable working condition.	1	160	\$160
4	Ice Rink Entrance	Ext.		Exterior Access Route	Exterior

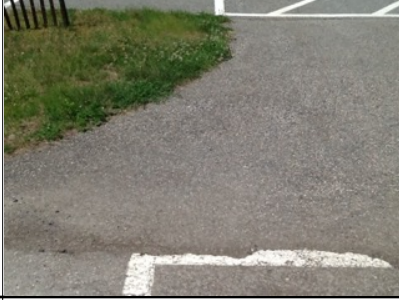
Route not maintained in operable working condition	1"	Ensure the accessible route is maintained in operable working condition.	1	160	\$160

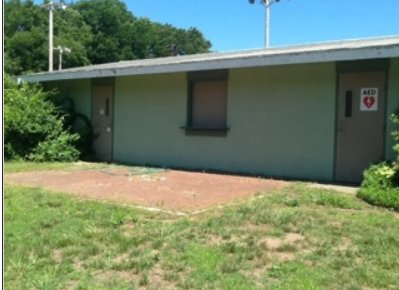
5	South Side of South Concession Between Field 1 and Field 2	Ext.		Exterior Access Route	Walkway

Accessible route not provided	-	Provide an accessible route to the toilet room, concession stand and office on the south side of the concession stand. (Cost estimate for 54' long, 4' wide asphalt route.)	1	2160	\$2160

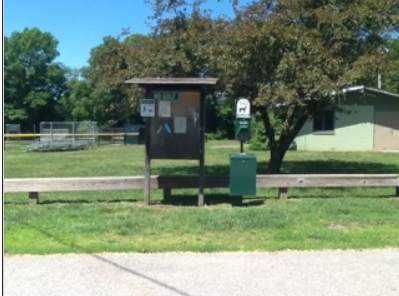
Accessible route not provided	-	Ensure an accessible route is provided. (Cost estimate for a 15' long by 4' wide asphalt route.)	1	600	\$600
<b>Off-Street Parking Lot or Garage</b>												
7	Parking Lot by Tennis Courts and Ice Rink	Ext.		Off-Street Parking Lot or Garage	Visitor

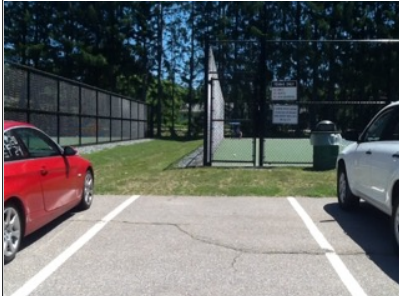
Total # of parking Total # of designated accessible parking spaces	86 0	Provide three car accessible parking spaces and one van accessible parking space in this lot. As best practice, locate at least one of each accessible space by the ice rink, one by the north tennis court and one by the south tennis court.	4	800	\$3200
8	North (Lower Featherland) Parking Lot	Ext.		Off-Street Parking Lot or Garage	Visitor

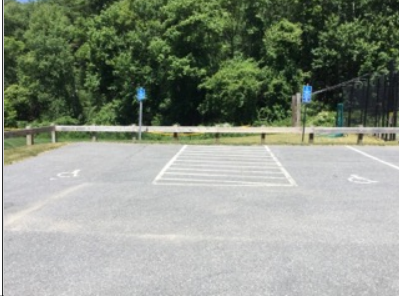
Total # of parking Total # of designated accessible parking spaces Sign does not have the designation "Van Accessible"	44 2 -	Add the designation "Van Accessible" to one of the parking spaces.	1	500	\$500

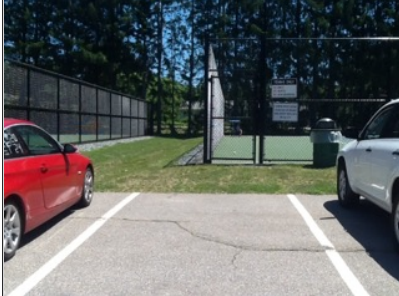
<b>Entrance</b>												
9	South Tennis Court, North Door by Parking Lot, and North and South Doors by Concord Road	Ext.		Entrance	Main Entrance

Entrance not on an accessible route	15%	Provide a directional sign indicating the location of the nearest accessible entrance.	3	346	\$1038
10	North Tennis/Basketball Court, Door on South by Concord Road	Ext.		Entrance	Secondary Entrance

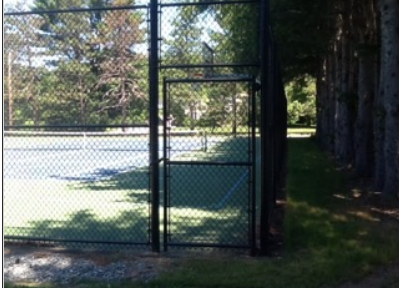
Entrance not on an accessible route	-	Provide a directional sign indicating the location of the nearest accessible entrance.	1	346	\$346

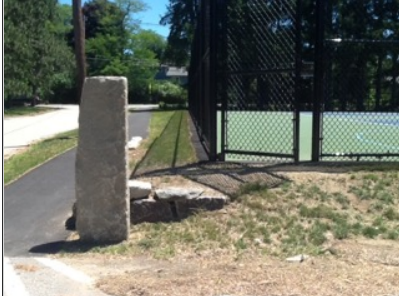
Entrance not on an accessible route	-	Provide a directional sign indicating the location of the nearest accessible entrance.	1	346	\$346
12	North Tennis/ Basketball Court, Path to the South Entrance by the Parking Lot	Ext.		Entrance	Secondary Entrance

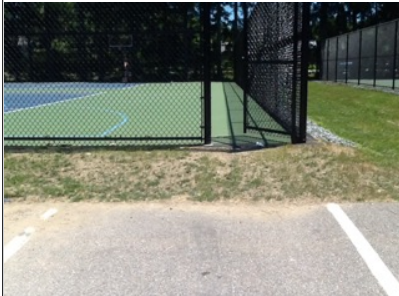
Entrance not on an accessible route	14%	Provide a directional sign indicating the location of the nearest accessible entrance.	1	346	\$346
13	South Tennis Court, South Door by Parking Lot (Accessible)	Ext.		Entrance	Main Entrance

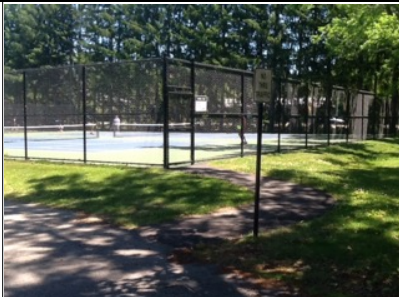
International Symbol of Acc. not provided	-	Provide a sign with the International Symbol of Accessibility (ISA).	1	346	\$346
14	North Tennis/ Basketball Court, Door on North by Concord Road	Ext.		Entrance	Main Entrance

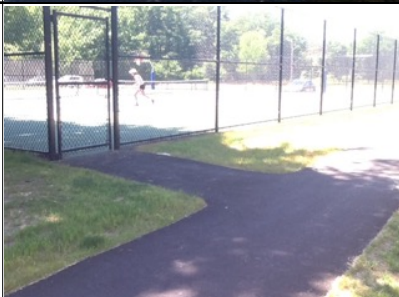
International Symbol of Acc. not provided	-	Provide a sign with the International Symbol of Accessibility (ISA).	1	346	\$346

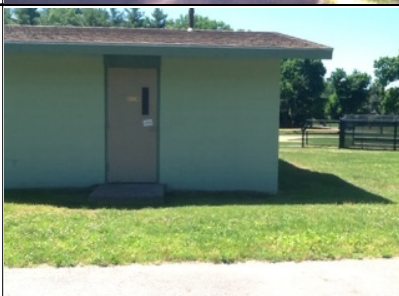
15	Men's Toilet Room in South Concession Between Field 1 and Field 2	Ext.		Entrance	Secondary Entrance

Threshold is > 1/2" high	5"	Provide an asphalt walkway to the step that is sloped no greater than 1:20 (5%). Cost estimate for 10' long by 4' wide asphalt walkway.	1	400	\$400

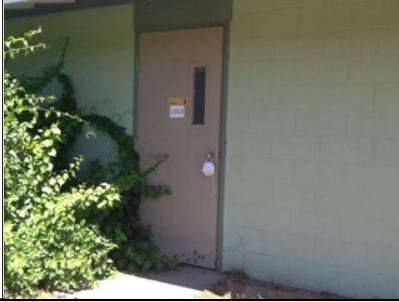
Hardware not operable with a closed fist	-	Provide hardware that can be operable with one hand and not require tight grasping, pinching, or twisting of the wrist.	1	484	\$484
<b>Access to Goods and Services</b>												
<b>Interior Access Route</b>												
17	South Concession Stand Women's Toilet Room	1		Interior Access Route	Interior

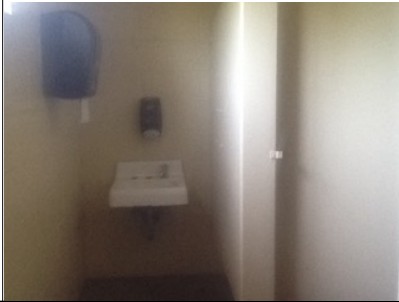
Route < 36" wide	34"	Ensure that a clear width of 36" min. is maintained at the lavatory when the toilet room is under renovation to add an accessible compartment. 36" clear is required when the depth is greater than 24".	1	Labor	\$0
18	South Concession Stand Men's Toilet Room	1		Interior Access Route	Interior

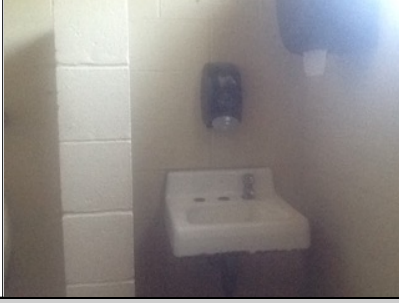
Route < 36" wide	34"	Ensure that a clear width of 36" min. is maintained at the lavatory when the toilet room is under renovation to add an accessible compartment. 36" clear is required when the depth is greater than 24".	1	Labor	\$0

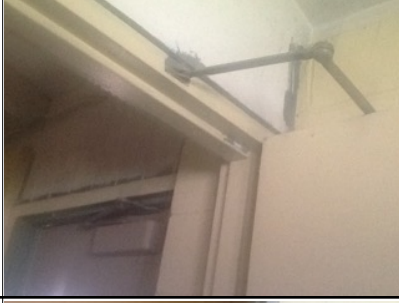
Maneuvering clearance(s) not provided	40"	Provide an automatic door opener.	1	3060	\$3060
20	South Concession Stand Men's Toilet Room Exit to the Exterior	1		Doors, Doorways, & Gates	Toilet Room

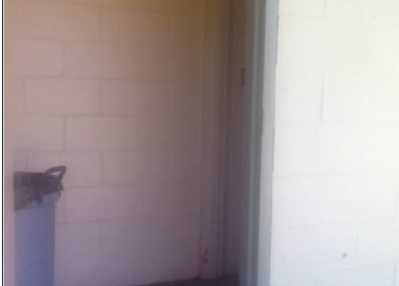
Maneuvering clearance(s) not provided	40"	Provide an automatic door opener.	1	3060	\$3060

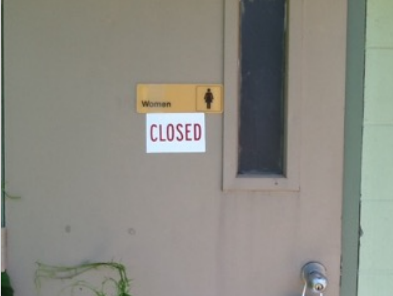
Raised characters not provided Braille not provided Sign not located on the latch side of the door	- - -	Provide text with raised characters duplicated in braille. Locate sign at permanent rooms alongside the door on the latch side.	1	232	\$232
28	North (Lower Featherland) Concession Stand Women's Toilet Room	Ext.		Signage	Designation

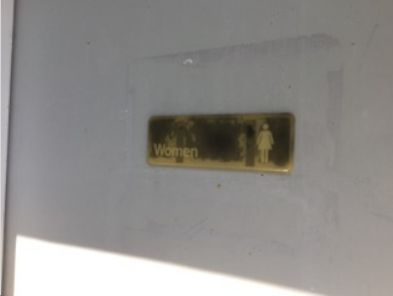
Raised characters not provided Braille not provided Sign not located on the latch side of the door	- - -	Provide text with raised characters duplicated in braille. Locate sign at permanent rooms alongside the door on the latch side.	1	232	\$232

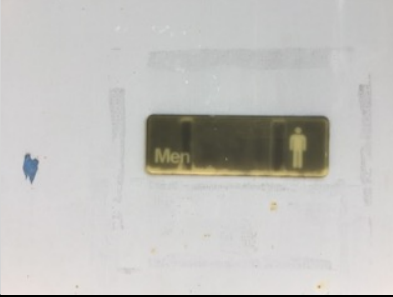
29	North (Lower Featherland) Concession Stand Men's Toilet Room	Ext.		Signage	Designation

Raised characters not provided Braille not provided Sign not located on the latch side of the door	- - -	Provide text with raised characters duplicated in braille. Locate sign at permanent rooms alongside the door on the latch side.	1	232	\$232
<b>Service Counter</b>												
30	South Concession Stand	1		Service Counter	N/A

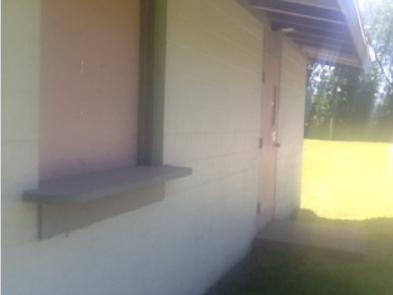
Counter > 36" high	47"	Provide a counter that is 36" max. above the ground.	1	880	\$880

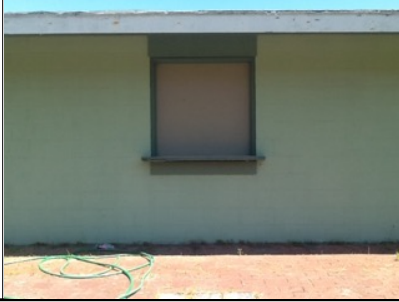
Counter > 36" high	41"	Provide a counter that is 36" max. above the ground.	1	880	\$880
<b>Picnic Tables</b>												
32	Picnic Area in Front of North Concession Stand in Lower Featherland Park	Ext.		Picnic Tables	N/A

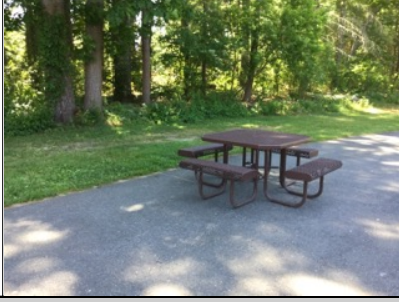
Toe or knee clearance at table not provided	-	Provide at least one picnic table with top between 28"- 34" above the ground and 27" clear height underneath.	1	1400	\$1400
<b>Trash / Recycling</b>												
33	South Tennis Court, North Door by Parking Lot	Ext.		Trash / Recycling	N/A

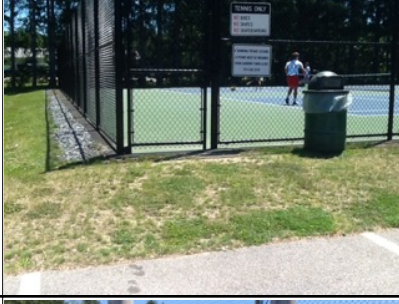
Trash container not connected to an accessible route	-	Ensure trash container is located on an accessible route.	1	Labor	\$0
34	Edge of Softball Field 2	Ext.		Trash / Recycling	N/A

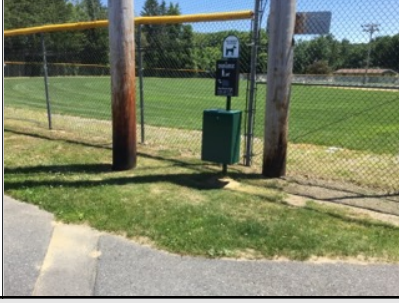
Trash container not connected to an accessible route	-	Provide an accessible route to trash container. (Cost estimate for a 6' long, 4' wide stone dust route.)	1	192	\$192

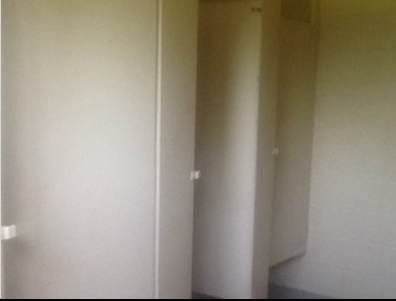
Accessible plumbing fixtures or stalls not provided	-	Provide one accessible wheelchair compartment.	1	6182	\$6182
36	South Concession Stand Men's Toilet Room	1		Overall Access	Toilet Room

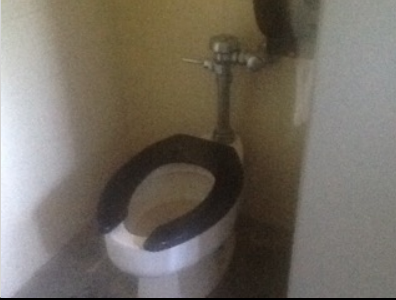
Accessible plumbing fixtures or stalls not provided	-	Provide one accessible wheelchair compartment.	1	6182	\$6182
<b>Lavatory</b>												
37	South Concession Stand Women's Toilet Room	1		Lavatory	N/A

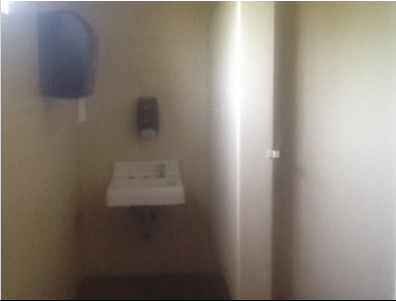
Toe or knee clearances not provided Faucet not operable with a closed fist Exposed plumbing underneath	25" - -	Provide knee and toe clearance positioned for a forward approach. Provide a faucet that can be operable with one hand and not require tight grasping, pinching, or twisting of the wrist at lavatory. Insulate or otherwise configure pipes to prevent contact at lavatory.	1	2764	\$2764

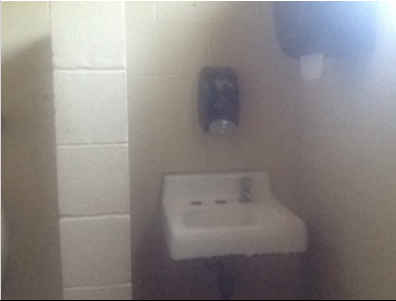
38	South Concession Stand Men's Toilet Room	1		Lavatory	N/A

Toe or knee clearances not provided Faucet not operable with a closed fist Exposed plumbing underneath	24" - -	Provide knee and toe clearance positioned for a forward approach. Provide a faucet that can be operable with one hand and not require tight grasping, pinching, or twisting of the wrist at lavatory. Insulate or otherwise configure pipes to prevent contact at lavatory.	1	2764	\$2764
<b>Urinal</b>												
39	South Concession Stand Men's Toilet Room	1		Urinal	N/A

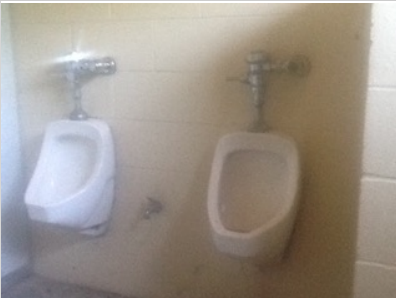
Rim > 17" high	-	Provide at least one urinal with the rim no higher than 17" above the finished floor.	1	3248	\$3248

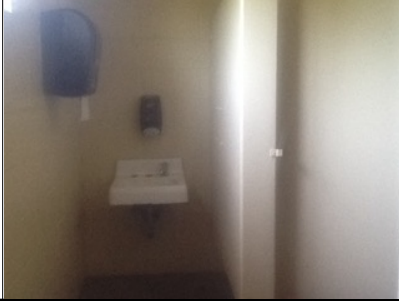
Controls > 42" (MAAB) Dispenser acts as a protruding object	50" -	Relocate the paper towel dispenser so that the operable part is 42" max. above the finished floor and out of the circulation path.	1	256	\$256
<b>Play and Sport Areas</b>												
<b>Field</b>												
41	Baseball Field 1 Entrance Team Seating Area 1	Ext.		Field	Baseball

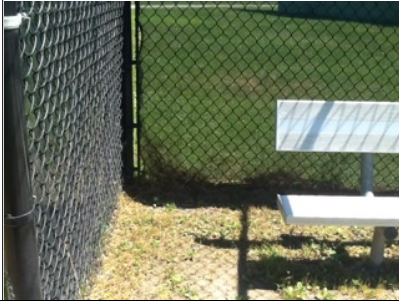
Accessible spaces are not provided at team seating	33.5"	Relocate bench to provide a 36" x 48" clear floor space at team seating. Provide a stone dust surface at accessible team seating space.	1	96 Labor	\$96
42	Baseball Field 1 Entrance Team Seating Area 2	Ext.		Field	Baseball

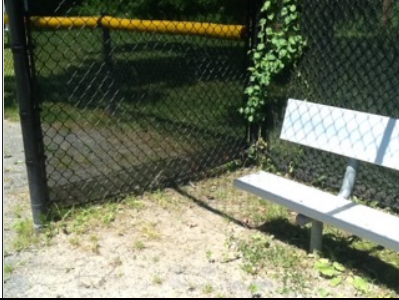
Accessible spaces are not provided at team seating	30"	Relocate bench to provide a 36" x 48" clear floor space at team seating. Provide a stone dust surface at accessible team seating space.	1	96 Labor	\$96

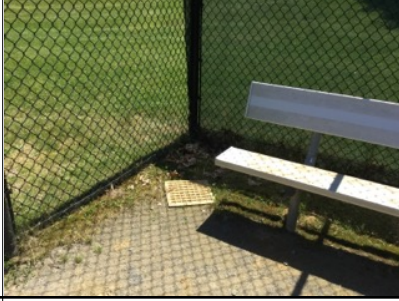
43	Baseball Field 5 Team Seating 1	Ext.		Field	Baseball

Accessible spaces are not provided at team seating	30.5"	Relocate bench to provide a 36" x 48" clear floor space at team seating. Provide a stone dust surface at accessible team seating space.	1	96 Labor	\$96
44	Baseball Field 5 Team Seating 2	Ext.		Field	Baseball

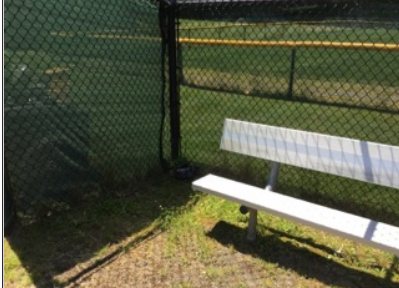
Accessible spaces are not provided at team seating	-	Provide a a 36" x 48" stone dust surface at accessible team seating space.	1	96	\$96

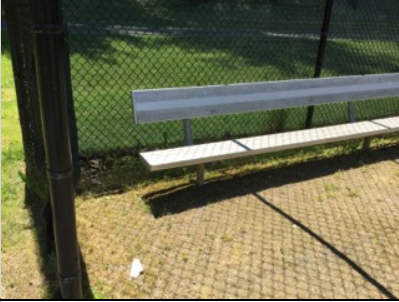
Accessible spaces are not provided at team seating	25"	Relocate bench to provide a 36" x 48" clear floor space at team seating. Provide a stone dust surface at accessible team seating space.	1	96 Labor	\$96
46	Baseball Field 4 Team Seating 2	Ext.		Field	Baseball

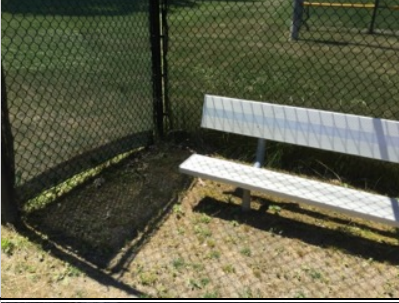
Accessible spaces are not provided at team seating	32"	Relocate bench to provide a 36" x 48" clear floor space at team seating. Provide a stone dust surface at accessible team seating space.	1	96 Labor	\$96
47	Baseball Field 3, Team Seating 1	Ext.		Field	Baseball

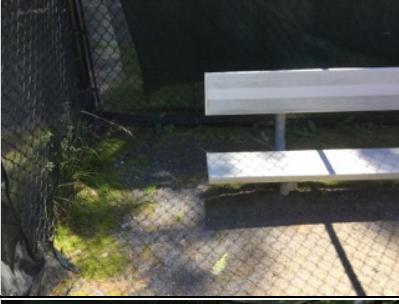
Accessible spaces are not provided at team seating	-	Provide a a 36" x 48" stone dust surface at accessible team seating space alongside the bench.	1	96	\$96
48	Baseball Field 3, Team Seating 2	Ext.		Field	Baseball

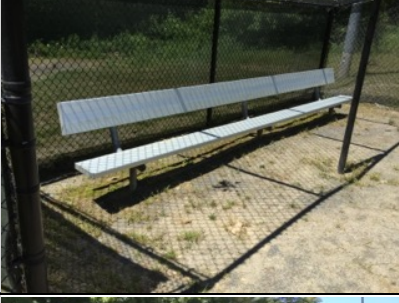
Accessible spaces are not provided at team seating	31"	Relocate bench to provide a 36" x 48" clear floor space at team seating. Provide a stone dust surface at accessible team seating space.	1	96 Labor	\$96

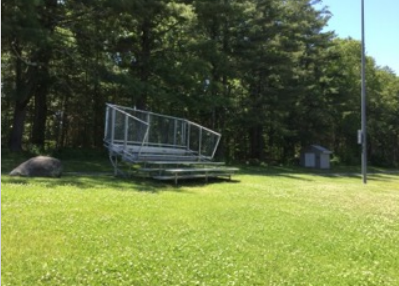
49	Baseball Field 4 Bleacher	Ext.		Field	Baseball

Accessible spaces not provided at sidelines seating	-	Provide a 36" x 48" clear floor space on each side of the bleacher. (Cost estimate for 15' long, 4' wide stone dust route.)	2	480	\$960

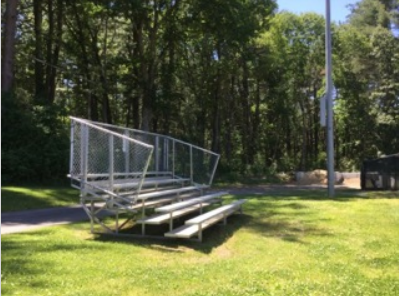
Accessible spaces not provided at sidelines seating	-	Provide a 36" x 48" clear floor space on each side of the bleacher. (Cost estimate for 15' long, 4' wide stone dust route.)	2	480	\$960
51	Baseball Field 1 Bleachers Near Team Seating Area 1	Ext.		Field	Baseball

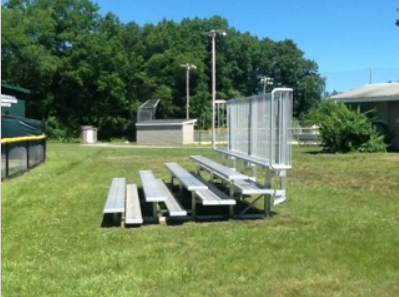
Accessible spaces not provided at sidelines seating Not connected to an accessible-route	- -	Provide a 36" x 48" clear floor space on each side of the bleacher. Provide an accessible route to the bleacher. (Cost estimate for 95' long, 4' wide stone dust route.)	1	3040	\$3040
52	Baseball Field 1 Bleachers near Team Seating 2	Ext.		Field	Baseball

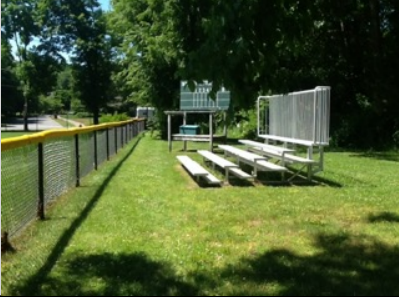
Accessible spaces not provided at sidelines seating Not connected to an accessible-route	- -	Provide a 36" x 48" clear floor space on each side of the bleacher. Provide an accessible route to the bleacher. (Cost estimate for 103' long, 4' wide stone dust route.)	1	3296	\$3296

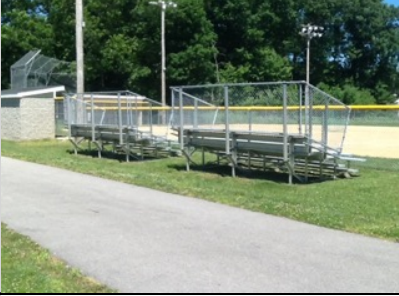
53	Adult Softball Field 2 Bleachers on South	Ext.		Field	Softball

Accessible spaces not provided at sidelines seating Not connected to an accessible-route	- -	Provide a 36" x 48" clear floor space on each side of each bleacher. Provide an accessible route to the accessible seating area. (Cost estimate for 18' long, 4' wide stone dust route.)	4	576	\$2304
54	Baseball Field 5 Bleacher	Ext.		Field	Baseball

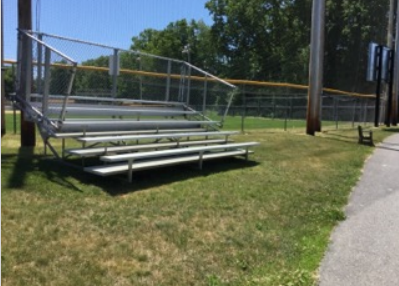
Accessible spaces not provided at sidelines seating Not connected to an accessible-route	- 8.1%	Relocate bleacher to an accessible route closer to the asphalt. Provide a level 36" x 48" clear floor space on each side of the bleacher. Provide an accessible route to the field. (Cost estimate for 4' long, 4' wide stone dust route.)	2	128	\$256

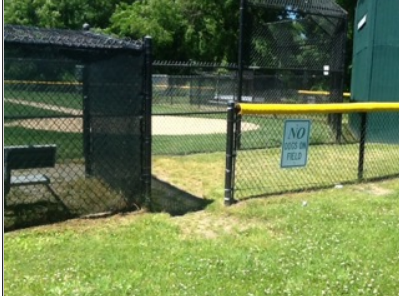
Not connected to an accessible-route	-	Provide an accessible route to the field and to each team seating area. (Cost estimate for 200' long, 4' wide stone dust walkway.)	1	6400	\$6400
56	Path to Baseball Field 5 Team Seating	Ext.		Field	Baseball

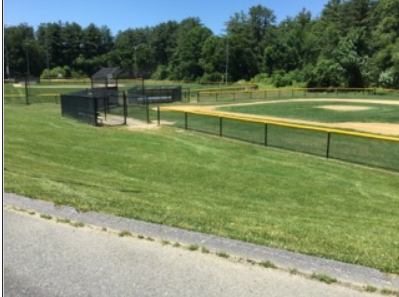
Not connected to an accessible-route	-	Provide an accessible route to the baseball field, including to the team seating areas. (Cost estimate for 210' long, 4' wide stone dust route.)	1	6720	\$6720
57	Entrance to Baseball Field 4	Ext.		Field	Baseball

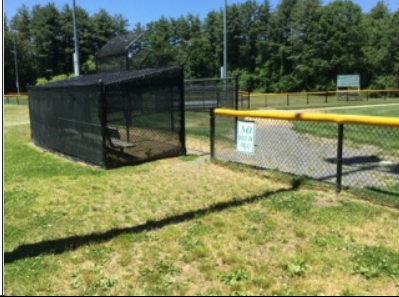
Not connected to an accessible-route	-	Provide an accessible route to the field and team seating areas. (Cost estimate for 120' long, 4' wide stone dust route.)	1	3840	\$3840
58	Adult Softball Field 2 Team Seating Areas	Ext.		Field	Softball

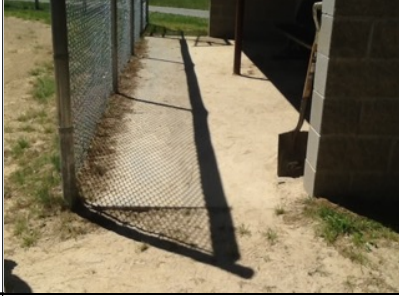
Not connected to an accessible-route Level changes > 1/4"	- 1.75"	Provide an accessible route to each team seating area. Ensure that level changes are no greater than 1/4" high. (Cost estimate for 12' long, 4' wide asphalt route.)	2	480	\$960

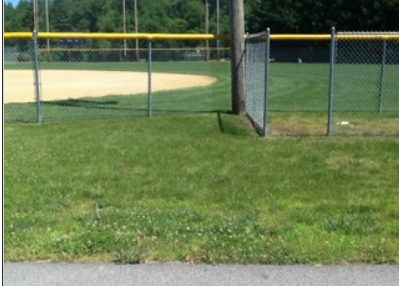
59	Adult Softball Field 2 Pitching Area on South Side	Ext.		Field	Softball

Practice areas are not on an accessible route	-	Provide an accessible route to the pitching area on the south side. (Cost estimate for 20' long by 4' wide stone dust route.)	1	640	\$640

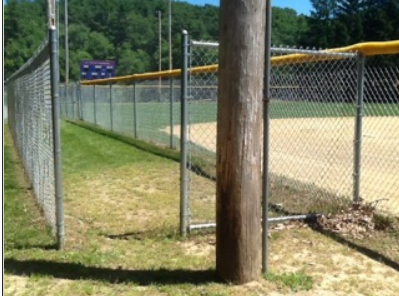
Practice areas are not on an accessible route	-	Provide an accessible route to the pitching area on the west side. (Cost estimate for 10' long, 4' wide stone dust route.)	1	320	\$320
61	Batting Cage	Ext.		Field	Baseball

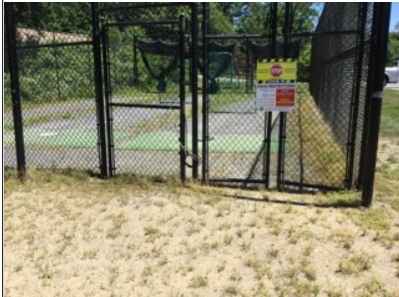
Practice areas are not on an accessible route	-	Provide an accessible route to practice areas. (Cost estimate for 54' long, 4' wide stone dust route.)	1	1728	\$1728
62	Entrance to Baseball Field 3	Ext.		Field	Baseball

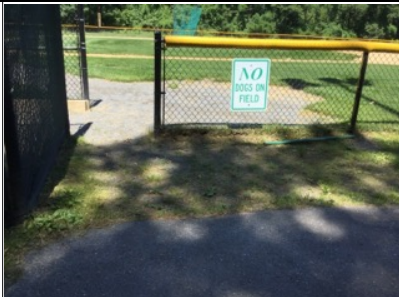
No accessible route to all areas of sport activity	-	Install an accessible route between all areas of sports activity including the team the field, team seating area and batting cage. (Cost estimate for 200' long, 4' wide stone dust route.)	1	6400	\$6400
<b>Best Practice</b>

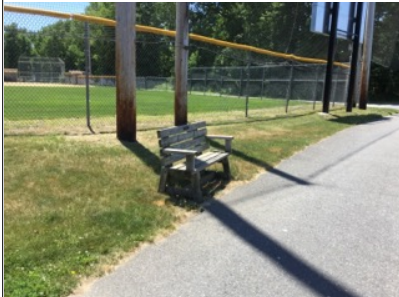
63	Bench Near Baseball Field 5	Ext.

Recommend providing clear floor space of 36" wide minimum by 48" deep alongside one bench so that a wheelchair user can sit alongside someone sitting on the bench.	1	-	\$0
