Feeley Field

Town of Sudbury ADA Transition Plan

December 2020

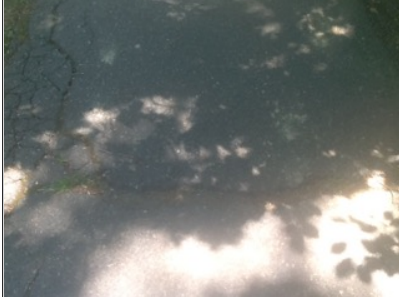
Route not maintained in operable working condition Level changes > 1/4"	2" -	Alter change in level to be 1/4" high max. Ensure the accessible route is maintained in operable working condition.	1	160	\$160
2	North Concession Stand and Toilet Room Building	Ext.		Exterior Access Route	Walkway

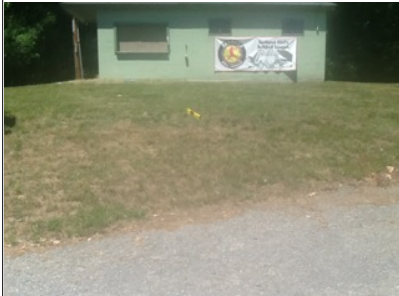
Accessible route not provided	13%	Ensure an accessible route is provided. (Cost estimate for 50' long concrete ramp to the building.)	1	59007	\$59007
3	Signage at Tennis Court	Ext.		Exterior Access Route	Walkway

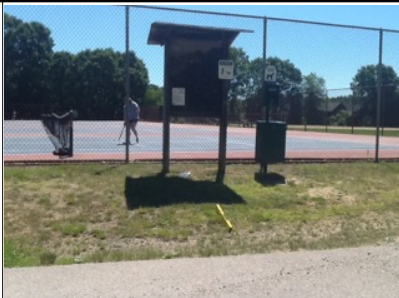
Accessible route not provided	27.8%	Relocate wayside sign to an accessible route.	1	Labor	\$0
4	Southwest Tennis Entrance From North Softball Field	Ext.		Exterior Access Route	Walkway

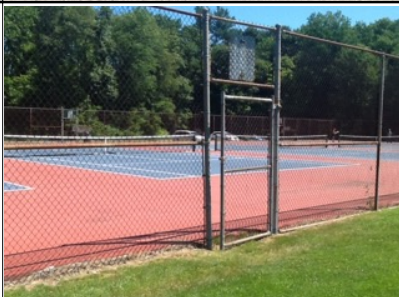
Accessible route not provided		Install an accessible route between all areas of sport activity. (Cost estimate for 6' long by 4' wide stone dust route.)	1	192	\$192

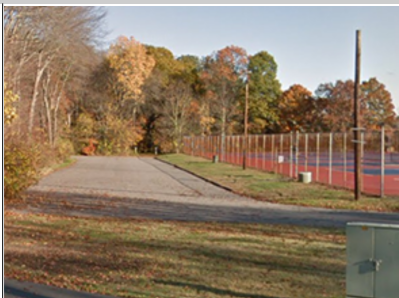
Total # of parking Total # of designated accessible parking spaces Total # of designated van accessible spaces	29 0 0	Provide one van accessible parking space and one car accessible parking space by the northwest entrance. (Cost of one accessible space, access aisle, sign and striping, including leveling space.)	2	1850	\$3700

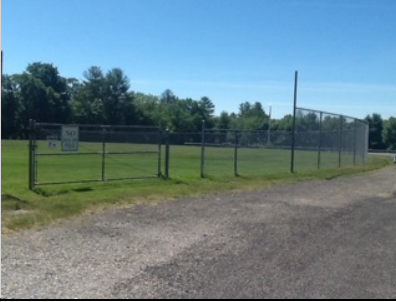
Total # of parking Total # of designated accessible parking spaces Total # of designated van accessible spaces	105 est. 0 0	Provide four car accessible parking spaces and one van accessible parking space. (Cost estimate for signage and striping.)	5	800	\$4000
7	Parking Lot by Southwest Softball Field, Accessible Parking Area	Ext.		Off-Street Parking Lot or Garage	Visitor

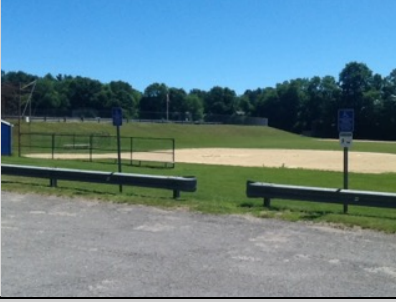
Total # of parking Total # of designated accessible parking spaces Access aisle not provided Sign does not have the designation "Van Accessible"	45 est. 2 - -	Provide a marked access aisle for one car accessible and one van accessible parking space. Add the designation "Van Accessible" to the sign located at the van accessible space.	1	1100	\$1100

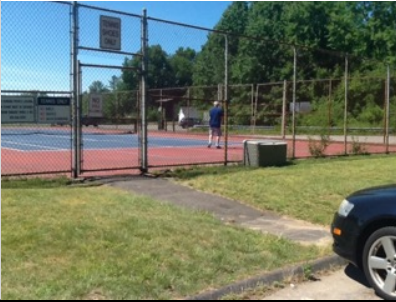
Entrance not on an accessible route	13.3%	Provide an accessible route into the tennis court from the parking lot. (Cost estimate based on a 30' long concrete ramp with handrails).	1	35404	\$35404
9	North Center Tennis Entrance	Ext.		Entrance	Gate

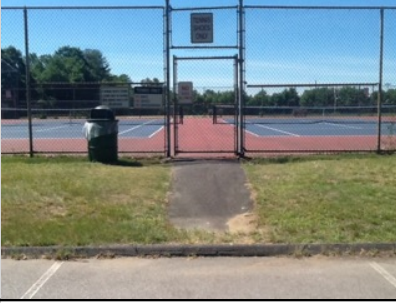
Directional sign to accessible entrance not provided	12%	Provide a directional sign indicating the location of the nearest accessible entrance.	1	346	\$346
10	Northeast Tennis Entry	Ext.		Entrance	Gate

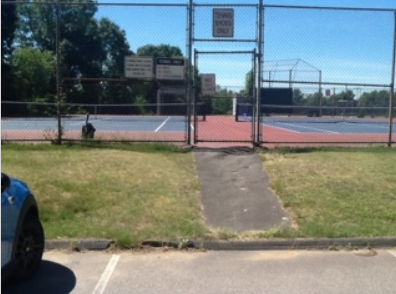
Directional sign to accessible entrance not provided	16.5%	Provide a directional sign indicating the location of the nearest accessible entrance.	1	346	\$346

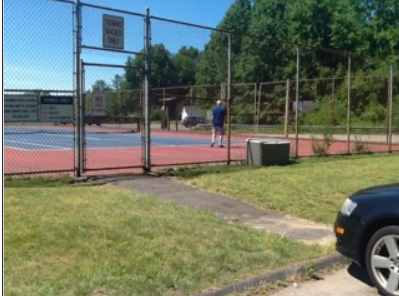
International Symbol of Acc. not provided		After entrance is made accessible provide signage with the International Symbol of Accessibility (ISA).	1	346	\$346
12	Tennis Entrances on South	Ext.		Entrance	Gate

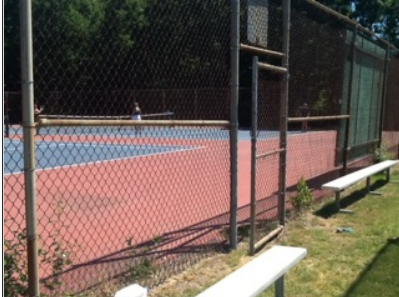
International Symbol of Acc. not provided	-	After an accessible route is made to both south entrances, provide a sign with the International Symbol of Accessibility (ISA) at each gate.	2	346	\$692
Access to Goods and Services												
Doors, Doorways, & Gates												
13	Women's Toilet Room	1		Doors, Doorways, & Gates	Toilet Room

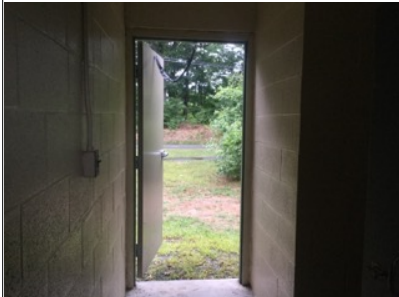
Maneuvering clearance(s) not provided	2"	Provide an automatic door opener.	1	3060	\$3060
14	Women's and Men's Toilet Room Doors	Ext.		Doors, Doorways, & Gates	Toilet Room

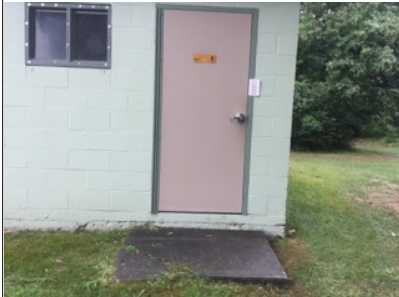
Threshold > 1/2" high	6", 10"	Threshold is 6" to 10" at the men's and women's toilet room. Recommend providing a raised walkway around building to connect concession counters, and toilet rooms. (Cost estimate based on 107' long, 4' wide min. walkway around building so that the maximum door threshold to both toilet rooms is 1/2 inch.	1	6848	\$6848

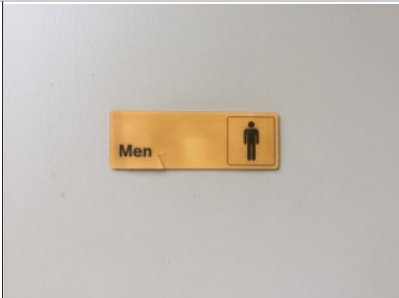
Raised characters not provided Braille not provided Sign not located on the latch side of the door	- - -	Provide text with raised characters duplicated in braille. Locate sign at permanent rooms alongside the door on the latch side.	1	232	\$232

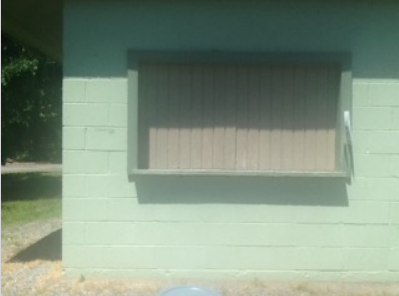
Not connected to a accessible route Counter > 36" high	- 41"	Ensure the counter is connected to an accessible route. Provide a counter that is 36" max. above the ground. (Note: If a raised walkway or plinth is built around the building, concession counter may not need to be lowered.)	1	Labor 880	\$880
18	North Concession Stand	Ext.		Service Counter	N/A

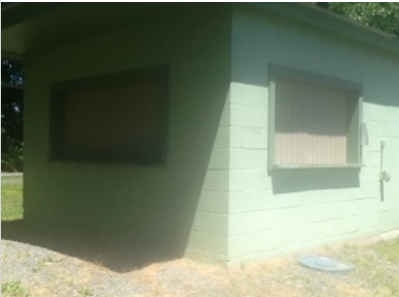
Not connected to a accessible route Counter > 36" high	- 38"	Ensure the counter is connected to an accessible route. Provide a counter that is 36" max. above the ground. (Note: If a raised walkway or plinth is built around the building, concession counter may not need to be lowered.)	1	Labor 880	\$880

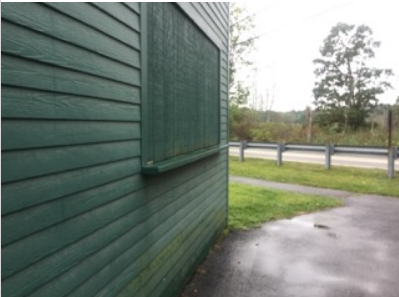
19	Baseball Field Concession Stand	Ext.		Service Counter	N/A

Counter > 36" high	47"	Provide a counter that is 36" max. above the ground.	1	880	\$880
Picnic Tables												
20	North Concession Stand Picnic Area	Ext.		Picnic Tables	N/A

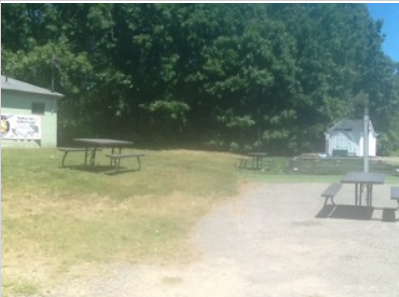
Toe or knee clearance at table not provided	-	Provide at least one picnic table with top between 28"- 34" above the ground and 27" clear height underneath. Ensure it is located on an accessible route.	1	1400	\$1400

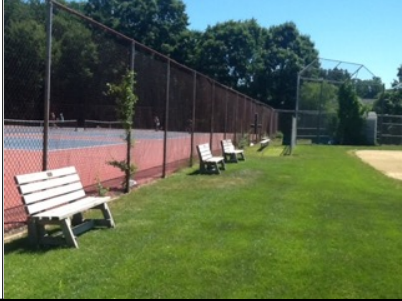
No accessible route to one bench in this area	-	Provide an accessible route to at least one bench in this area. (Cost estimate for 4' long by 4' wide stone dust route.)	1	128	\$128
Trash / Recycling												
22	North Center Tennis Entrance	Ext.		Trash / Recycling	N/A

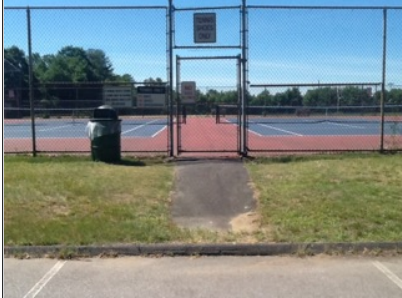
Trash container not connected to an accessible route	12%	Ensure trash container is located on an accessible route.	1	Labor	\$0
Toilet & Bathing Rooms												
Overall Access												
23	Men's Toilet Room	1		Overall Access	Toilet Room

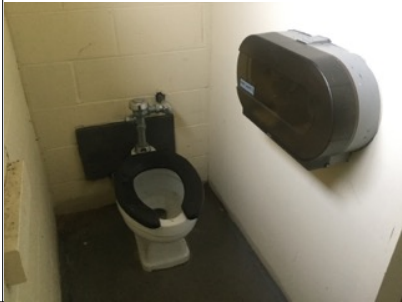
Accessible plumbing fixtures or stalls not provided Toe or knee clearances not provided Faucet not operable with a closed fist Exposed plumbing underneath lavatory Urinal rim > 17" high Clear floor space not provided at urinal Flush control too high or not properly located at urinal	- - - - - -	Renovate toilet room to be an accessible single-user toilet room. Provide a faucet that can be operable with one hand and not require tight grasping, pinching, or twisting of the wrist for at least one lavatory. Insulate or otherwise configure pipes to prevent contact at lavatory. Provide at least one lavatory with knee and toe clearance positioned for a forward approach.	1	24604	\$24604

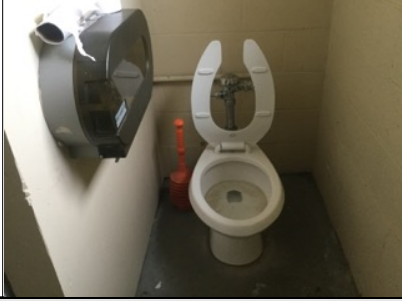
24	Women's Toilet Room	1		Overall Access	Toilet Room

Accessible plumbing fixtures or stalls not provided Faucet not operable with a closed fist Exposed plumbing underneath	-	Renovate toilet room to be an accessible single-user toilet room. Provide a faucet that can be operable with one hand and not require tight grasping, pinching, or twisting of the wrist for at least one lavatory. Insulate or otherwise configure pipes to prevent contact at lavatory.	1	24604	\$24604
Play and Sport Areas

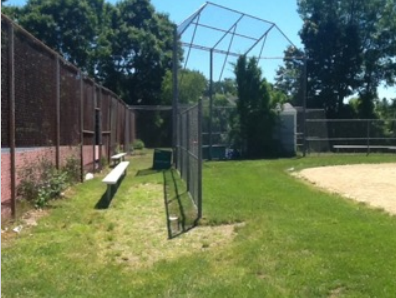
Accessible spaces are not provided at team seating	-	Provide a 36" x 48" clear floor space at team seating alongside bench. (Cost estimate for 3' by 4' stone dust area.)	2	96	\$192
26	Southeast Softball Field Team Seating	Ext.		Field	Softball

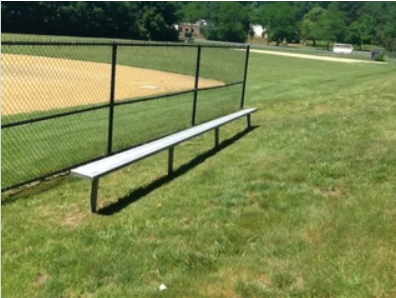
Accessible spaces are not provided at team seating Not connected to an accessible-route	- -	Provide a 36" x 48" clear floor space at team seating. Provide an accessible route to the field. (Cost estimate for 420' 4' wide stone dust route from southwest softball field.)	1	13440	\$13440
27	Southwest Softball Field Team Seating	Ext.		Field	Softball

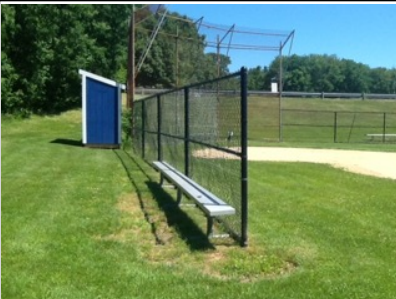
Accessible spaces are not provided at team seating No accessible route to all areas of sport activity	- -	Provide a 36" x 48" clear floor space at each team seating area Install an accessible route to each team seating area. (Cost estimate for 216' long, 4' wide stone dust route from the parking lot.)	1	6912	\$6912

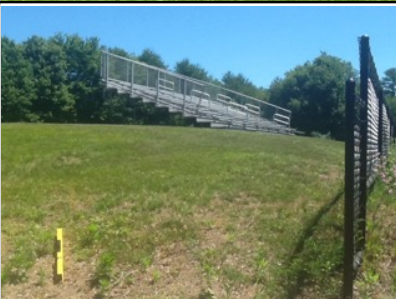
28	Baseball Field, Access to Bleachers	Ext.		Field	Baseball

Accessible spaces not provided at sidelines seating	-	Provide an accessible route to team seating area from the parking lot to the north. Provide a 36" x 48" clear floor space on each side of the bleacher. (Cost estimate for 173' long, 4' wide stone dust route.)	1	5536	\$5536
29	Baseball Field, Bleacher In Front of Press Box	Ext.		Field	Baseball

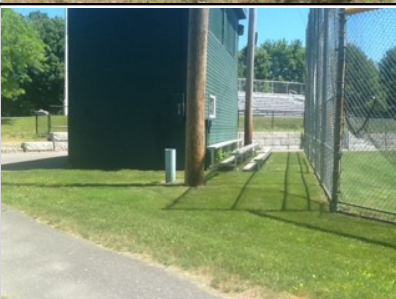
Accessible spaces not provided at sidelines seating	-	Provide an accessible route to sideline seating and a 36" x 48" clear floor space alongside each side of bleacher. (Cost estimate for 34' long, 4' wide stone dust route.)	1	1088	\$1088

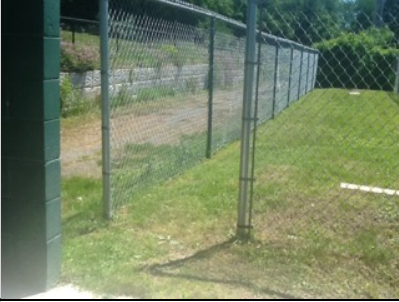
Practice areas are not on an accessible route	-	Provide an accessible route to pitching practice area. (Cost estimate for 10' long, 4' wide asphalt route.)	1	400	\$400
36	Baseball Field, Route Between West Team Seating Area and Pitching Practice Area	Ext.		Field	Baseball

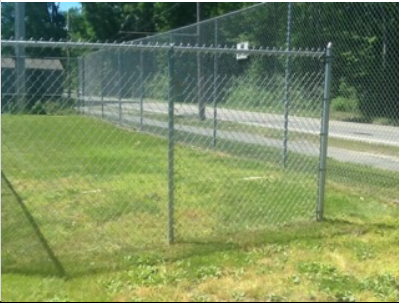
Practice areas are not on an accessible route	-	Provide an accessible route to practice areas. (Cost estimate for 12' long, 4' wide asphalt route.)	1	480	\$480
Court												
37	Tennis Entry on Southeast From North Softball Field	Ext.		Court	Tennis

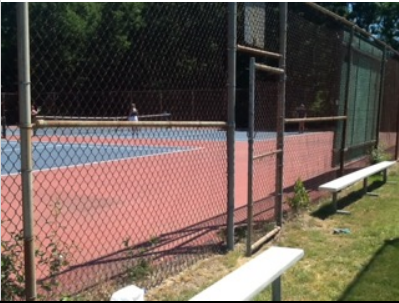
No accessible route between all areas of sport activity	-	Install an accessible route between the tennis court and softball field. (Cost estimate for 4' long by 4' wide stone dust route.)	1	128	\$128

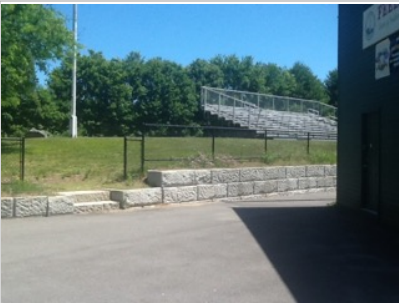
Recommend providing handrails at the stepped route to spectator seating.	1	-	\$0
39	North Concession Stand and Toilet Rooms	Ext.

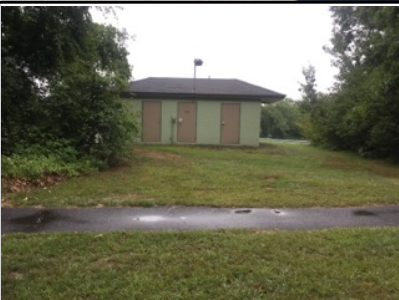
Recommend providing an accessible route from this facility to the sidewalk.	1	-	\$0

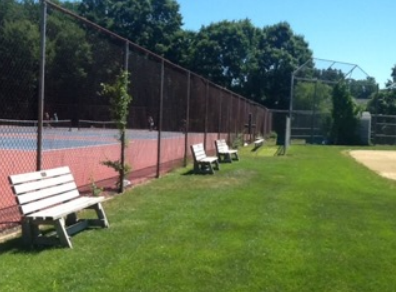
Recommend providing clear floor space of 36" wide minimum by 48" deep alongside one bench so that a wheelchair user can sit alongside someone sitting on the bench.	1	-	\$0
