Haskell Field

Town of Sudbury ADA Transition Plan

January 2021

Institute for Human Centered Design

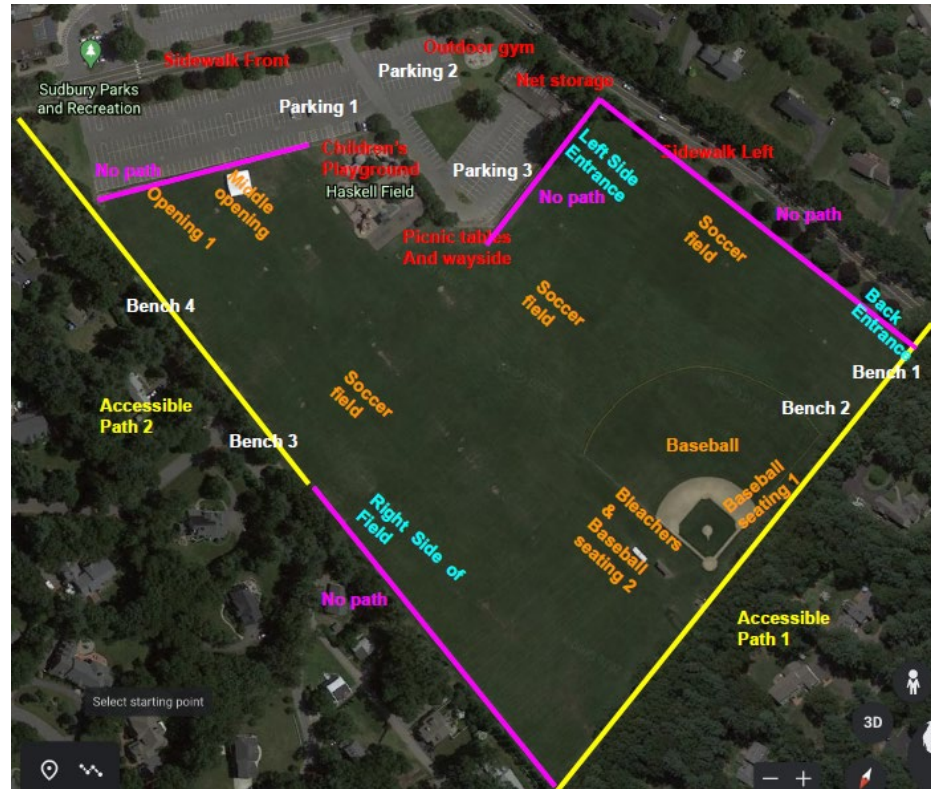
Figure 1: View of Haskell Field showing the approximate location of accessible routes (yellow lines) and the approximate suggested location for new accessible routes (purple lines) that connect existing paths to all of the boundaries of sport activity and to park amenities.

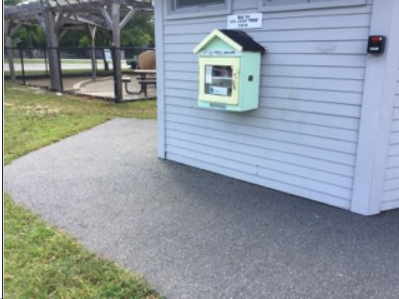
ID	Location	Floor	Room	Element	Type	Photo	Issues	Current Measure	Recommendations	Quantity	Price	Cost Estimation
Approach and Entrance												
Exterior Access Route												
1	Library - Children's Playground	Ext.		Exterior Access Route	Exterior

Route obstructed by protruding objects	15"	Provide a cane-detectable barrier below book exchange 27" max. above the ground. (Book exchange protrudes 15.75".)	1	306	\$306
2	Left Side Entrance From Parking 3 to Soccer Fields	Ext.		Exterior Access Route	Walkway

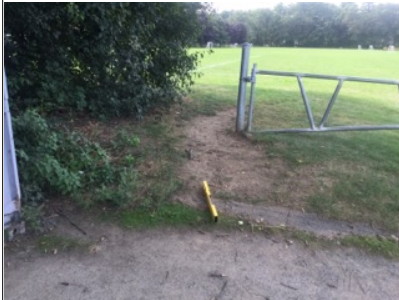
Running slope > 1:20 (5%)	10.2%	Reduce running slope to be no steeper than 1:20 (5%), reduce change in level from parking to soccer field entrance to 1/2" max.	1	Labor	\$0
3	Path to Children's Playground	Ext.		Exterior Access Route	Exterior

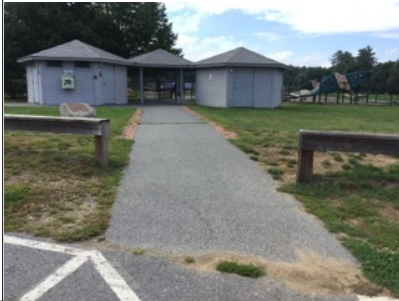
Route not maintained in operable working condition	-	Ensure the accessible route is maintained in operable working condition.	1	Labor	\$0
4	Wayside Next to Parking 3	Ext.		Exterior Access Route	Exterior

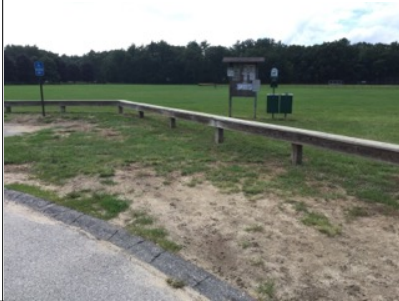
Accessible route not provided	- -	Ensure an accessible route is provided to the wayside and the dog waste bag dispenser. Either relocate both to an accessible location or provide a firm, stable and slip resistant route to both. (Cost based on a 4' wide min. x 15' long stone dust path to both amenities.)	1	480	\$480

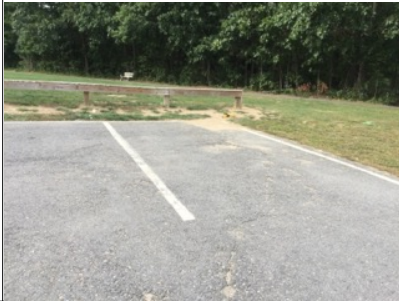
5	From Right Side of Parking 1 to Accessible Path 2	Ext.		Exterior Access Route	Exterior

Accessible route not provided	-	Ensure an accessible route is provided between the parking lot and the existing accessible path. (Cost based on a 4' wide min. x 15' firm, stable and slip resistant accessible path to the existing path.)	1	960	\$960
Access to Goods and Services

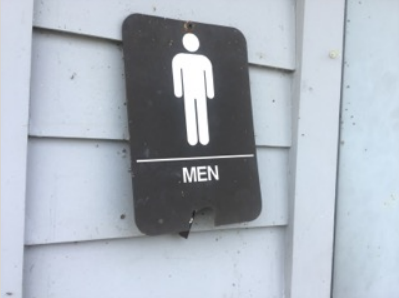
ID	Location	Floor	Room	Element	Type	Photo	Issues	Current Measure	Recommendations	Quantity	Price	Cost Estimation
Signage												
6	Men's Toilet Room	Ext.		Signage	Designation

- Lack of an accessible picnic table in four locations.
- Lack of a drinking fountain for a standing user and an existing drinking fountain for a seated user that is not maintained in operable working condition
- The service counter at the concession stand is higher than the maximum height allowed.
- The designation sign at the men's toilet room is damaged and needs to be replaced.

Sign not maintained in operable working condition		Provide new sign with raised characters and braille.	1	232	\$232
Service Counter												
7	Concession Stand - Children's Playground	Ext.		Service Counter	N/A

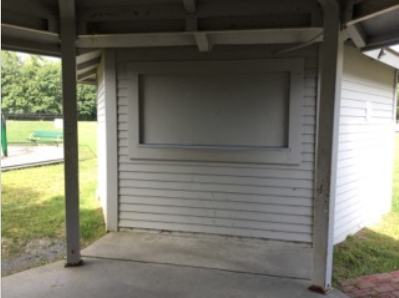
Counter > 36" high	41.5"	Provide a counter that is 36" max. above the ground.	1	880	\$880
Operable Parts												
8	Wayside	Ext.		Operable Parts	N/A

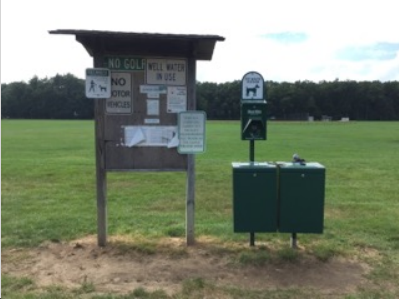
Reach < 15" or > 48"(forward/side approach)	53.5"	Reposition dog waste bag dispenser to between 15"- 48" above the finished floor.	1	Labor	\$0
Picnic Tables												
9	Picnic Table Near Accessible Play Structure 1 - Children's Playground	Ext.		Picnic Tables	N/A

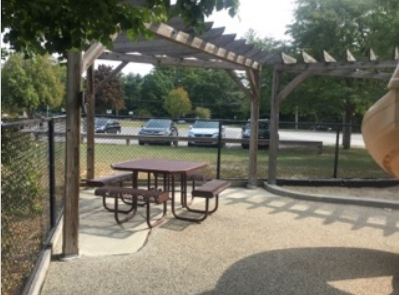
Toe or knee clearance at table not provided	-	Provide at least one picnic table in this area with top between 28"- 34" above the ground and 27" clear height underneath.	1	1400	\$1400

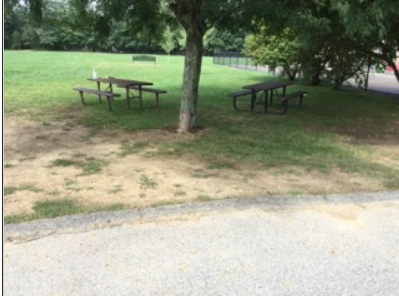
ID	Location	Floor	Room	Element	Type	Photo	Issues	Current Measure	Recommendations	Quantity	Price	Cost Estimation
10	Picnic Tables Next to Parking 3	Ext.		Picnic Tables	N/A

Toe or knee clearance at table not provided Picnic table not on an accessible route	- -	Provide at least one picnic table with top between 28"- 34" above the ground and 27" clear height underneath. Ensure that the dining surface is connected to an accessible route.	1	1400	\$1400
11	Opening 1 Near Accessible Path 2 From Right Side of Parking 1	Ext.		Picnic Tables	N/A

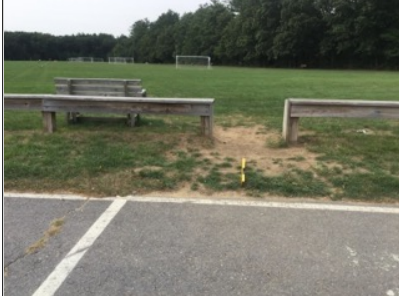
Toe or knee clearance at table not provided Picnic table not on an accessible route	- 17%	Provide at least one picnic table with top between 28"- 34" above the ground and 27" clear height underneath. Ensure that the dining surface is connected to an accessible route. (Cost based on an accessible picnic table and a 4' wide min. x 15' firm, stable and slip resistant accessible path to the picnic table.)	1	2360	\$2360

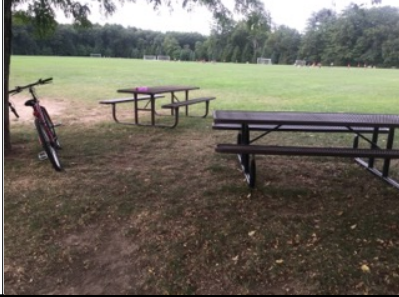
12	Picnic Tables Near Parking 3	Ext.		Picnic Tables	N/A

Toe or knee clearance at table not provided Picnic table not on an accessible route	- -	Provide at least one picnic table with top between 28"- 34" above the ground and 27" clear height underneath. Ensure that the accessible picnic table in this area is connected to an accessible route.	1	1400	\$1400
13	Outdoor Play Gym	Ext.		Picnic Tables	N/A

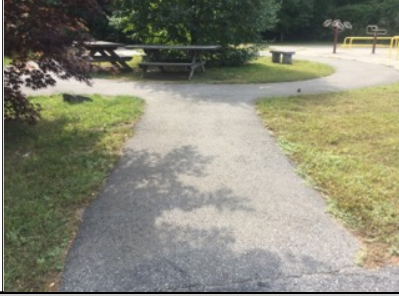
Picnic table not on an accessible route	-	Ensure that the picnic table is connected to an accessible route. (Cost based on a stone dust patch, 3'x4' min., at the accessible end of the accessible picnic table.)	1	240	\$240
Benches												
14	Bench Next to Children's Playground	Ext.		Benches	N/A

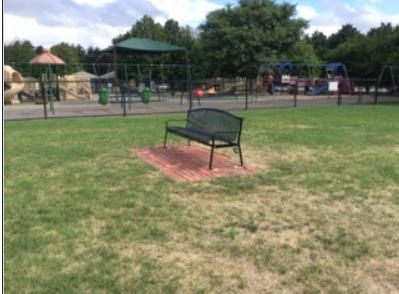
No accessible route to one bench in this area		Provide an accessible route to at least one bench in this area. (Cost based on a 4' wide min. x 15' long stone dust path to bench.)	1	480	\$480

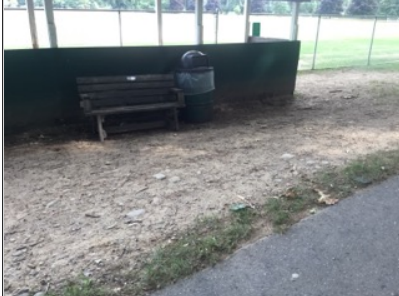
ID	Location	Floor	Room	Element	Type	Photo	Issues	Current Measure	Recommendations	Quantity	Price	Cost Estimation
15	Baseball Seating	Ext.		Benches	N/A

No accessible route to one bench in this area	-	Provide an accessible route to at least one bench in this area and to the trash receptacle or relocate both to an accessible route. (Cost based on a 4' wide min. x 6' firm, stable and slip resistant path to bench and trash receptacle.)	1	240	\$240
16	Right Side Soccer Field	Ext.		Benches	N/A

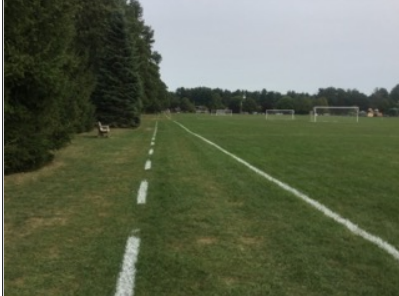
No accessible route to one bench in this area	-	Install an accessible route with a 5.00% max. running and 2.00% max. cross slope between towards benches and the resumed accessible path. (Cost based on a 4' wide min. x 60' long path leading towards benches and the resumed accessible path.)	1	1920	\$1920
17	Accessible Path 2	Ext.		Benches	N/A

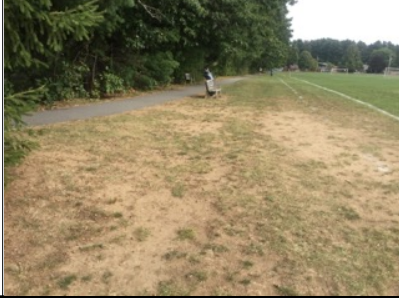
No accessible route to one bench in this area	-	Install an accessible route with a 5.00% max. running and 2.00% max. cross slope between towards benches and the resumed accessible path. (Cost based on a 4' wide min. x 60' long path leading towards benches and the resumed accessible path.)	1	1920	\$1920

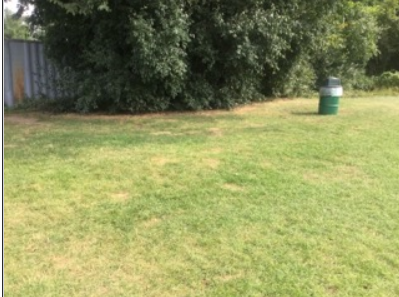
Trash / Recycling												
18	Left Side Entrance From Parking 3 to Soccer Fields	Ext.		Trash / Recycling	N/A

Trash container not connected to an accessible route	-	Ensure trash container is located on an accessible route.	1	Labor	\$0
19	Path 2	Ext.		Trash / Recycling	N/A

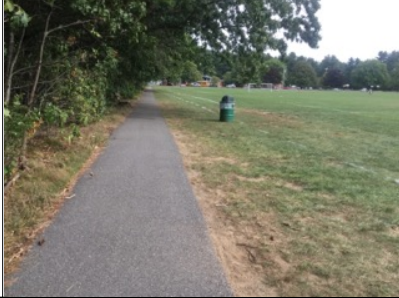
Trash container not connected to an accessible route	-	Ensure trash container is located on an accessible route.	1	Labor	\$0
Toilet & Bathing Rooms

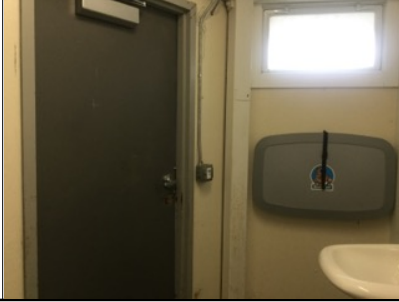
ID	Location	Floor	Room	Element	Type	Photo	Issues	Current Measure	Recommendations	Quantity	Price	Cost Estimation
Overall Access												
20	Men's Toilet Room	Ext.		Overall Access	Toilet Room

Audible and visible alarms not provided	-	When fire system is updated, ensure that a visible and audible fire alarm is installed.	1	-	\$0
Single-User Toilet												
21	Women's Accessible Toilet Room	Ext.		Single-User Toilet	N/A

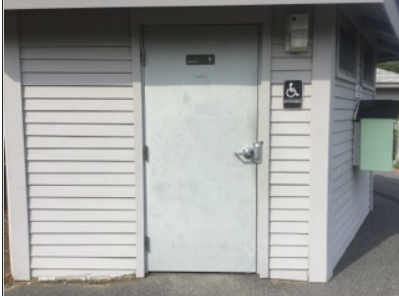
This toilet room was locked on the day that IHCD was at Haskell Field and could not be surveyed.	1	-	\$0
Additional Access												
Drinking Fountains												
22	Fountain - Children's Playground	Ext.		Drinking Fountains	Seated

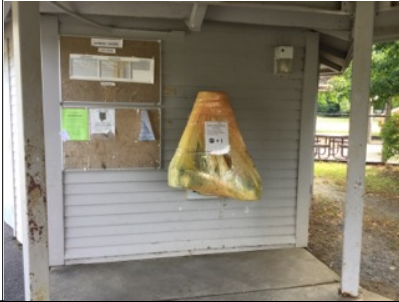
No drinking fountain provided for standing users	-	Provide an additional drinking fountain for standing users or install a Hi-Lo drinking fountain.	1	4028	\$4028
Play and Sport Areas												
Play Areas												
23	Accessible Play Structure 2 - Children's Playground	Ext.		Play Areas	N/A

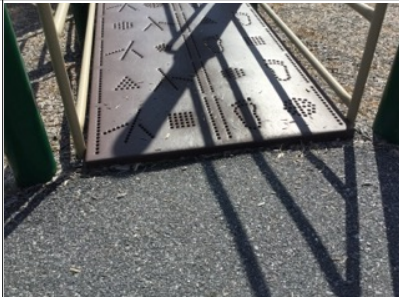
Accessible route not provided at play components	1"	Reduce change in level to 1/2" max.	1	Labor	\$0

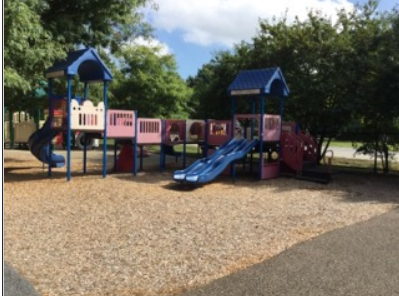
ID	Location	Floor	Room	Element	Type	Photo	Issues	Current Measure	Recommendations	Quantity	Price	Cost Estimation
24	Play Structure 3 - Children's Playground	Ext.		Play Areas	N/A

Accessibility issues include lack of an impact-attenuating firm, stable and slip-resistant surface to and around play components in one portion of the playground.

Note: The Massachusetts Architectural Access Board (MAAB) does not consider engineered wood fiber (EWF) or any loose surface to comply with its regulation requiring an accessible route to each play component and around the playground.

Accessible route not provided at play components	-	Provide a compliant impact-attenuating surface under and around the play components. Note: IHCD team has been told that Sudbury has budgeted \$163,000 to address this issue at Haskell Field.	1	-	\$0
25	Near Climber	Ext.		Play Areas	N/A

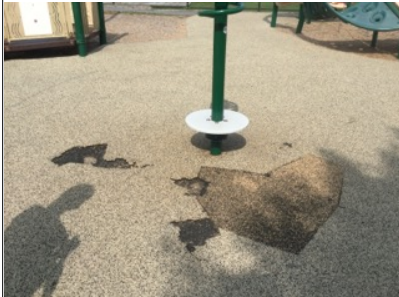
Play areas not maintained in operable working condition	-	Ensure play area is maintained in operable working condition/repair patch as needed.	1	Labor	\$0
26	Accessible Play Structure 2 - Children's Playground	Ext.		Play Areas	N/A

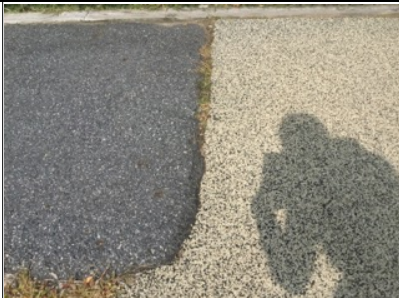
Play areas not maintained in operable working condition	-	Ensure play area is maintained in operable working condition.	1	Labor	\$0
27	Ground Play Components	Ext.		Play Areas	N/A

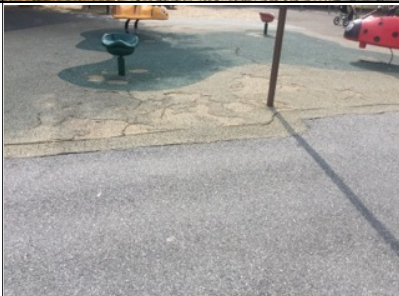
Play areas not maintained in operable working condition	-	Ensure play area is maintained in operable working condition.	1	Labor	\$0

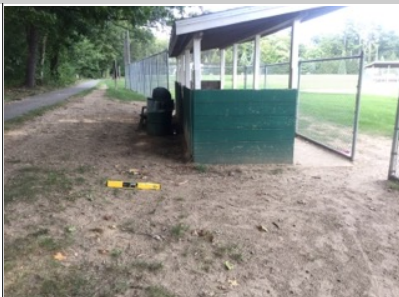
Field												
28	Path 1 Baseball Seating	Ext.		Field	Baseball

Accessible spaces are not provided at team seating	14%	Provide a 48" wide min. firm, stable and slip resistant path to team seating with a 5.00% max. running and 2.00% max. cross slope. (Cost based on a 48" wide x 15' long stone dust path.)	1	480	\$480

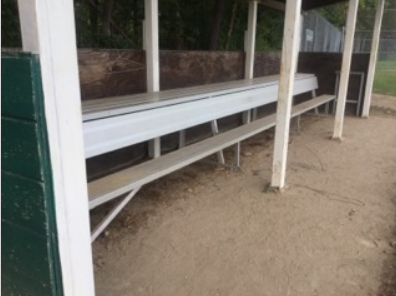
ID	Location	Floor	Room	Element	Type	Photo	Issues	Current Measure	Recommendations	Quantity	Price	Cost Estimation
29	Baseball Seating	Ext.		Field	Baseball

Accessible spaces are not provided at team seating	-	Provide a 36" x 48" clear floor space at team seating.	1	Labor	\$0
30	Baseball Seating 2	Ext.		Field	Baseball

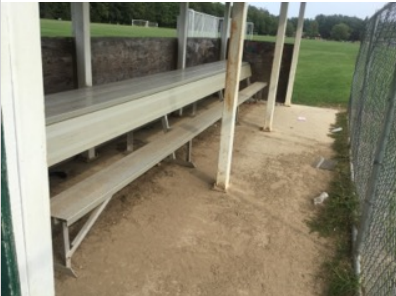
Accessible spaces are not provided at team seating	-	Provide a 36" x 48" clear floor space at team seating.	1	Labor	\$0
31	Bleachers	Ext.		Field	Baseball

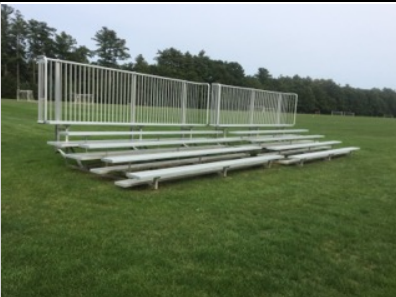
Accessible spaces not provided at sidelines seating	-	Provide a 4' wide min. firm, stable and slip resistant route to the sideline seating bleachers with a 5.00% max. running and 2.00% max. cross slope. Provide a 36" x 48" clear floor space at sidelines seating. (Cost based on a 4' wide min. x 30' path.)	1	960	\$960
32	Baseball Dugout to Field	Ext.		Field	Baseball

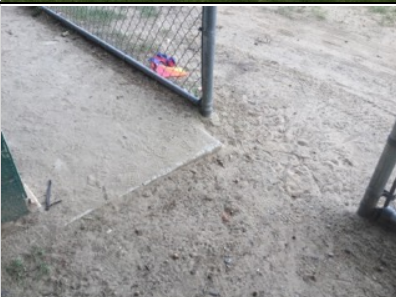
Not connected to an accessible-route	28.5"	Provide an accessible route to the field. Widen gate to 32" min.	1	Labor	\$0

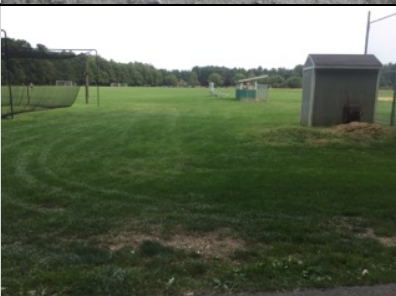
33	Towards Baseball Seating 2	Ext.		Field	Baseball

Not connected to an accessible-route	-	Provide a 4' wide min. firm, stable and slip resistant route to the equipment storage shed, the boundary of sport activity, and to the second team seating dugout with a 5.00% max. running and 2.00% max. cross slope at baseball. (Cost based on a 4' wide min. x 60' path.)	1	1920	\$1920

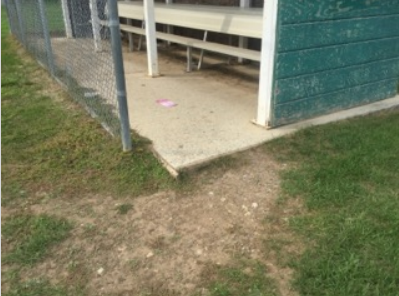
ID	Location	Floor	Room	Element	Type	Photo	Issues	Current Measure	Recommendations	Quantity	Price	Cost Estimation
34	Baseball Seating 2	Ext.		Field	Baseball

Not connected to an accessible-route	3"	Reduce change in level to 1/2" max. (Cost based on a concrete patch.)	1	256	\$256
35	Batting Cage	Ext.		Field	Baseball

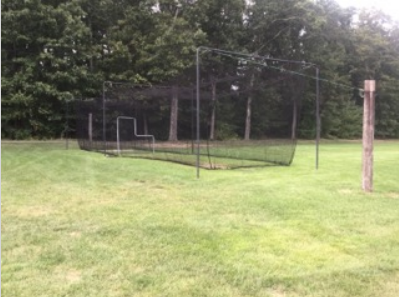
Not connected to an accessible-route	-	Provide a firm, stable and slip resistant accessible route to the batting cage entry with a 5.00% max. running and 2.00% max. cross slope.	1	960	\$960
36	Right Side of Soccer Field	Ext.		Field	Soccer

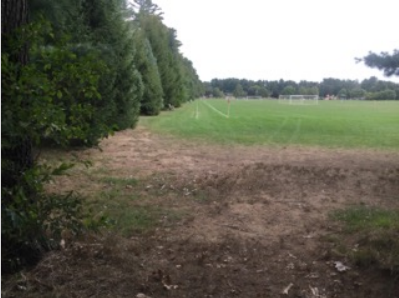
No accessible route to all areas of sport activity	-	Install an accessible route with a 5.00% max. running and 2.00% max. cross slope between the existing path and boundary of sport activity at the soccer field. (Cost based on a 4' wide min. x 60' long path leading towards the benches and the resumed accessible path.)	1	1920	\$1920
Best Practice
