March 3, 2022

Re: Important Wildlife Habitat Features Mapping and Supplemental Restoration Plan Sudbury to Hudson Transmission Reliability Project Sudbury, Massachusetts
SWCA Project No. 00678949-000-AMH

# SUDBURY, MA Wildlife Habitat Features Map

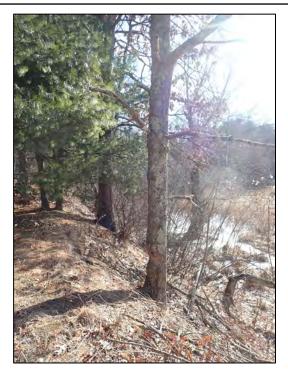
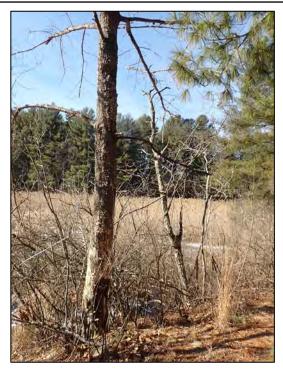
**Photo #1**: View of two significant snags located within Wetland Impact Area 5. Both snags are located near the southern bank of Hop Brook. Considering the diameter of the tree, the height, and location, these snags were identified as significant. *Facing southeast and southwest*.

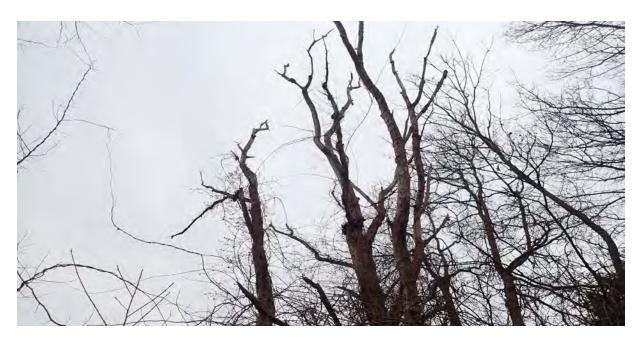
**Photo #2:** View of snag located within Wetland Impact Area 20. There are four dead trunks connected at one base and therefore identified on the map as one significant snag. Each of the trunks is approximately 10" dbh or greater and contains woodpecker holes. The snags are very tall and located near a wetland area. *Facing west*.

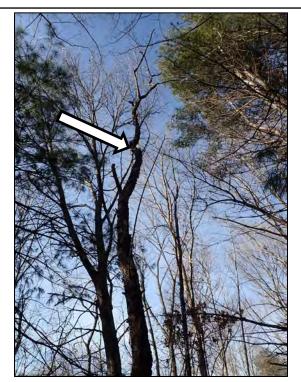
**Photo #3**: View of snag located within Wetland Impact Area 6. The snag is tall and shows signs of bird use. Facing west.

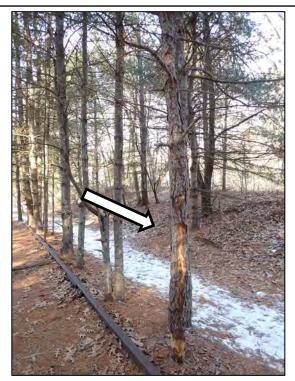
**Photo #4**: View of snag located within Wetland Impact Area 3. Snag is a pine growing along the Rail Road bed. *Facing west*.

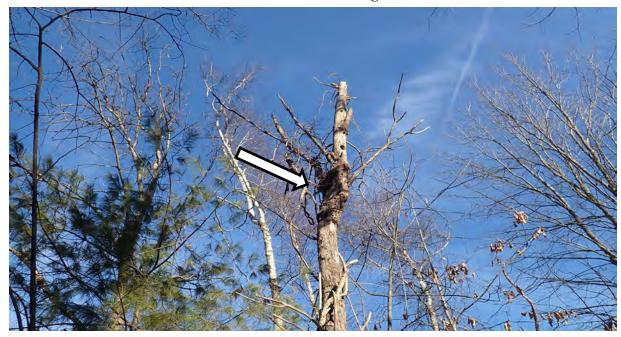
**Photo #5:** View of snag located within Wetland Impact Area 15. Snag is estimated to be greater than 10" dbh, has at least two visible cavities and a nest at the top of the tree. Asian bittersweet has engulfed the snag. *Facing northeast*.

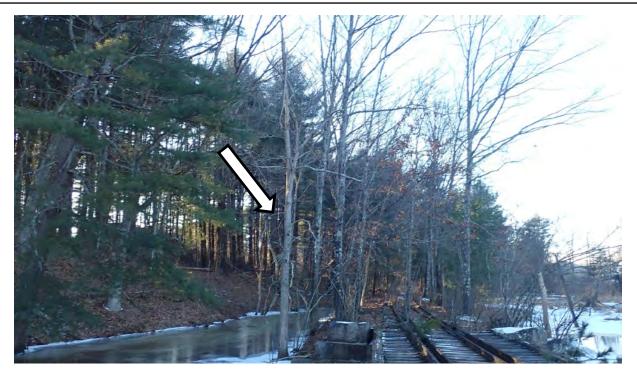
**Photo** #6: View of a snag near edge of the water within Wetland Impact Area 17. Snag has branches that are overlooking the water. Eversource will work with the contractor to determine if the snag at the edge of the impact area can remain. *Facing northwest*.

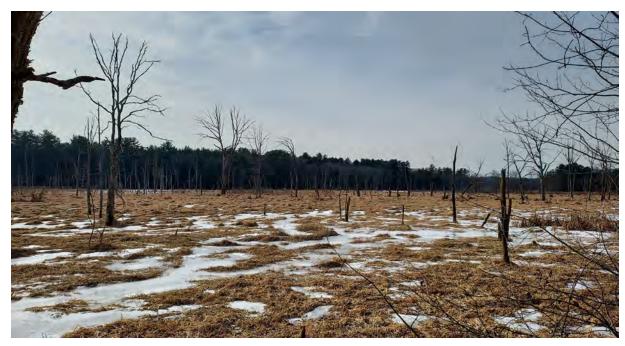
**Photo #7:** View of snags located outside the Wetland Impact Area 17 and 18, at the Hop Brook crossing. Many snags are available within the resource area that are more suitable for perching and nesting, due to their location. These snags will not be impacted by the project. *Facing south*.

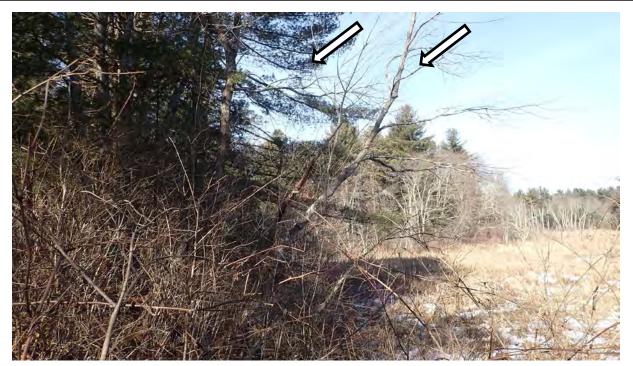
**Photo** #8: View of overhanging tree examples in Wetland Impact Area 4. Tree or tree limbs that overhang a wetland or waterbody have been identified. *Facing northwest*.

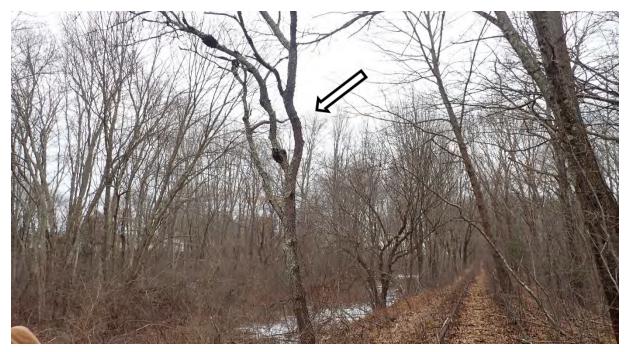
**Photo #9:** View of overhanging tree located just on the edge of Wetland Impact Area 19. Tree has branches overhanging a wetland (located downgradient on the left). Eversource will work with the contractor to determine if overhanging trees at the edge of the impact area can remain. *Facing west.*

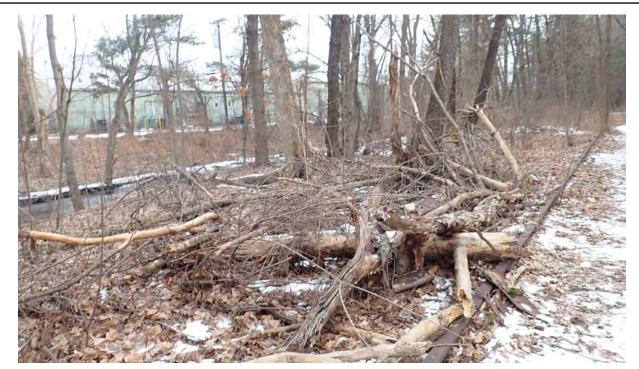
**Photo** #10: View of large woody debris/ brush pile located within Wetland Impact Area 16. *Facing northeast*.

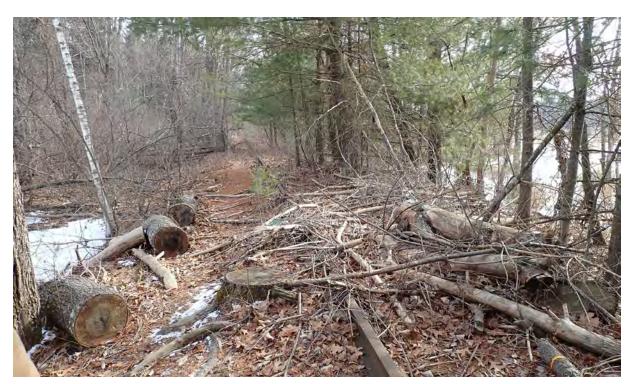
**Photo #11:** View of large woody debris/ brush pile located within Wetland Impact Area 19. The brush pile appears to consist of a downed pine tree that was cut up and left in pace. *Facing east*.

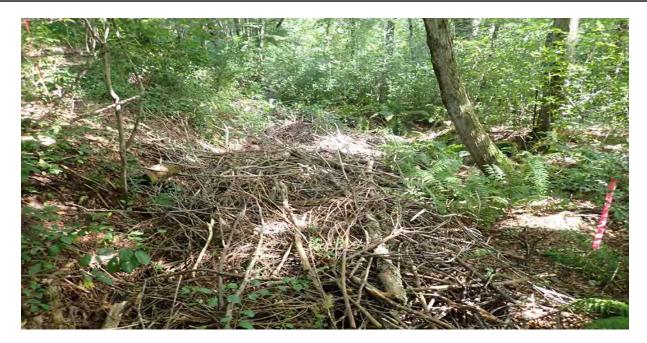
**Photo** #12: View of brush pile located outside Wetland Impact Area 8. Brush pile will remain and continue to provide wildlife habitat value. *Facing east*.

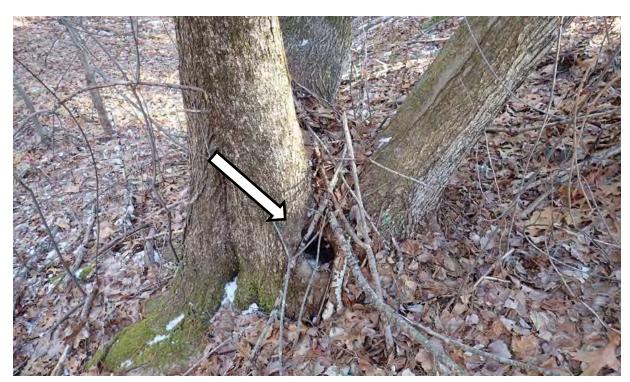
**Photo** #13: View of cavity in a live tree located along the southern side of Wetland Impact Area 11, within the Wetland Impact Area. Eversource will work with the contractor to determine if trees at the edge of the impact area can remain. *Facing north*.

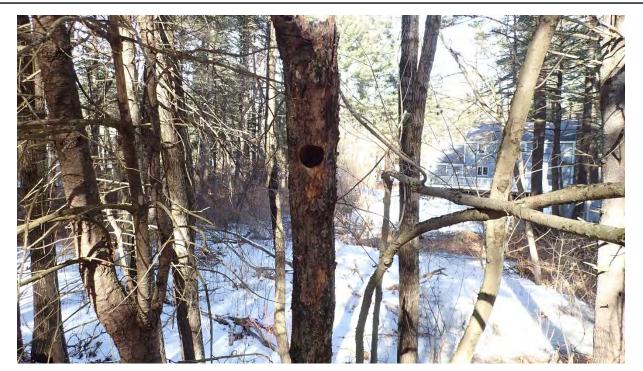
**Photo #14**: View of cavity in a snag within the Wetland Impact Area 9. Facing north.

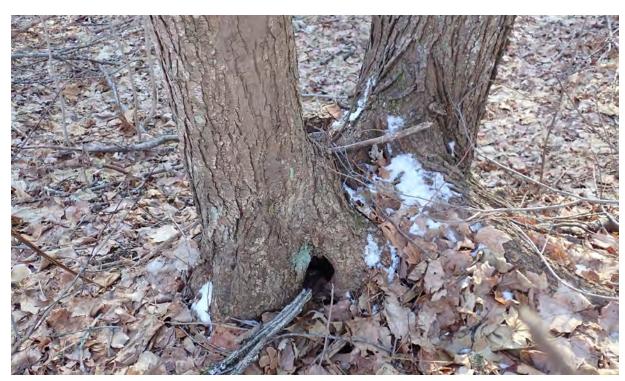
**Photo #15:** View of cavity at the base of a live standing tree in Wetland Impact Area 16. Facing north.

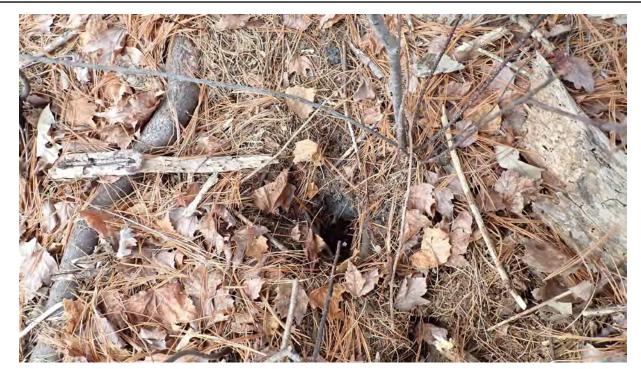
**Photo #16**: View of small mammal burrow located within Wetland Impact Area 18. Facing west.

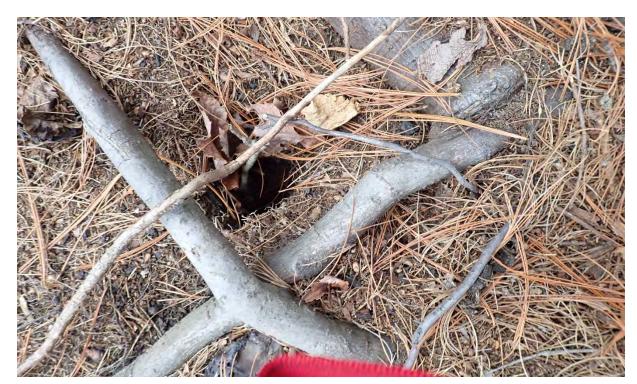
**Photo #17:** View of small mammal burrow within Wetland Impact Area 18 near the bank. Facing west.

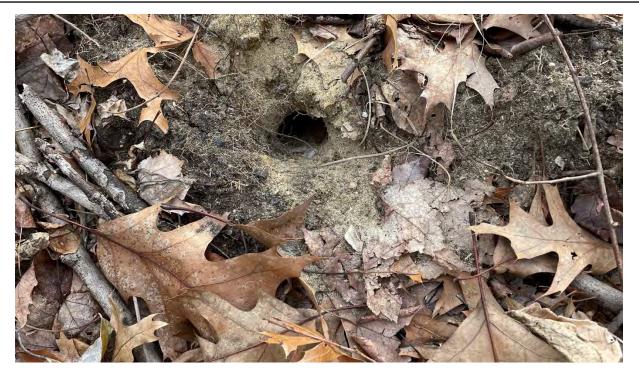
**Photo #18**: View of small mammal burrow located within Wetland Impact Area 19. Facing west.

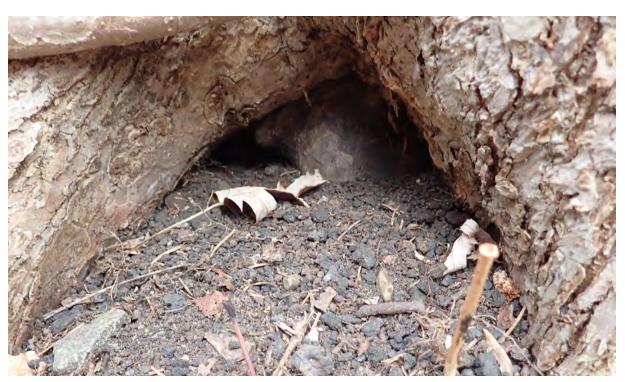
**Photo #19:** View of small mammal burrow within Wetland Impact Area 16 at the base of a live tree trunk. This particular tree also contained several small cavities that could potentially be used by small mammals. Facing north.
