**WATER & WETLAND**  
LAKE, POND & WETLAND MANAGEMENT

## FIELD NOTES SUMMARY

**Customer:** Hop Brook Protection Association  
**Pond Name:** Carding Millpond, Grist Millpond, Stearns Millpond  
**Site Location:** Sudbury, MA  
**Date:** 8/1/24

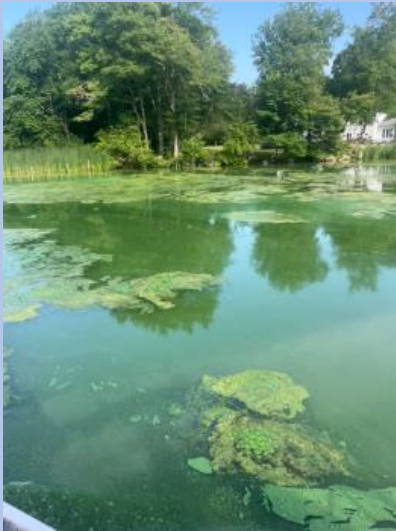
**Photo 1 - Grist Millpond**

Grist Millpond contained sparse densities of water chestnut, though the majority of the plants noted were found near the outlet and the boat launch. Only a handful of plants were located near the inlet. Dense mats of filamentous algae were observed in the middle of the pond, and the water was bright green due to what visually appeared to be a dense microscopic algae bloom. Water clarity was extremely low. The treatment went well, and we anticipate an extremely high level of control.

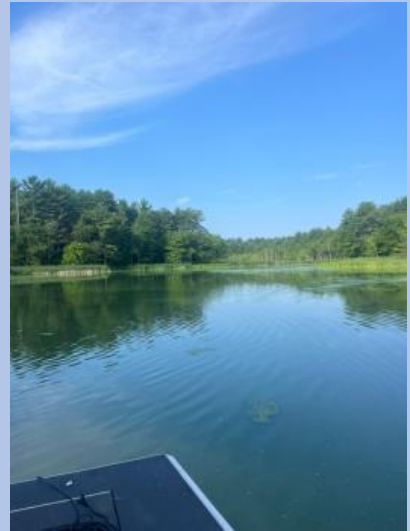
**Photo 3 – Carding Millpond**

Carding Millpond contained scattered patches of water chestnut plants in low densities throughout the entire water body; however, the densities of plants were greatly reduced compared to the conditions documented during/immediately prior to the last treatment. There was also an algae bloom present at Carding, but this bloom appeared to be less dense than Grist Millpond. The treatment went extremely well.

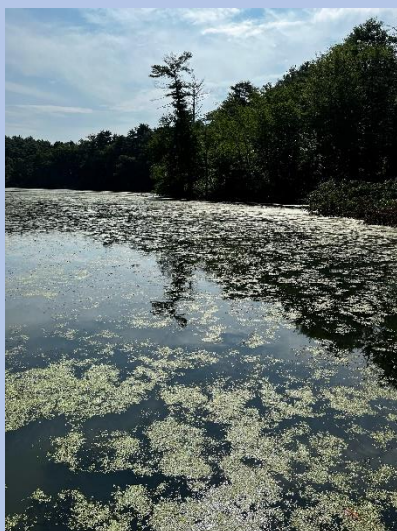
**Photo 5 – Stearns Millpond**

Stearns Millpond also had an algae bloom that discolored the water. Water chestnut in Stearns was scattered in smaller bunches throughout the waterbody. Based on the densities in Stearns Millpond, hand-pulling was also incorporated with the treatment. Navigation in Stearns was especially challenging due to dense vegetative mats, although this was manageable.
