FIELD NOTES SUMMARY

Customer: Hop Brook Protection Association
Pond Name: Grist Millpond
Site Location: Sudbury, MA
Date: 6/30/23

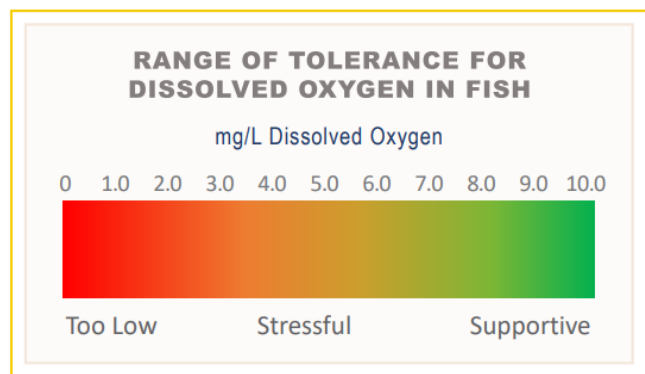
While on-site, dissolved oxygen (DO) and temperature readings were collected using a calibrated YSI meter with optical sensor. Dissolved oxygen is the amount of oxygen in water that is available to aquatic organisms. DO is necessary to support fish spawning, growth, and activity. Tolerance varies by species, but the figure below provides a general range of fish tolerance (Source: epa.gov). Dissolved oxygen can

be affected by many outside factors, such as: temperature, time of day, and pollution. Dissolved oxygen levels are typically lowest early in the morning. Healthy water should generally have concentrations of about 6.5-8+ mg/L.
