FIELD NOTES SUMMARY

Customer: Hop Brook Protection Association

Pond Name: Stearns Millpond

Site Location: Sudbury, MA

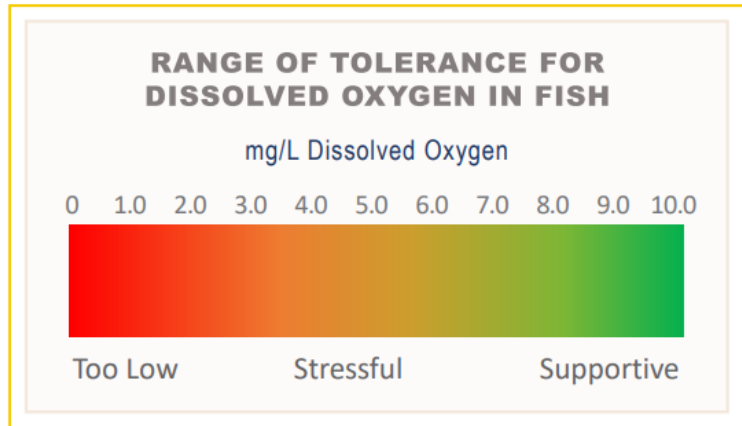
While on-site, dissolved oxygen (DO) and temperature readings were collected using a calibrated YSI meter with optical sensor. Dissolved oxygen is the amount of oxygen in water that is available to aquatic organisms. DO is necessary to support fish spawning, growth, and activity. Tolerance varies by species, but the figure below provides a general range of fish tolerance (Source: epa.gov). Dissolved oxygen can be affected by many outside factors, such as: temperature, time of day, and pollution. Dissolved oxygen levels are typically lowest early in the morning. Healthy water should generally have concentrations of about 6.5-8+ mg/L.

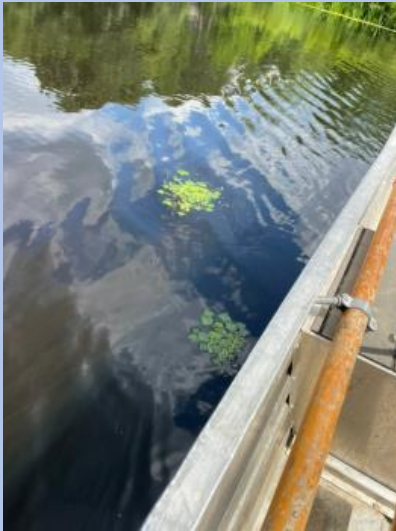
Photo 1

Upon arrival, water chestnut could be seen in various locations in low densities throughout the pond. Some of the water chestnut was covered and/or surrounded by duckweed and filamentous algae, thus hard to see. Elodea was also present in high densities throughout the pond and topped out throughout the majority of it. Additional, curly leaf pondweed was present and mature at the time of the visit. Stearns Millpond also has a large population of bluegill and other sunfish species, as well as, large mouth bass. This is typical of this type of ecosystem in the northeast; however, there were some large specimens observed during the visit. Along with the fish species, eastern painted turtles and snapping turtles were also observed in the pond. This treatment took more time than the other two ponds due to the lower density, thus seeking out patches, plants, and hard to find water chestnut mixed within other species.

A treatment was conducted for the control of water chestnut. The liquid herbicide, Clearcast (imazamox), was applied using the most appropriate boat, equipped with a calibrated pump, which is used to target the water chestnut plants via foliar application methodology. This method allows for even and precise coverage. Weather was also closely monitored prior to treatment to ensure a treatment date without rain or high winds. The treatment was rescheduled from 6/30/2023 due to the previous forecast.
